Restoration of Bulle Clock Serial Number 11536.

This restoration by courtesy of the owner.

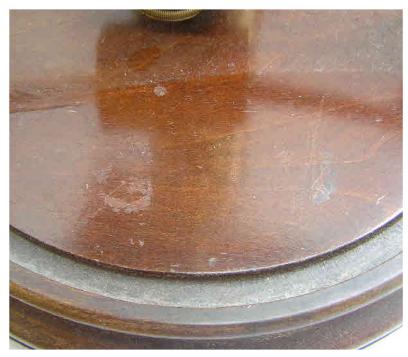
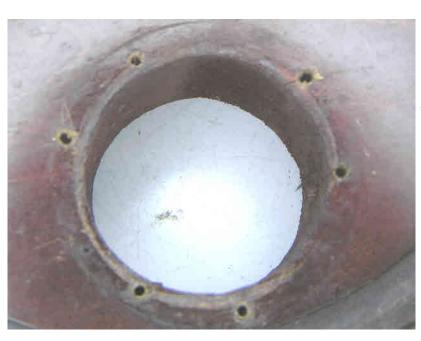
abrasions and dents. It is just a little to far gone for a clean and a coat of wax so it will be cut back and French Polished. But I'll keep as much of the character as I can by only removing the polish and leaving as much of the surface colour and patina as possible including the lumps and bumps. A worrying aspect can be seen when the main frame of the clock is removed. Note the six screw holes when the column only has three! This mean that the clock has been apart sometime in the past and for some reason it was decided to move the column ring around. Maybe there is a broken screw in the wood somewhere. Either way it

means there may be other problems ahead.

The Base is somewhat tired with various

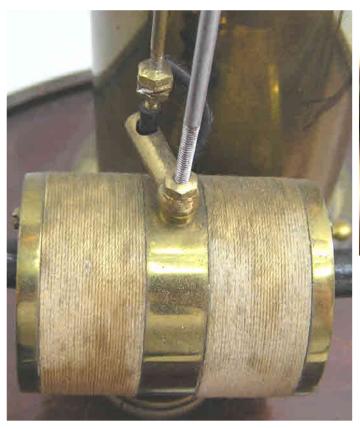
There are some problems here. The first photo shows the state of the pendulum bob. The wire is sleeved in modern plastic so the coil has probably been messed with. The cord is discoloured, stained and very brittle where the darkest areas are. It may have had some solution dropped on it at some time. Another one of those decisions to be made as to whether it will survive cleaning. We'll see.

The tube has battery acid burns which in some cases have burn through to the outside, but I don't think it is that bad. They certainly don't look as though they are much more than pin holes. There should be enough material left to take the cleaning but some marks are inevitable on the outside when cleaned and polished. The last photo shows the magnet support pillars that sit in the wooden base. They have been hammered flat for some reason. Probably to make them a tighter fit in the holes. They will have to be sorted out before the washers can be removed.

The magnet is a big giveaway. I've just checked it and it has only North and South Poles. So someone has re-magnetised it but did not understand the working of a Bulle.

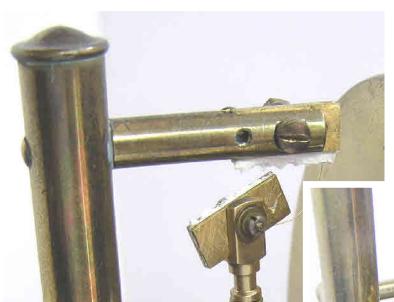
The suspension is broken as usual but the rest of the assembly looks complete bar the two blued steadying screws. which will have to be made.

The photo at right e shows the movement, dial and hands in situ and all look to be in good order. Nothing seems to be missing.

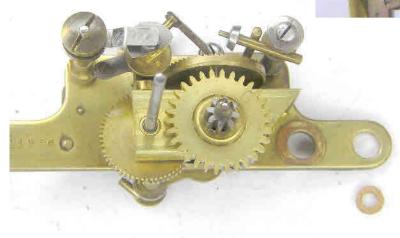
This is interesting though. When the movement was removed from the frame the outside holes which hold the dial support pillars and much bigger than need to be and have fibre spacers inserted. They look original so it may be that this movement was intended for another role.

Oh dear. The pawl arbour seems to have a small problem. It is in two pieces. The main part has been drilled out to accept the end piece which must of broken off when the pallet assembly got stuck when it was being removed. This type of break is typical when the assembly is forcibly removed. If the proper tools are not used then undue pressure is applied to one side of the arbour and, being hardened steel, it snaps.. We shall have to see what can be done here. The repair is not a bad one and may be re-usable.

The fork contacts are well worn and will be replaced.

The last two photos show the coil and it's wiring. It can be seen that it has indeed been removed and modified in the past. On end has been soldered to the spacing tube instead of being wrapped around it. The other end has been lengthened by soldering a new piece of wire on. But the joint has been left open!!. These modifications will be removed and replaced with new wire and sleeve. Luckily the coil reading is a good 1140 Ohms

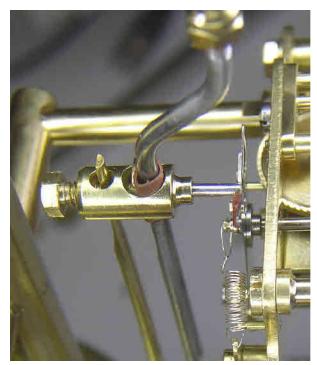
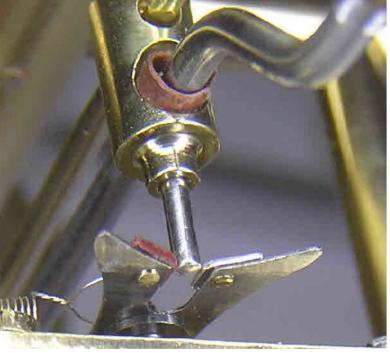
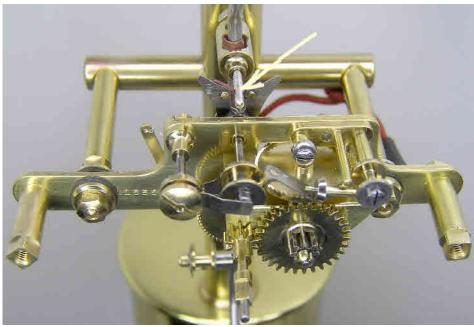
The photos above show that the contact pin is having great trouble reaching the fork. This was not noticeable when the clock first came in as the suspension was broken. How this could possibly have worked I do not know. The contact pins for Bulle's are different lengths depending on the model so, I'm guessing that the original must have broken and been replaced at some point. The photo at left shows the finished movement and replacement contact pin. (arrowed).

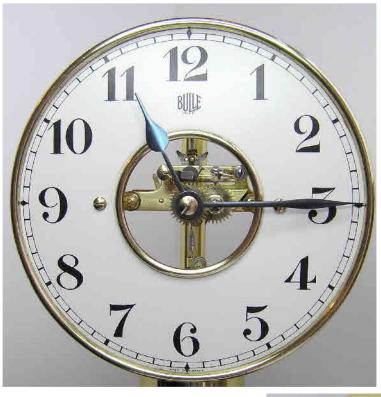
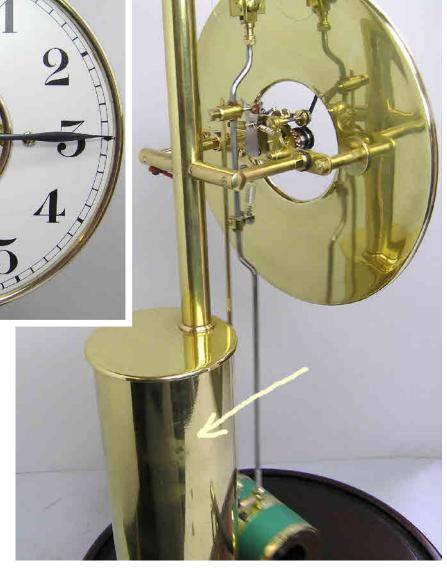
The cleaned and finished dial. Not much work was needed here other than the brass being cleaned and the dial washed in soapy water. The hands just needed a coat of was and a good buffing. The photo at right shows the back of the column where some of the battery acid burns have come through to the outside. They are not too bad and show only as pin holes on a dull area.
