Restoration of Bulle Clock Serial Number 125374.

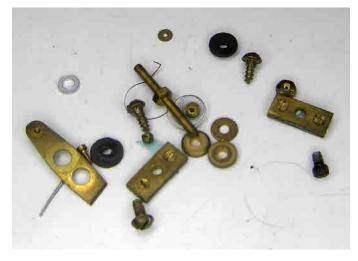
The photo above shows the bag of parts supplied with the clock.

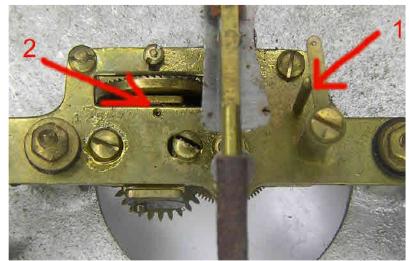
The photo at top left shows a small threaded hole immediately under the count wheel (2). This should have a long thin banking pin screwed in here that restricts the swing of the pendulum to the left. It's twin brother can be seen on the right hand side (1). This will need to be replaced.

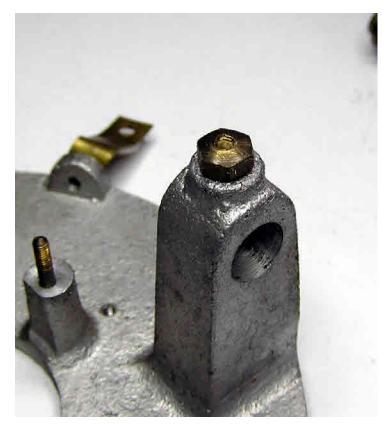
The next photo shows one of the insulating washers covered in oil. Most of the clock was saturated with the stuff. All this will need to be removed. Some washers are of fibre and these will need to be cleaned very carefully. Either that or replaced.

The final photo at left shows the right hand magnet retaining screw that is broken just below it's head. This will be replaced.

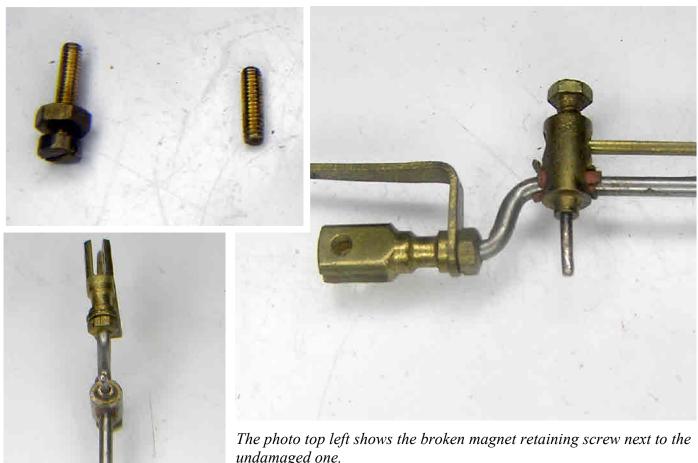
The pendulum at left is bent at the top suspension bracket..

The contact pin is also bent and will need straightening.

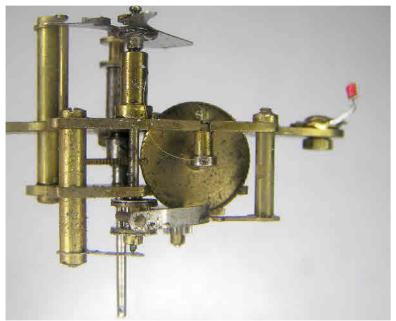
The top left photo shows the general state of the movement. Very heavily contaminated with old gummy oil. Under the movement (above) is a hardened steel plate which acts as an end stop the the vertical count wheel arbour. The style on this clock is wrong as it is normally of a smaller thicker steel with two screw holes. We'll soon find out when we removed it..

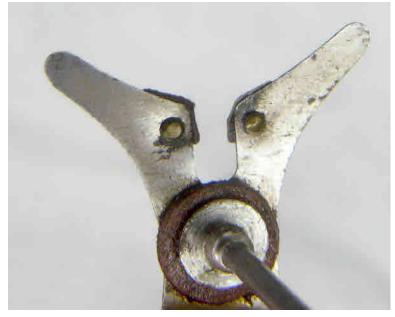
The fork is well worn as can be seen at left. Both contacts will need replacing. If the clock was not so contaminated with oil then the fibre looks as though it would have been good enough to keep as there is not much ware evident.

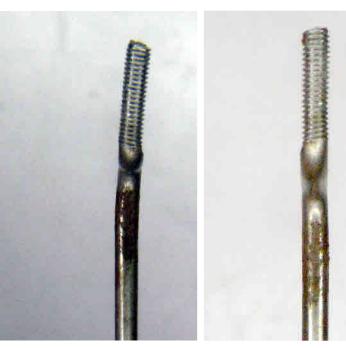
These two photos show the top of the pendulum rod before and after straightening..

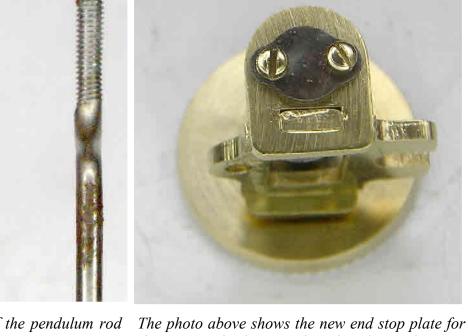
the photo above shows the new end stop plate for the count wheel. Note that this design has two screws. The original plate must have gone walkabout at some time in the past and a plate from different movement used as a replacement.

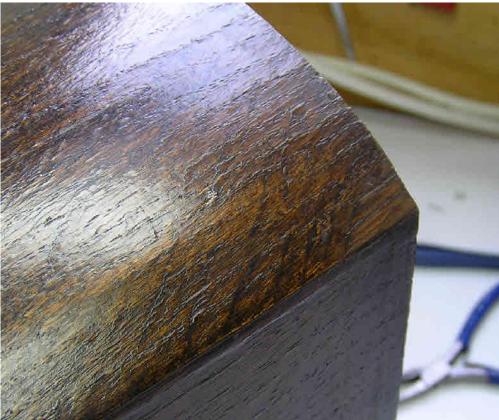
The photo at top left shows some of the replacement parts.

Top right shows the new pendulum contact assembly plate in position. The original had been cut in half for some reason?

The last photo shows the top of the case with the small veneer insert coloured to match the existing wood.
