Restoration of Bulle Clock Serial Number 180859.

Horologix

—Early Battery Clock Parts & Restoration

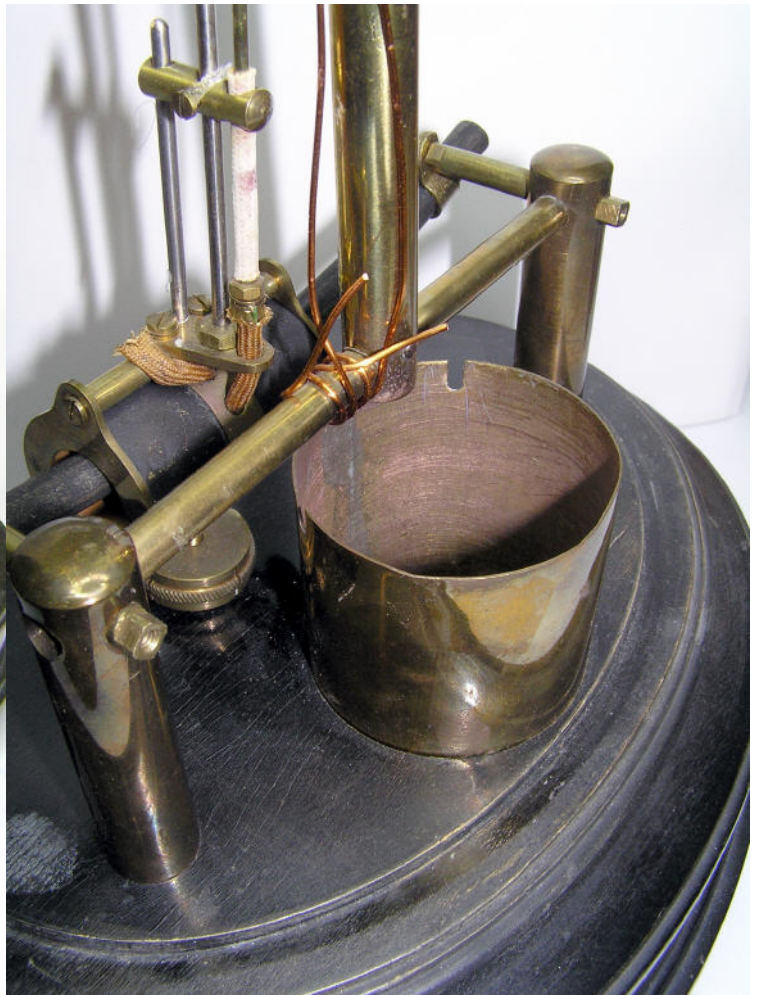
The most obvious problem at first glance is the cap of the battery tube is missing. This will need to be manufactured. Note also the copper enamelled wire used to connect the battery to the movement. This will be discarded and replaced by new cloth covered wire

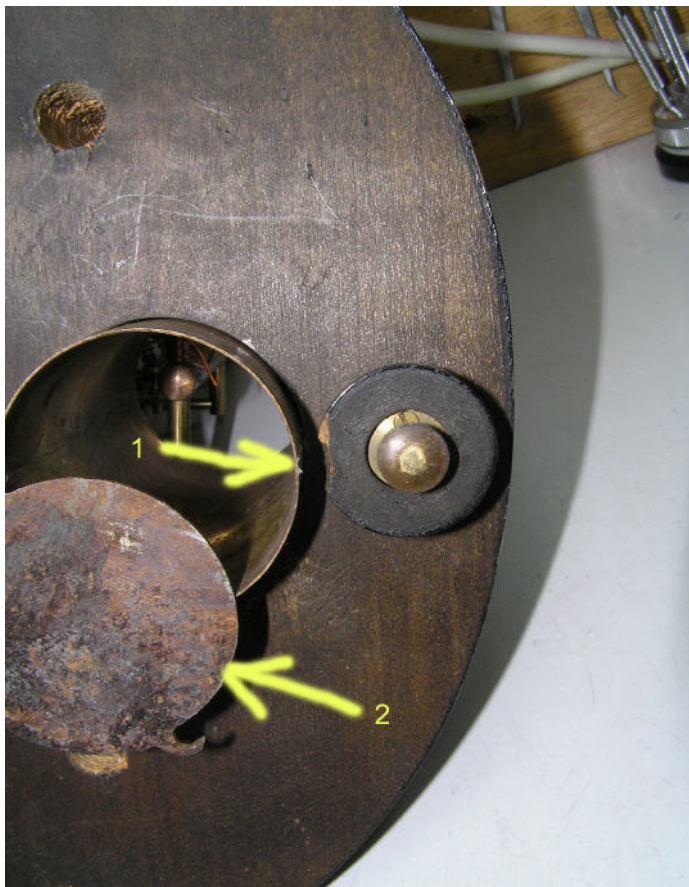
This photo shows the badly rusted battery door (2) under the base. Hopefully there is enough metal left to restore. These clocks have the battery compartment made of a brass tube very similar to the tall movements under a dome except that the tube is actually pushed through and embedded in the black wooden base. The top carries a brass cap which we know is missing. The bottom protrudes by about a half inch and has two small brass threaded rounds soldered to the side to accept the door screws. One of these is missing on this clock (1).

The steel battery cover has been cleaned of all rust and sprayed black. The cover is heavily pitted but still usable. The new threaded tube can be seen in place with matching dome head screw. You may just notice that sometime in the past a couple of pieces of brass shim have been forced between the battery tube and the wood. This was probably to stop the tube from falling out of the wood base. The tubes are only held by friction and so must be a good tight fit in the hole. There was also some fracturing of the end of the tube.

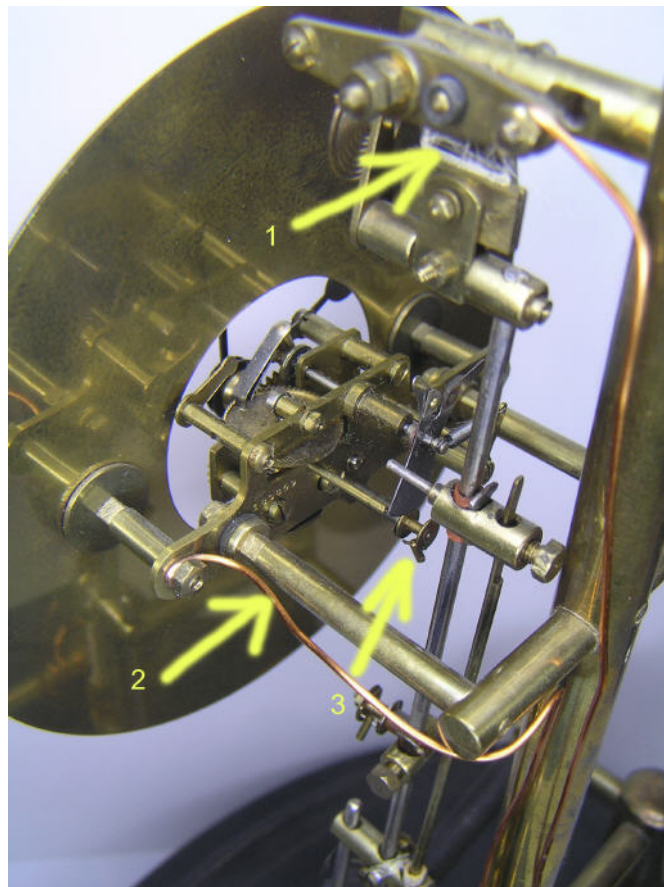
The suspension can be seen to be broken in this photo (1). A new one will replace it. The copper enamelled wire mentioned earlier is shown at the terminal ends on the movement (2). There seems to be a problem here with the Isochron bracket attached to the movement. On closer inspection the threaded end of the arbour seems to have been snapped off (3) with the loss of the nut and first steel washer. This will need to be manufactured.

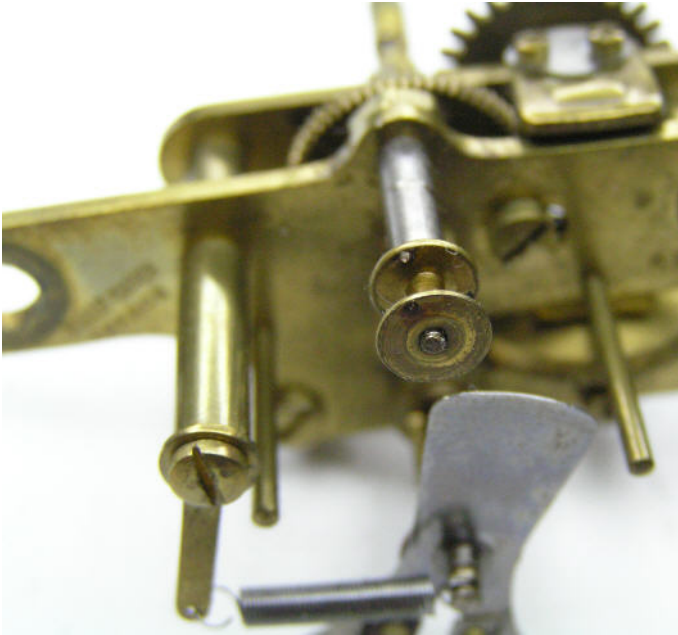
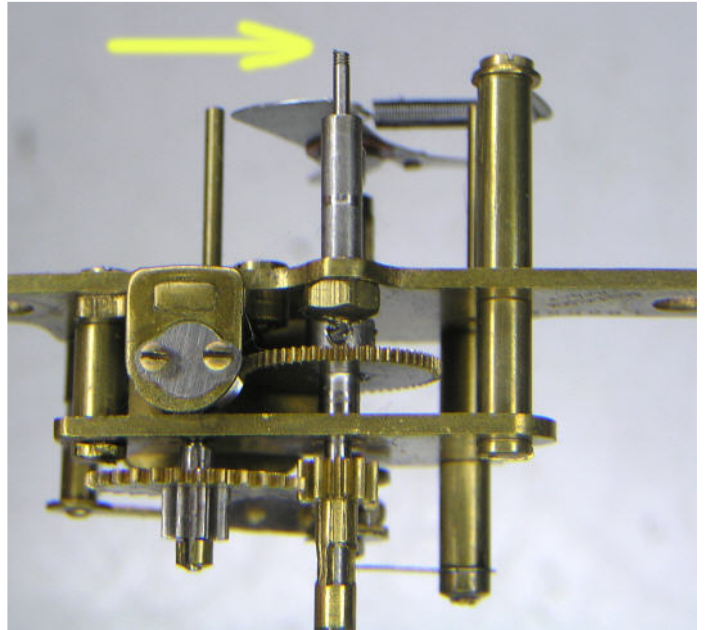
The broken Isochron arbour can be seen more clearly in these two photos.

The new Isochron bracket arbour in place.

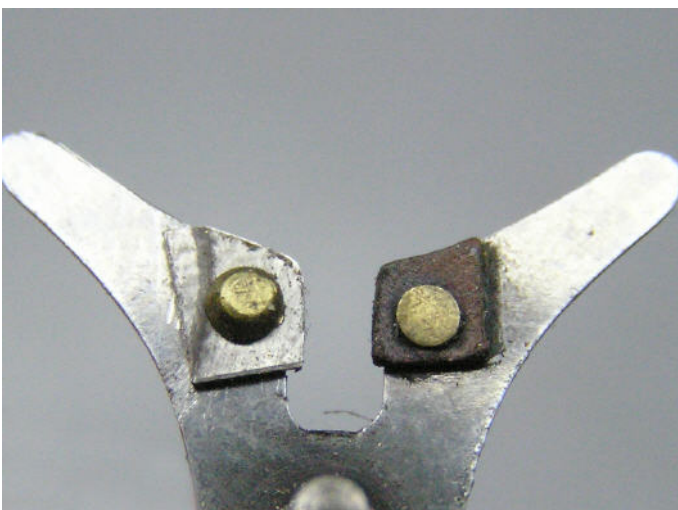
The silver fork contact looks to be a later replacement. Notice the domed rivet head. It contrasts with the normal flat head rivet. It also seems to have suffered from a blow with a hammer or stake. The fibre insulator seems as though it is impregnated with oil. Both will need to be checked carefully .

The fork contacts proved to be oil soaked and unreliable so the opportunity was taken to replace them. This procedure has been shown already in previous restorations so I won't go into detail here. The other problem with this particular fork was that the silver stub at the end of the arbour was also loose. It was removed, cleaned and reshaped slightly to be a much tighter fit so that good contact was made between it and the arbour. This silver stub holds the loop of the Silver Contact spring.

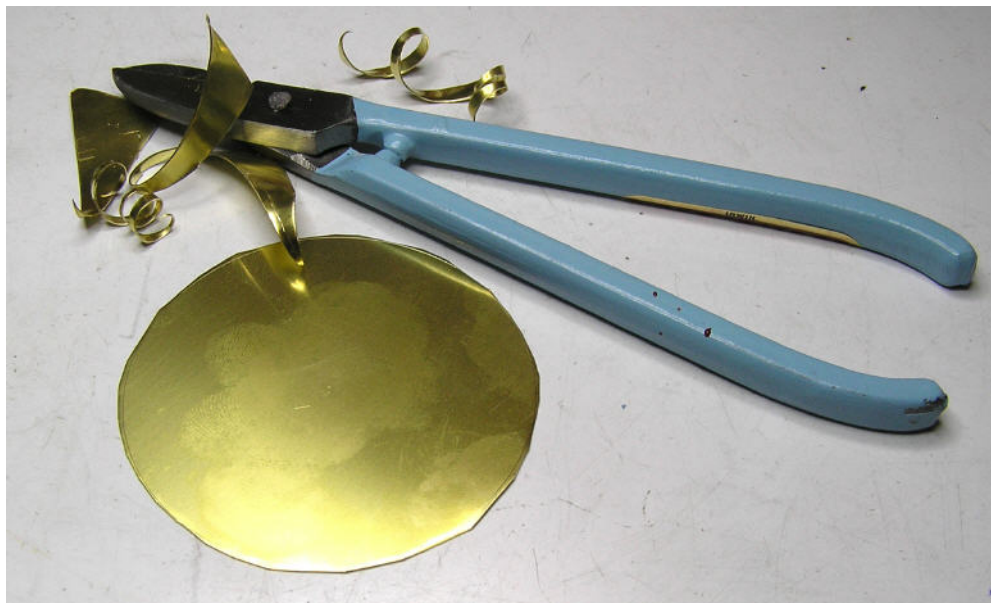
The replacement cap poses a bit of a problem. The originals look as though they were spun rather than punched. After measurement they turn out to be made from 0.50mm brass plate with an internal diameter of 53.00mm. The first stage in manufacturing the replacement is to procure the material and roughly cut to shape. The lip extends for 4.00mm. Therefore allowing another 1.00mm for

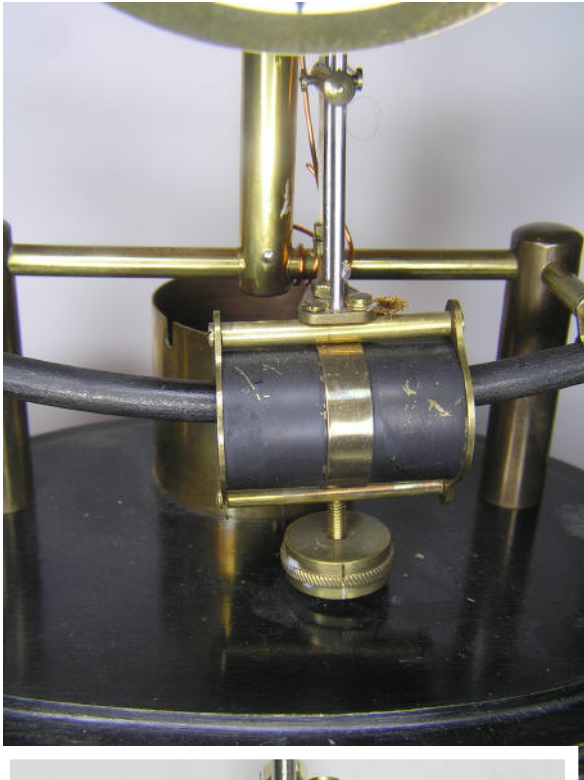
The bob was dismantled completely and the coil checked. It was still in good condition and showed 1190 Ohms.

The bob shell was in need of some attention as can be seen at the top left. It was cleaned and sprayed black. Only the brass parts of the pendulum bob itself were lacquered. .

The pendulum assembly before and after.
