Restoration of Bulle Clock Serial Number 201191.

Horologix Early Battery Clock Parts & Restoration

Bulle Clock Serial Number 201191. (By kind permission of the owner)

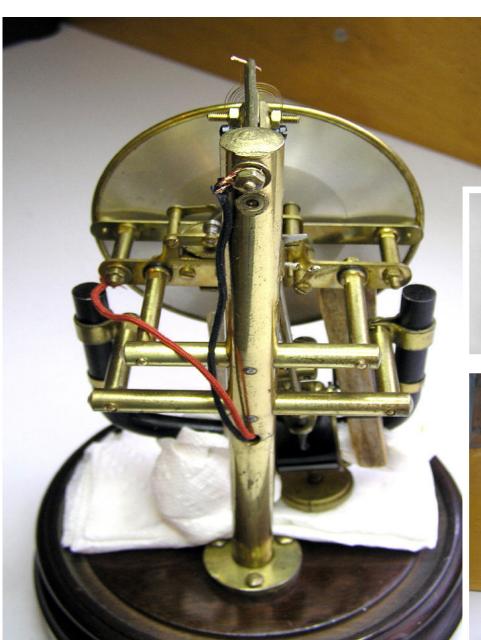
The clock has at some stage been subject to excessive oiling as can be seen in the oil soaked insulating bushes which will now need replacing. The movement also seems to tilt at an odd angle?

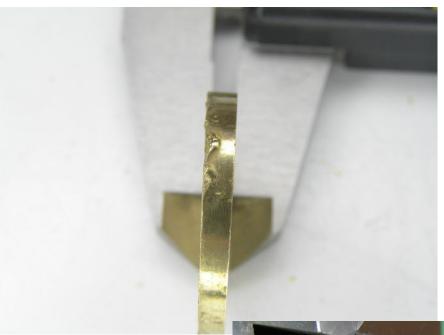
The thick spacer under the column turned out to be wedge shaped and pretty battered as can be seen in the photos. I hope you can see that the spacer thickens as it reaches the damage. The thickness was measured at 3.1mm on one edge and 3.55mm on the opposite side. No wonder the column leaned out at an angle. Fortunately all the damage was on one face only.

The opposite face was clean and square. So I mounted it on a mandrel in the lathe and resurfaced it parallel..

I also machined the perimeter to remove the bruises..

The resurfacing took off 0.5mm, so the thickness is now an even 3.0mm. We'll have to reassemble the column to make sure there is still enough height for the pendulum to swing freely.

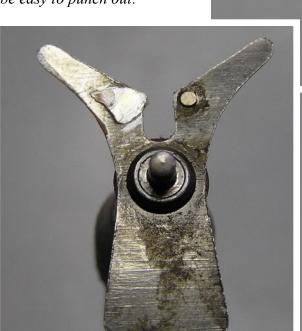
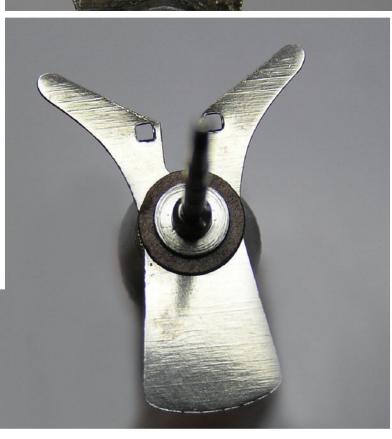
The bottom photo shows the fork after the rivets have been removed using the Staking set. The whole fork and arbour have been cleaned and polished ready for the new contacts to be riveted in place. Note how the original holes were square punched when manufactured.

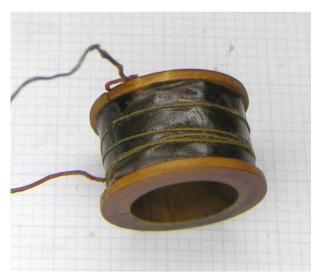
As can be seen from the photo on the right, the coil seems to be dead, in that I could not get a resistance reading at all. After checking all other possibilities (including the meter) it must be assumed that the coil has a break somewhere in its windings. The probable areas are the joints where the 42 gauge wire is soldered to the heavier gauge contact wire. Hopefully this will be at the outer end and not the inner!

Thankfully the former was the case and it is an easy job to clean and re-solder the connection.

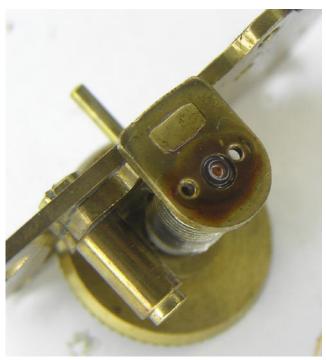
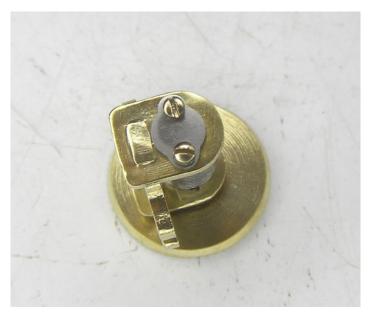
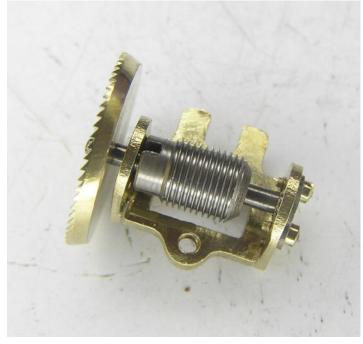
The photo below shows the state of the count wheel assembly. It was thick with oily sludge. The photos at right show the the same assembly after cleaning. The clock coil and magnet must have had a hard job trying to overcome the drag created by this mess.

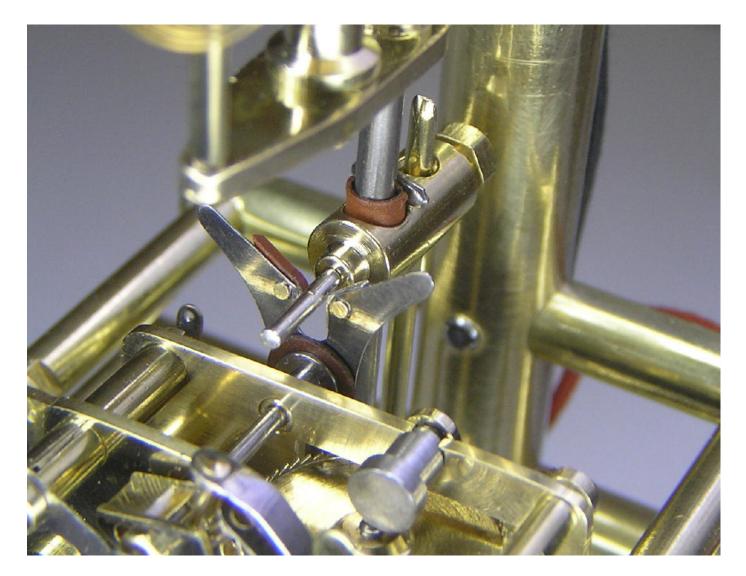
The clock, finished. The next two pages show the completed clock. It is now keeping good time. This photo shows the repaired fork and contacts, once again performing good service as they were originally designed to do. The silver pin shows a score mark which was probably caused by the sharp edge of the fork when it was left to start its cutting action after the silver contact on the fork was partially worn away. The contact assembly was re-assembled with the clean un-worn side of the pin at the bottom.
