Restoration of Bulle Clock Serial Number 313749.

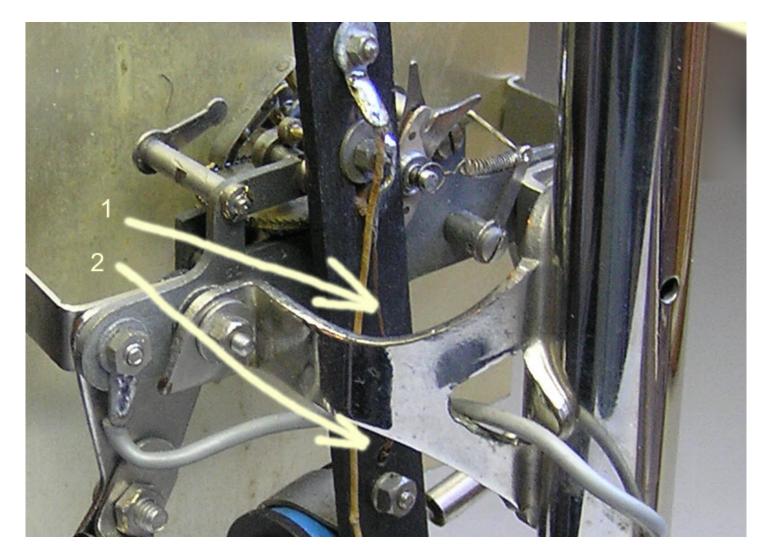
This photo shows the lead (1) from the coil to the contact pin is completely bare and devoid of insulation. The cable passes from the front to the rear of the wooden pendulum rod though a small hole (2).

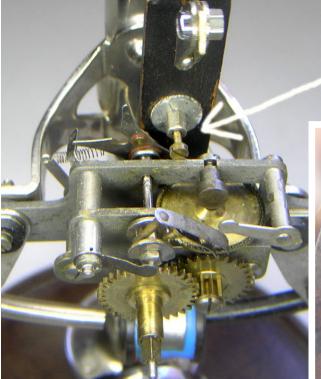
The contact pin has been replaced with a brass screw!!! They could have at least trimmed the head off before using it. The body of the fitting that passes though the pendulum rod has been butchered during this process. The thread has been stripped. A new body will need to be manufactured.

The new parts for the contact pin assembly ready to be attached. The body of the assembly has been threaded to accept the new silver contact pin.

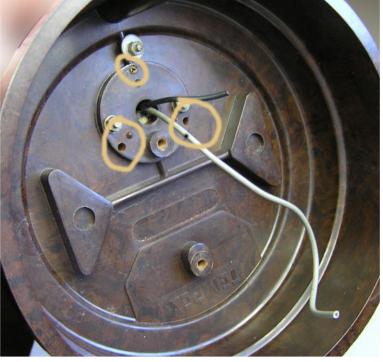
The photos left and above shows the three extra holes (circled) in the bakelite base. The column is now offset with only a third of the hole up the column visible from underneath. It is only by luck that the holes are not visible from the top when the column is in position. The wide base of the chromium plated column extends over them as can be seen from the dark area in the photo left. I have no idea why it was done.

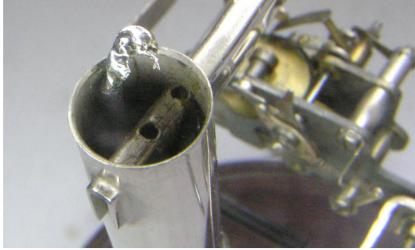
These two photos show one of the reasons the clock failed to run. One of the battery wires was soldered to the inside of the column. Unfortunately it was a dry joint as can be seen in the second photo. It just lifted off when the wire was waggled from underneath. The best place for this wire to be attached is underneath the Bakelite base using one of the column securing nuts and bolts that are easily accessible.

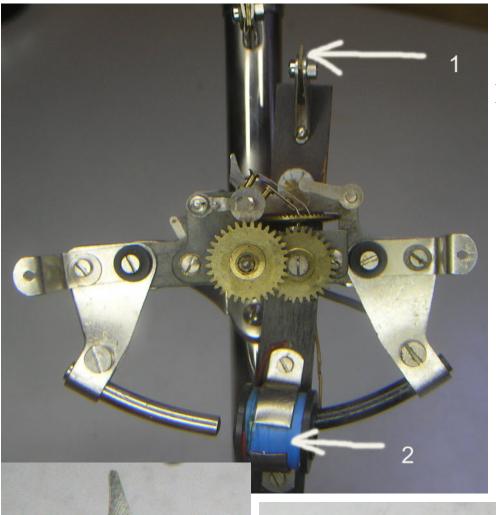
This photo shows the broken suspension spring and how it has been clamped by over tightening the nuts on both the pendulum and frame mounting points (1).

The coil can be seen clearly in this photo. It has been wrapped in blue insulation tape which leaves a sticky residue on the coil and will tend to lift the wire if it is not removed very carefully. (2).

The lower two photos show that threaded end of the fork arbour had been broken off at some time in the past. Probably due to prizing off the pawl assembly with a screwdriver. A new hole had been drilled in the end of the arbour and the threaded end inserted.

There is nothing wrong in this type of repair other than the wrong adhesive used. So I will clean it and reattach with Loctite 603.

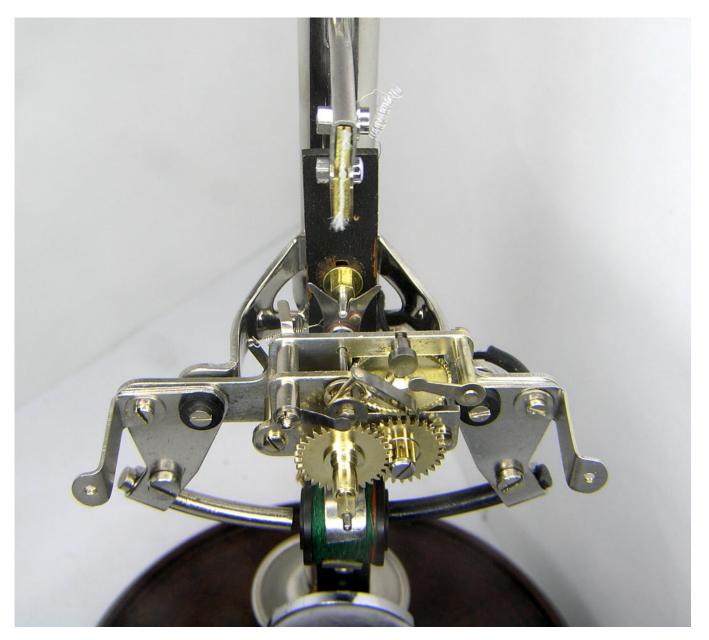
The finished movement with the new contact assembly in place, The new suspension can also be seen. The frame had to be manipulated carefully to it's original dimensions for the suspension to fit. The recovered pendulum coil can also be seen (green).
