# Restoration of Bulle Clock Serial Number 5962.

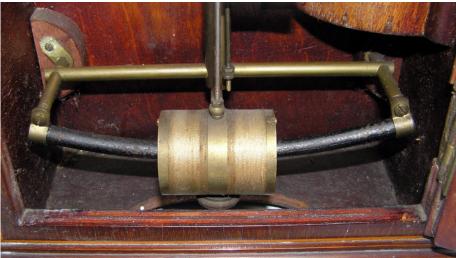
The dial is in good condition with no major marks and will clean up quite well with just some warm soapy water. The dial will be protected by a brass shim cover whilst the surround is cleaned with "0000" gauge wire wool and brass cleaner. The hands are fine but will need cleaning and spraying. They are of exactly the same size and design as those from clock 5937.

The pendulum cord covering look sa bit ropy and is not in such good condition as it's twin 5937. I will check the strength of it and decide whether to replace it.

The magnet is a little rusty in places but will clean up OK and will look good with a little Fire grate Black.

I have subsequently removed the magnet and tested it on the magnetometer and found it a little weak at about 150 mm. So it has been "Zapped" and now gives a 180 reading. Just about right.

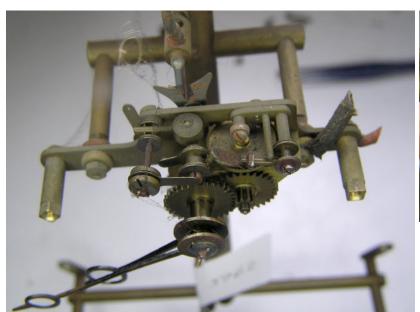
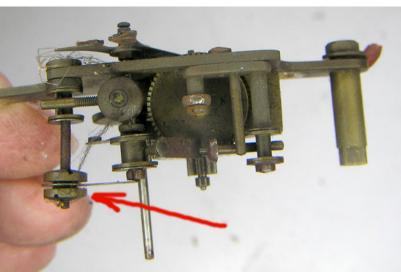
The two photos above shown the general state of the movement. The clock is covered in gummed oil and dust deposits. The lower photo shows the bent arbour that carries the forward stop and the damper arm. This will have to be straightened or replaced.

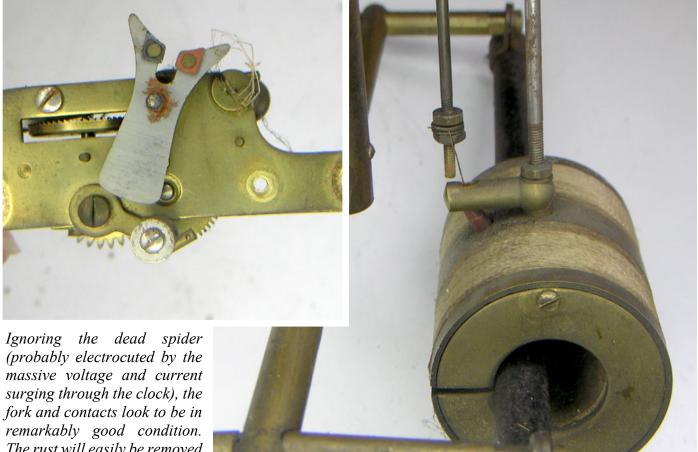
The suspension assembly showing that most of the screws, nuts and washers that are usually missing on these clocks are in fact still in place. The only ones missing are the blued suspension securing screws. More work for the lathe.

The lower photo shows the bent foot at the rear of the frame. This should straighten out OK with a little judicious bending.

(probably electrocuted by the massive voltage and current surging through the clock), the fork and contacts look to be in remarkably good condition. The rust will easily be removed with the soft rotary wire brush. The contacts, although dirty, are dry and free from oil. Both the silver and fibre show little signs of wear. So this is going to be one of those unusual situations where I don't need to replace them. The final check though will be when the clock is set running.

The rear of the pendulum shows the coil contact emerging un-insulated from the rear of the cover. This single strand will need to be clean and strengthened with the addition of a few strands of copper wire. These will be connected within the coil cover. The wire will then be protected by a rubber sleeve that will protrude right the way through the cover and bracket giving full protection and insulation the the wire.
