# Restoration of Bulle Clock Serial Number 7894.

The full restoration of this Bulle with kind permission of the owner.

This Bulle is of the tall A type movement and frame but in a four glass case. The serial number 7894 puts it with the first two years of production.

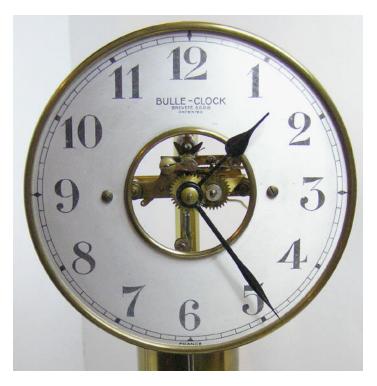
The dial is of the alloy insert type and is is good condition with no large marks. The hands are slightly unusual in that a clock of this age would normally have moon hands.

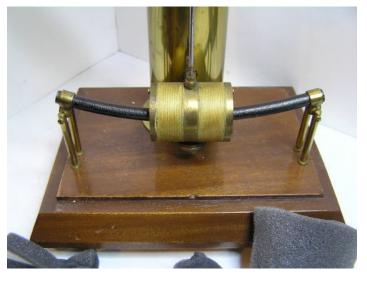
The woodwork of the top and bottom are pretty good and will only need a good waxing with maybe a bit of colour to revive the existing patina. The cord around the coil though is a different matter. On closer inspection it was found to be as dry as parchment and flaky when touched. So, unfortunately this will need to be replaced as it won't stand up to being handled in any way. The back has already been glued down with some form of superglue.

The coil itself read a healthy 1190 Ohms..

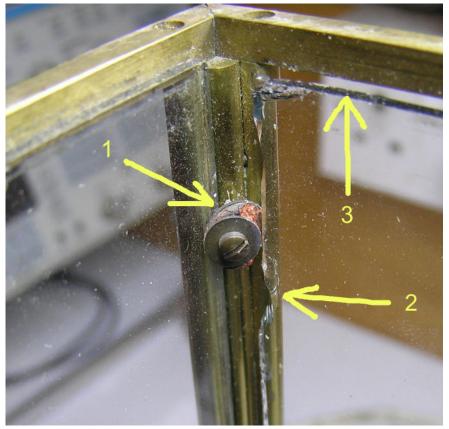
The glass has a few problems. The screws that hold the glass in place have a soft rubber type washer which pushes safely against the glass shown with the arrow 1. This insulation id now rock hard and brittle. The glass is therefore rattling around free and at one point has has been pinched by the brass washers that capture the rubber washer and shelled the glass quite badly as shown 2. The last point to note is that the glass is too short on one side. Maybe this is already a replacement piece.

So we have to look for replacement cushioning washers and maybe some new glass.

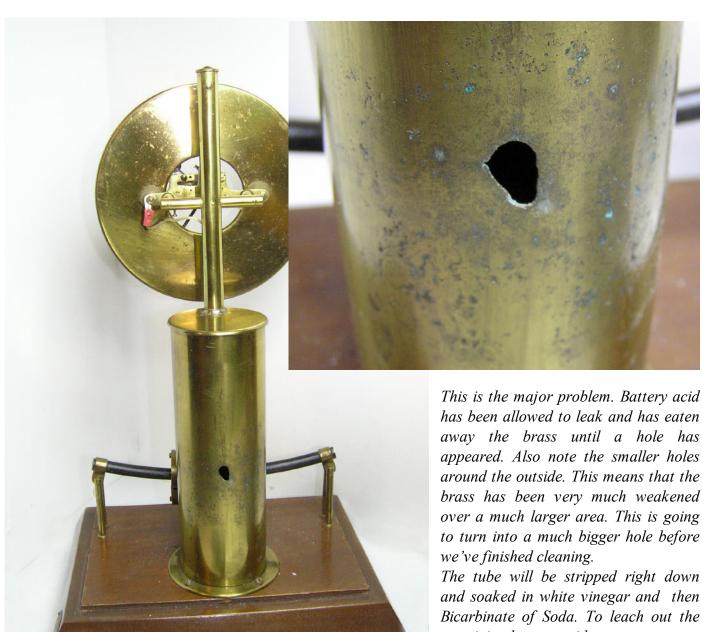
has been allowed to leak and has eaten away the brass until a hole has appeared. Also note the smaller holes around the outside. This means that the brass has been very much weakened over a much larger area. This is going to turn into a much bigger hole before

The tube will be stripped right down and soaked in white vinegar and then Bicarbinate of Soda. To leach out the remaining battery acid.

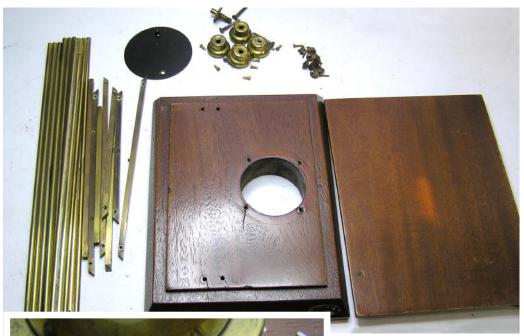
The case and brass frame stripped down ready for cleaning and polishing. All the parts were numbered beforehand so that reassembly will be easier.

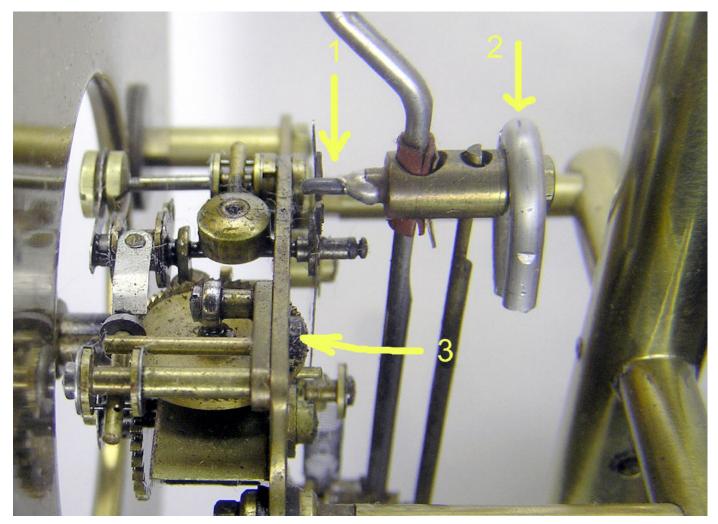
A few points to note here. 1. The first is the silver contact pin is quite short and has been soldered into position in the pin assembly. This will have to be replaced. 2. There is a nice lump of lead wrapped around the bolt at the rear of the assembly. I guess someone was trying to influence the rate of the pendulum because the rating nut at the bottom of the pendulum was ineffective being wound fully to the top or bottom. 3. Note the thick oil deposits all over the movement. This has congealed and is like thick molasses. The count wheel needed a good push with the finger before it would move. The swinging pendulum would have had no chance to move this wheel.

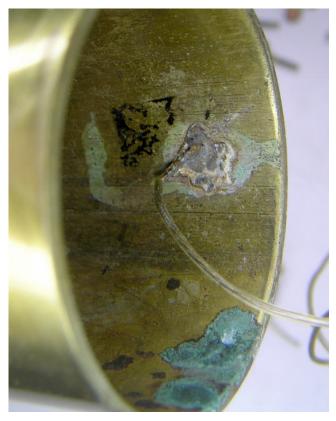
The negative lead soldered to the inside of the battery stem.

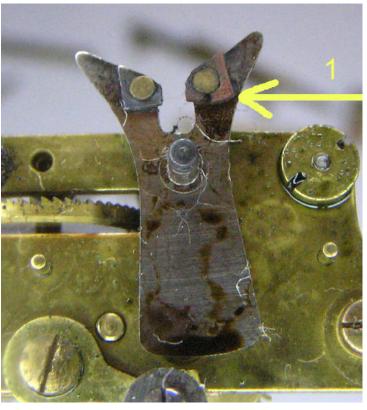
Besides the thick coat of congealed oil, the fork contacts are also in a bad way and need replacing.

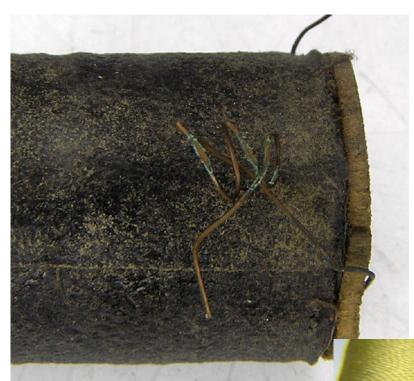
The coil removed. Note the corrosion taking place where the copper wire is in partial contact with the brass coil cover. The wires will be cleaned thoroughly before reassembly. The coil though is still holding it's own with a healthy reading that hasn't wavered since the first reading when the clock was received.

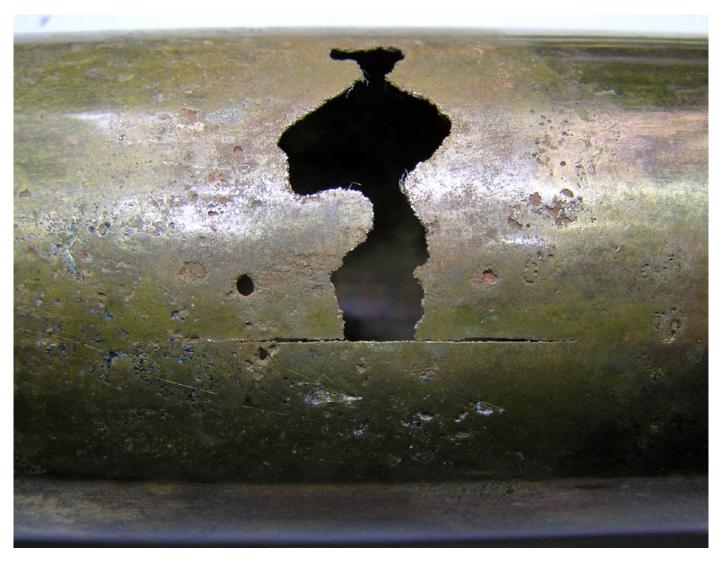
The battery cover after soaking and cleaning. The hole is now much larger and the whole area is paper thin.. The battery acid has now been removed and brass will not detiriorate further. The acid has eaten its way to the seem of the rolled tube and clearly shows the joint. In a polished tube this would not be noticable at all. But it is interesting as it shows how the tubes were manufactured.

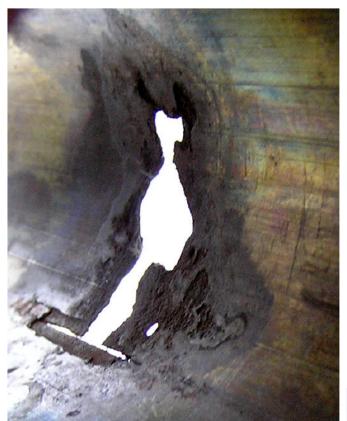
This photo shows the extent of the damage from the inside. The whole area is very thin and weak. The seam has been opened up by the acid attack.

I will keep this tube and perhaps experiment with ways to effect some form of repair that would hopefully not be too obvious from the outside.

Meanwhile I have separated the tube from the rest of the stem( as seen below) and have replaced it with one from a clock that I have had for a while that has a damaged column but the tube is in a reasonable state. There are a few marks in it from acid burning but nothing in comparison to this one. Besides, we don't want it too look new and therefore stand out like a sore thumb. So with a good clean up I should be able to set up u jig to hold the parts together whilst soldering the parts.

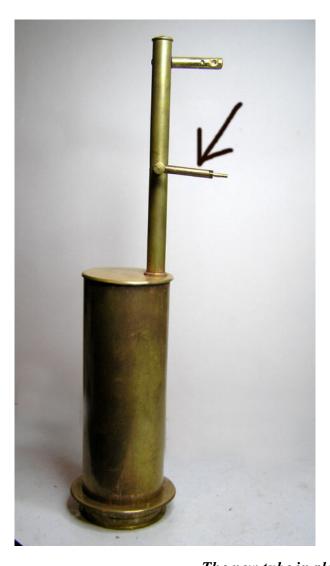
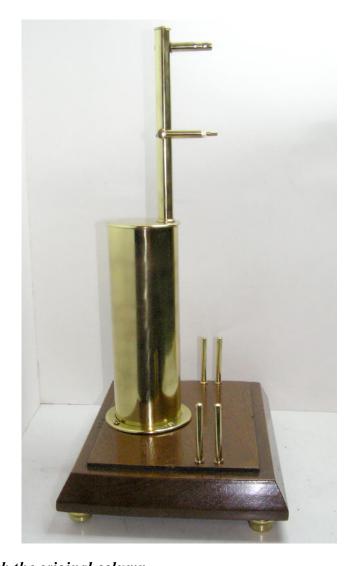
The new tube in place with the original column.

The only thing to do now is to correct the drop of the movement support arms that is quite evident in this photo (arrowed). This is a problem with the horizontal arm that is riveted through the main column. This particular one has been redone sometime in the past with a brass rivet that is too small for the job. A new steel one has been made and the result can be seen in the photo on the right. The column and stem have been cleaned and polished and match very well. There are a few marks left in the column but this matches well with the rest of the clock.

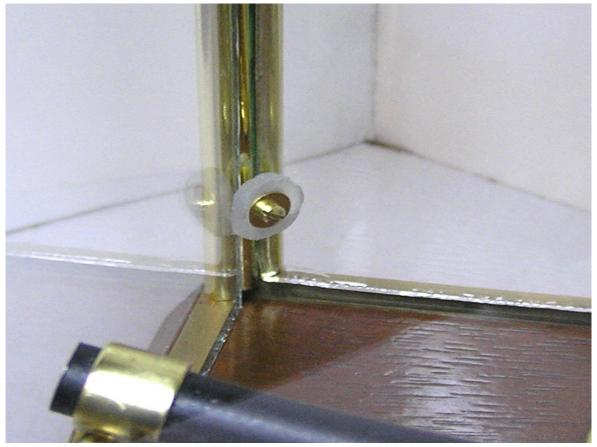
The rubber mounting between the glass retaining screws and washers was rock hard and disintegrating badly. I needed to replace it with a material that was both strong but very pliable so that it would both retain the glass and yet bend easily to take the shape. I looked around and found the very thing. I sliced up sticks of glue that are used withe Hot Glue guns. This has proved very effective with the added advantage of being reasonably clear and therefore less intrusive when when the clock is viewed from the front.
