Eureka Clock Serial Number 7085

*Restoration of Eureka
Clock Serial Number 7085*

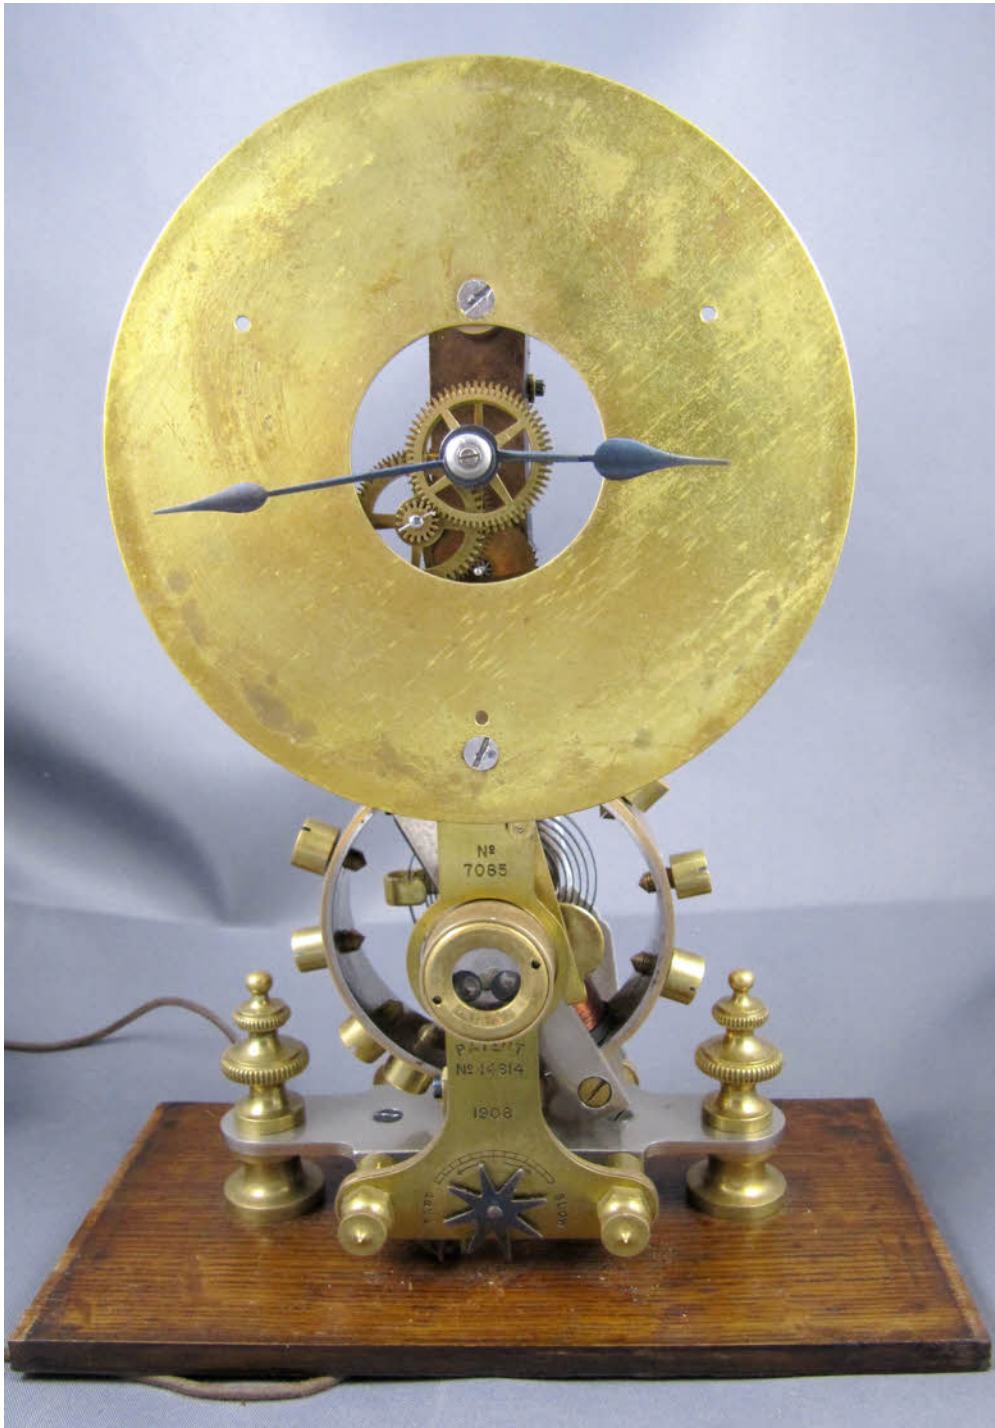
As delivered this is a tall 2 ball movement without case or dial, but the base suggests that the clock comes from a wooden case model. From an initial inspection all seems to be OK with nothing missing or badly damaged.

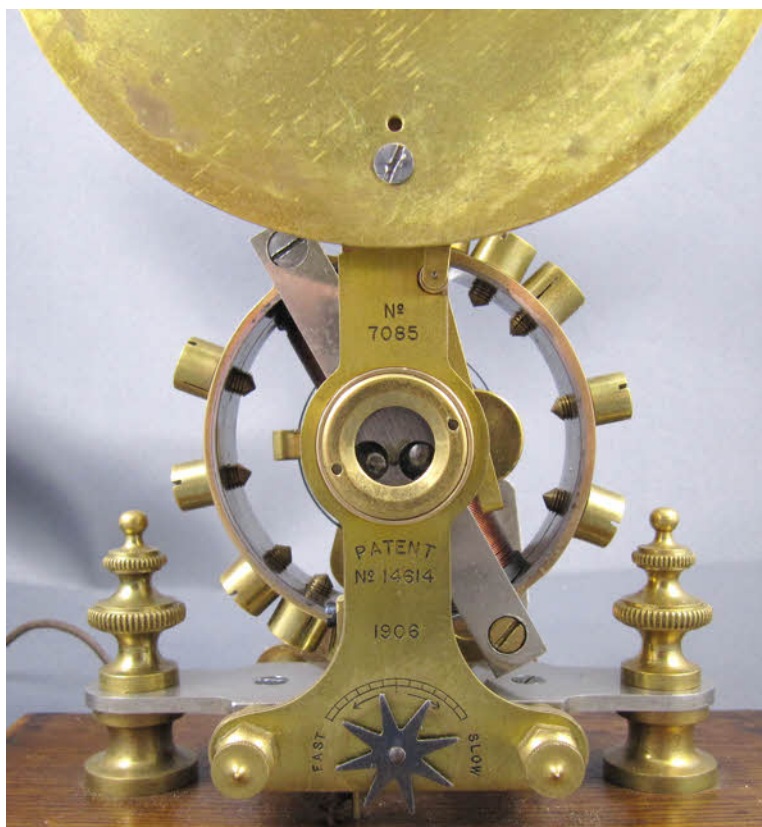
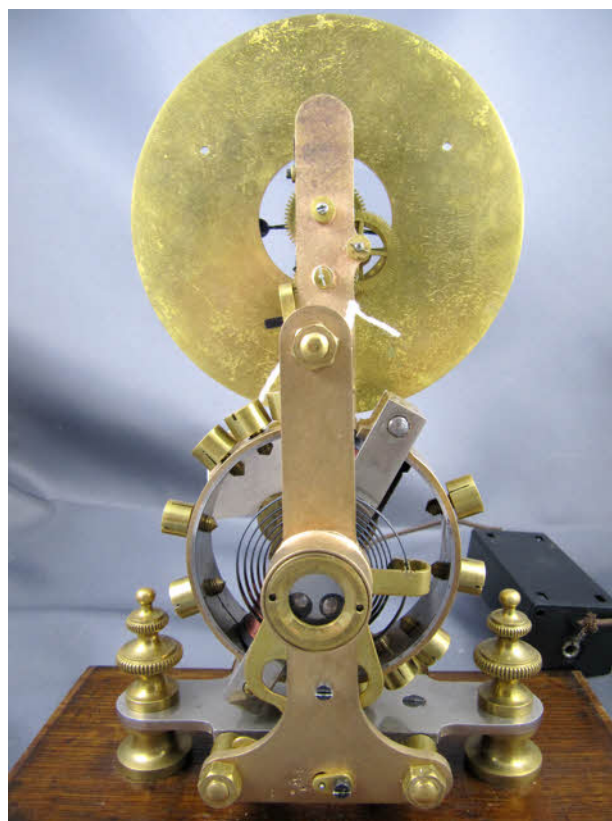
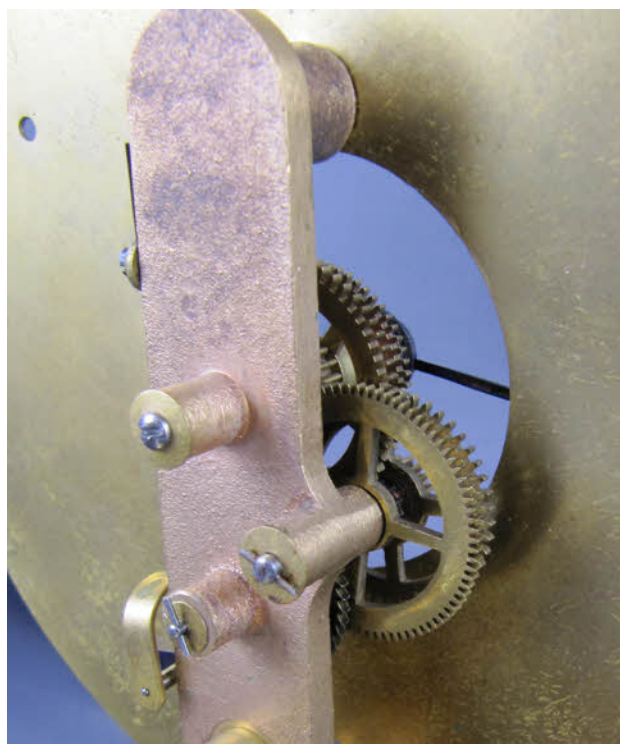
This group of photos shows the front and rear of the movement. The top photos show the registration plate which has lost some of the wax infill from the engraved characters. This will be corrected. Some of the screws are slightly damaged or have lost some of their colour. These will be polished and blued. Note the steel windowed plates in the bearing housing. These provide hardened end bearings for the pivots which would otherwise bear straight onto the glass. From the number of clocks I have seen it would appear that all two ball movements have these bearing plates while the three ball movements don't. What then stops the pivots touching the glass on these movements? Well on all the three bearing movements there is a brass push on collar on each pivot which bears against the balls if the balance wheel moves too far to the left or right. The last photo shows the excess number of collars on the rear of the motion work. The top one is certainly not needed as the large screw head acts as the end stop. The addition of the collar has been known to be too tight and not allow enough end shake for the arbour thereby jamming the motion work and stopping the clock.

These two photos show the finished front and rear bearings. Note the registration plate engraving has been wax filled and the then polished and lacquered.

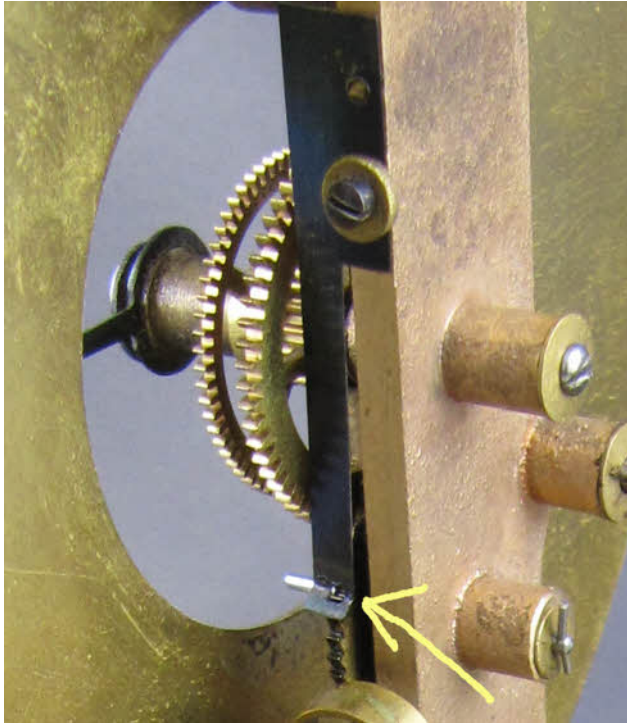
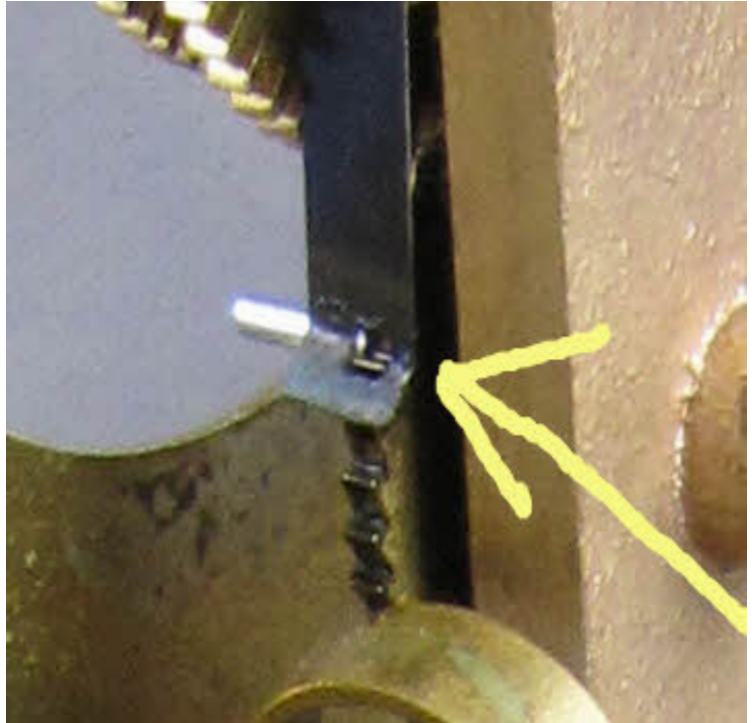
These two photos shows the position of the motion click spring and a close up of the damage caused by the constant wearing of the count wheel teeth. It has worn completely through and will need replacing.

The photo above shows both the original and new click spring ready for testing. At left we see it being checked for position and function before removal and final finishing.

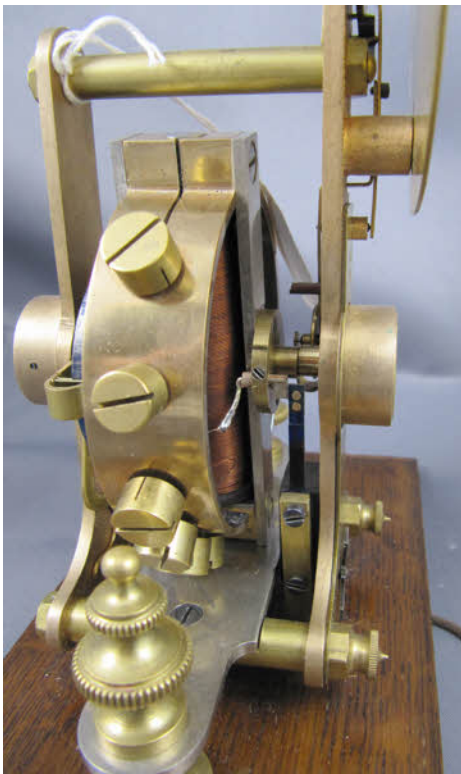
A side view of the clock. Note that the movement already has a new replacement flag and pin set. The owner of the clock had already purchased a new set from me but could still not get a good function from the balance wheel. This set will be kept and reused.

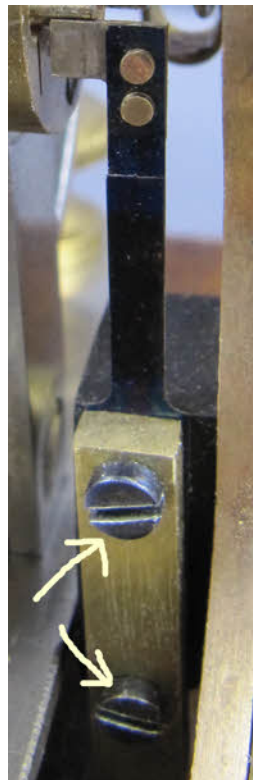
Note the position of the two screws securing the contact block. They are sitting proud of the block which is incorrect. So the block may have problems.

Above is the connecting block which is a replacement. It did not have counter bores (A) to accept the head of the screws which is why they were sitting proud. But the block itself is of the correct dimensions and therefore I have used it and counter bored the holes. The photos shows the position with one hole already bored (B). Both screw heads will now sit in the recess.

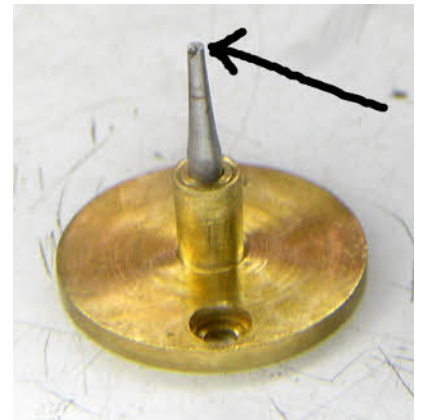
The rear pivot has been replaced and has a broken end. This will need replacing.

The rear pivot above has now been replaced with a new one turned from blue pivot steel. The end has been polished round so that no damage will be done to the steel plates.

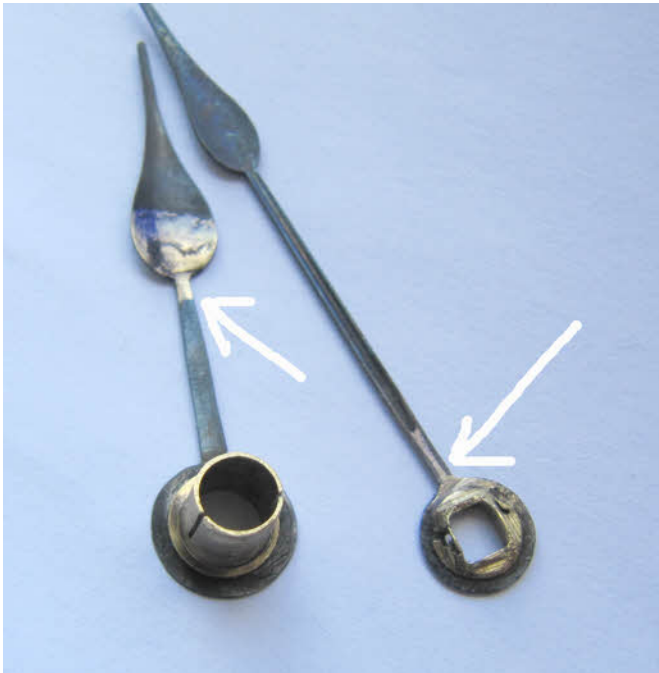
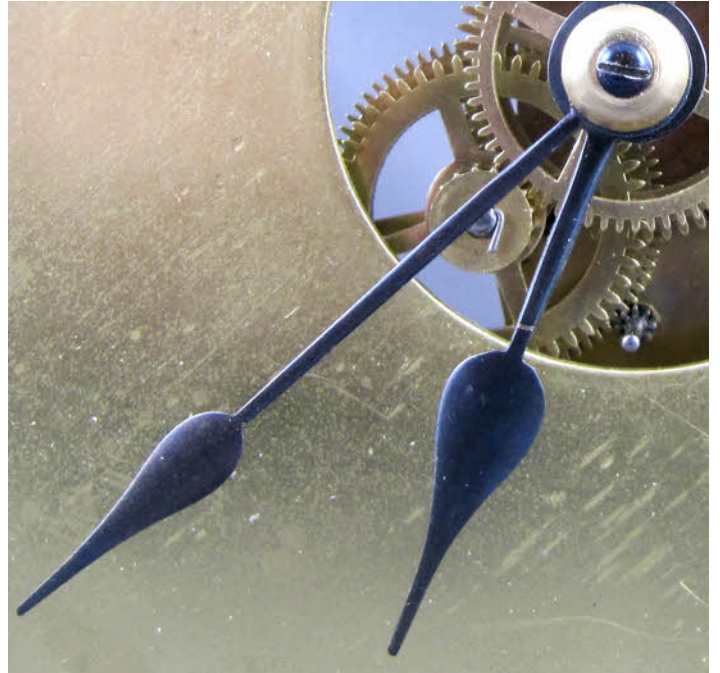
Both hands have been repaired by silver soldering. This is an effective method of repairing hands. The solder is strong enough to “butt” weld the thin steel and should withstand many years of use. The photo on the right shows that the soldering has been done well enough that the repair cannot be seen from the front. This method of repair means that the original hands can be kept with the clock.

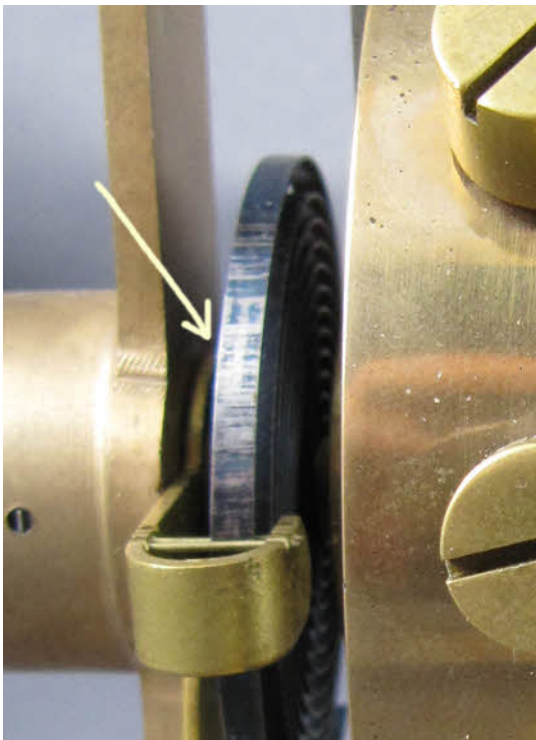
This photos shows the wear marks on the balance spring. These are caused by the two wires in the regulator segment that capture and restrain the spring allowing the segment to adjust the timing. It seems therefore that the clock has seen many years of adjustment back and fro. It sign that the clock has always had timing issues. After removing the spring I found that it was short at only 11.5 turns where normally they are 12.5 turns. I have seen one other clock with a short balance spring which also happened to only 11.5 turns. So it is difficult to say whether they came from the factory like this or were shortened later.

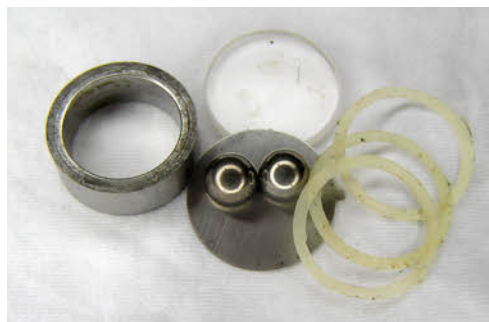
The rear bearings and ballrace assembly. Note the thin paper washers that protect the glass.

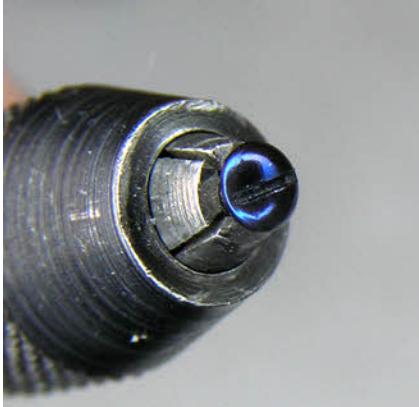
Not all the screws needed treatment, but here we see one of them after polishing and blueing.

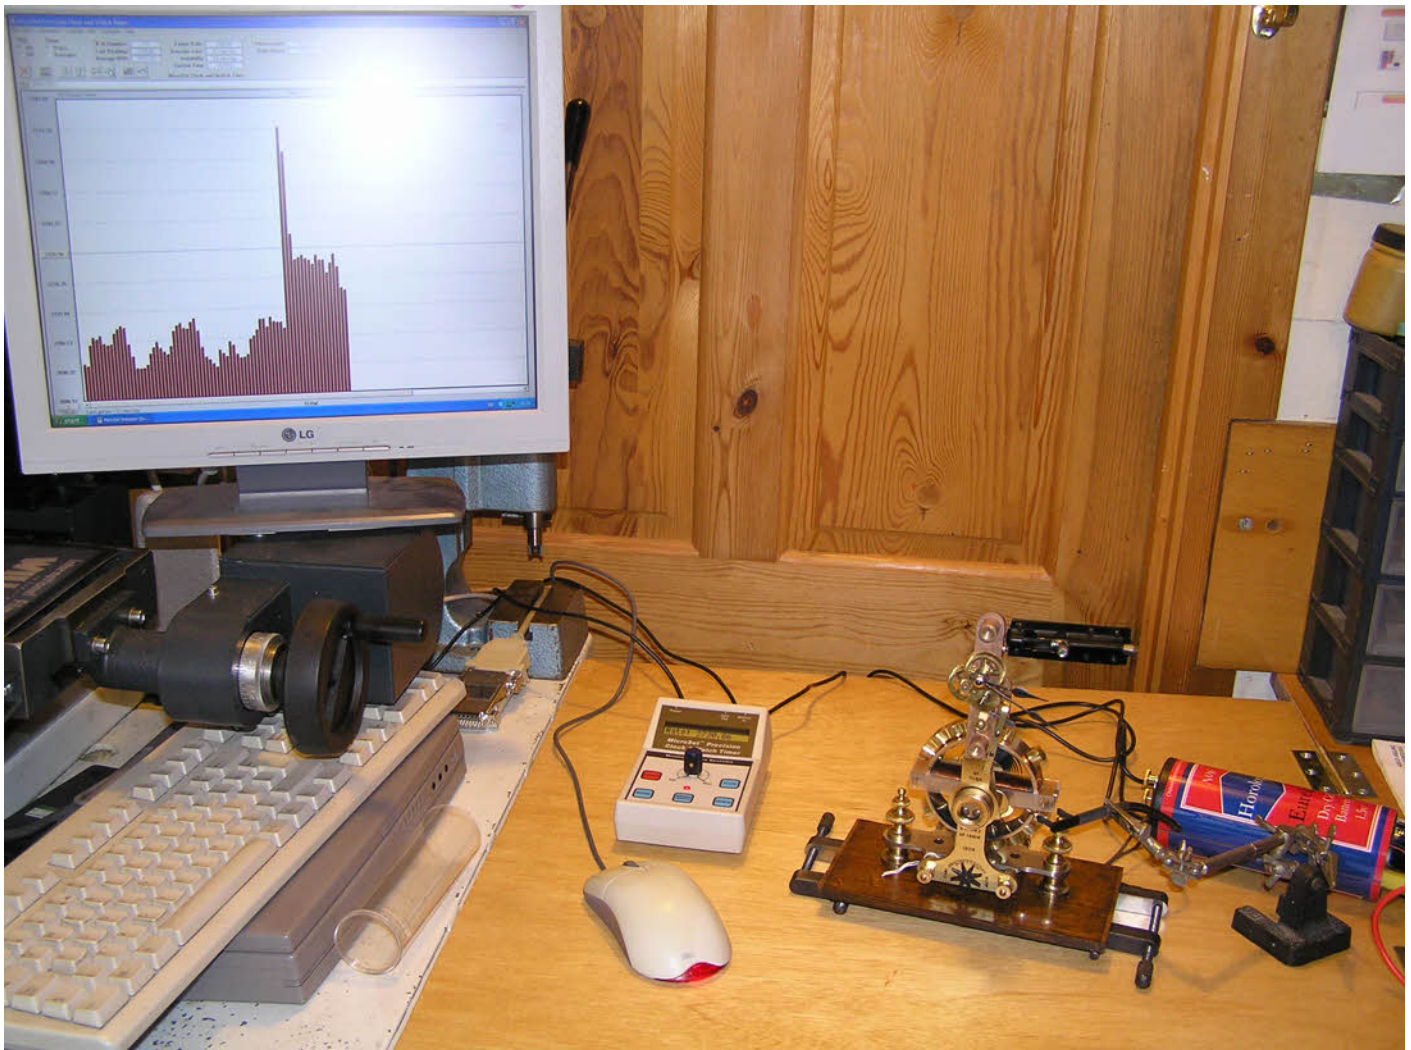
The shortened balance spring definitely has some problems. Look at the graph on the computer screen. It is quite erratic. I use the Mumford Microset (www.bmumford.com) to record twenty-four hours of readings from the clock to check for anomalies. Eureka clocks are not renowned for their timekeeping. If you get a "good un" then you may perhaps be accurate to within a couple of minutes a day. But most seem to fall in the 5 to 10 minutes a day category. Even when new the springs were never consistent in their behaviour such that the factory used 40 tooth and 45 tooth count wheels in conjunction with many different weighted balance screws to try and get the clocks to perform adequately.

In this case I used my voltage regulated battery to set the amplitude to get the accuracy with tolerable limits. The strength of the spring meant that a full amplitude of 360 degrees would give beats of less than the required 45 beats per minute (2700 beats per hour). Adjusting the screws helped. Finally I settled on an amplitude of about 300 degrees with a constant voltage of 1.77v to give an acceptable count of approx 2700 beats per hour.
