# Restoration of Bulle Clock Serial Number 12199.

Bulle Clock Serial Number 12199. (By kind permission of the owner)

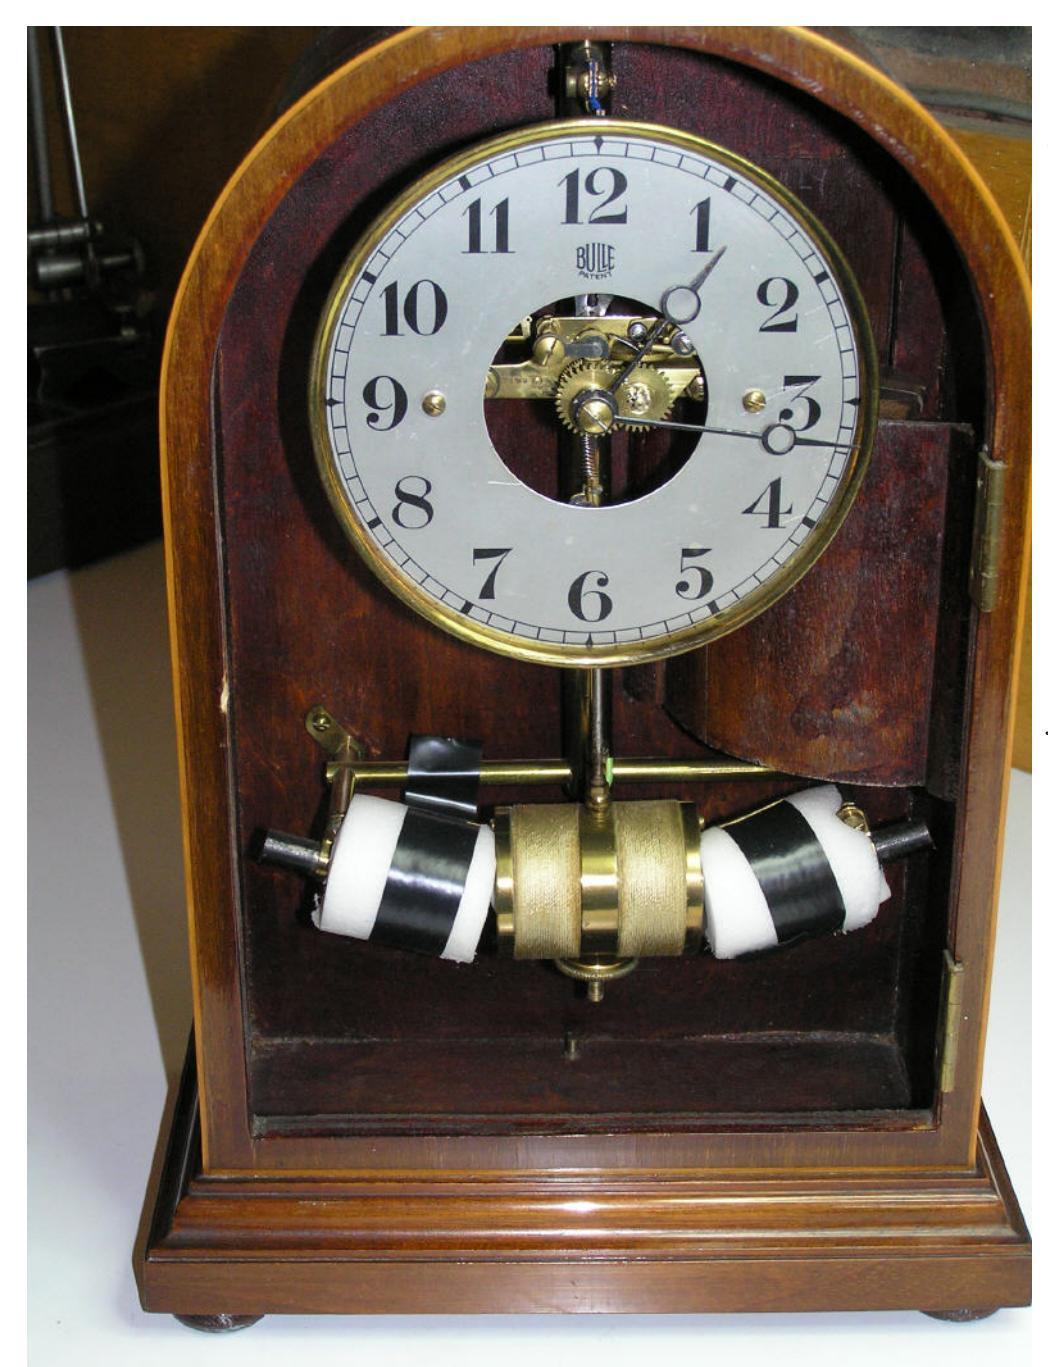
This clock is the subject of the restoration with kind permission of the owner.

The photo shows the clock as received. The door has been retained by the owner as their is no point in sending glass through the post especially as the case is in good condition and not in need of repair or polishing.

The pendulum has been secured for transit by the use of foam pipe lagging wrapped around the bar magnet. A small piece of foam has also been inserted between the coil and magnet to stop front to back movement. This method is very effective in stopping transit damage to the clock.

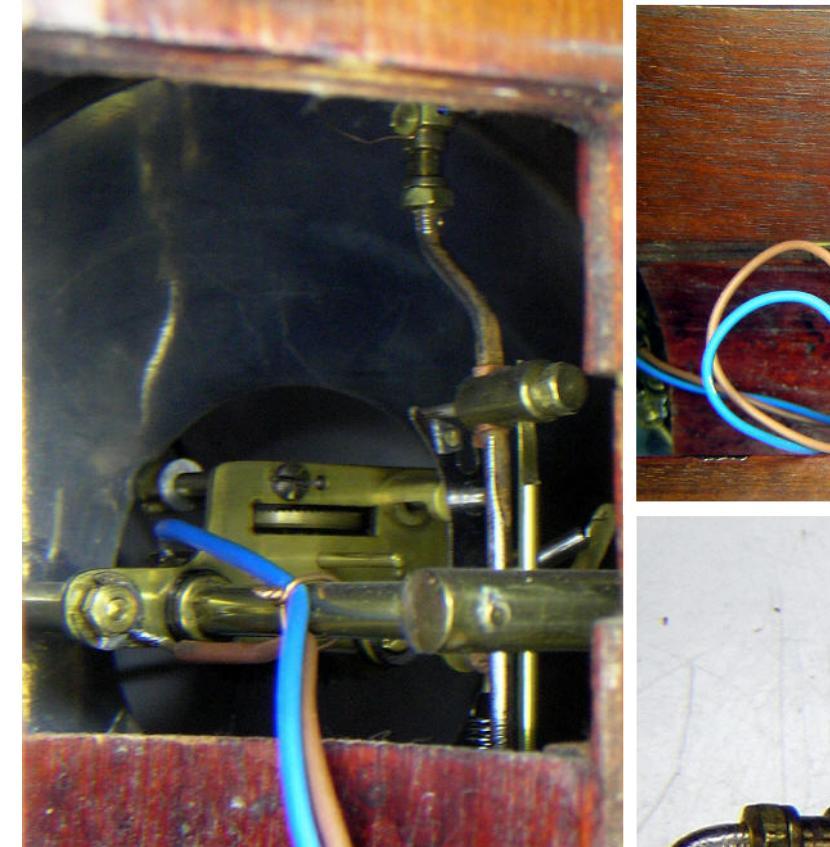
Peering through the battery door at the back, we can spot some interesting wiring techniques. The negative wire being connected to the movement plates.

The battery holder is a home made 1.5volt "D" cell holder.

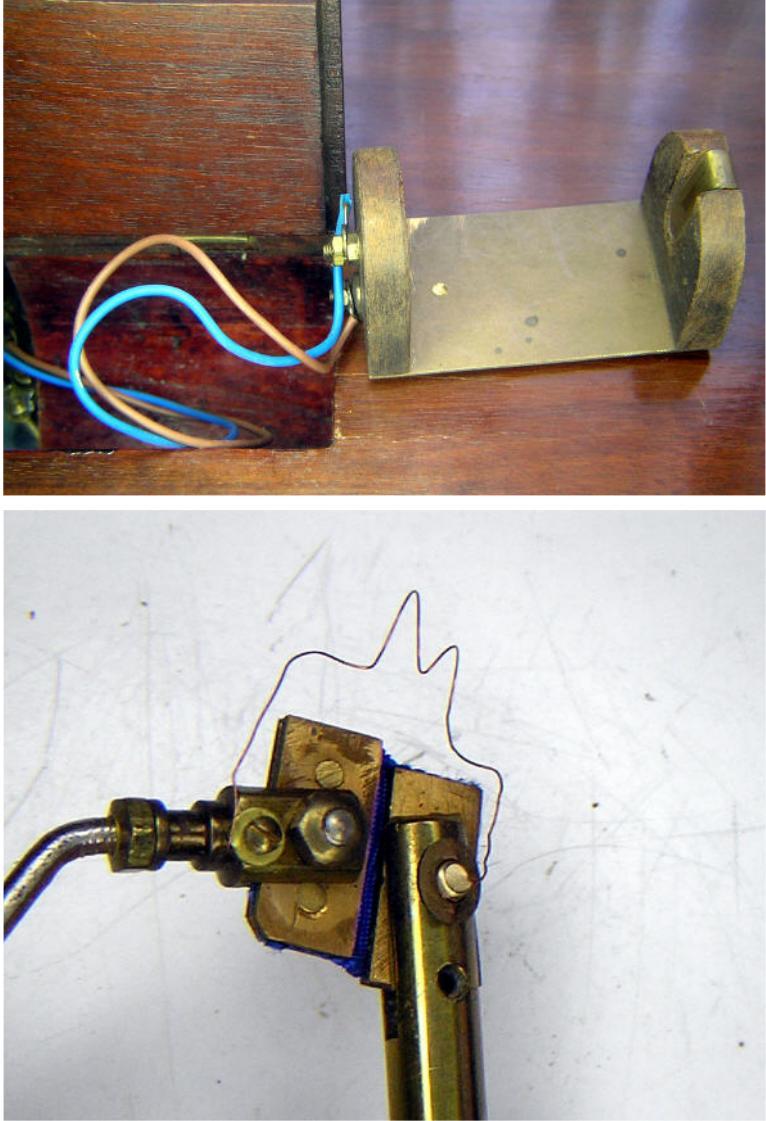
The suspension is also home made probably using the original brass chops and a piece of what looks to be medal ribbon?

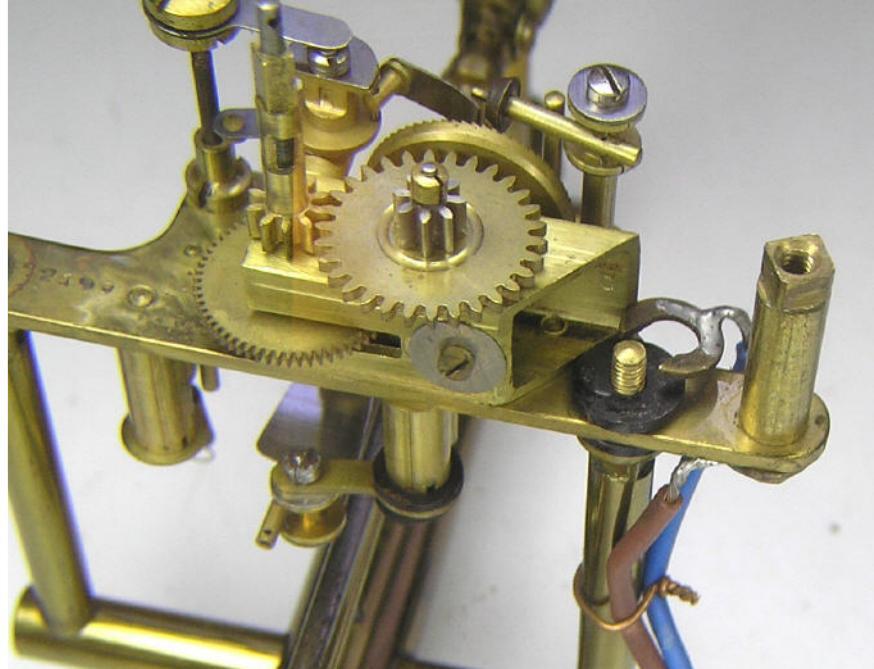
The photo at left shows how the negative lead from the battery was connected. Besides being incorrectly placed it also left little thread for the nut to engage with. One turn and it was off. This wire although theoretically correct in that it connected to the frame, left little thread left for the spacer and nut as well as potentially causing a short by touching the movement plates.

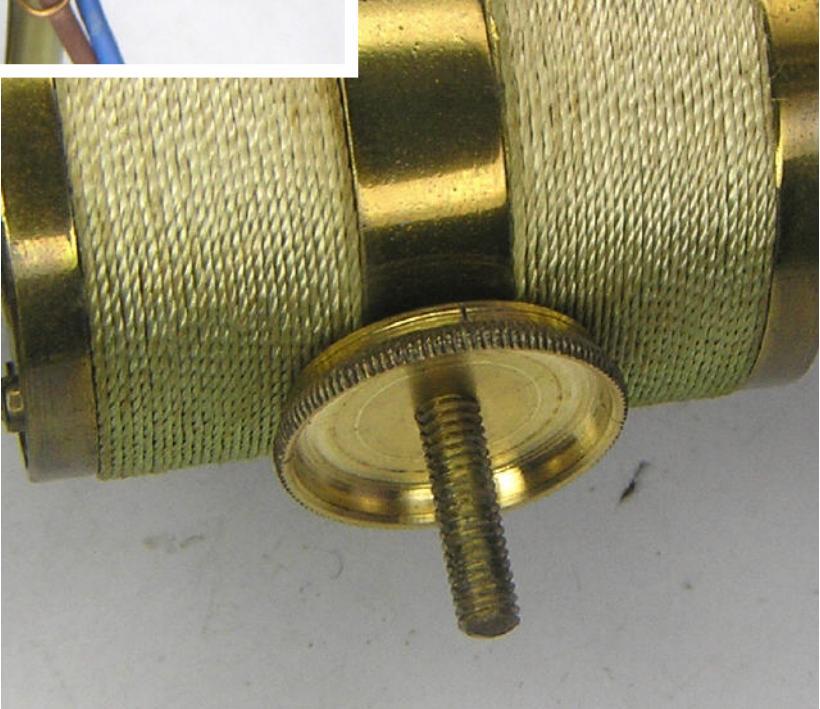
The observant amongst you might spot a problem with the rating nut on this pendulum!

Someone has decided that the clock was running to slow and when this could not be corrected by raising the rating nut, they decided to bore the middle out of it. I must admit it was done neatly so that it could not be seen when the clocks was standing in position in the case. But it's still a bodge and shows that the person who did it does not understand the principles involved in Bulle clocks.

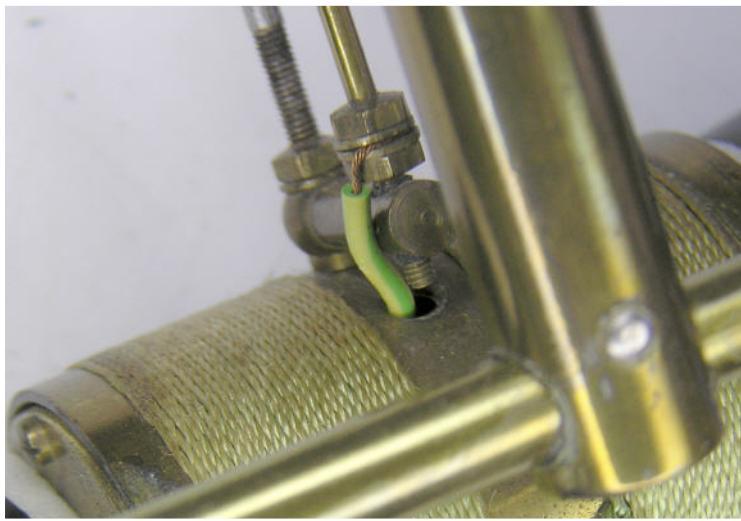
The contact assembly shown here is lacking the steel T piece that stops the screw from penetrating the fibre. This will have to be made.

The contact pin assembly with the new steel "T" piece back in place. The "T" piece was cut from mild steel strip 0.5mm thick. I held it in a small hand vice while cutting and shaping..

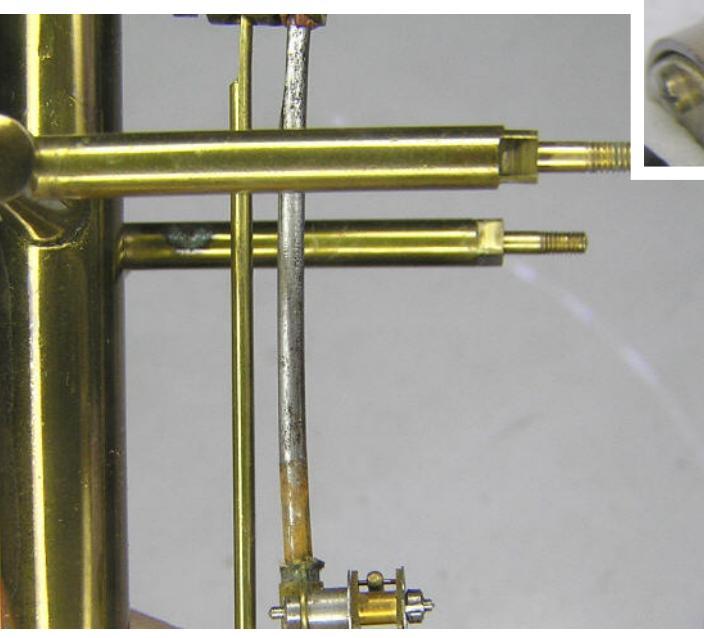
The steel pendulum rod looks a little cock eyed here! It has been bent and will need straightening. Not also the rust.

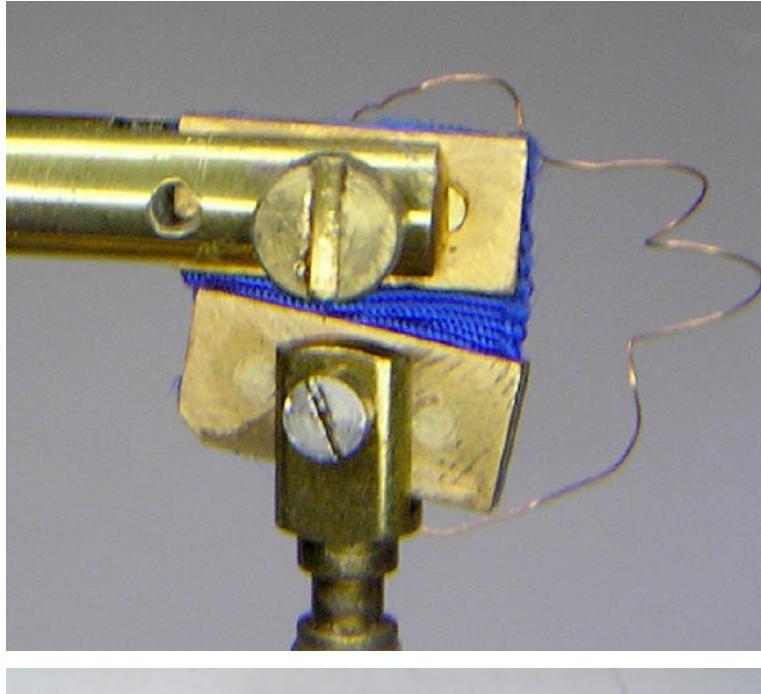
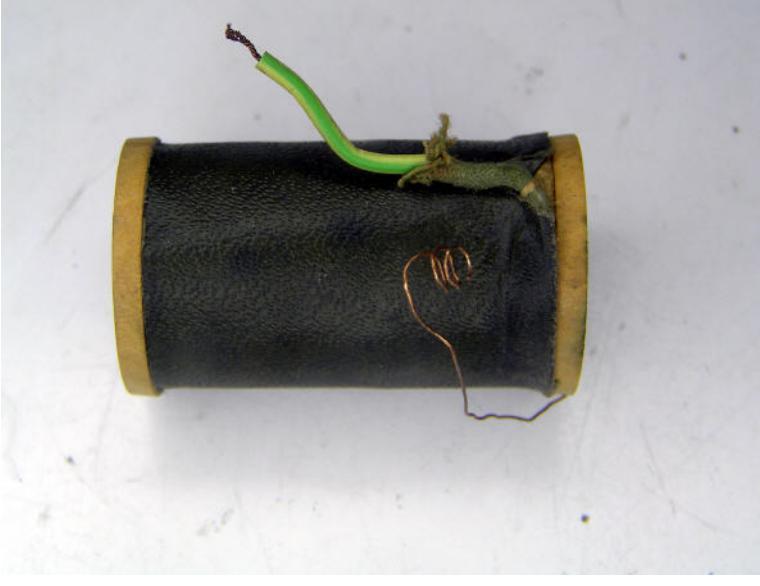
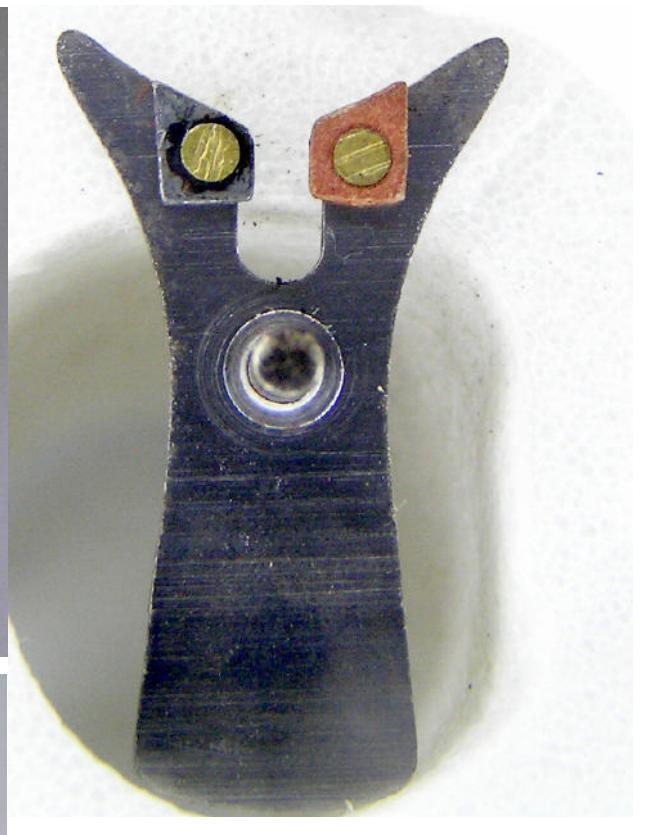
The top left shows the suspension. This assembly has none of the right screws, washers or nuts. All will need to be made from scratch. The fork is in good condition if a little dirty. The contacts still have 50,000 miles left on them!. A good clean up should suffice here. The photo at lower left shows the coil. It stiil has its original wrapping but we'll need to carefully peel that back to look at and replace the wire. The good news though is that it shows a good resistance of 1150 ohms. Spot on for this clock.

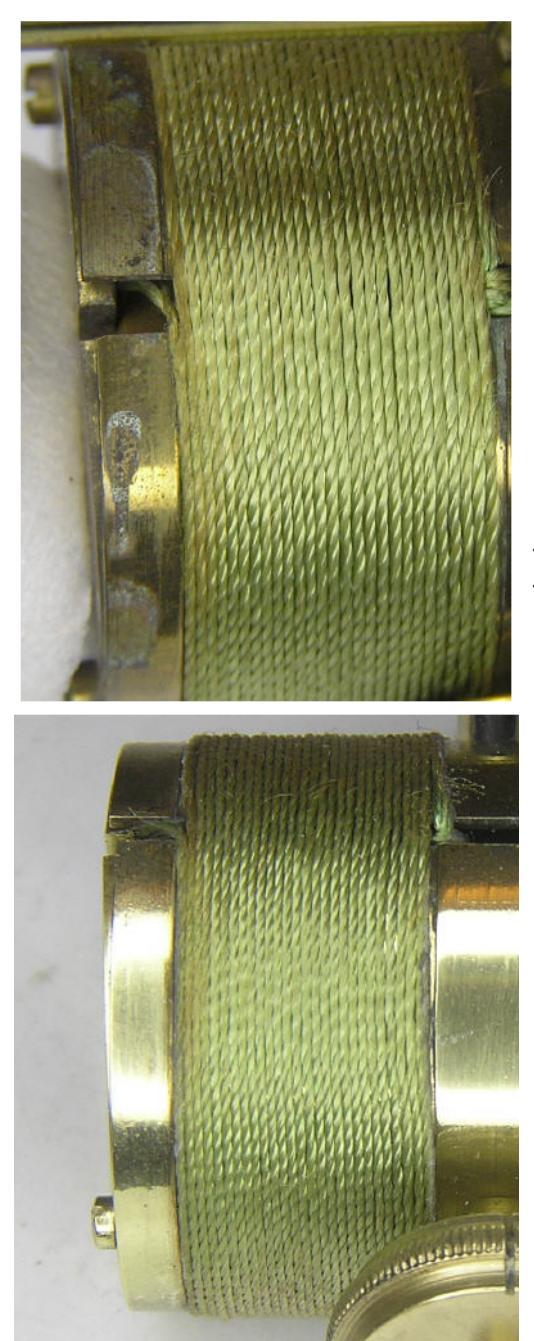
This type of Bulle is of course encased on three sides with wood and has much less sunlight falling on the back of the pendulum which has, in this case, resulted in a hint of the original colour being evident in the cord. It has still faded but not to the same extent as the front. Though the only part that is closest to original is that that is usually found knotted up inside the coil.

The photo also shows some damage to the brass coil casing which will need to be polished out.

There is always a conflict of interest when presented with a coil that has much of the cord intact (especially when it is in reasonable condition such as here) yet the brass cover needs repairing or cleaning.. To really get at the brass it is preferable to remove the cord so as to effect a good job. But it is then impossible to rewind the cord without it twisting and presenting a Zebra pattern when finished. Besides, the cord is usually so fragile after 80 years that it falls apart at the slightest touch..

In these cases I wrap some light duty masking tape around the cord only and try and clean the brass with 0000 grade wire wool. The tape I use is not as sticky as the normal white variety and does not tug so hard on the cord when it is removed.. I admit you still have to be very careful and it does take much longer but you are preserving a s much as possible of the original clock. There may also be some discolouration of the outside coil of the cord due to dirt migrating under the masking tape when cleaning. But it should be hardly noticeable if you're careful.
