Bulle Clock Serial Number 183374. *(By kind permission of the owner)*

Restoration of Bulle Clock Serial Number 183374.

Early Battery Clock Parts & Restoration

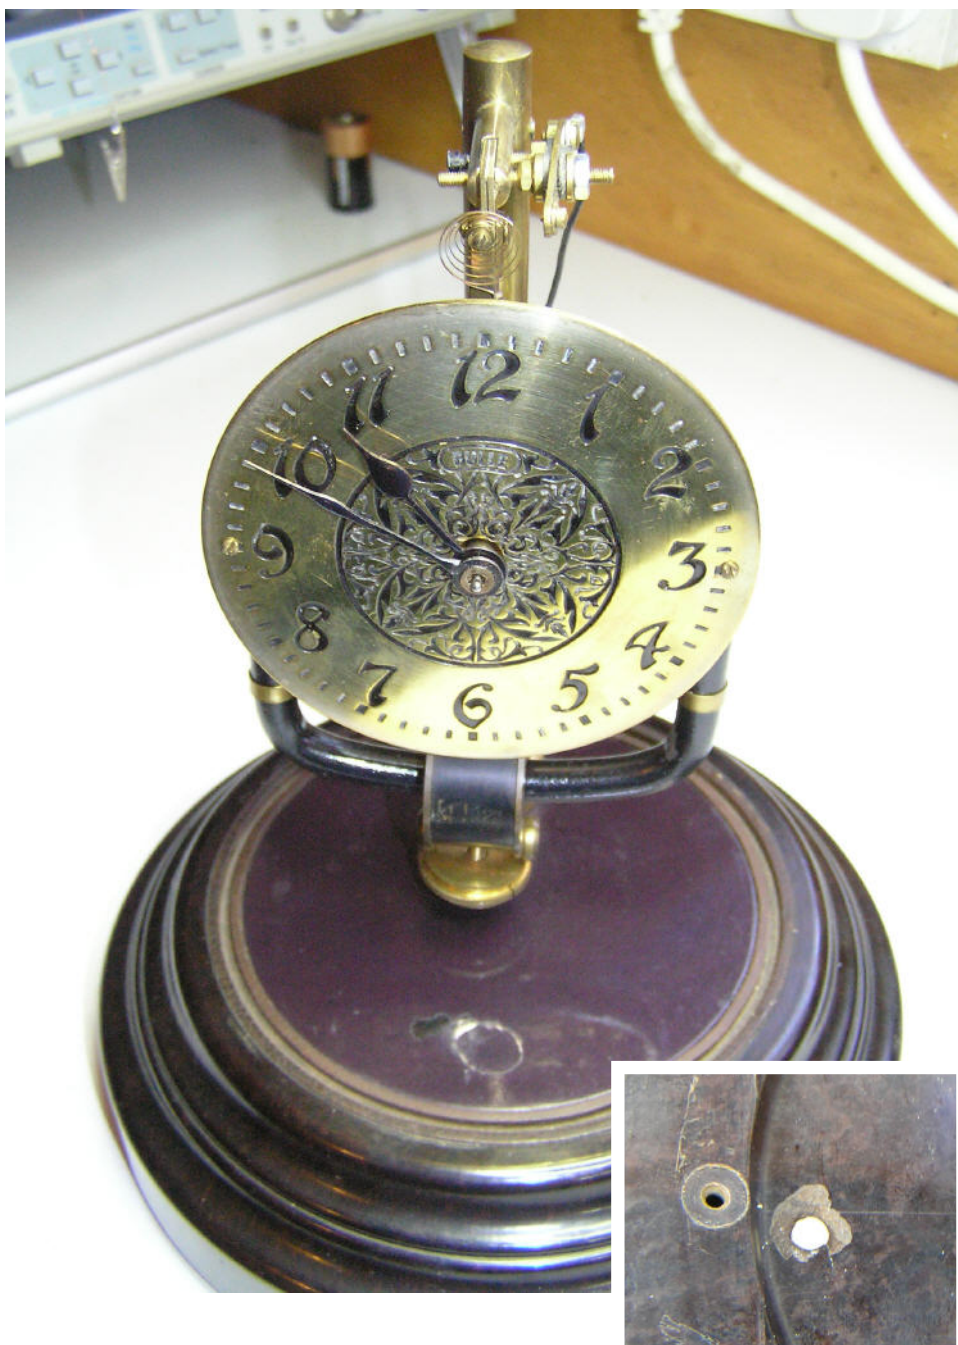
The clock as delivered.

This clock is in for a full restoration and is of the short type on a Bakelite base.

The first thing to note is the filled hole at the front of the Bakelite base. This is the result of someone's attempt at fitting a screw on the underside. They Chose a thin point in the Bakelite and drilled (see inset photo) all the way through to the top where the material flaked off in a large chunk. They have then stuffed it with filler. Obviously not too successfully. To cover up the mess they have then re-sprayed the surface with a purple paint. We shall have to see what we can do about it. The first thing will be to strip of the paint layer and see what condition the Bakelite is in underneath. The dial is in good condition but the silvering has worn off the outer chapter ring.. This will be re-silvered.

The Bakelite base after removing the paint and given a good polish. It is in excellent condition bar the botched and filled screw hole. Unfortunately the hole is right at the front of the clock in eyes view and no amount of filling will disguise it. It would also be a pity to spray it and cover up that lovely sheen of brown Bakelite. So I think the best solution is to cover the hole with an old Bulle label as seen in the lower photo. I will adjust its position until it is dead centre and symmetrical with the clock movement. If the hole had been more to one side of the other then this would not have been a suitable remedy as the label would of been off centre and looked odd.

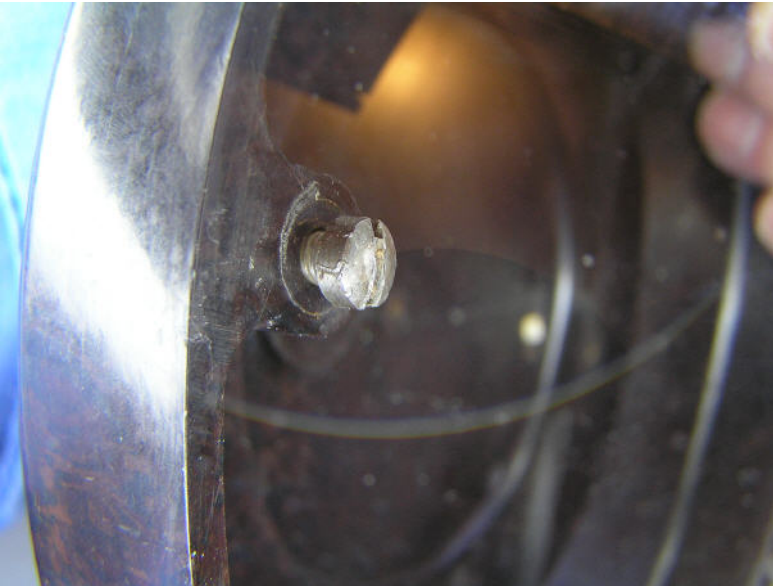
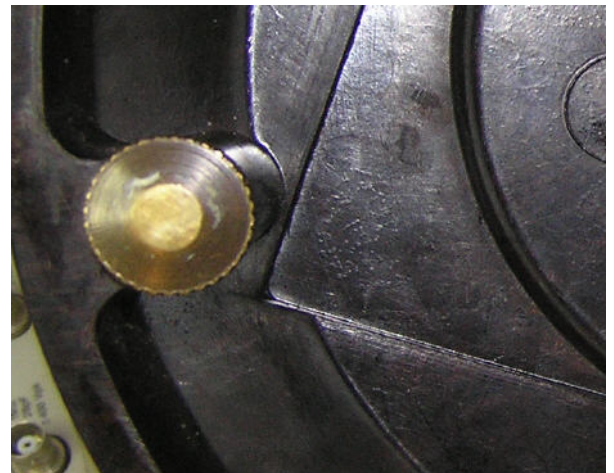
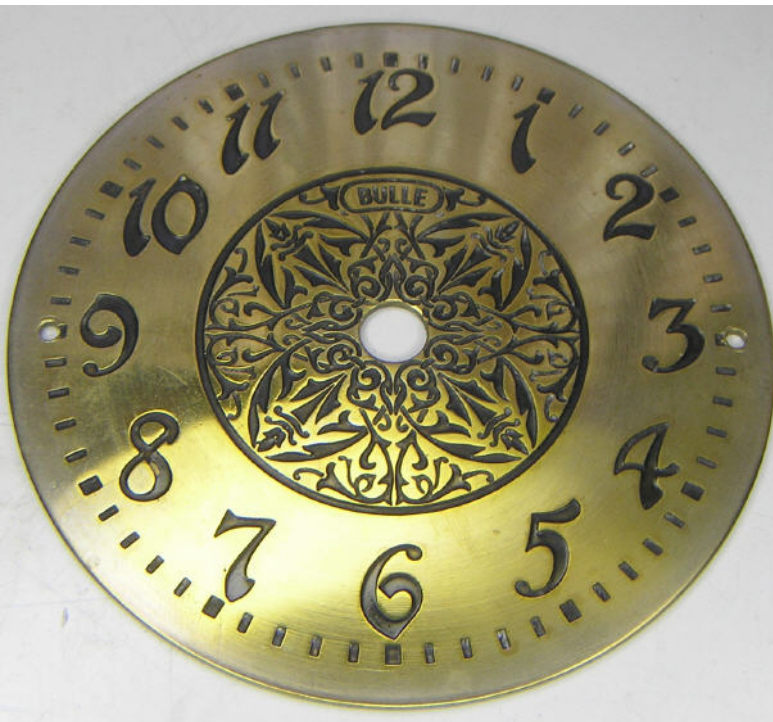
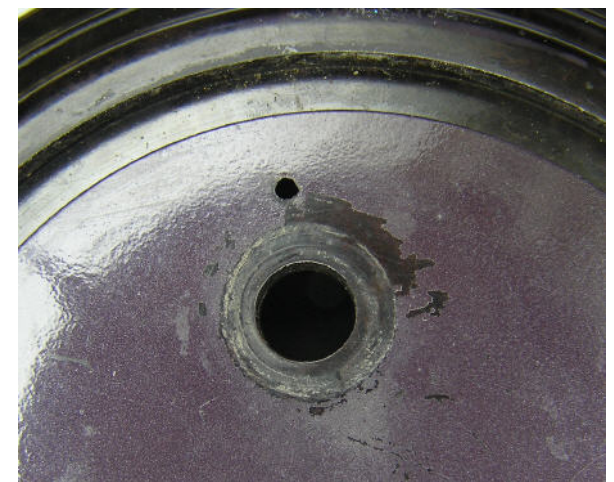
The photo at top left shows that one of the feet has been replaced by a steel screw. A new screw will be turned up to the same design as the other two in brass (above). The remains of the silvering can be seen on the outside of the chapter ring in the photo to the left. The photo below not only shows the paint flaking off but also how it must have been sprayed with the brass column in place.

The photo at left shows the missing screw foot has been turned on the lathe to match the other two. When all are cleaned and polished it's hard to tell the difference. Hopefully no one will!

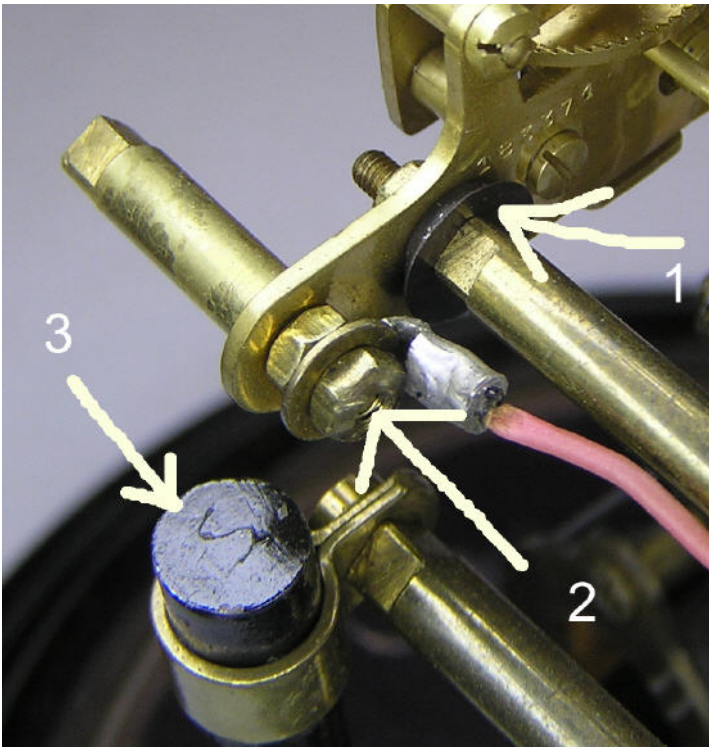
The two shaped brass washers that should be sitting either side of the movement insulation washers are missing and seem to have been replaced with thin metal shim that has been sprayed black (1). The photo below shows the detail once the movement has been removed.

The four new spacing washers. These can be seen in their correct position in the photo at the far right. They sandwich the insulating washers that separate the main movement plate from the frame.

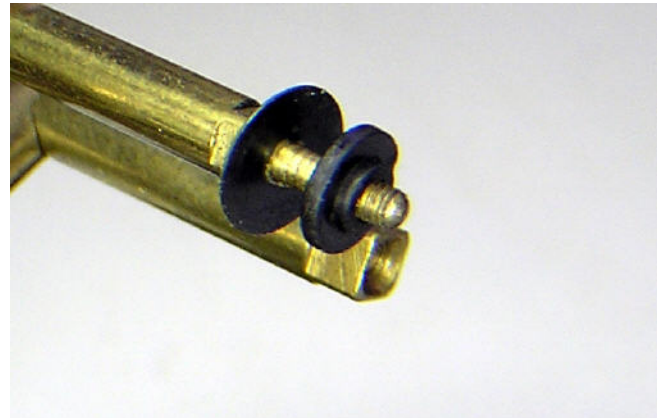
Note the extra nut used to secure the positive lead to the main movement frame. That means there is probably one missing from somewhere else on the clock (2).

The photo below shows a steel nut used instead of the original brass one.

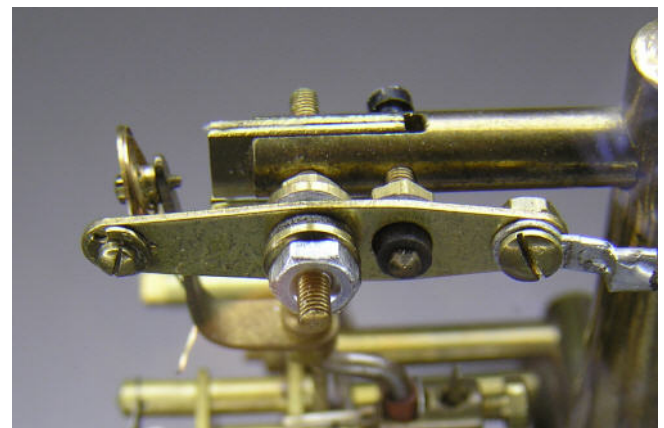
The letter "S" scribed onto one end of the Bar magnet has a matching "N" at the opposite end. I have checked the poles with a compass and they are in fact both South as they should be. The North is at the centre. So why they have marked it this way I have no idea. Perhaps it was just a way of marking it to facilitate re-assembly. But of course with a Bulle, it makes no difference which way round you position the magnet as the poles will be the same at either end (3).

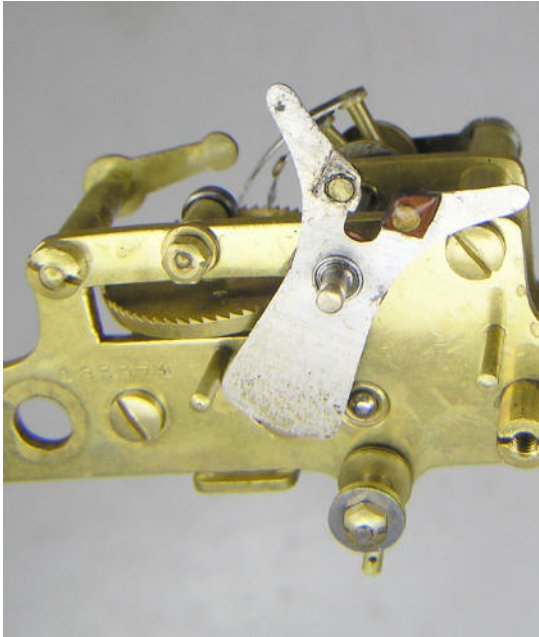
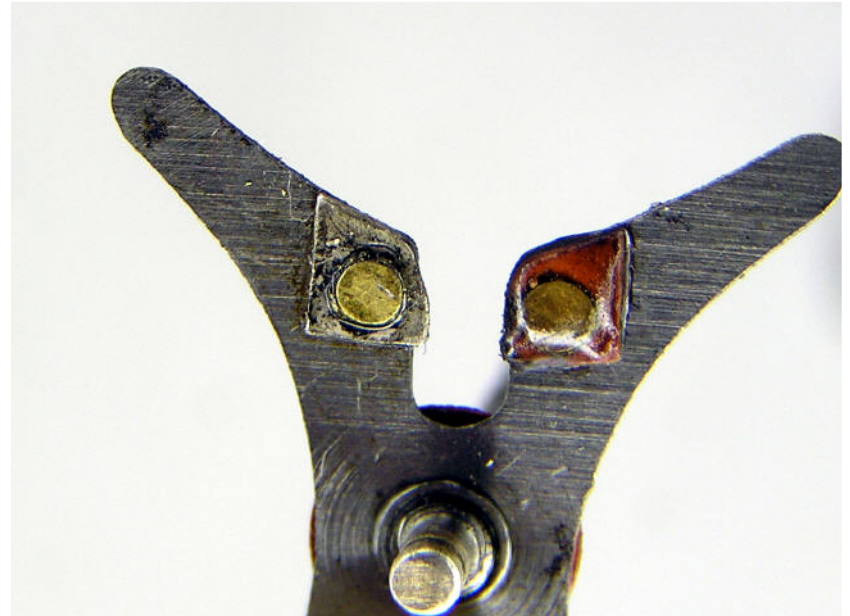
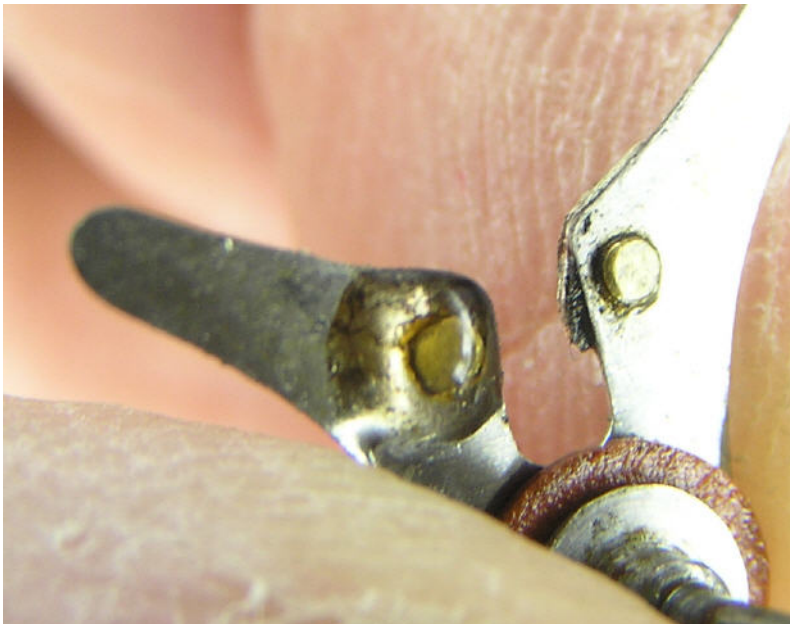
This group of photos shows the state of the fork contacts. The silver contact has a notch worn into it that reaches right down to the steel of the fork itself. Whilst the fibre has been "Supplemented" with what I can only guess is Araldite" or some other epoxy type substance. Why? I don't know. Perhaps the fibre also had a notch worn in it. So both the fibre and Silver will need replacing.

The photo at right shows the fork after the new silver and fibre contacts have been riveted in place and roughly shaped. . All that remains is to check for electrical consistency between the silver and the arbour then finish and polish the faces for smooth contact with the pin.

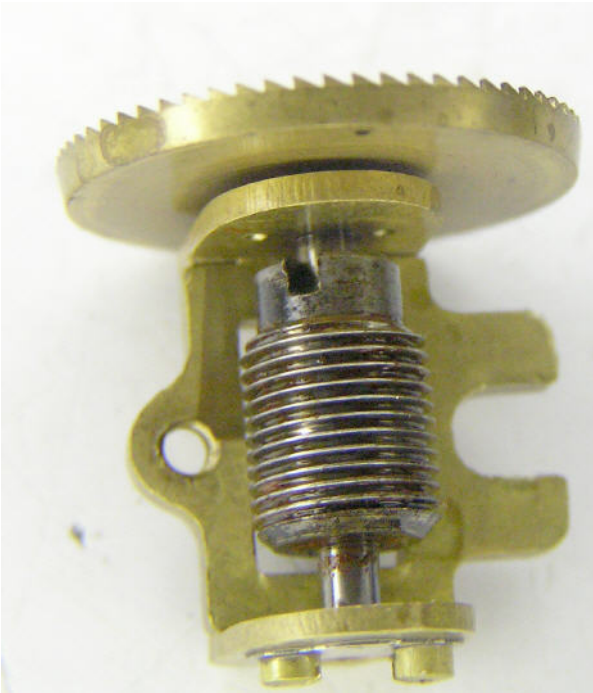
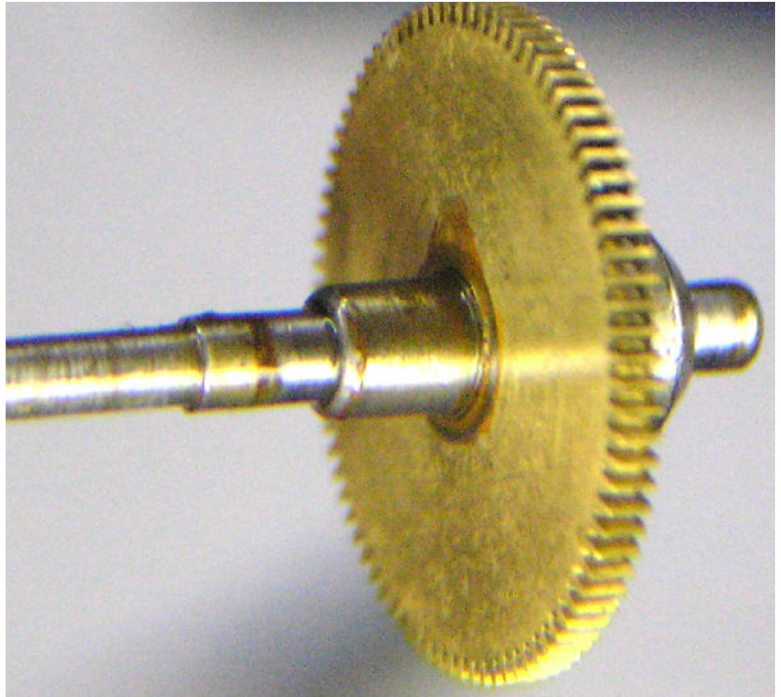
The clock must have been damp at some time as the rust in these photos show. But it doesn't look very bad. Certainly not enough to produce pitting.. All the steel work will be polished and the pivots burnished.

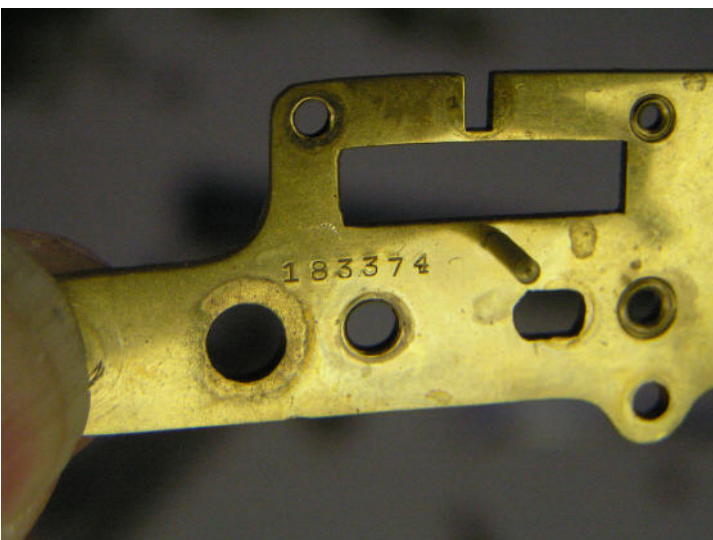
Once the movement has been stripped down it is easy to find and check the serial number.

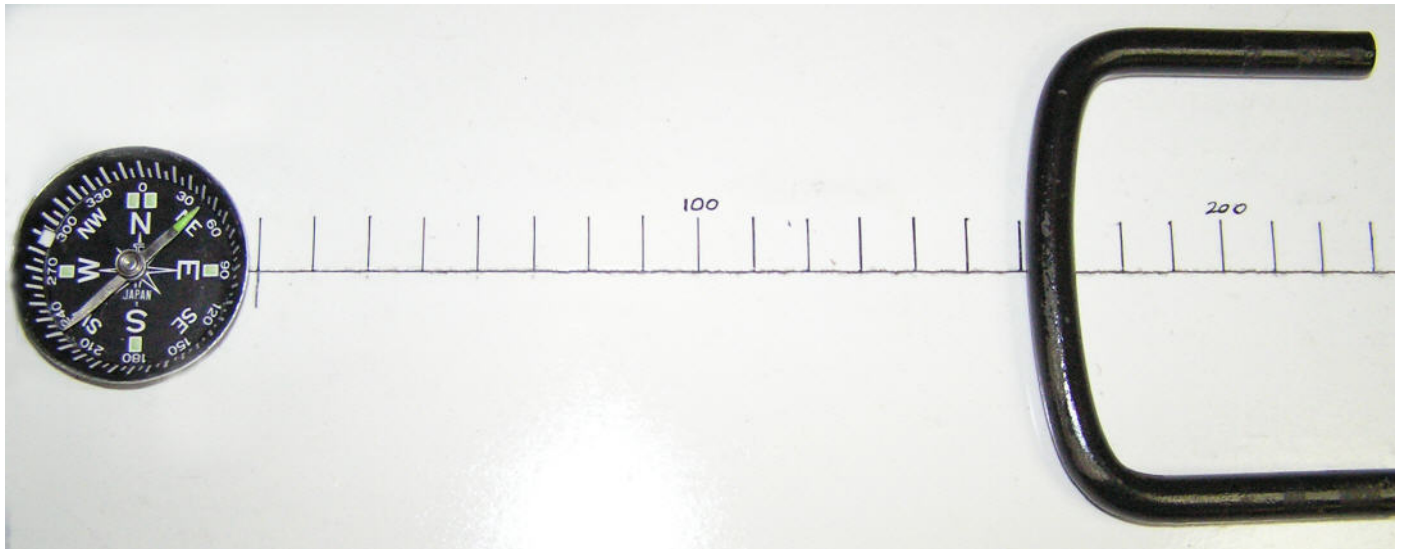
The magnet was a little weak showing only 160mm on the magnetometer. It will be regenerated to reach at least 180mm when the compass needle reads 45 degrees.

The bar magnet on the Magnetometer after regenerating the South-North-South poles. Note that the magnet has had to be withdrawn to 210mm to offset the compass needle to 45 degrees. A strong and very healthy magnet. The simple principle of this magnetometer is explained in the Restoration of Bulle clock serial number 186300 and 12199. Both are available as pdf downloads in the [Downloads section](#).

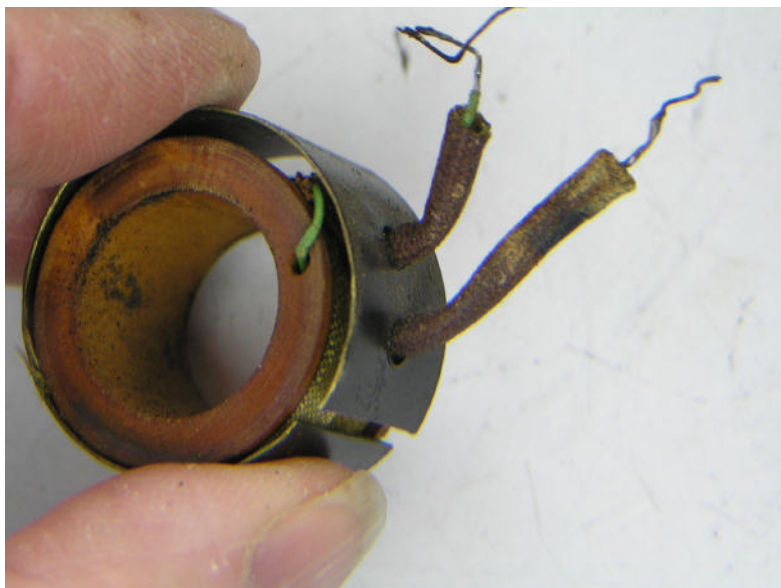
The coil gives a satisfying 1160 Ohms resistance although the wiring and wax covering are very brittle and prone to breakage. I will probably need to replace these. The cover will be cleaned and re-sprayed black.

The assembled pendulum coil. The scratched cover has been painted black as per original.

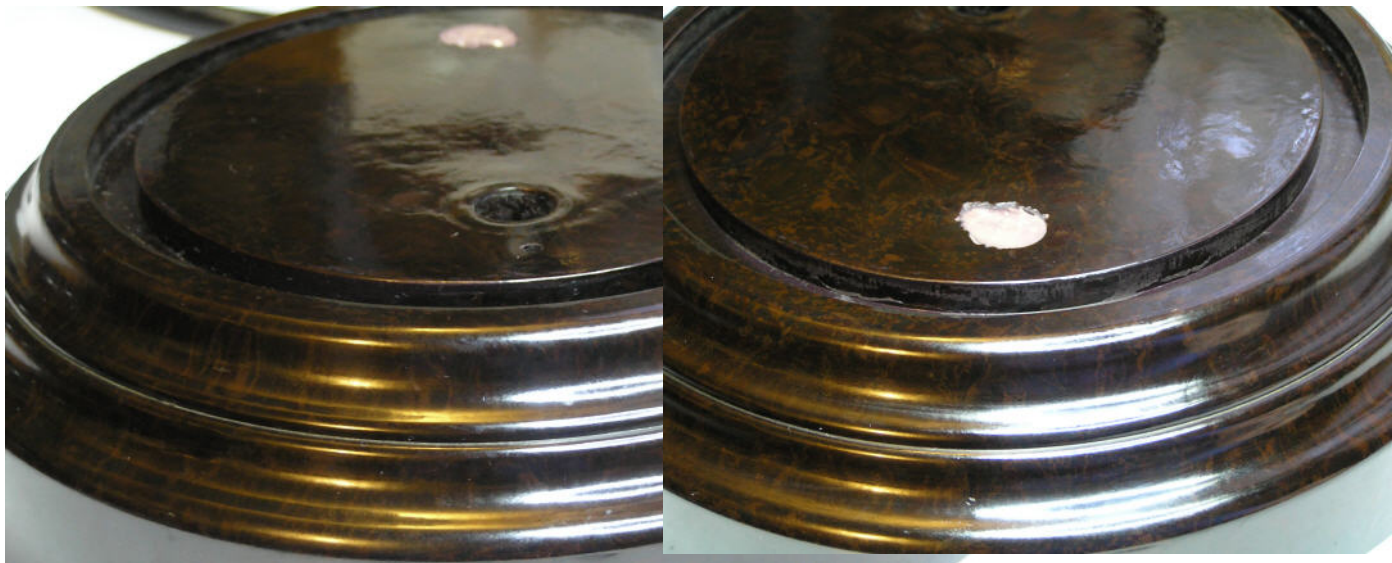
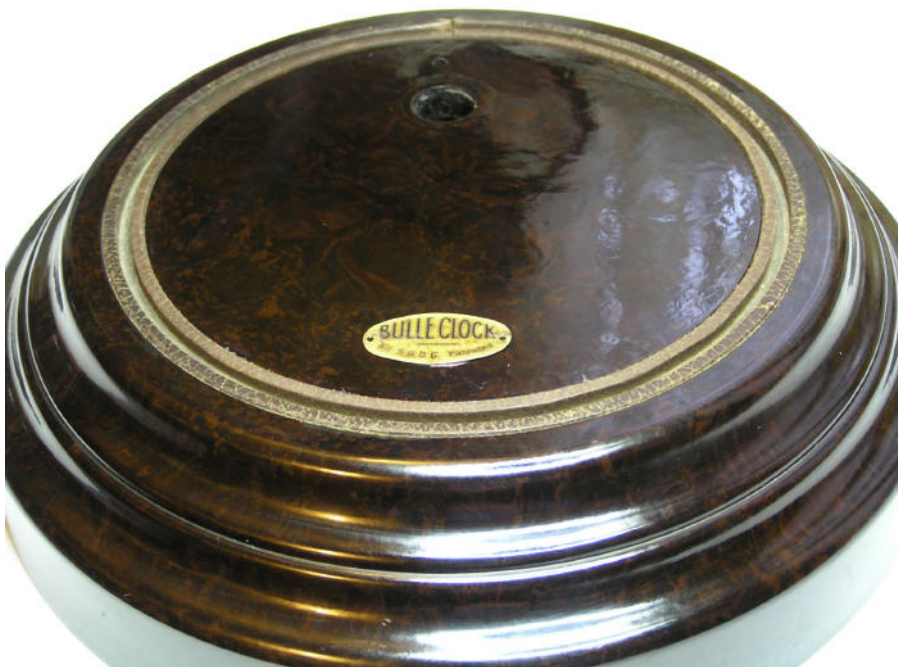
Compare these photos with those at the beginning of the restoration.

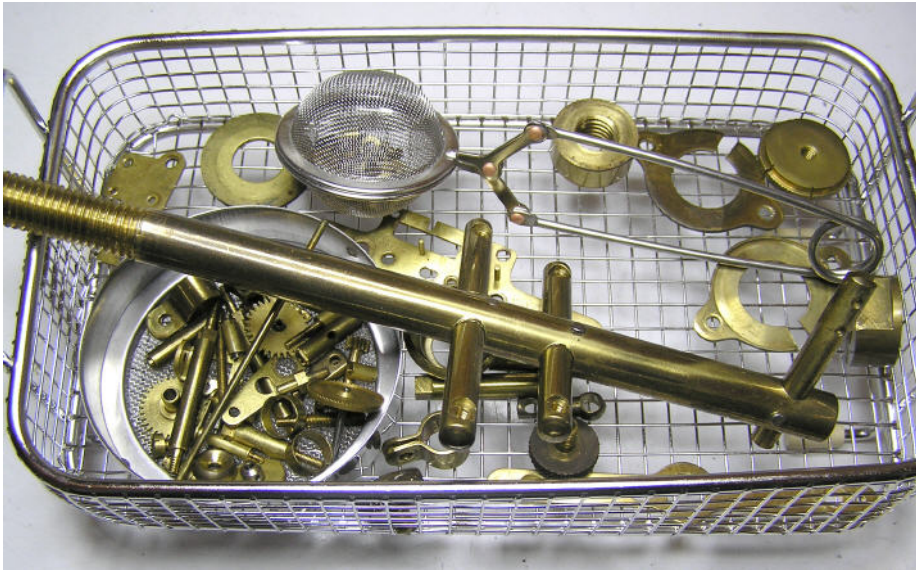
The clock stripped and prepared for the Ultra Sonic cleaner. The parts are roughly graded by size. The smallest parts that are easily lost are placed in the fine mesh holder that looks like a double Tea strainer. The handle acts on the opposing mesh covers and clamps them tightly shut. Nothing is going to escape from there. The next are placed in the open fine mesh cup. Finally the largest parts are placed in the standard wire basket that comes with the tank.

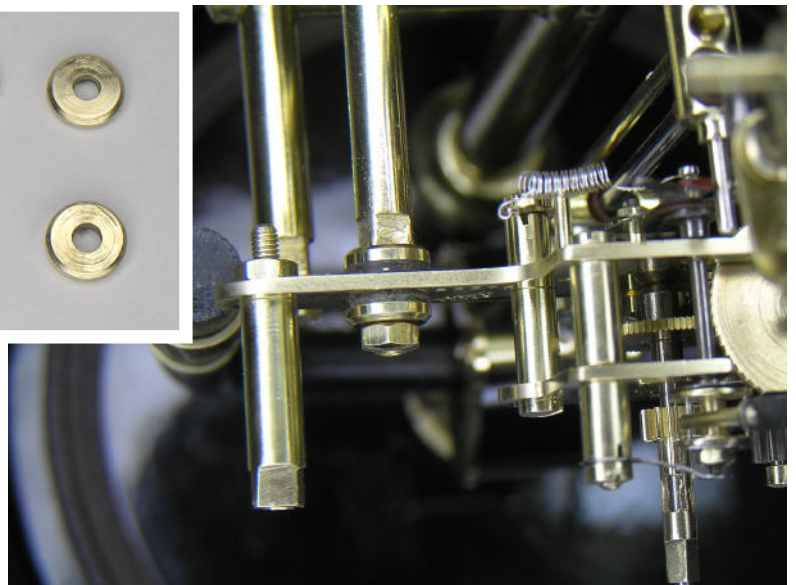
The photo also shows the Silver Contact spring in position. This must be tensioned very slightly to give a forward pull to the fork arbour. This encourages the arbour to move forward against the steel stop at the front of the clock.

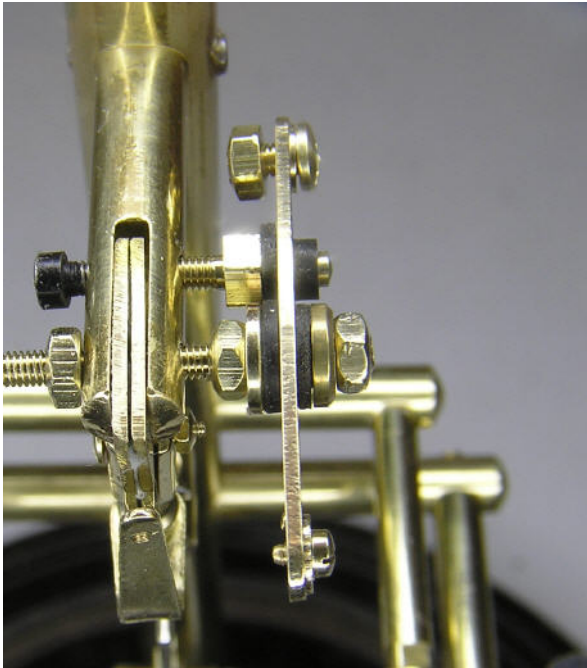
The arm that carries to the current to the Spiral torsion spring is shown in position. The arm is tested to make sure it is correctly insulated from the frame. The long threaded rod also secures the silk suspension and must be positioned carefully before tightening as the suspension must be held securely here and not allowed to rock in any direction. The small blued screw at the rear, in conjunction with the insulated bolt on the opposite side finally trap the top of the suspension and prevent any vertical or sideways movement. The spiral torsion spring can now be fitted to the pendulum and connected to the small screw at the end of the arm.

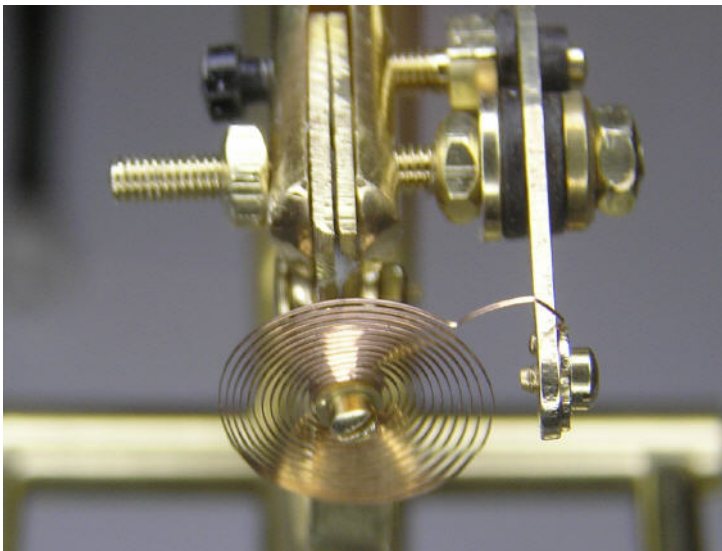
The new Spiral Torsion Contact spring in position at the top of the pendulum. The spring has no other function other than to provide electrical continuity so its characteristics as a spring are completely irrelevant as long as it's long enough

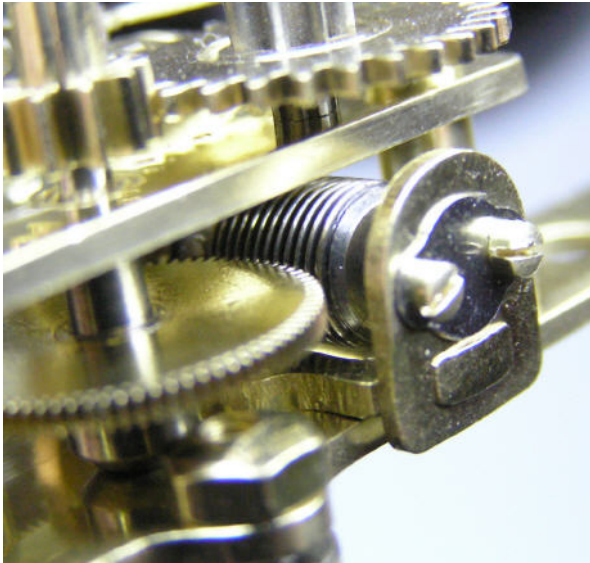
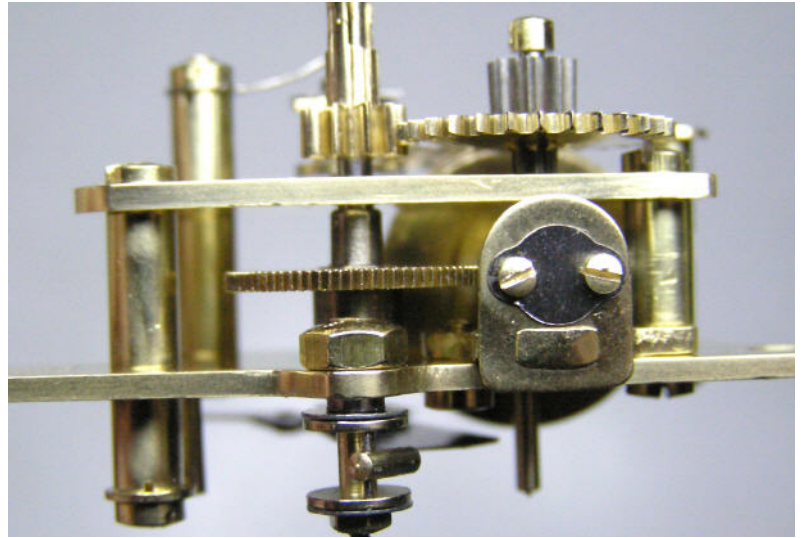
The worm wheel and minute arbour cleaned and in position..

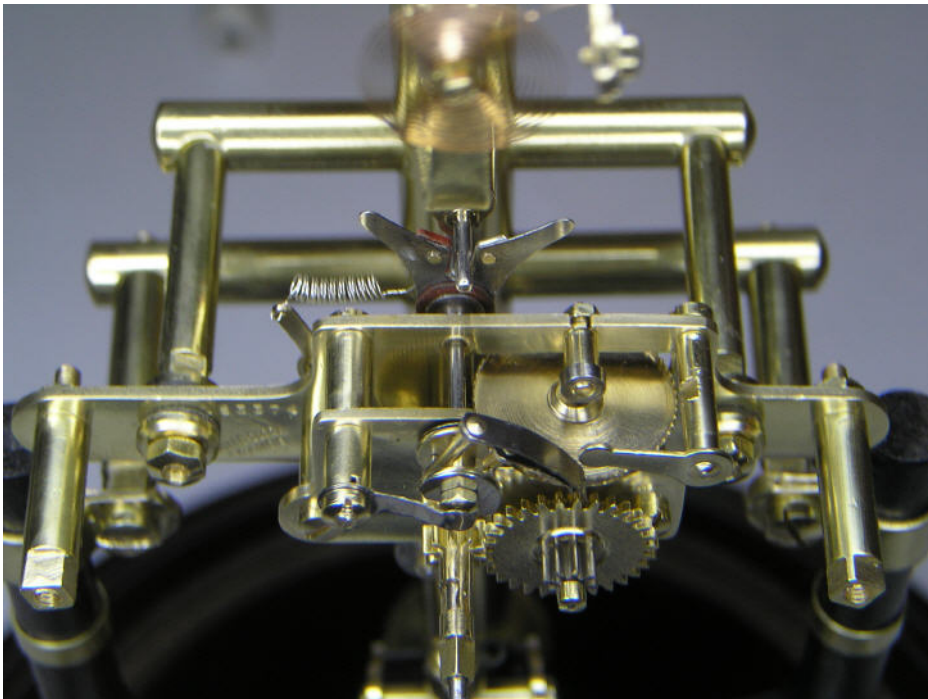
The completed movement in position on the frames. The contact assembly has been adjusted to sit with half of its diameter in the fork. Everything is now ready for the wiring to be added and the clock tested before turning our attention to the dial. The clock will be checked for pendulum amplitude as well as making sure that the pawls only collect one tooth of the count wheel for each complete swing.

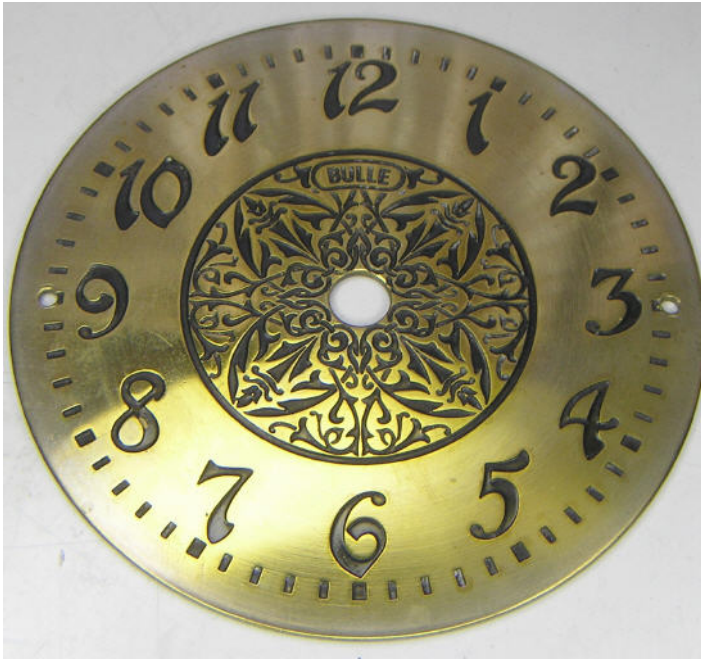
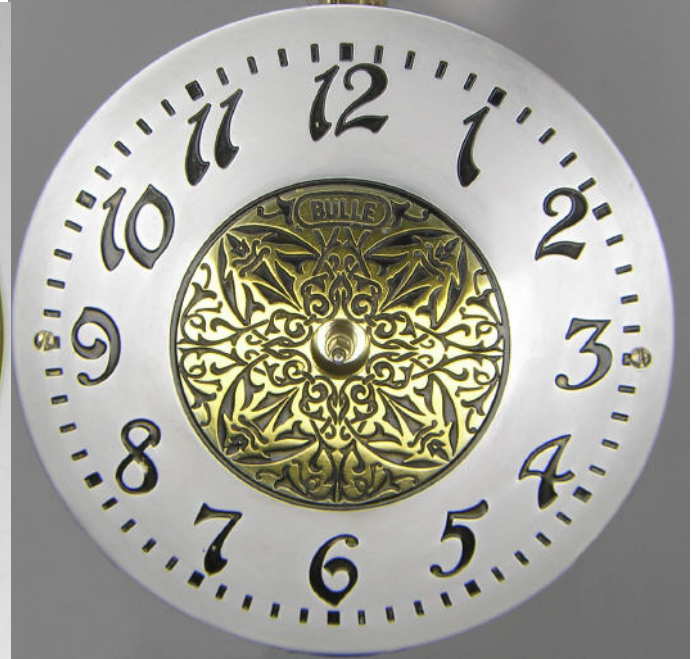
The dial before and after. The chapter ring has been cleaned, silvered and lacquered.. Notice how the characters show up much more clearly against the silvered background.

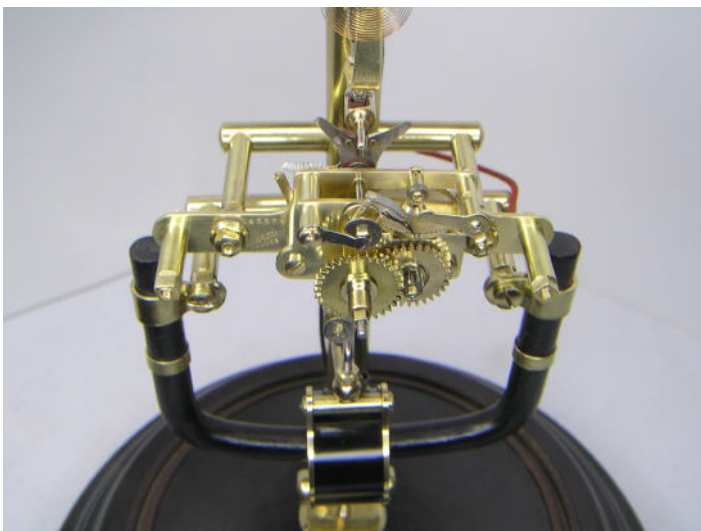
The clock is now ready to receive the dial.

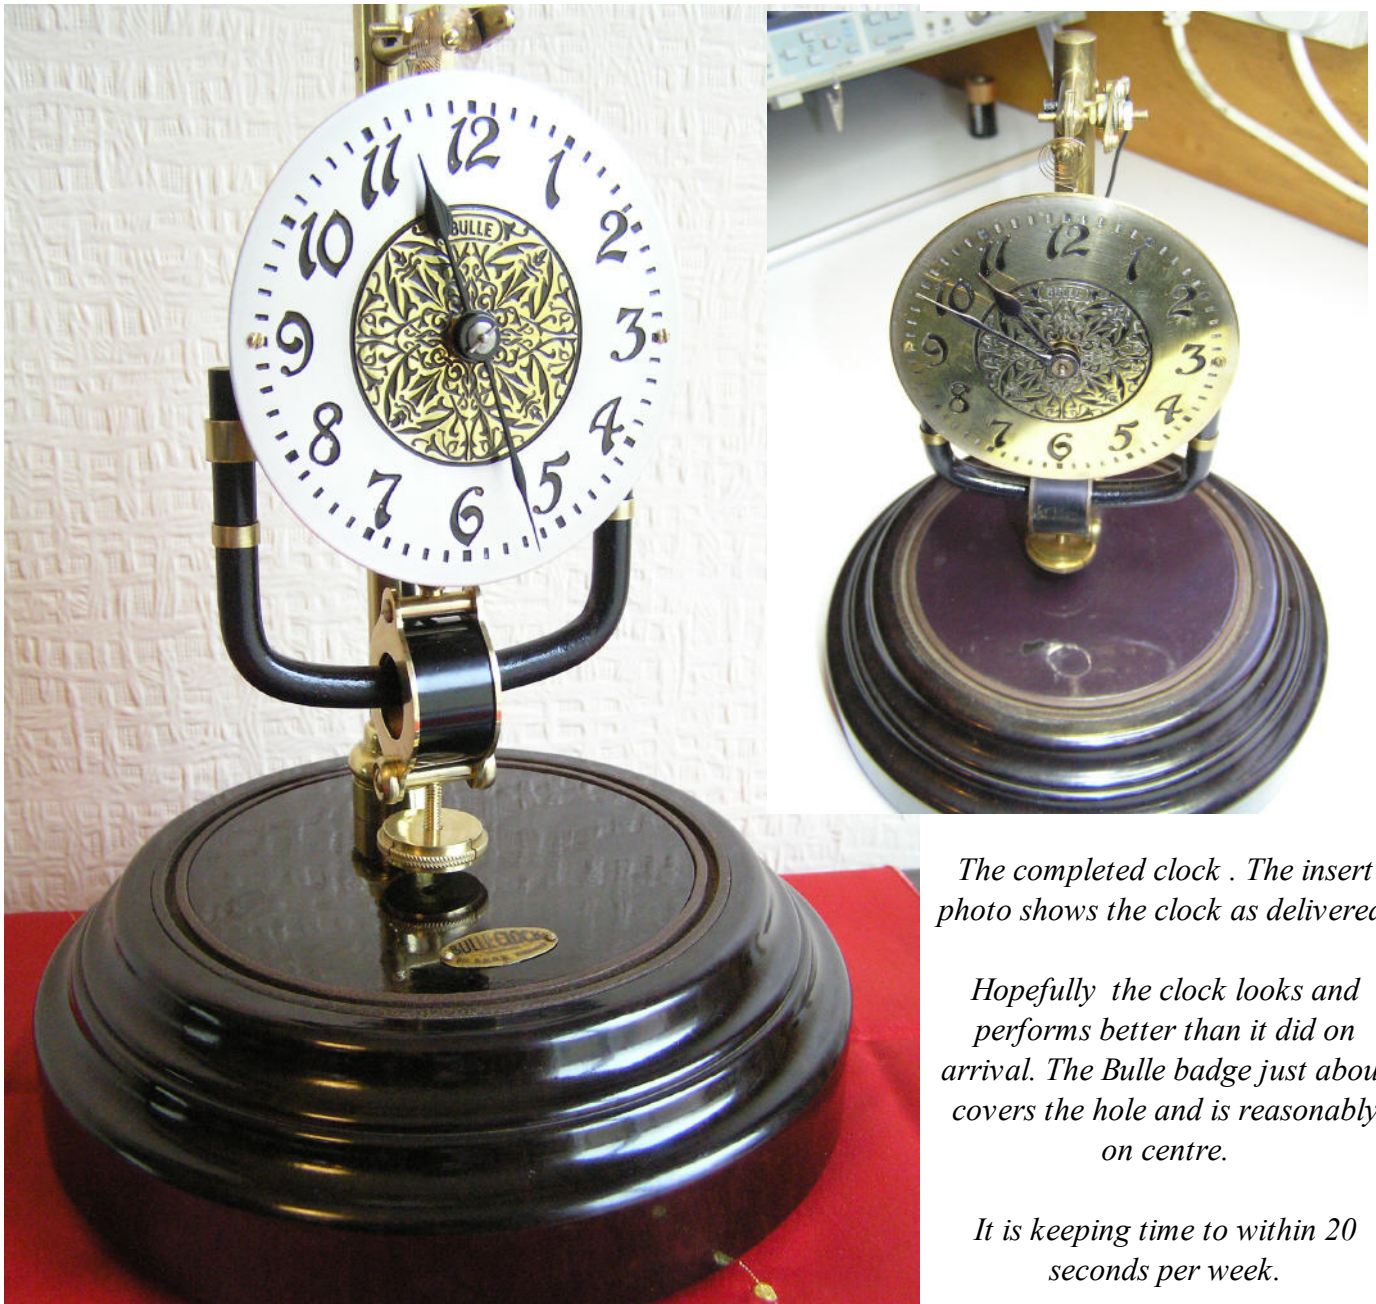
The completed clock . The insert photo shows the clock as delivered.

Hopefully the clock looks and performs better than it did on arrival. The Bulle badge just about covers the hole and is reasonably on centre.

It is keeping time to within 20 seconds per week.
