Restoration of Bulle Clock Serial Number 186300.

—Early Battery Clock Parts & Restoration

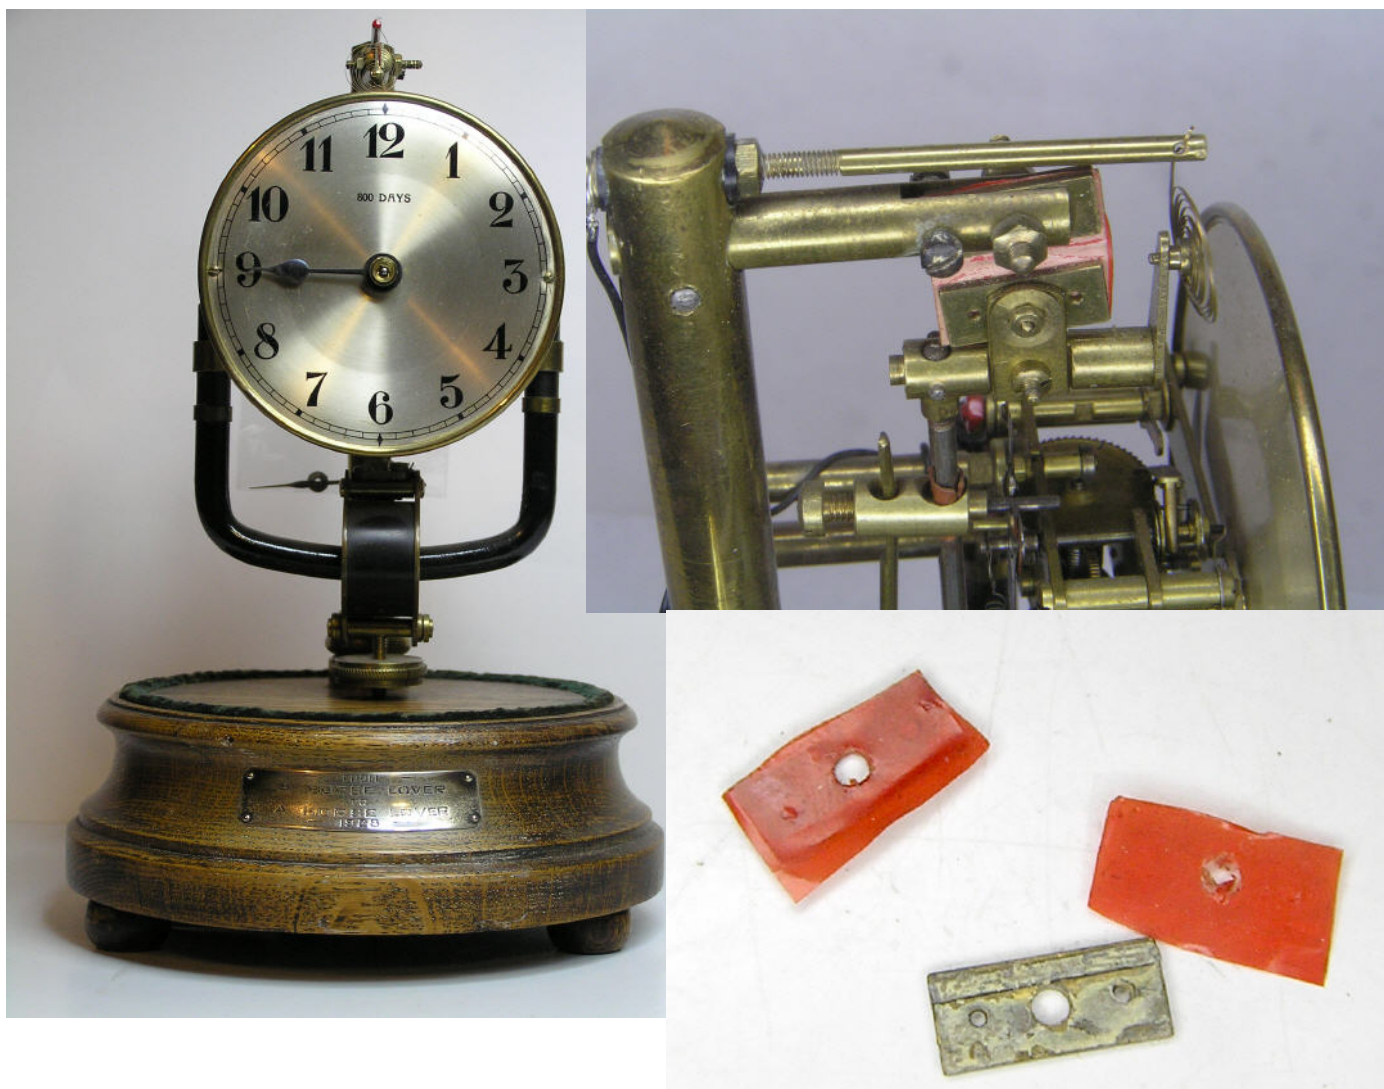
This Bulle clock is in for a full, restoration and the owner has kindly agreed for it to be shown in the various stages of repair. The suspension was made from the original chops pinched together with some form of thin red plastic sandwiched between.. It wouldn't have lasted long. Besides which it was much too long and the pendulum was hitting the base. The hairspring was loose and the end was loosely looped into the overarm with no pin.. The dial is in quite good condition although the minute hand had come away from it's collet. And will need to be re-set or a new collet made. The base has a silver engraved plate which states "**From a Horse Lover to a Horse Lover, 1928**". Good dating evidence.

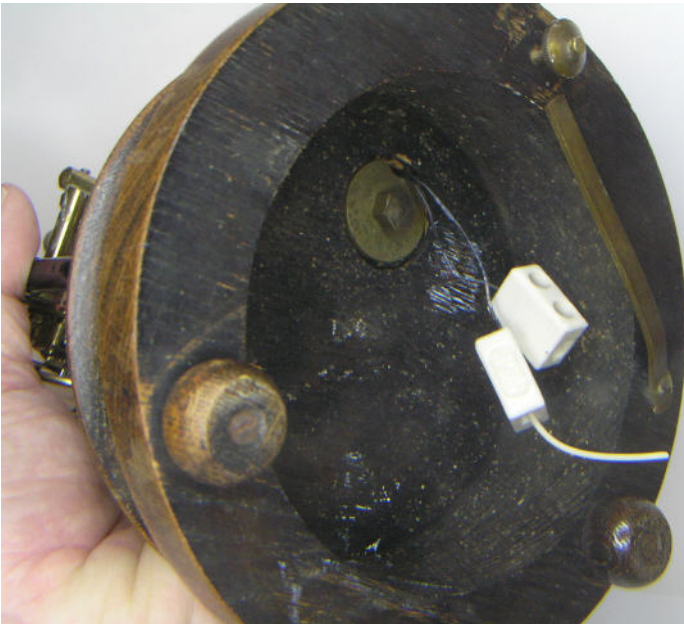
The base is generally in good condition but is flat and tired. In this case the base was not French Polished originally, so I shall stain the wood, seal it and wax polish.

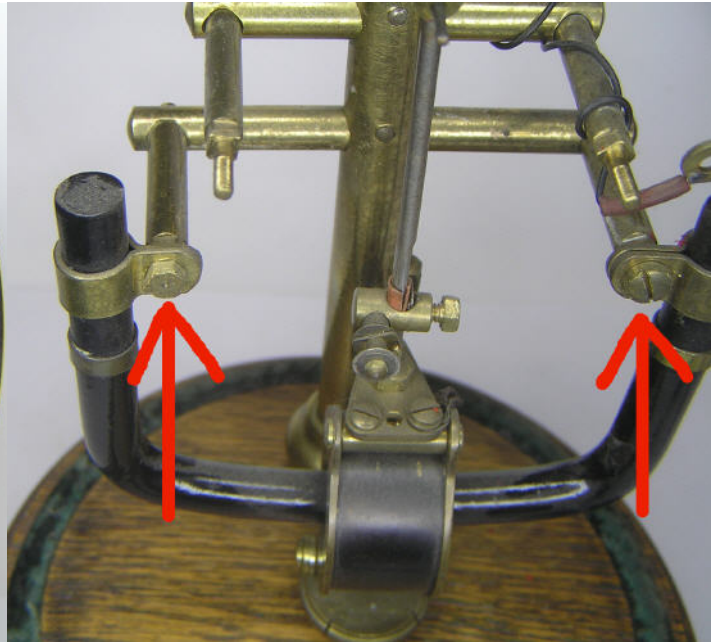
The clock has been apart in the past and some screws and nuts re-assembled in the wrong places. Note the magnet retaining screws have been mixed up with the contact pin assembly.

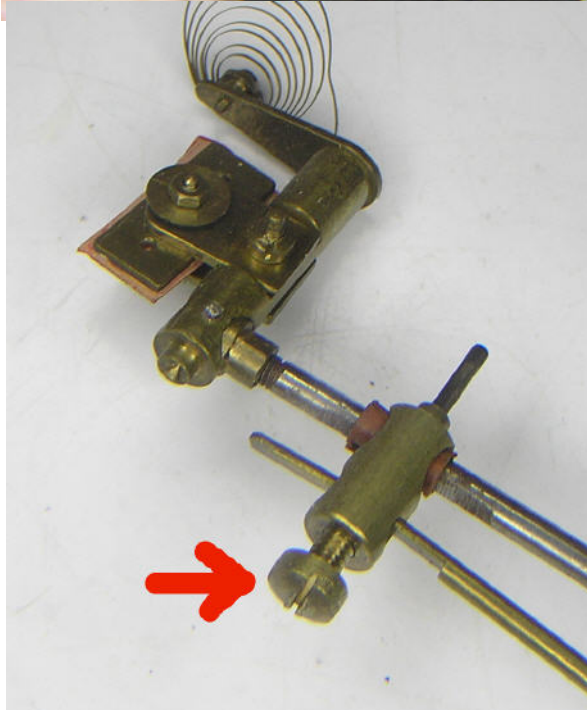
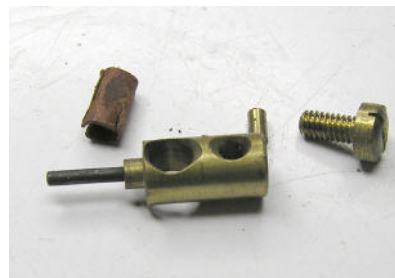
The assembly itself is missing the steel "T" piece which stops the fibre from being pierced and so shorting the pendulum.

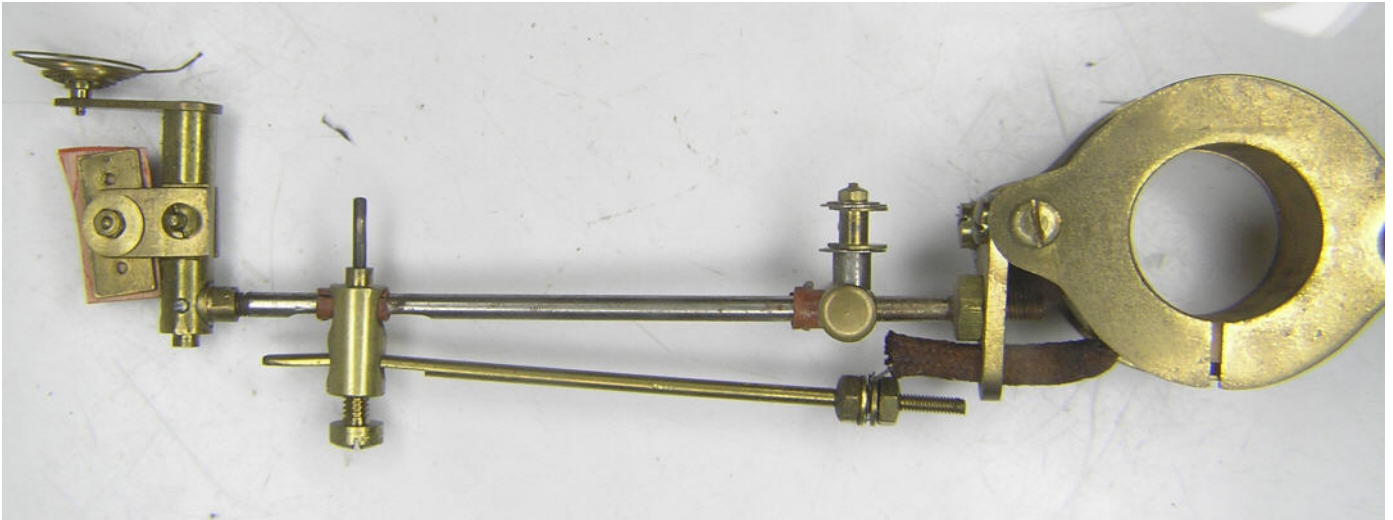
The pendulum assembly which shows the brass rod is outside it's insulating sleeve. This was wrongly re-assembled at some time in the past.

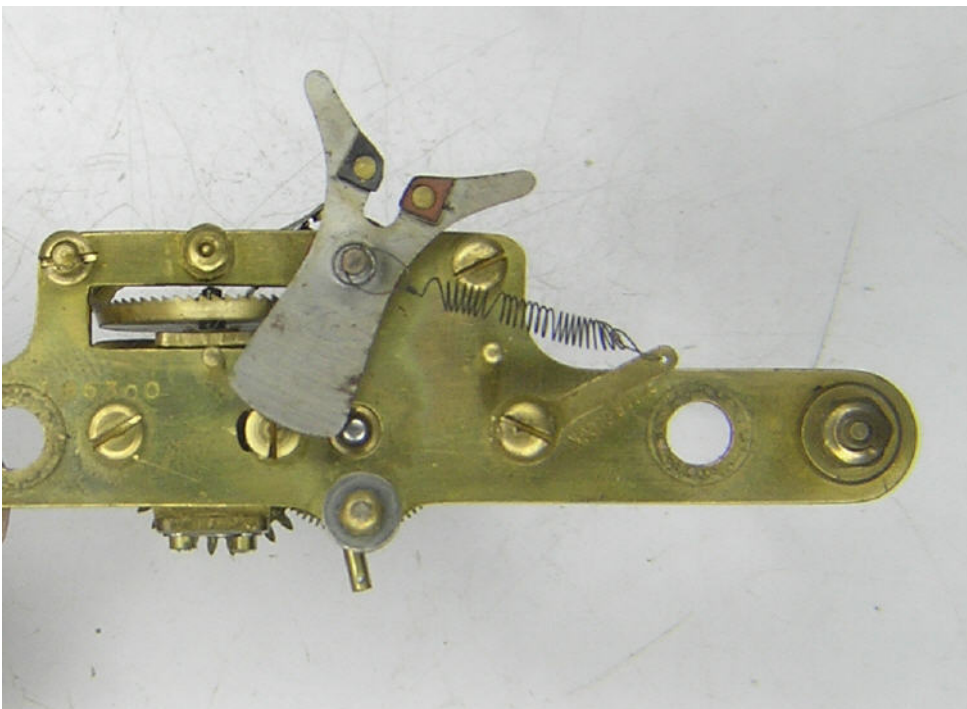
The rear of the movement looks to be in quite good condition with the exception of the Contact spring which looks to be a very stretched replacement. The fork though shows signs of wear on the fibre and silver contacts. The close up photos on the next page show the problem in more detail.

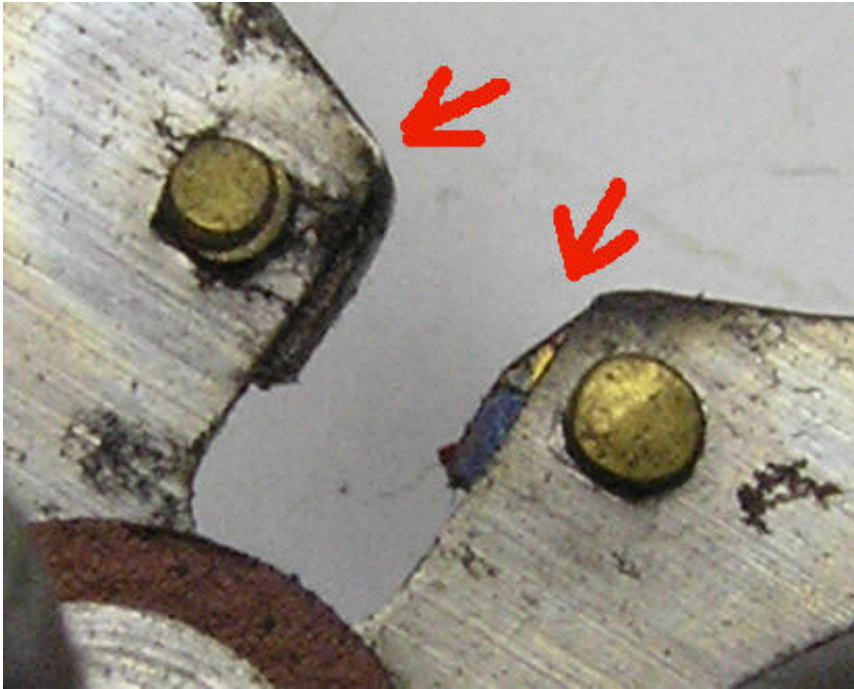
This photo clearly shows the wear on the silver contact. The result is that the contact pin is starting to wear on the hard steel of the fork. The other side shows where the fibre has also worn away leaving the pin to contact the other side which would then allow the current to make an intermittent flow to the coil in the pendulum at the wrong time and so decrease the amplitude of swing.

Altogether, not a good condition for the fork assembly to be in. We shall need to replace both sides., silver and fibre.

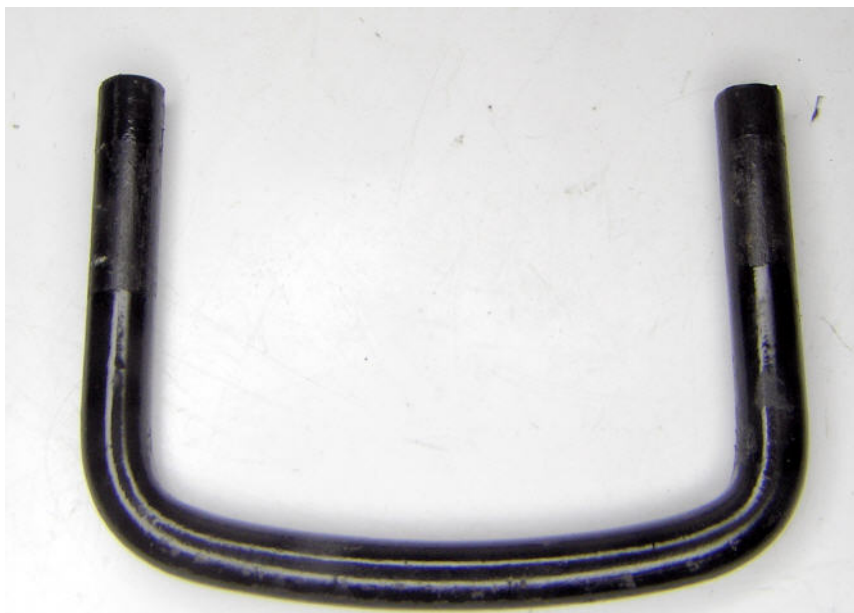
The Horseshoe magnet has been painted at some time in its history. Note that the area that was under the retaining brass rings is left unpainted suggesting that it was painted after manufacture. This paint will be removed and the magnet polished with Grate Black.

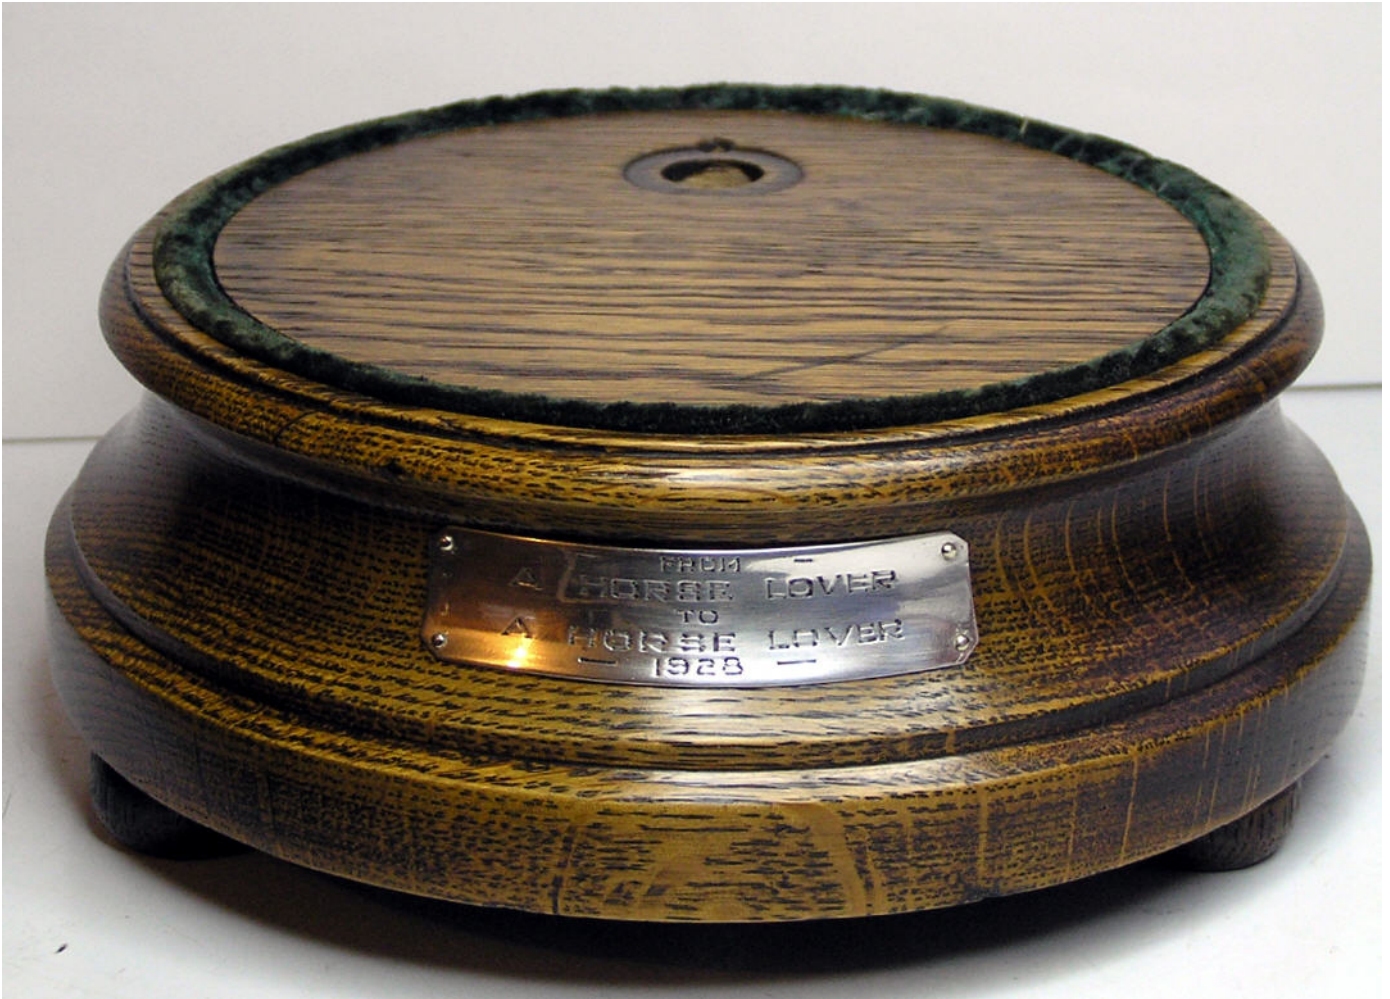
The base after cleaning, staining, sealing and polishing. The silver plate was removed and cleaned separately, the silver pins removed with tweezers. After cleaning the plate was lacquered to resist tarnishing. The oak had a good patina which has been retained with just a little more depth of colour obtained with the stain. The base is now ready to accept the column.

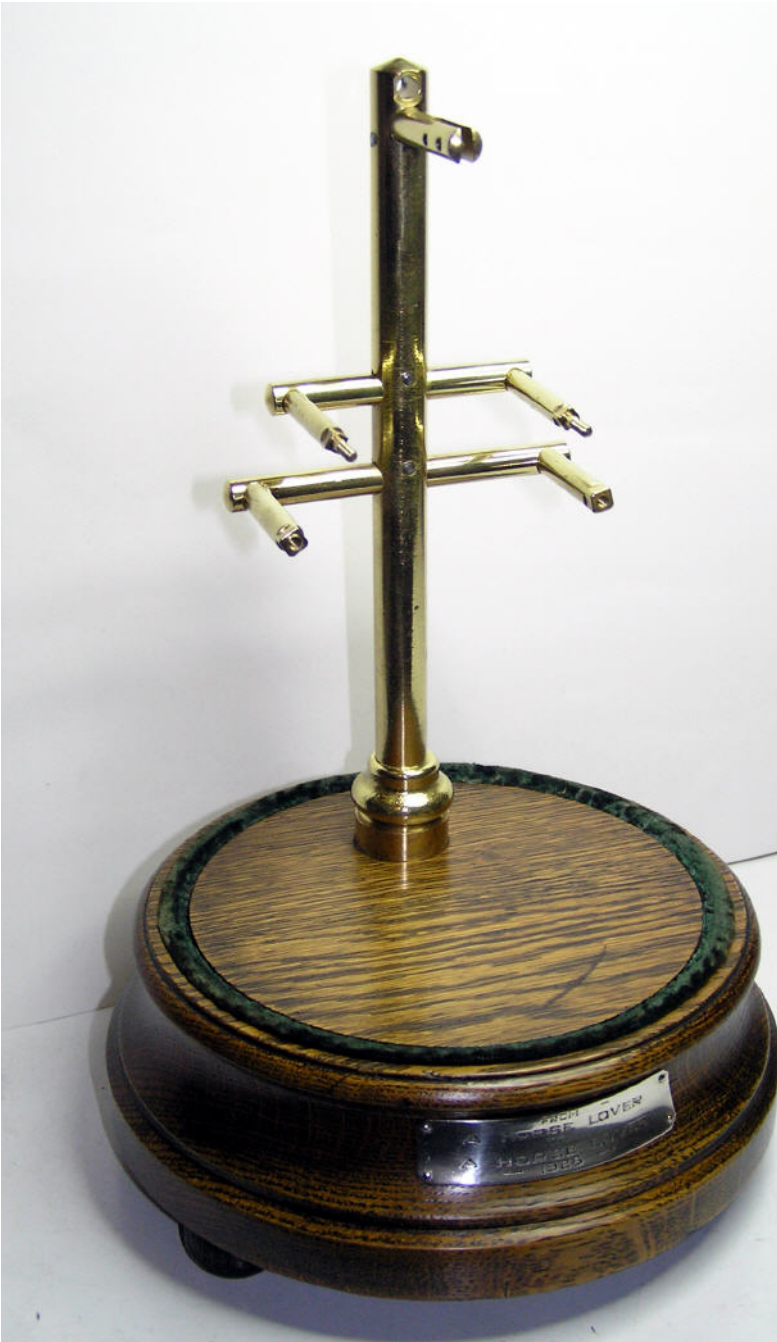
The base and lacquered column reunited ready for the movement and pendulum assembly.

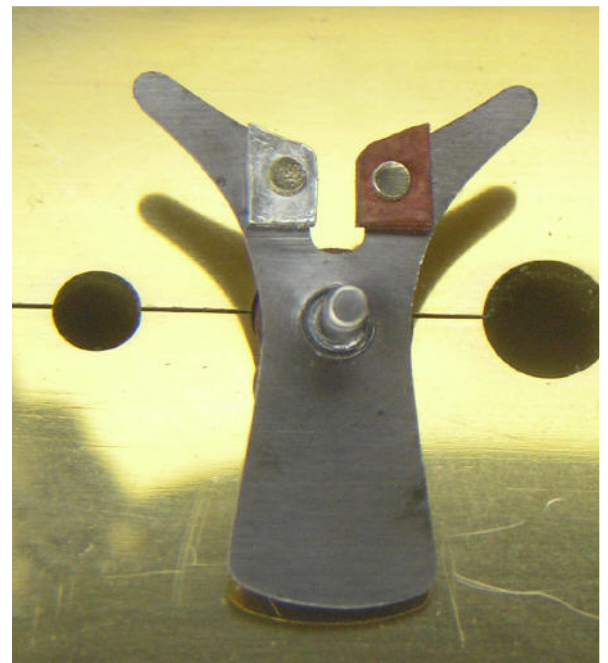
The fork with new silver and fibre contacts. The new pieces have been riveted in position and roughly shaped. Final shaping and smoothing will be done when the movement is checked in position with the Contact pin of the pendulum.

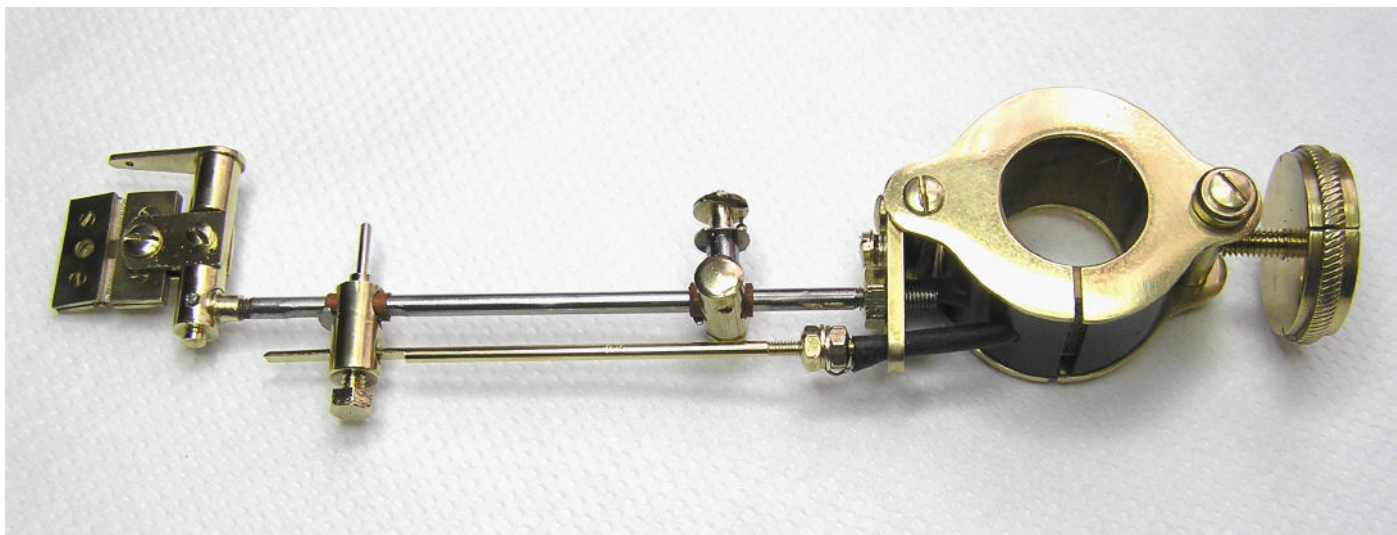
The pendulum reassembled ready for hanging in the frame. New insulation has been added to the connections from the pendulum bob. The new "T" piece has also been made and added to the contact pin assembly. The whole assembly has then been tested for continuity and a resistance. The reading in this case was a steady 1170 Ohms.

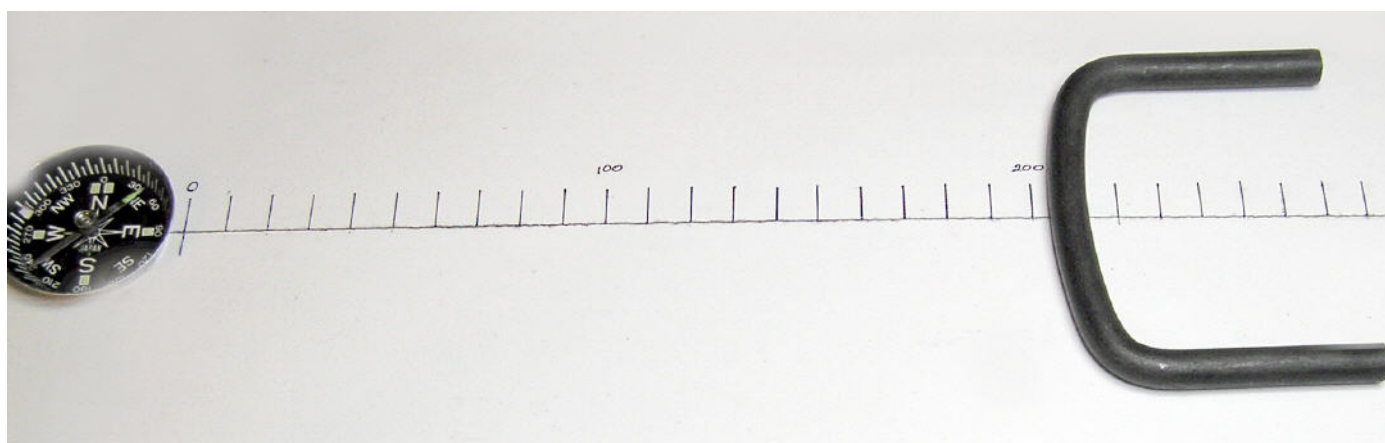
A simple Magnetometer to check the comparative strengths of Bulle magnets. A board with a compass permanently fixed to it, is lined up so that the needle points North. A scale is marked on the board along the East / West line. A magnet is then introduced along the scale from the right until the needle is deflected 45 degrees from North. The scale is in millimetres, marked at 10mm intervals. In this case the magnet deflects the needle to 45 degrees at about 205mm which is right for the Bulle. Before I re-magnetised this one, it read about 170mm. I re-magnetise any magnet that falls below 180mm.

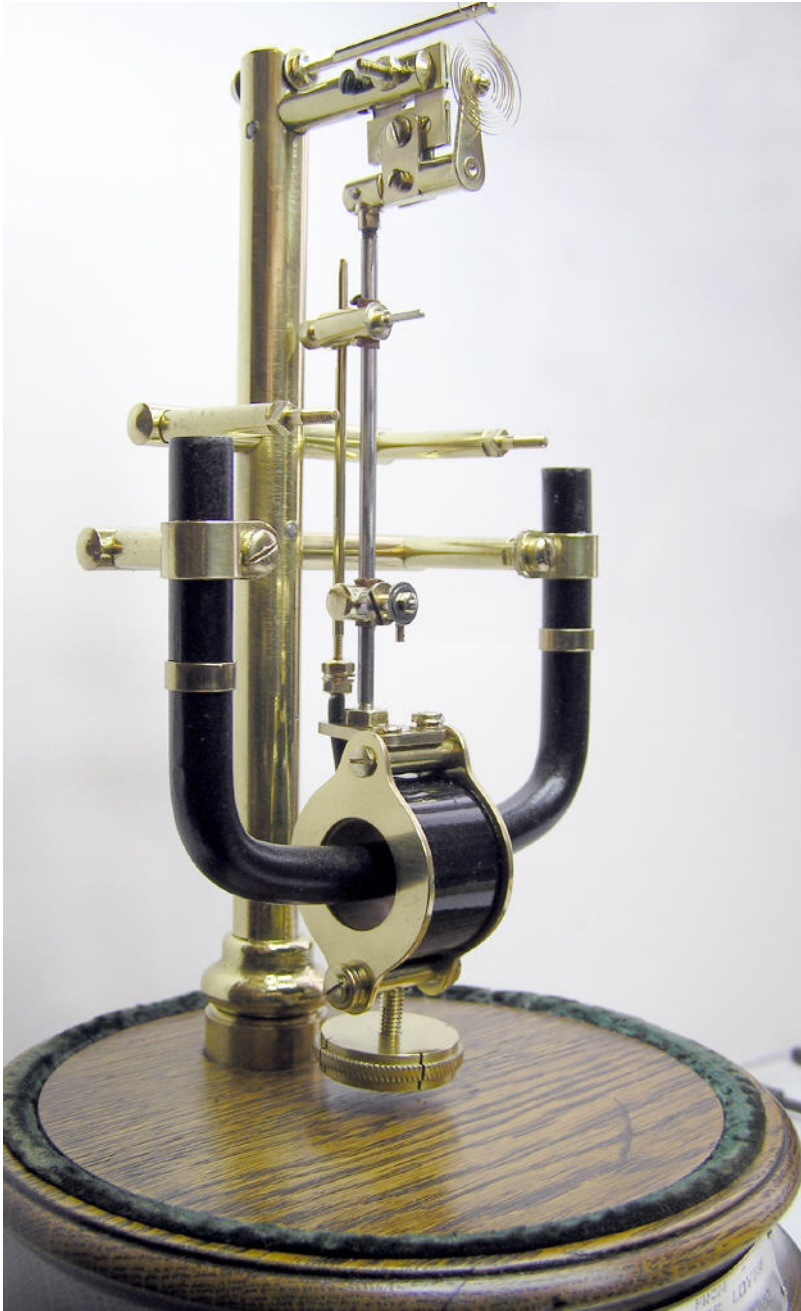
The Magnet and pendulum reunited with the frame and base. The height of the pendulum is checked for length so that it is about 4mm off the base. The hairspring coil at the top will be reconnected next and the whole circuit tested for continuity again. I always find it prudent to keep checking this at every stage just in case you introduce a problem. It's better to find out now than later when the whole clock is rebuilt.

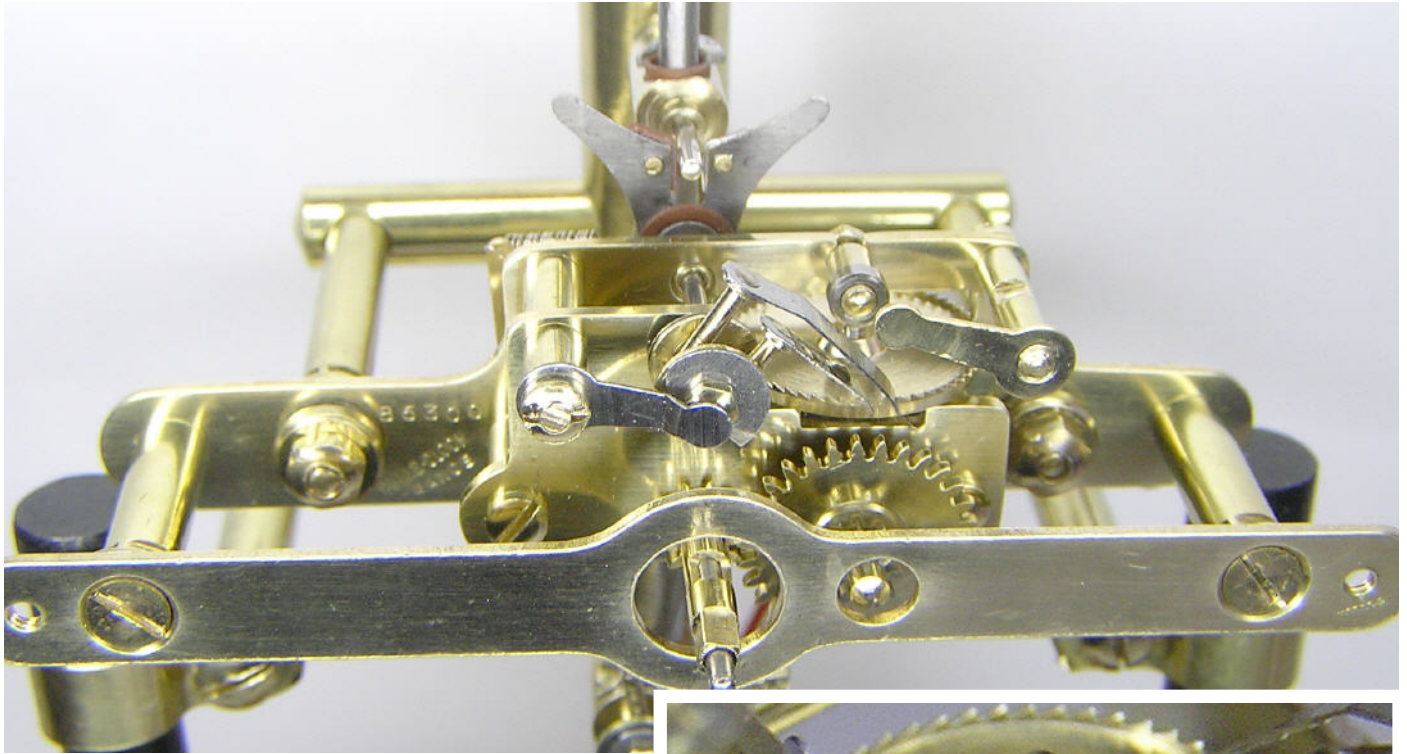
The movement finished and in place on the frame. Note the depth of the contact pin in the fork. This should be adjusted up or down to suite the pawl throw. The small pawl should advance the wheel one tooth at a time only.

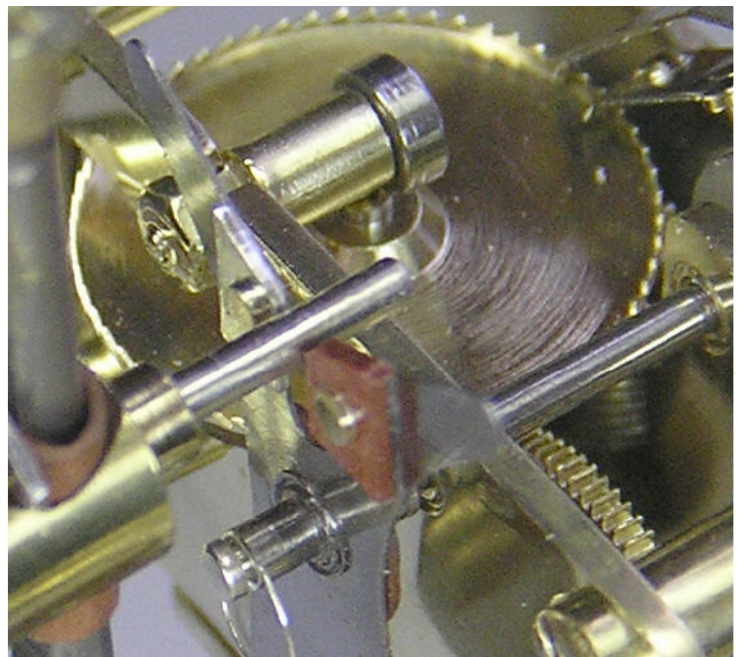
The second photo shows the fork and it's new silver and fibre contacts.

The loop of the silver contact spring can also be seen in the groove of the silver end of the fork arbour.

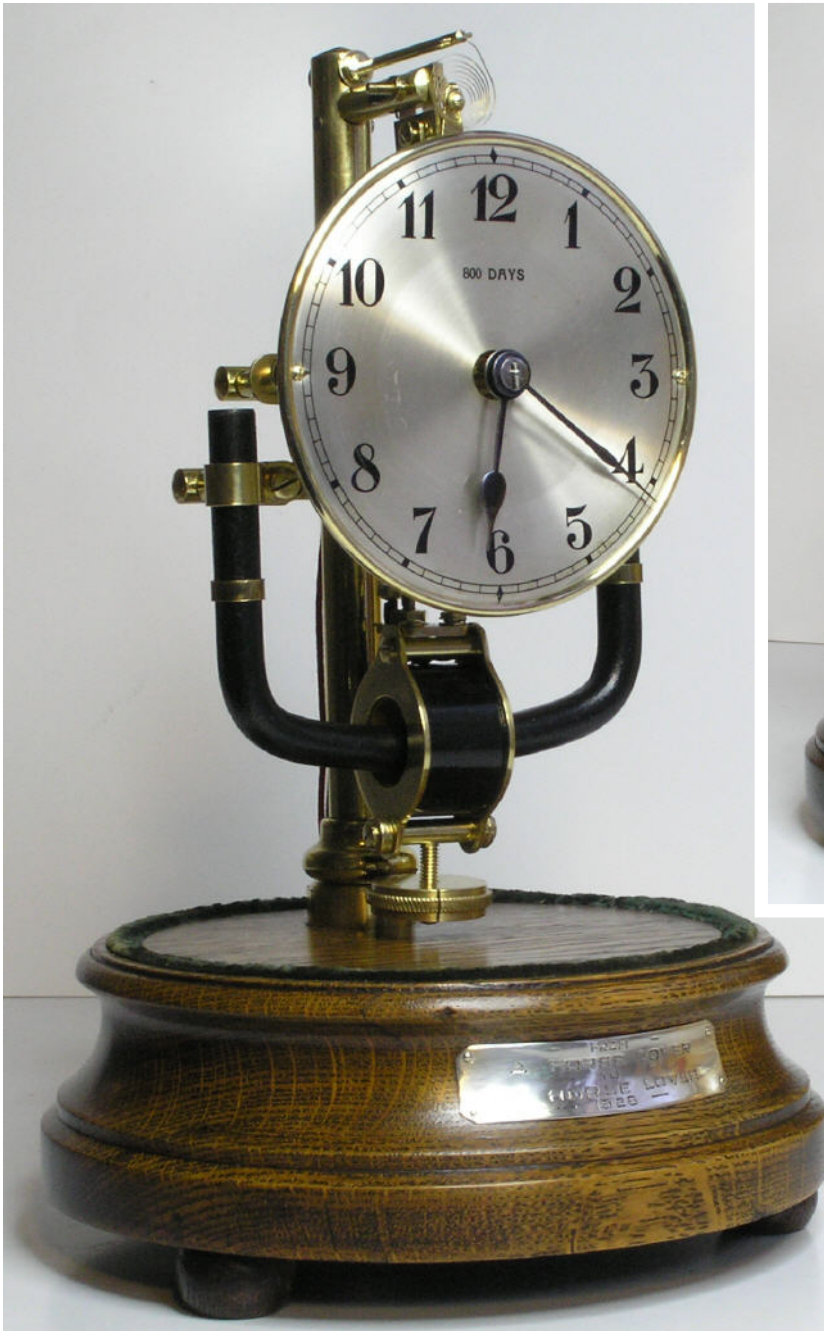
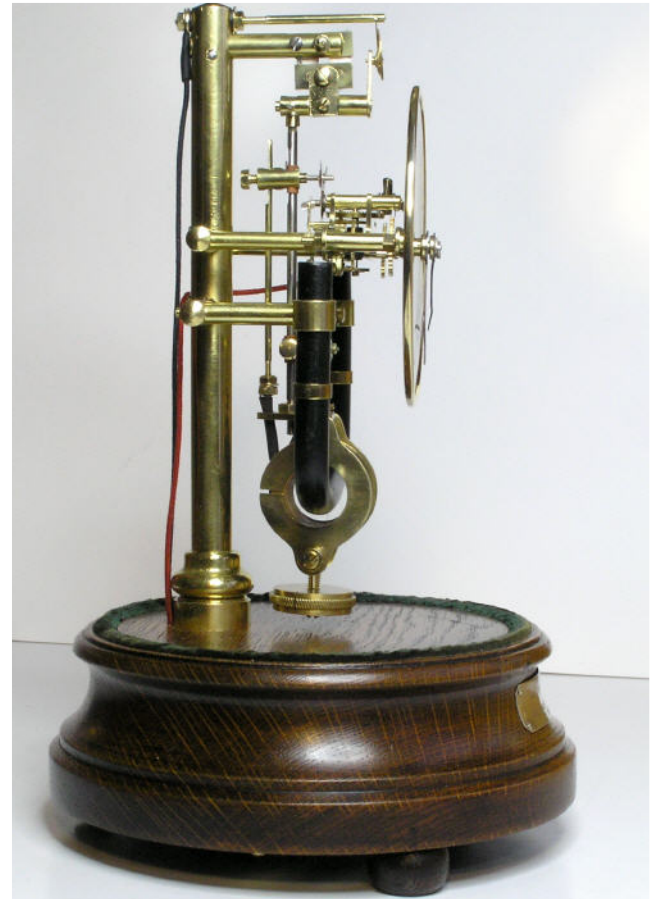
The finished clock ready for a weeks testing. The minute hand has been riveted back on the collet and polished. When the battery was connected for the first time the pendulum immediately started to oscillate and a good amplitude was gained in about 20 seconds.
