# Horologix

*Early Battery Clock Parts & Restoration*

## *Restoration of Bulle Clock Serial Number 26561.*

## **Bulle Clock Serial Number 26561.** *(By kind permission of the owner)*

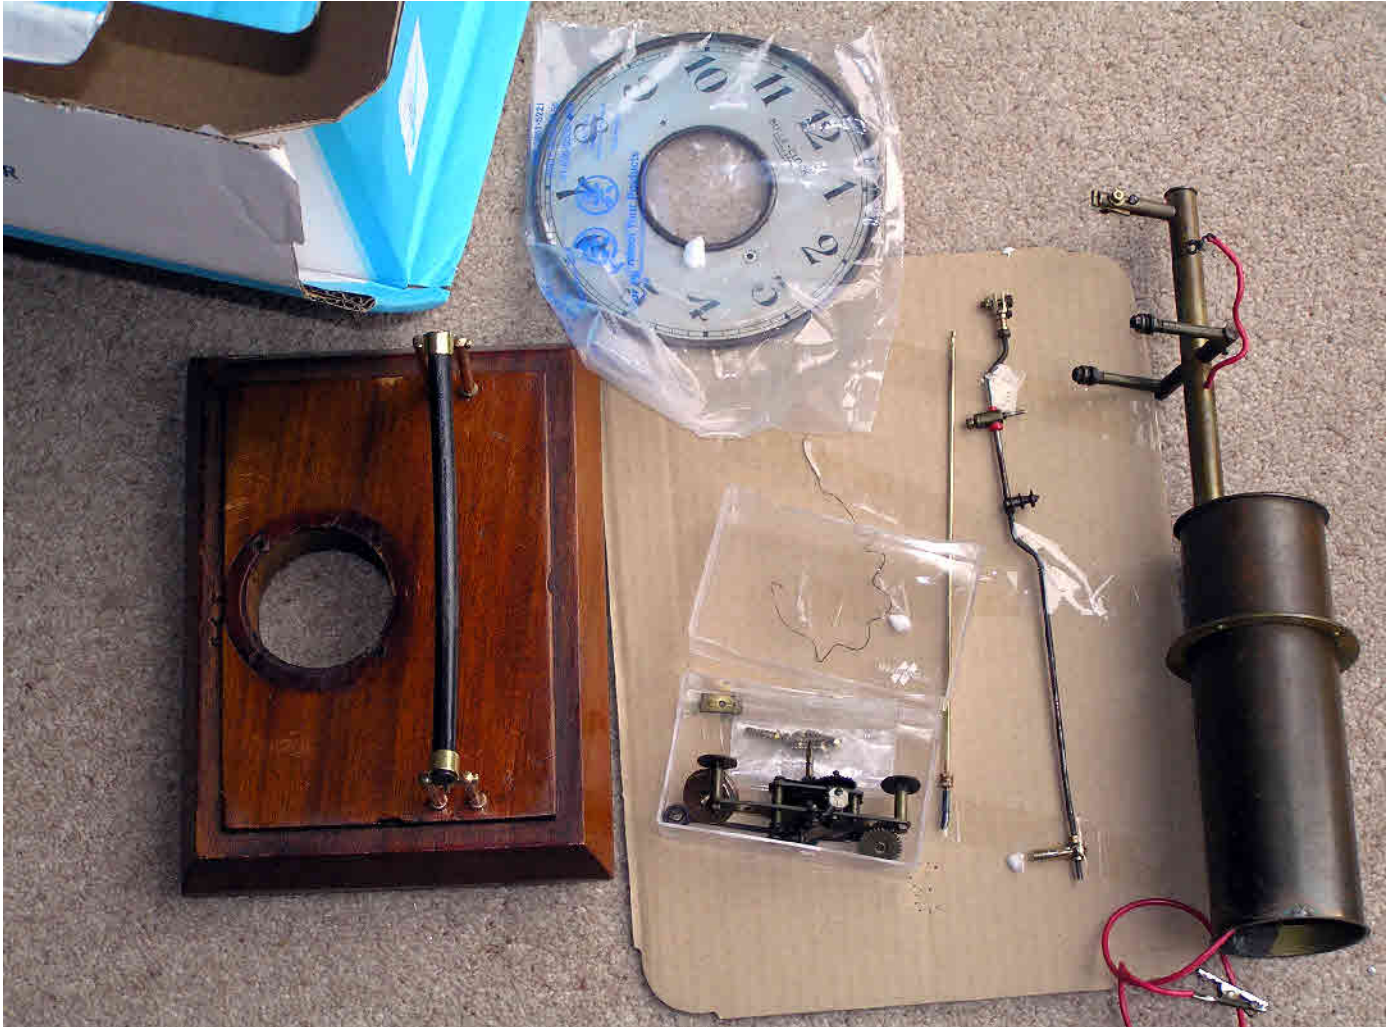
This Bulle's a tall movement on a square mahogany base. Most of the clock looks as though it is there with the exception of the Pendulum bob and coil, which was found later. The clock as found can be seen in the photo below.

*The column on first inspection looks as though it has had battery acid burns (not unusual for a Bulle) and has had some soldering done at some time. It looks as though this was to attach a wire rather than trying to fill any holes.*

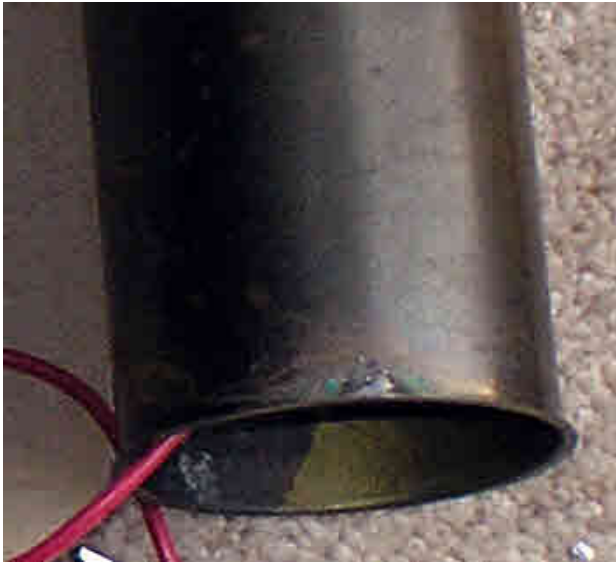
This photo shows the damage in more detail. The acid burns look bad but they have not caused any major holes although they will leave some tell tale marks or stains when polished. Hopefully not too bad though. The solder is shown to be purely where a past repairer has tried to connect a wire.

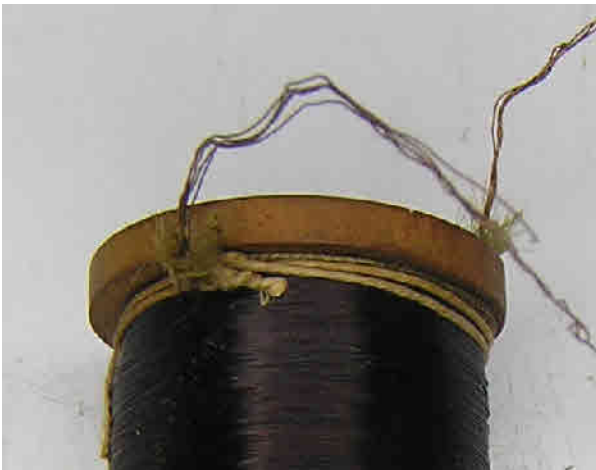
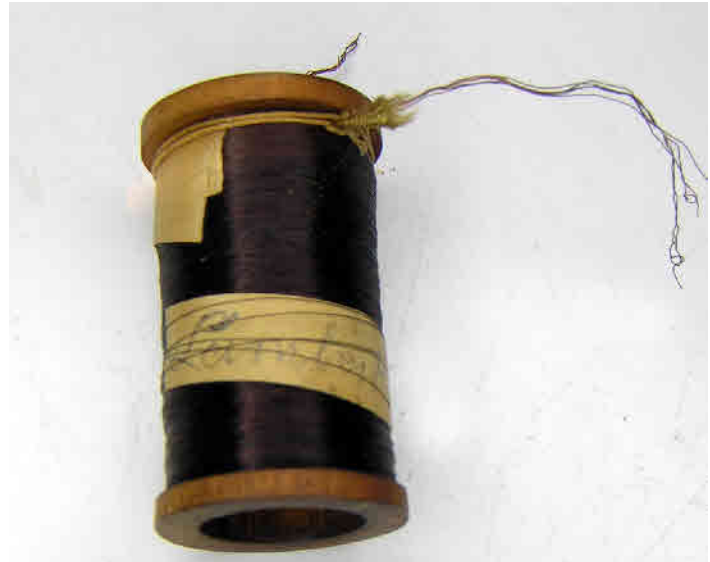
The coil looks to be in good condition but in fact proved to be dead. There should be a resistance of between 1100 and 1300 Ohms. I hope that the damage is in the joint at the end where the small 6500 turns of 42 gauge enamelled wire is soldered to the large multi strand copper wire. The original winder of the coil has added his name to the paper covering the joint. He never thought that in Eighty years time his signature would be seen on a computer screen available for all the world to see.

I have unwound the coil for about 30 turns but it is still dead. There are no obvious cuts or marks on the coils so it looks as though the break must be at the other end where the joint is under the 6500 turns and impossible to fix. I will use another coil that I have wound ready for such an occasion. This one will then be rewound and put away ready for another dead one. The new one is wound on a wooden bobbin in exactly the same way as this one.

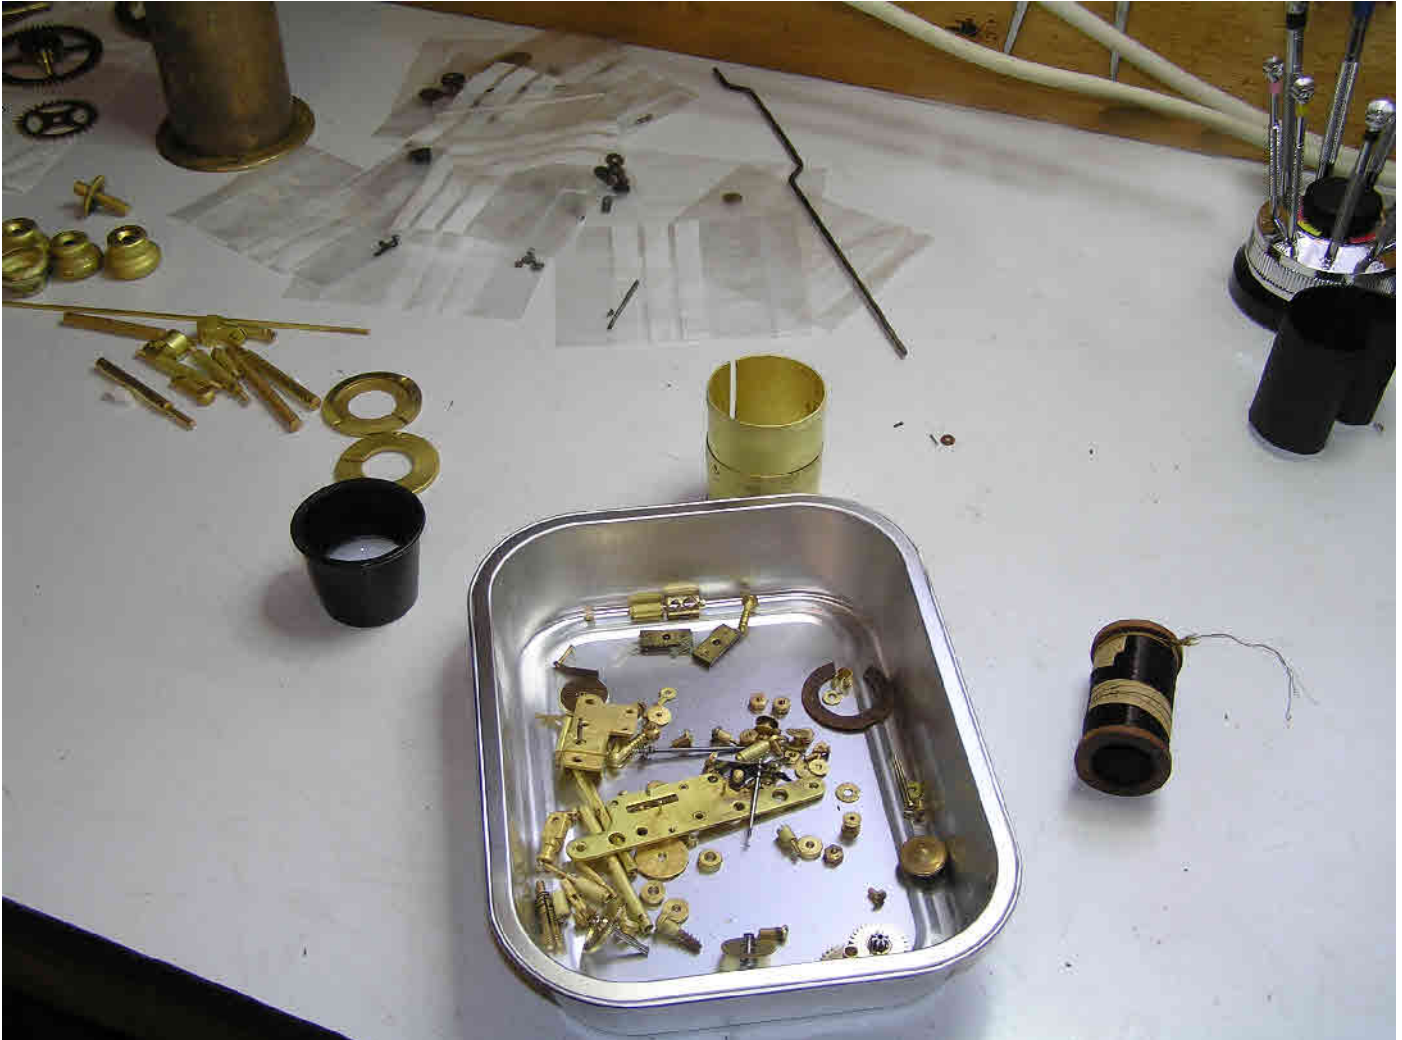
*The clock after disassembly and initial cleaning in the Ultrasonic tank,. Note that the steel and fibre parts are kept separate in plastic bags. They will be cleaned and used as required. Note also the paper washer that is found on the inside of the pendulum bob. Make sure it is put back when reassembling. The cord around the bob was in a terrible state and was heavily glued in place. I normally like to keep the original where possible but this was too badly corroded. I will rewind with new green cord as original. Note Also the textured paper that is usually wrapped around the coil. This should also be carefully put aside for rewinding once a coil has been repaired..*

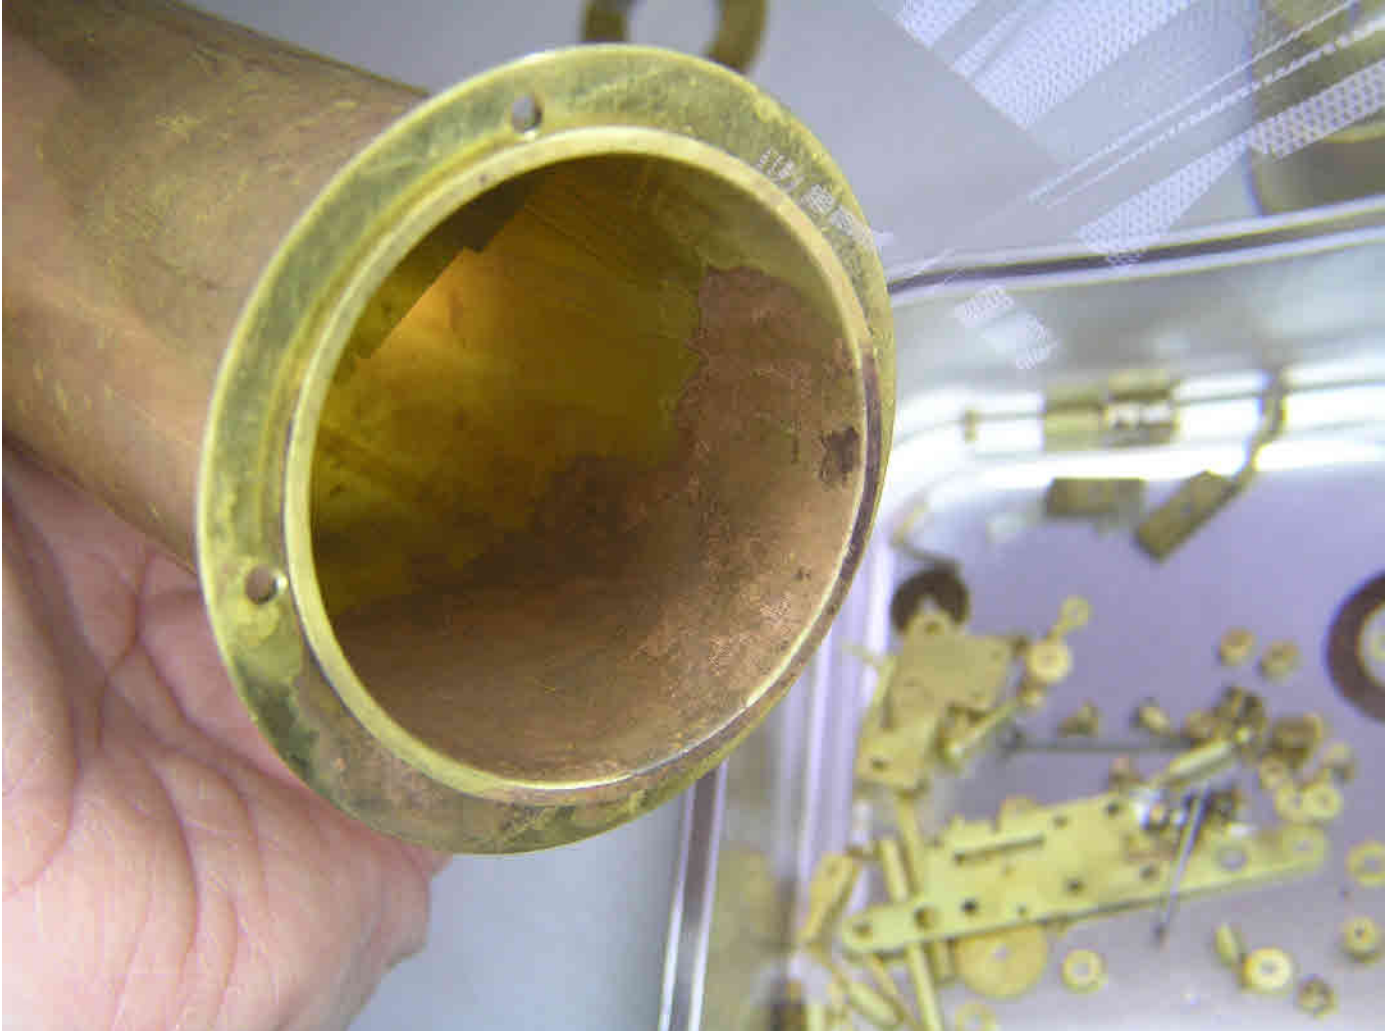
*The column after initial cleaning in Horolene and then White Malt vinegar. The corrosion has been removed leaving clean bare metal. The colour is the copper that has been left, I guess, after some of the Zinc has been eaten away by the battery acid. There is some discolouration on the outside as well but most will be polished away. There are no large burn through areas.*

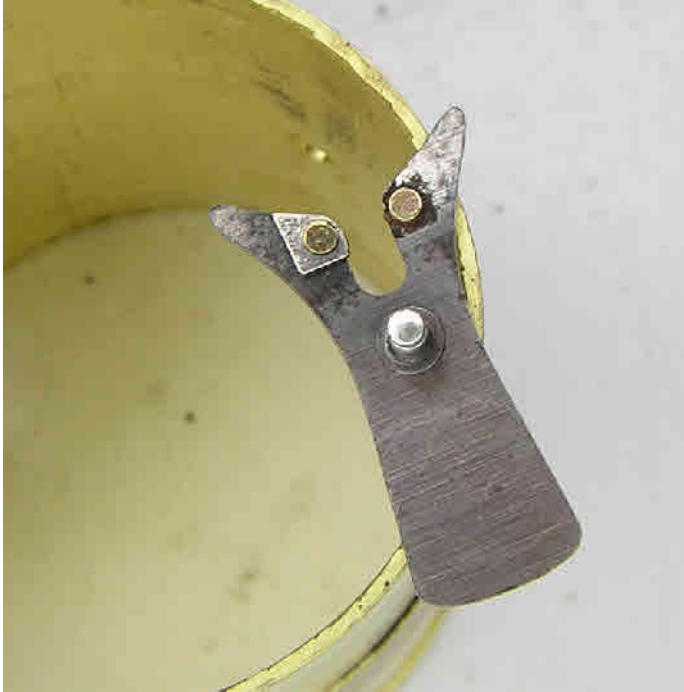
*The fork is pretty well worn and will need some work. The fibre is all but gone and just leaves the brass rivet. The silver has worn down the the fork. A new silver contact will be made from silver flat. The new fibre will be cut from the solid.. Two new 1mm rivets will be turned on the lathe.*

*The silver end of the fork arbour is still in good condition and will last another 80 years. There is some rust on the steel fork but this will be cleaned and will cause no further problems.*

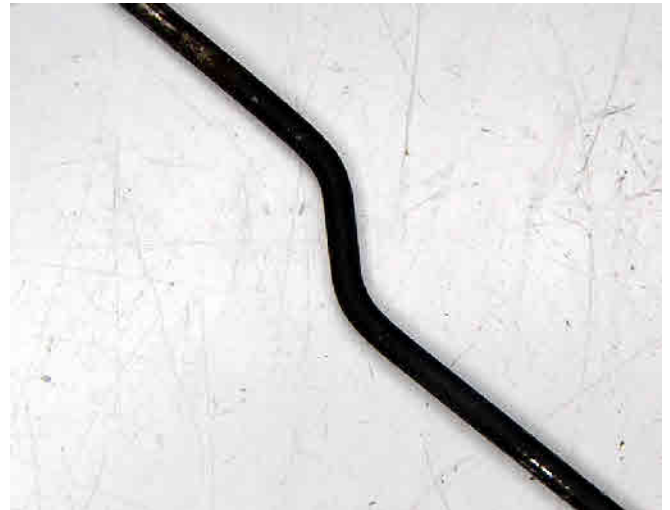
*This photo shows that the steel pendulum rod is in a pretty rusty state but has no serious damage. The threads at both ends are still in good condition and will clean up well.*

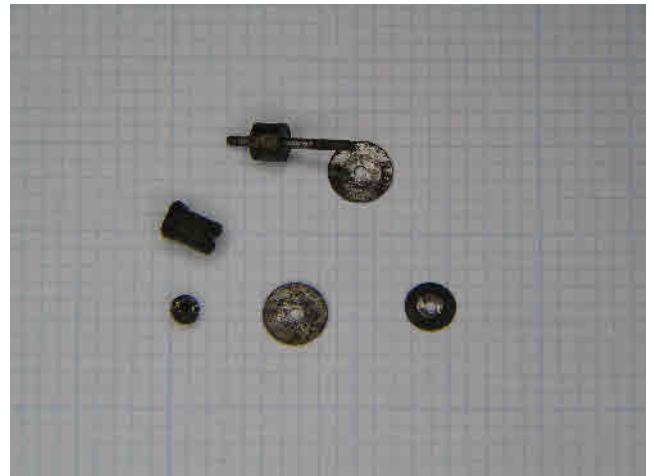
The components of the pendulum Isochron attachment are also rusty but otherwise in good condition.

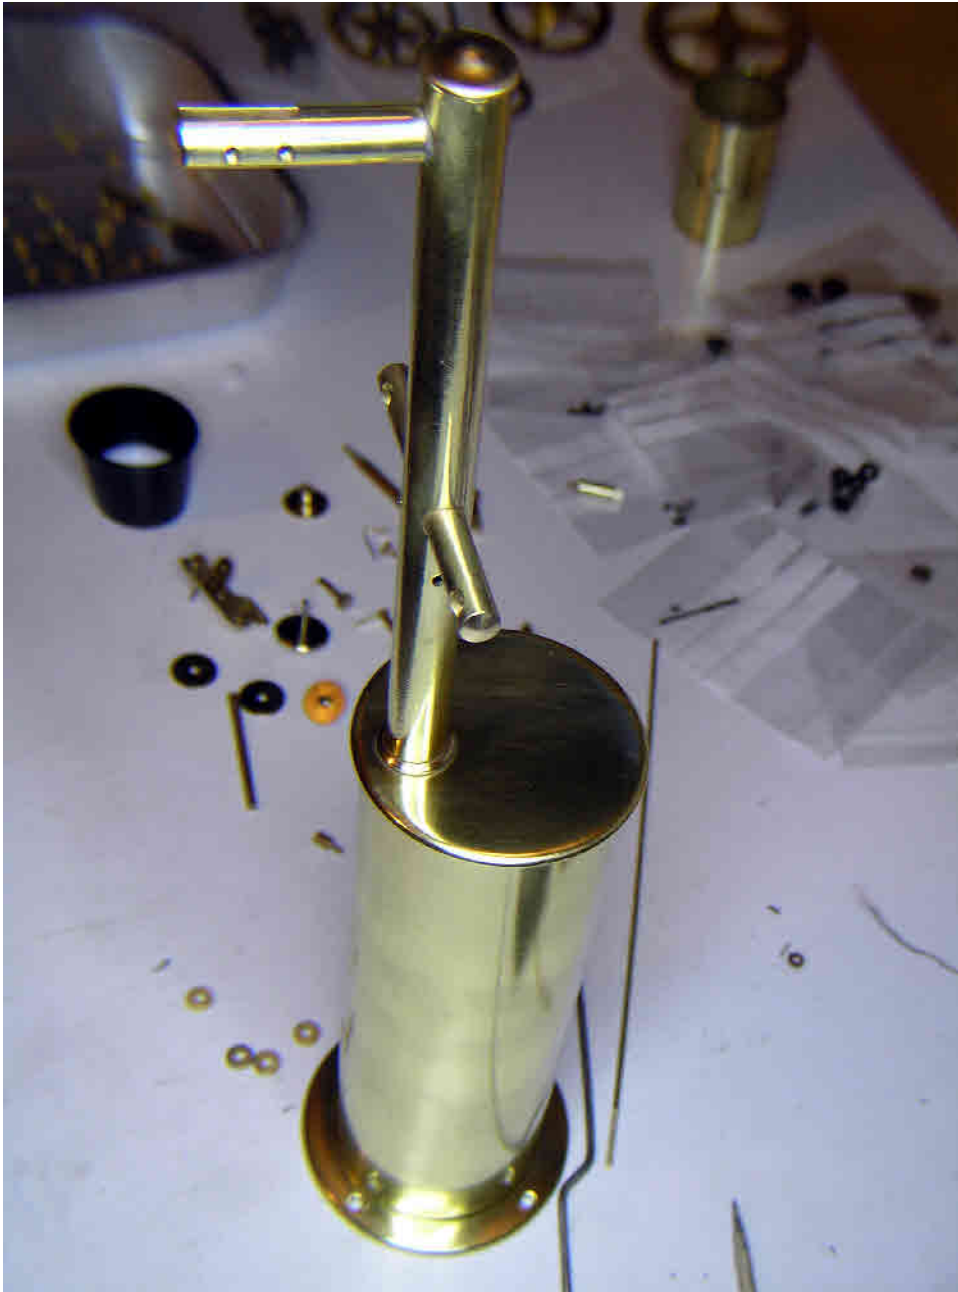
*The column after a final polish and lacquer. Most of the marks have come out and the overall feel is one of aged lustre. Interestingly there are some old turning marks that have shown up in the brass. They show up as a very light screw thread pattern running down the tube. You'd have to look closely to spot them. It may be marks left by the turner as he polished the tube.*

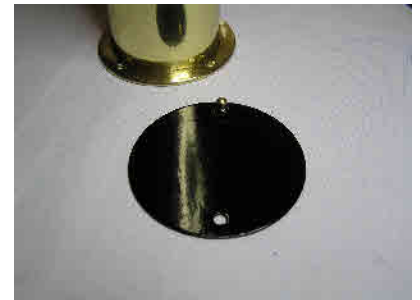
*The bottom cover was also missing from this clock so a replacement has been supplied that was recovered from an original scrap movement. Most of the clock was missing except for the base fittings.*

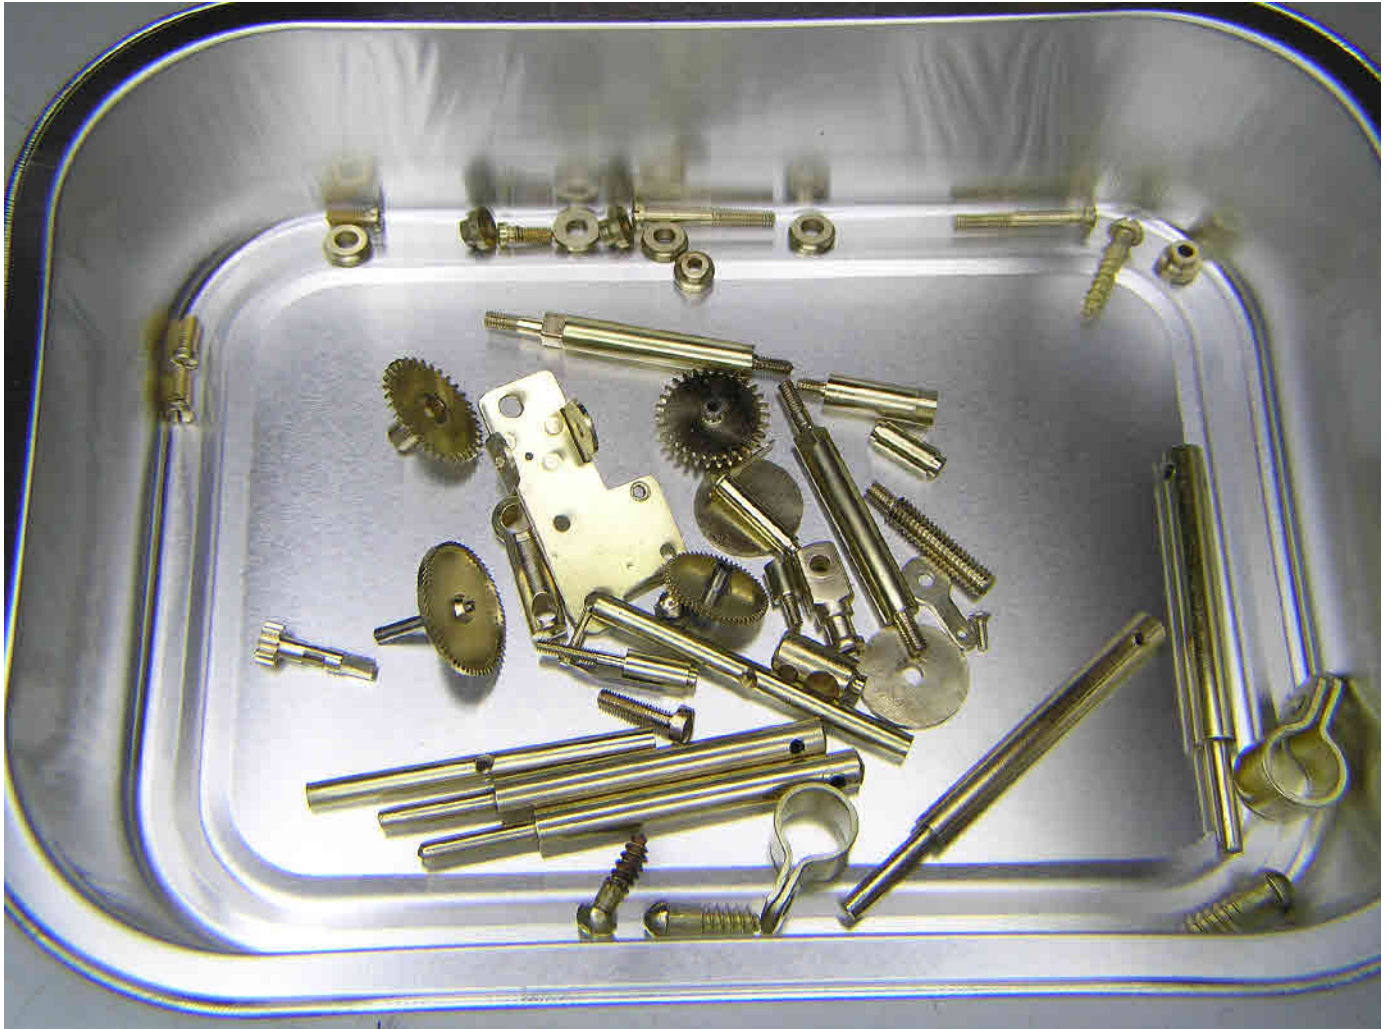
*Some parts ready for reassembly. Although a good ultrasonic tank will remove all the dirt and tarnish from brass it will not impart a polished finish. Therefore each individual part of the Bulle including all the screws and washer need to be polished by hand. This is a laborious and painful task. The only method I have found acceptable by being kind to the parts, is unfortunately painful to the hands. I use a Dremel fitted with a mini soft wire rotary brush. It imparts a nice polish quickly to the part but leaves your fingers aching and rubbed raw. I have tried all sorts of alternatives including barrelling machines, but none come close to the Dremel. The parts are so small and easily lost.*

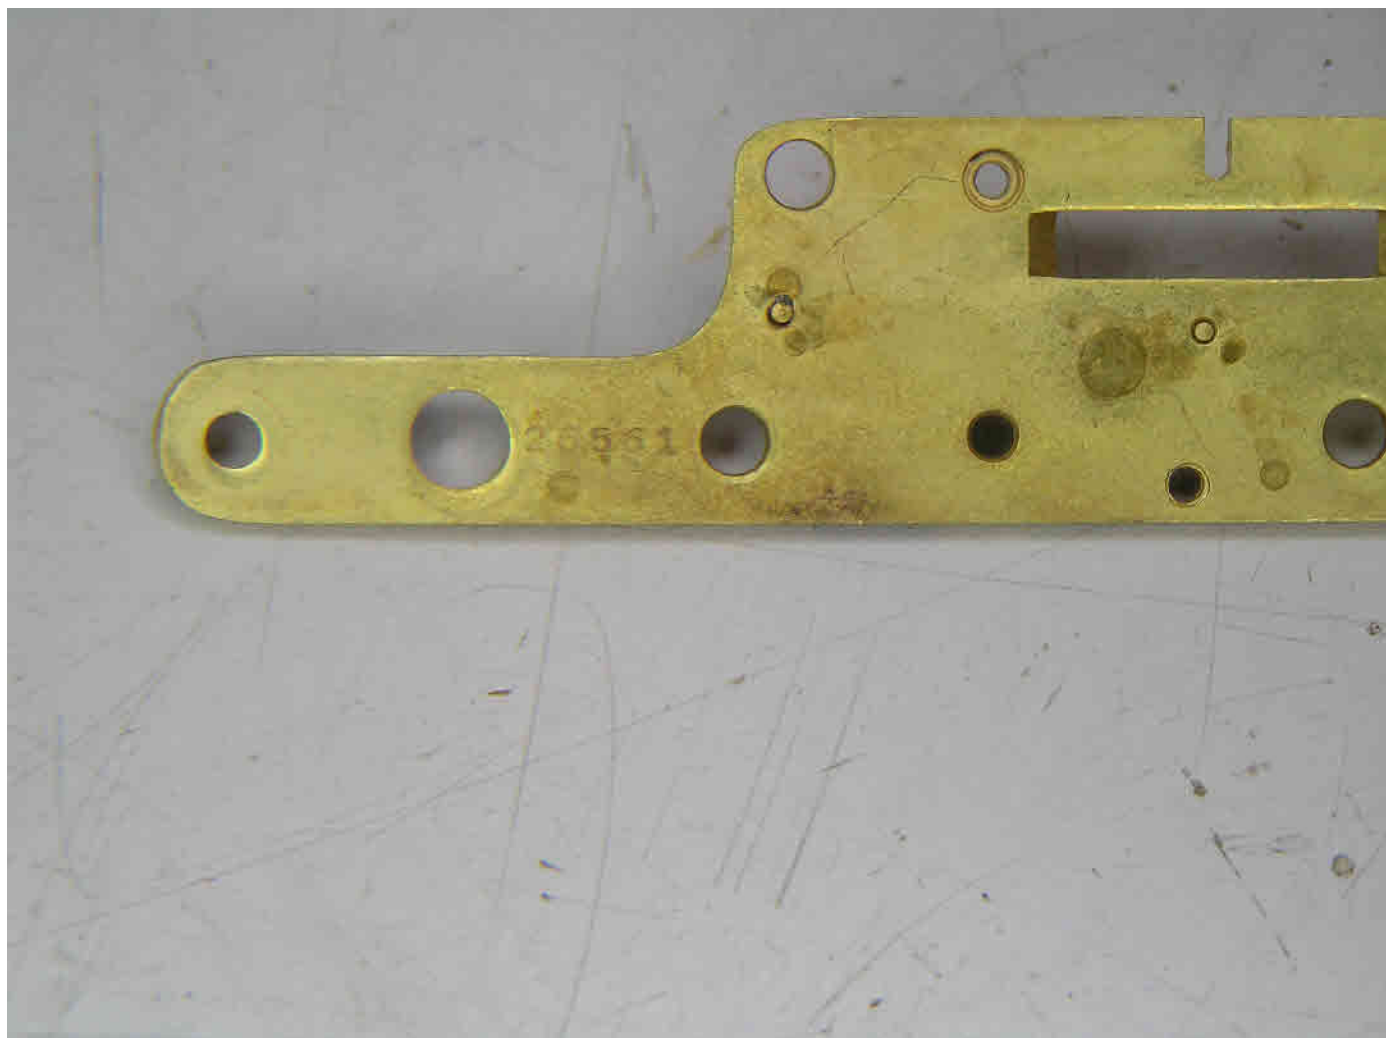
*The main movement plate before polishing showing the serial number 26561. Be careful when recording Bulle clock serial numbers. As can be seen from this photo the number is very close to the mounting hole. A fibre washer and nut are fitted here and normally cover the first digit. If this clock was all together then the serial number would read 6561 as the 2 would be hidden under the washer.*

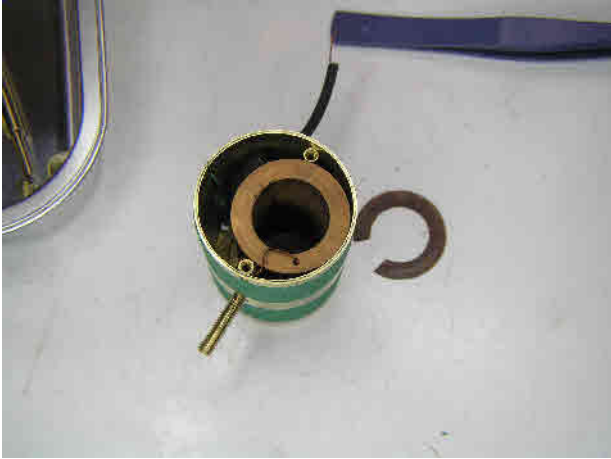
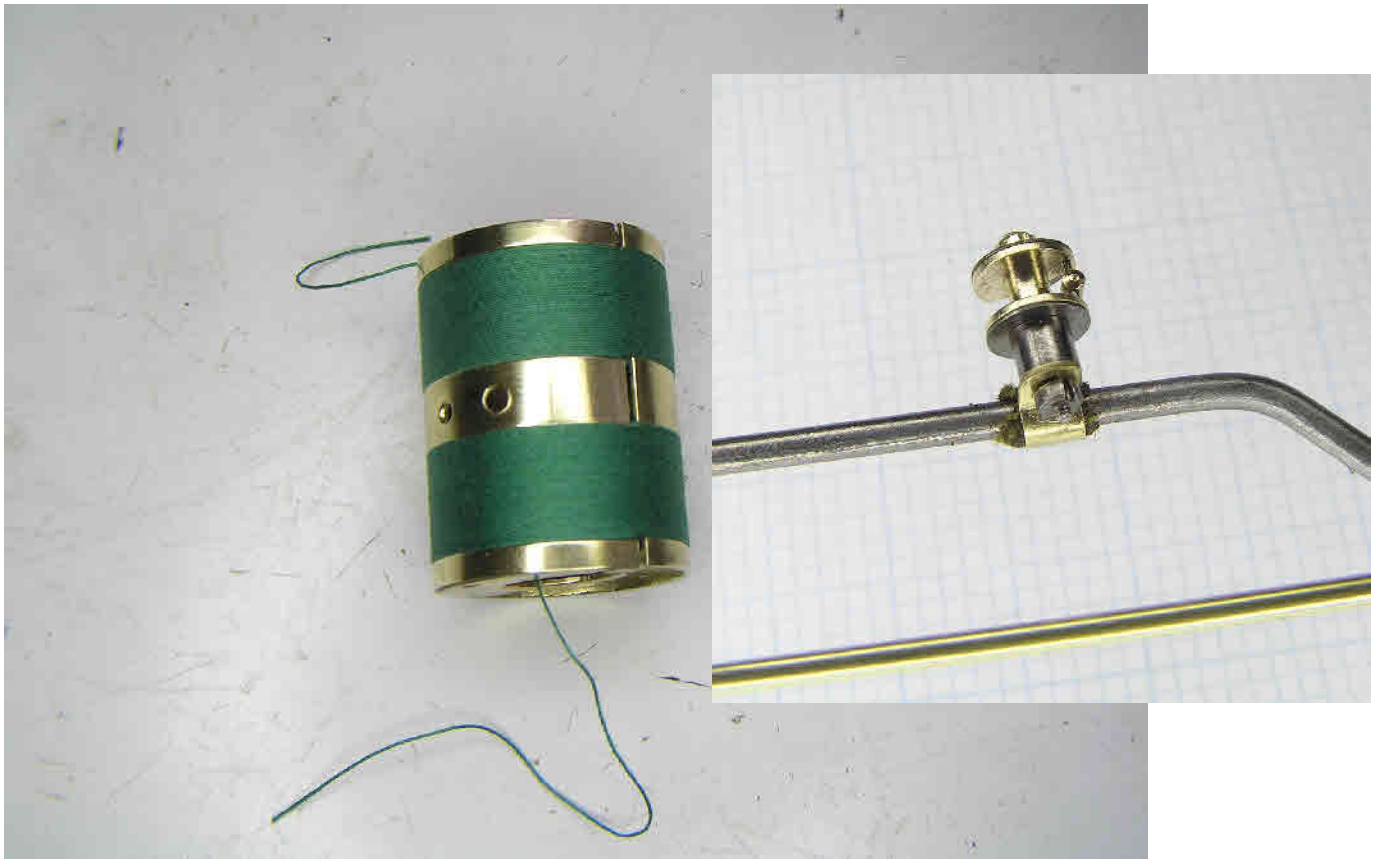
*These photos show the pendulum bob after the new cord has been wound and before the coil cap is fitted. Note the paper washer ready to be inserted. This colour green is the closest match to the original colour that I have found so far. The brass has been polished and lacquered. I only lacquer the column, pendulum bob and case fittings on a Bulle clock. The rest is left in a polished condition. The movement needs to be free of all dirt and contamination to ensure good electrical contacts. The other photo below shows the cleaned Isochron attachment refitted and the pendulum rod after cleaning away the rust.*

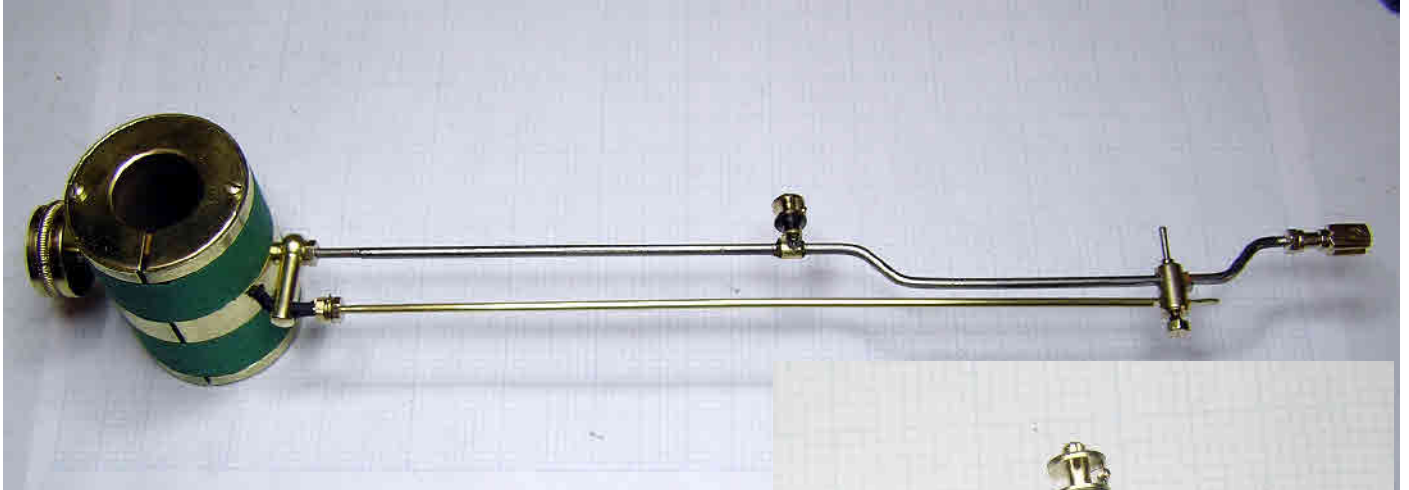
*The completed pendulum ready for hanging on the column.*

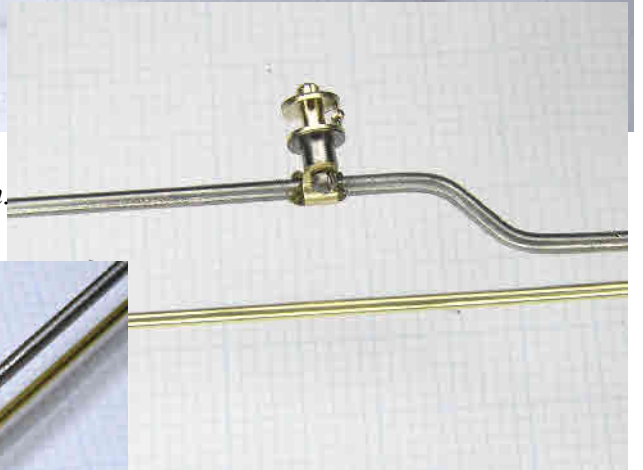
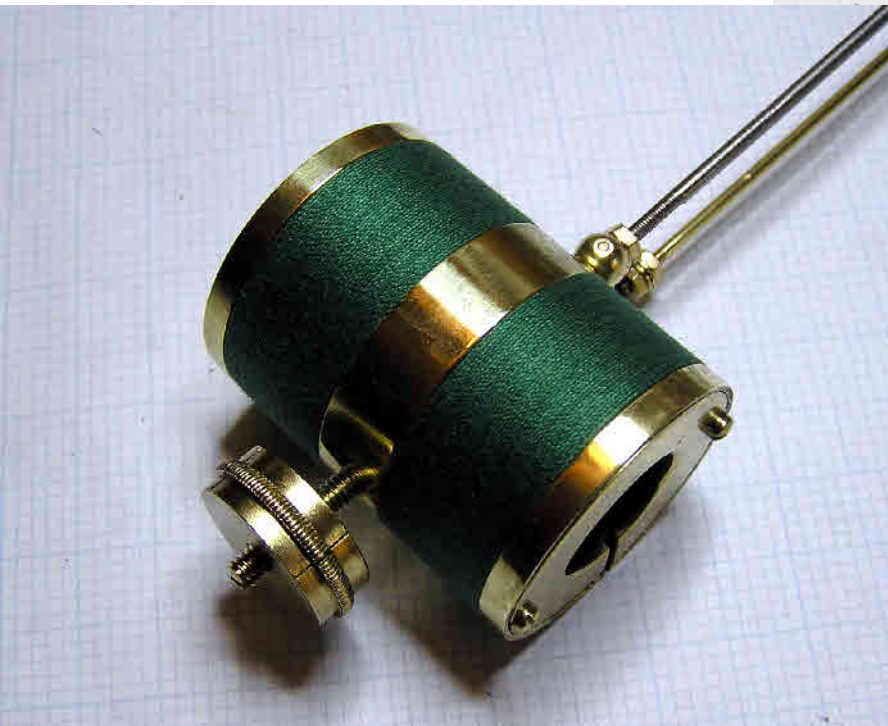
*Some close ups of the pendulum and the reassembly Isochron attachment. This attachment needs to be completely isolated from the pendulum and has a small Emery Cloth type insulator between it and the pendulum rod.*

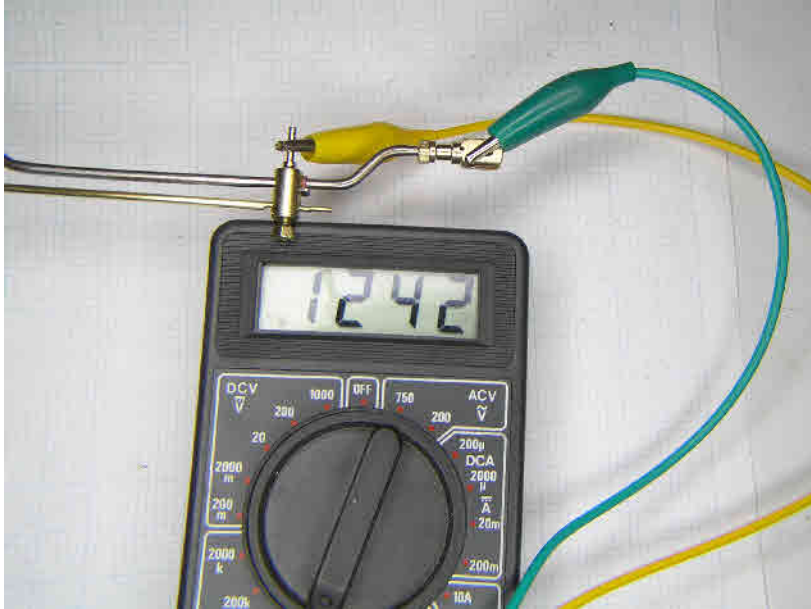
*Checking the resistance of the completed pendulum assembly. If all is well and the components properly insulated then we should have a reading of about 1100 Ohms between the end of the pendulum rod and the silver contact pin. This reading shows 1242 Ohms which is within the correct range.*

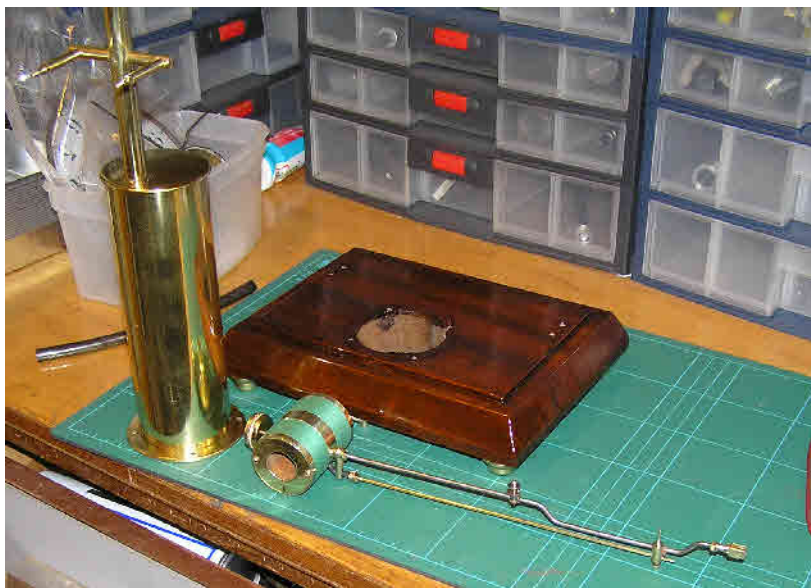
*This photo shows the finished column and pendulum assembly together with the base which is in the process of being French Polished. It has about eight coats so far and will need another ten before finally being cut back and gently buffed. It would look to garish and bright if left in this state. The surface is cut back after every three coats to flatten the surface and remove blemishes. We will be aiming for a subtle sheen commensurate with its age leaving some of the knocks and dents it has received over its life.*

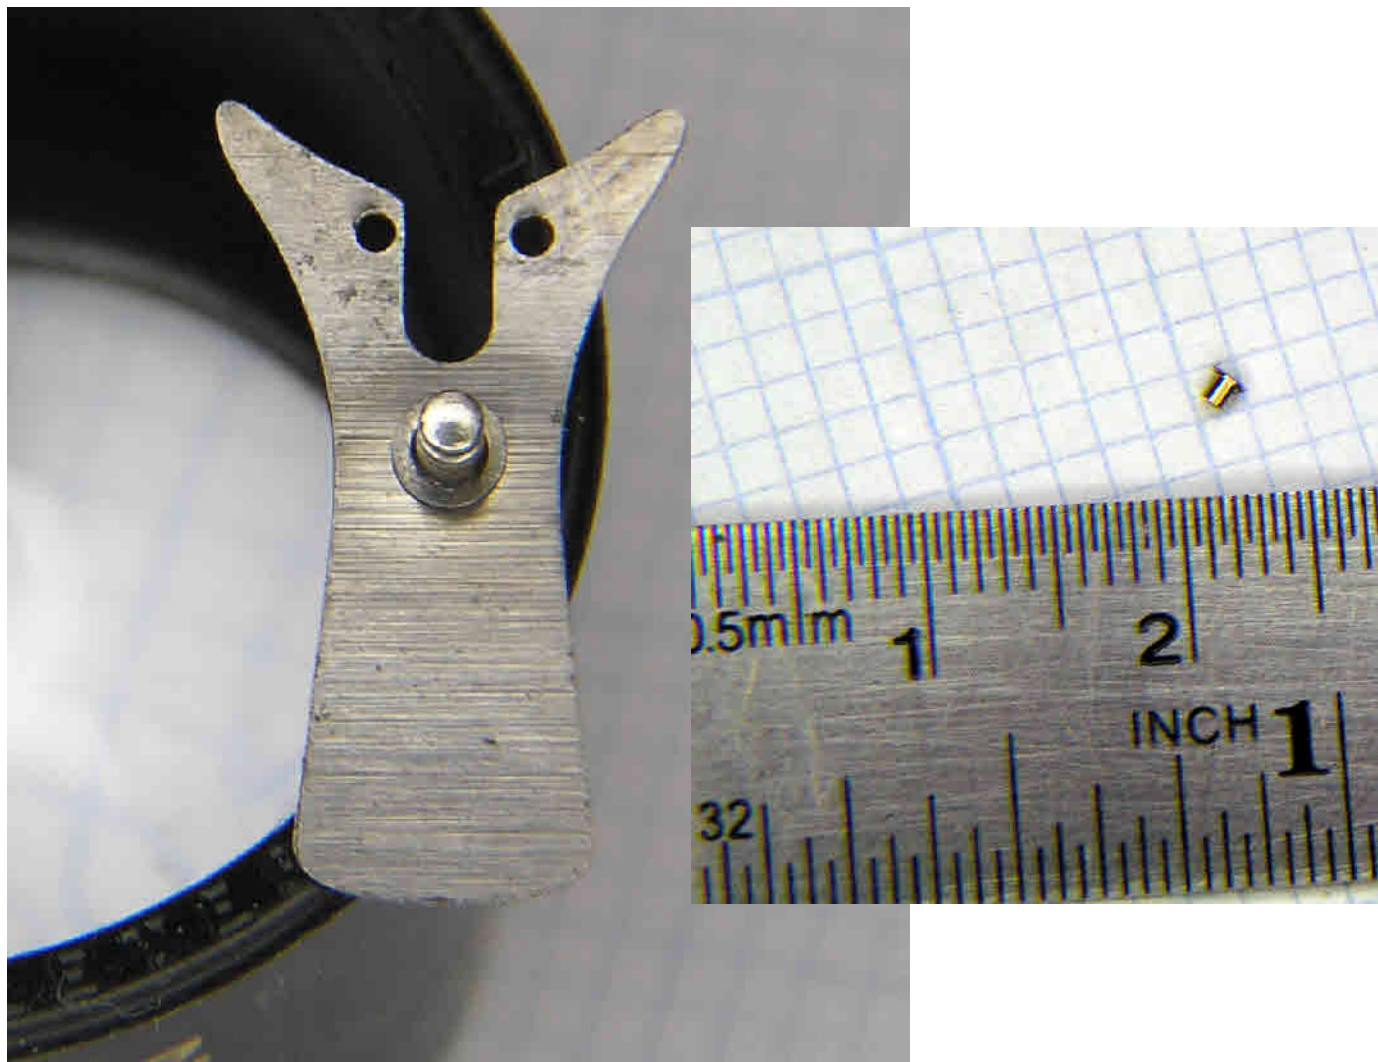
*The fork after the old silver contact and fibre has been removed. The rivet holes are about 1.10mm in diameter. The fork has been cleaned up to remove the rust but some pitting will remain.*

*The New rivets have been turned on the lathe. The photo shows the size against a ruler. The have a 1.5mm head and a 1.00mm diameter body of 0.85mm length.*

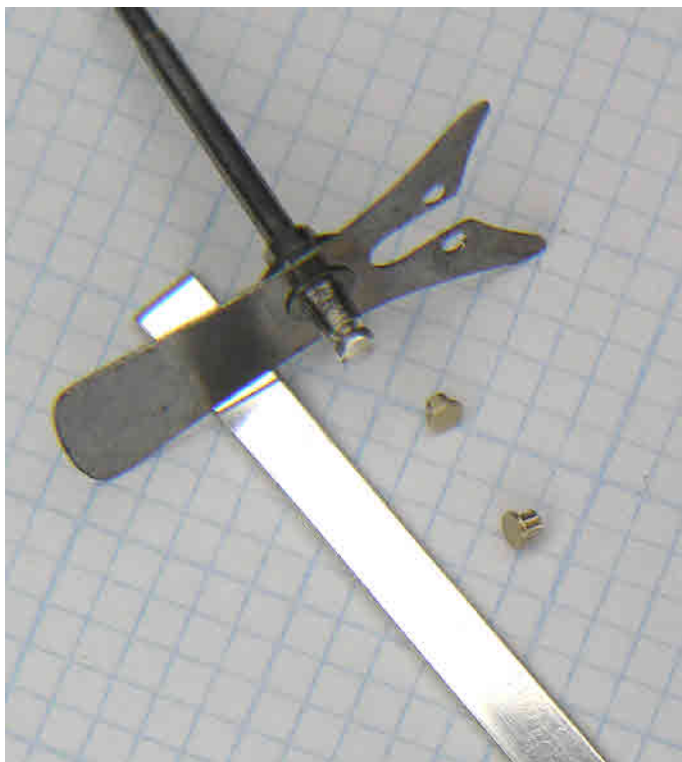
*The photo on the left shows the new rivets and the Pure silver strip from which the contact will be made. The fibre will be made in the same manner.*

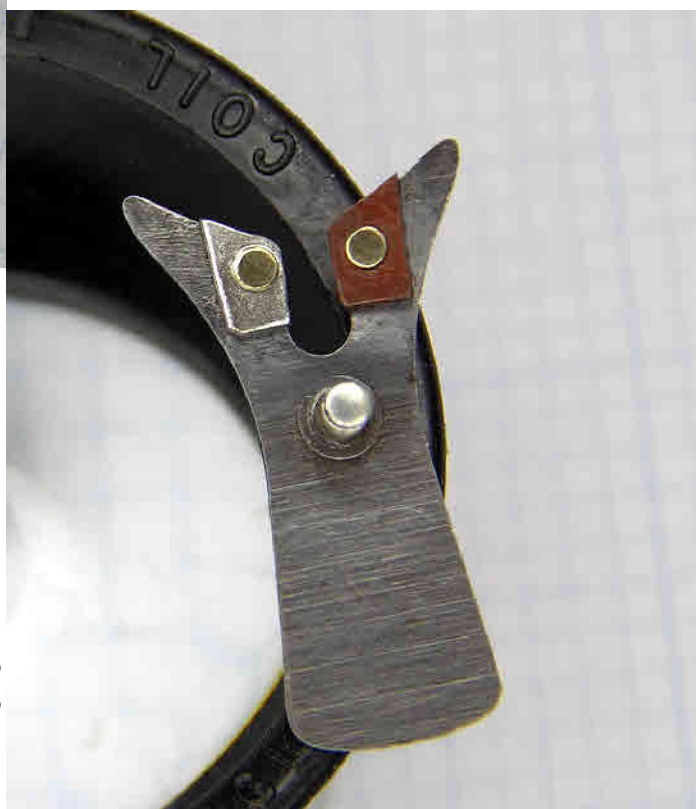
*The finished fork. The gap has to be wide enough to accept the contact pin and should not be made too narrow. The fork should last another 80 years.*

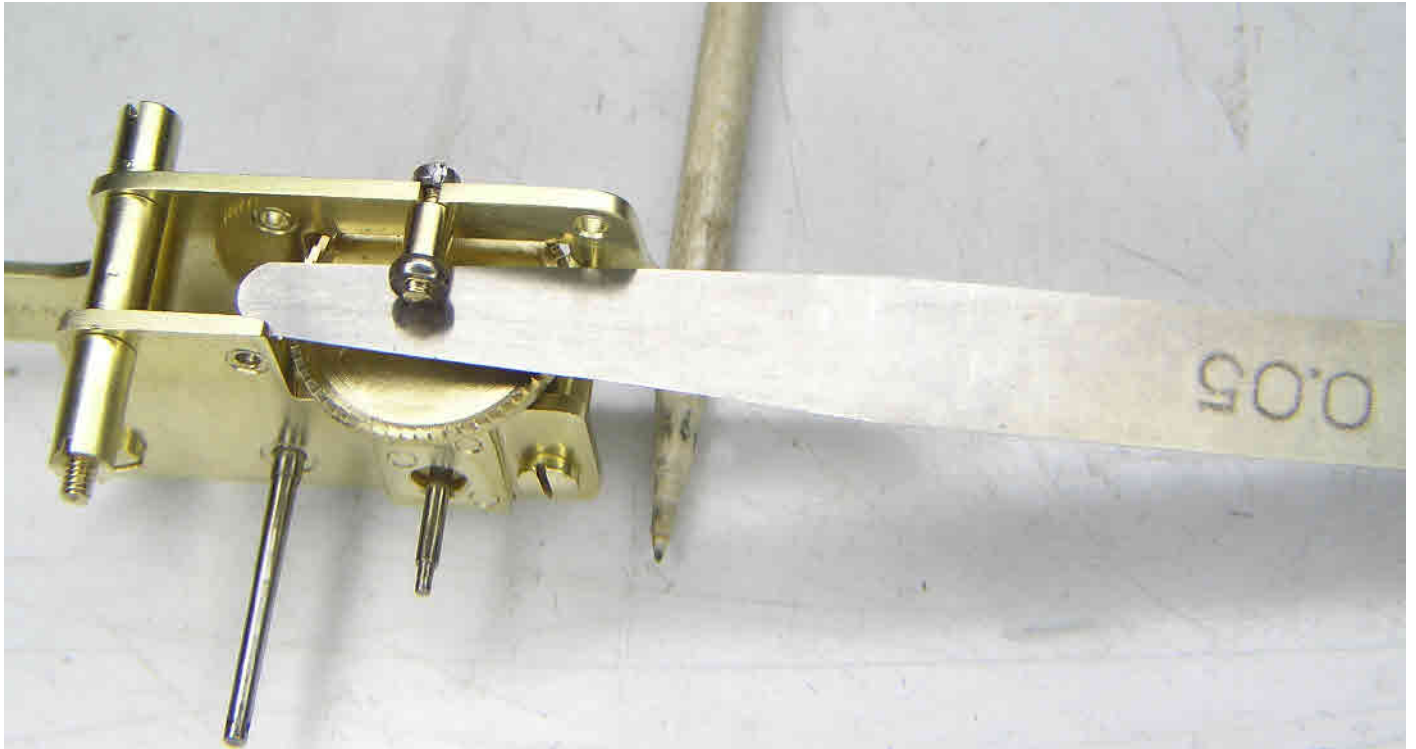
*This photo shows setting the end shake on the count wheel. I usually set this to about 0.05mm (0.002") which allows the wheel to run friction free and yet not allow the minute hand to be too loose.*

*The arbour runs in two pivot holes and rests on a hardened steel plate at the bottom. The motion is transferred through the worm, that is attached directly to this arbour, to the wheel on the minute arbour. The weight of the minute hand when it is being lifted past the half hour position, would likewise lift the count wheel. The result would be that the minute hand would lag behind and misrepresent the time by several minutes. The reverse would happen past the twelve o'clock position. It would seem that the timekeeping was very erratic. So this gap needs to be as small as possible conducive with free movement of the count wheel and driving pawl.*

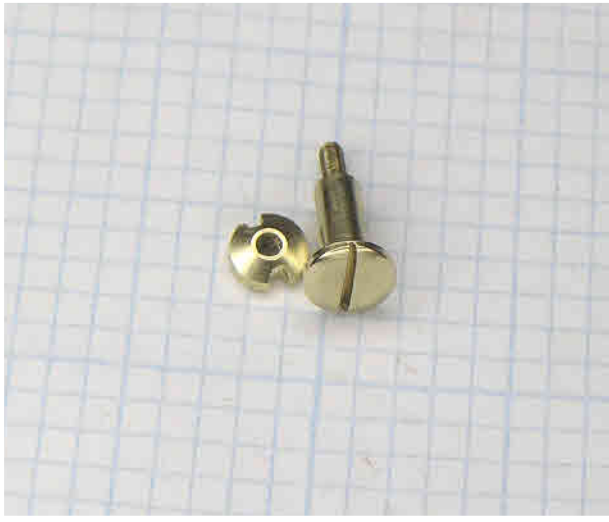
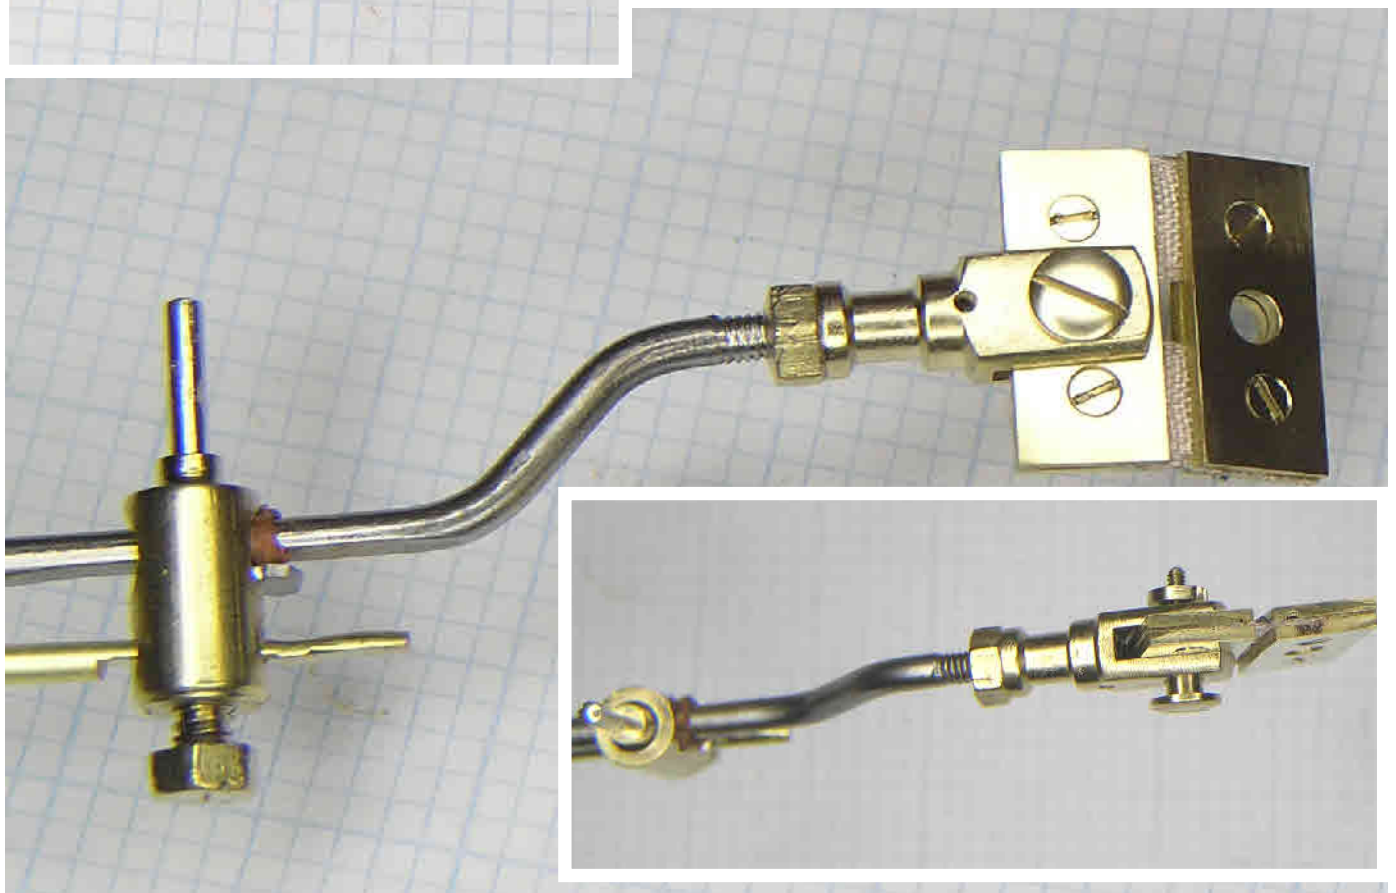
*These photos show the new pendulum suspension bolt and nut that was turned up from brass. This bolt needs to have a shaft that is not only a loose fit in the suspension unit, but also is slightly longer than the total width of the suspension and the pendulum block in which it sits. This enables the pendulum to swing freely forwards and back so that it finds its own level regardless of how much the clock is leaning front to back (within the limitations imposed by the bar magnet). The top of the suspension will be held firmly at its other end mounted in the column, with no allowance for movement other than initial setting up.*
