# Horologix

*Early Battery Clock Parts & Restoration*

## *Restoration of Bulle Clock Serial Number 26561.*

## **Bulle Clock Serial Number 26561.** *(By kind permission of the owner)*

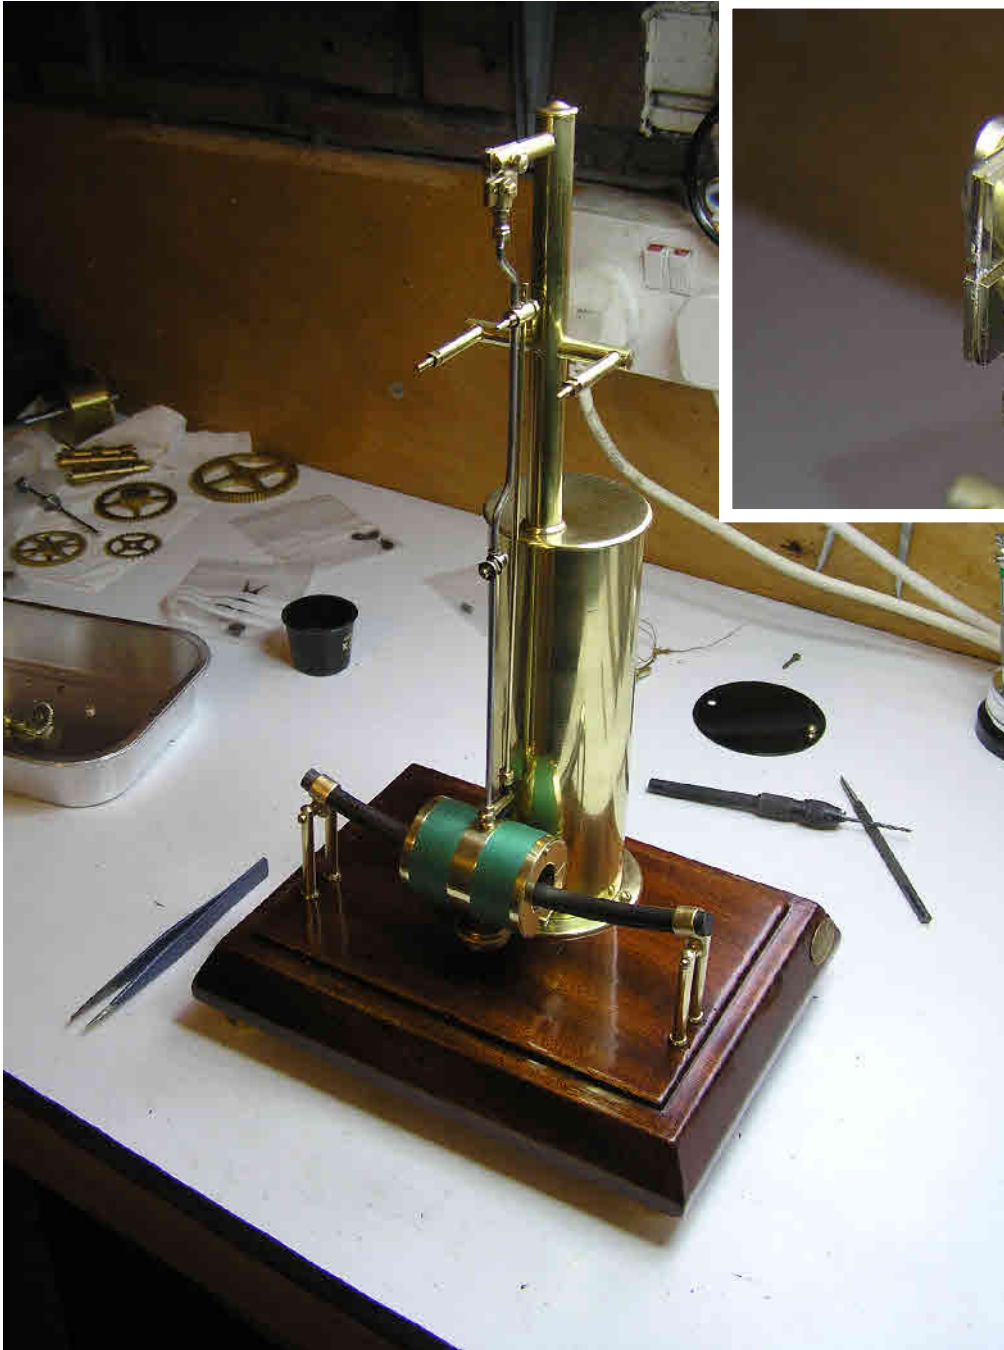
The photo on the left shows the column, base and pendulum in place ready for the movement. The Isochron attachment is low down on the pendulum rod just to keep it out of the way for the time being. It will be raised into place when the spring is ready to be fitted. The insert photo shows the suspension mounting on the main column. There are two washer behind the nut ready to take the contact wire. This wire will connect the pendulum rod to the main column because the contact is broken by the non conductive silk suspension.

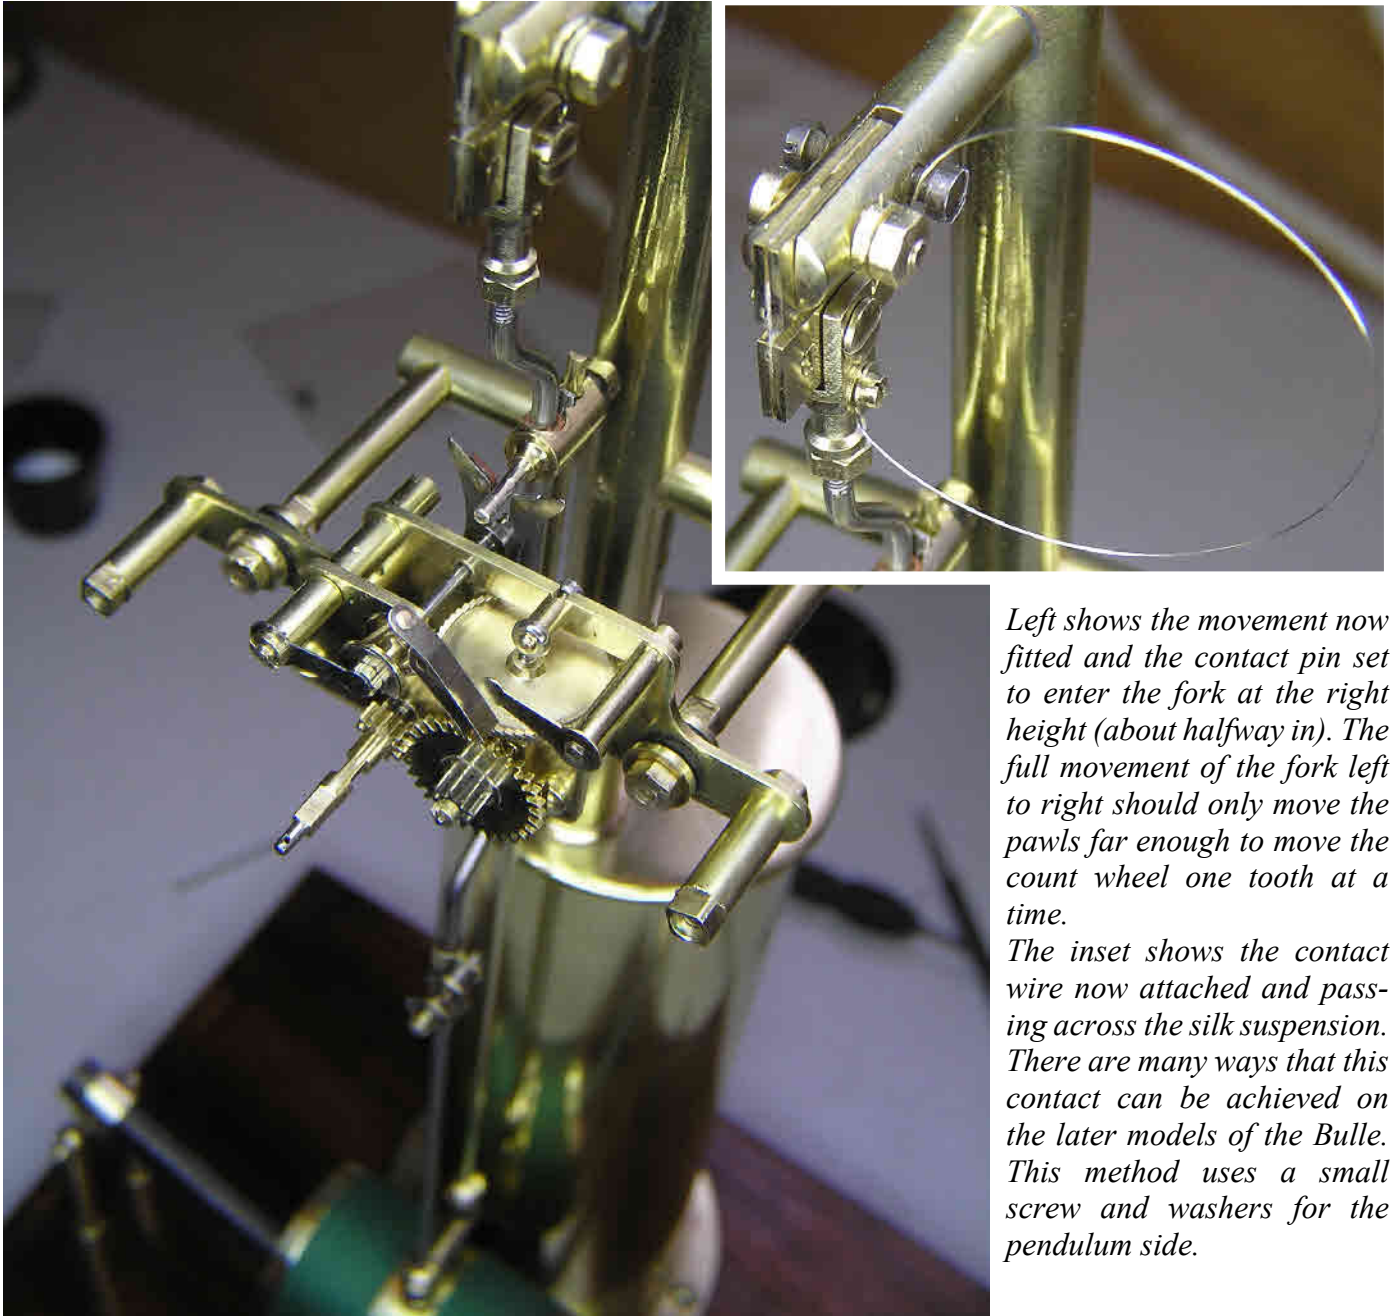
*Left shows the movement now fitted and the contact pin set to enter the fork at the right height (about halfway in). The full movement of the fork left to right should only move the pawls far enough to move the count wheel one tooth at a time.*

*The inset shows the contact wire now attached and passing across the silk suspension. There are many ways that this contact can be achieved on the later models of the Bulle. This method uses a small screw and washers for the pendulum side.*

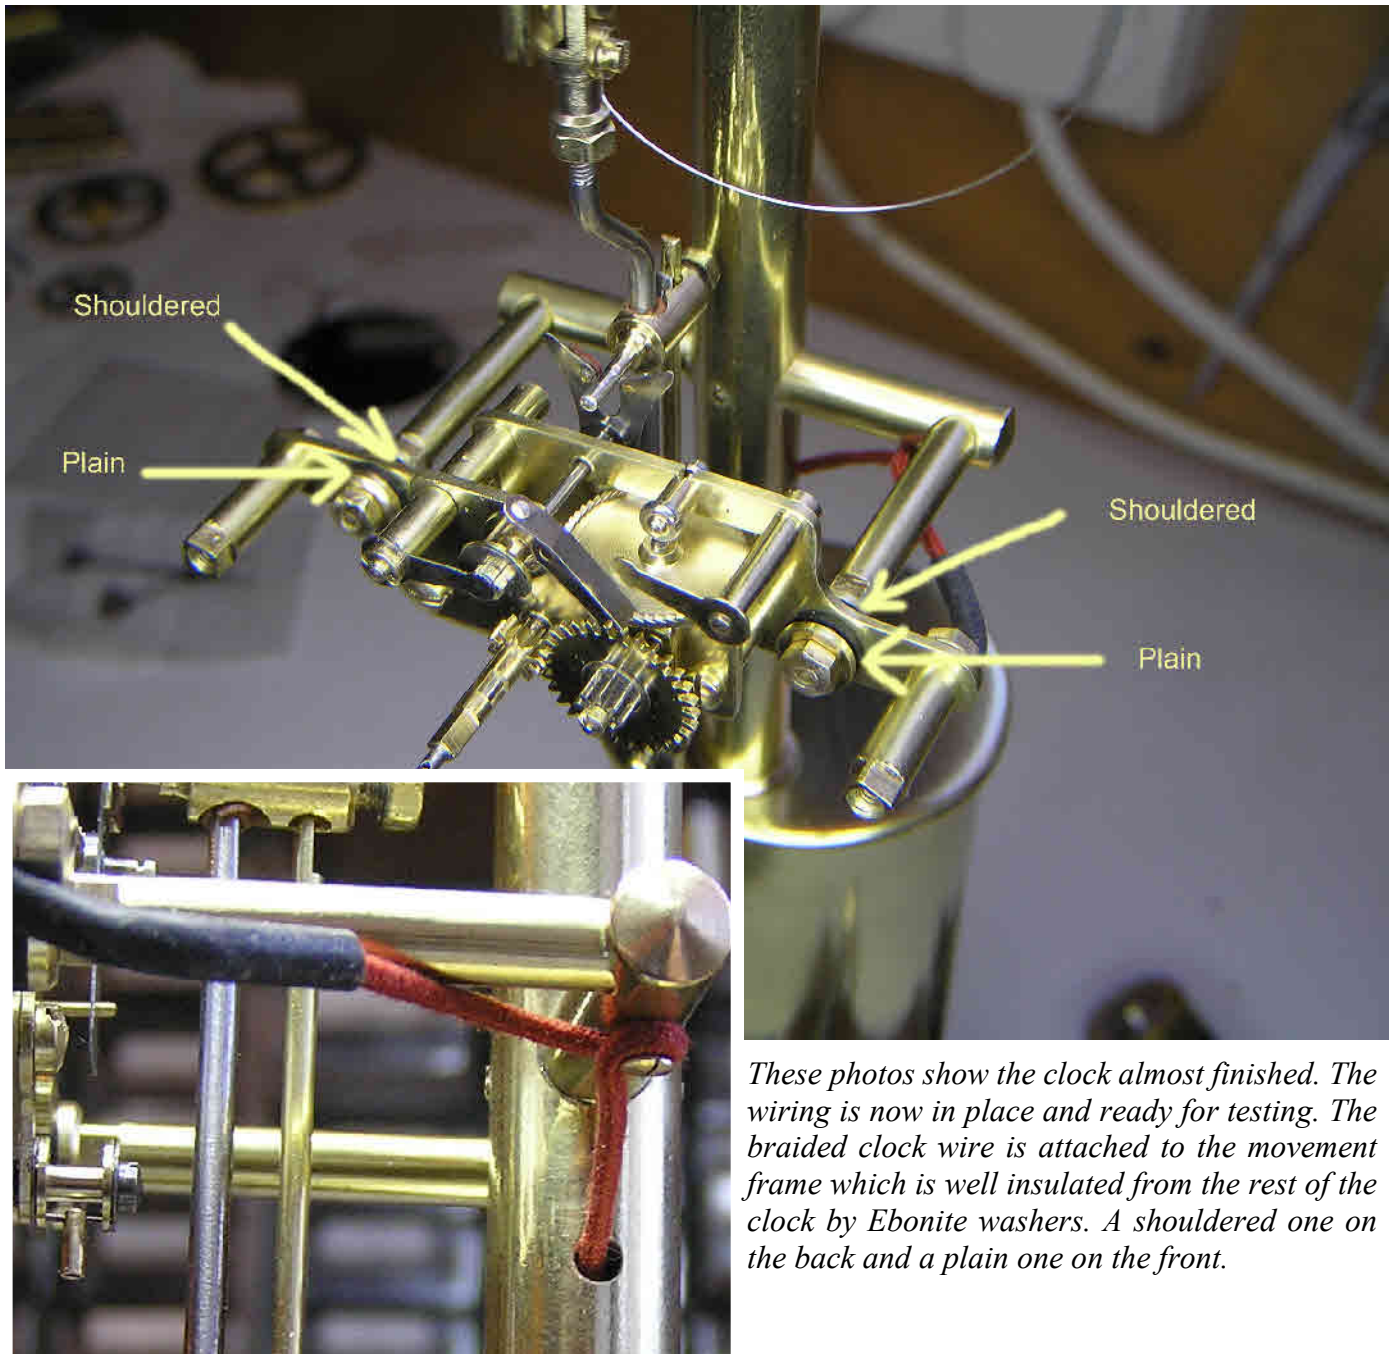
*These photos show the clock almost finished. The wiring is now in place and ready for testing. The braided clock wire is attached to the movement frame which is well insulated from the rest of the clock by Ebonite washers. A shouldered one on the back and a plain one on the front.*

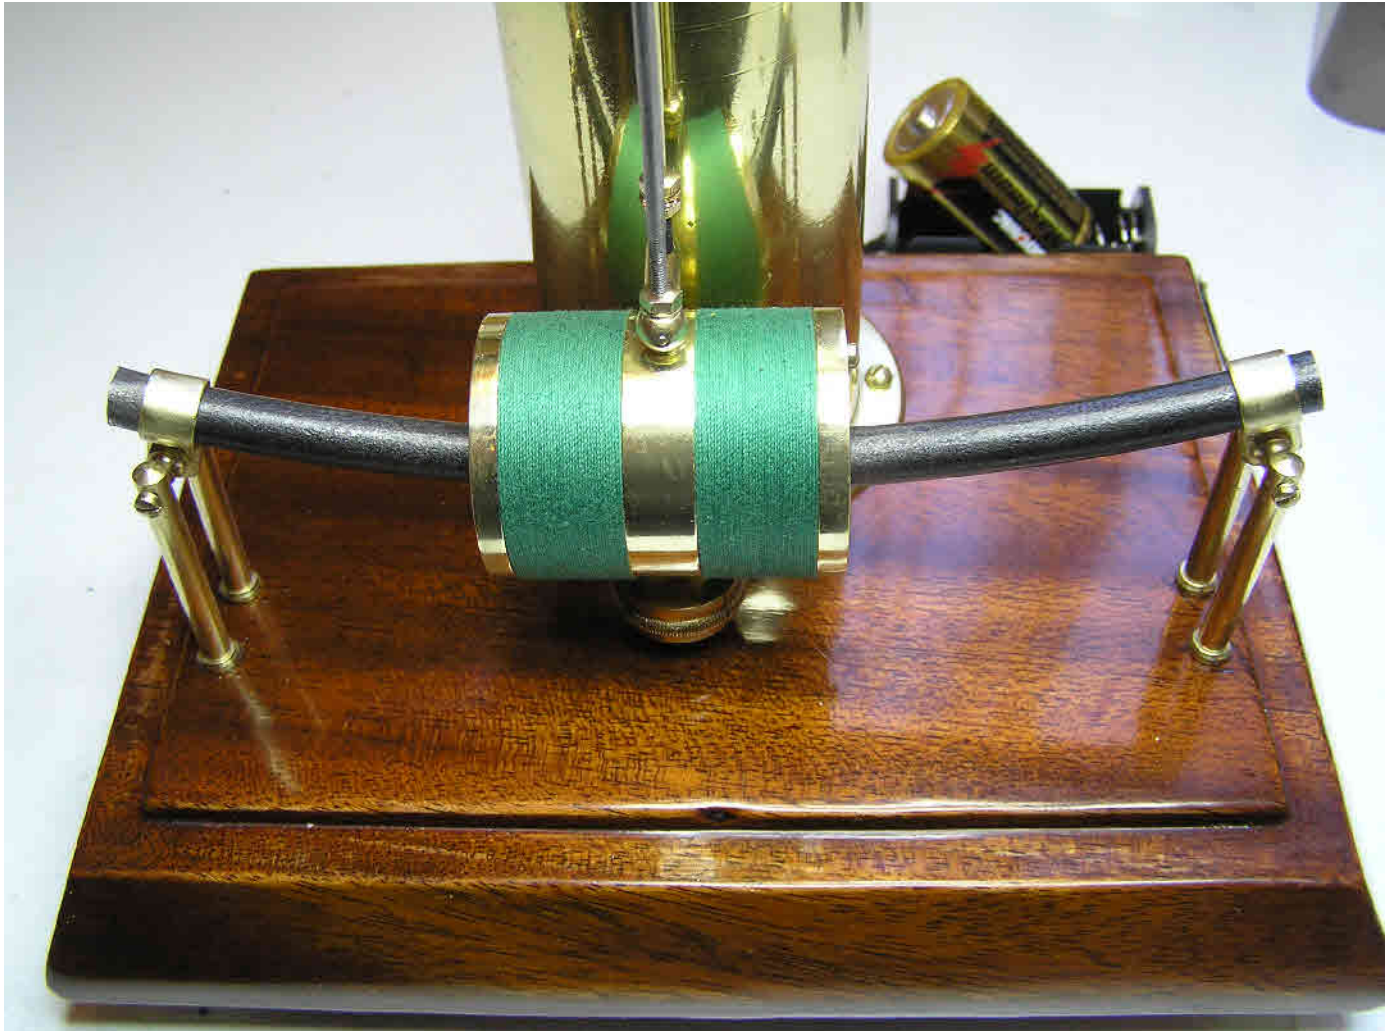
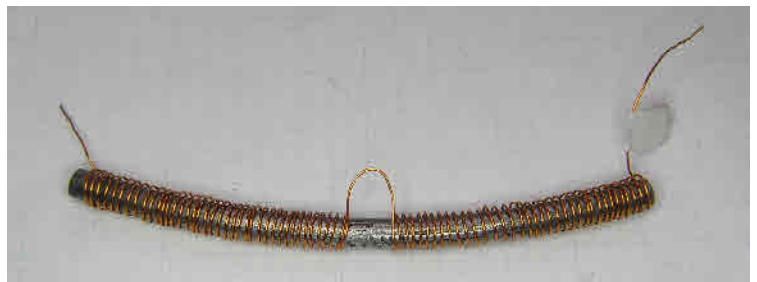
*The finished base and bar magnet. The base has had about 20 coats of Polish with cut backs every 3 coats. I have left all the old "Lumps & Bumps" in the wood so as to retain its age. The magnet was a little weak and has been re energised. Note that the enamelled wire has a "Loop Back" in the middle to induce the North-South-North poles.*

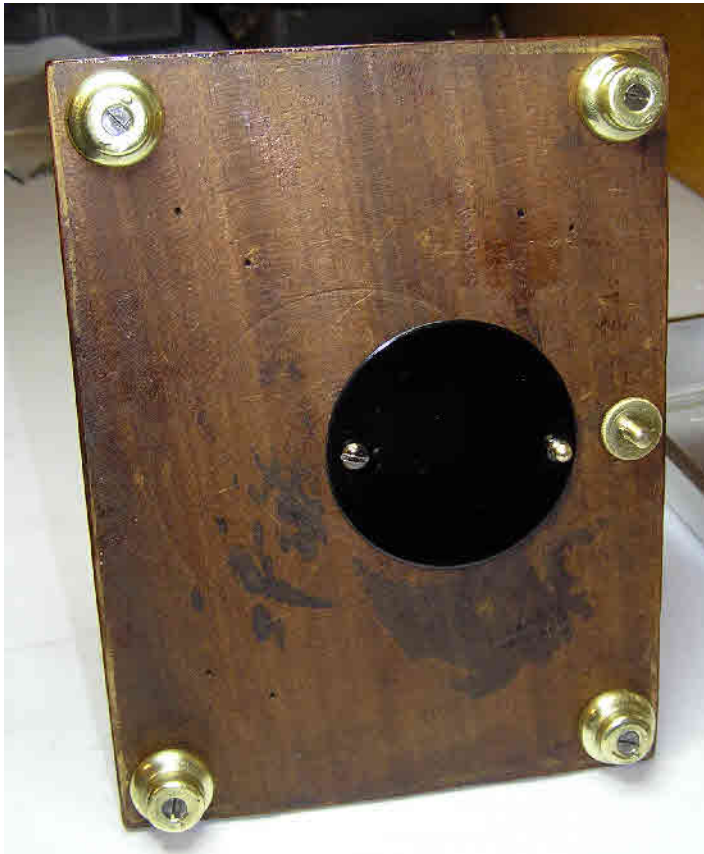
*The bottom of the base with it's four brass feet/ The two at the rear are shorter than the front pair to allow the screw foot to have a greater distance of effective adjustment. The replacement door is also in place.*

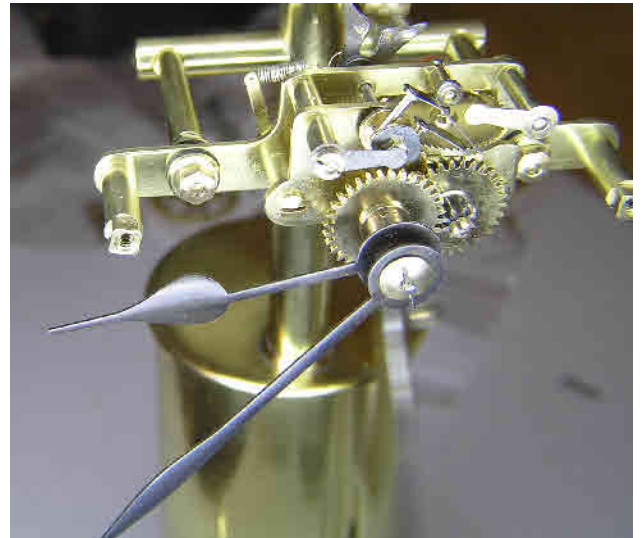
*Testing the cleaned and blued hands for size and alignment before the dial is cleaned and refitted. The minute hand was badly rusted.*

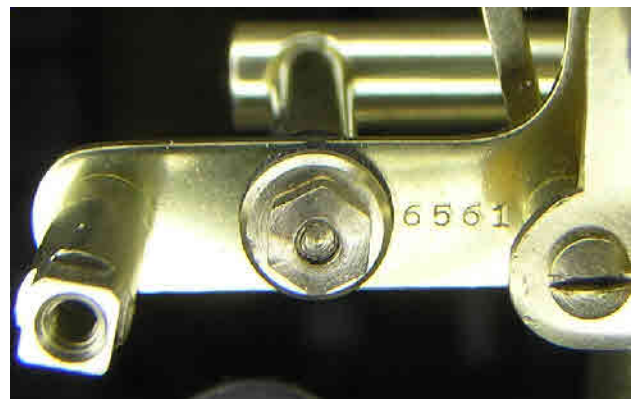
*This photo shows clearly what happens when the movement is mounted on the column with the fibre and brass washers in place. The first digit of the serial number disappears.*

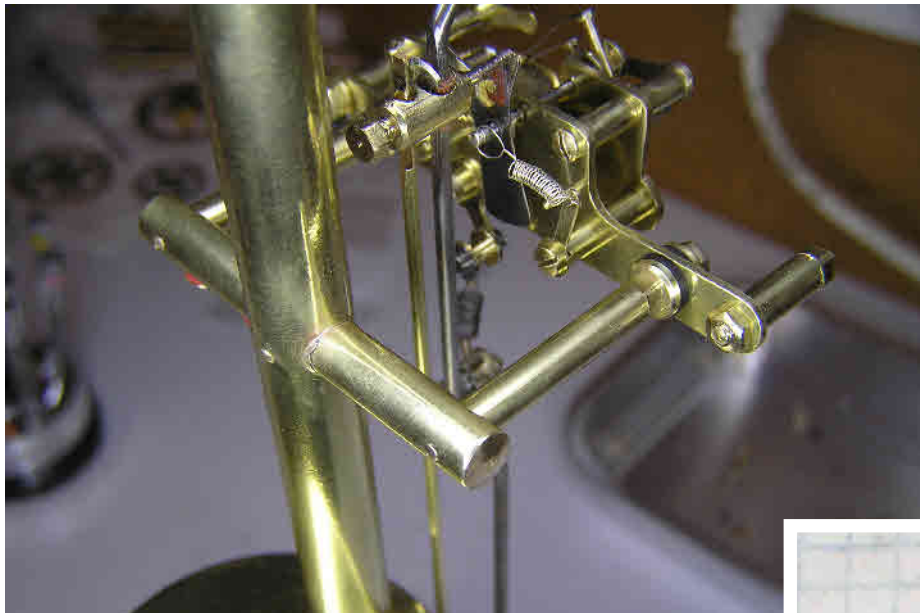
*This photo shows the new silver contact spring in place. The large loop rolls around the silver contact at the back of the Fork.*

*The clock is left on test whilst the dial is cleaned.*

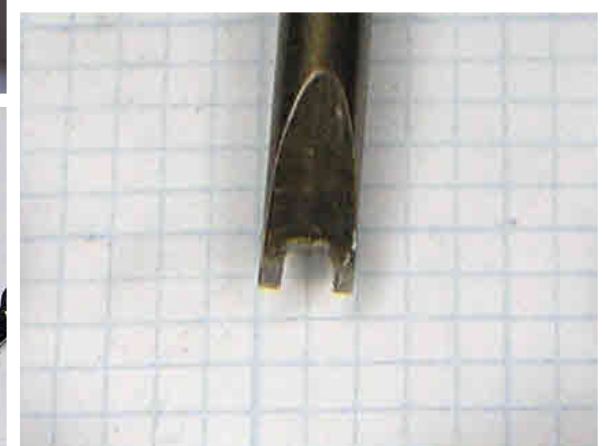
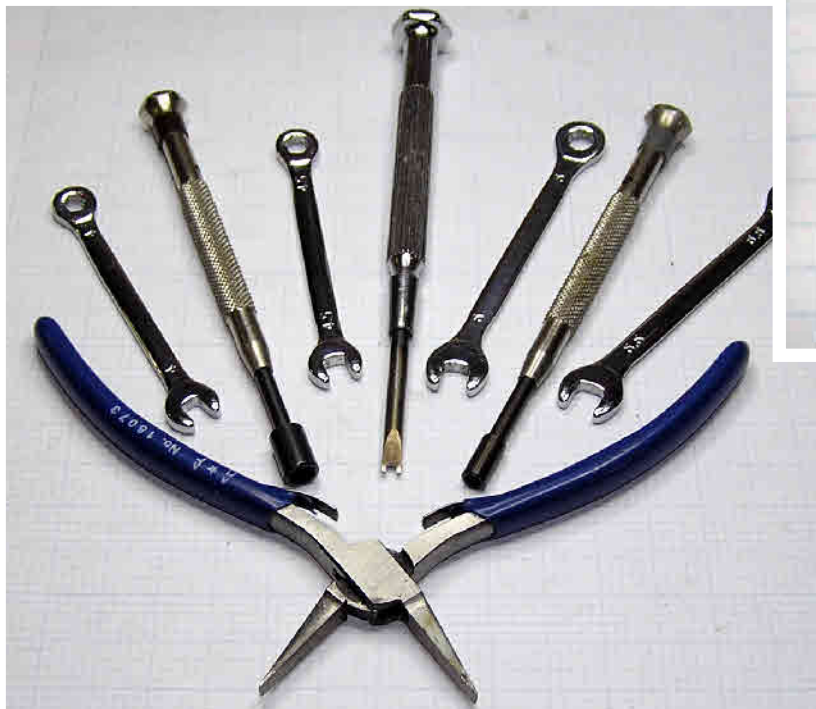
*The small selection of tools necessary to strip a Bulle. Mainly, Nut Spinners and Open Ended Spanners in the range 4mm to 5.5mm. The pliers are smooth faced so as not to damage the parts. Note the modified screwdriver.*

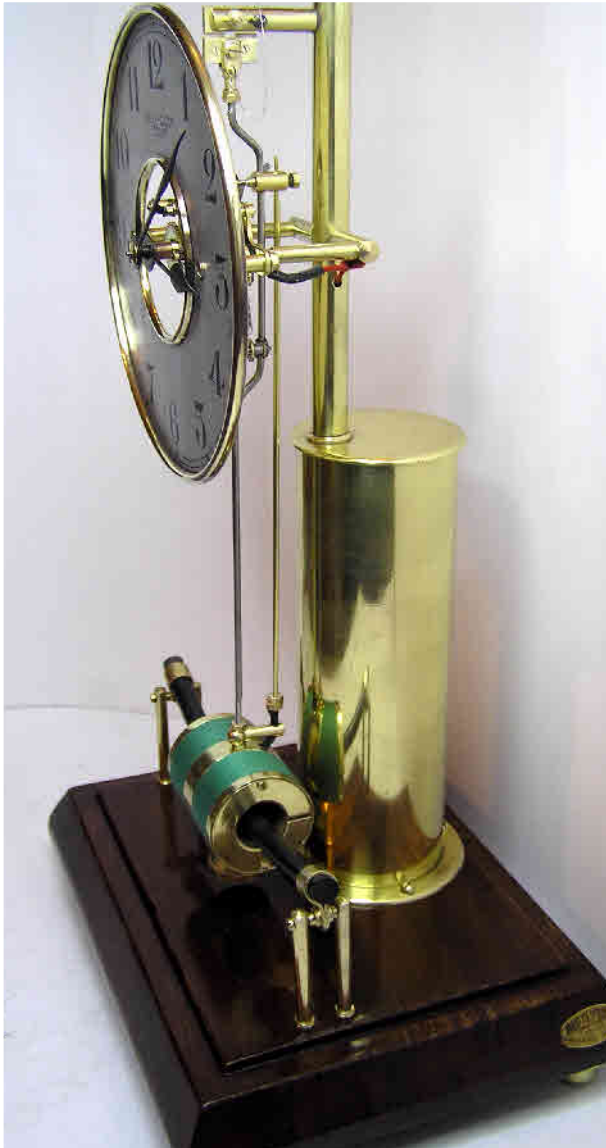
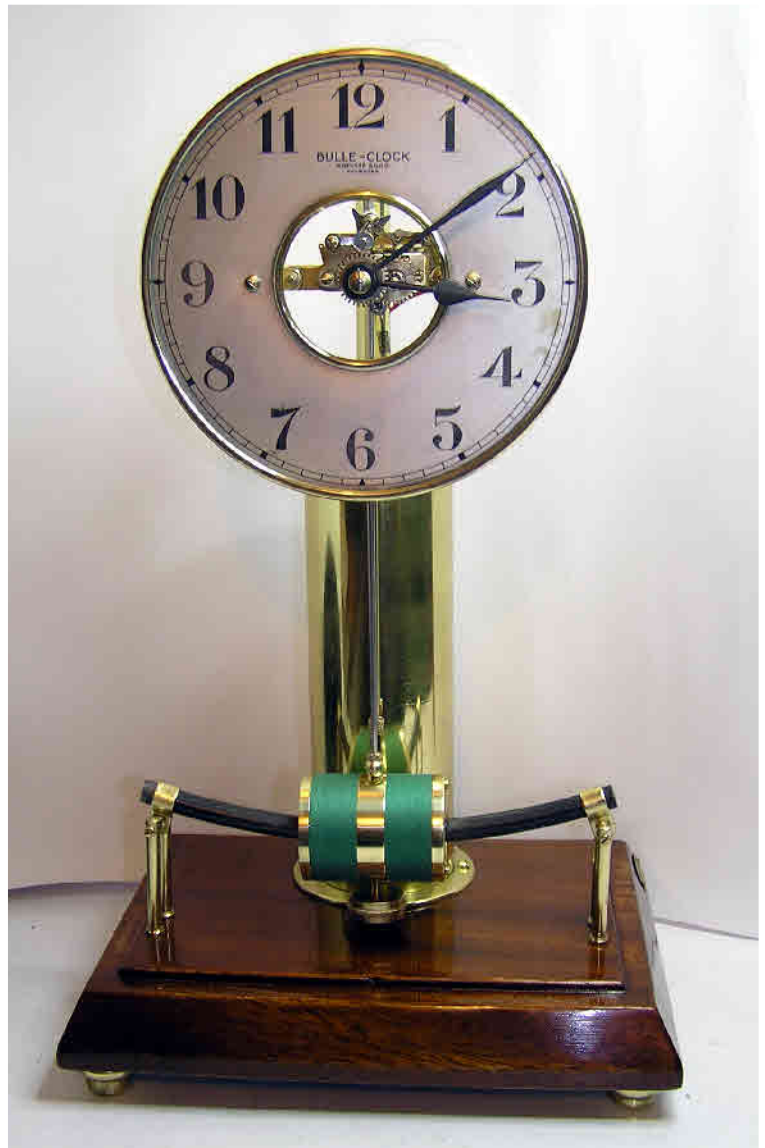
*The finished clock. The dial has been cleaned but there are still some marks left on the dial which cannot be removed without damage to the surface and characters. The brass has been cleaned with "0000" gauge wire wool and Solvol Autosol. The face has been sponged with warm water with a very mild soap. No lacquer has been applied as this will prove difficult to remove in the future, especially around the rim of the face.*

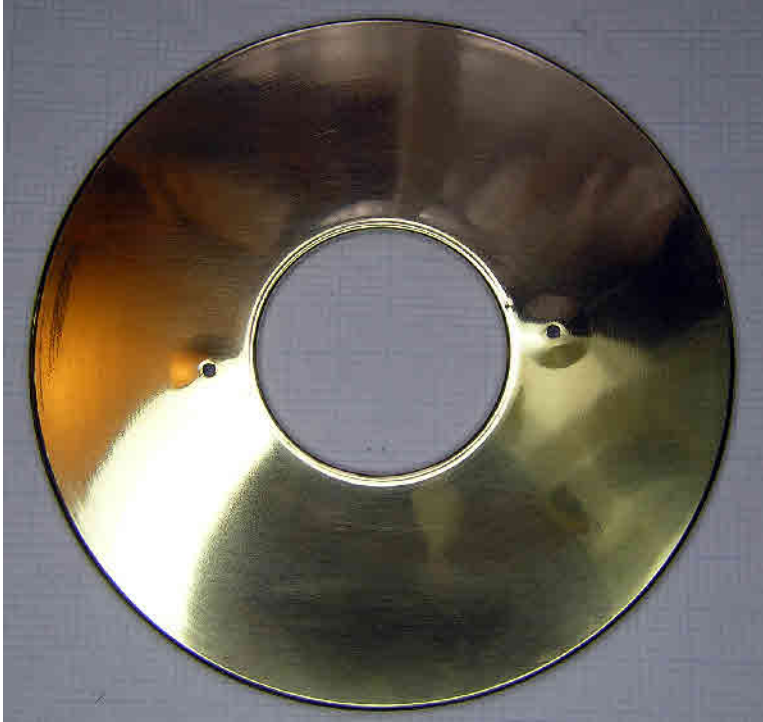
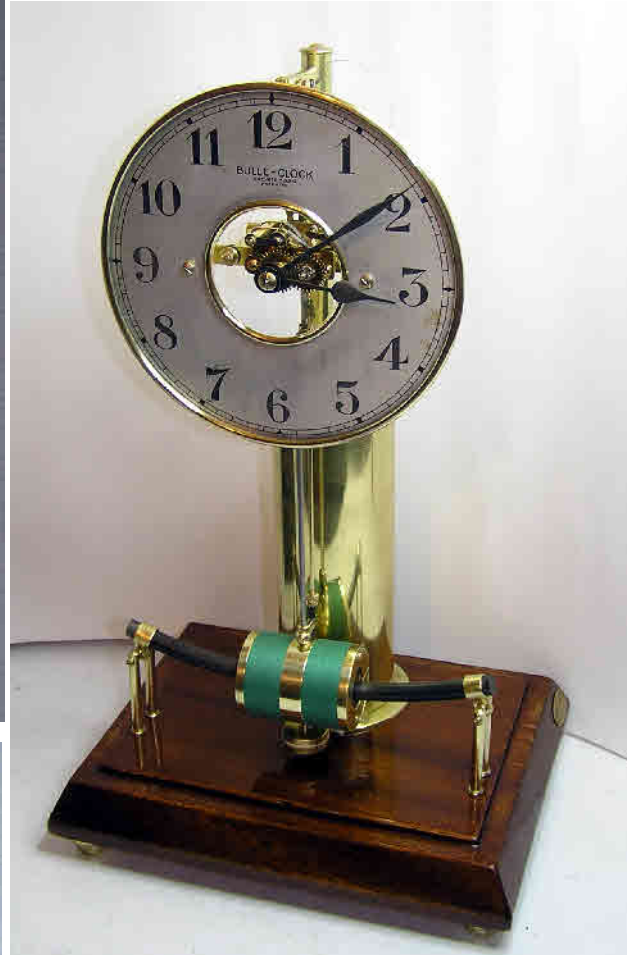
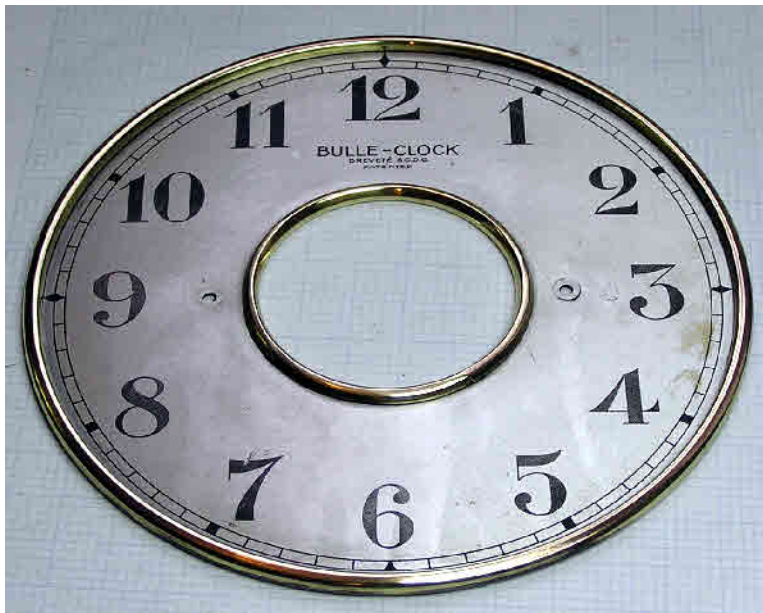
*The reverse of the dial cleaned pan and detail of the face showing the marks.. I've adjusted the lighting to show them off much worse than they actually appear.*

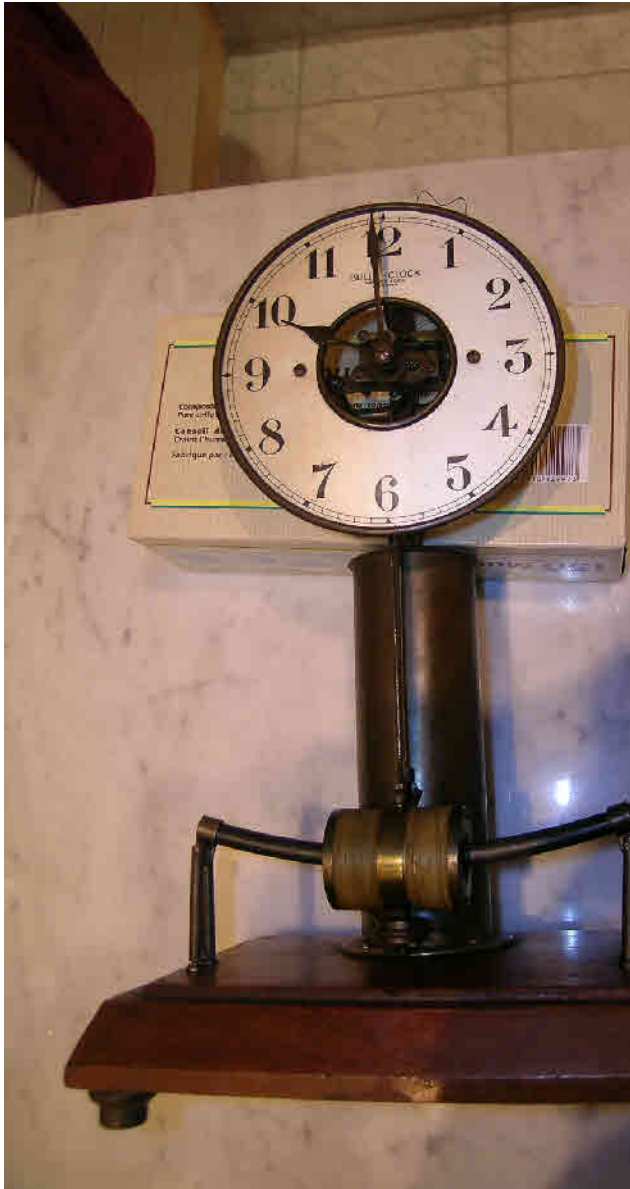
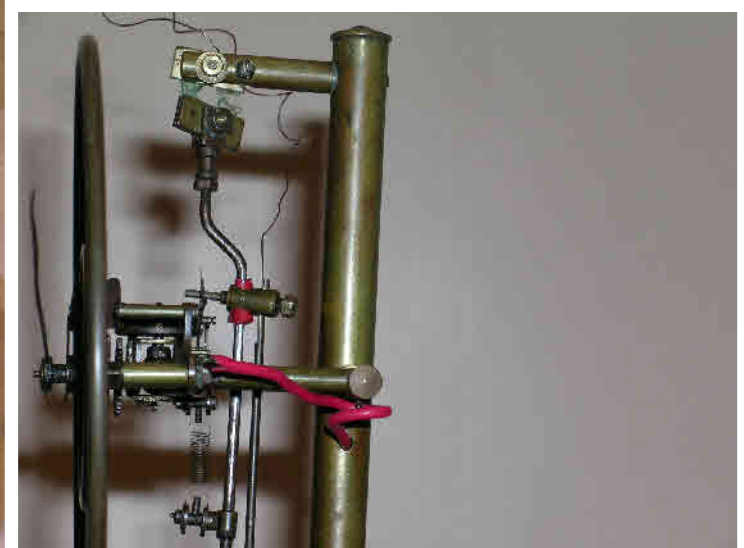
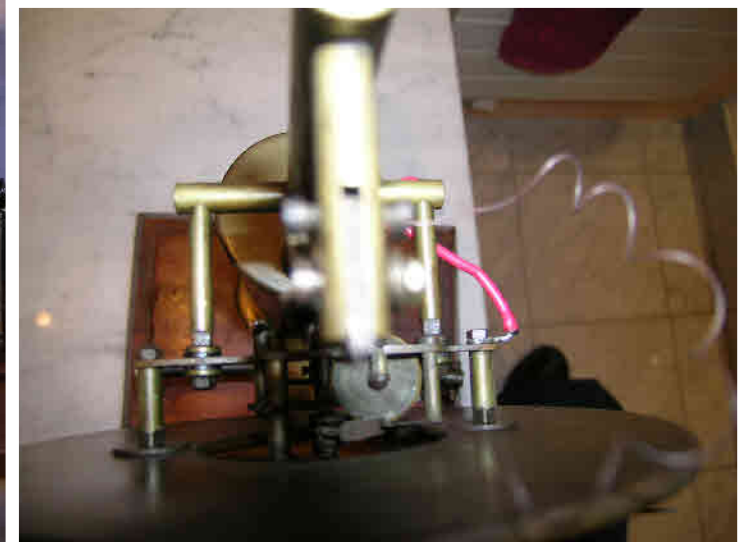
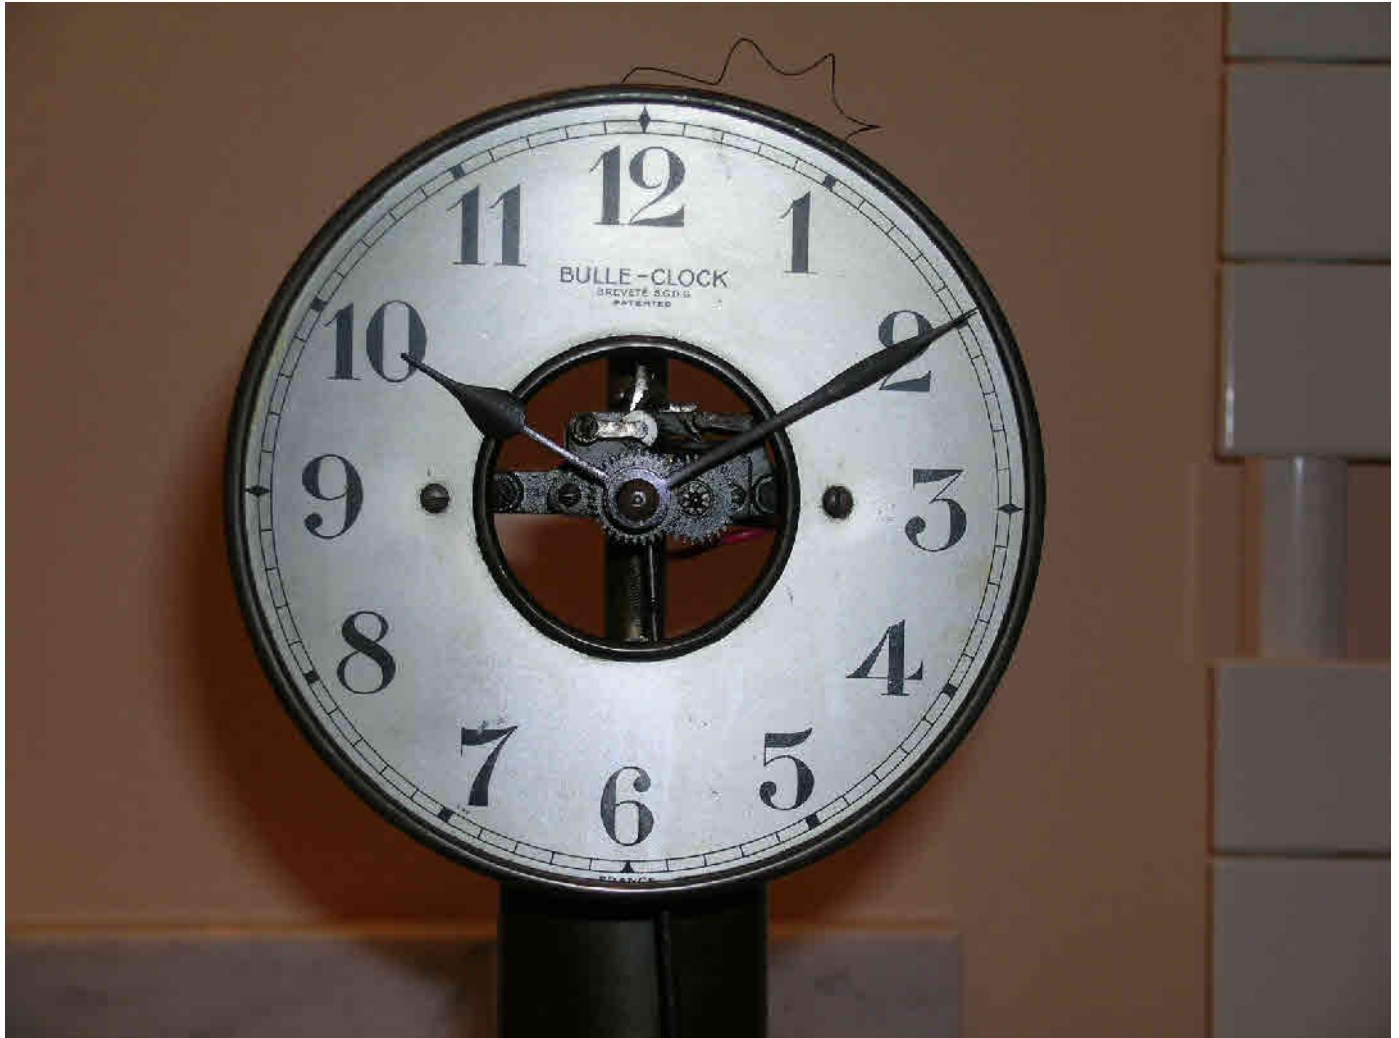
Finally, on this and the next page, a few shots of the clock in its original condition for comparison..
