Bulle Clock Serial Number 51540.

Early Battery Clock Parts & Restoration

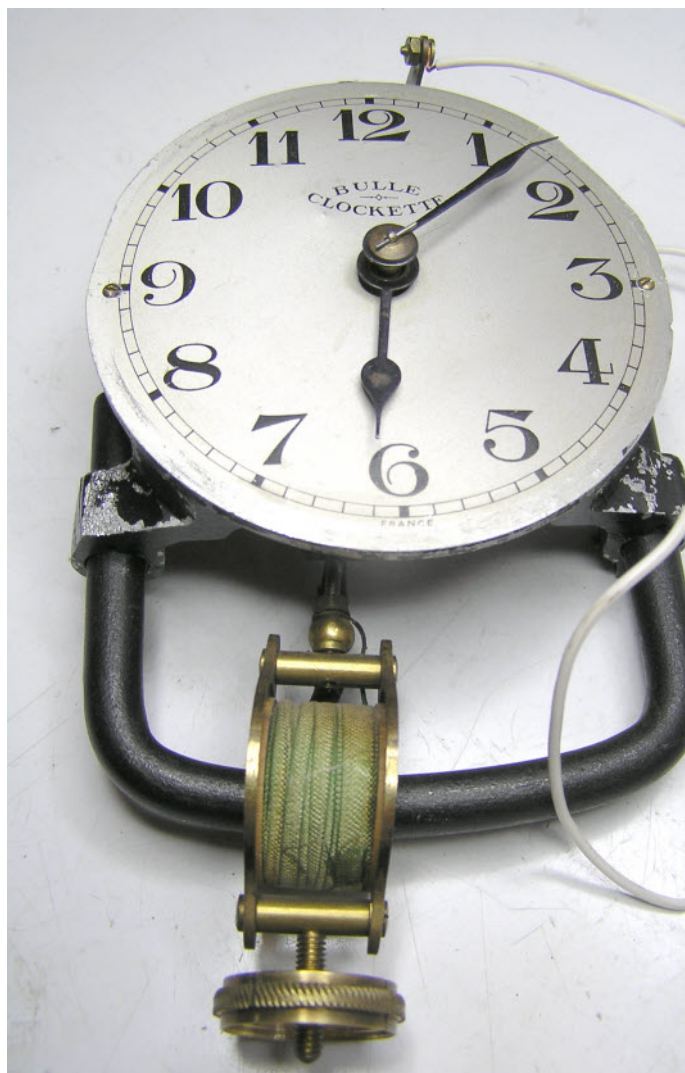
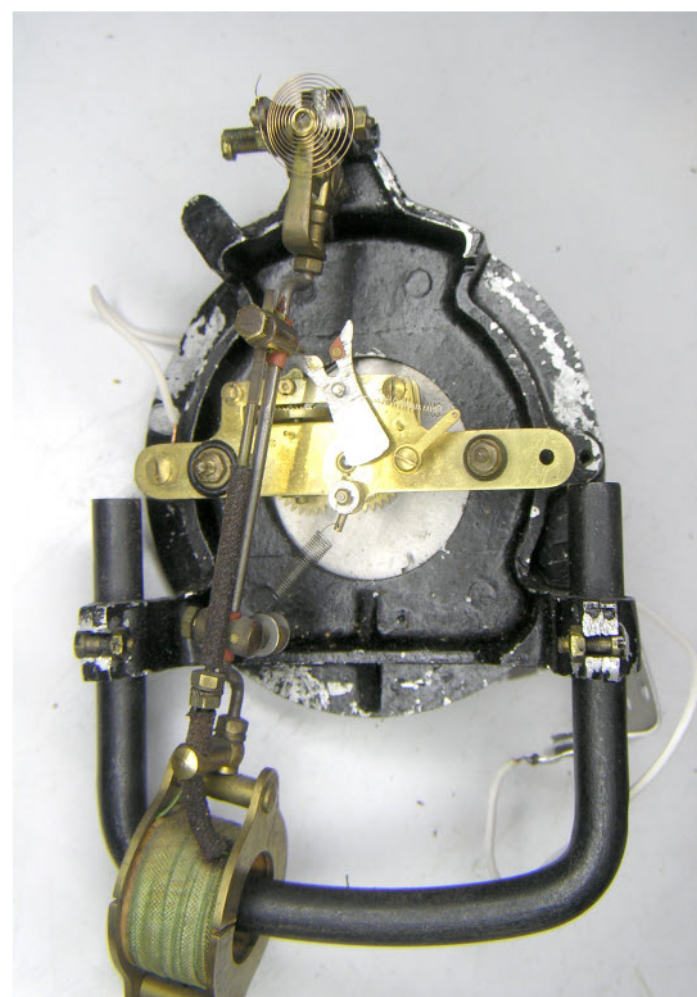
This Bulle frame and movement is shown as delivered. It is obviously from a small enclosed wood case. The aluminium frame acts as a dial support, movement frame and magnet support. At first glance everything looks to be in reasonable order with just the usual knocks and dinks expected from a clock of this age. Note that the pendulum coil is covered in green ribbon and was never intended to be on show. This was purely a functional timepiece and not in any way decorative.

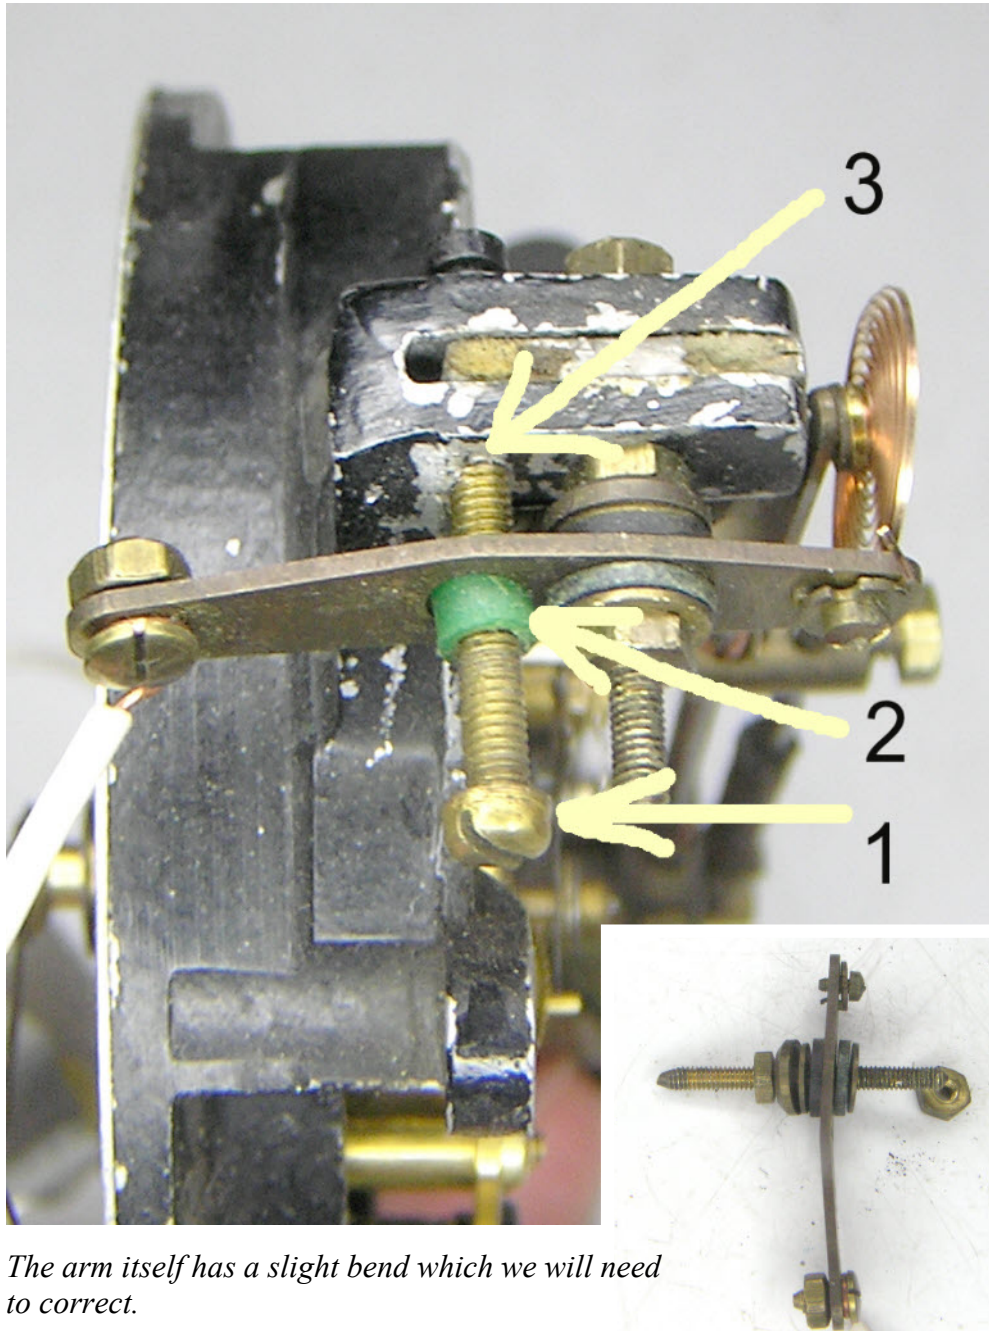
There is a problem here though. The screw shown (1) is completely wrong. It should be a small threaded stud with an insulating stepped washer which in this case is a piece of green plastic (2). The screw is much too large and has been forced into the aluminium casting (3).

The resultant hole is now too big to accept the original 2.5mm threaded stud and we will need to think about correcting it. The whole point about this arm is that it provides a way of providing contact between the negative side of the battery and the pendulum rod. The white lead shown at left runs to the battery while the small balance spring provides the contact with the pendulum. The whole arm is then insulated from the aluminium frame by the insulating washers. The washers are also wrong in that they are formed from rubber rings.

The arm itself has a slight bend which we will need to correct.

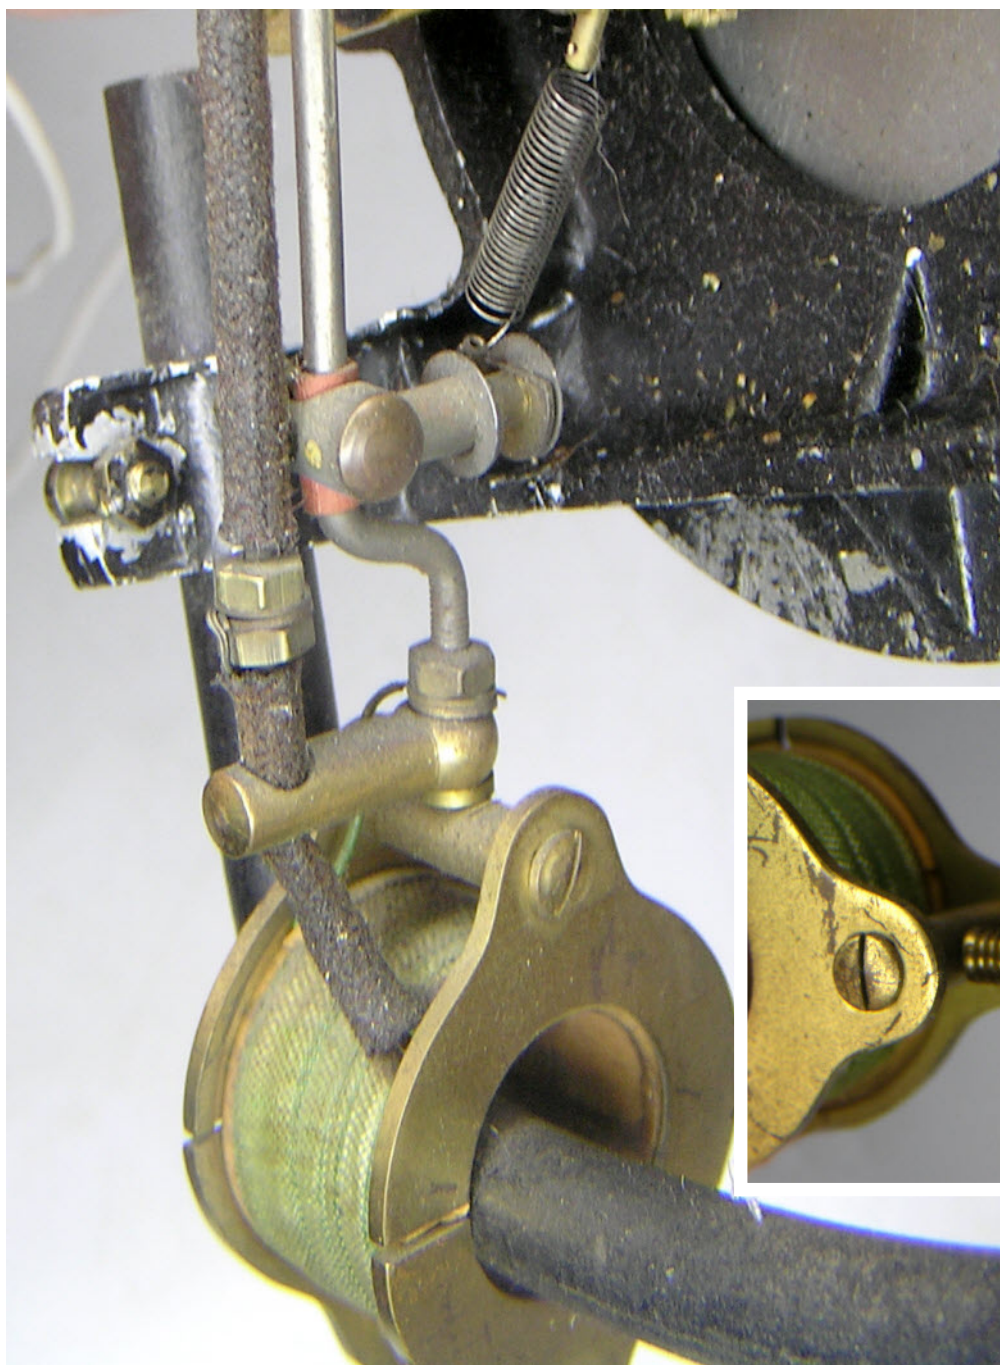
The pendulum looks to be complete and in good condition. Note the method of securing the magnet. The arm is clamped in position with a small nut and bolt. The problem with this is that the the whole pendulum has to be removed before the magnet can be released. It wont matter in this case as the whole clock id being stripped down for repairs and cleaning.. This photo shows the condition of the rating

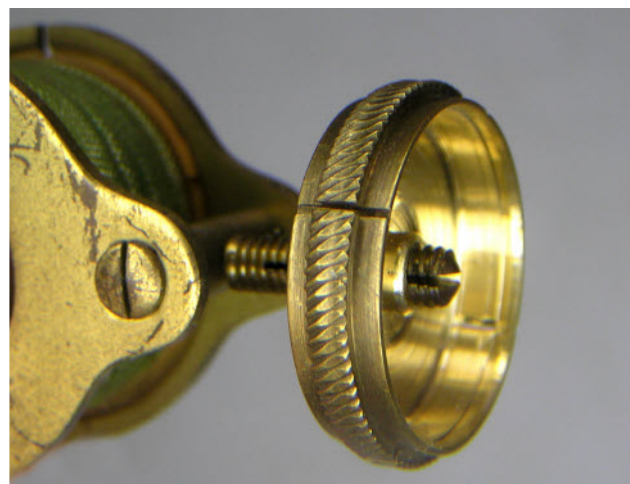
nut. It has been hollowed out so that is is lighter. So there might be a problem elsewhere. This will need to be repaired

The remains of the rating nut and the new insert ready for fixing. The insert has been turned for a push fit with a bored centre to fit over the remains of the threaded centre. The last photo shows the insert in place and turned back. Being a push fit all it needed was a small amount of Loctite 603 to retain it in position.

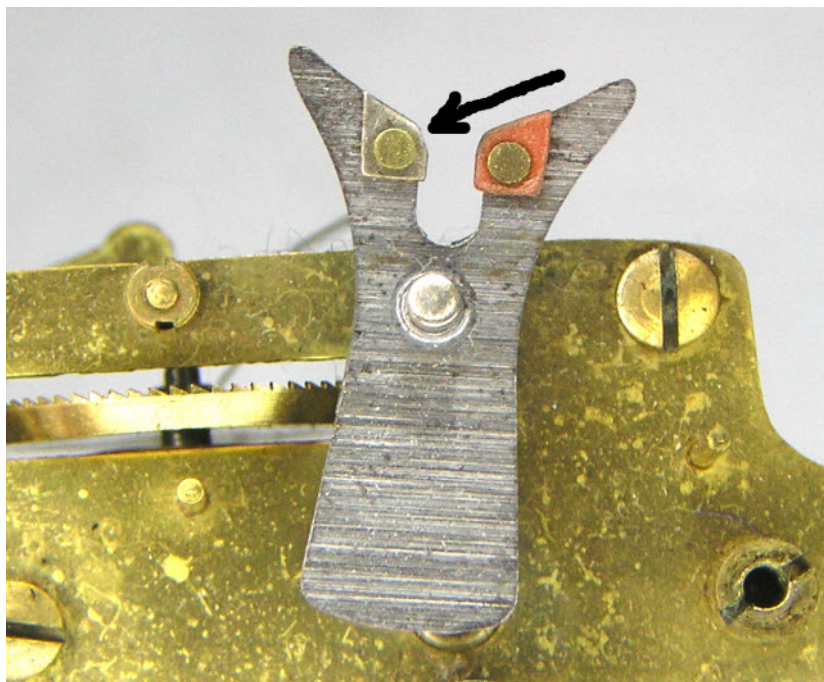
As is so often the case there is a good amount of wear on the silver contact of the fork. This will be replaced. The fibre side though looks to be OK so I'll leave that and check it out in testing later.

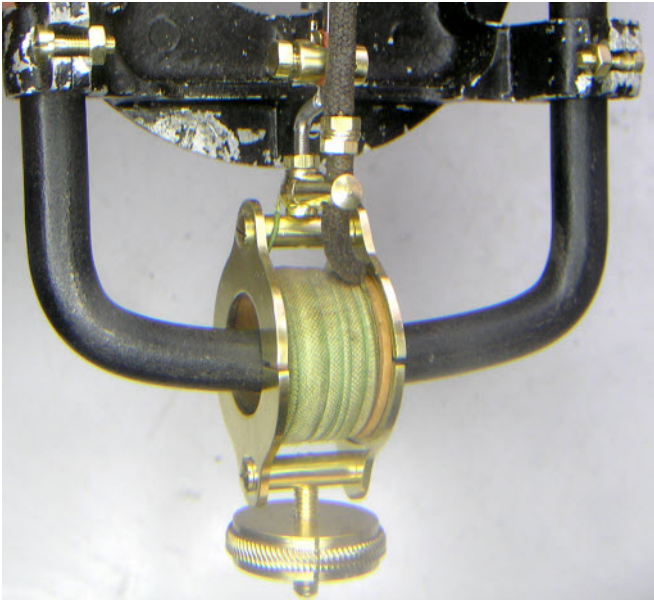
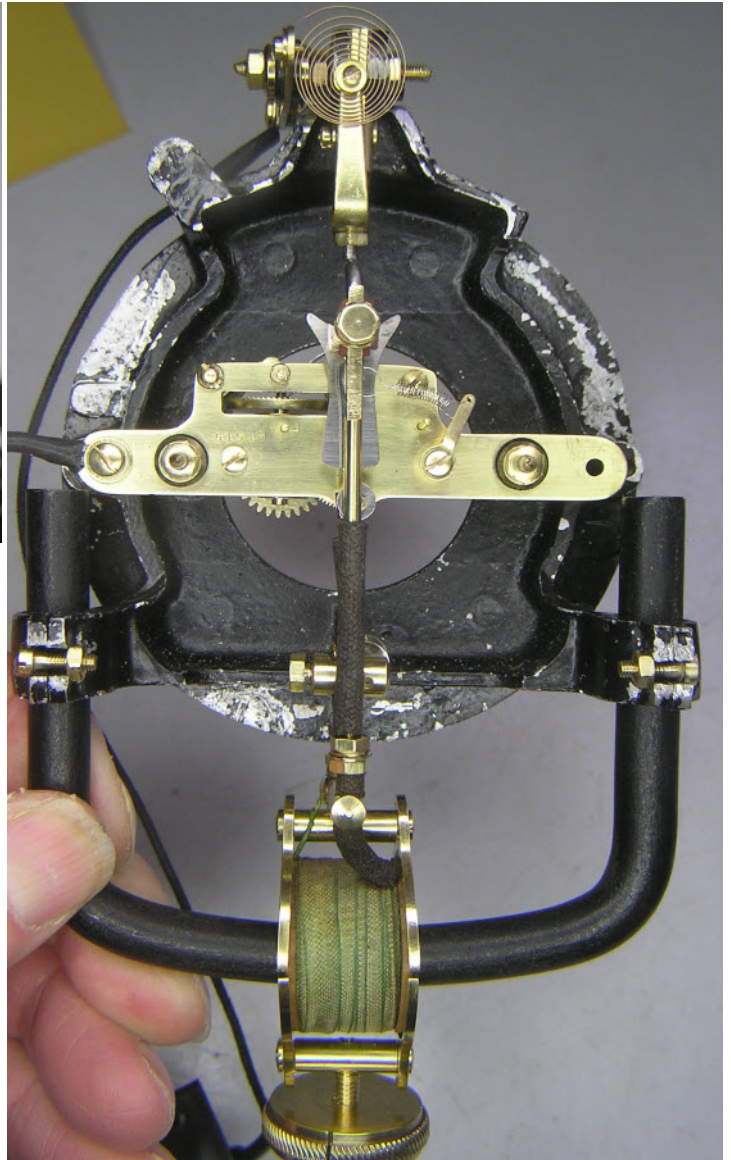
The finished clock.
