Bulle Clock Serial Number 57470. *(By kind permission of the owner)*

Restoration of Bulle Clock Serial Number 57470.

—Early Battery Clock Parts & Restoration

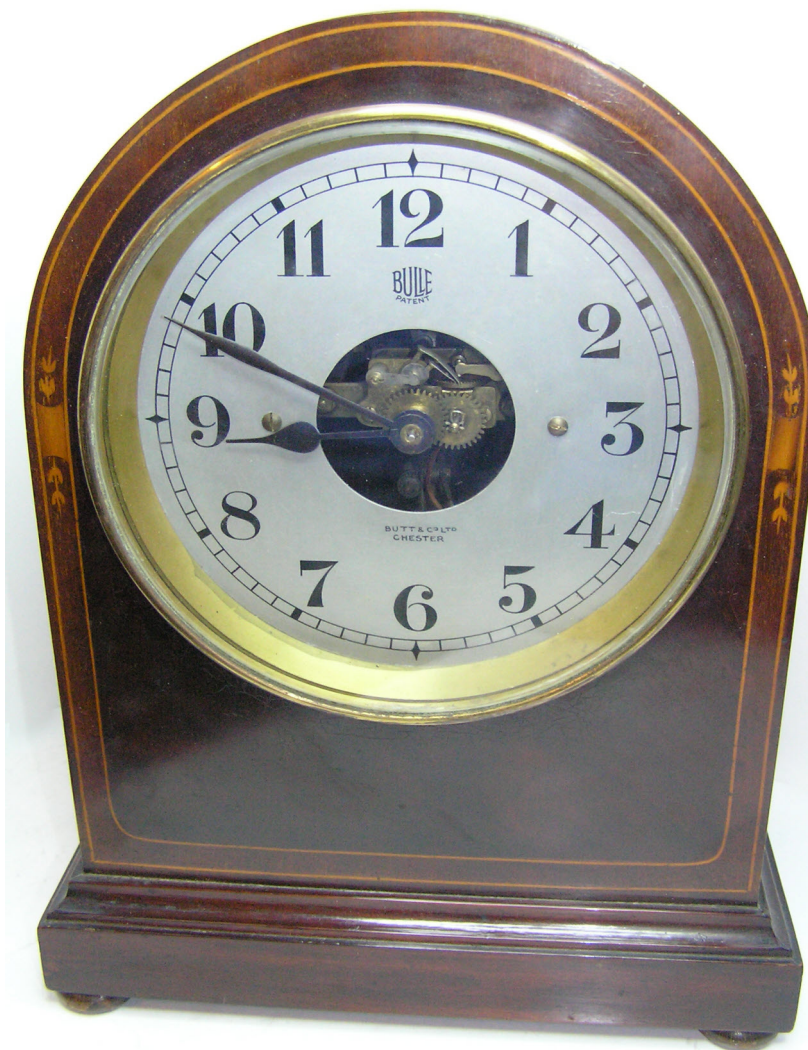
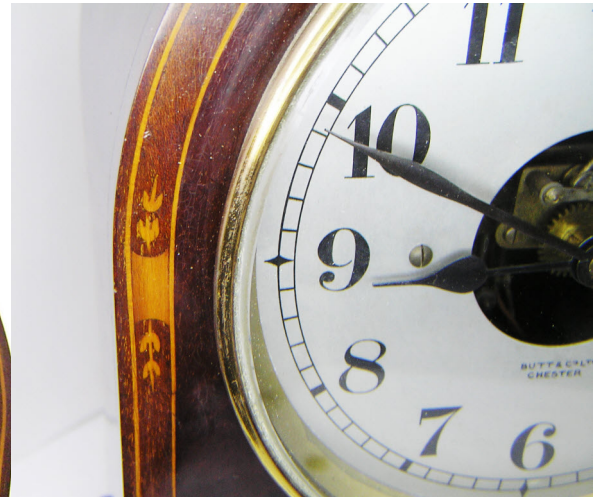
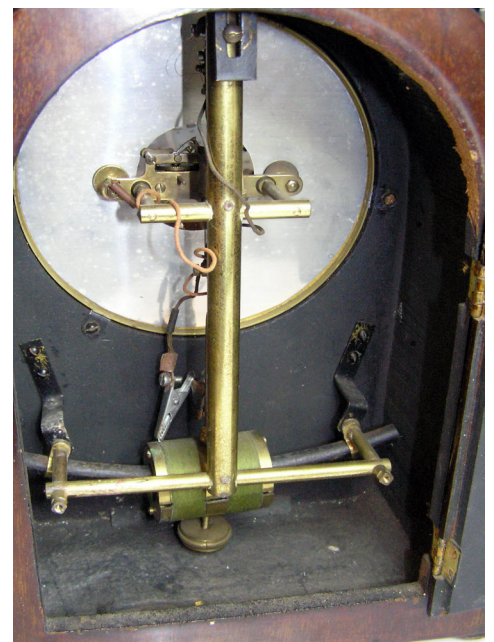
The renovation of this $\frac{3}{4}$ movement is reproduced here by kind permission of the owner. The movement is fully enclosed by this lovely mahogany case. Only the movement of the pawls is visible through the dial aperture. The case has some subtle inlay which the inset photo shows in more detail. The dial, bezel and wood work are all in very good condition and will only need a dusting and polish. The first impressions of the movement leads us to think it is also in good condition.

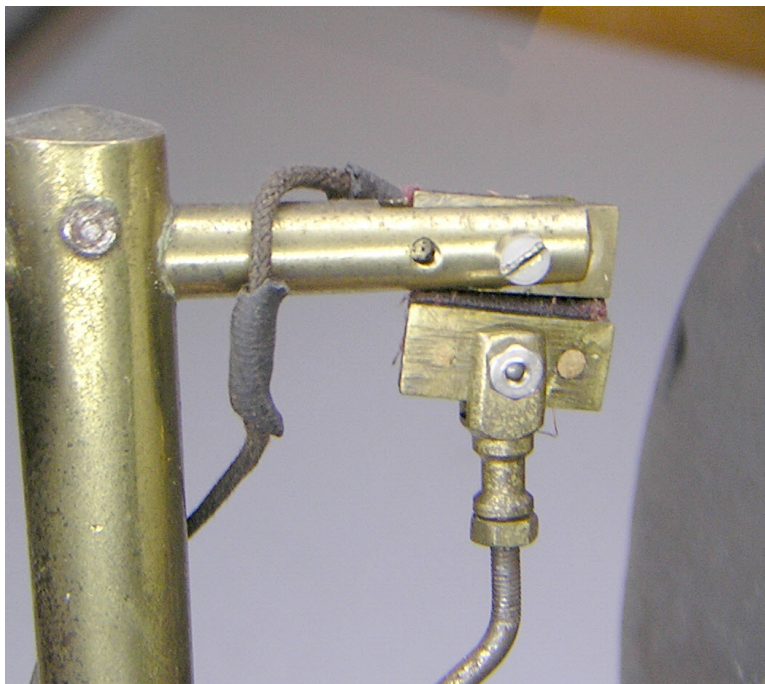
The suspension has a few problems. The suspension itself is made up from an old unit and is too thick for the support arm. The sides of the arm have been spread to accommodate. All of the screws and nuts are wrong. And must have been replaced at the same time as the suspension. It would seem probable that the suspension was taken out when it failed and not replaced for a long time. Meanwhile the screws and nuts were lost. They were then replaced with these steel ones. There are also two Blued steel screws missing from the rear of the suspension. These act to stabilise and clamp the suspension in position. All of these will need to be made.

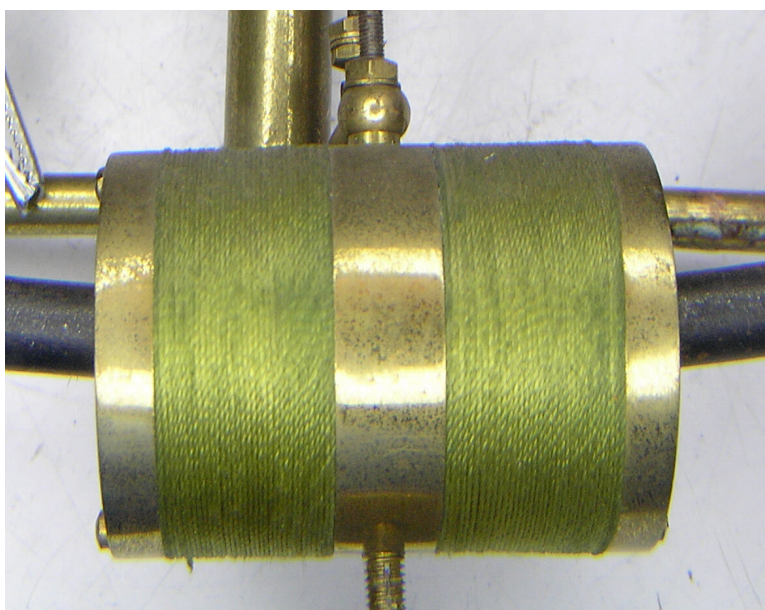
Bar the tarnish the pendulum bob is in excellent condition. The cord is very dirty but is complete and has retained a good colour. We must try and keep this intact and endeavour to clean the brass without touching it. This takes a lot longer but is well worth it if we can retain the original cord. The best way I've found to protect the cord is to wrap it carefully with a low glue masking tape. This tape will only adhere lightly to the cord and can be easily removed if done so within a few hours. Otherwise there is a danger of pulling or ripping the cord. The brass can then be worked on with cleaner and "0000" grade wire wool before removing the tape and then washing the whole thing, including the cord, in warm soapy water.

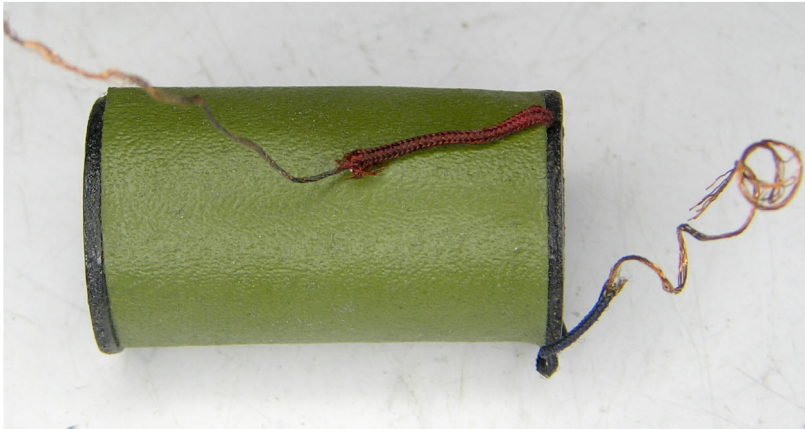
The coil also is in excellent condition giving a constant 1240 Ohm resistance reading. The copper wires are also clean and free from corrosion.

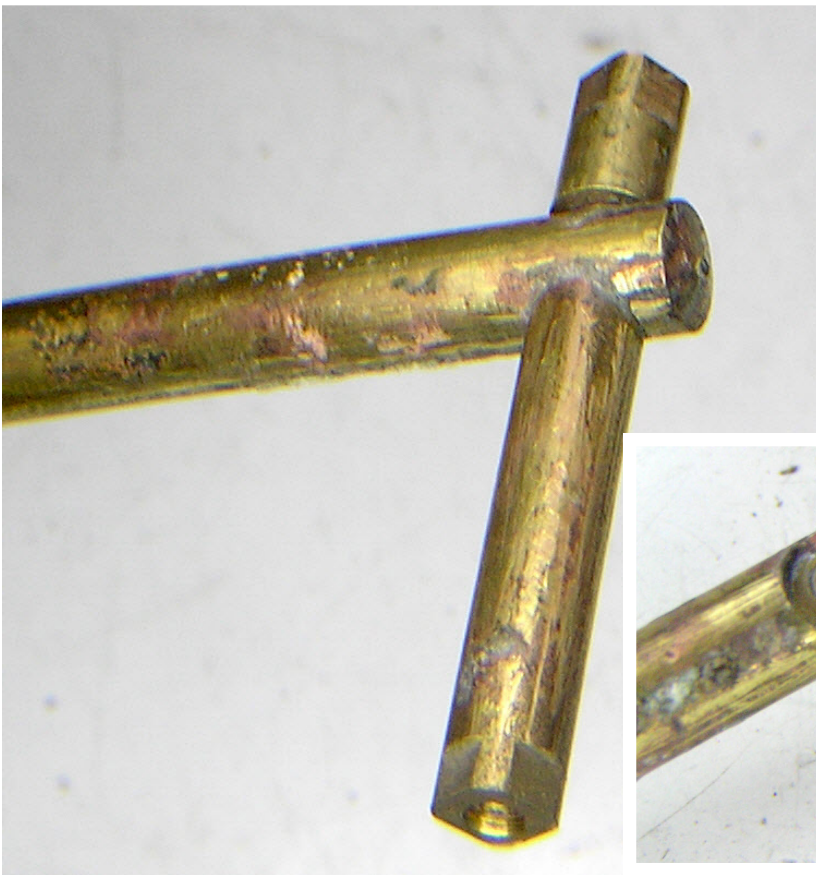
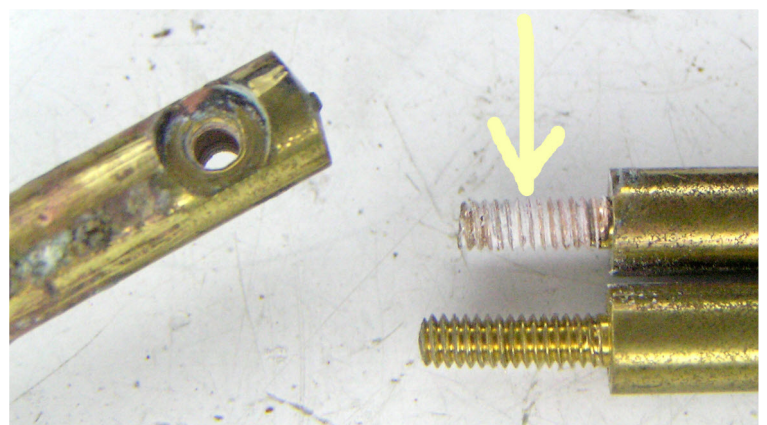
The frame has not fared so well though. As can be seen there is corrosion on the lower frame and magnet supporting arm. This has resulted in some damage to the brass and also the thread of the arm. These parts will need to be soaked in the usual solutions to remove all traces before polishing. Note also that the thread is shorter than the its mate on the other side. Fortunately there is still more than enough to capture the short arm at the rear.

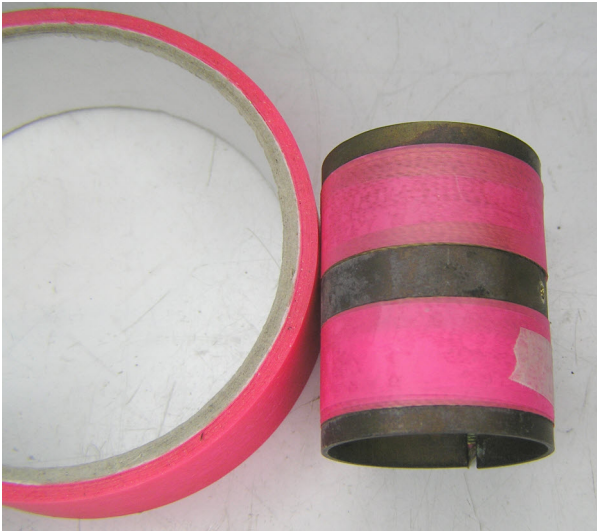
The pendulum bob masked up and ready for cleaning.

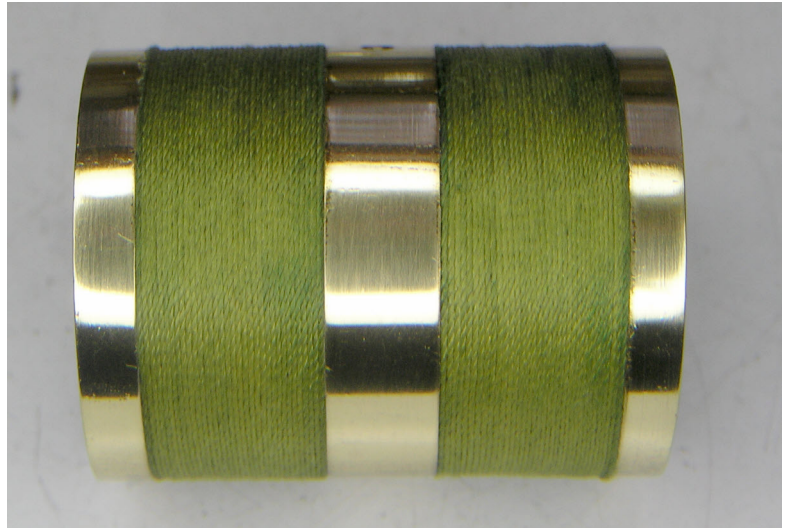
The pendulum bob and cord after cleaning. The masking tape worked very well and we have succeeded in retaining the original cord.. I used a small tooth brush to give the cord a gentle scrubbing while immersed in the warm soapy water. After drying the cord was again wrapped in masking tape while the brass was spray lacquered.

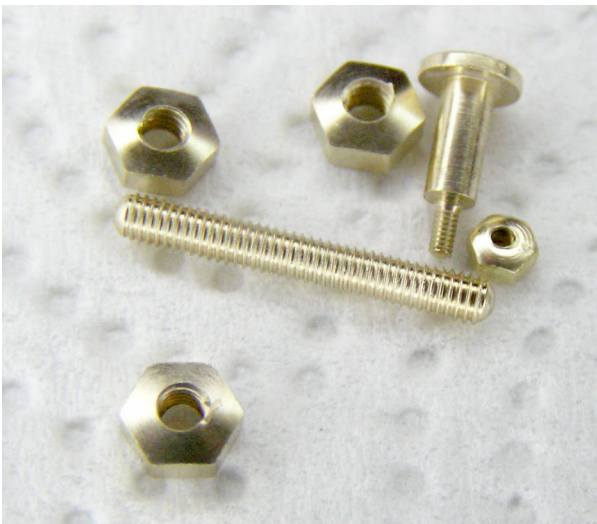
These items were made to replace the steel nuts & screws that were wrongly used on the pendulum assembly.

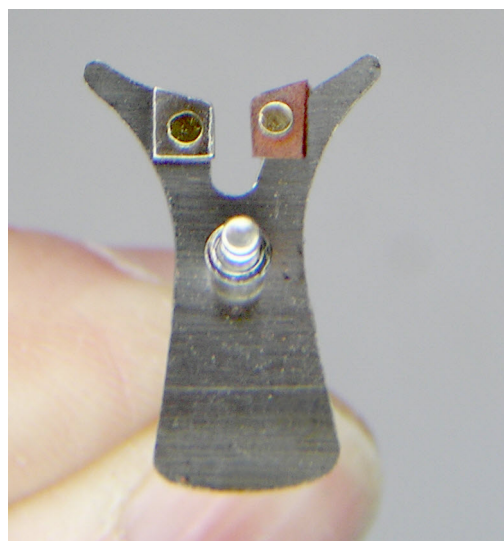
The fork is shown here after the fibre contact has been replaced. The silver side is in good condition and, along with the silver end to the arbour, has been cleaned and polished to provide a good electrical contact.

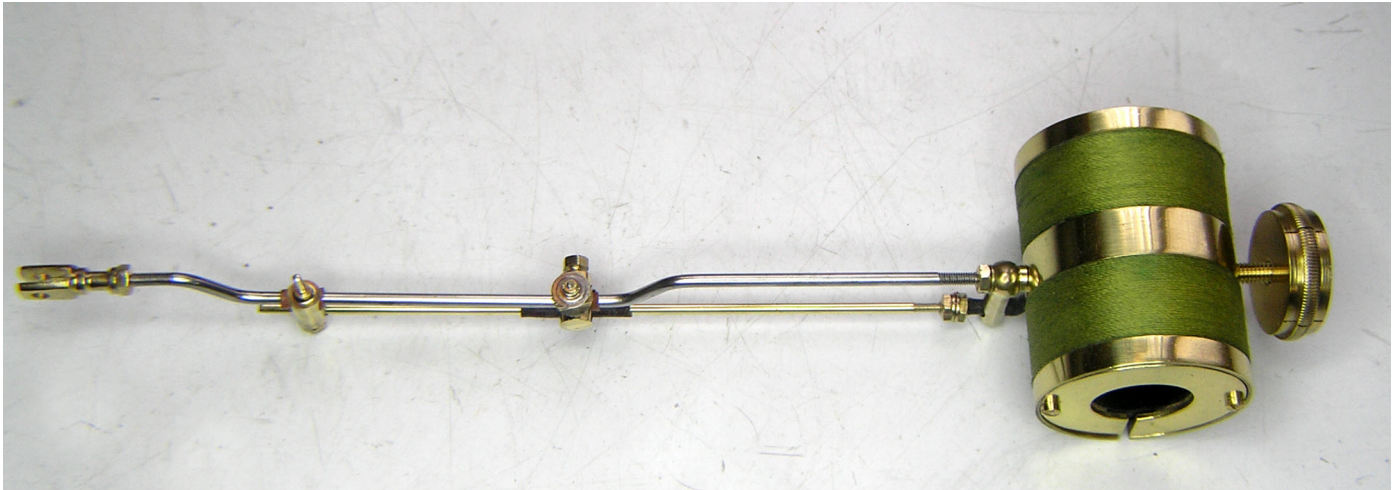
The pendulum reassembled ready for attaching to the frame.

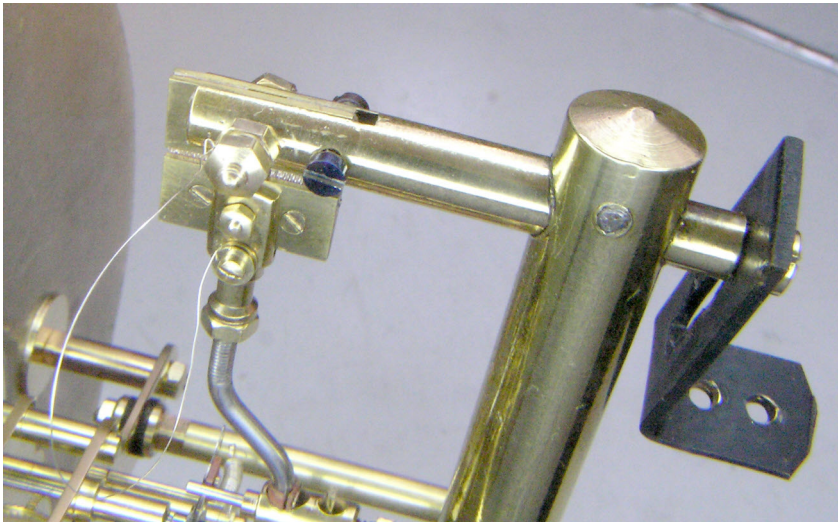
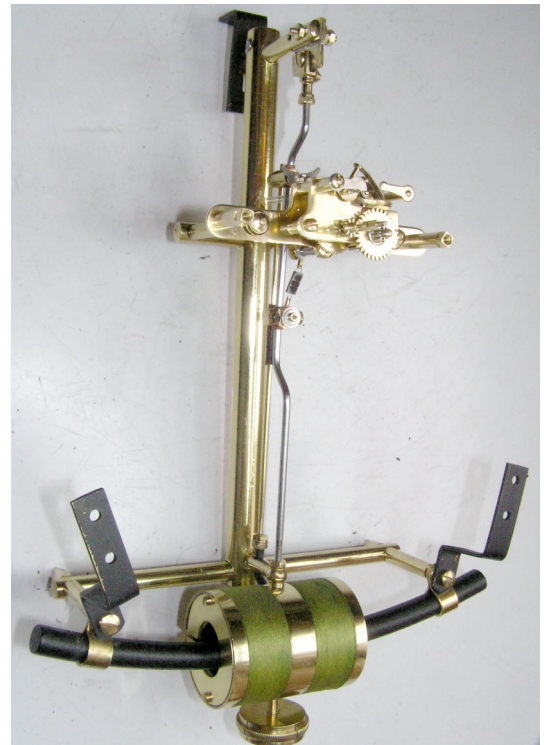
The pendulum assembled with the frame using the new parts. Note the two new blue steel crews that grip and position the top of the silk suspension.. The photo at right shows the whole movement, pendulum and frame with the case brackets ready for insertion into the case.

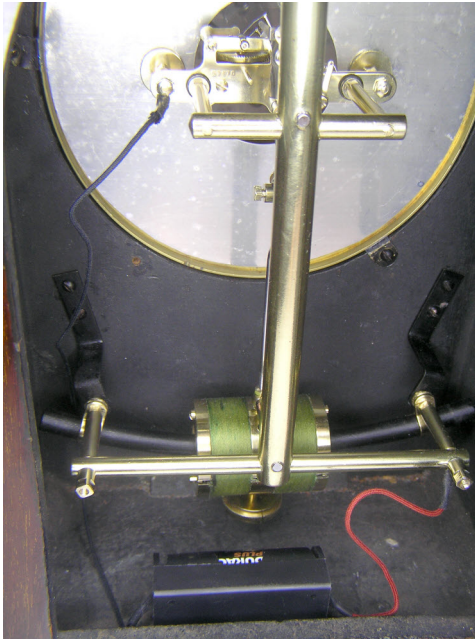
The insert photo above shows the Bulle movement and frame from the rear of the clock. The dial is in excellent condition and only needed a wash with warm soapy water. The case, although it has a few marks and blemishes, needed no more than a good going over with wax polish.
