**Bulle Clock Serial Number 5937**

*Restoration of Bulle Clock  
Serial Number 5937.*

Early Battery Clock Parts & Restoration

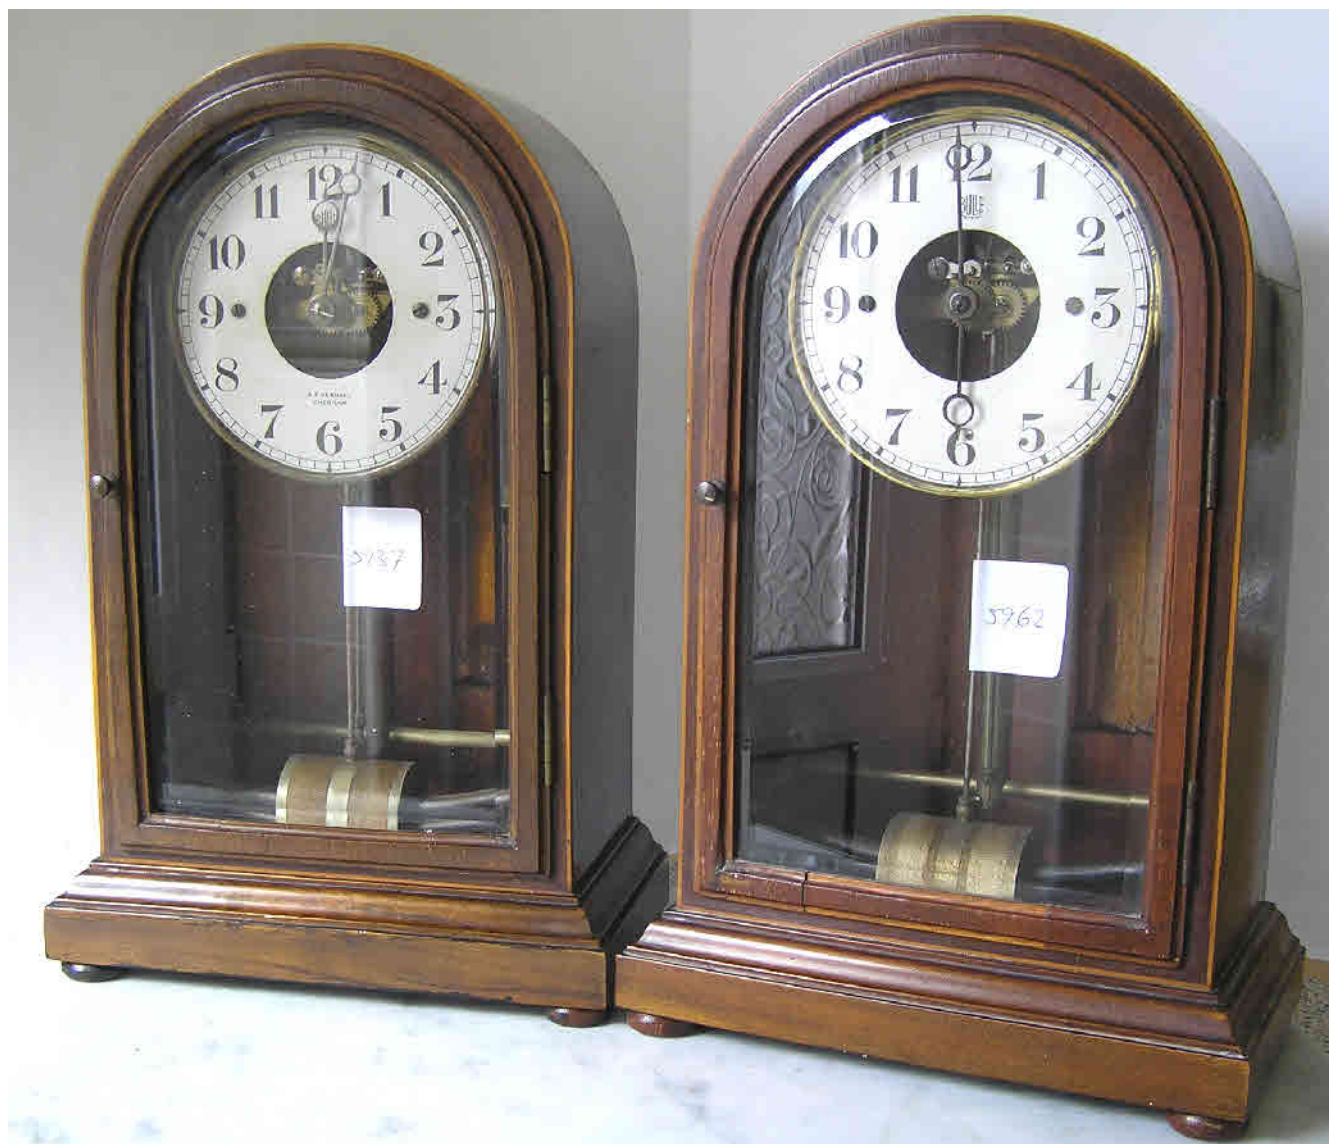
*This pair of clocks is unusual in that the serial numbers are within 30 of each other and they are exactly the same model. In fact there are no discernable differences in these two clocks which allows us to the rare opportunity to say that the features seen are all original. Before I acquired the second clock I had thought that the hands were replacements being cut down from a taller clock. But that is obviously not the case as both are clocks are the same.. Both clocks date from the first year of manufacture.*

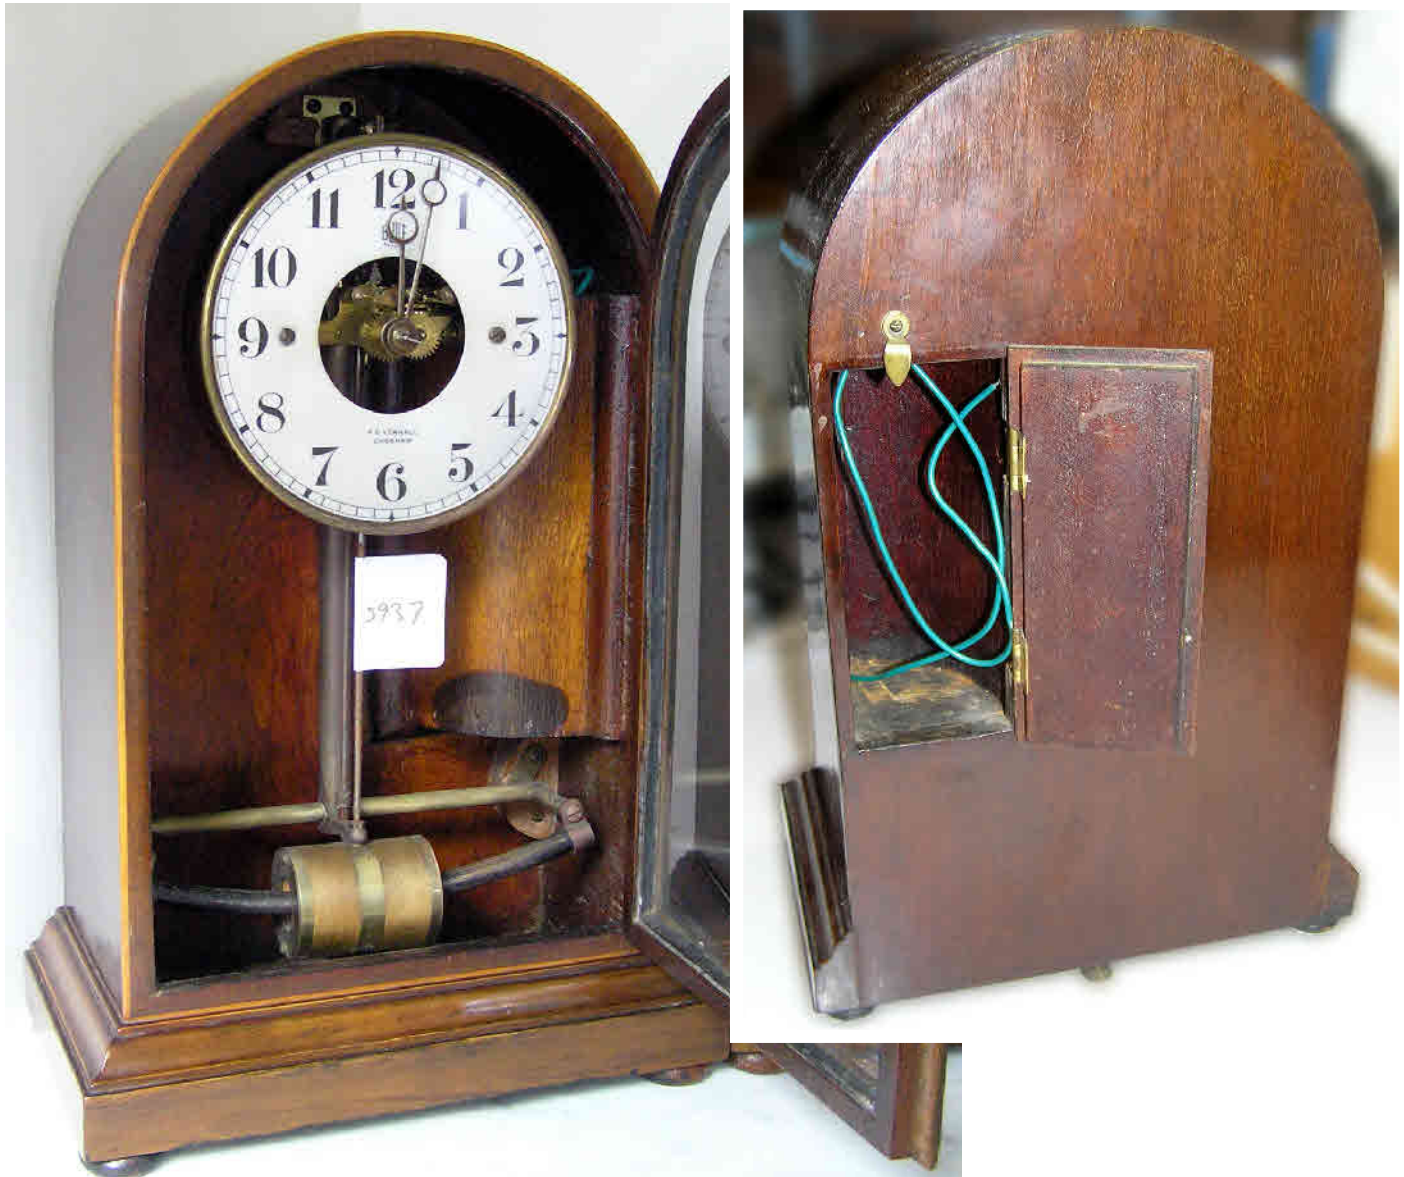
*The restoration will be of serial number 5937. The clock looks to be complete with little damage if any. It is obvious that the wiring has been changed at some time though. The battery compartment looks generally clean and free from any acid damage.*

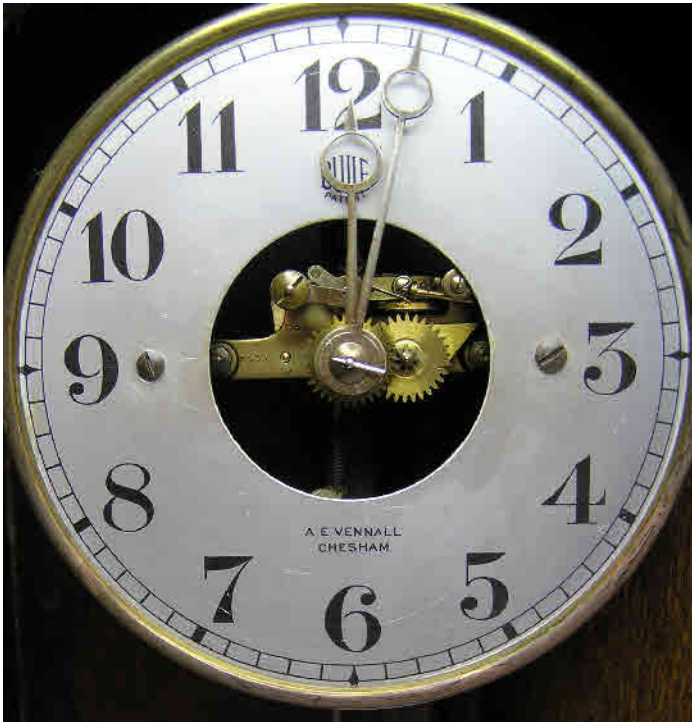
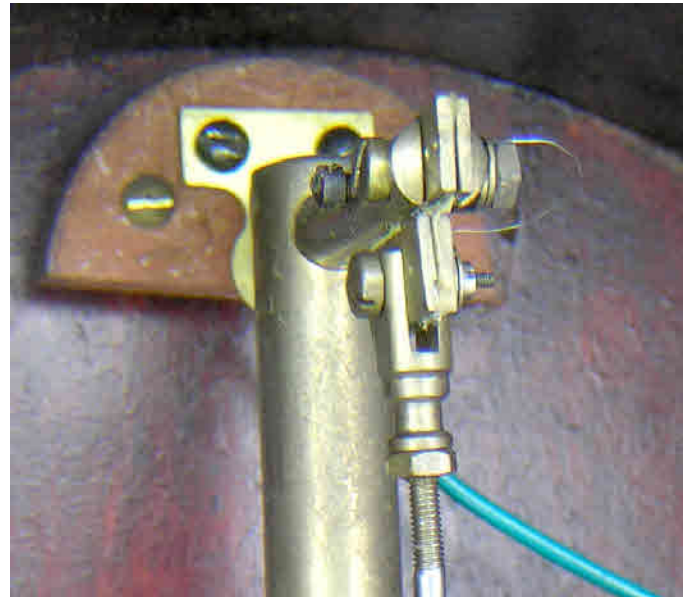
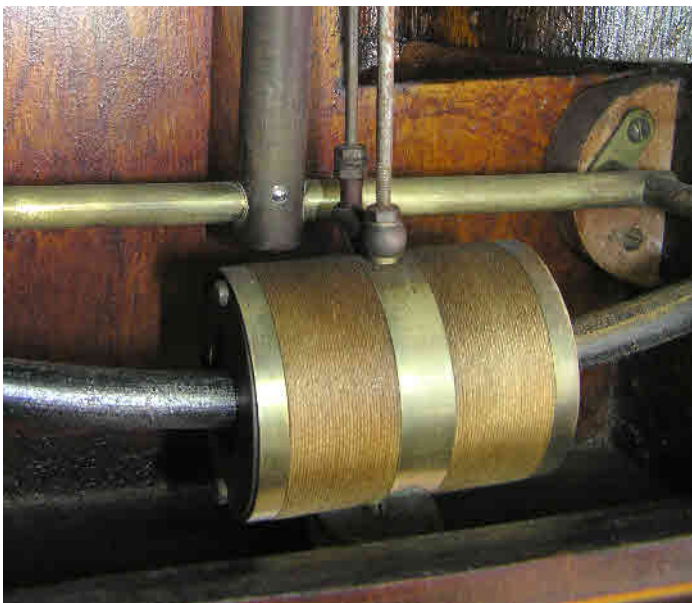
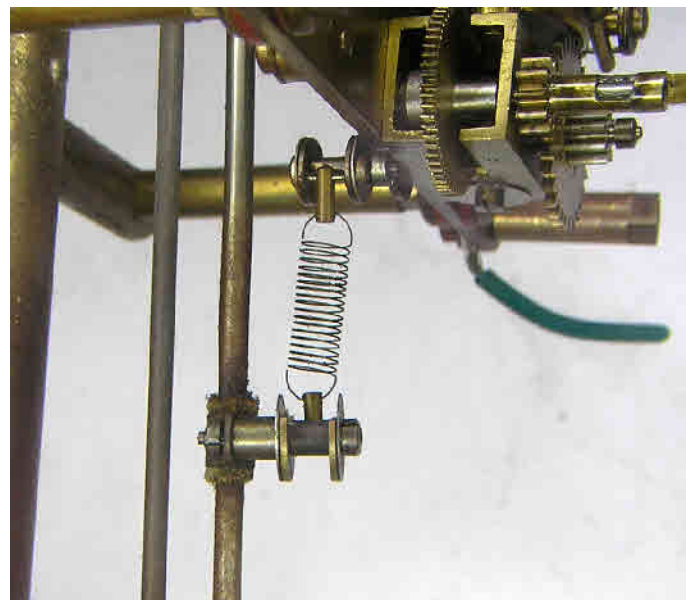
*This all looks promising. All the parts are original with nothing missing. A good clean clock. Even the Isochron spring is still in place and unstretched.*

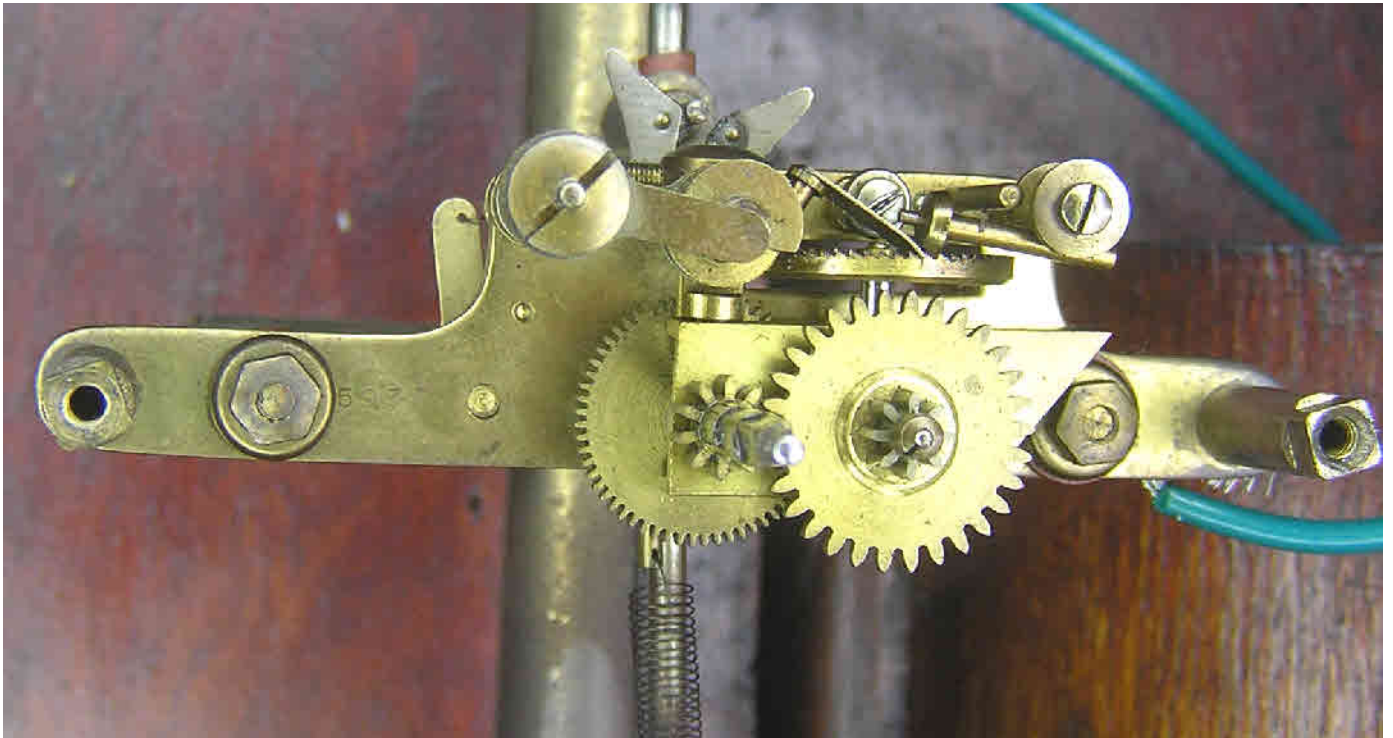
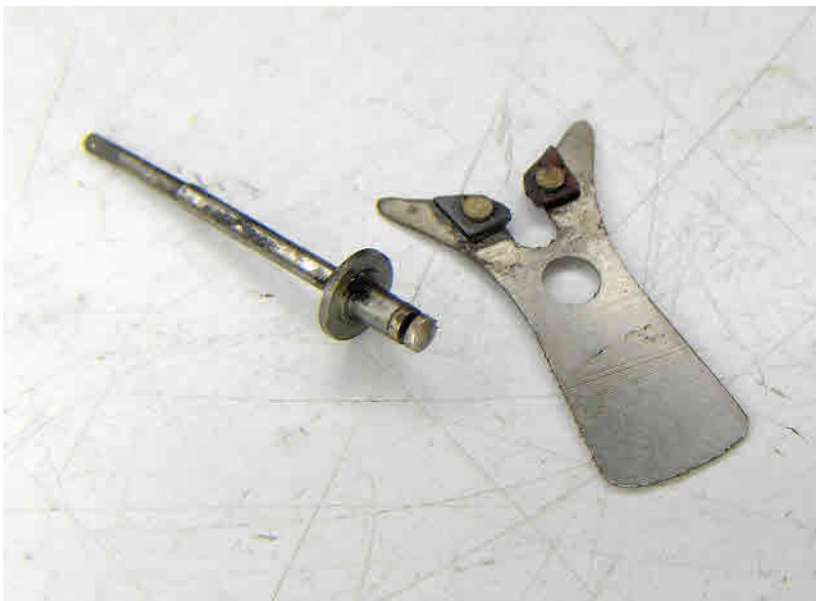
*Well, I was going to say that this was going to be an easy restoration but look at the fork arbour in the photo on the left! I thought it felt a bit wobbly when I removed it from the movement above. But it just fell apart when it was out. But it's not that bad. It will just need re-riveting in place. This may very well explain the fact that this clock had a very weak action when it was tested when first acquired. The arbour is integral to the circuit and must have a good contact with the silver fork contact.*

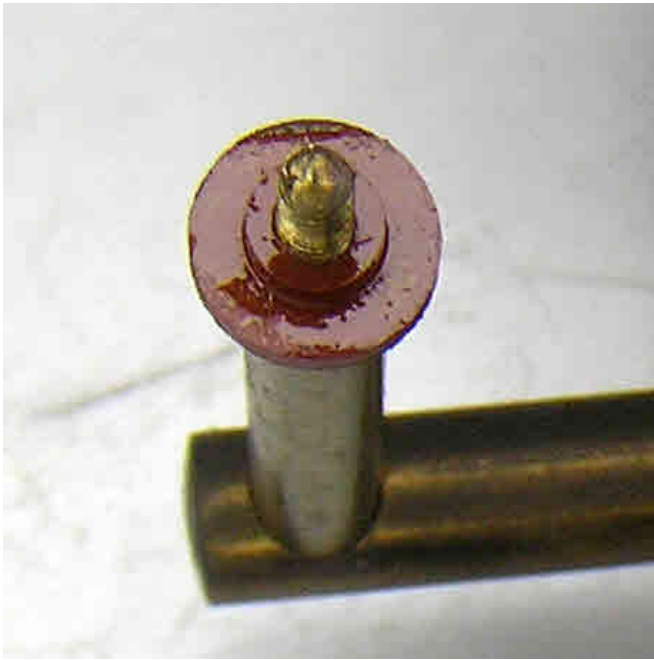
The photo at top left shows the state of the fibre insulating movement washers. They are impregnated with oil. The fibre is absolutely awash with the stuff and I will probably replace them.

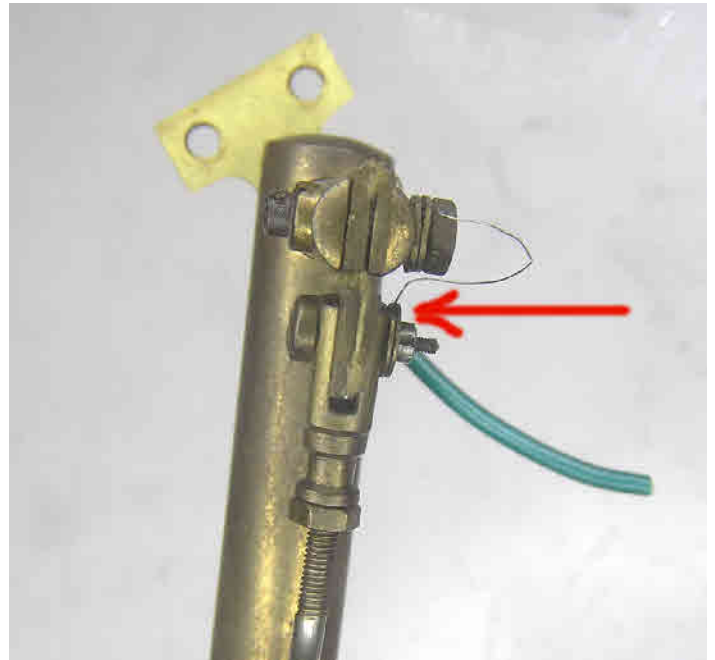
The next photo shows where the pendulum contact wire was connected. This is the worst position to connect it as the bolt at the top of the pendulum should be free to turn and slide. This enables the pendulum to find it's best position if the clock is placed on an un-level surface. This means that the bolt will be loose in the silk suspension and the assembly at the top of the pendulum. I will connect it lower down between the nut and assembly.

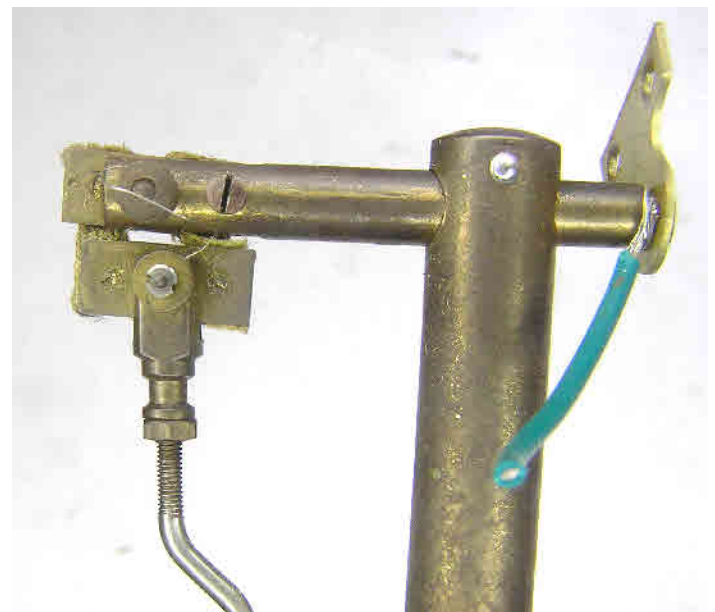
The final photo shows the state of the suspension unit which will also be replaced .

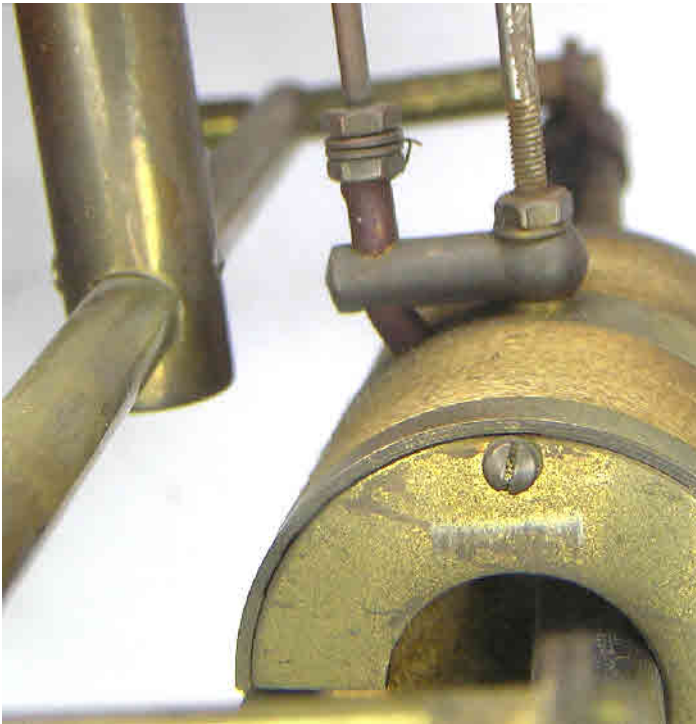
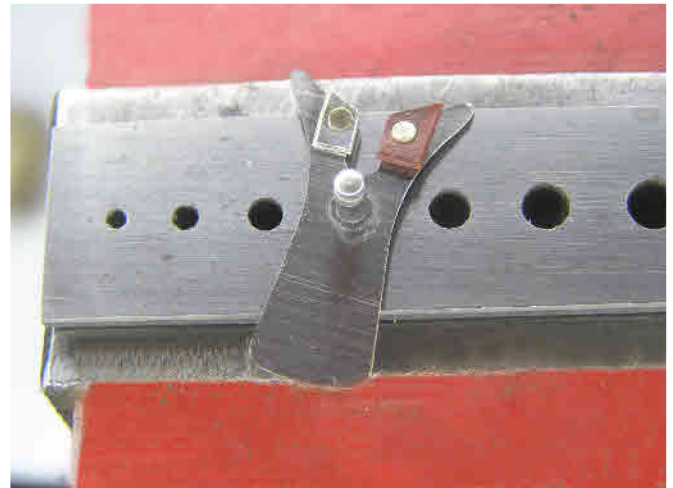
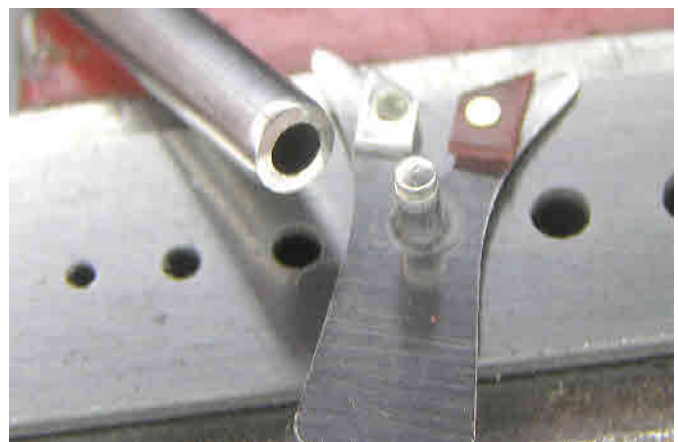
*This photo above shows the coil assembly and the original insulating tube as it exits the bob casing. After 70 years or so this insulating tube is as brittle as a dry biscuit. One touch and it will fall apart. It is impossible to remove it from the assembly in one piece and replace it. So I know that it has never been apart. The photos on the right show the new fork contacts in place and the method of riveting the fork back on the arbour. I used one punch with a hole that was larger than the bush on the arbour that allowed me to push the fork on. Then I used one with a hole just slightly larger than the arbour which allowed me to punch down on the bush thereby expanding it to be a tight fit in the fork hole. I then tested it for strength and electrical continuity.*

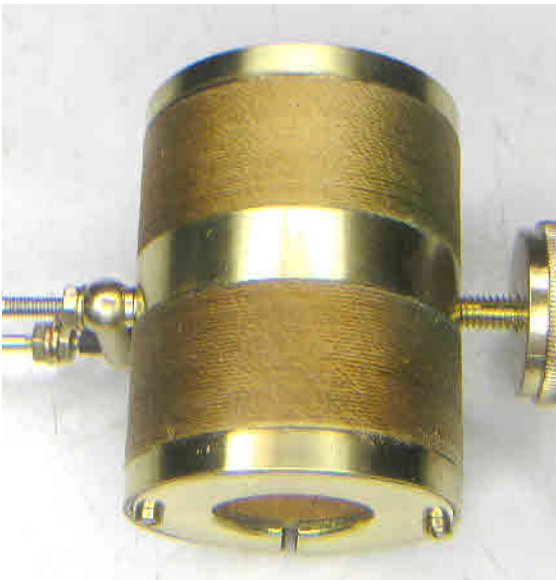
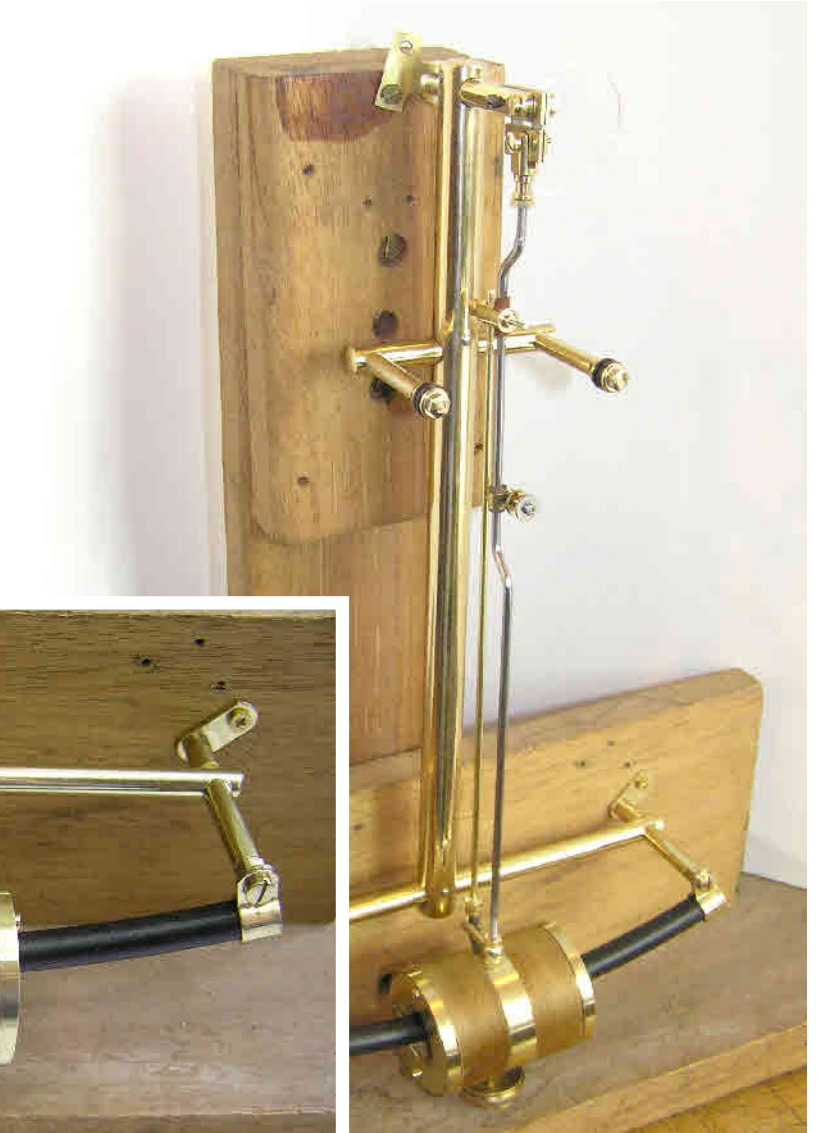
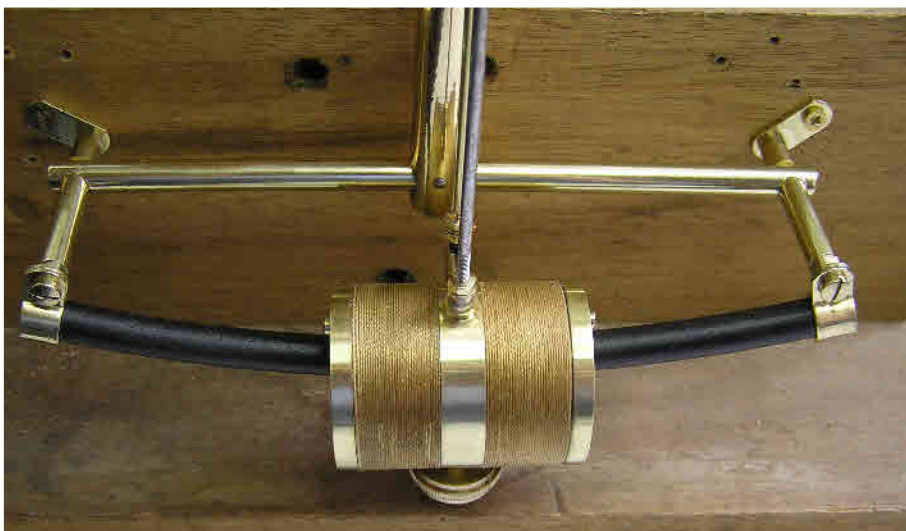
*This sequence of photos show the pendulum bob that has been cleaned whilst still keeping the original cord intact. This takes a lot longer but can be done if the cord is in a good condition. The magnet has been re-magnetised, cleaned and "Grate Blacked". The frame is then shown on a test stand with the pendulum assembly attached for testing lengths and clearances.*

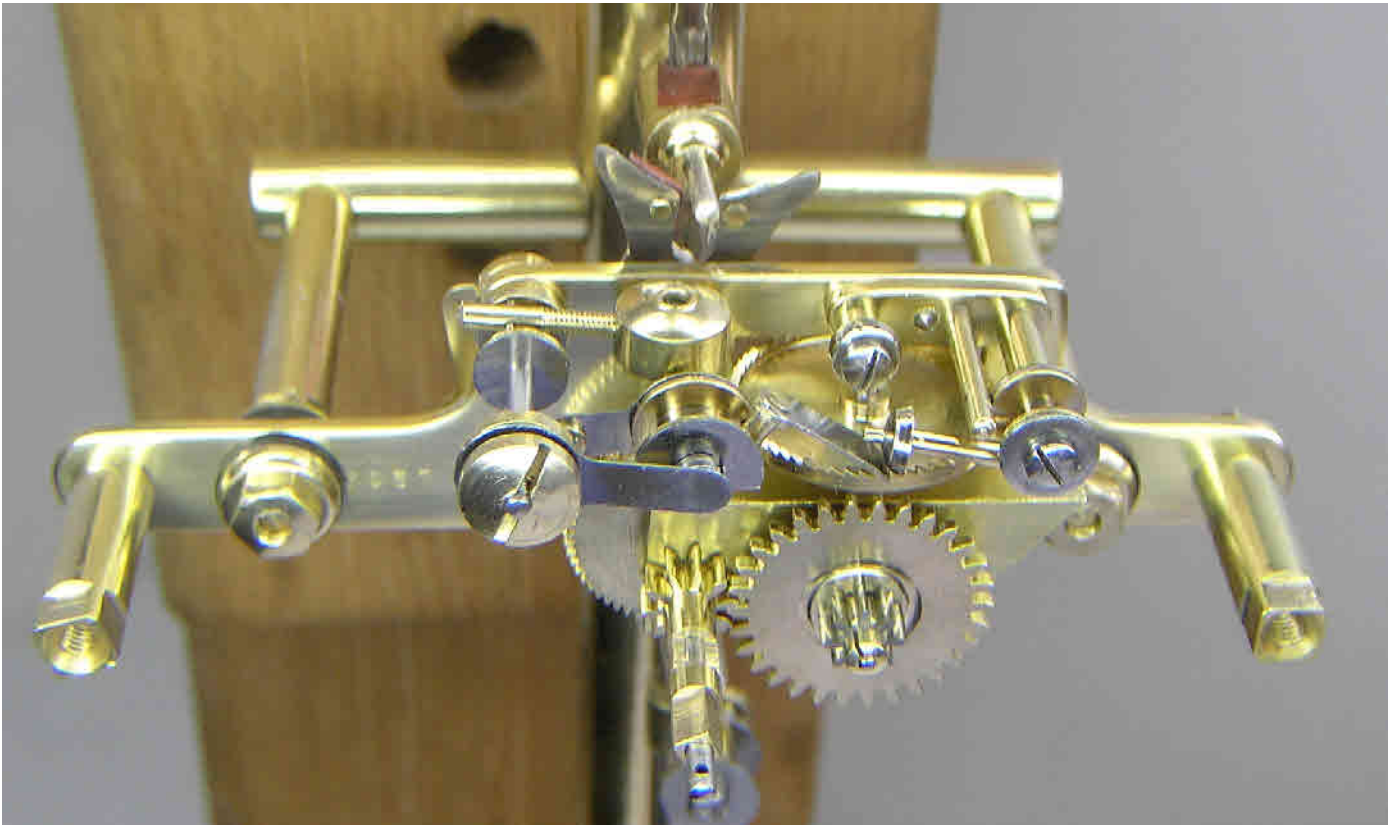
*The movement back in position on the main clock frame. The damper arm has been refilled with new cord and oiled. All steelwork has been cleaned and polished. The action of the pawls has been tested so that only one tooth is gathered at a time. The depth of the pin in the fork has been adjusted to suite this action. What you are aiming for is one tooth to be pushed and gathered over as much of the pendulum amplitude as possible. If you increase the pin depth then the impulse will occur with the minimum of swing but it will probably gather two teeth when it reaches 2/3rds of it's swing. If the pin is raised then it may then gather only one tooth at the higher amplitude and not gather any teeth at less than a third of the swing.. You have to adjust it to the best compromise.*

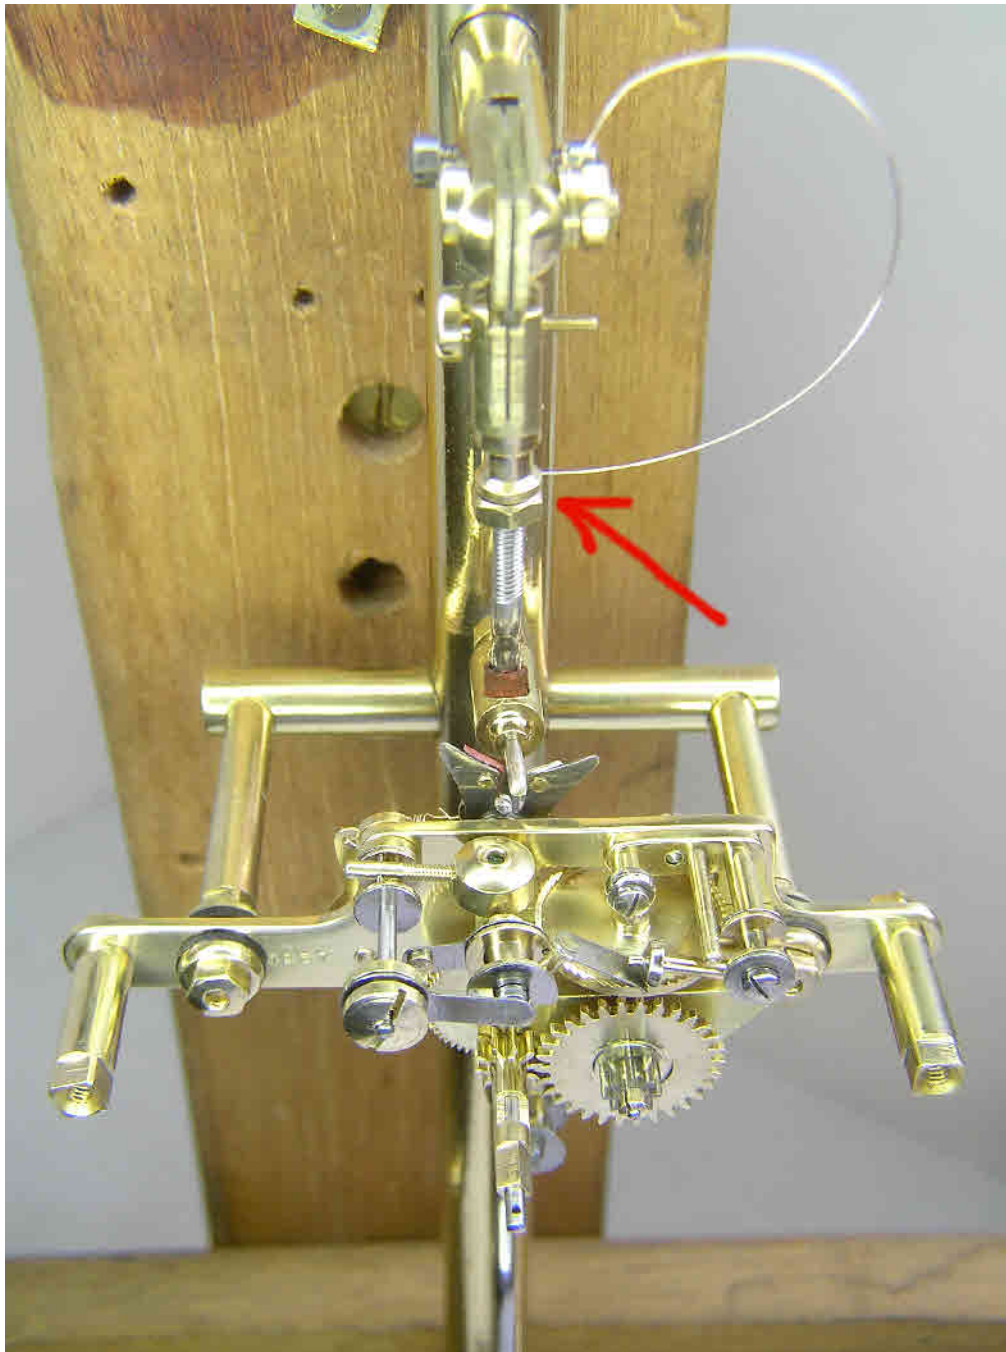
*The frame, pendulum and movement all in place. Note that I secured the contact wire to the pendulum using the nut that secures the suspension assembly in place. The wire is now firmly attached at both ends and is a much more reliable contact.. I can now screw the nut on the bolt attaching the pendulum to the suspension and test the electrical continuity for the whole circuit. The best way is to attach a meter to both ends of the battery holder and read of the resistance whilst holding the silver contact side of the fork against the contact pin. This should then read the resistance of the coil within a couple of Ohms. You will need to keep the pendulum still otherwise the readings will fluctuate because the movement of the coil over the magnet will induce a voltage and affect your reading.*

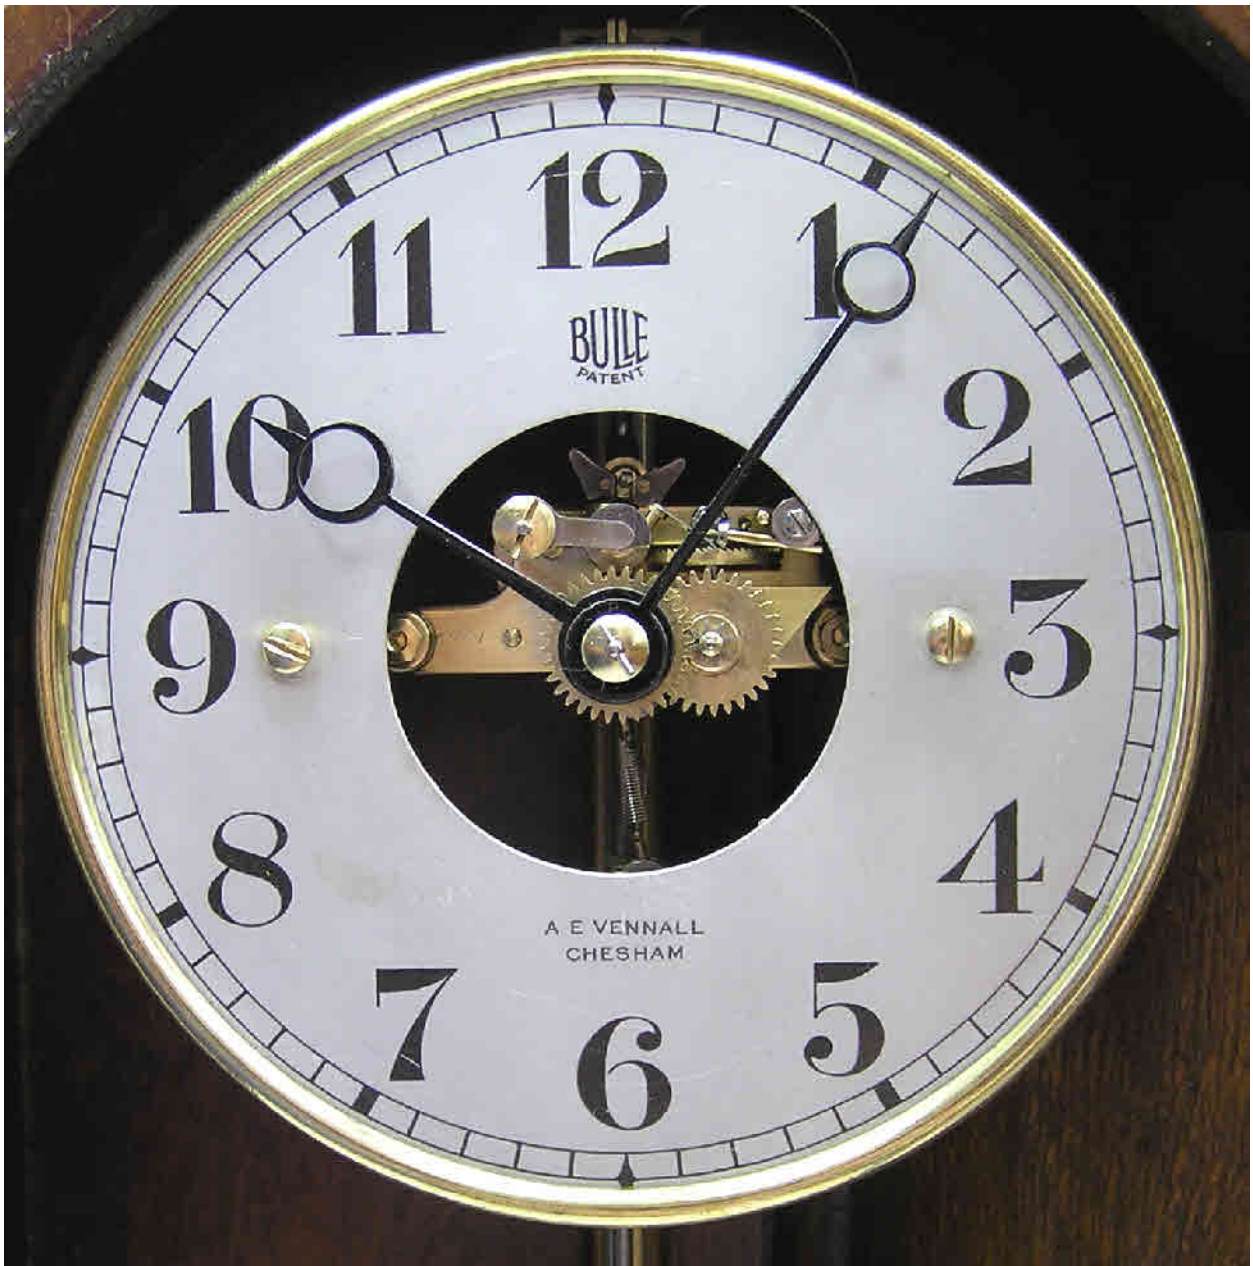
*The hands and dial in place. The dial surround was cleaned in the usual way by covering the face with brass shim cut to size. Finally the dial was washed in clean soapy water.*

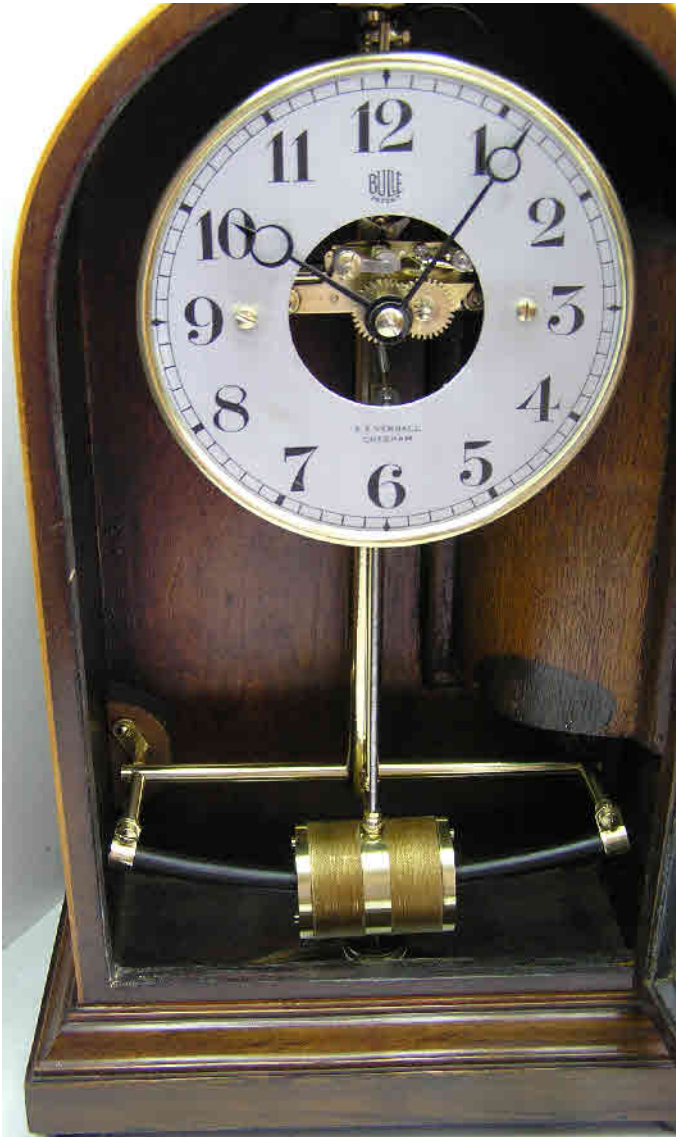
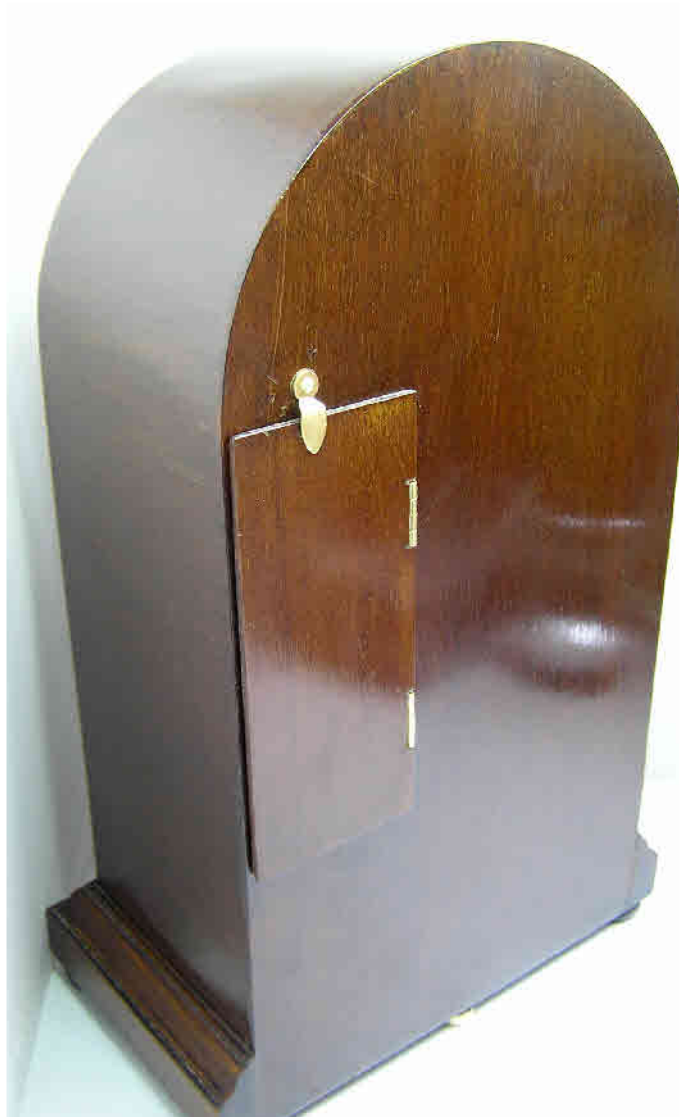
*The clock replaced in the case ready for fixing on the door. The back of the clock is shown with the battery door in place. The whole case was in good condition and only needed a good buffing with beeswax polish.*

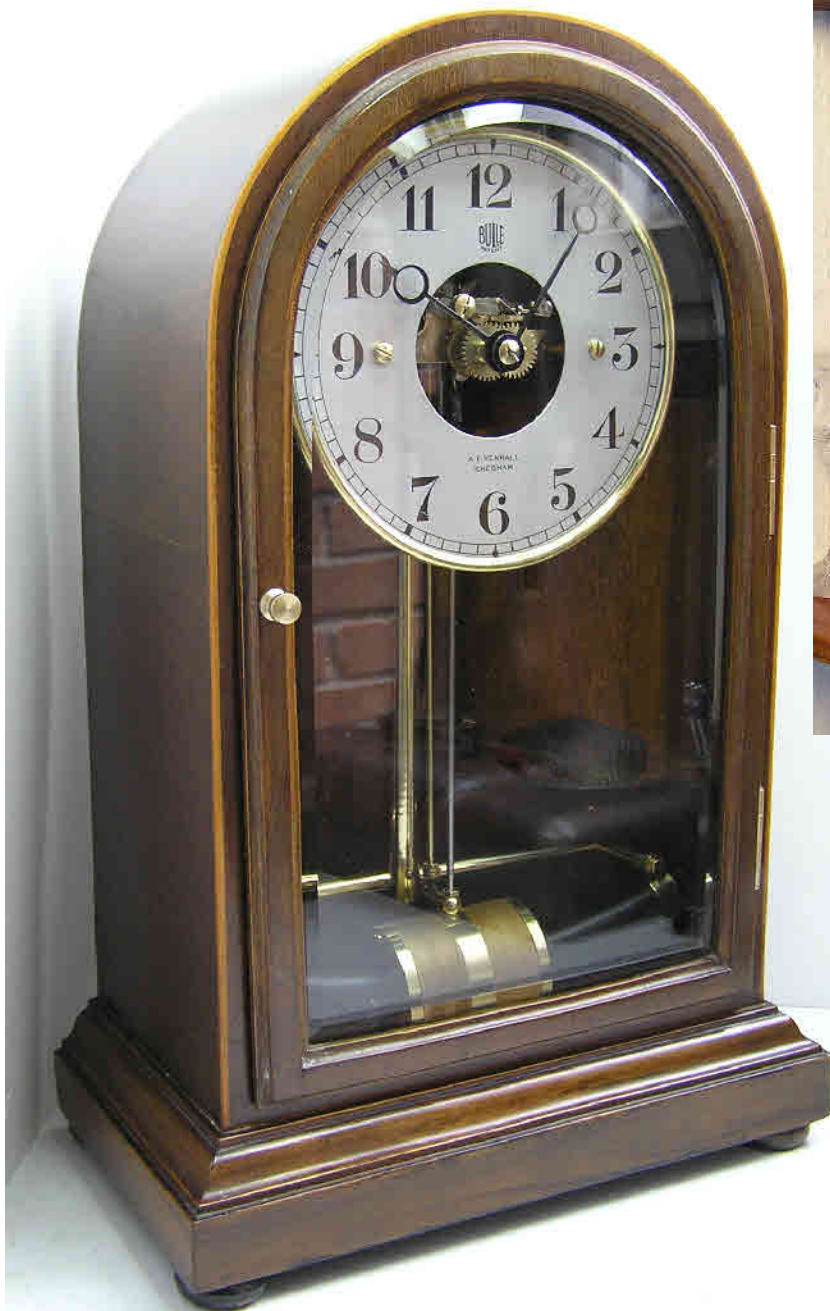
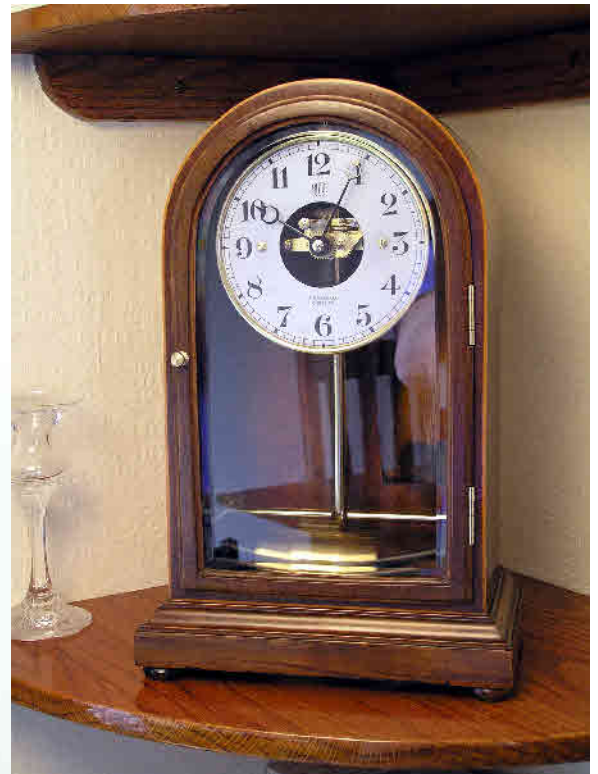
### **The Finished Clock.**

*The case has had all the brass work removed, cleaned and polished. The glass is thick and bevelled and runs the whole length of the case to show off the movement to great effect.*
