Bulle Clock Serial Number 65897

*Restoration of Bulle Clock
Serial Number 65897.*

Early Battery Clock Parts & Restoration

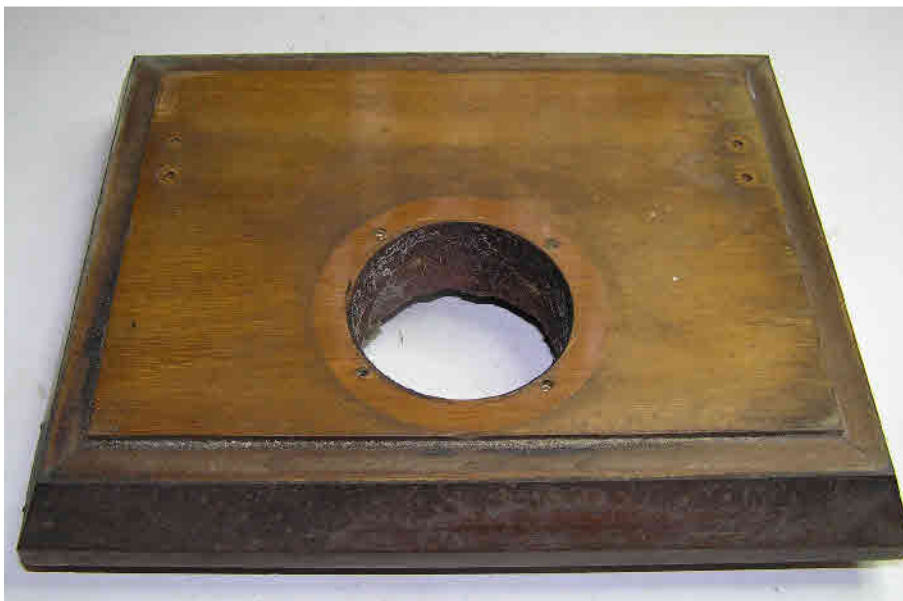
The lower photo shows the condition of the wood after being kept so long in a damp atmosphere. The polish will need to be stripped down and the wood rubbed down gently with "0000" grade wire wool to smooth out the raised grain. I'll leave all the other marks and dinks so that the character and patina of the wood will still. Show through..

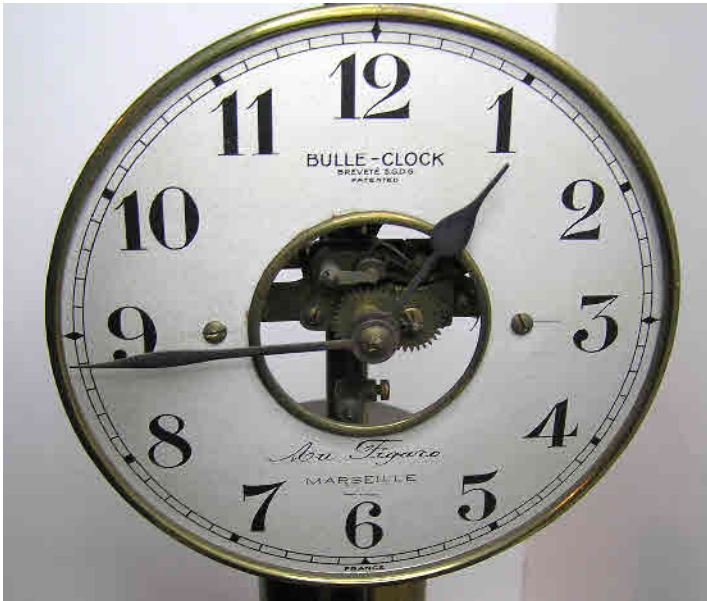
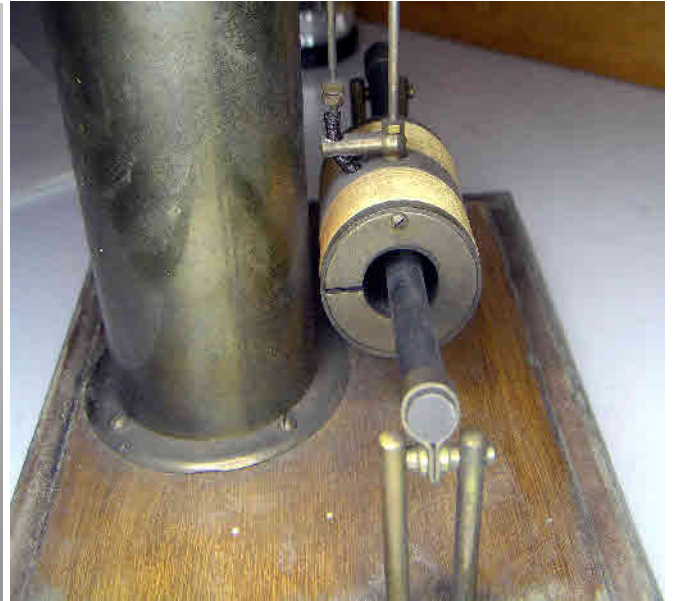
The dial is free of any serious marks and will only need the brass polished and the face washed. The hands are original and blued and slightly rusty but will benefit greatly with a wax polish.

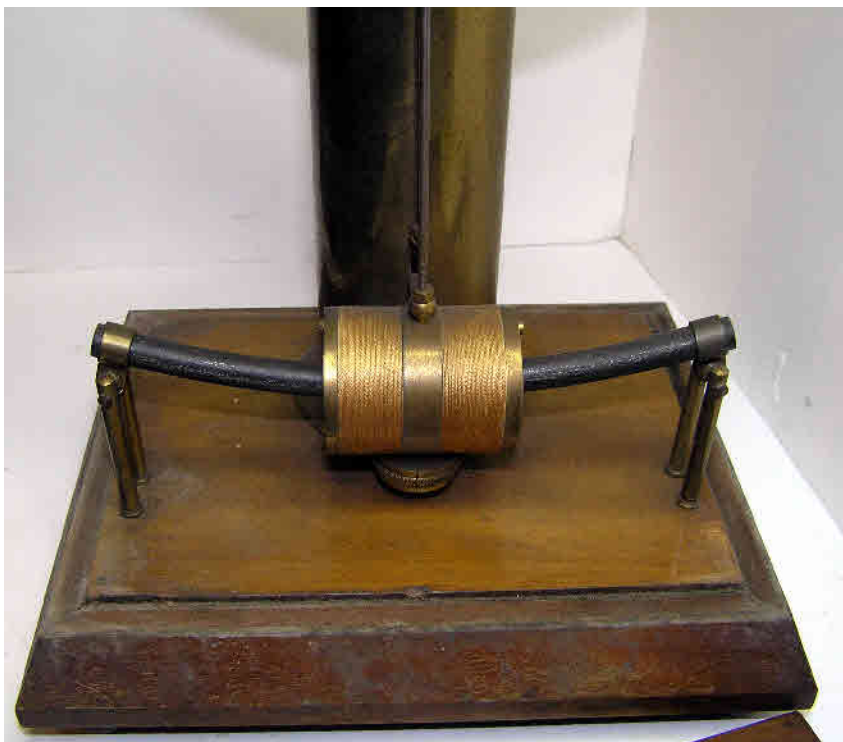
The other two photos show the pendulum bob, magnet and base. The magnet was reading 140mm on the homemade magnetometer and will need to be re-magnetised.

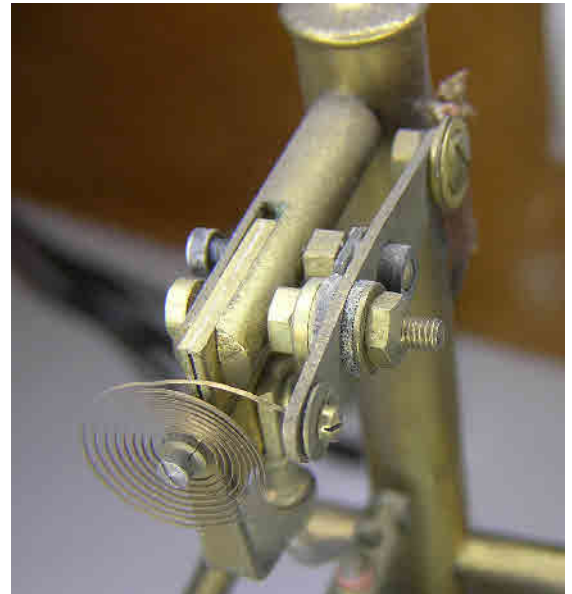
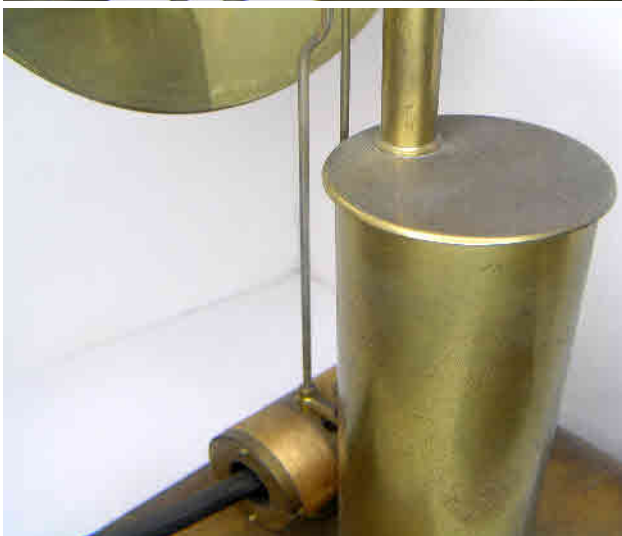
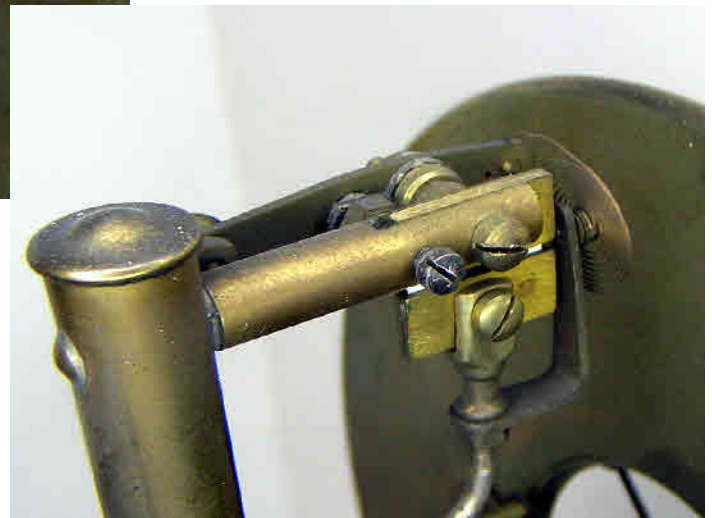
All the parts of the movement are slightly rusty but in remarkably good order. Even the silk suspension looks to be original with the silk in fine condition. This is one of the few times when I can re-use it.

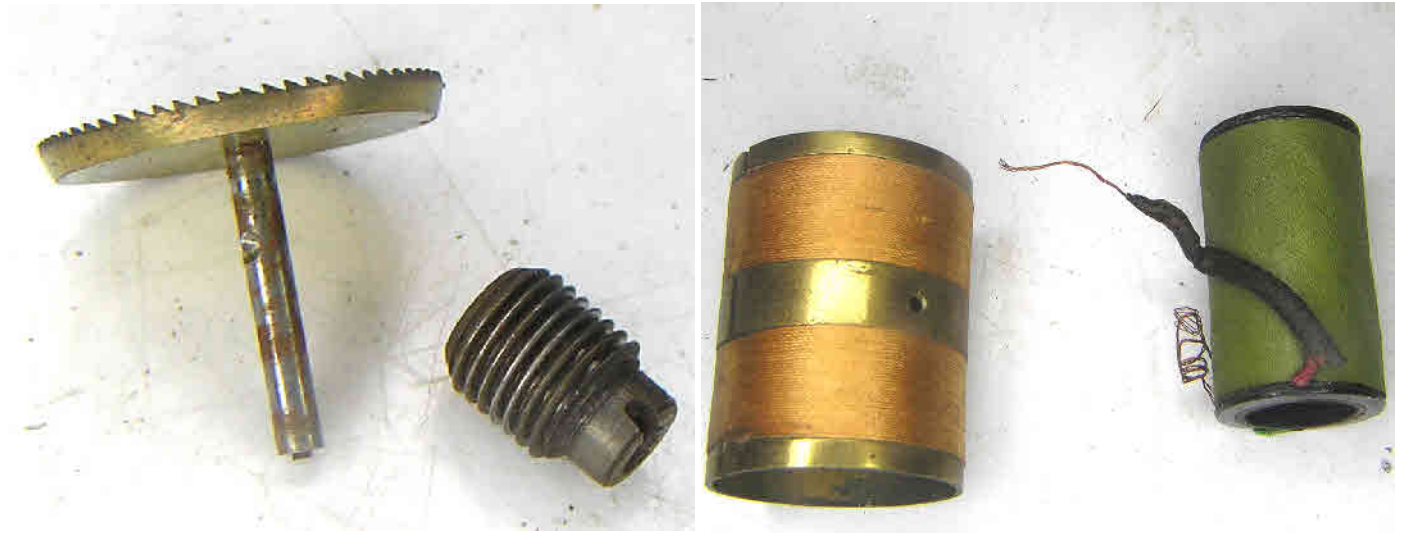
The photo above shows the count wheel and worm. Again they show no signs of wear and other than the rust are in great shape. The rust will be removed easily enough but the arbour and worm will need to be polished with a pivot file to remove and slight pitting that may be evident.

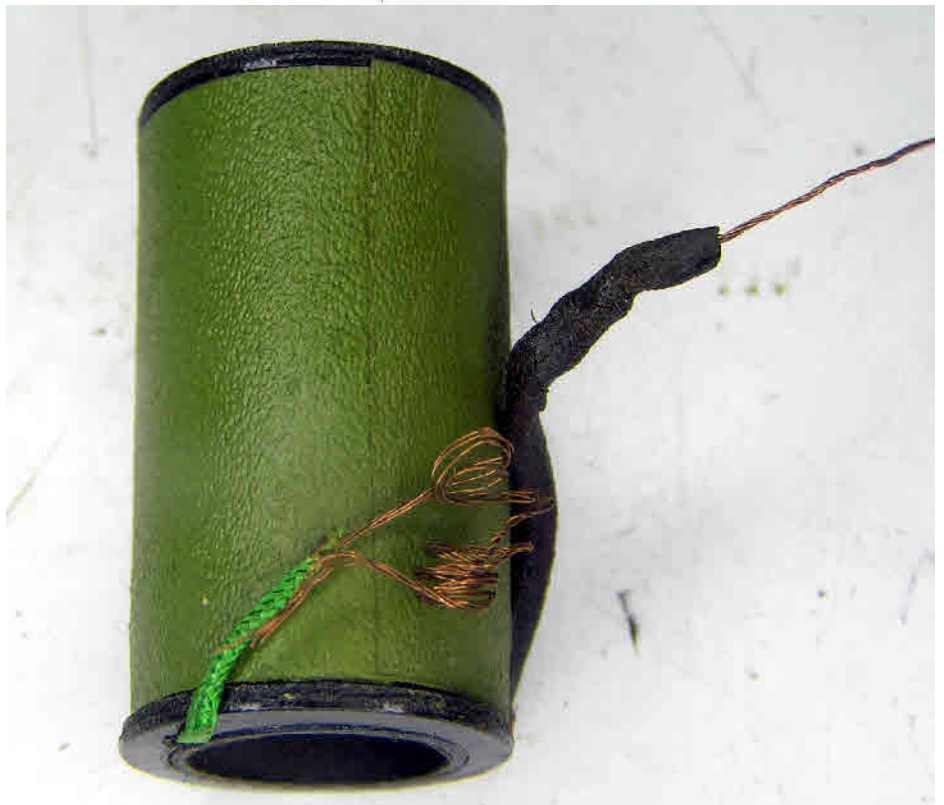
The coil is all original and shows a healthy resistance of 1170 Ohms. There will be no need to strip it down any further than is shown here. The covering is in good condition as well as the lead wires. The copper wires will just be cleaned up with "0000" gauge wire wool before re-assembly.

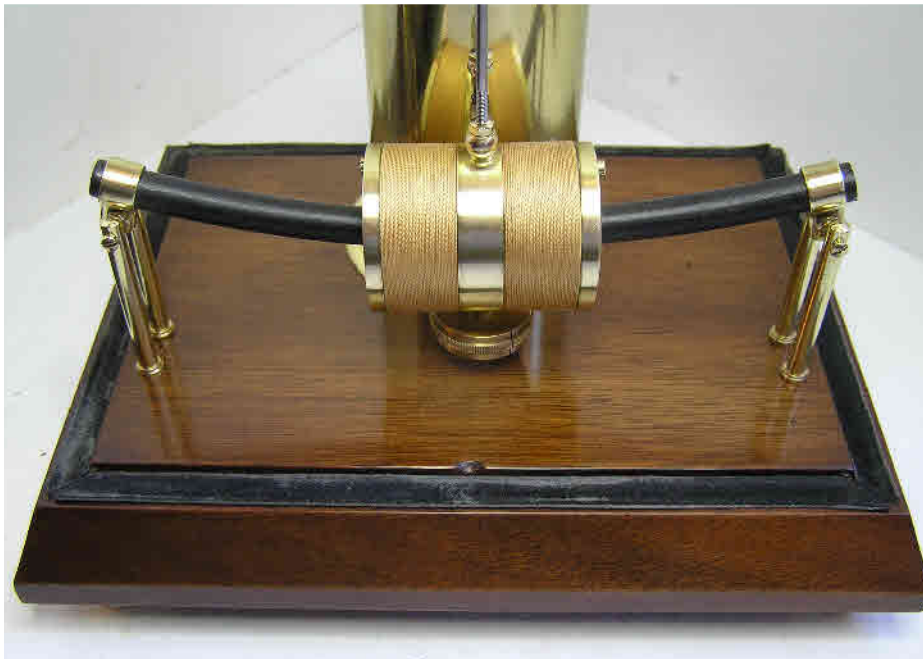
The wood base after cleaning and polishing. The old black baize has been re-fitted after brushing with a stiff brush. All of the blemishes and stains in the wood have been retained under the eight coats of French Polish. This was then cut back with a good Beeswax polish applied using "0000" grade wire wool. The whole was then buffed to leave a subdued sheen.

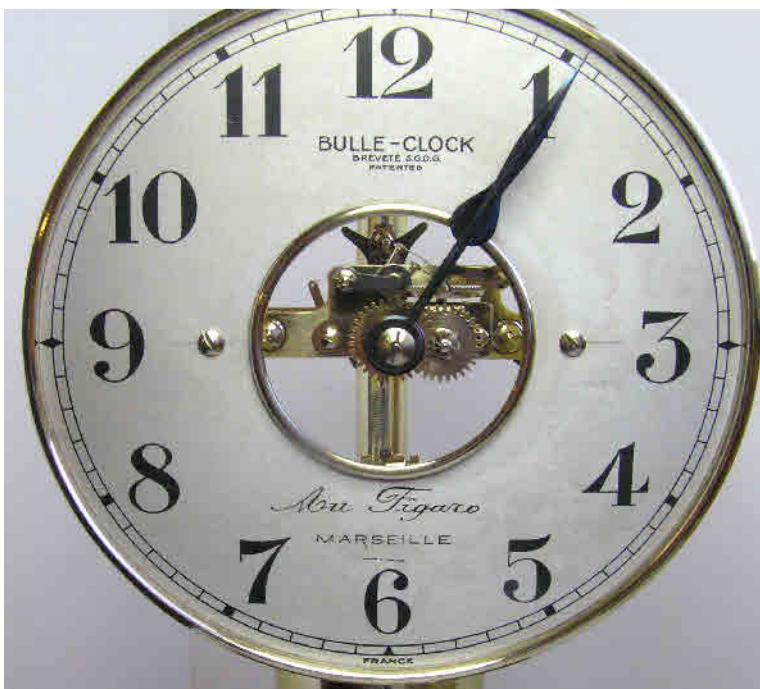
The face was masked off with brass shim while the brass surround was cleaned and polished. The face itself was then washed in warm soapy water. The hands have been polished with beeswax and have come up really well.

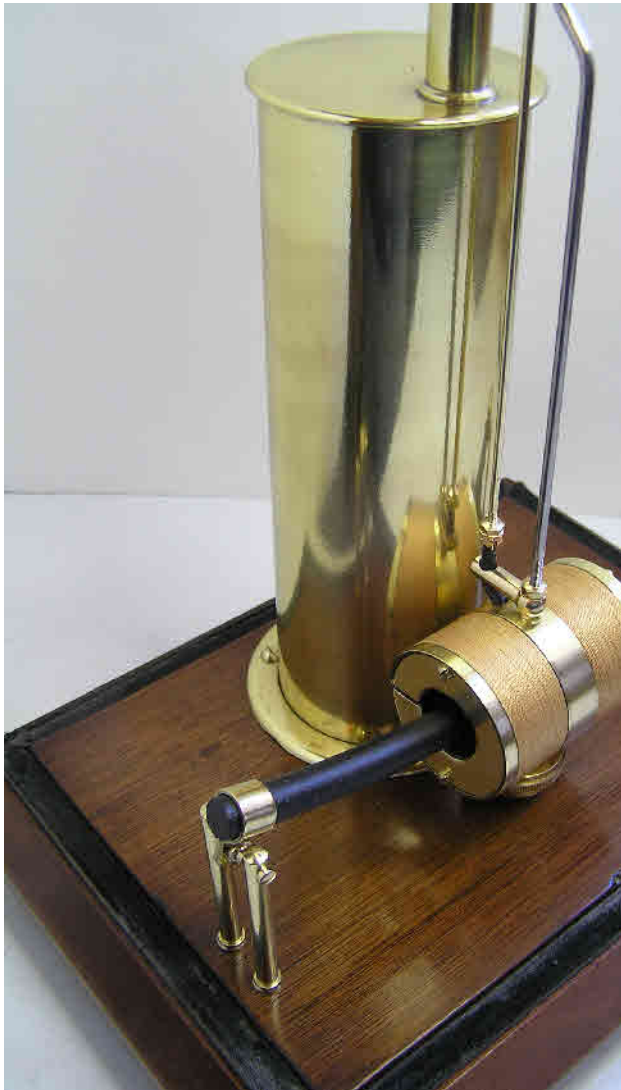
The column showed no major damage from battery acid although there are some very minor blemishes in the colour of the brass. Nothing though that detracts from the finish. The second photo shows the movement, pendulum and suspension assembly in place. The silk suspension was re-used being in excellent condition. Unusually the red and black braided wire was also in surprisingly good condition and so was also re-used. In 80% of cases the wiring is very badly corroded and broken in multiple places.
