## *Restoration of Bulle Clock Serial Number 6792.*

*This is an early Type "A" Bulle clock probably dating from the first year of production 1921.*

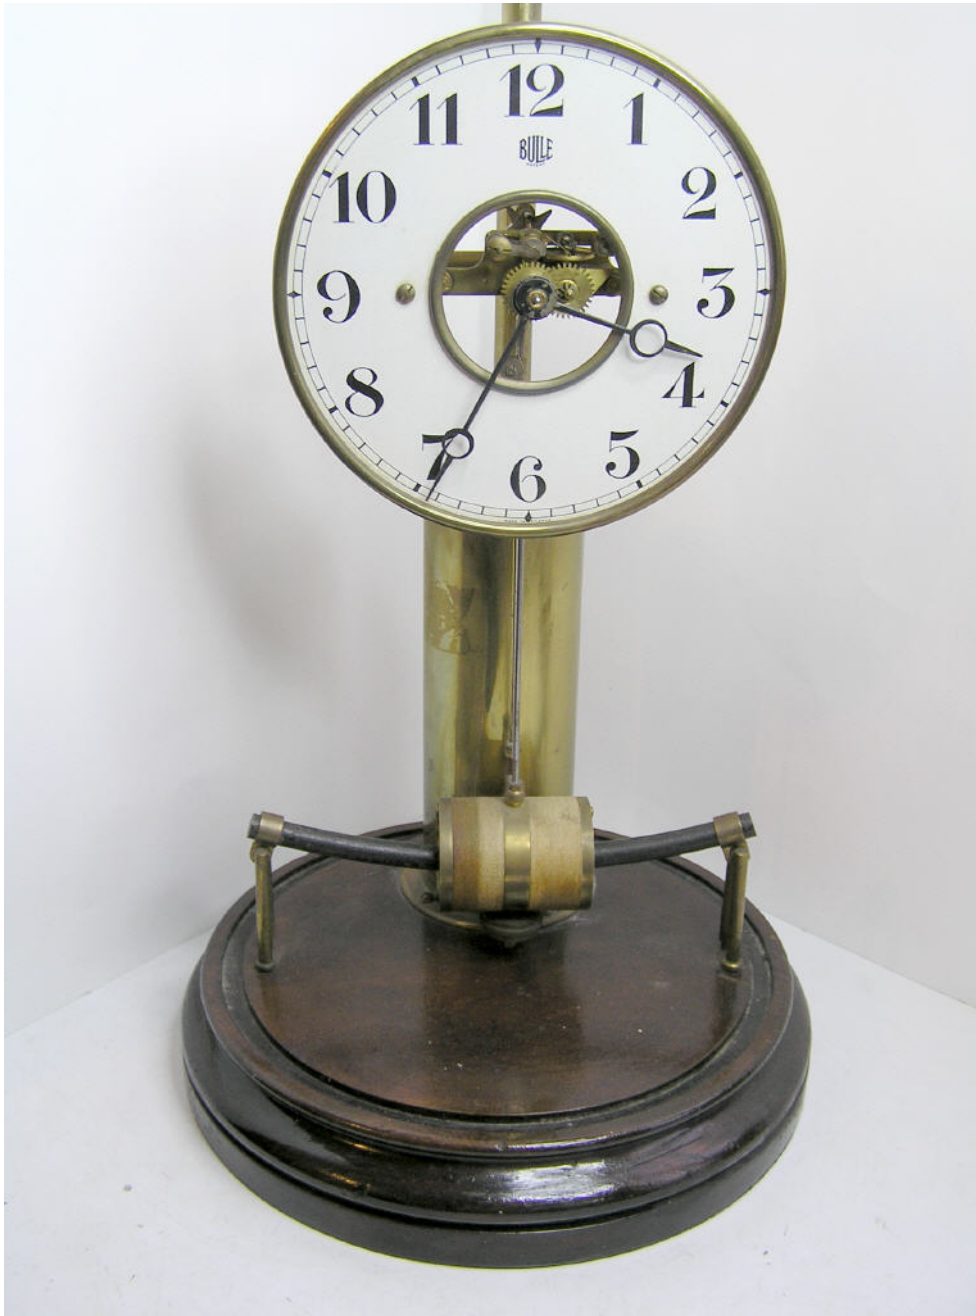
*There are a number of problems with the base. It is missing the two front wooden feet and also the third brass levelling foot. It has been varnished at some stage in its life and this will have to be removed and the whole French Polished.. First impressions of the battery tube are that it is marked but not holed. There are two small pin holes at the front of the base where the Brass label should be. The Dial indicates that this would be the English version. The dial looks to be in excellent condition with only the brass needing to be cleaned.*

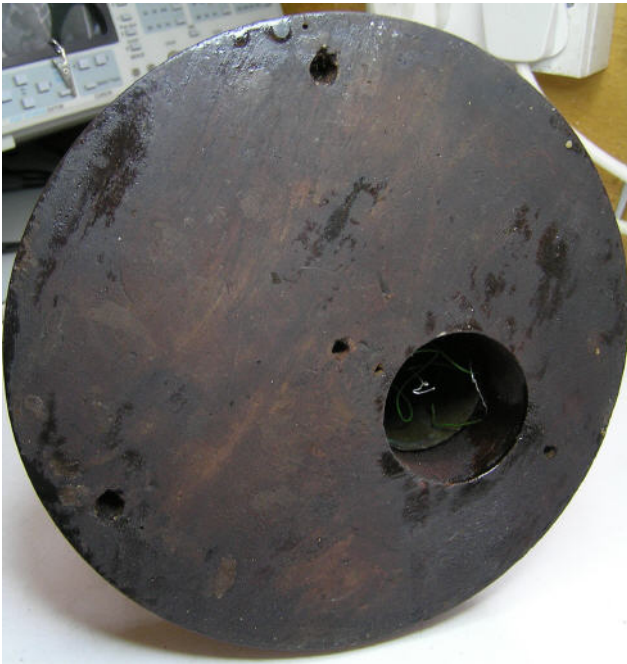
The underside of the base showing the “Runs” of the varnish that has been applied to the top. The feet are marked by their absence from the two holes at the front. The brass levelling foot at the rear is also missing as well as the steel battery cover. All will need to be made.

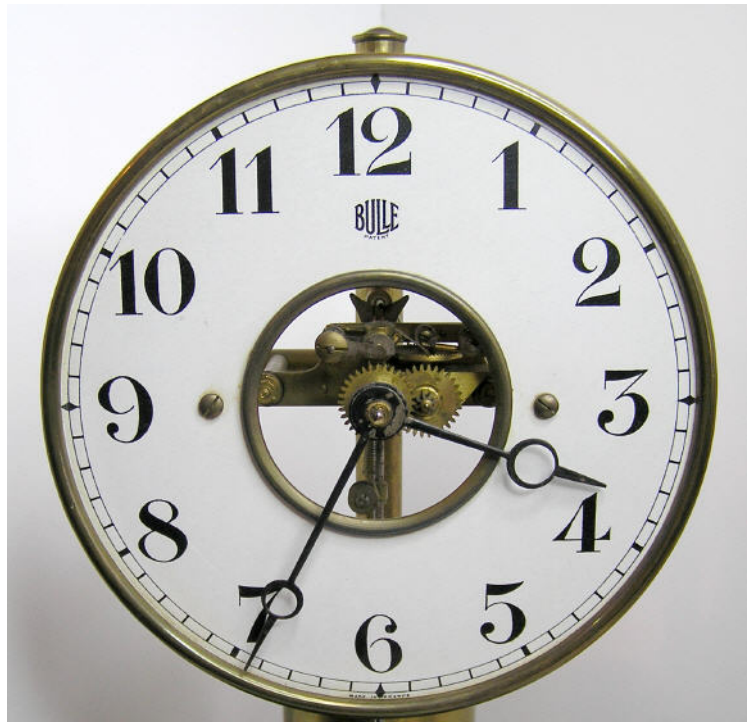
The dial shows no major marks or fading..

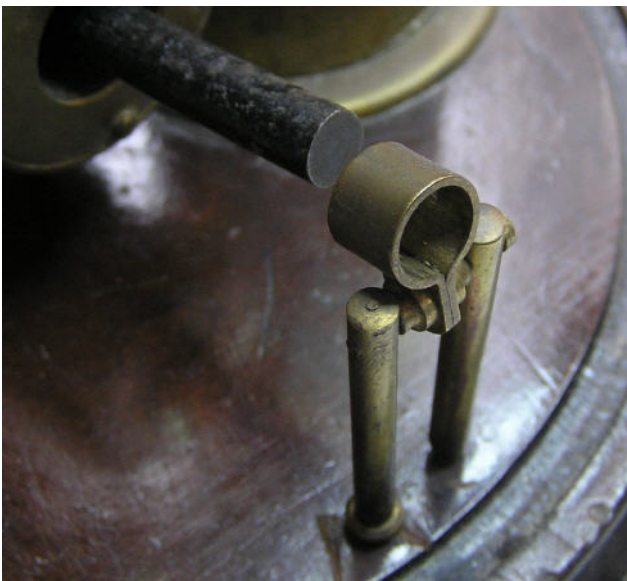
This is quite interesting. The magnet, although it looks right, is a very loose fit in both brackets. The screws are tight and the bracket pulled in tight as it will go. The magnet may be some sort of replacement and will need to be checked thoroughly.

*The magnet, battery frame and pendulum remounted. The magnet itself is loose in the frame and after measuring its diameter it seems to smaller at 8.4mm than the normal 8.8mm. Now whether this is a replacement from another clock or was a manufacturing fault we will probably never know. The simple answer is the wrap the magnet with some padding until the brackets can be tightened to pinch the magnet securely. I have done this and the modification cannot be seen unless the magnet is removed. An of course the mod is reversible and will not damage the clock in any way. It has also been re-magnetised and Grate blacked.*

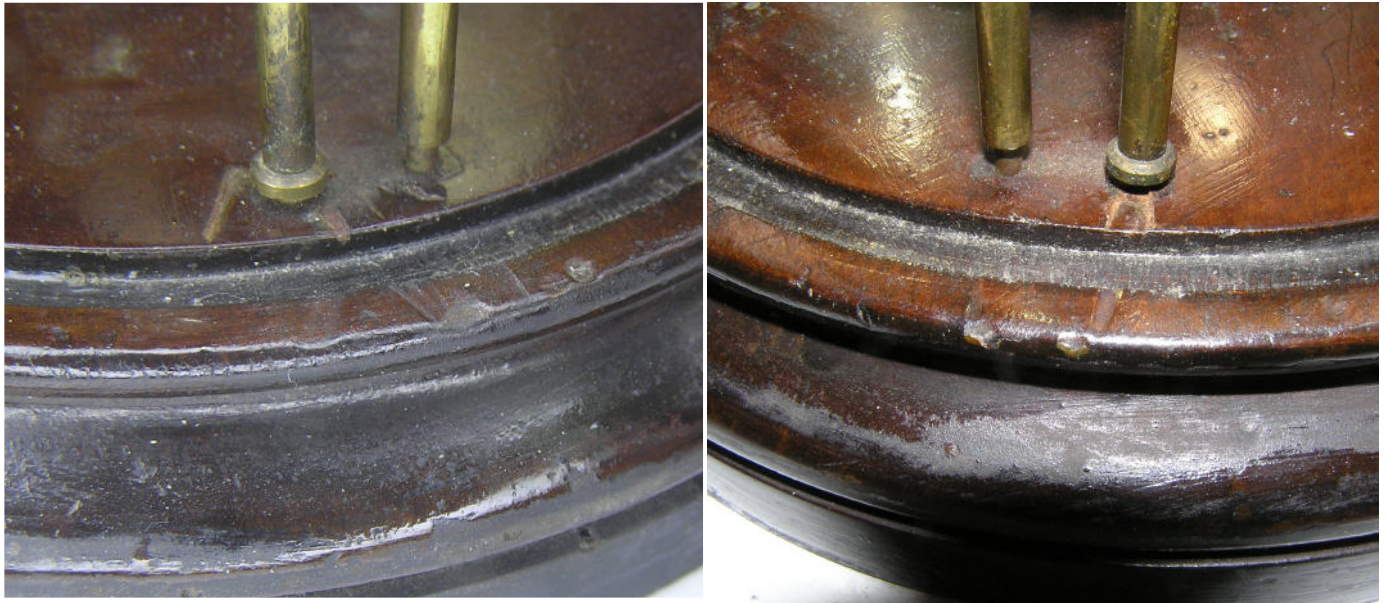
*These two photos show the damage caused by someone trying to remove the magnet bracket pillars; probably using a screw driver as a lever against the wood base. Note the grooves and dents. You should also note that the pillars themselves are missing the brass washers on the rear two. Another job for the lathe. The poorly applied varnish also shows up quite well..*

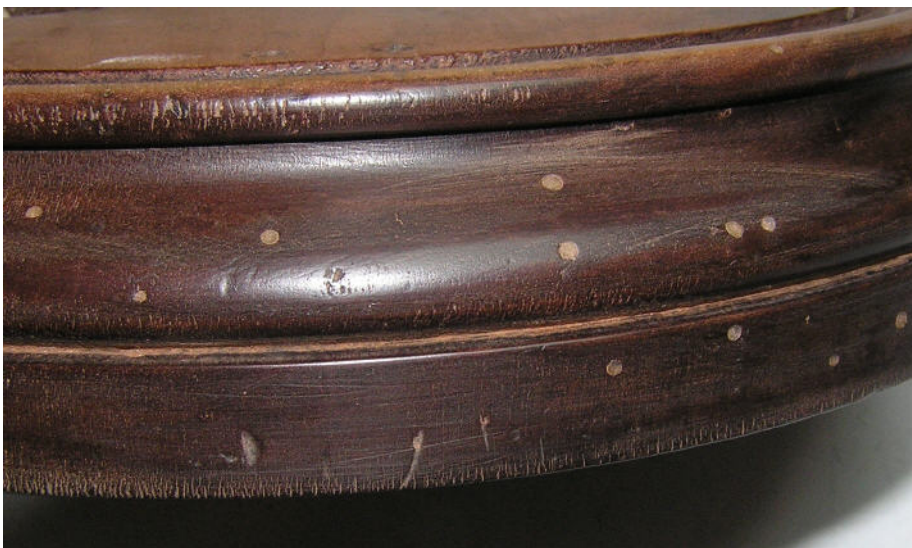
*Look what turns up under the varnish after it was cleaned away. The base has had some little visitors in the past. All the holes look to be filled and there are no new ones. So it looks as though the infestation has been cleared. It will be given another dose of wood worm treatment though before staining, filling and French polishing.*

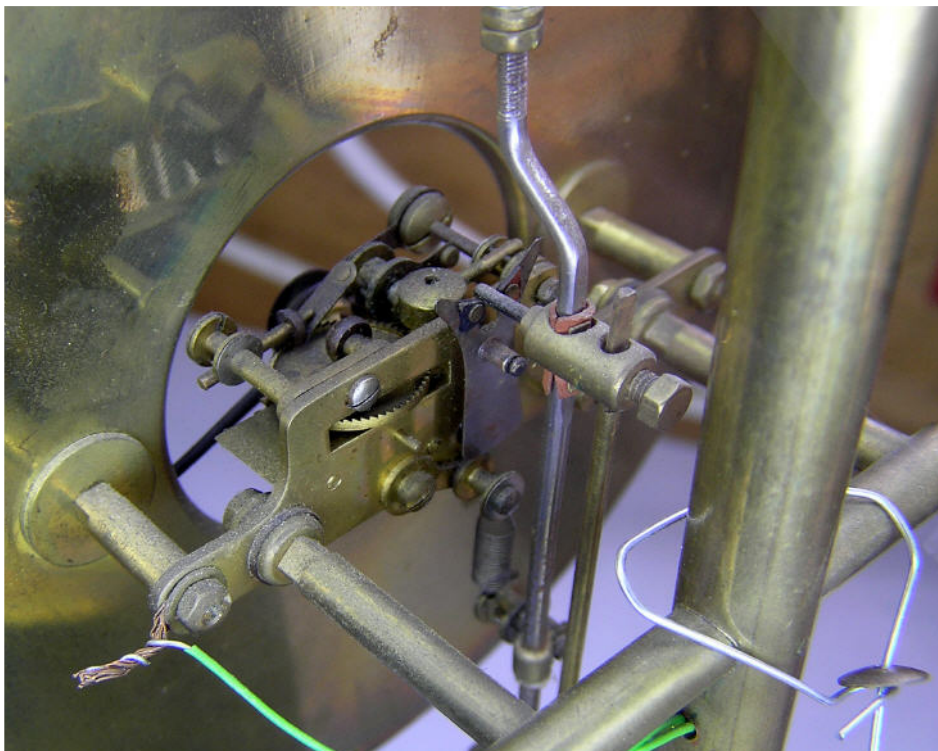
*The movement generally looks pretty good with everything intact. The only real problem seems to be the dirt and oil.*

*The owner has thoughtfully kept the hand collet attached to the clock with the loop of wire. That's one thing we don't need to manufacture.*

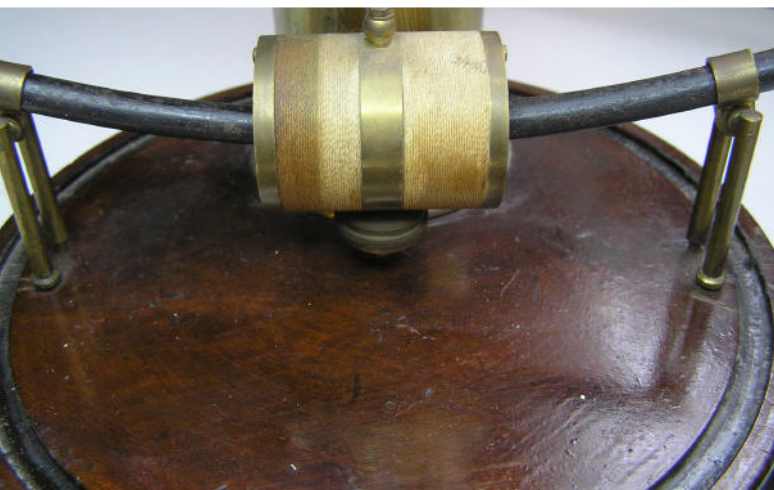
*The photo above shows the the amount of cord inside the damper cap. This is the same cord as is wrapped around the pendulum bob. It will be replaced and primed with a small amount of oil.*

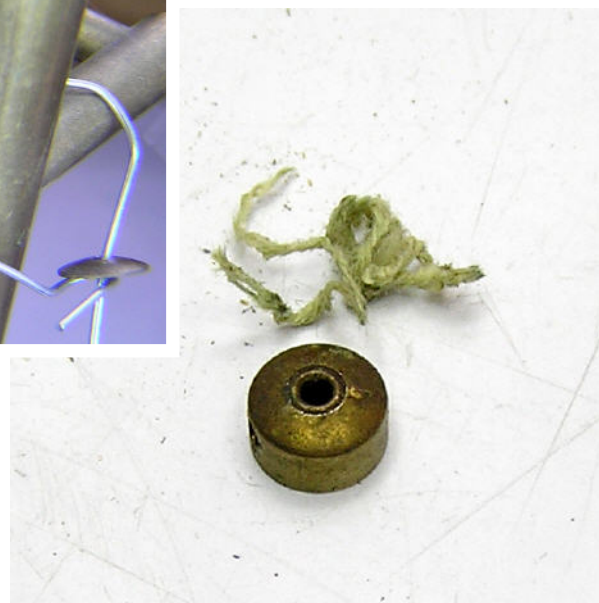
*The cord on the pendulum bob is very tired and brittle. I will look at saving it but I'm not hopeful.*

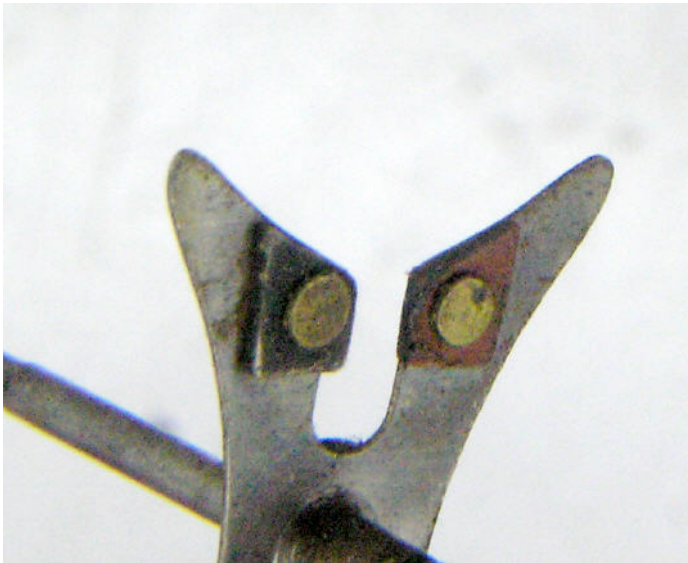
*The fork contacts are both worn down to the steel and will be replaced.*

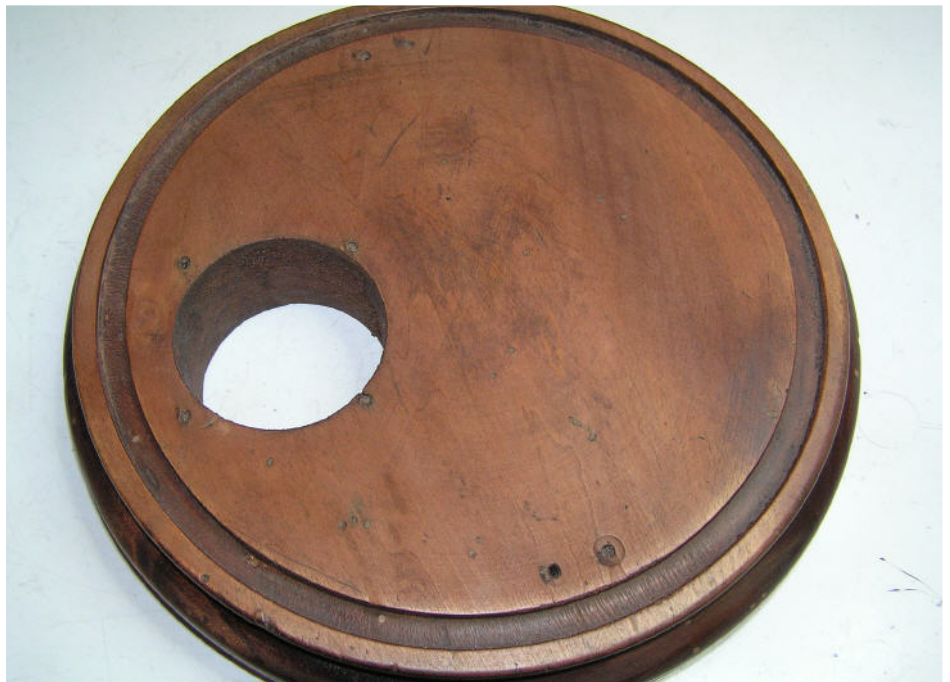
*The base after the varnish has been removed, ready for filler and polishing. I will try and keep all the small nocks and blemishes.*

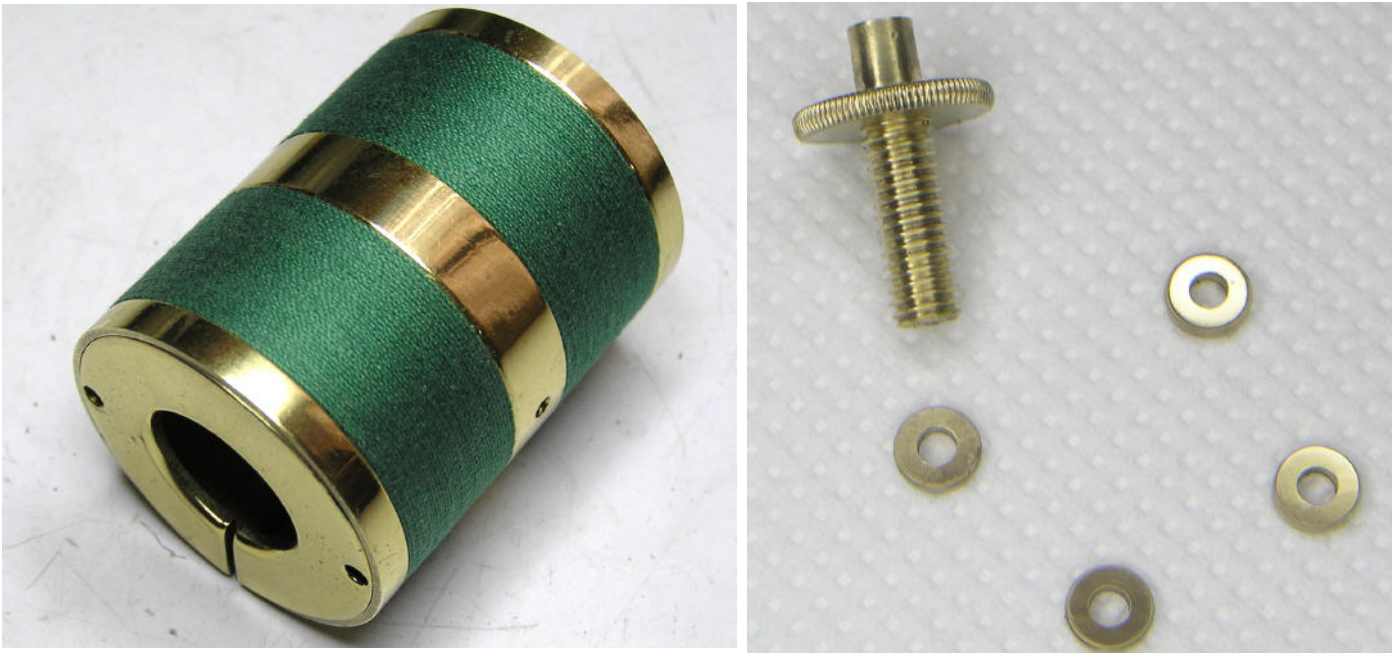
*The rewound pendulum bob and the replacement parts so far. The bob has been rewound with “Gutterman 237” cord. The four washers are the replacements for the the ones missing at the base of the pillars that support the bar magnet. The photograph doesn’t show it well but there is a small chamfer on the outside of the washers as per original. The 6.00mm threaded and knurled brass is the new adjustable foot for the rear of the base. This screws directly into the wood. With these parts finished we can now start to rebuild the pendulum and magnate support assemblies.*

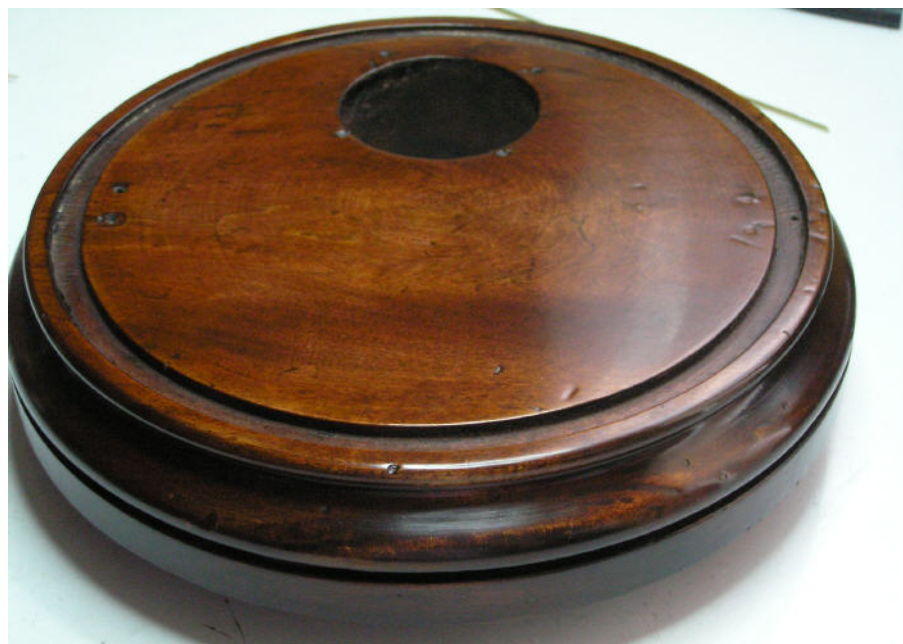
*The base polished and waxed. There are about ten coats of French Polish on the base. This has been cut back to leave a soft quiet sheen rather than a bright dayglo finish. Any more coats would have filled in most of the knocks and dents in the wood which would have made it look a bit too bright and new. This way you can still see and feel the holes and blemishes giving it a well used yet waxy feel.*

*The lower photo shows the two holes left by the original brass pins that held the “British Horo Electric” label.*

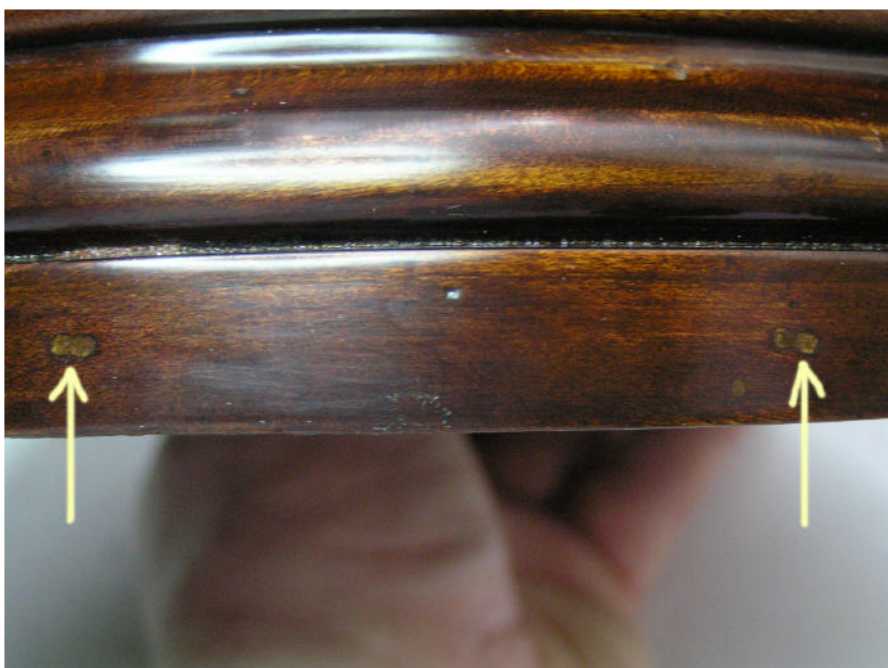
*This has been replaced with a Horologix reproduction. These are made in exactly the same way as the original using the same materials. The holes line up perfectly.*

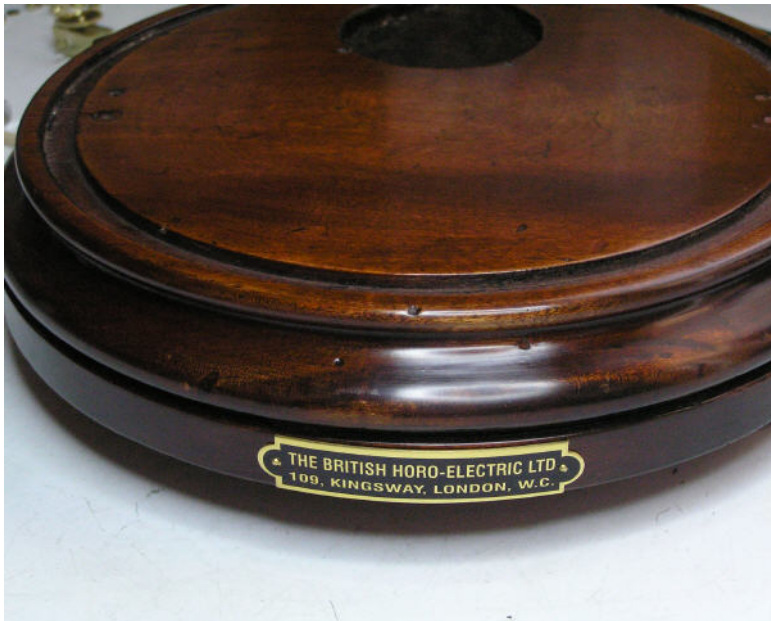
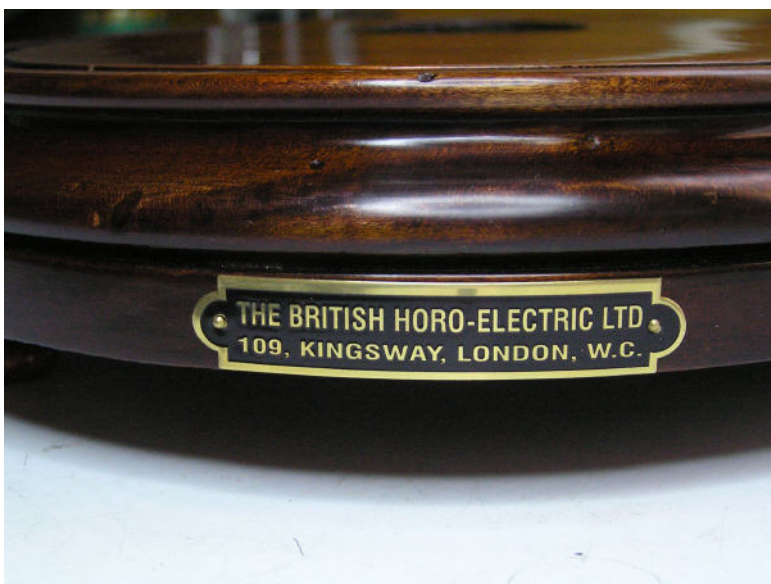
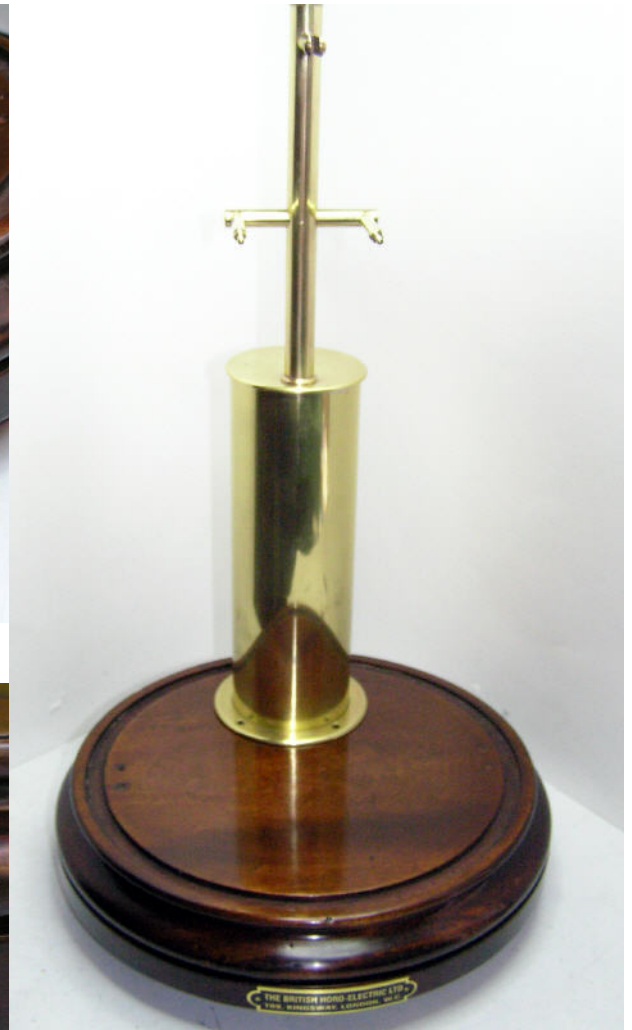
*The brass battery frame ready to screw into the base. The photos left show the reproduction label in place.*

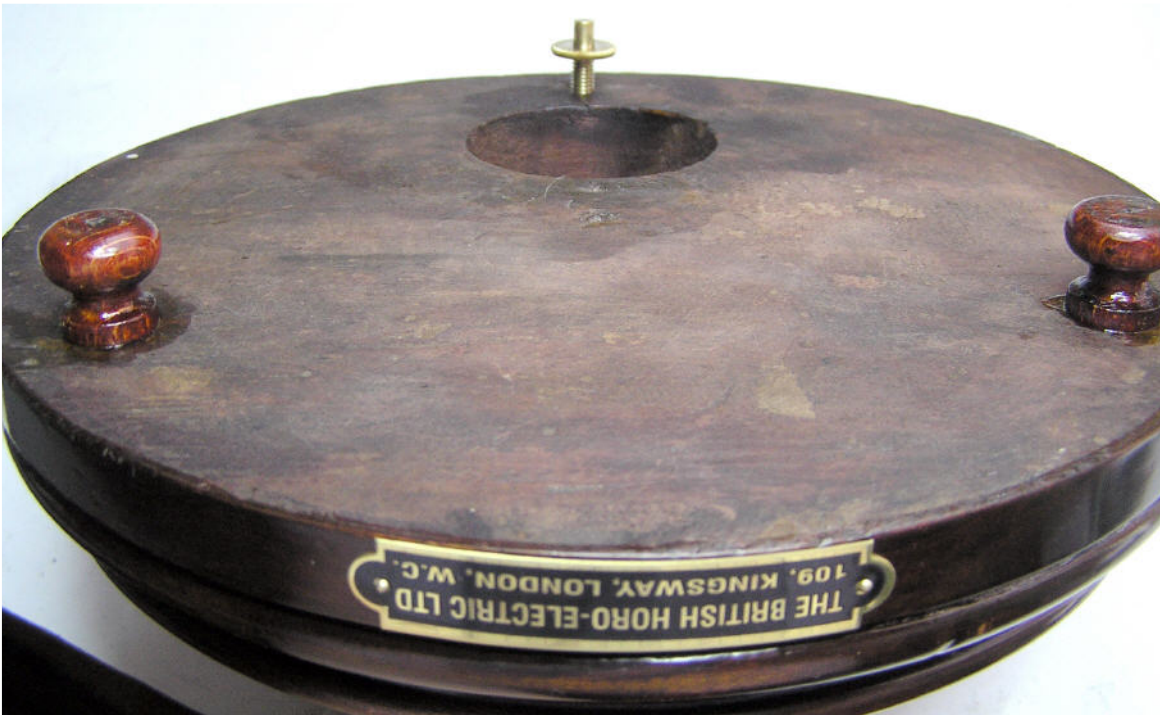
*The new wooden front feet and the replacement brass stabilising 3rd foot.*

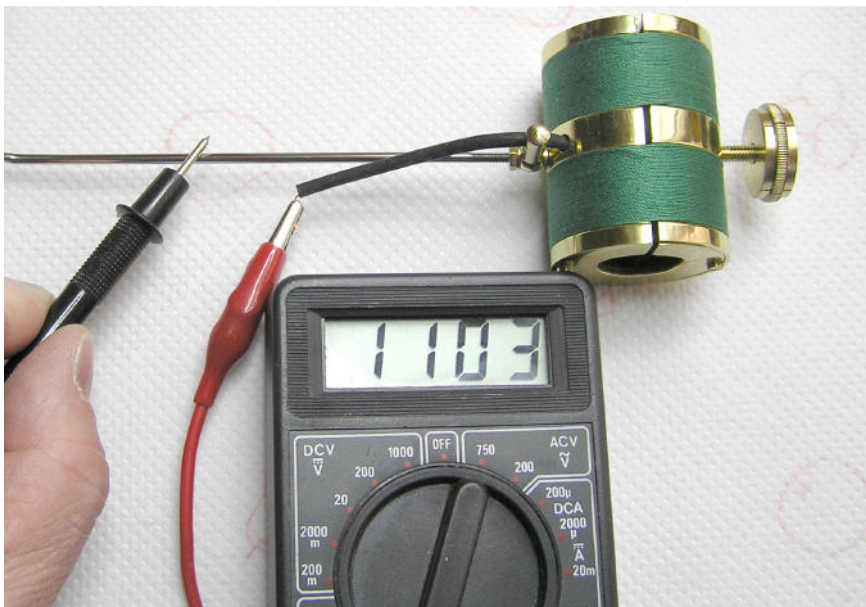
*The coil is checked constantly for continuity. The photo shows the pendulum after the bob assembly has been completed and reattached to the rod. Before the wire and insulation are cut to length the reading is checked. In this case we still have a steady 1103 Ohms. The contact pin assembly can now be added with the brass connecting rod.. The whole pendulum is then checked again.*

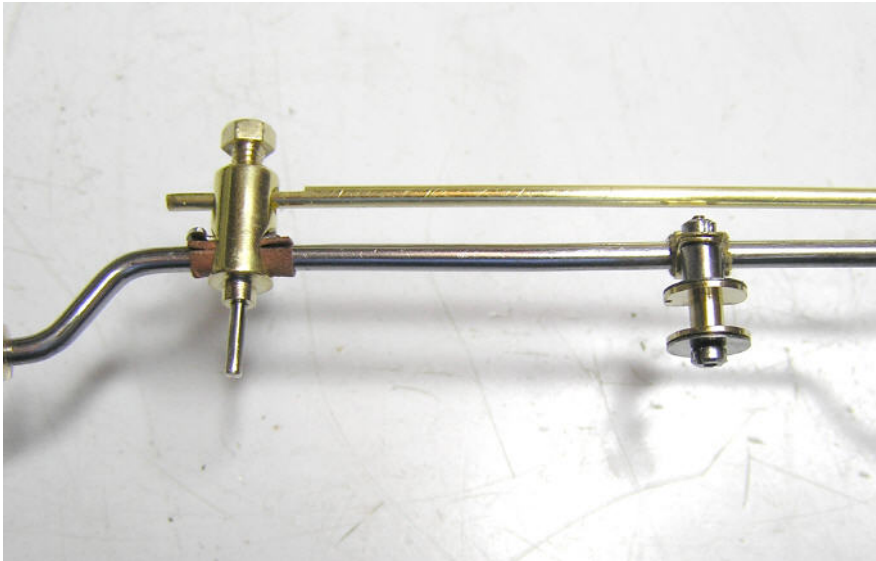
*The contact pin and Isochron spring arbour assemblies. In place.*

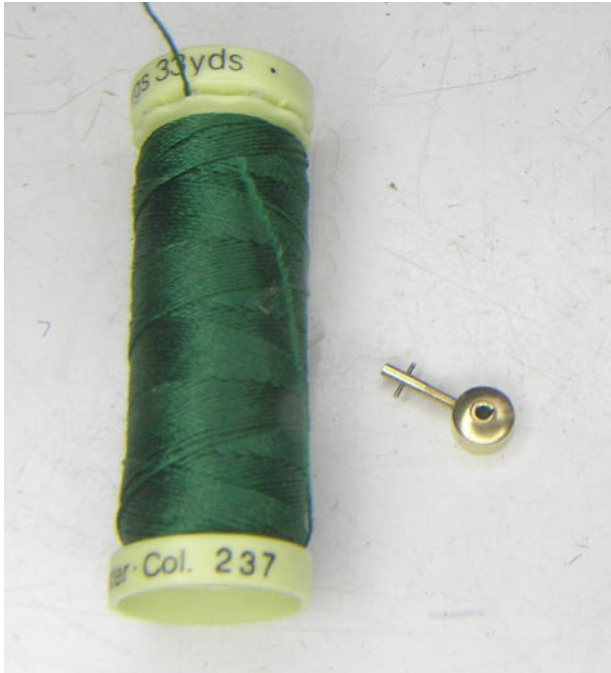
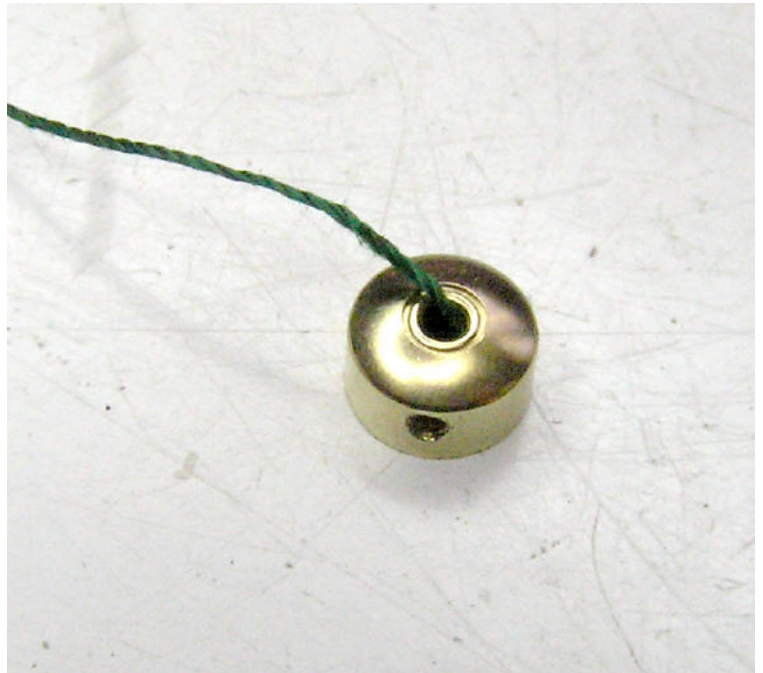
*The damper has been cleaned out and filled with the same cord as was used to recover the pendulum bob. The smallest amount of oil has then been syringed into the cap to allow a smear to appear on the underside.*

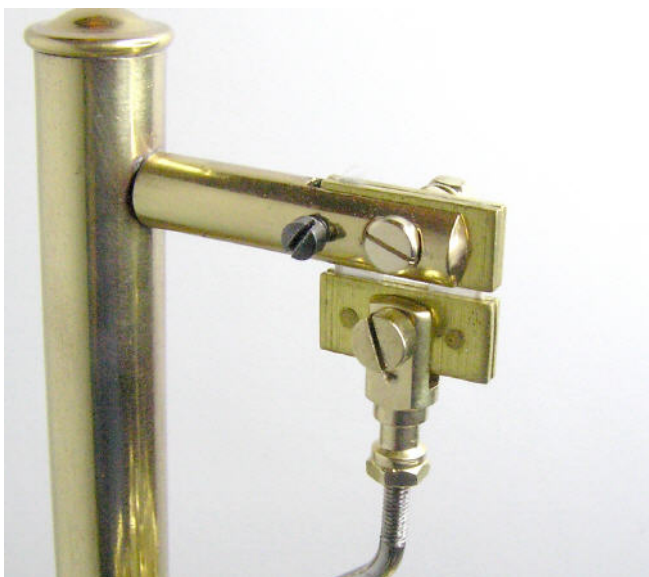
*The suspension assembly in place with new silk suspension and replacement screws and nuts. The small blued screws, one either side, are there to pinch the top block of the suspension in place and not allow it to move once it has been positioned correctly. The top of the pendulum is loose in the bottom suspension block to allow it to swing freely front and back as well as to twist very slightly. This allows the pendulum to swing freely over the magnet even though the clock may not be level. If both top and bottom blocks of the suspension were tightly secured then the pendulum will have a tendency to oscillate badly if not perfectly setup.*

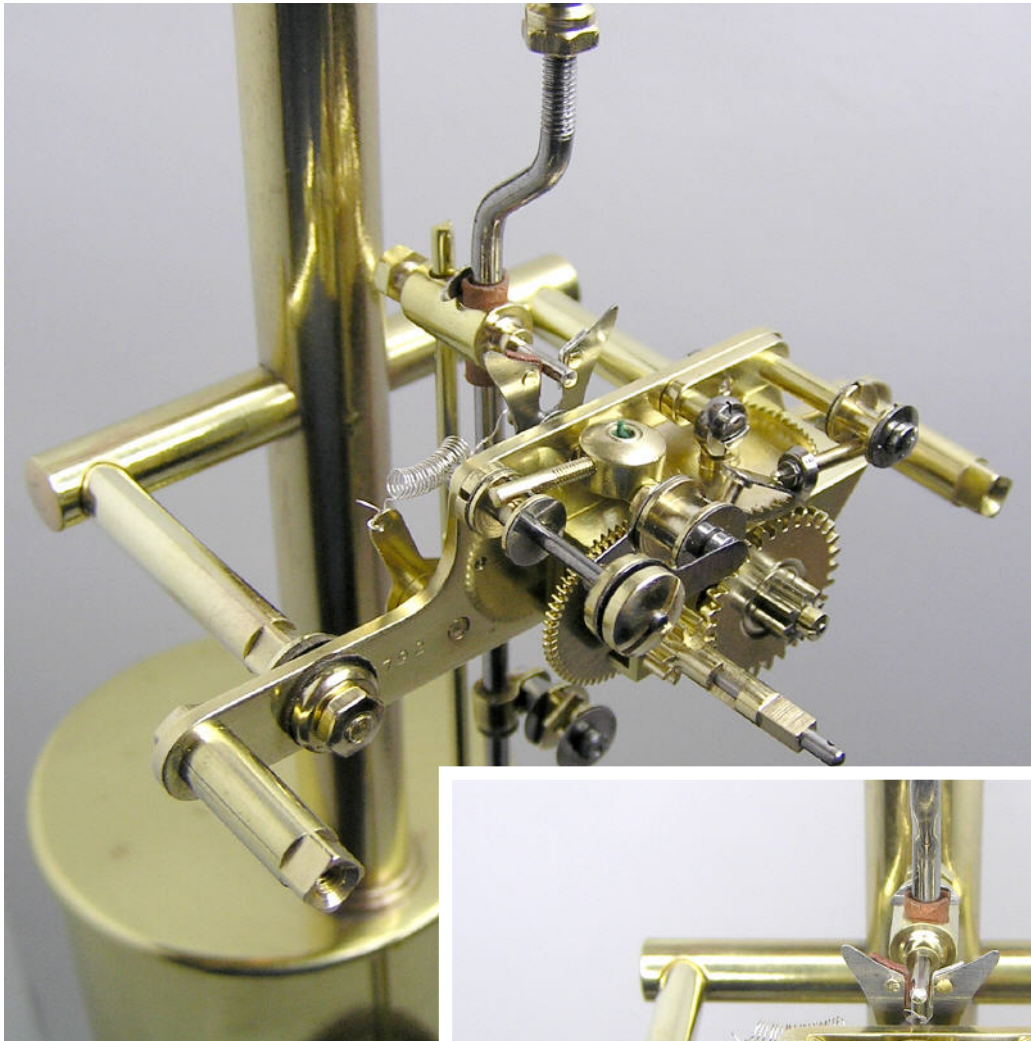
*The movement in position ready for wiring up and attaching the isochron spring. It is important at this point to make sure the pawl and stop act correctly by picking up one tooth only on each full swing of the pendulum. Swing the pendulum by hand and watch the action. On these early clocks there is no adjustment possible on the pawl barrel as the arbour has a flat to engage it. The depth of the contact pin in the fork is therefore critical*

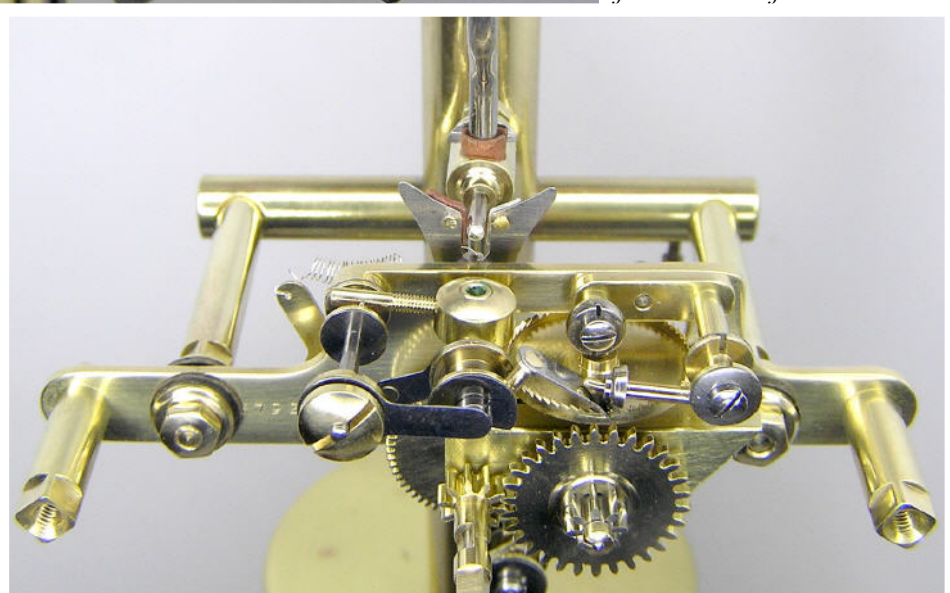
*Another view of the movement in position.*

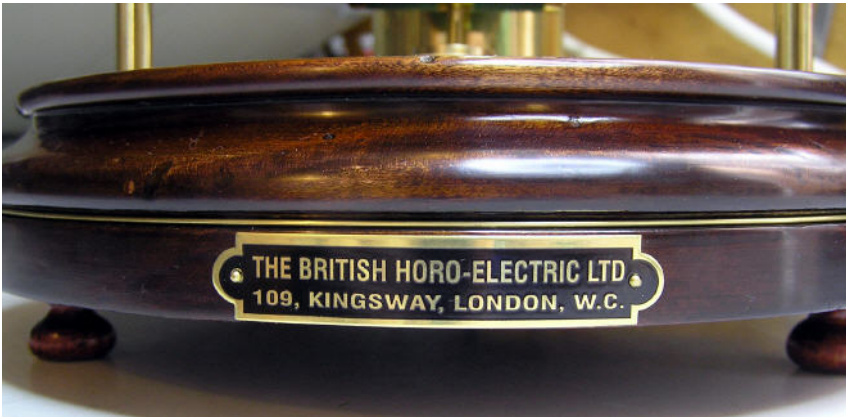
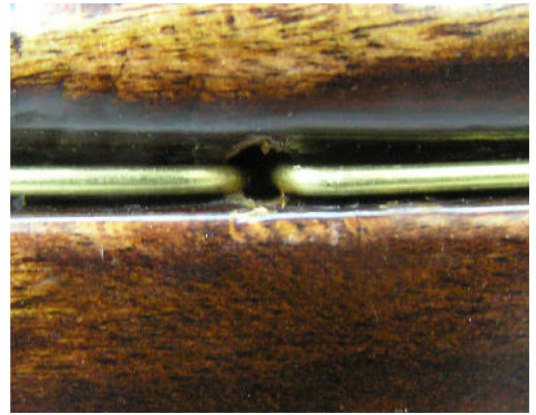
Most, but not all, of the early “A” type clocks had a brass wire band around the waist of the wooden base. This band was secured at the rear by bending the ends at right angles and forcing the them into a small hole about half an inch deep. It is easy to decide whether a clock was originally fitted with the brass by searching for the hole at the back. It may be difficult to spot if the base is covered in dirt, wax or paint etc. The brass wire is normally 1mm but can be up to 2mm. The wire should not be fitted when restoring a clock if the hole

is not present.

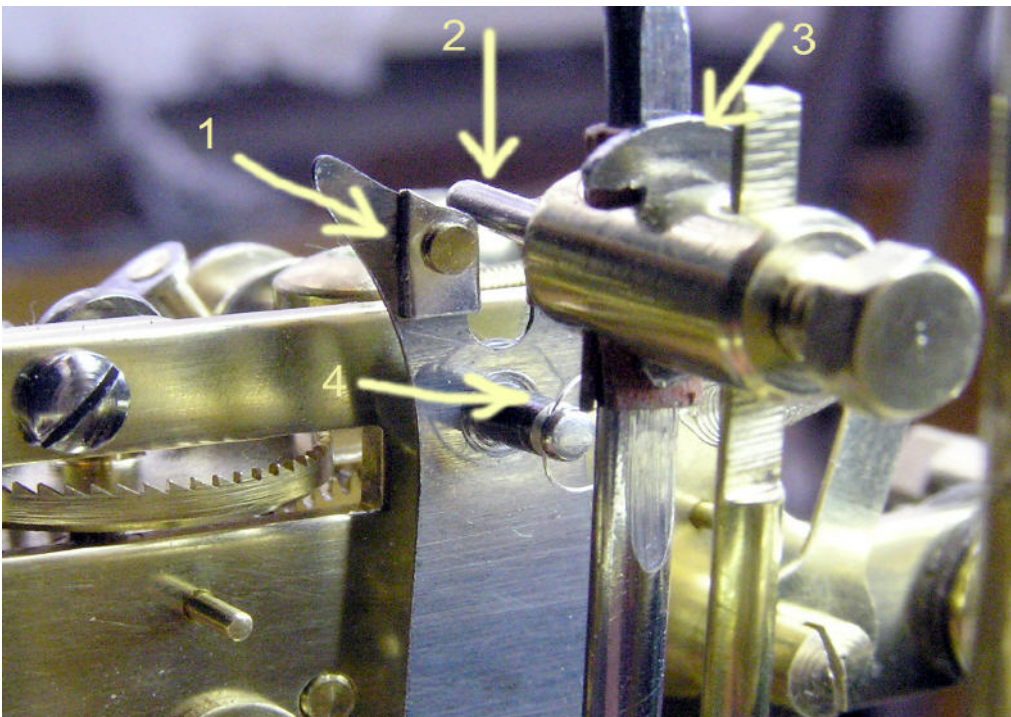
Points to note in the movement. 1. The new riveted silver fork contact. 2. The contact pin should engage in the fork by about half its diameter. Testing the action of the pawls previously described should decide this critical depth. 3. The new “T” piece inserted in its proper position between the fibre insulator and the brass plug inside the contact pin assembly. 4. The contact spring is engaged in a rolling action in the silver end of the fork arbour.

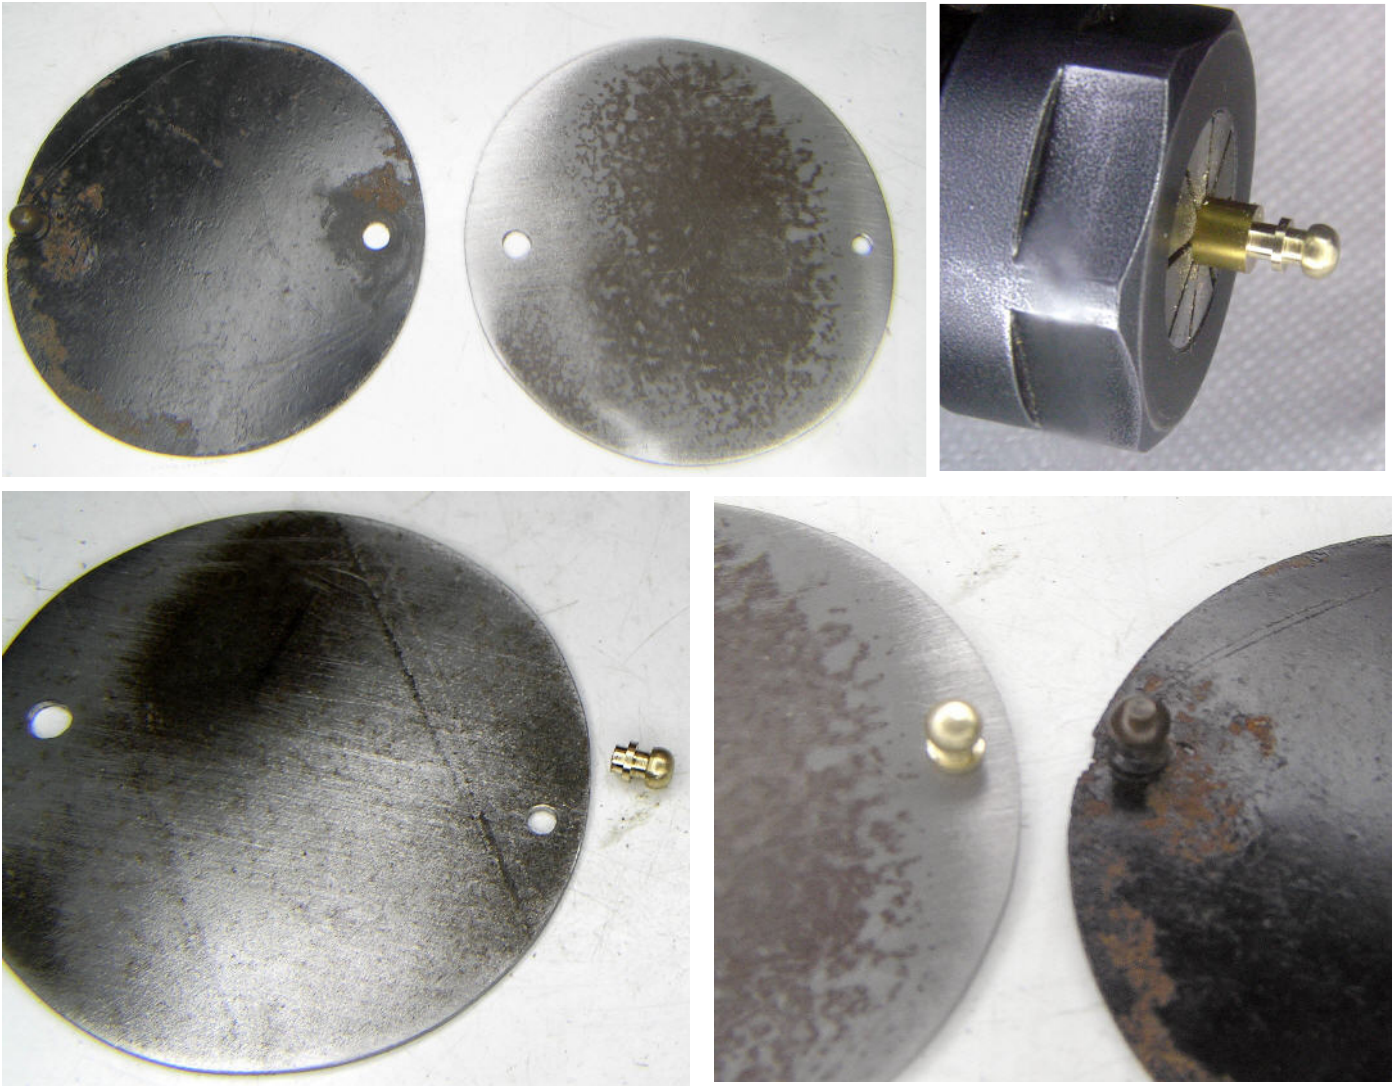
*The tall Type "A" Bulle clocks had a small round steel cover over the bottom of the support tube to hold the battery in place. On many clocks this is missing or badly damaged by leaking battery acid.. This clocks cover is completely missing and needs to be manufactured. These photos show the stages in manufacturing a new one from 1.25mm steel plate. It is a simple process to cut and trim the steel, drill a 5mm and 3mm hole, turn the 5mm brass knob and rivet in to the plate. All we need do now is clean it and undercoat it before spraying it black..*

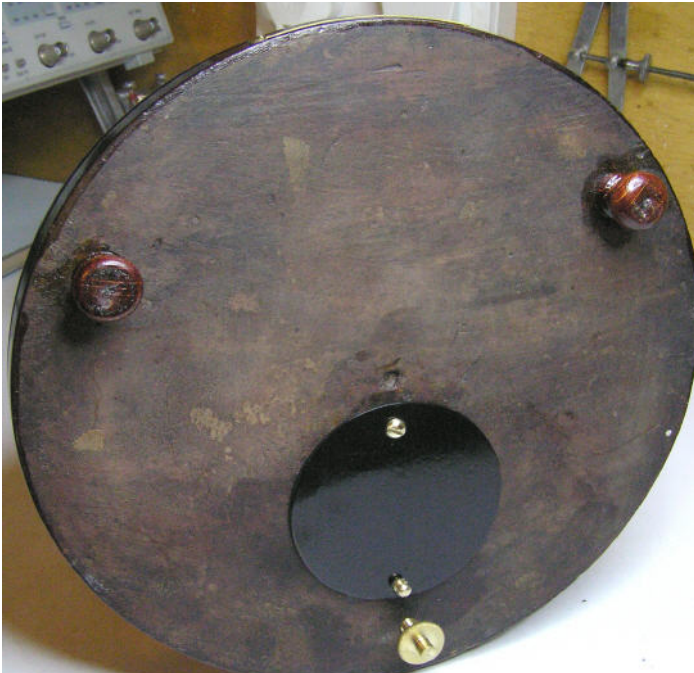
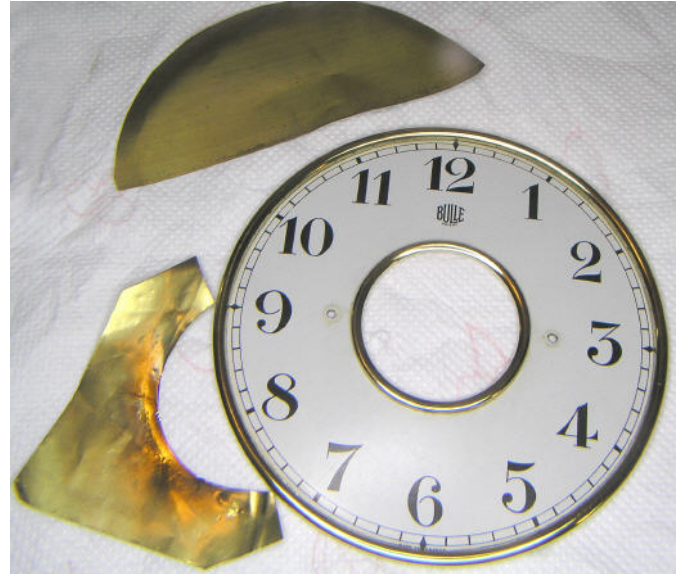
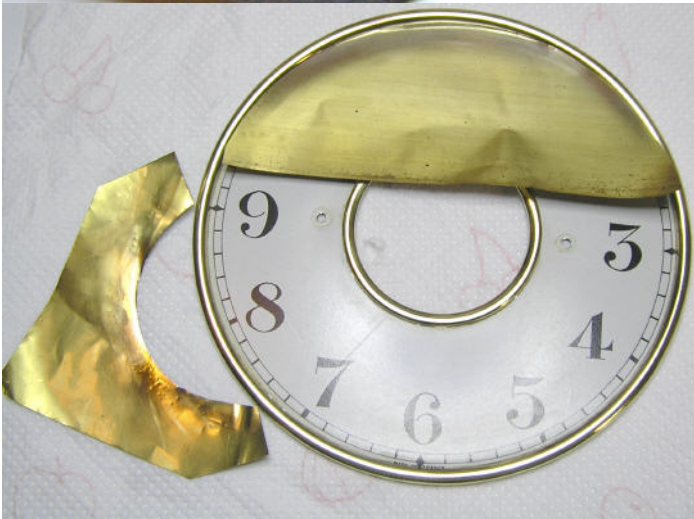
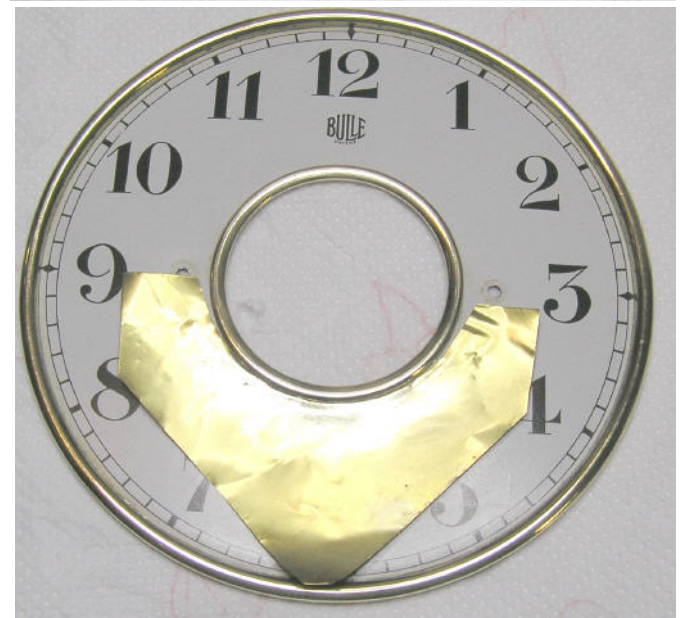
The photo top left shows the new cover in position.. The next series shows the method I use to clean the dial surround without damaging the dial itself. I cut two pieces of brass shim (about .006") to the inside and outside diameter of the face as shown. Then using 0000 grade wire wool I polish the surround piece by piece, moving the shim around to cover the area of the dial I'm working adjacent to. It works very well.
