## *Restoration of Bulle Clock Serial Number 6792.*

*This is an early Type "A" Bulle clock probably dating from the first year of production 1921.*

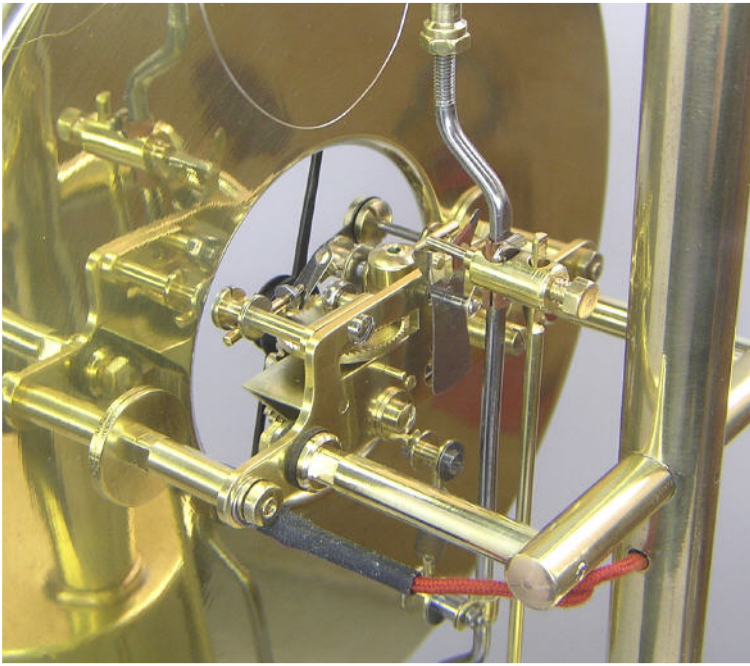
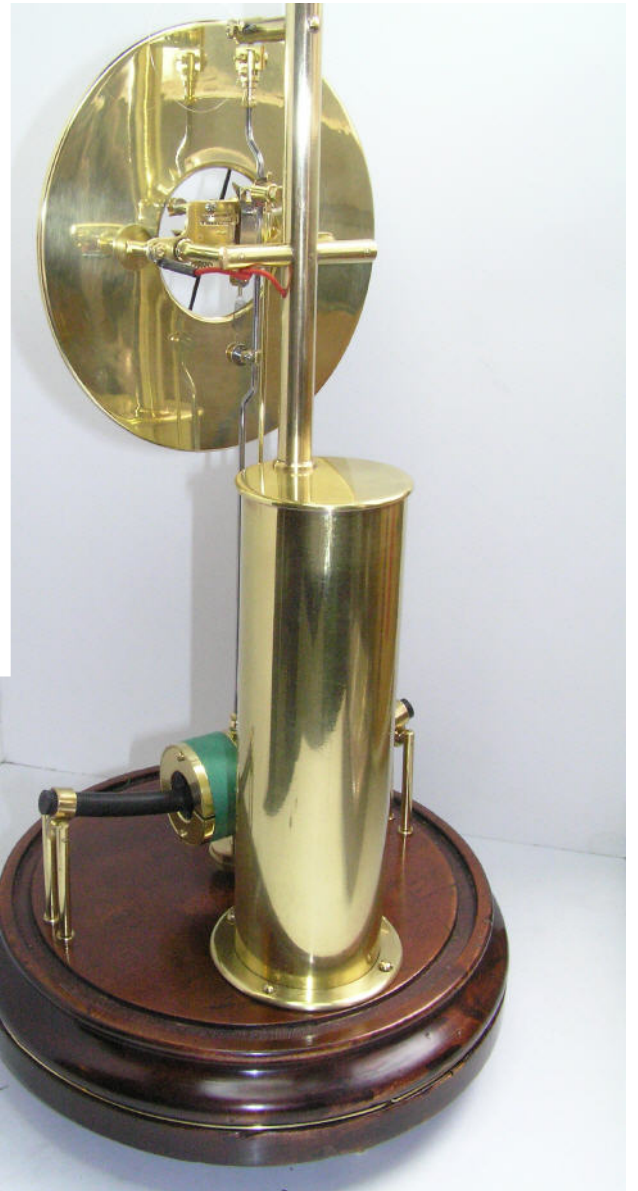
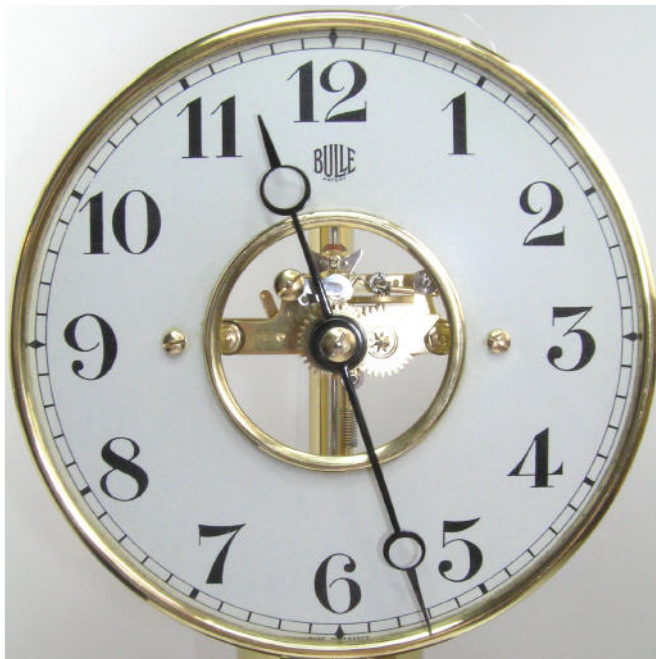
*The completed restoration showing the movement, dial and rear of the clock*

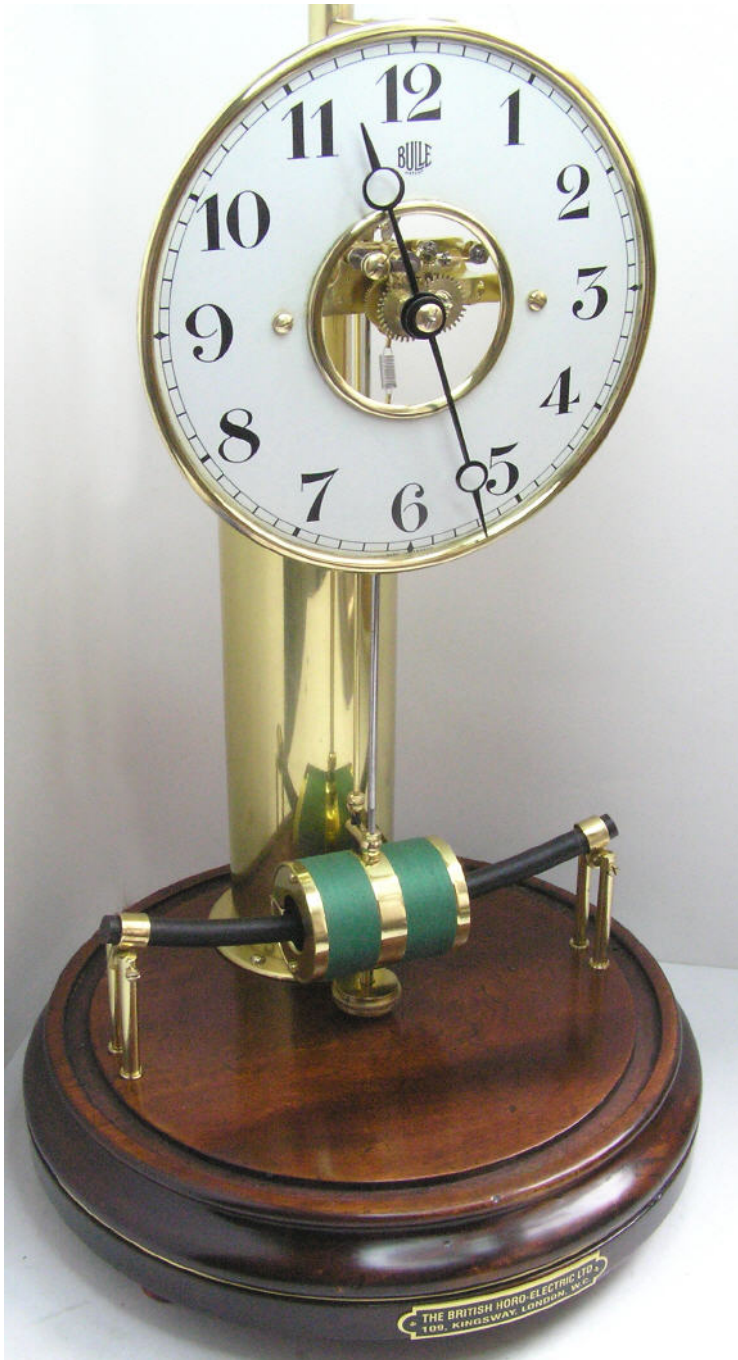
*The completed Restoration.*
