Eureka Clock Serial Number 3067

Restoration of Eureka Clock Serial Number 3067

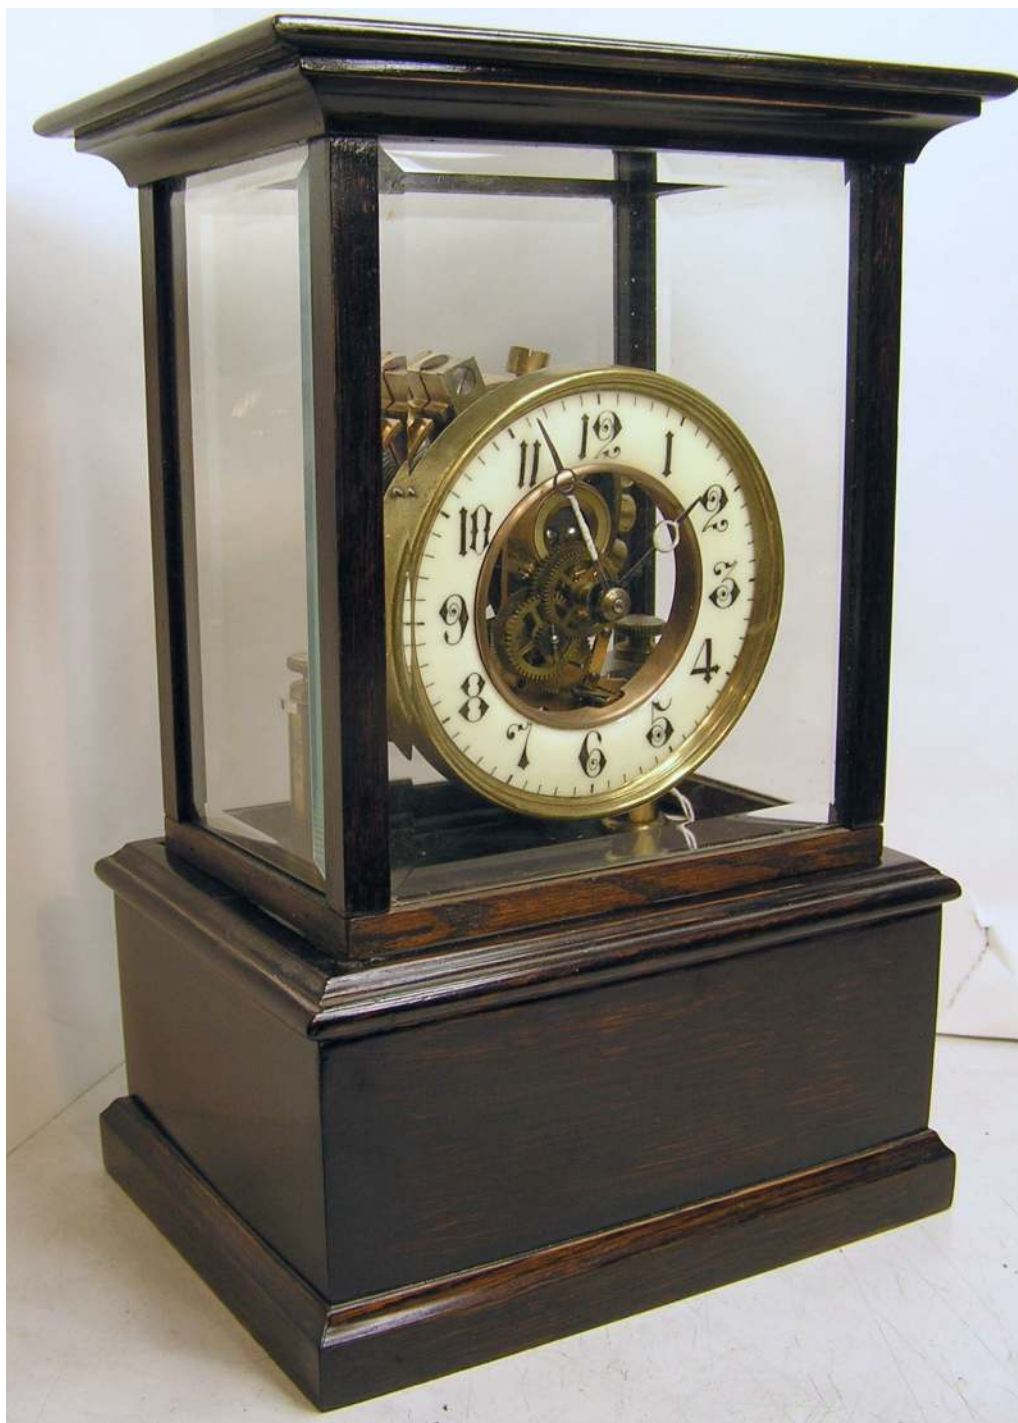
Photos by kind permission of the owner. This short movement sits within a four glass case which seems to have been made for another clock. As you can see the movement seems a little lost sitting in the bottom of the cabinet. Unfortunately if the case was shortened to fit then all four side pieces of glass would have to be cut and reground.

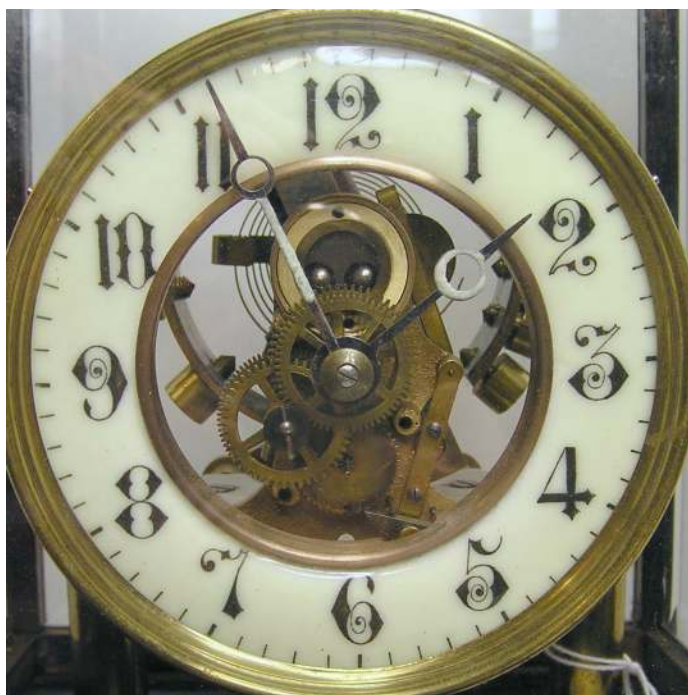
The dial is a replacement, probably from a French Slate clock, Note the fussy arabic numerals. The Eureka had a much plainer style. The owner wishes the dial to be re-enamelled.

The finished clock showing the new bezel, inner bezel and enamelled dial. Note the numerals in this photo compared to the dial as first delivered. Much simpler and tidier. The radium has been removed from the hands before they were cleaned and painted.

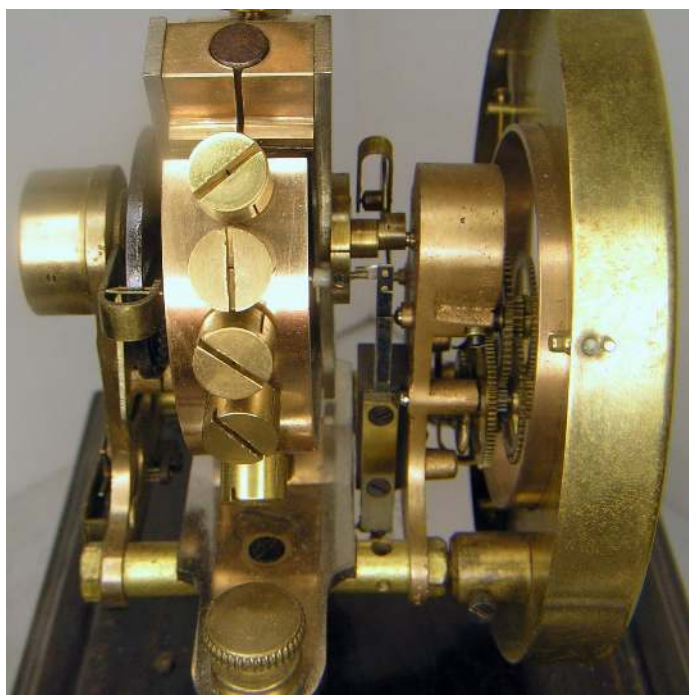
The dial surround is also wrong. It is of thin pressed brass whereas the Eureka should be machined from the solid and is much wider, heavier and ornate. I will have to turn up another.

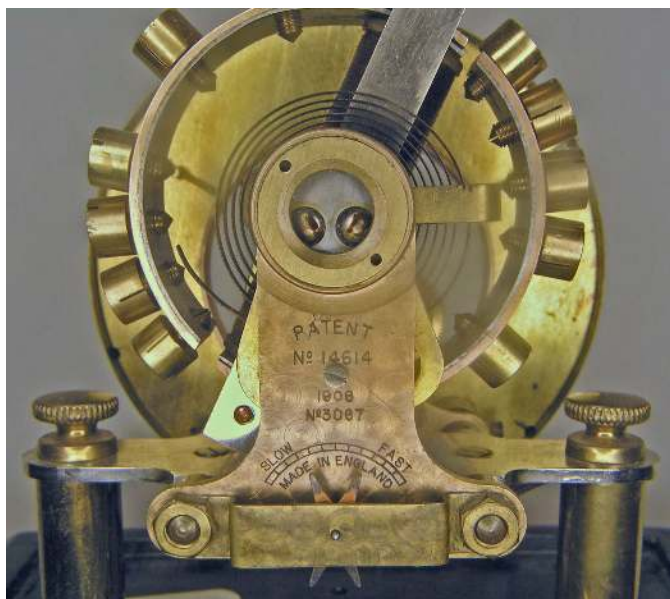
The rear shows the name and serial number engraved into the back plate. However it is very shallow and ill defined such that the wax fill is very feint.

The rear of the clock. Unfortunately there was not enough depth in the engraved plate to refill the wax characters, so it still looks quite faint.

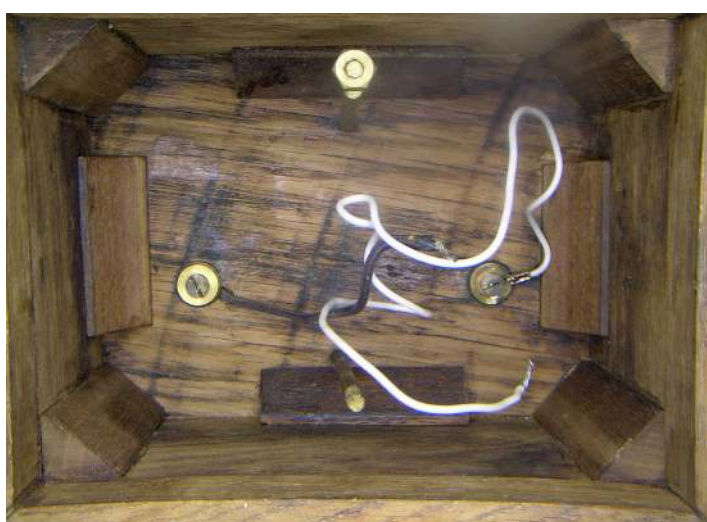
The underside. Not quite the standard you would expect with a Eureka. The wood is quite thin and only one battery stud is original. The battery retaining plate is also missing as are the ornamental nuts. All will need to be made.

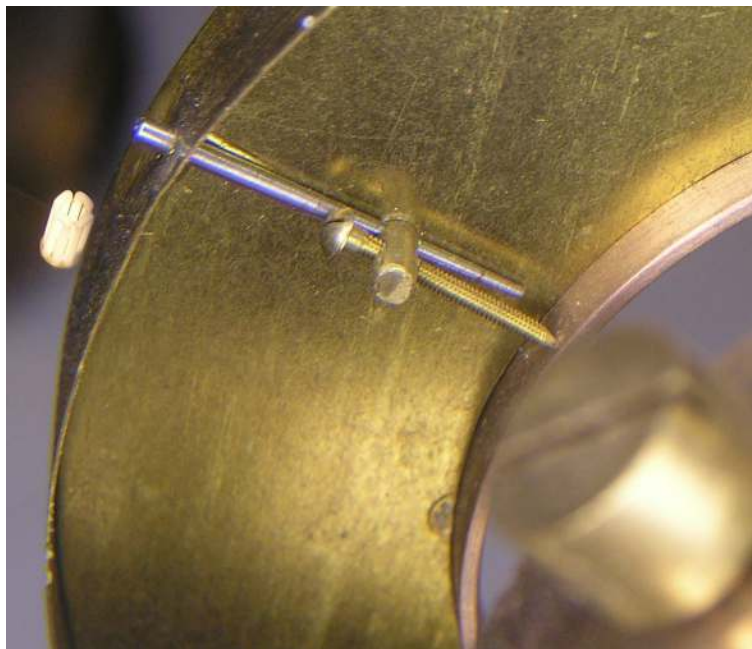
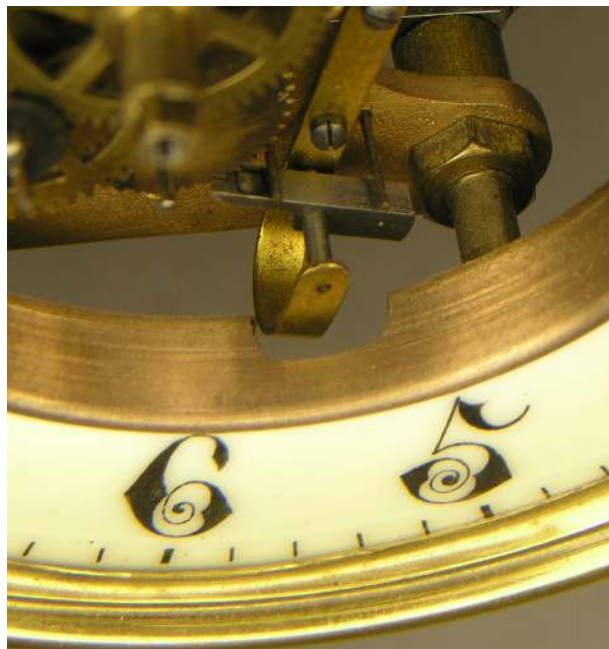
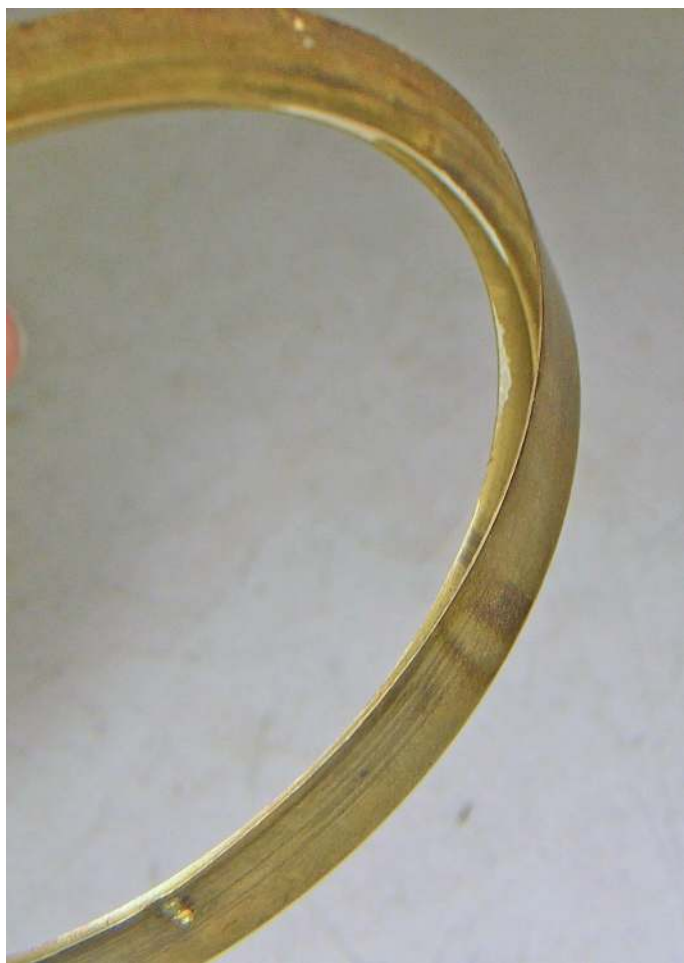
Here we see the thin spun bezel and how it has been pinned through studs that have been added to the back plate. Note also in the photo above the inner bezel has been made up from a different coloured brass which is too deep and has had to have notches cut to avoid the movement. A new ring will have to be made.

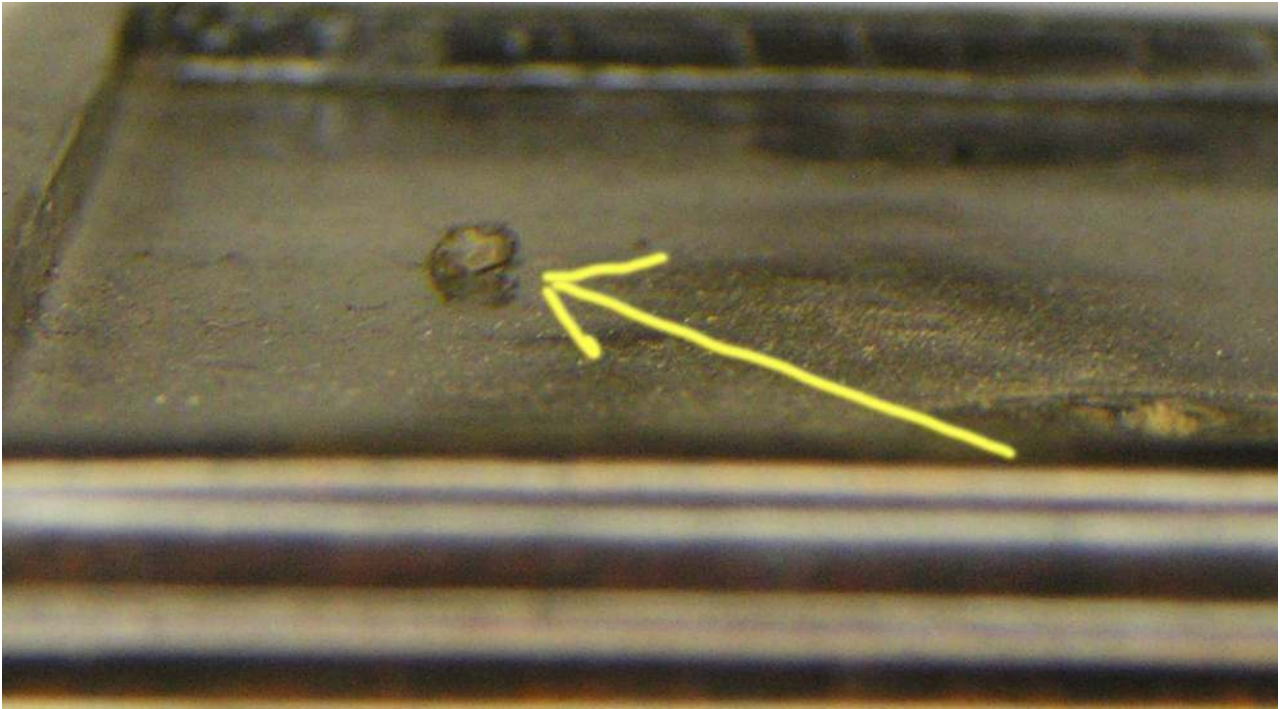
Above we see that the battery studs protrude through the thin wood base. But there is not much we can do about this. The owner wishes to leave the case as is. Below we see the elegant method of bringing the wiring through the base to the movement.

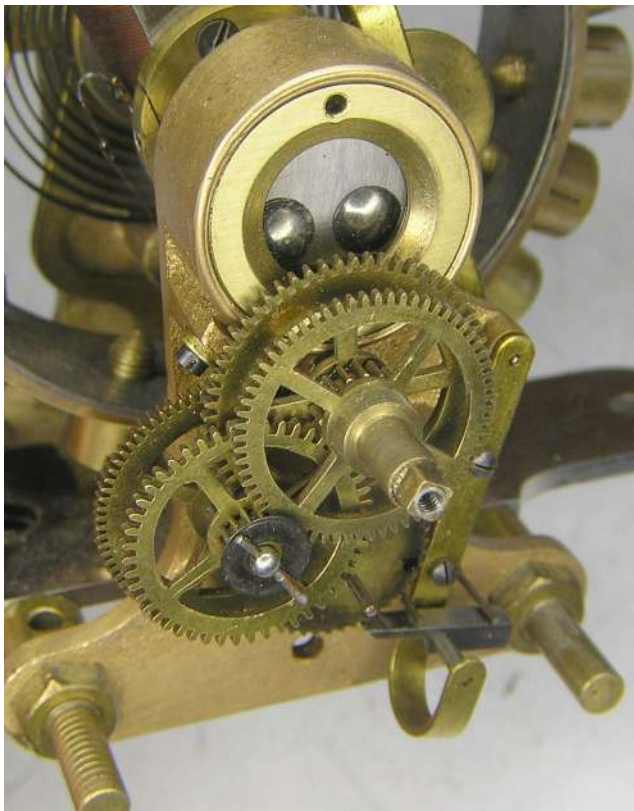
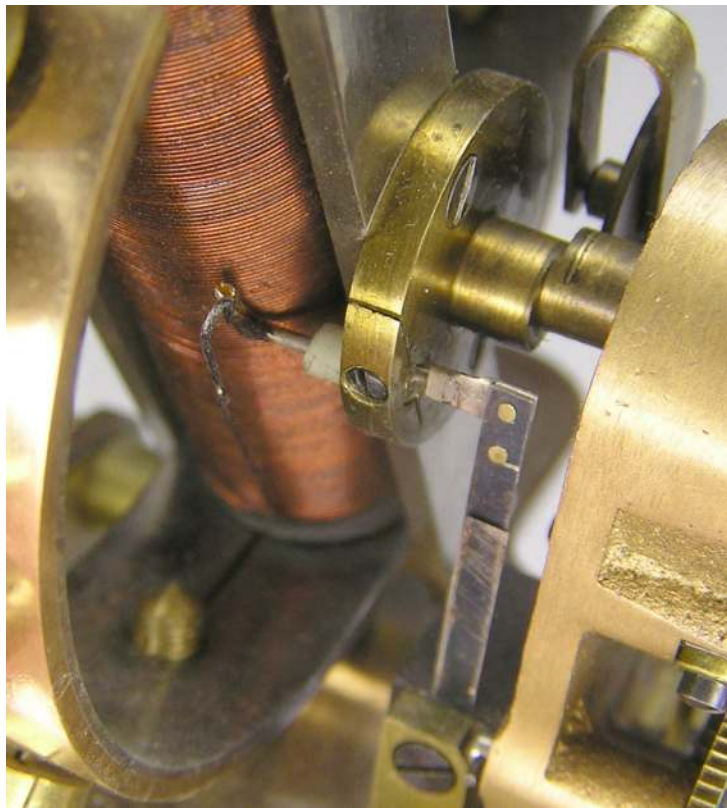
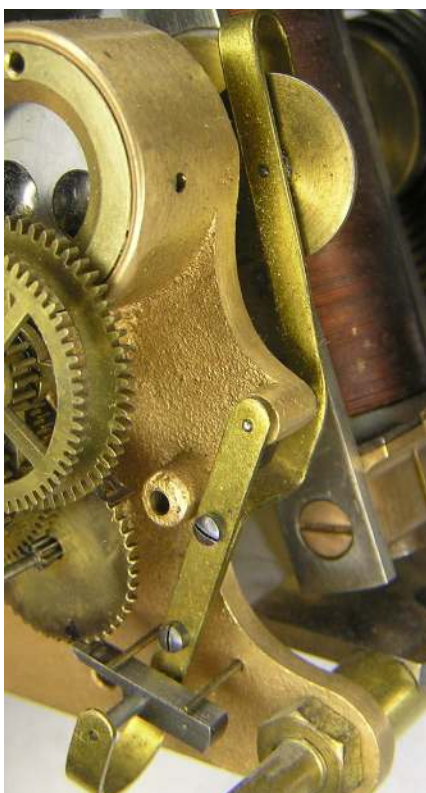
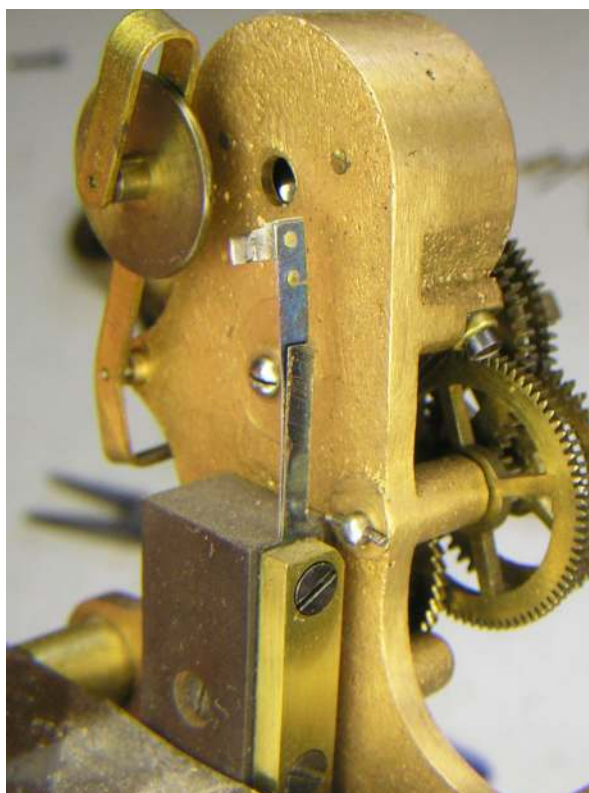
*This group of photos
show that the move-
ment seems to have es-
caped any major
damage and looks to
be all original with
nothing major missing.*

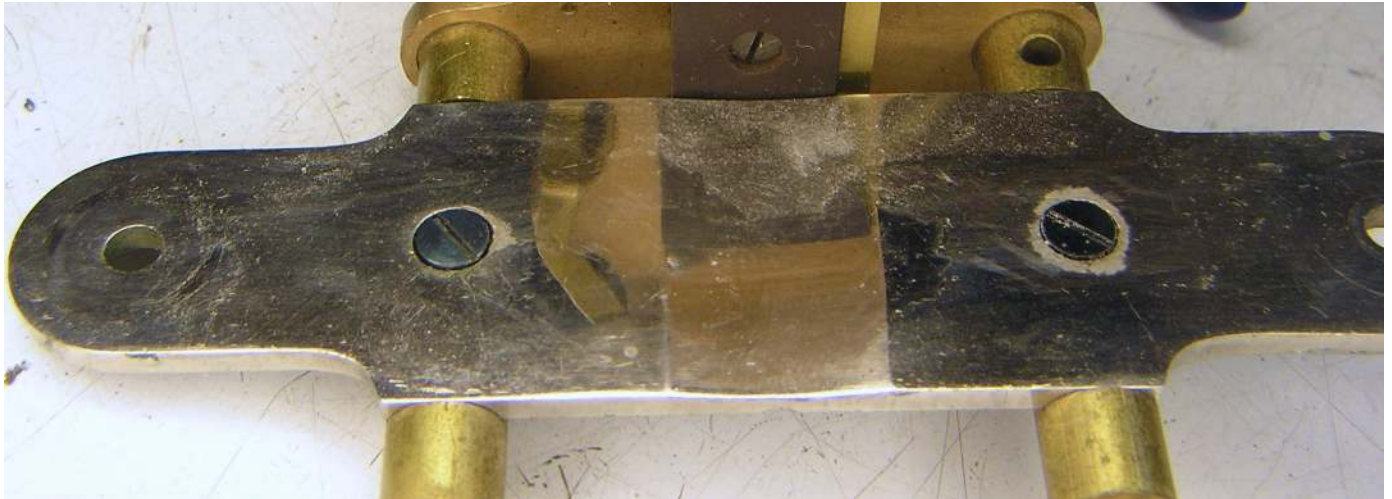
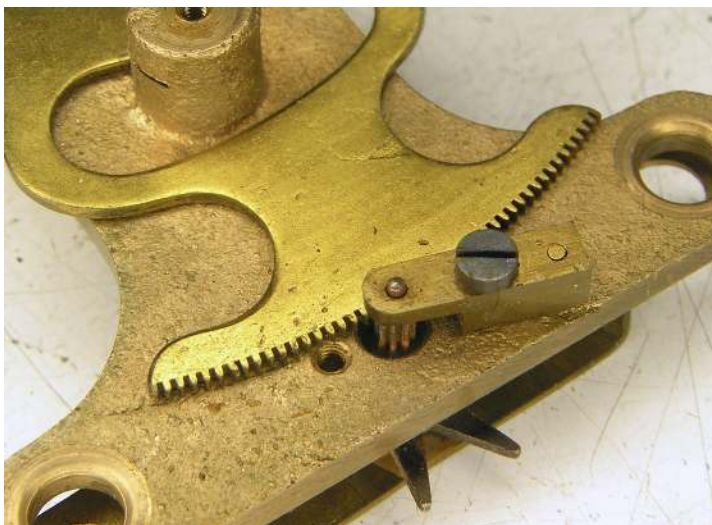
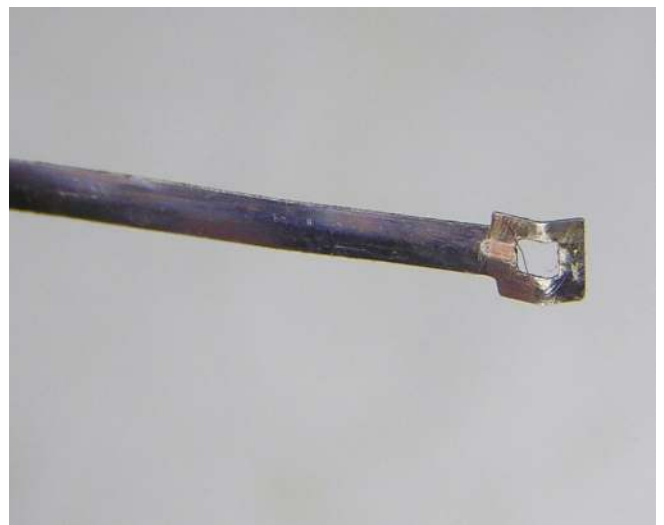
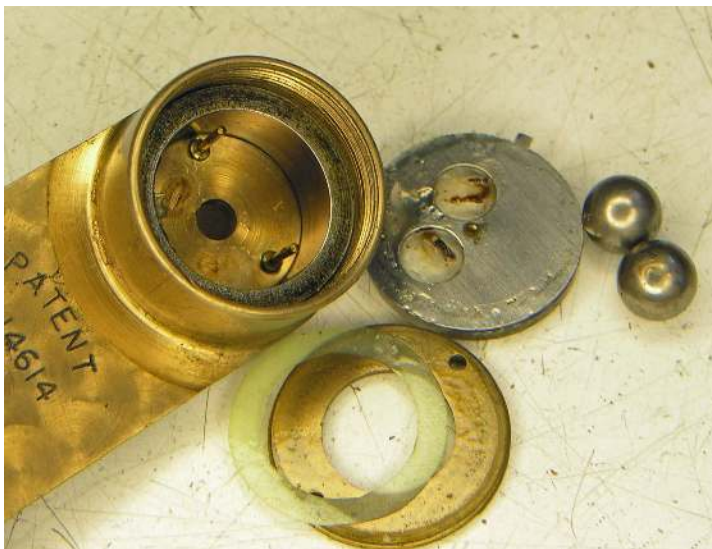
Generally the movement looks OK with just a bit of rust on the steel parts. But, as is common with Eureka clocks, the click spring has worn through and will need repair.

The rear bearing housing looks good with no rust.

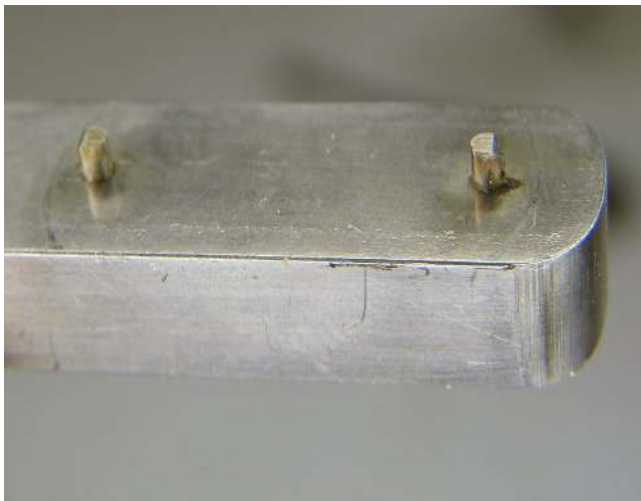
A simple tool with tapered steel pins to open the bearing housings.

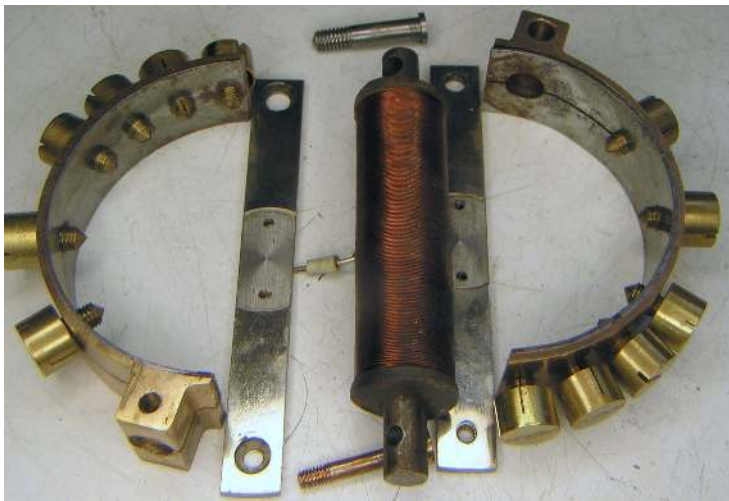
The balance wheel disassembled.

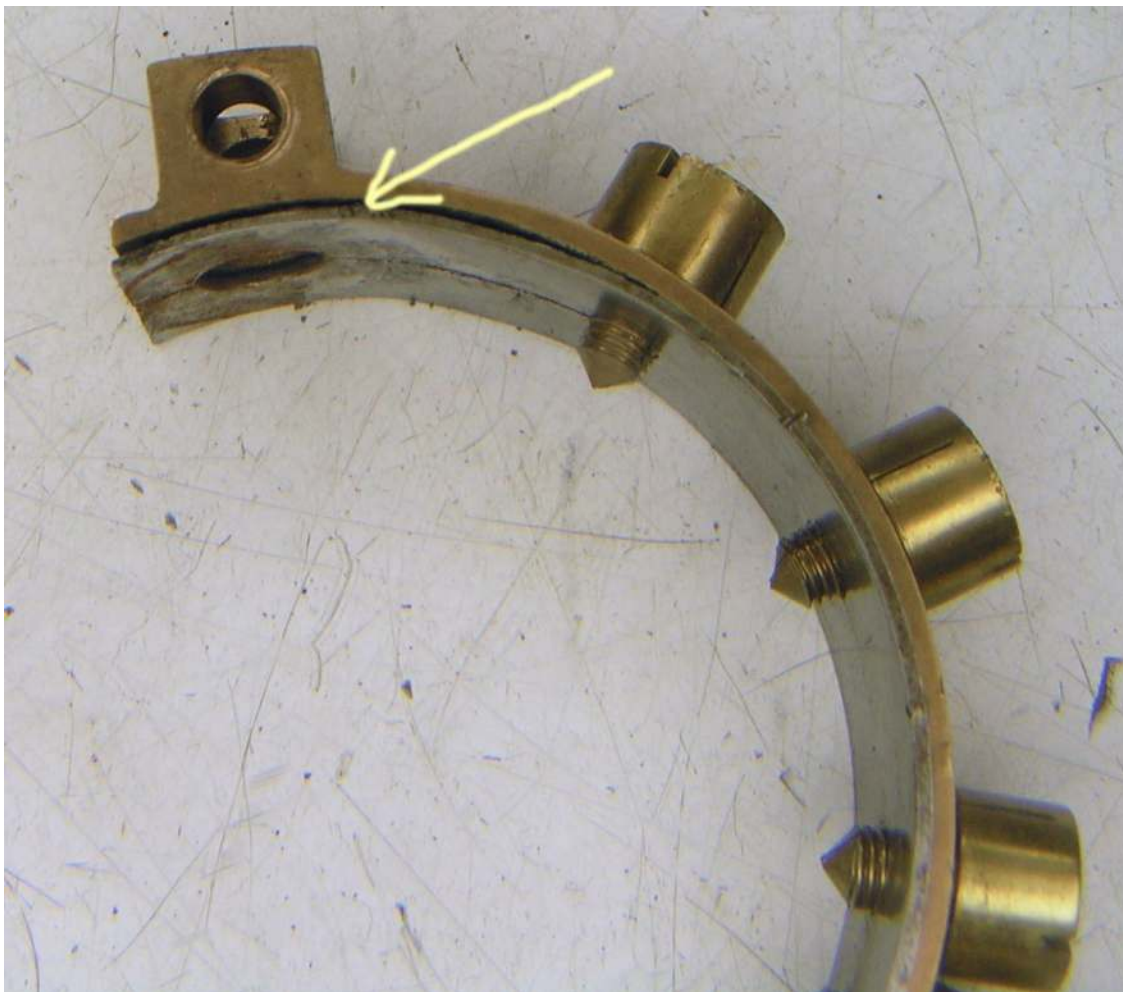
This is going to be a problem. The inner steel rim has separated from the outer brass rim. It looks as though it has been like it for some time as it looks rather rusty.

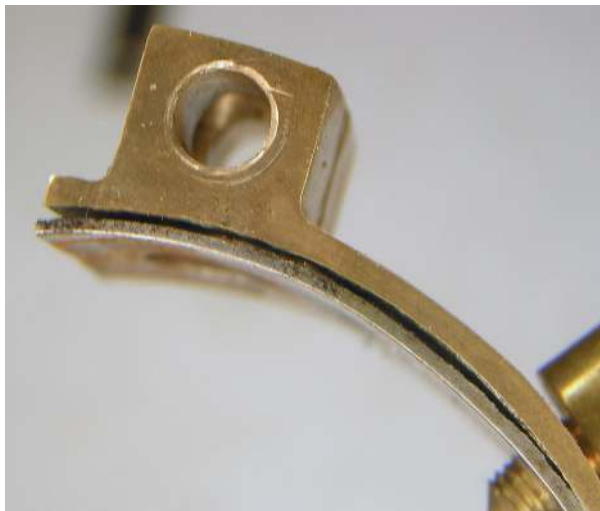
The rim has been separated completely and it is now evident that the corrosion is bad and has been like this for some years. I will try and clean the parts and re solder but the problem is lining up the holes and threads.

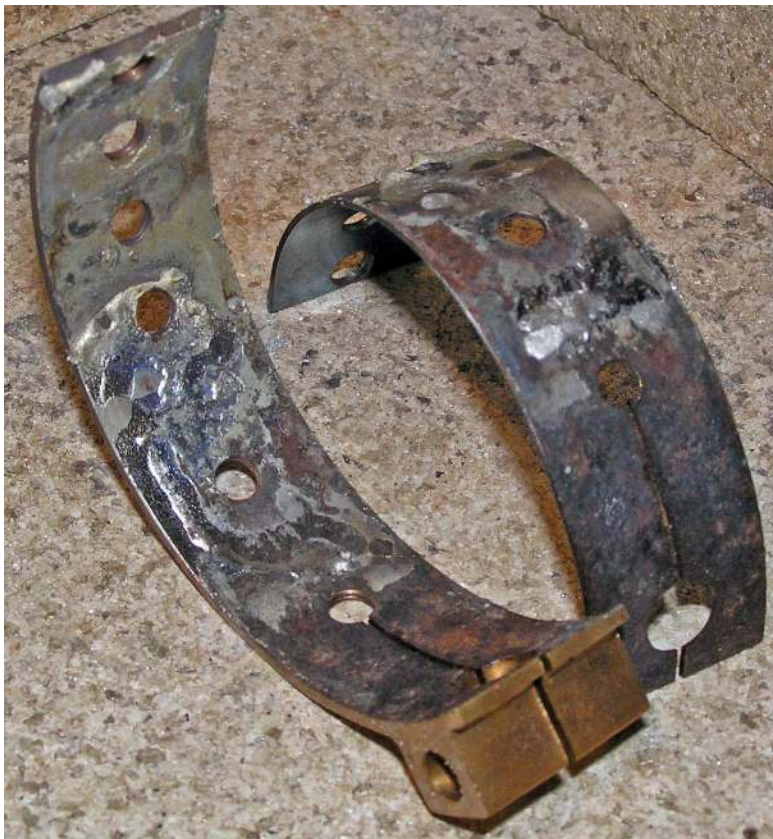
The corrosion is not just limited to the balance wheel as the photo on the left shows. This will all have to be carefully cleaned. It looks as though the clock may have been in contact with a very damp atmosphere at some point.

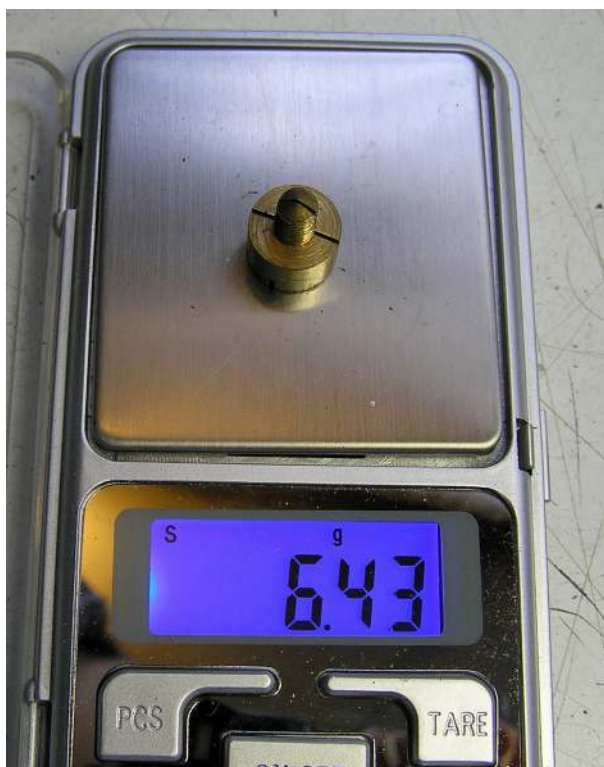
A method of making sure the balance wheel screws get re-assembled in the correct order. This of course assumes that they are in the correct place in the first place and have not been moved in the past. I set them out like the hours on a clock and then weigh each one with a set of scales capable of reading to 0.1 grams. It is then easy to weigh them when cleaned for replacement.

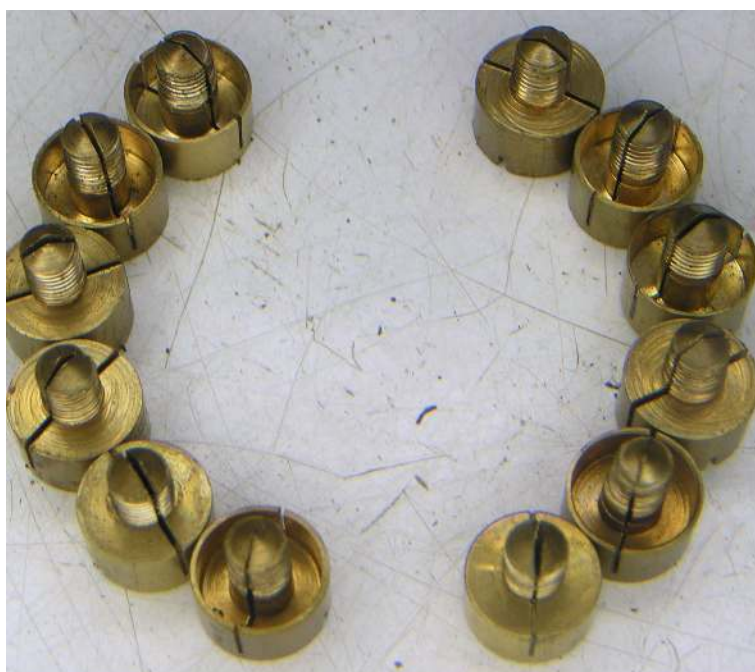
S/W 3067 6/

12	4.00	1	6.42
11	4.39 4.40	2	3.90
10	6.37	3	3.85
9	6.35	4	6.36
8	6.21	5	4.30
7	4.10	6	6.20

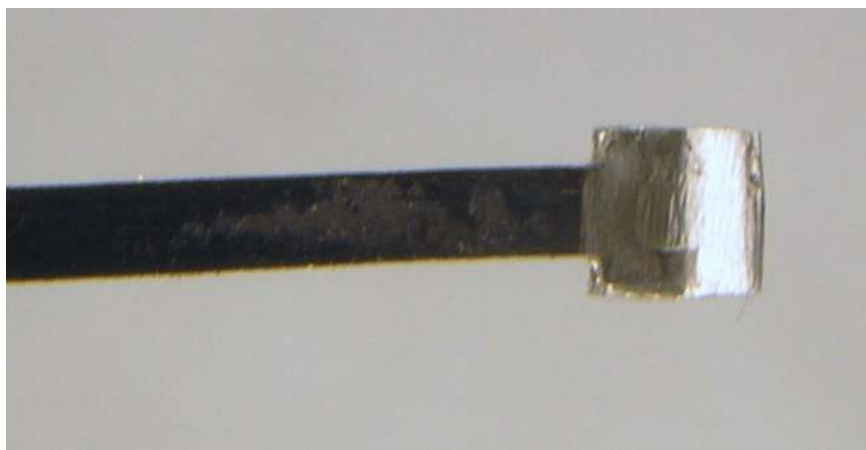
The click spring with new steel, soft soldered in place. This view is from the top or inside the "V" where the original hole can still be seen

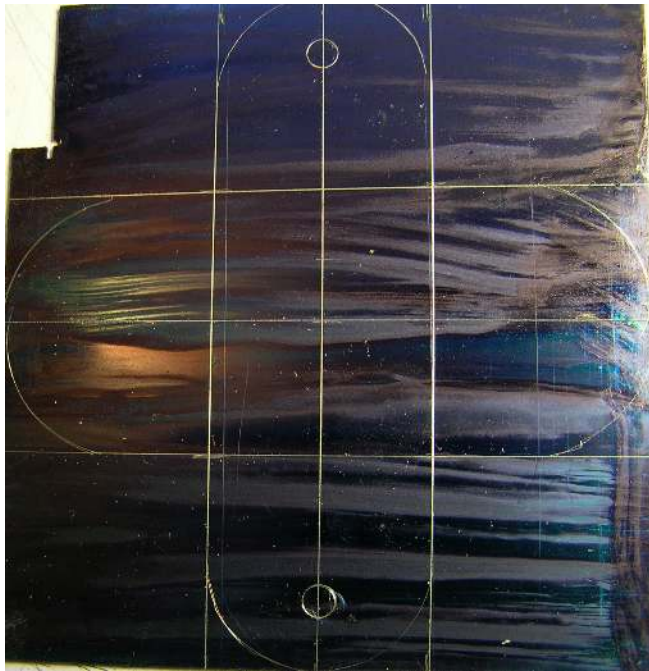
Stages in making a new battery retainer. The retainer is marked out on flat brass sheet. Note that the dimensions have taken into account the curve that will need to be put in later. The photo on the right shows the retainer after cutting to the line.

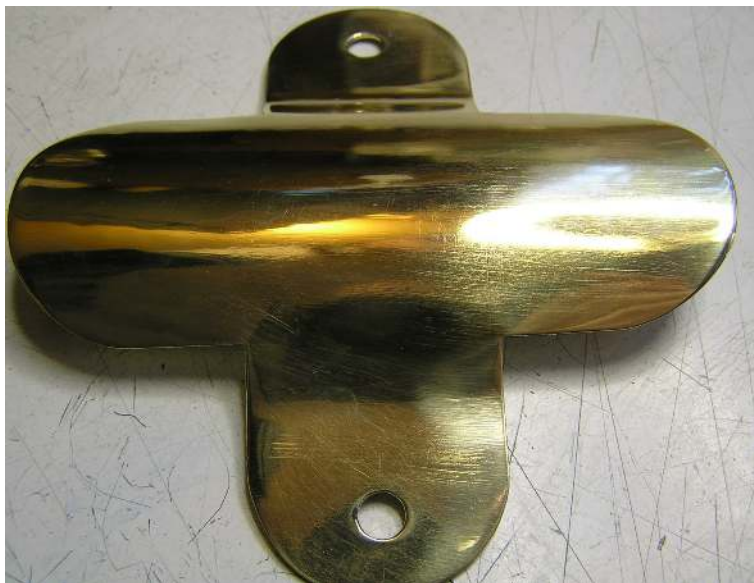
The finished battery retainer.

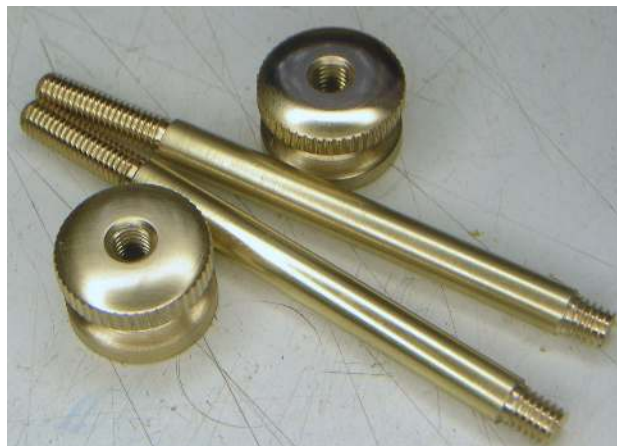
The new studs and nuts for the battery retainer.

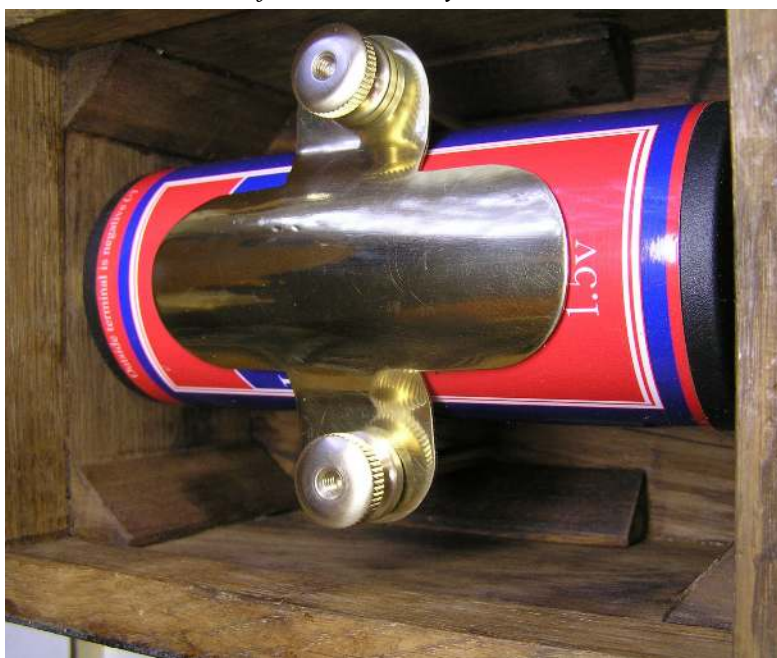
The new parts holding the flag cell battery in place under the base.

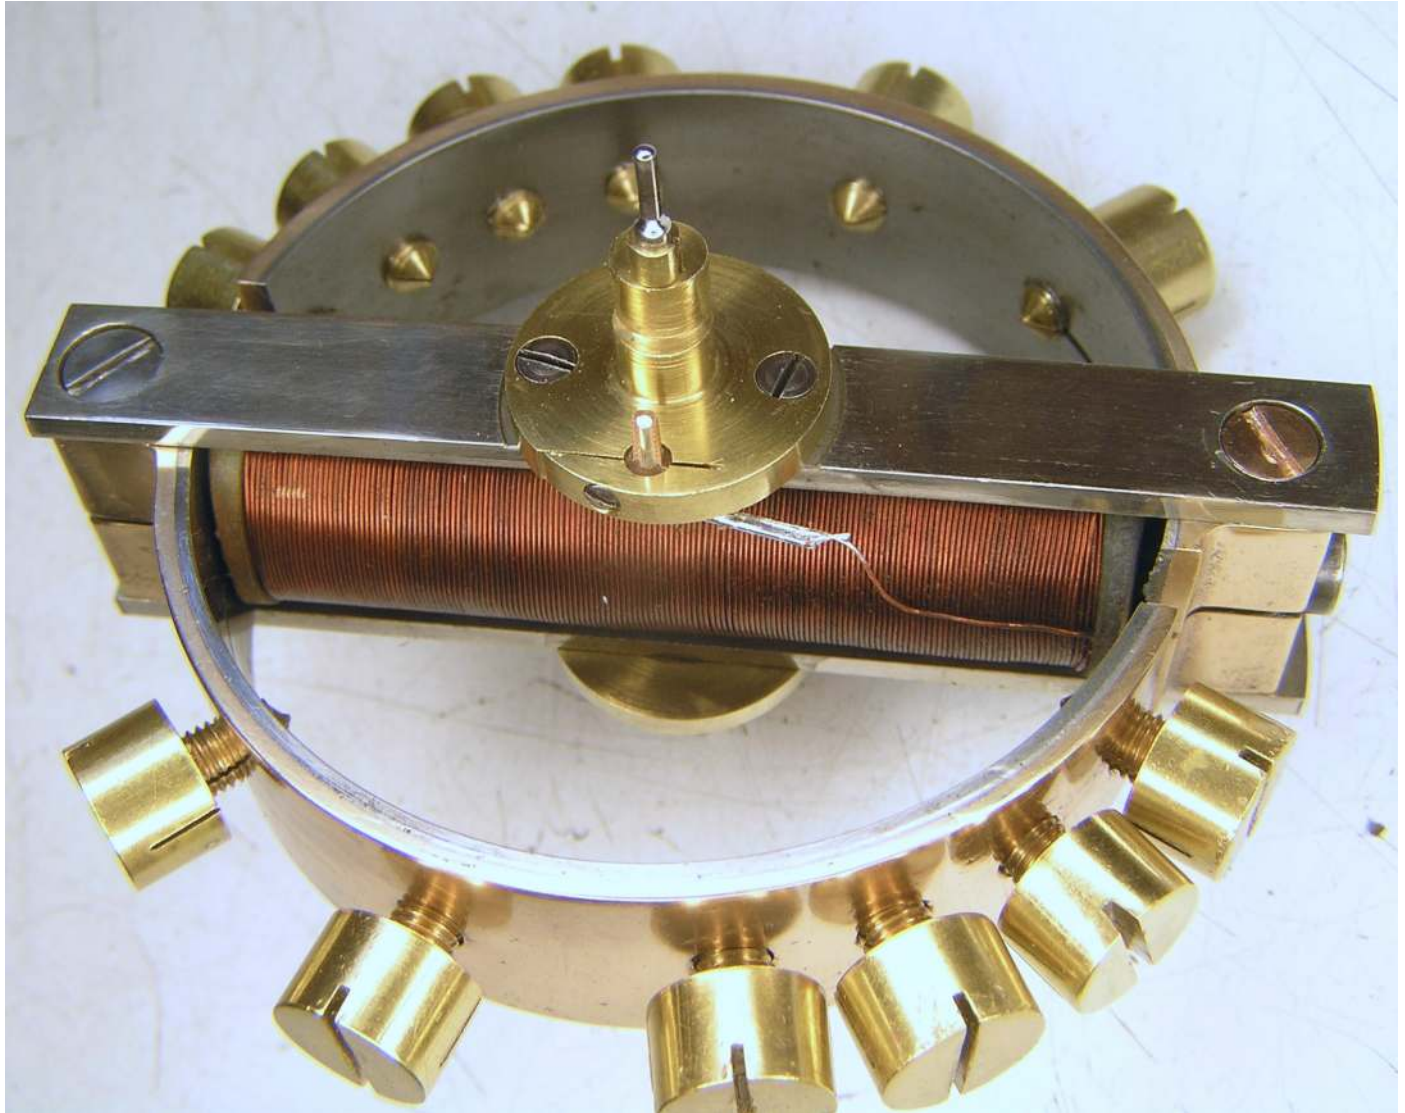
The balance wheel with repaired rim. All the steel work has come up fine after treatment for the rust.

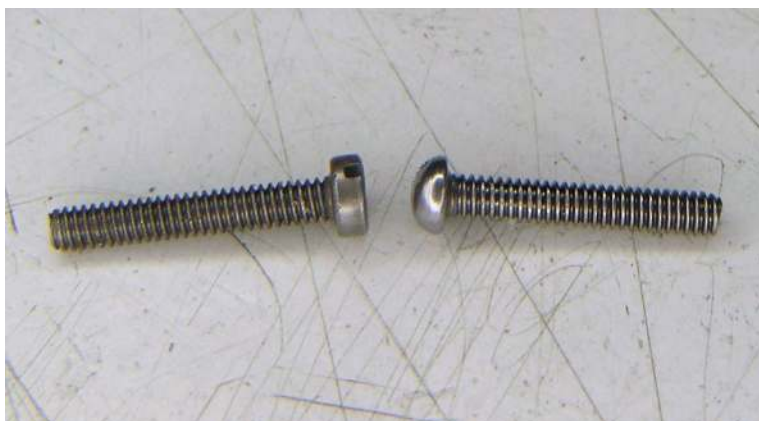
I had to make new screws for holding the dial in the rim. I used existing pan head 2 BA screws which I turned the heads round on the lathe. They are shown here before cutting, polishing and bluing.

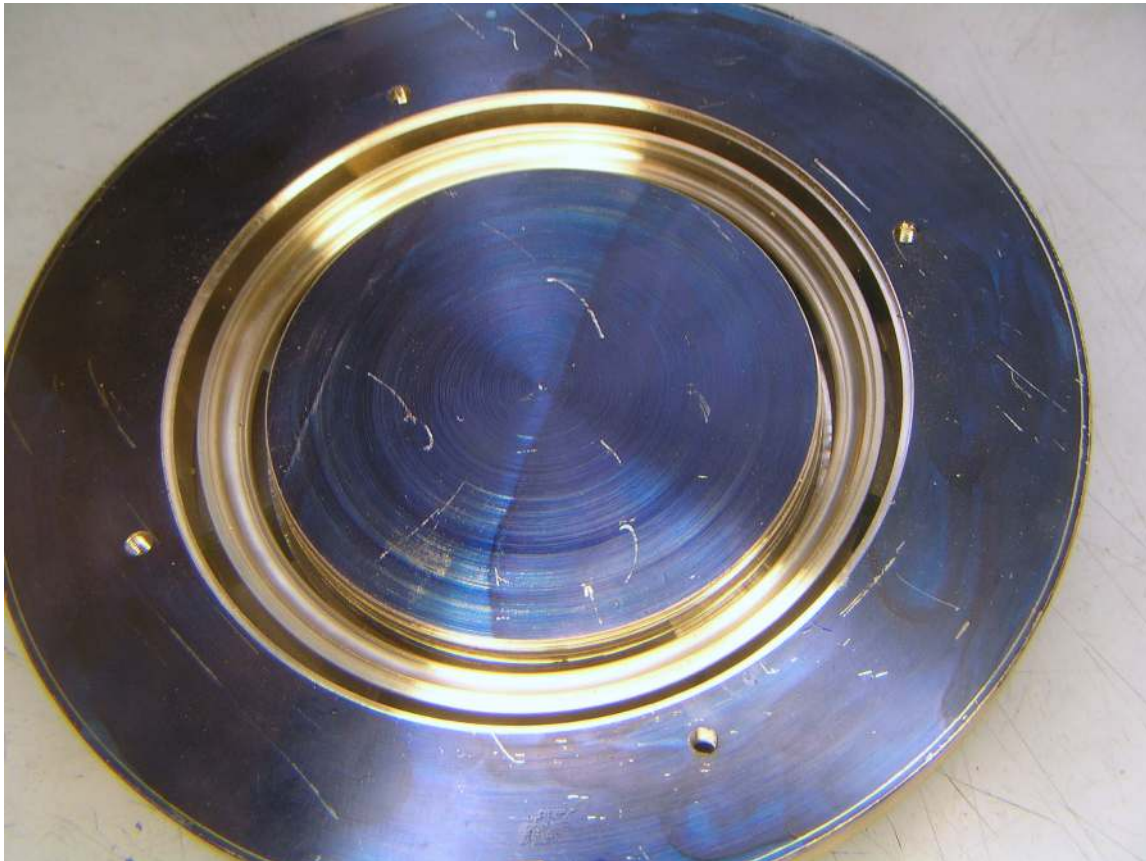
Some stages in machining the bezel and sight ring. Most of the detail photos are shown in the "Making a Eureka Bezel" pages in the downloads section of this website, and so not reproduced here.

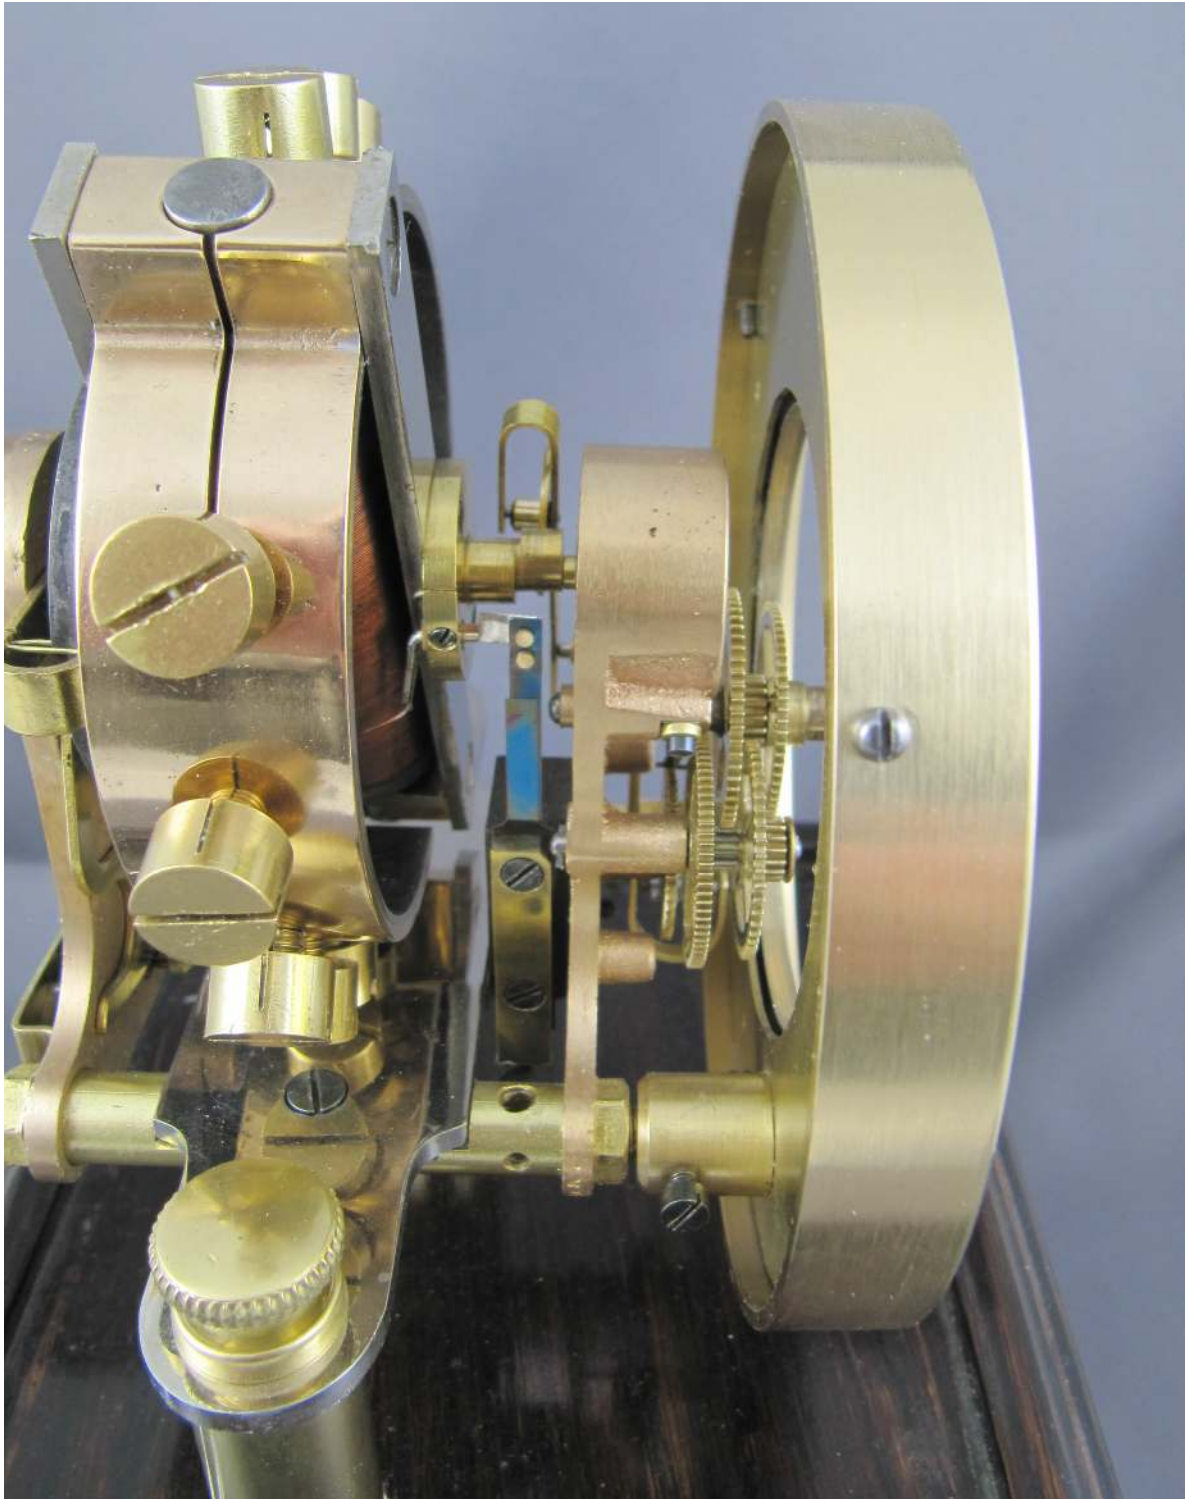
The dial rim screws tested for length and function before being finished. They should be the correct distance front to back so that the dial and back plate are held without being loose or being too tight such that the ceramic dial is under too much pressure and cracks.

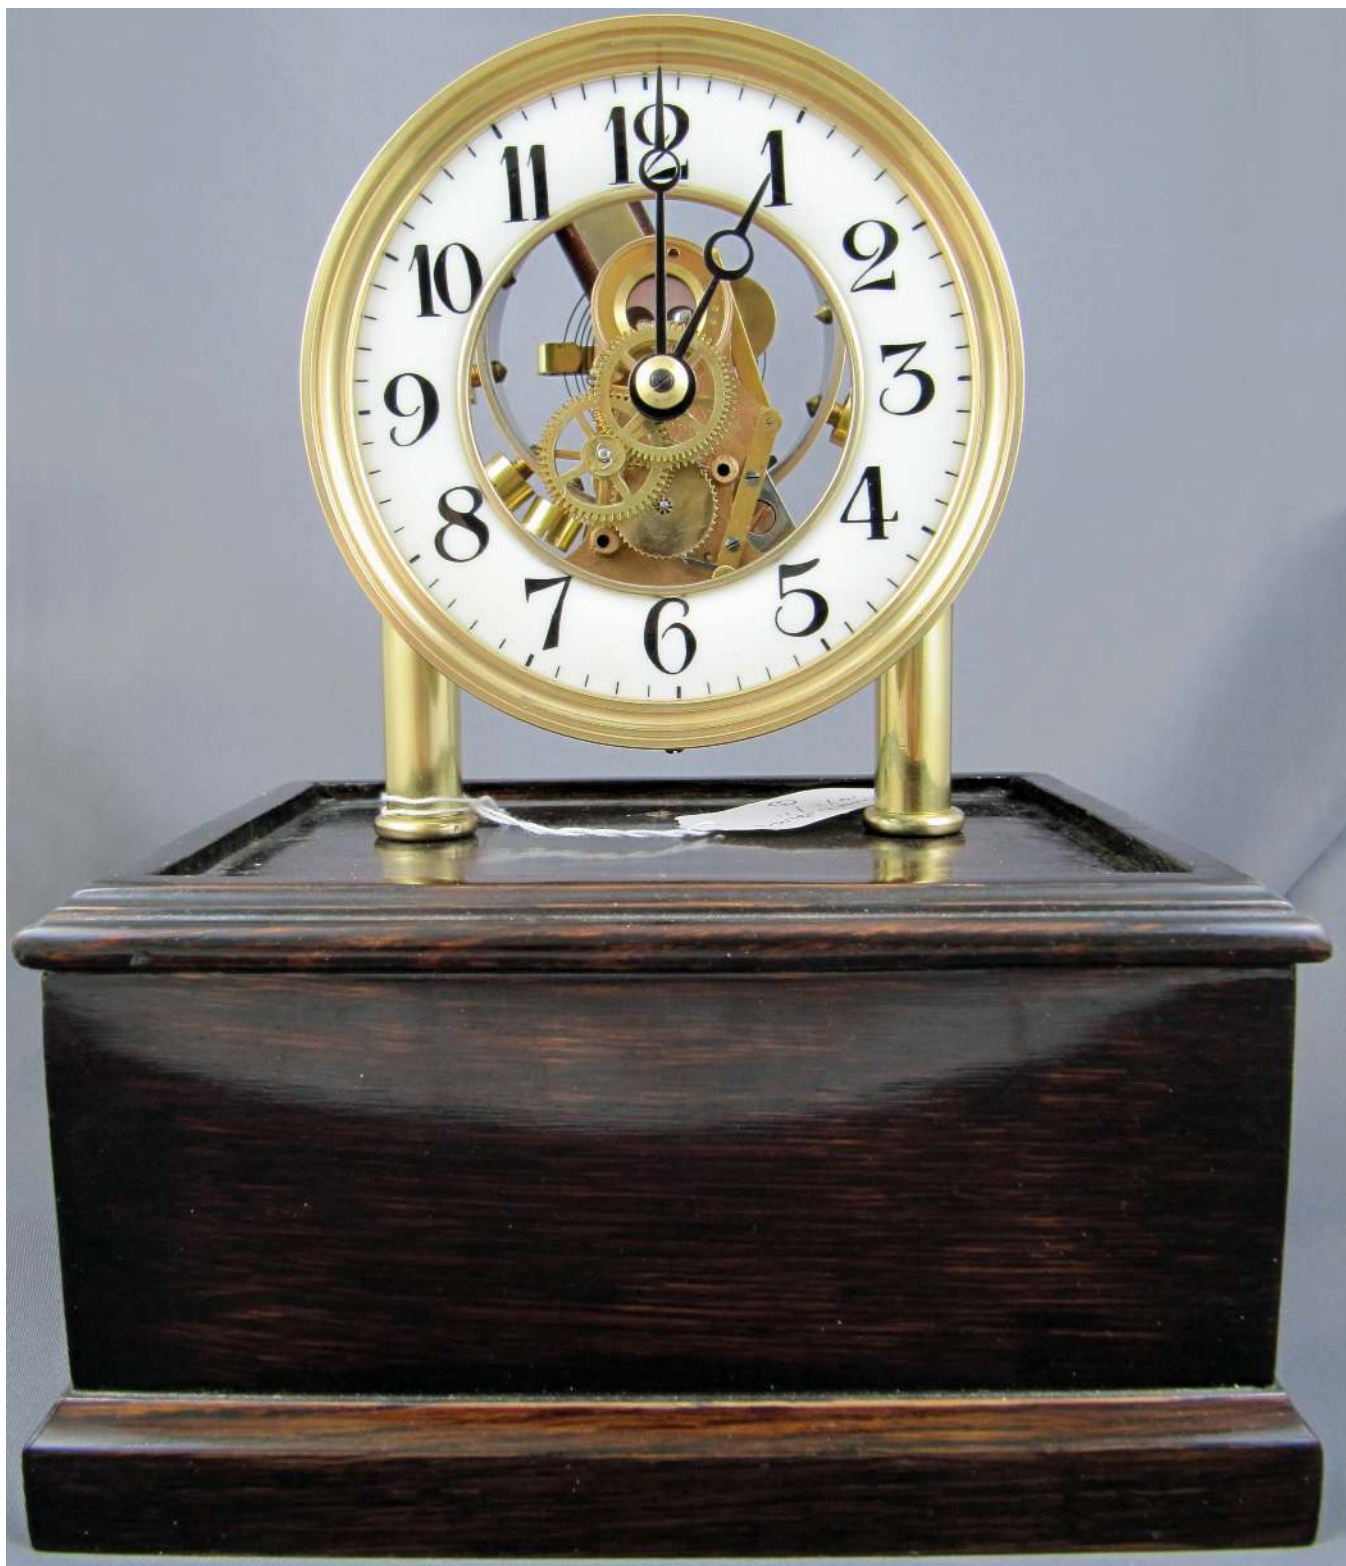
The finished clock back on the base
