Eureka Clock Serial Number 3067

Restoration of Eureka Clock Serial Number 3067

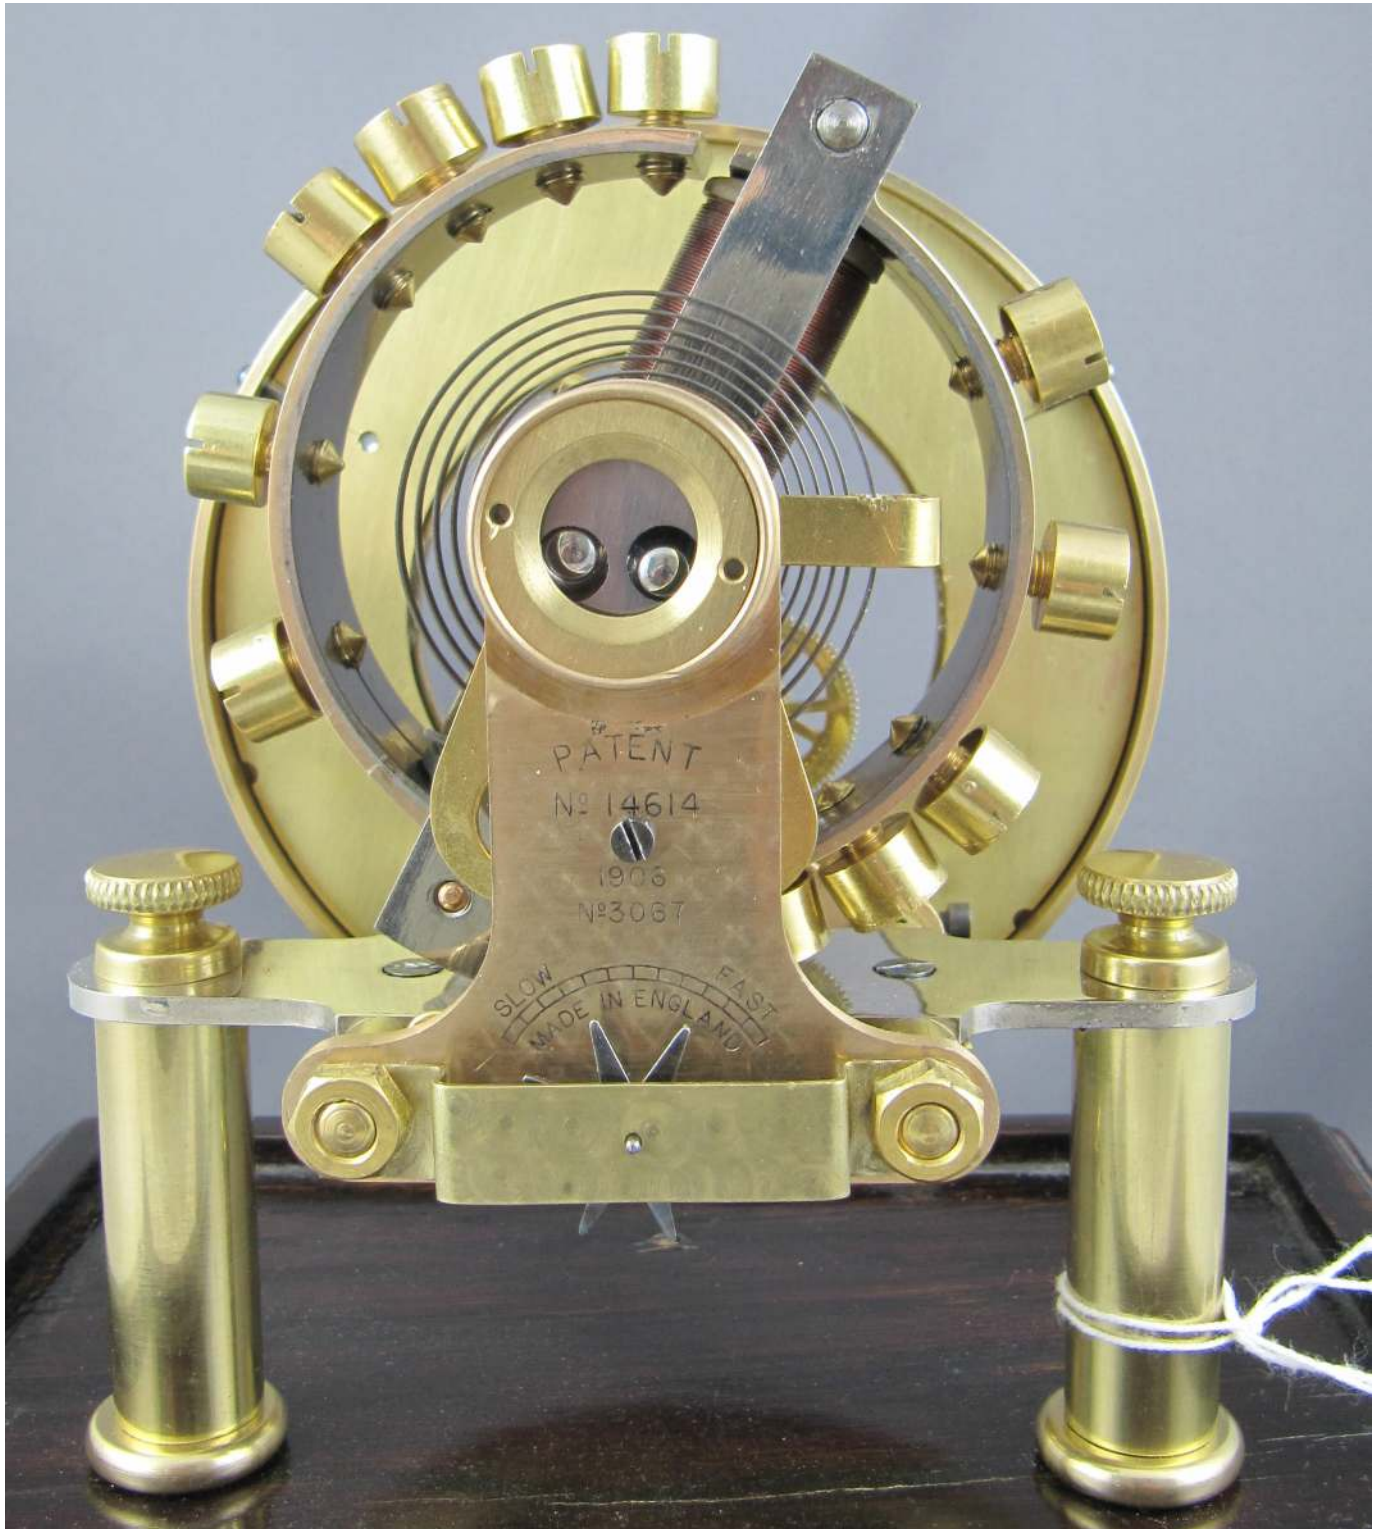
The rear of the clock. Unfortunately there was not enough depth in the engraved plate to refill the wax characters, so it still looks quite faint.

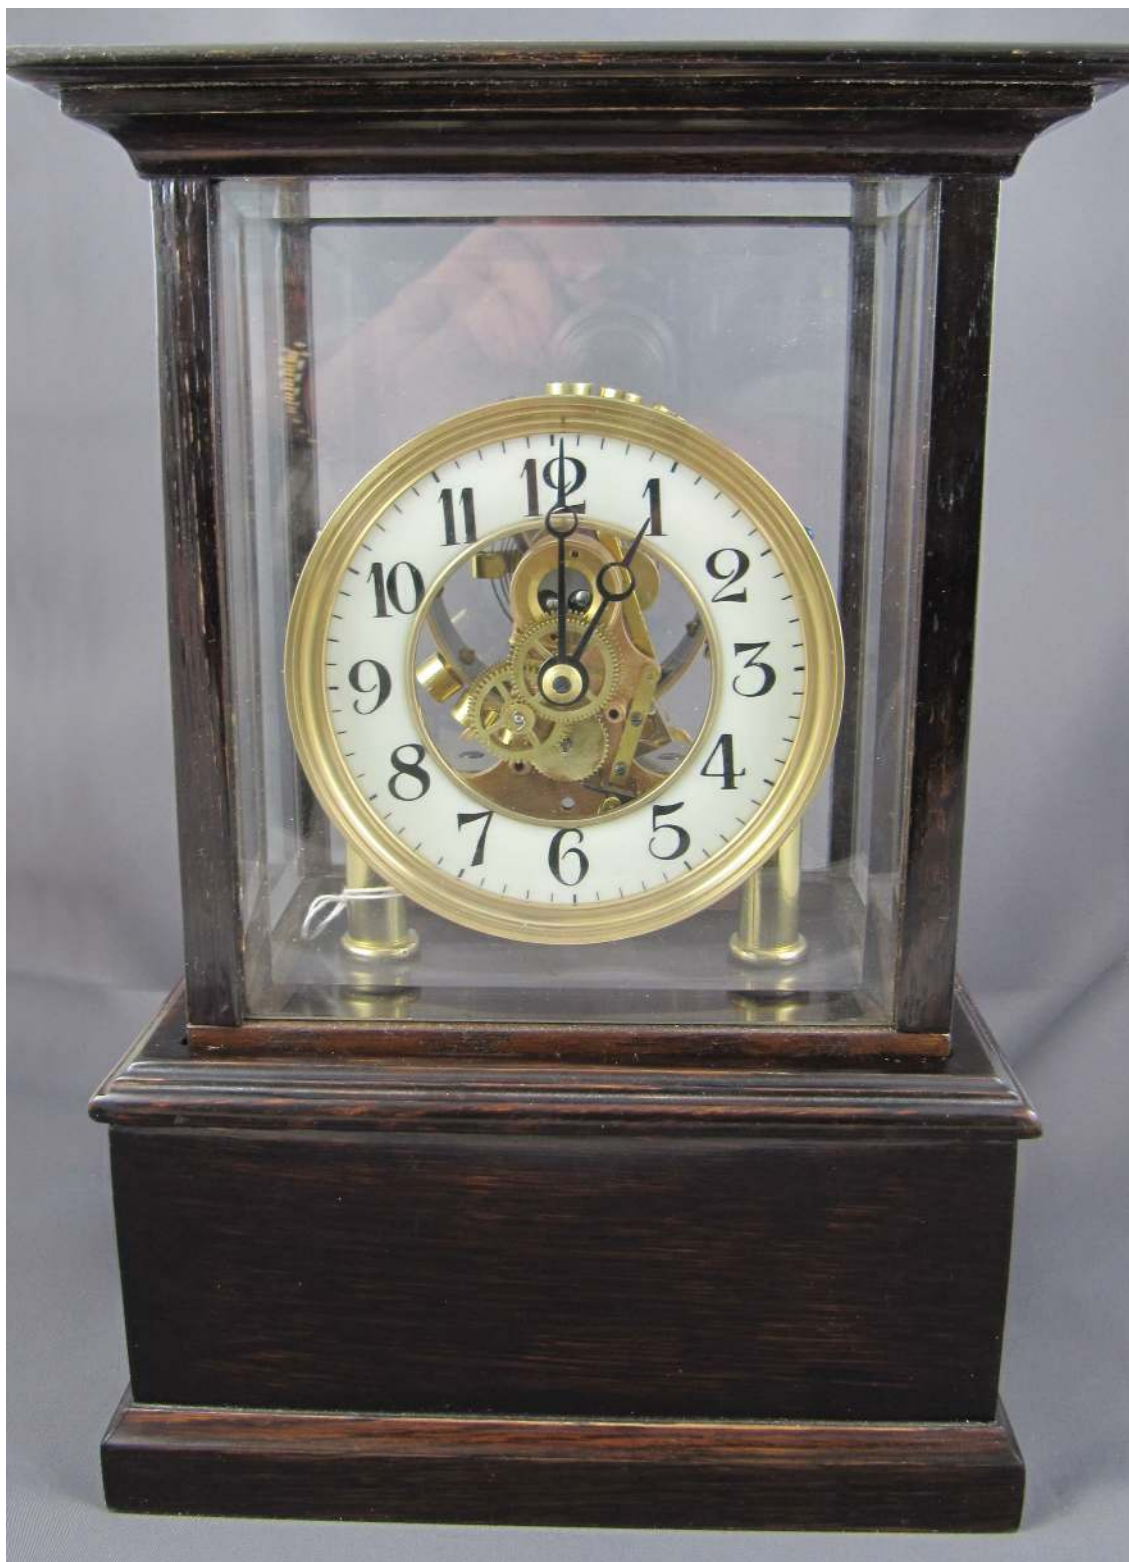
*The finished
Clock*
