Bulle Clock Serial Number 123079

*Restoration of Bulle Clock
Serial Number 123079*

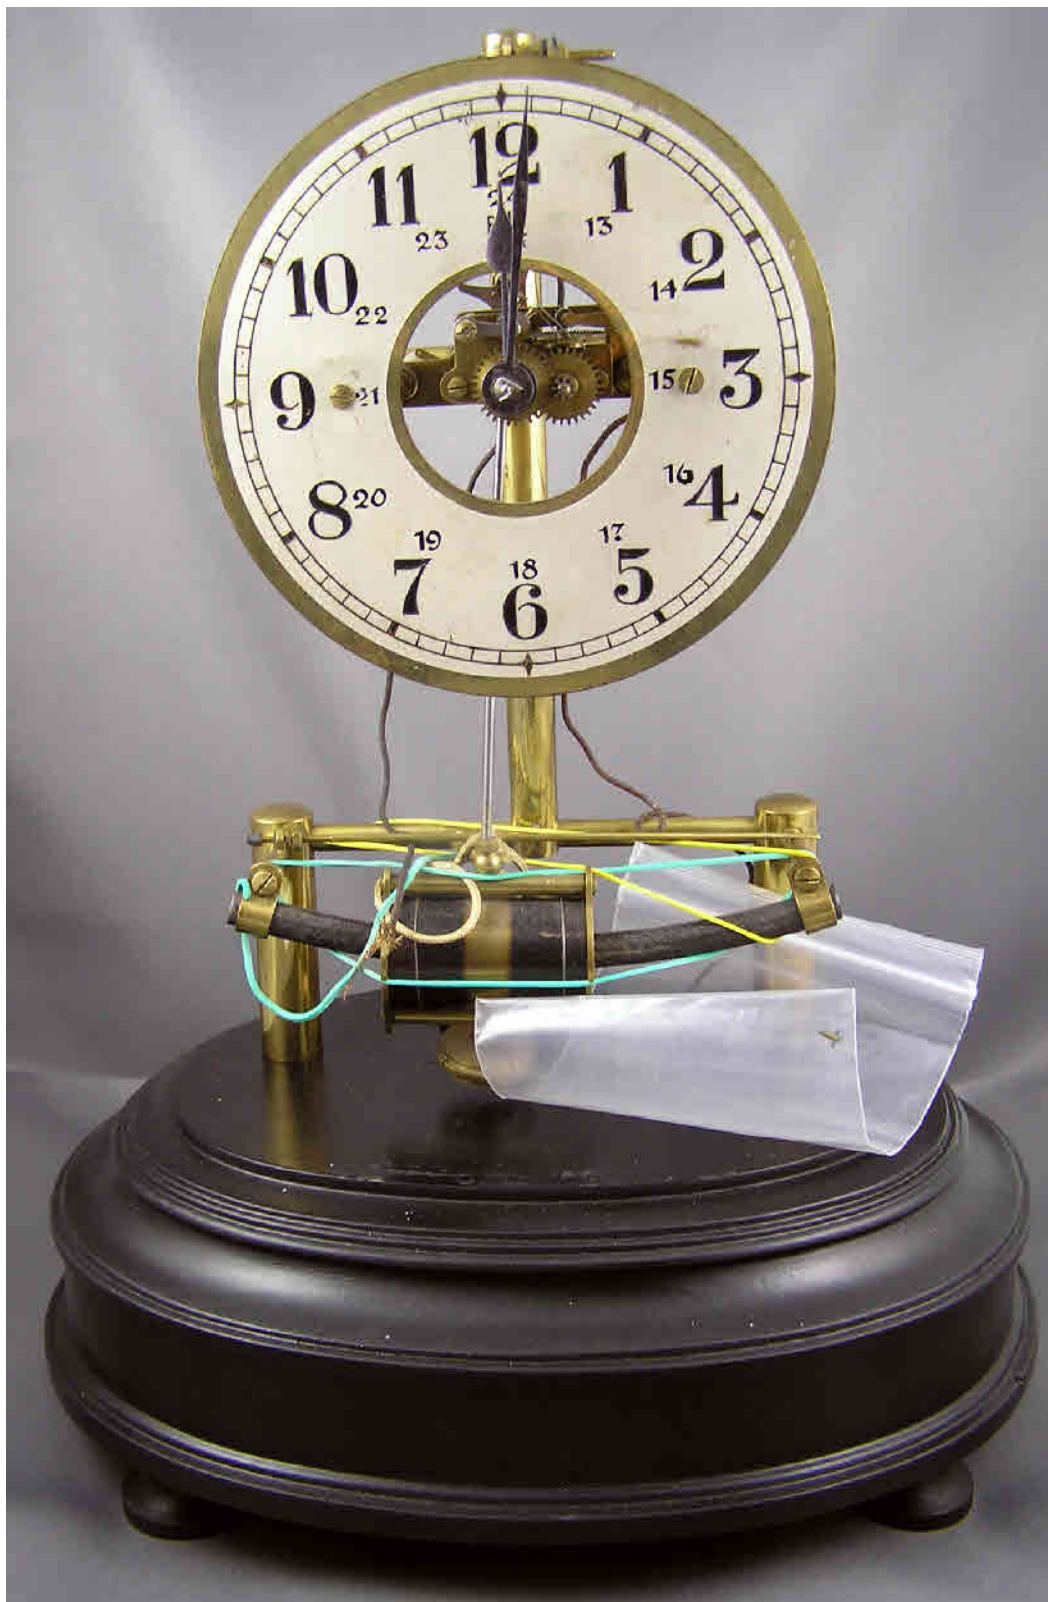
The clock as delivered is of medium length pendulum set on a black oval wood base. The dome would be a crystal type (not supplied). First things of interest are the small plastic bag containing one of the Isochron "T" piece hangers either from the pendulum or main plate; we'll see which later. The dial looks reasonable although it has buckled at the two points where the dial screws hold it to the movement. The silvering has also worn away at these points. The base has been resprayed at some point and has been left quite dull and rough. The coil leads into the cover look as though they have been pulled out and seem excessive in length.. The brass rod which runs up the back of the pendulum and joins the contact pin is also supplied loose.

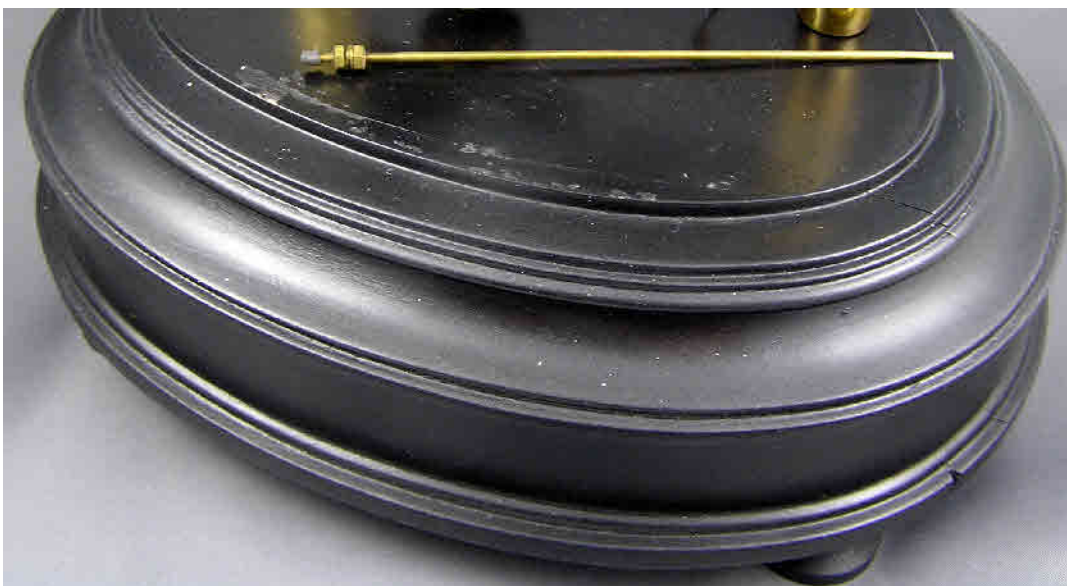
The base has some damag to the top where the surface may have been scratched by the dome being replaced over the years. We can also see the dull and rough appearance.

The new cap manufactured by spinning. The base has been cleaned up and cut back with black wax polish. The top has been filled in places and touched up but not completely French polished. I think it looks more natural if it's not gleaming out like new.

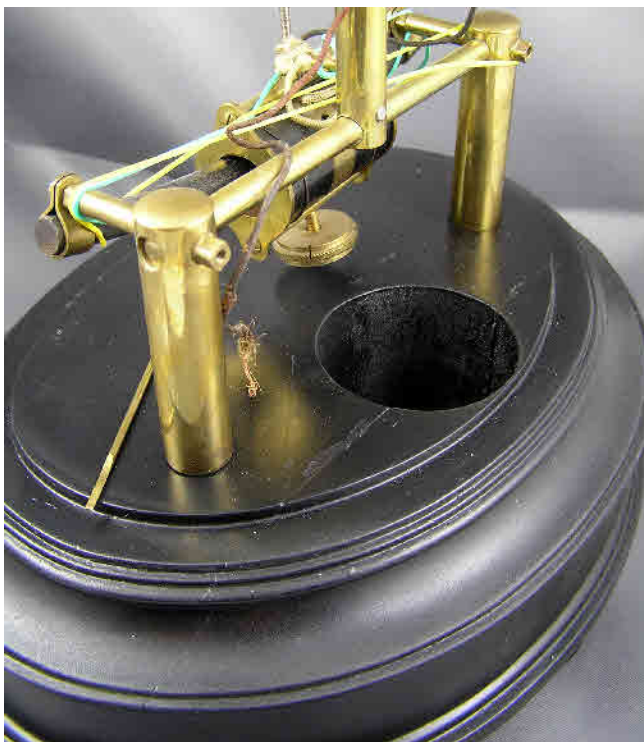
This photo left shows the hole left by the missing battery container. This is usually a brass tube fitted very snugly into the hole with a brass end cap. The cap was purely decorative as it was tight up beneath the clock frame and could not be removed. The battery was replaced from underneath the base. Via an iron sliding plate which is also missing (below).

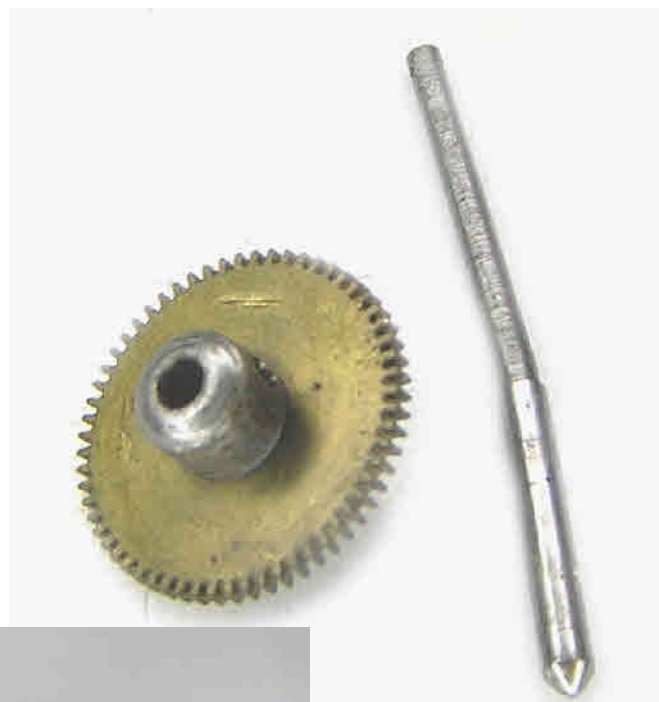
Above we see the centre arbour after disassembly. It should be relatively easy to straighten it.

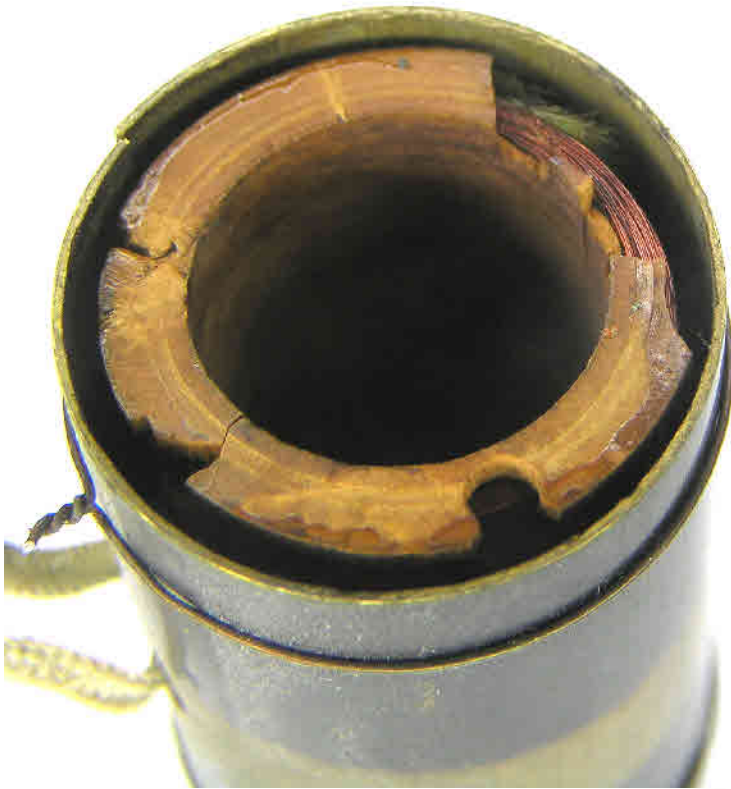
The coil with the brass cheeks removed. The coil bobbin looks to be in a bad way which is not uncommon to find on Bulle clocks. It may have been damaged by a repairer in the past or it could just be cracking and flaking caused by atmospheric changes and dampness. They were machined from the solid and were sometimes very thin in structure. As long as the coil itself is intact then it will be quite acceptable to leave it as it is. We must make sure that no undue pressure is applied when re-assembling the caps. Below we see the coil cover after the binding wire has been removed. It sprung out to an oval shape.

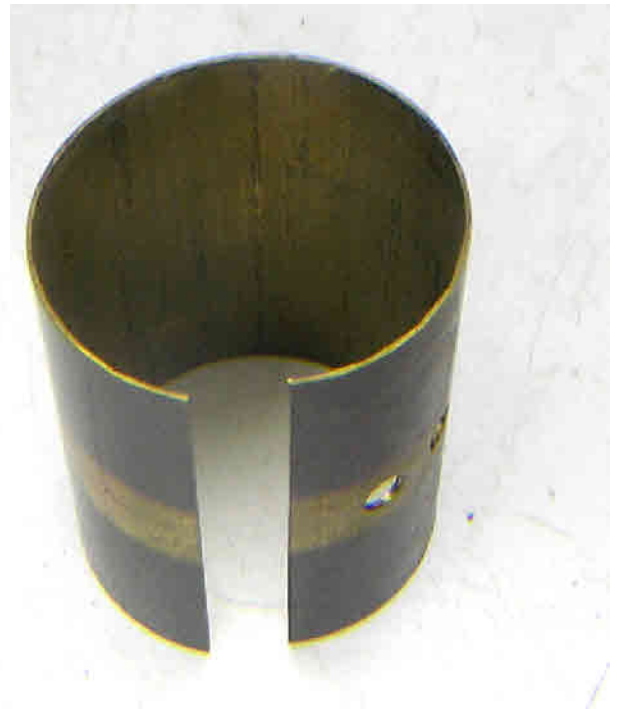
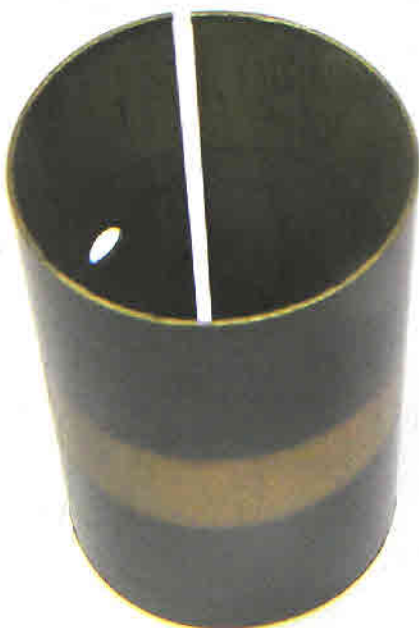
The photo at left shows the cover after a bit of warm manipulation. It is now round again. It's worth trying it in the cheeks before re-assembly with the coil, just to make sure.

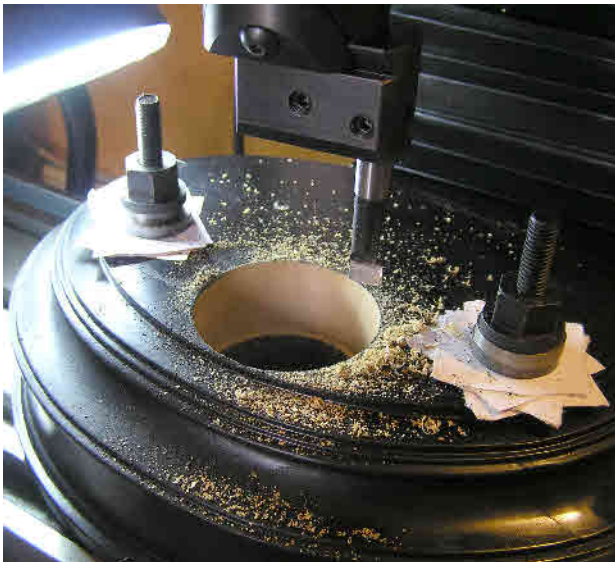
Here you can see the base secured to the machine table with boring just about finished. The hole is now round and 55mm diameter.

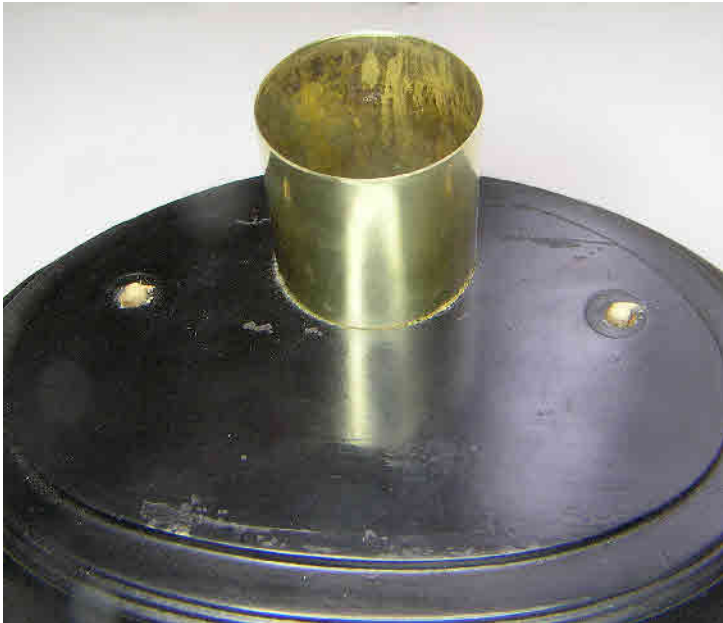
Here the replacement tube can be seen in the newly bored hole in the base.

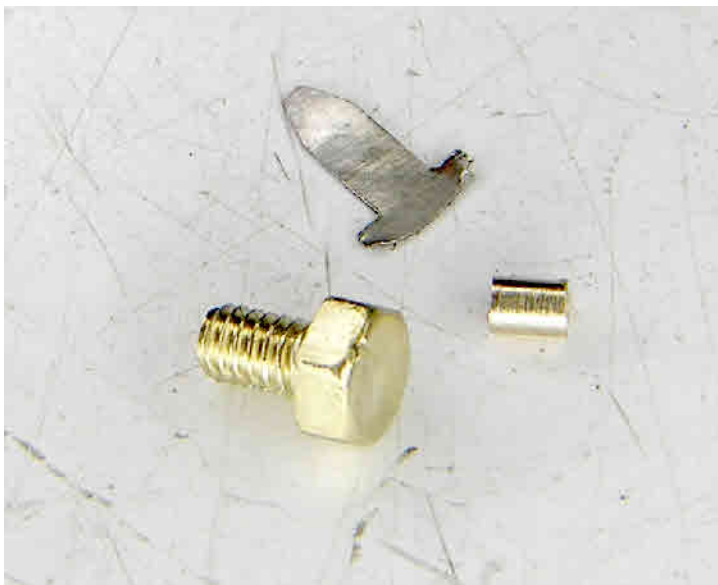
The new contact assembly parts required to complete the pendulum

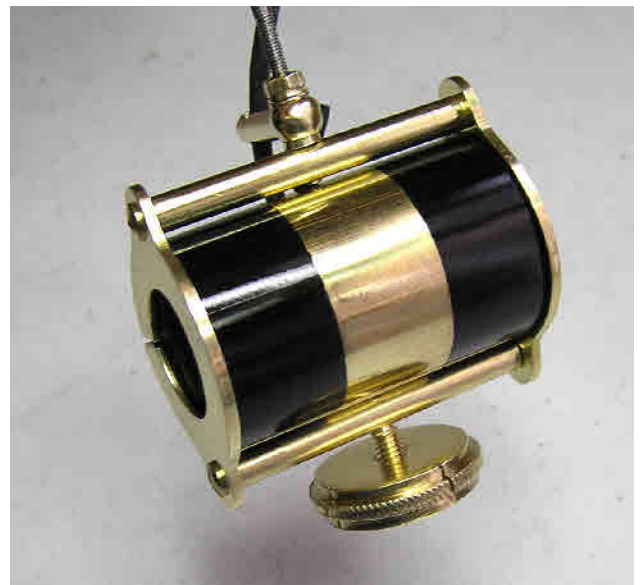
The finished and re-assembled pendulum coil.

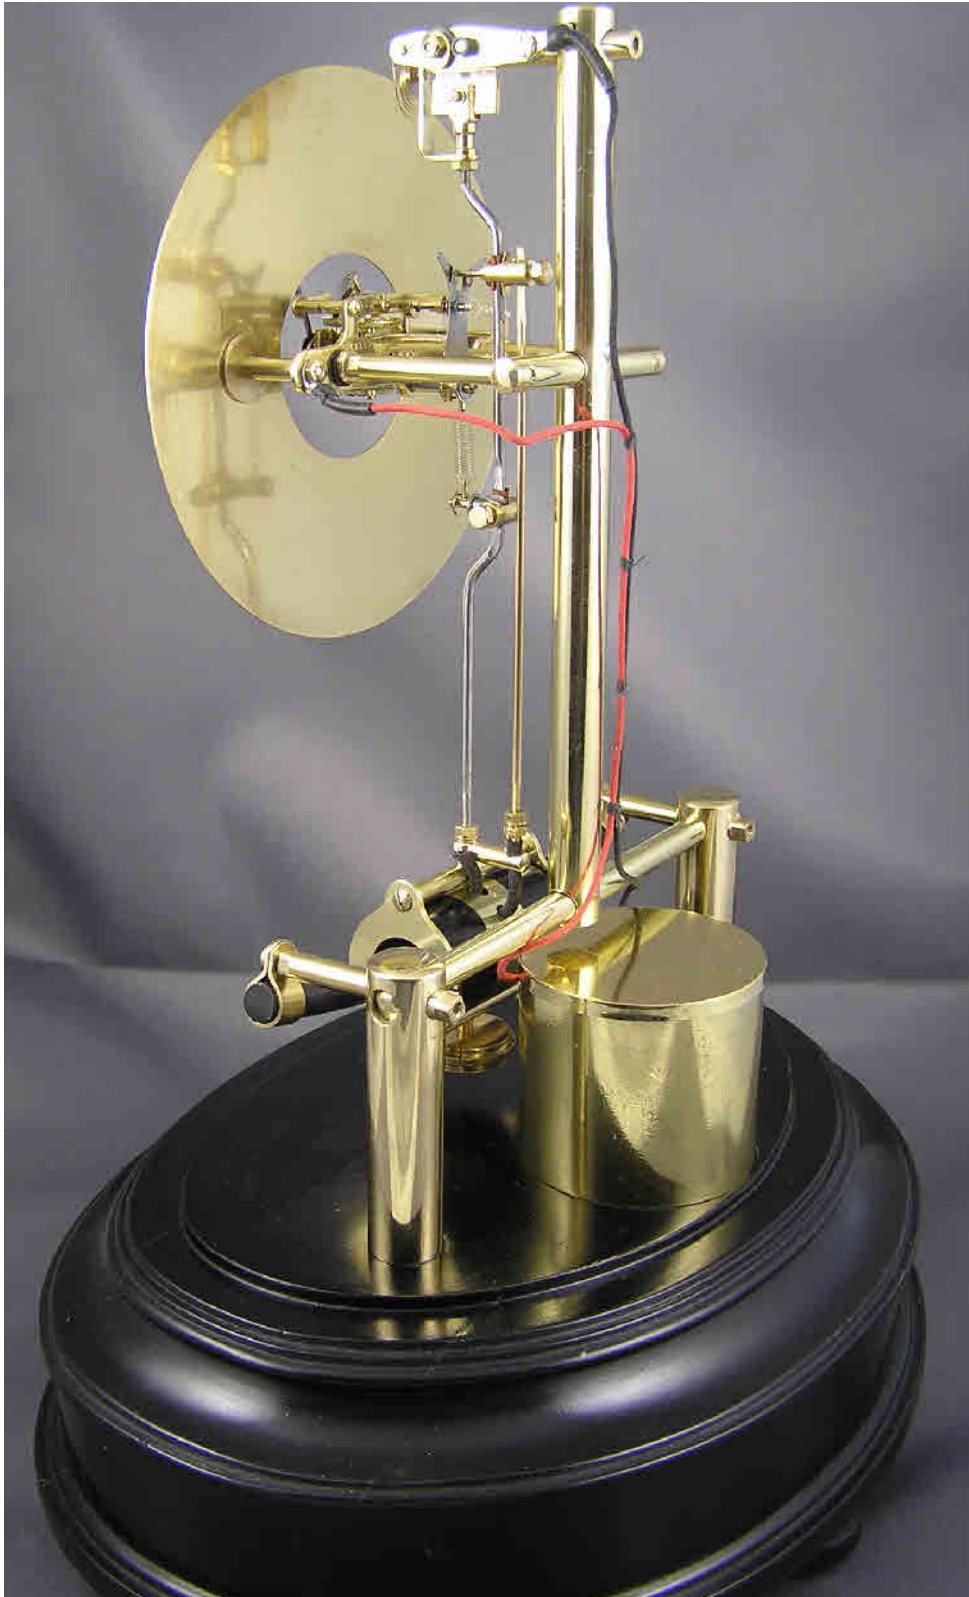
The rear of the clock showing everything back in place.

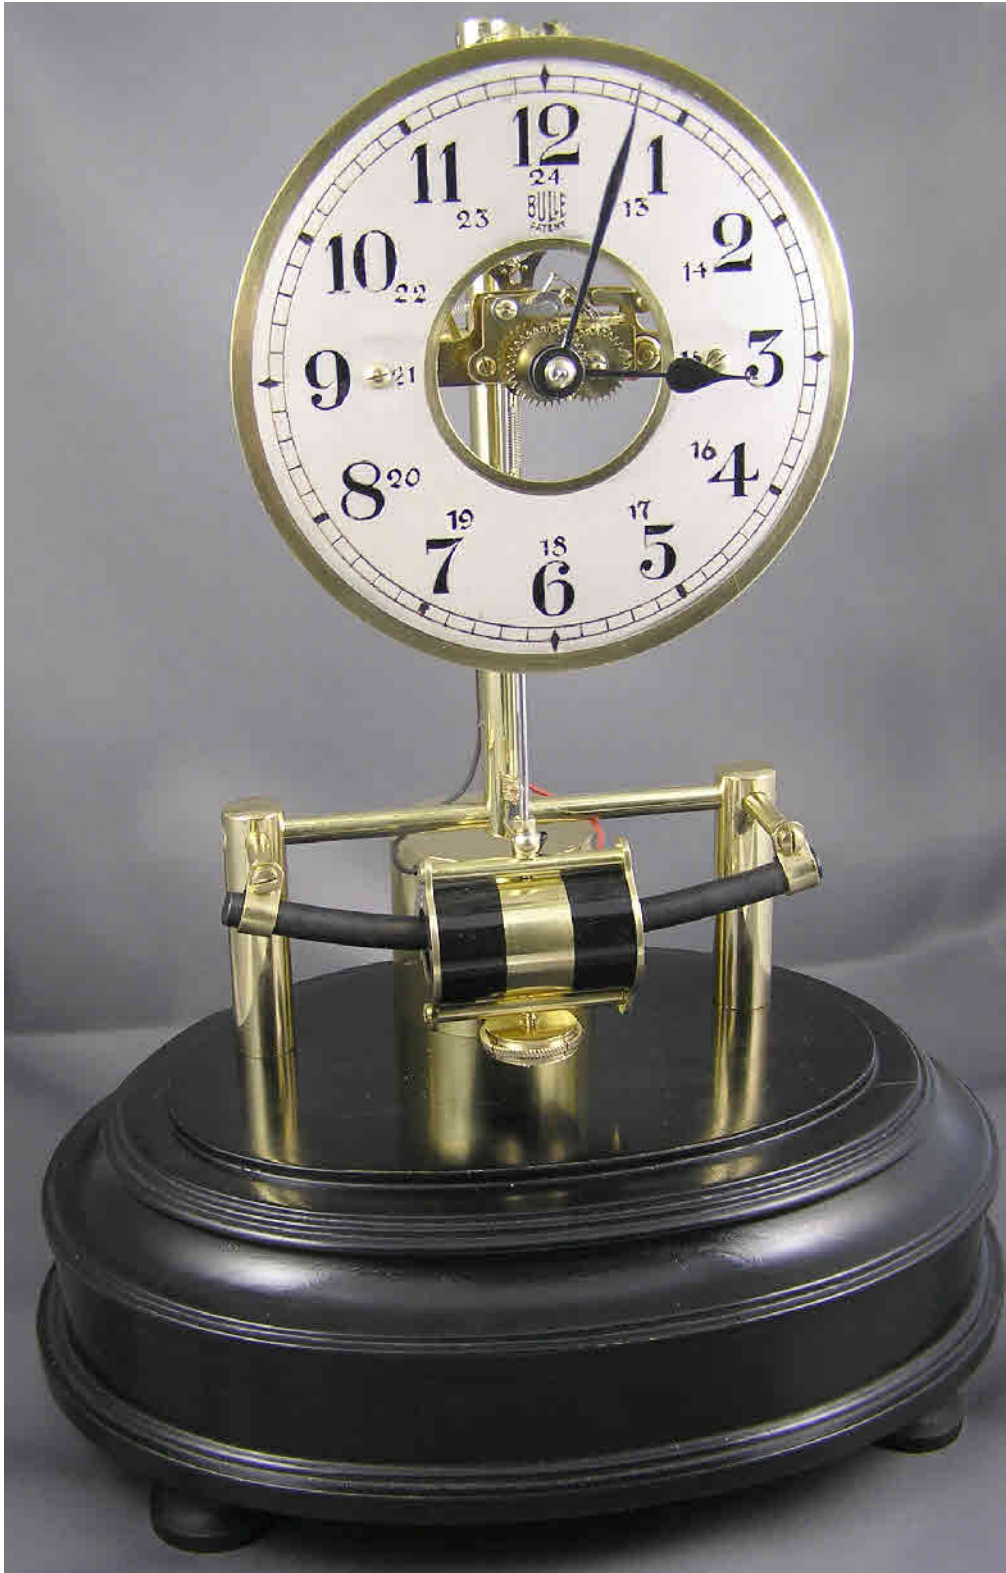
The completed clock

It's interesting to note on these medium frame movements that the magnet is short than the tall movements and the strength is a little less at 160mm on the magnetometer as against 180mm.

The dial has been cleaned and partly re-silvered to try and clean up those places where it had worn due to the bending around the screw holes. It hasn't turned out too bad!
