Bulle Clock Serial Number 130288

*Restoration of BulleClock
Serial Number 130288*

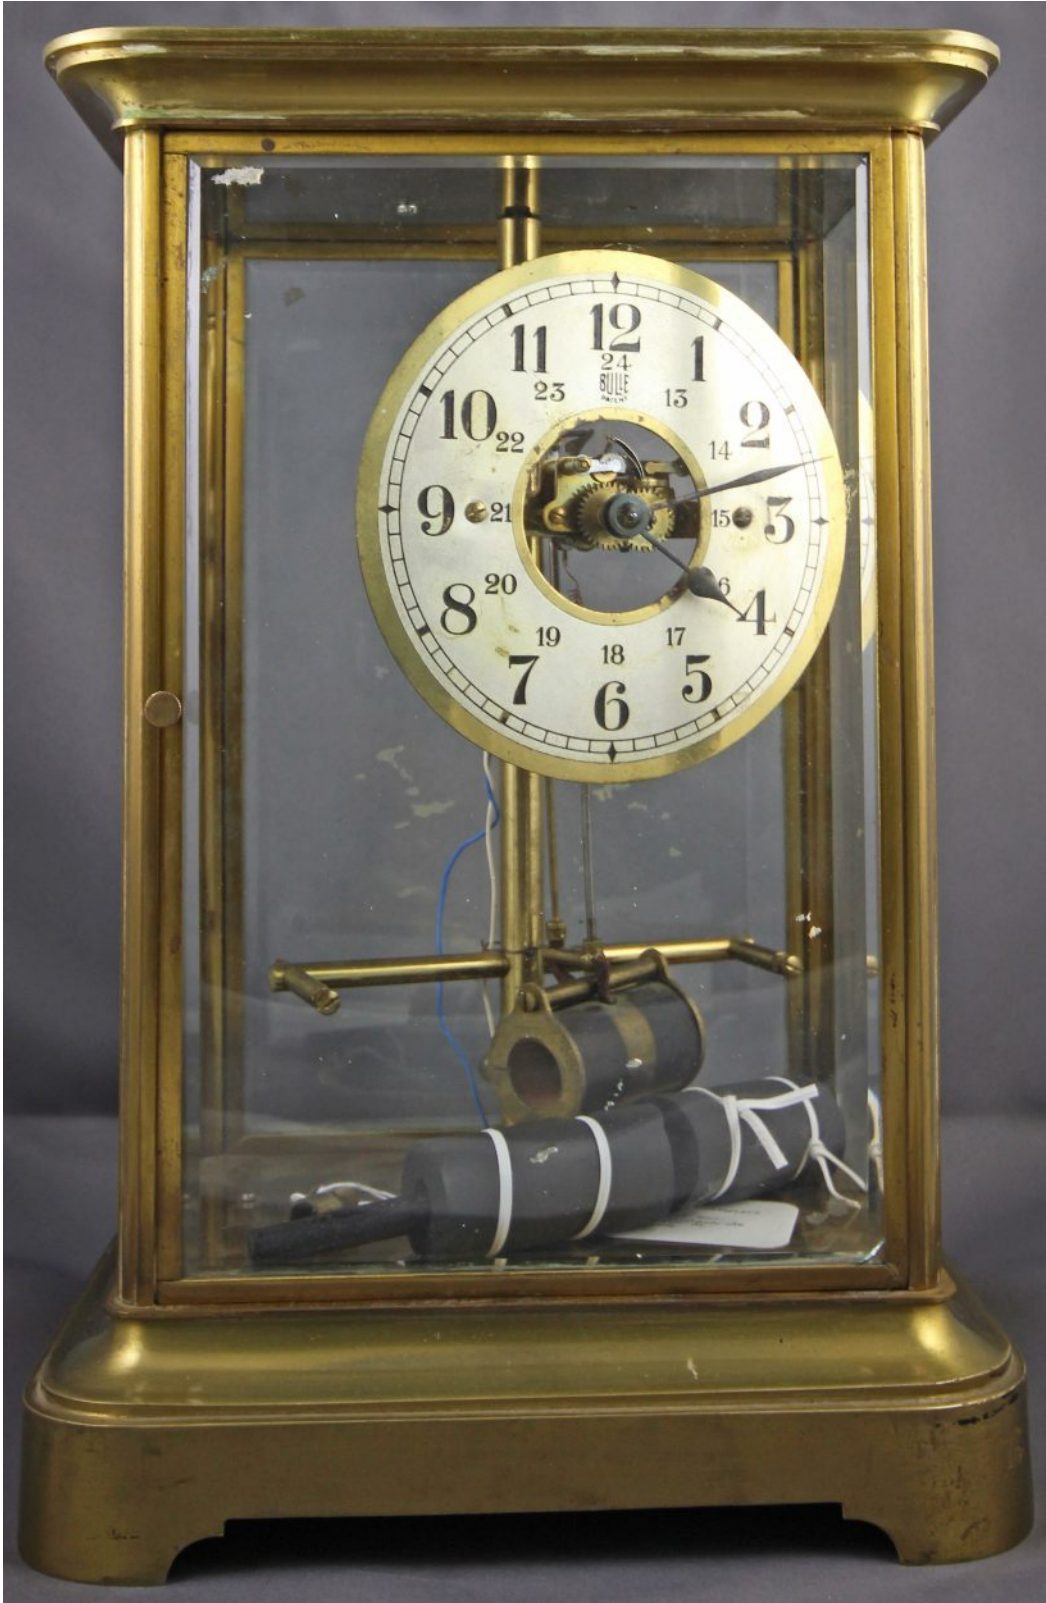
*A medium Bulle move-
ment in a four glass case
with a partially silvered
dial. I must admit it looks
a little worse for wear but
looks to be complete. The
magnet is loose in the
case but the brackets are
attached. The dial is
probably the biggest
problem as it is only par-
tially silvered, which
makes it difficult to clean
and re-silver whilst leav-
ing the brass inner and
outer circles untouched.
It has also suffered with
bends and bruises. It
looks as though the dial
supporting washers nor-
mally behind the dial
have gone missing which
leaves the screws to pull
the dial out of shape. We
will see what we can do.*

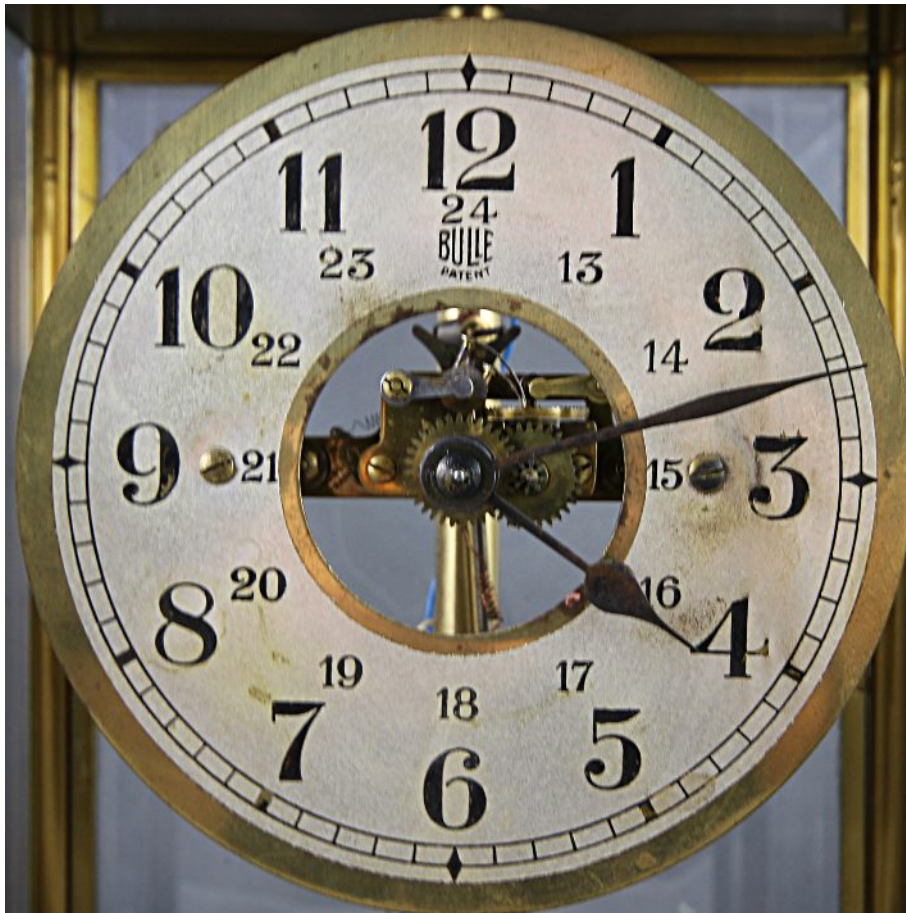
A larger image of the dial showing the marks and tarnish.

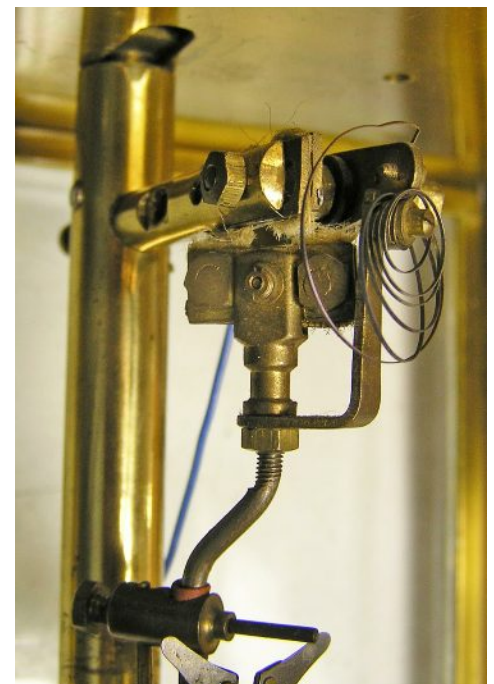
The photo above shows the badly made suspension and the twisted hair spring.

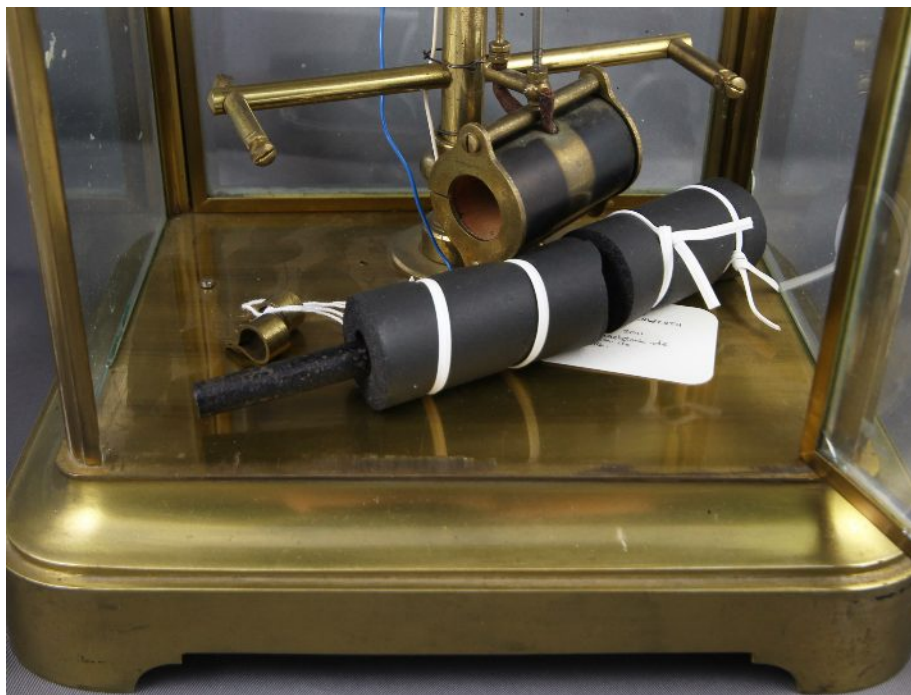
The photo on the left shows the base of the clock with the loose magnet. The frame is also loose.

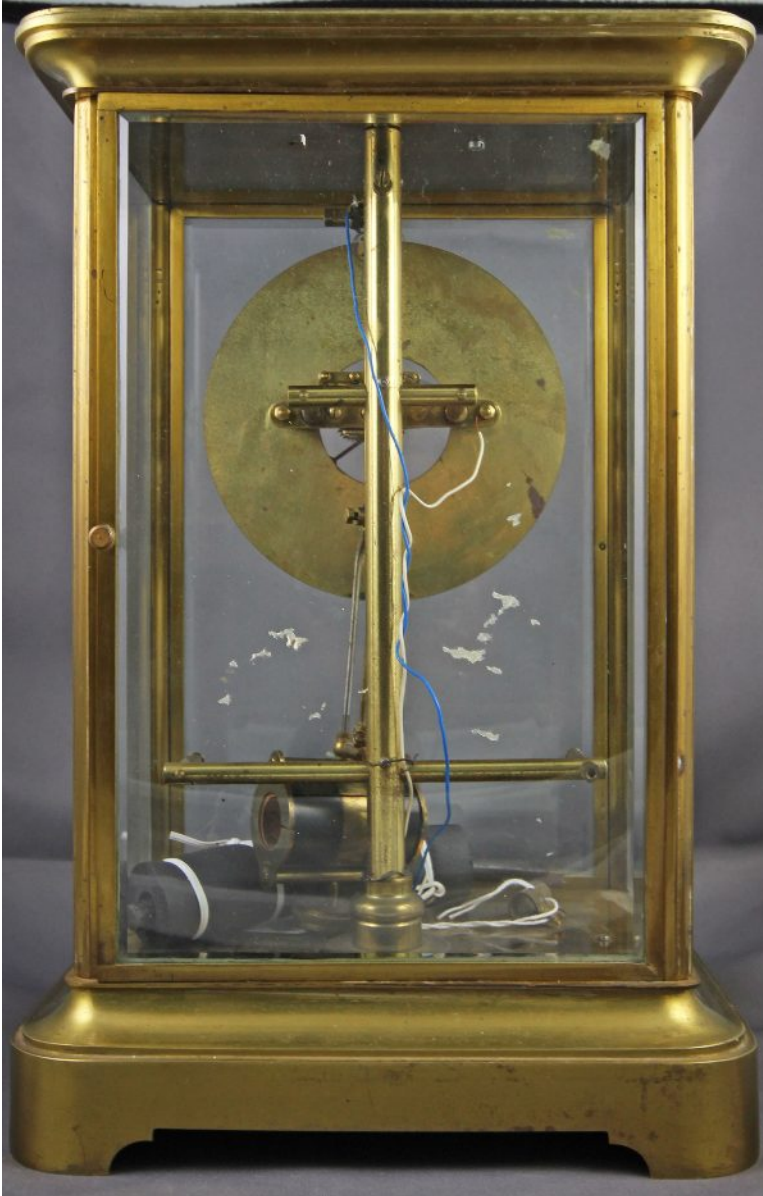
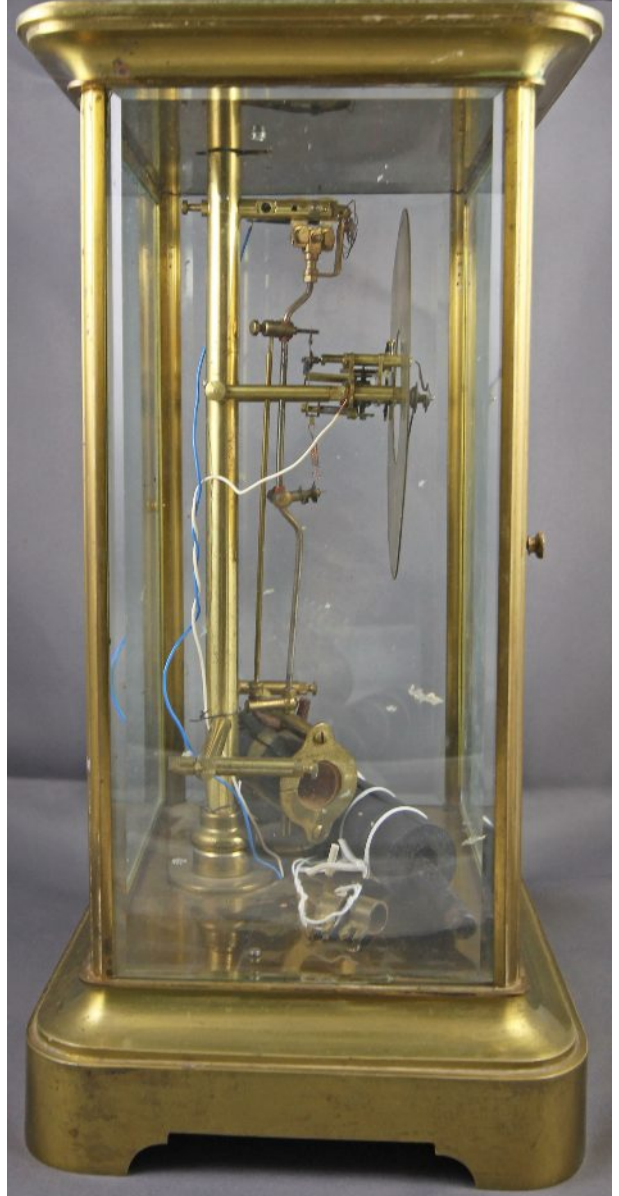
Rear and side views of the clock. The odd thing is the wiring which should go through the top of the case and then down the inside. But the wiring here goes through the case and disappears through a large hole in the base. This will need to be investigated. The rest of the clock looks OK.

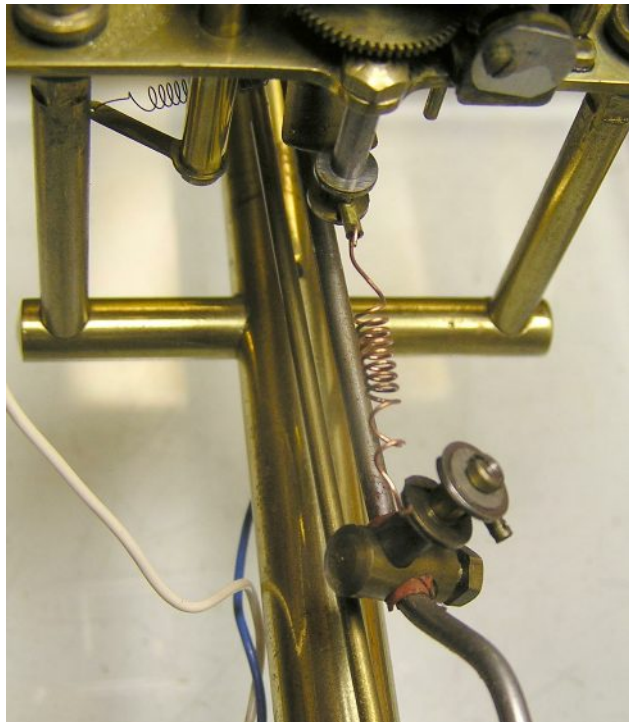
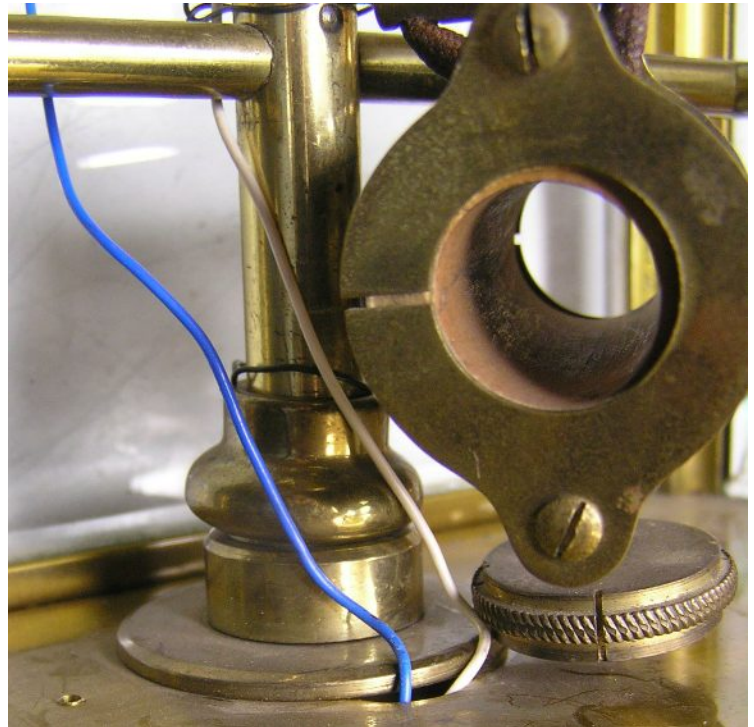
The photo above shows the piece of coiled copper wire used as an Isochron spring. Odd! I don't see how it could of been any use at all!

There must be a long slot cut into the base to take the two wires. This must be why the large round washer has been added. I hope its big enough to cover the slot when the wire is re-routed via the top.

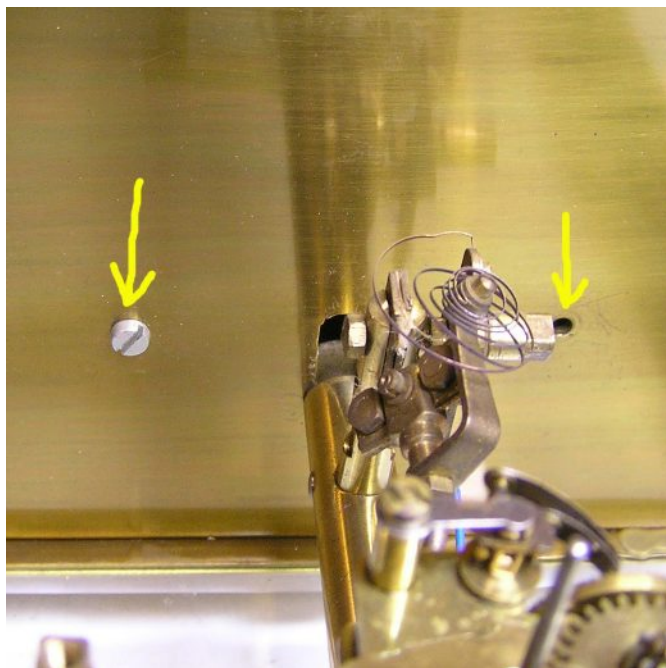
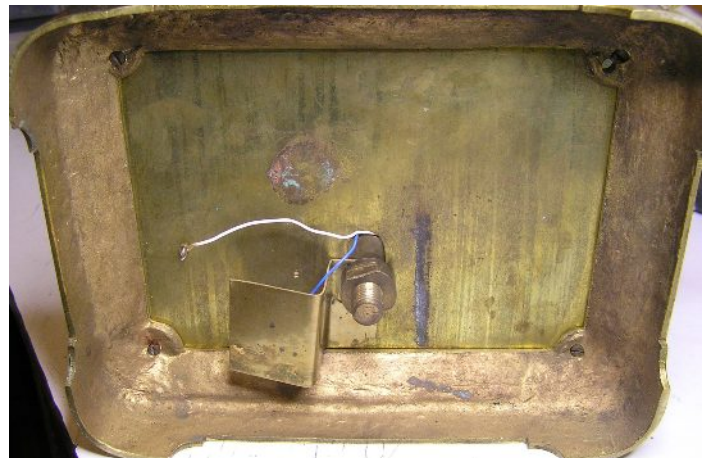
Above is the underside of the base showing the enlarged slot along with a battery retainer. None of this is original. The photo at left shows the missing top retaining screw as well as a steel replacement. A new set will be turned up on the lathe.

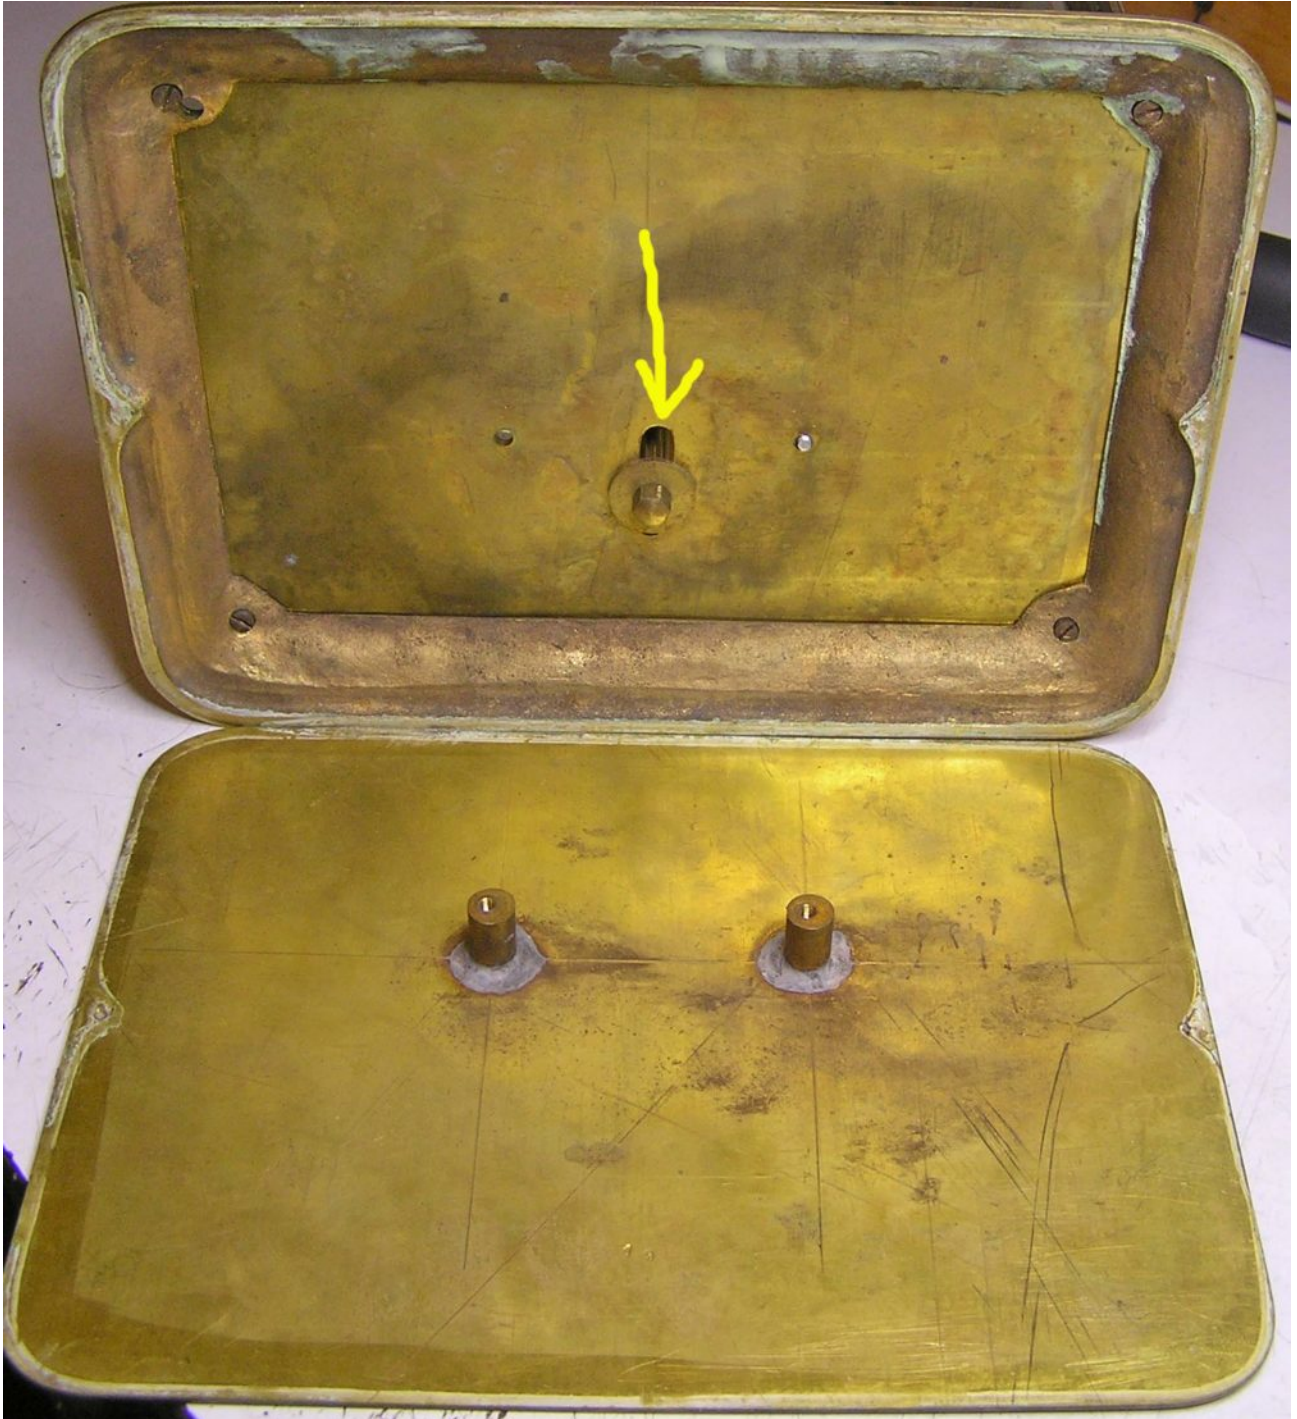
This photo shows the top of the case removed. Note the two threaded pillars that the two screws mentioned on the previous page screw into to hold the top cover down. There is also a slot cut into the top which I can only assume allowed the movement frame to be slid forward or backward. Again this is not original. The wiring for the movement should come up through the top and across to the front door hinge side from where it should pass down the inside of the door pillar to the battery compartment under the base.

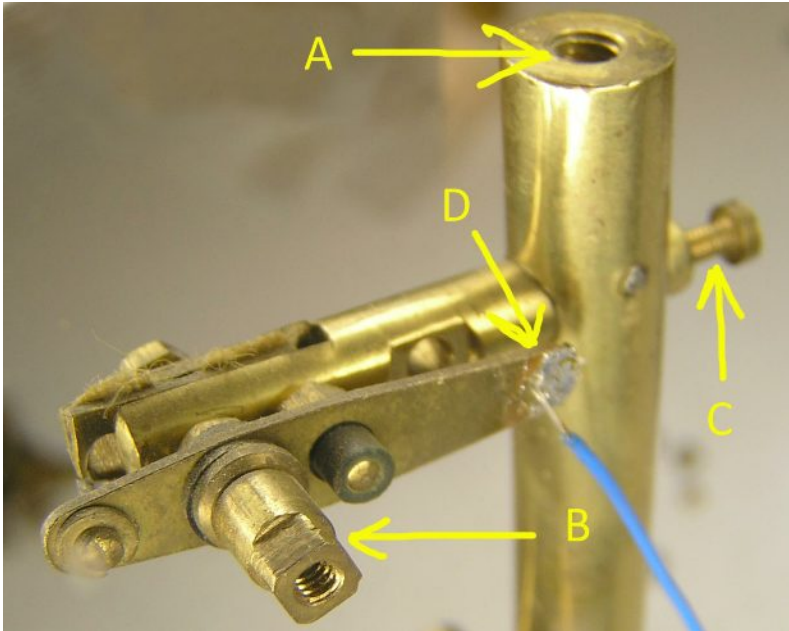
The photo above shows A) the threaded hole for the screw that retains the frame in place to the top of the case. B) should be in the position where screw C) is attached. D) should be a nut and bolt to hold the negative wire., Not a solder joint

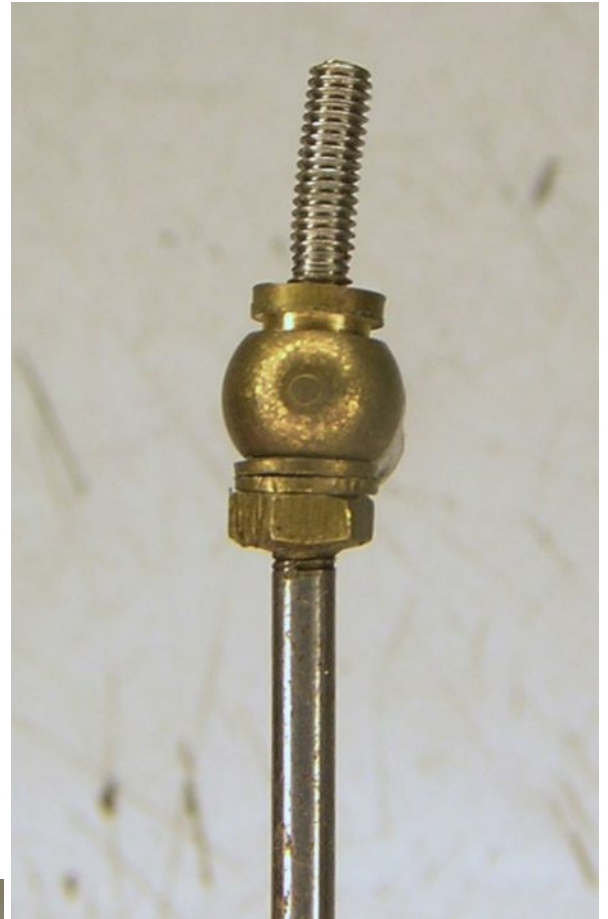
The photo above shows the bent pendulum rod where it fits into the bob casing. This will have to be straightened.

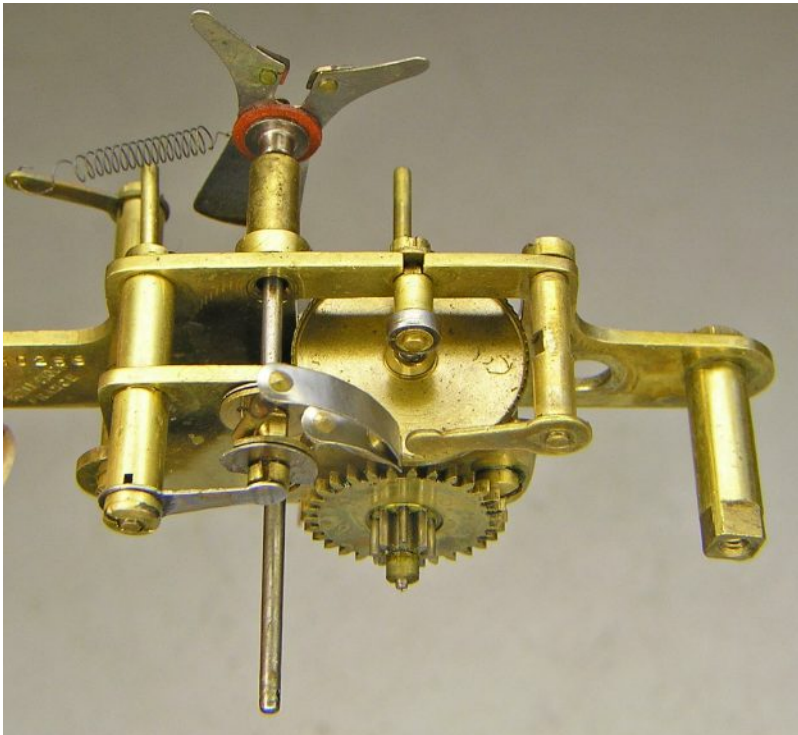
This last photo shows the movement which looks to be in good condition. The fork is not that worn and will survive another twenty ears or so.

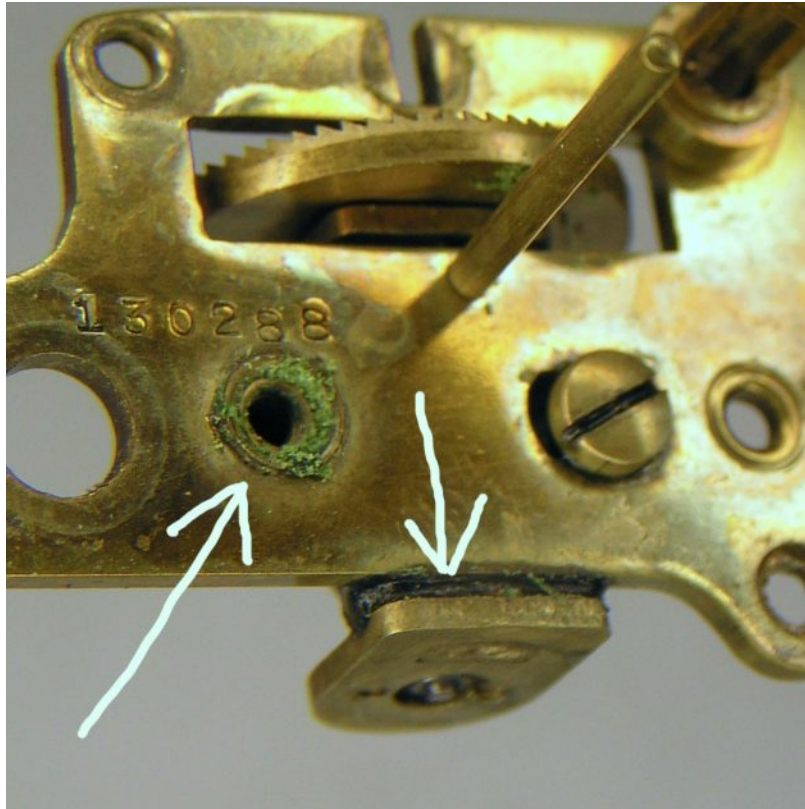
These two photos on the left show how old oil tends to congeal into a hard paste that can gum up the free movement of the wheel work. The points arrowed are quite hard and needed a little help with a needle to dislodge before the parts were cleaned in the ultra sonic tank.

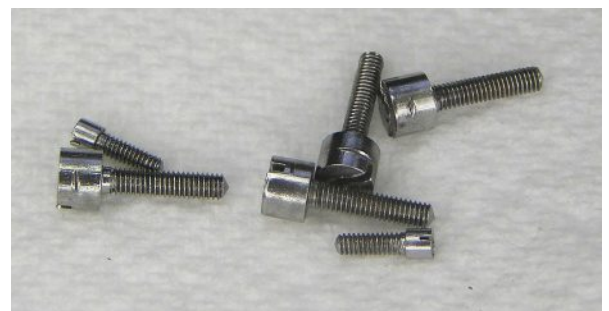
These two photos show how a steel rotary brush can quite easily clean and polish the hard steel screws of the case.

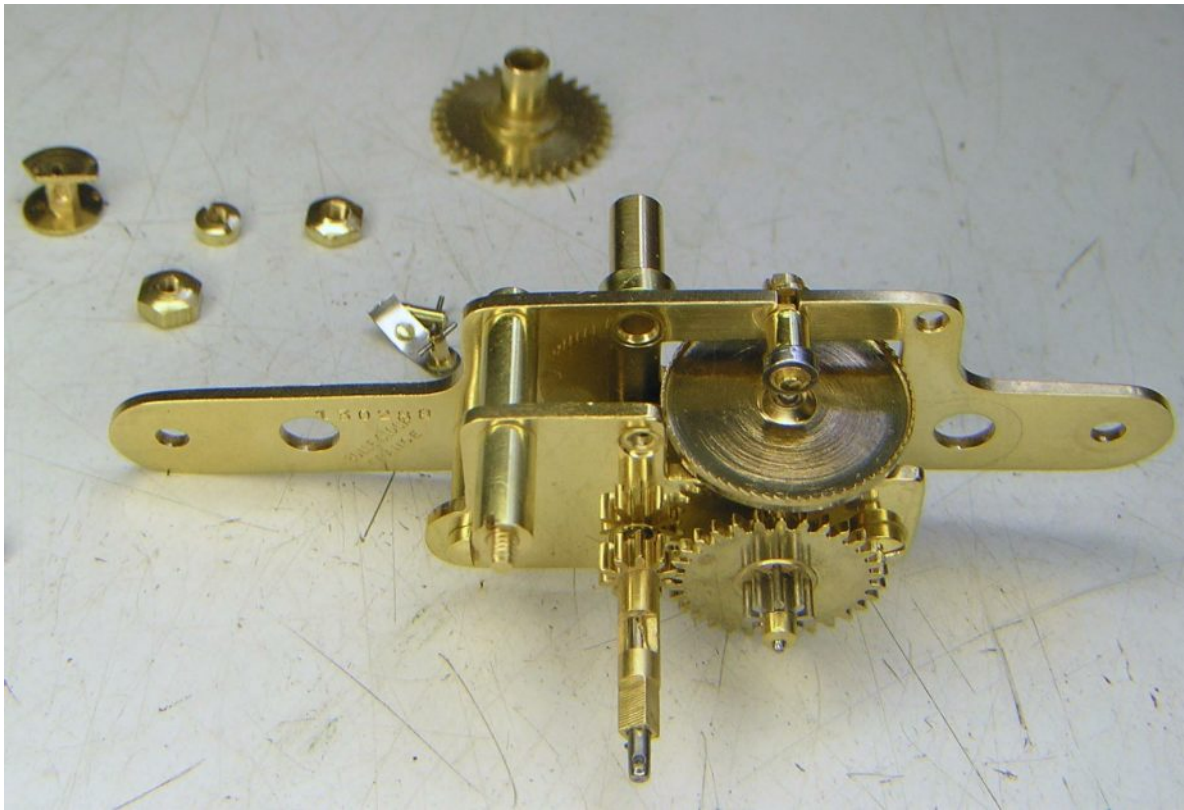
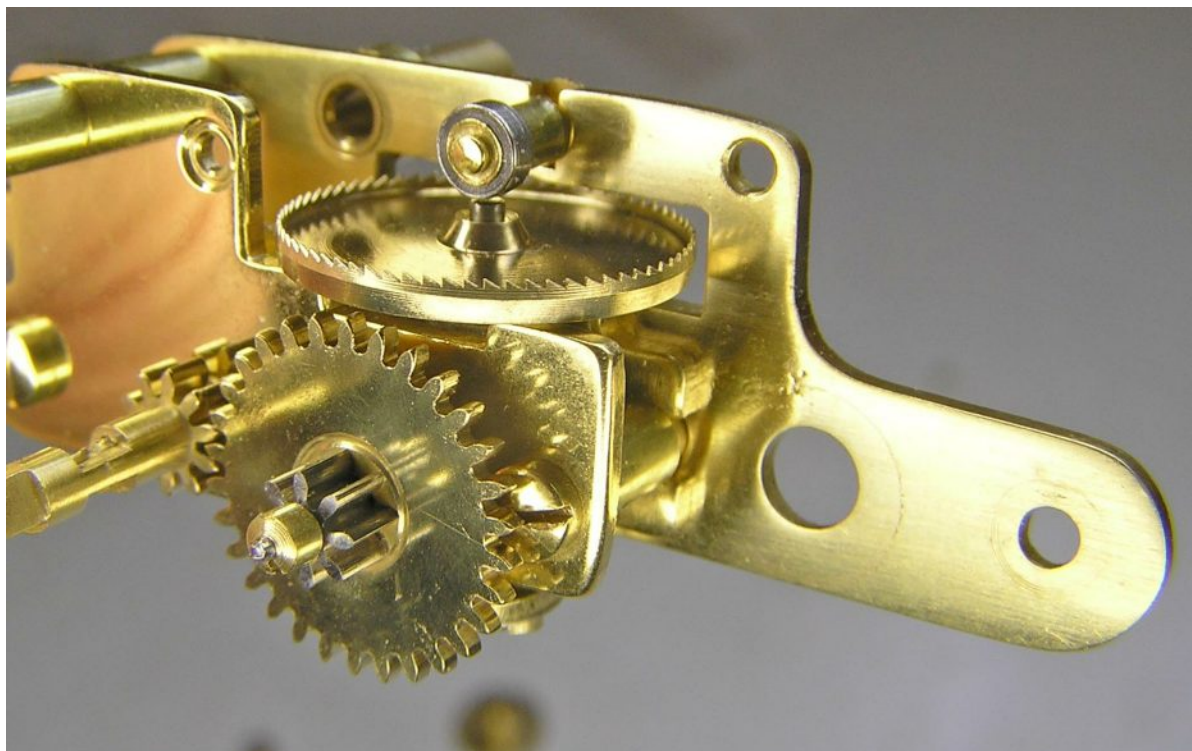
The movement being rebuilt after cleaning and polishing.

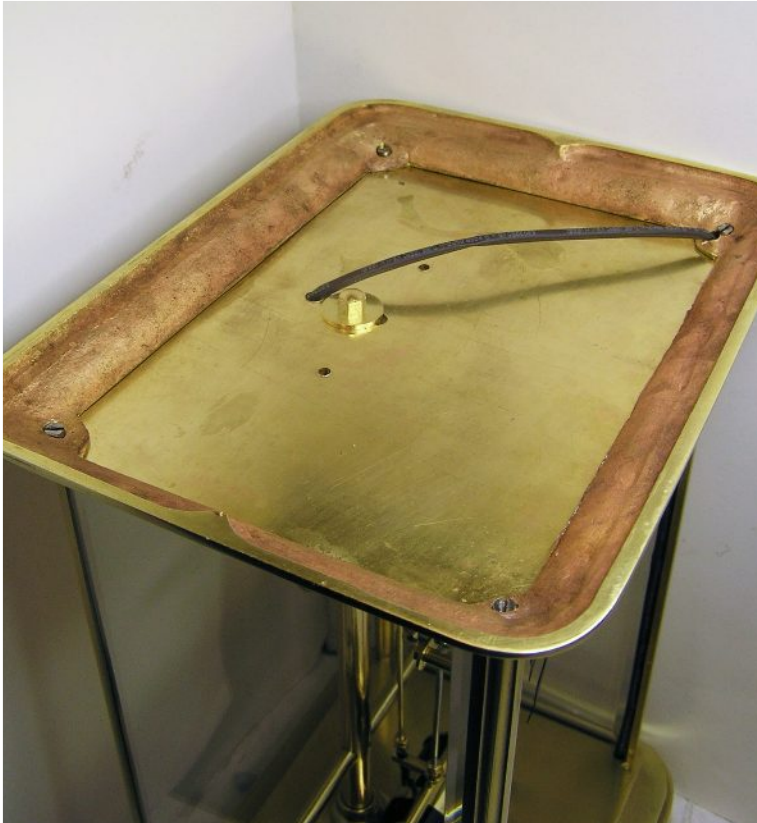
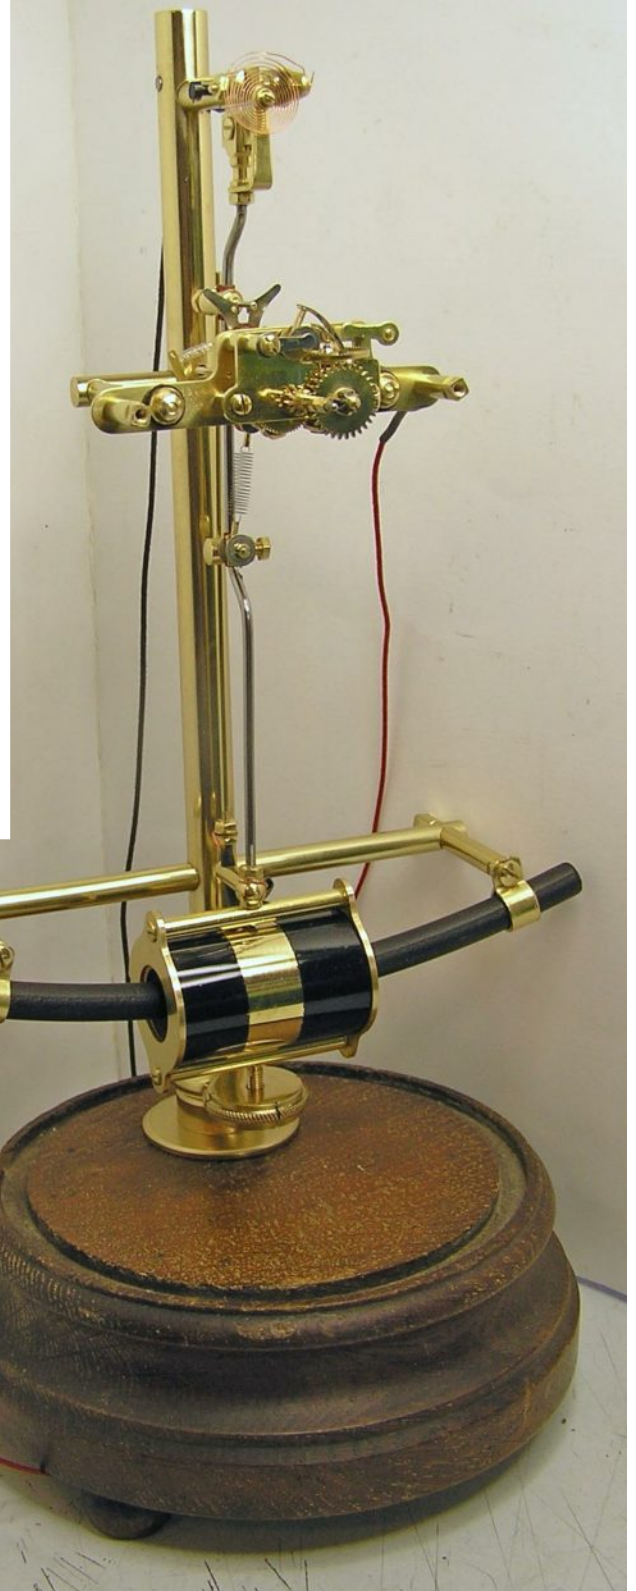
He photo above shows the correct route for the wiring. Once it has crossed the top of the case it passes through a hole and runs down the inside of the front door pillar. Although this method hides the wires, it is a real pain to try and assemble case, wire, glass and doors all at the same time. I must also stress that it is better to test the clock on an old base for a long period before fixing in the case as it is very difficult to make any changes once the movement is in the case.

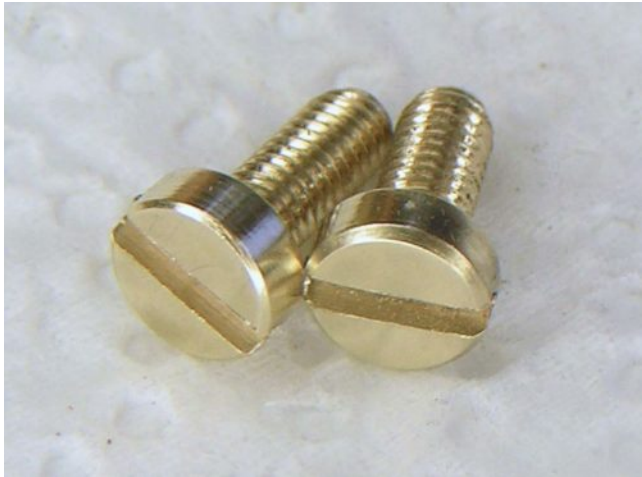
The new screws to retain the top.

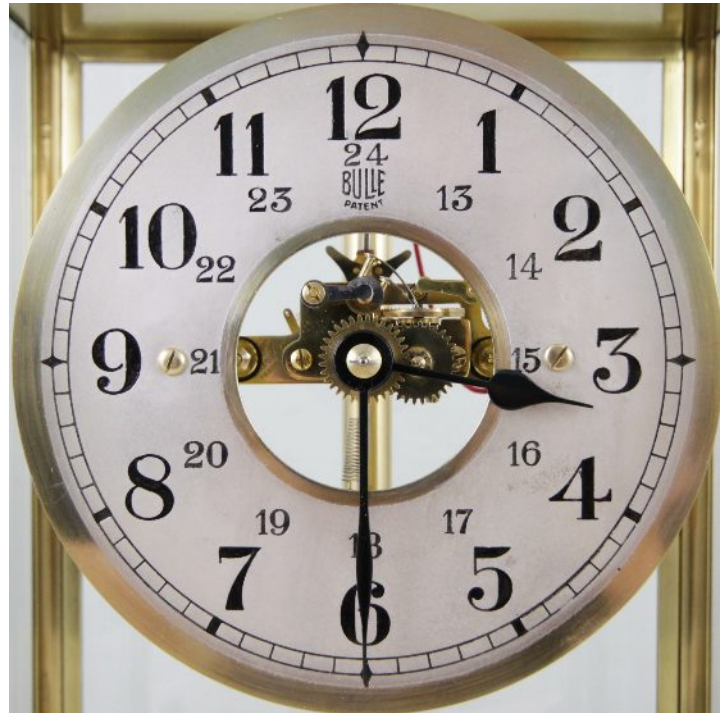
The dial after cleaning and applying silver. Not perfect but a hell of a lot better than when it arrived.

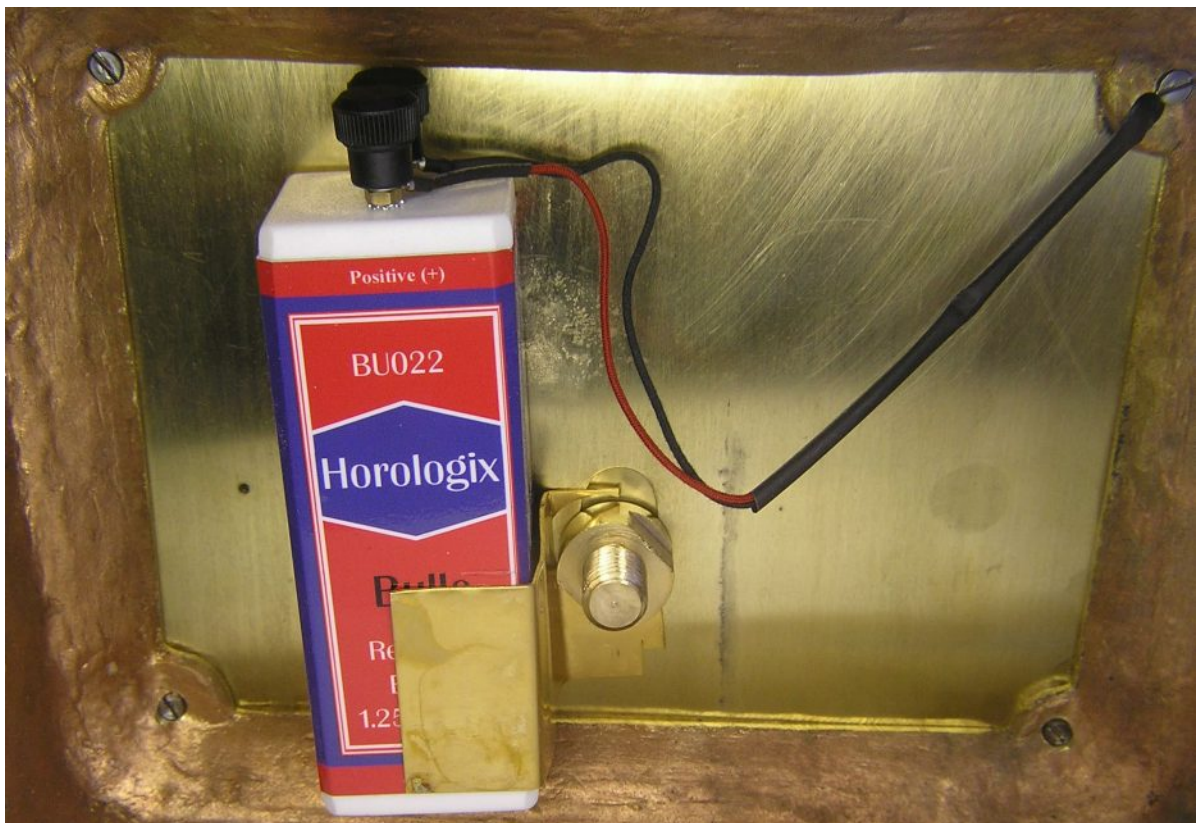
The battery compartment with a Horologix regulated battery fitted. Note the wiring coming through from inside the case after running down the side of the door pillar.

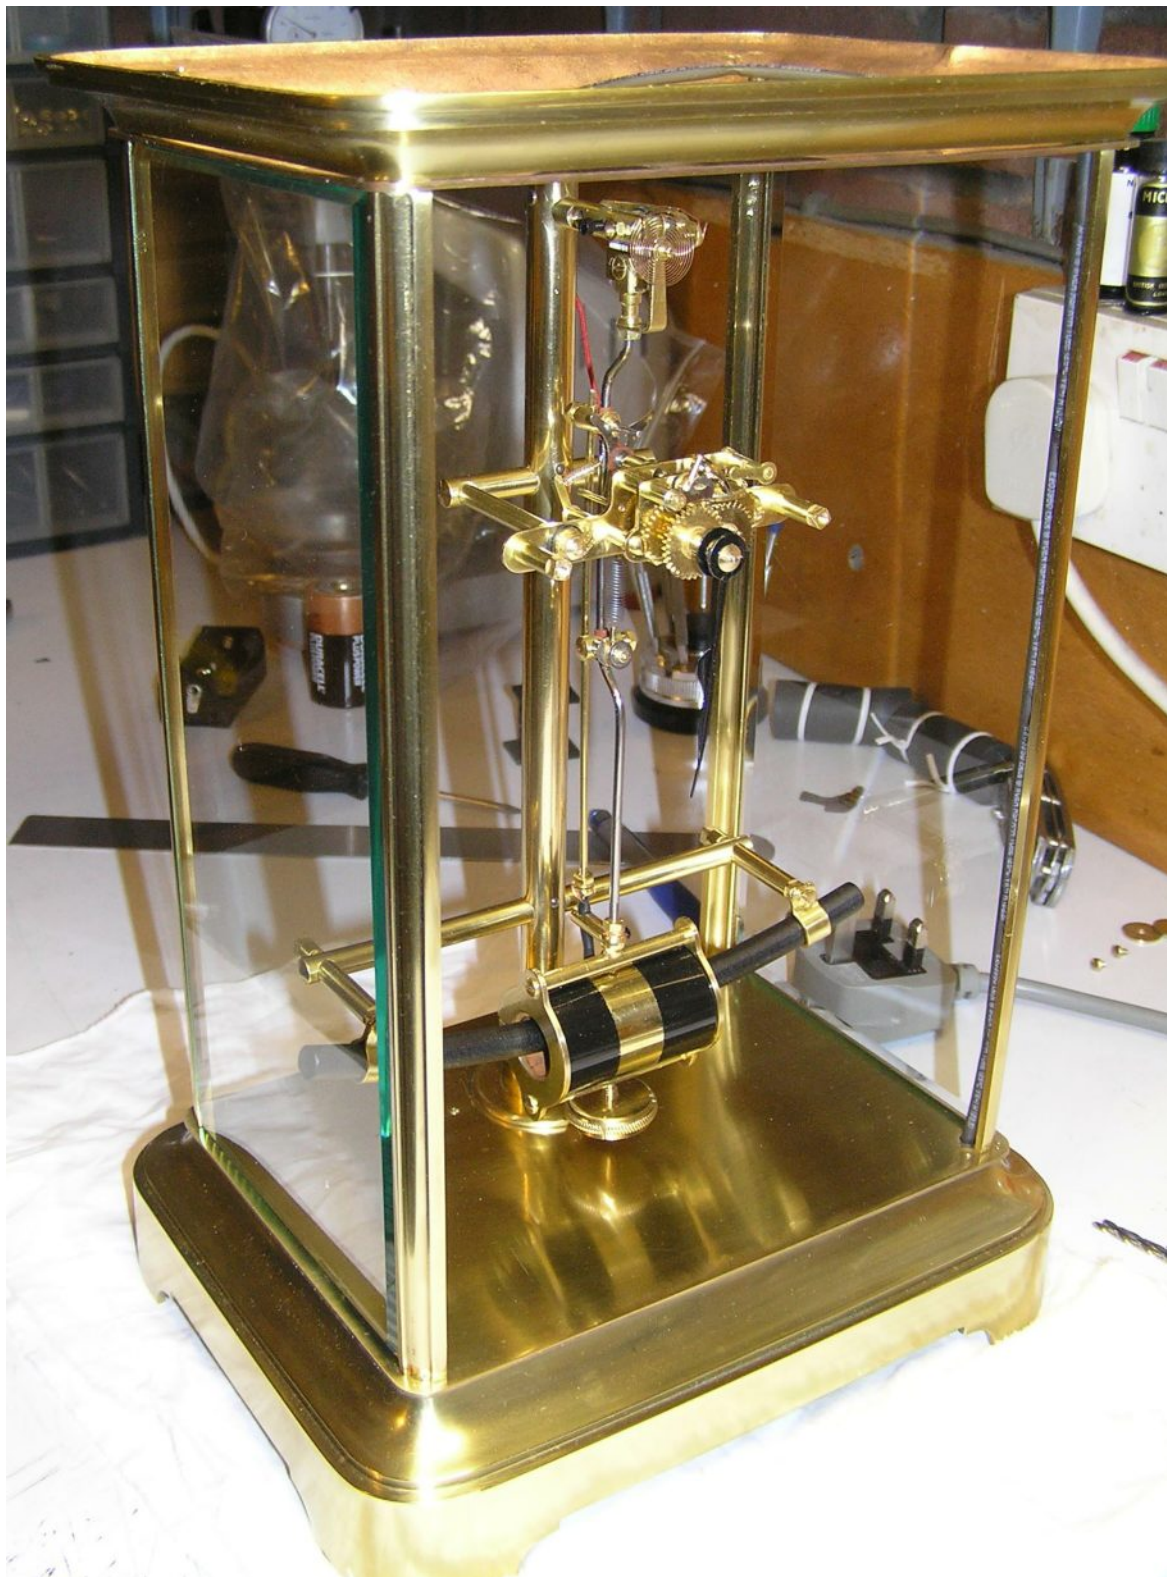
The movement frame installed before the doors and top are finally fitted.

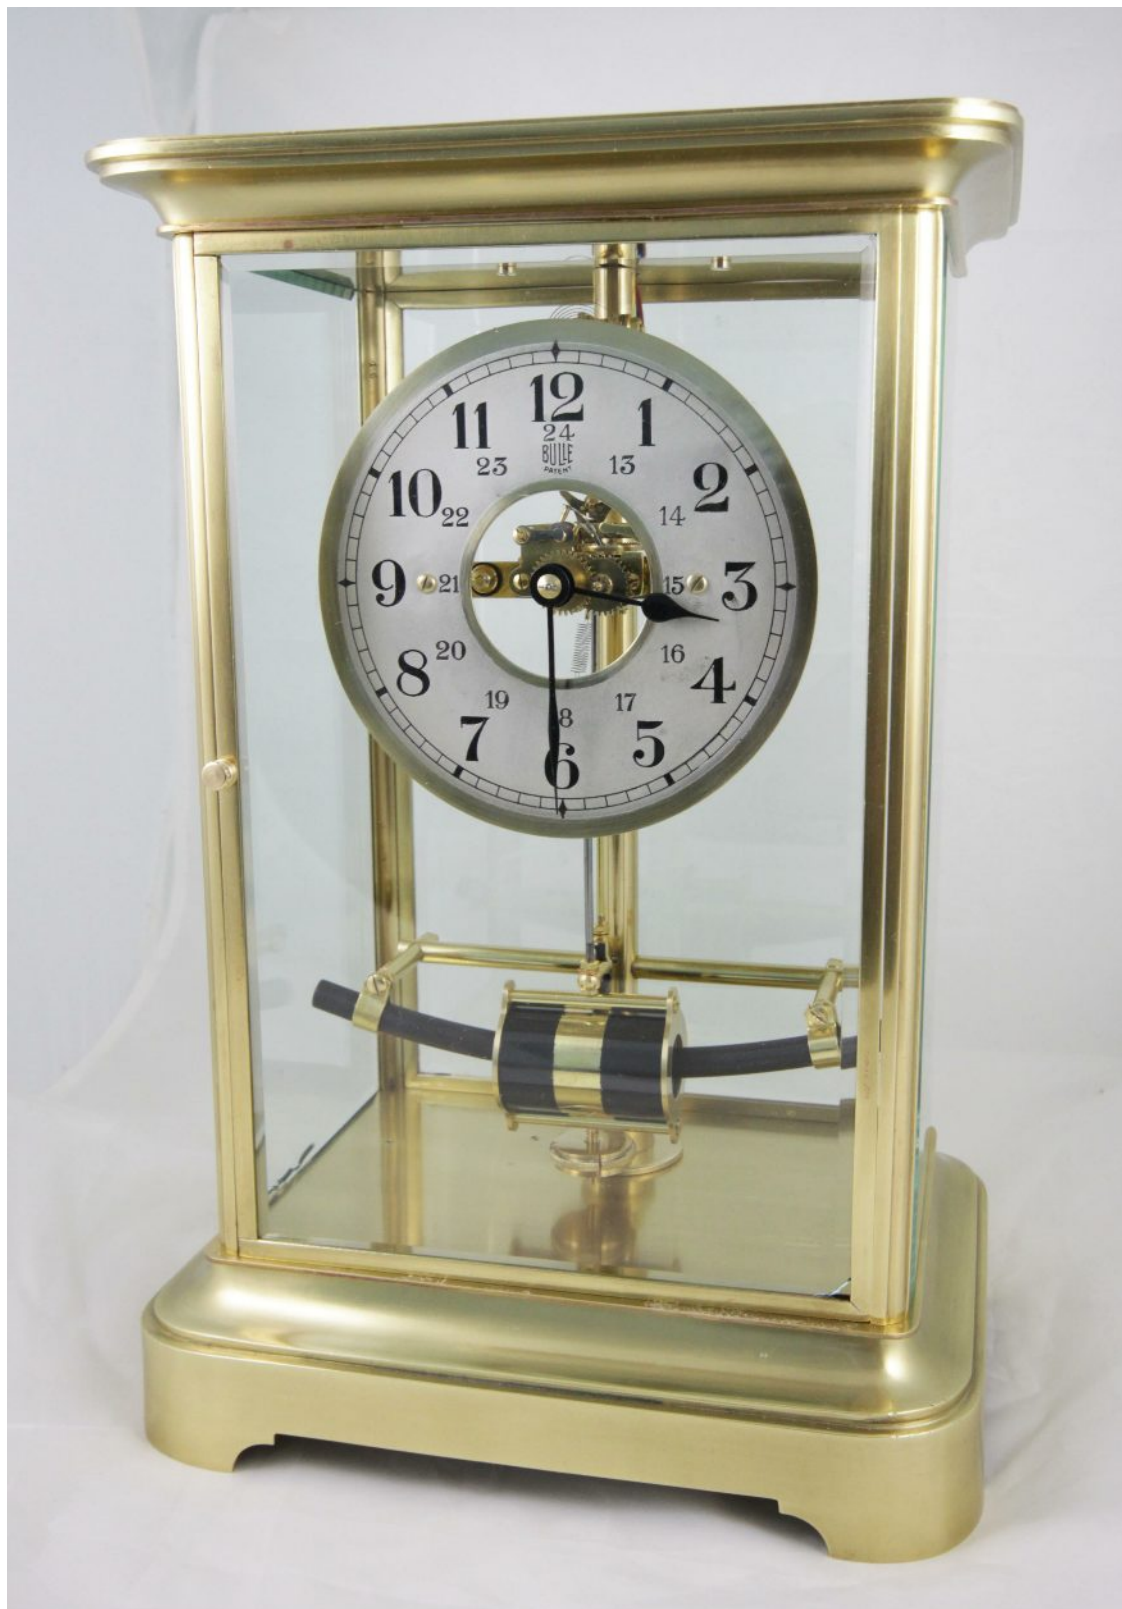
This and the following page show the finished clock.

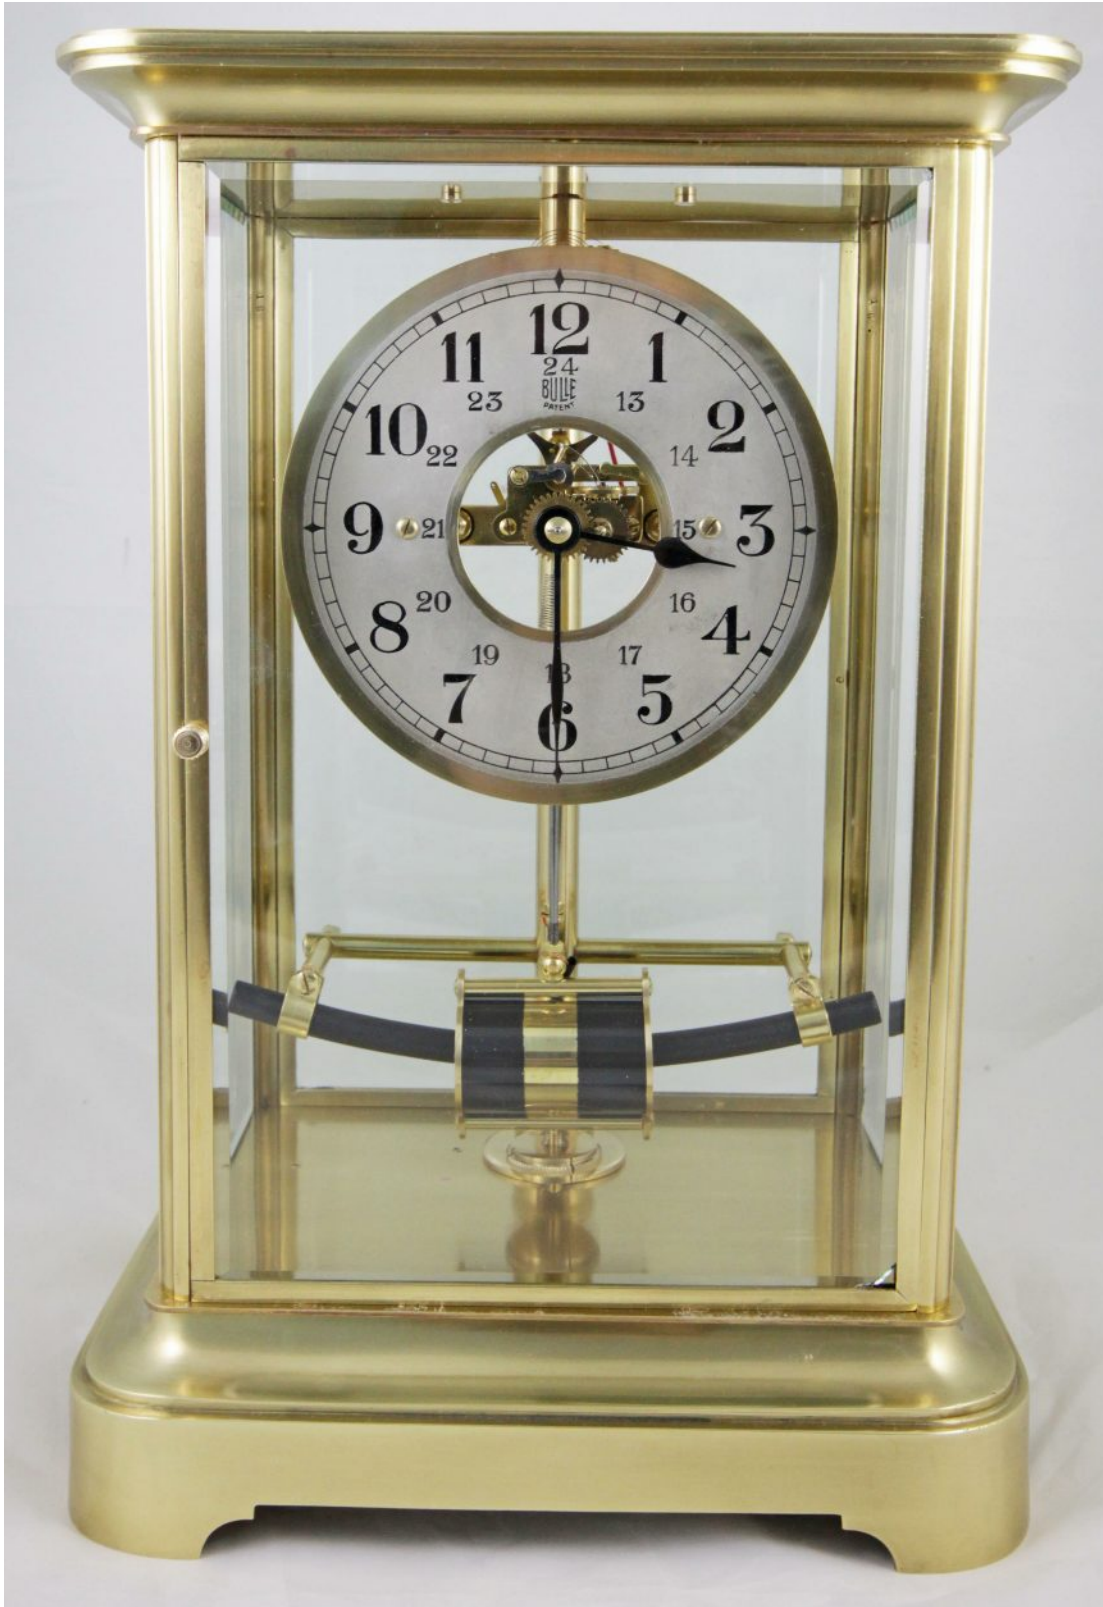
The finished Clock
