Bulle Clock Serial Number 1491

*Restoration of Bulle Clock
Serial Number 1491*

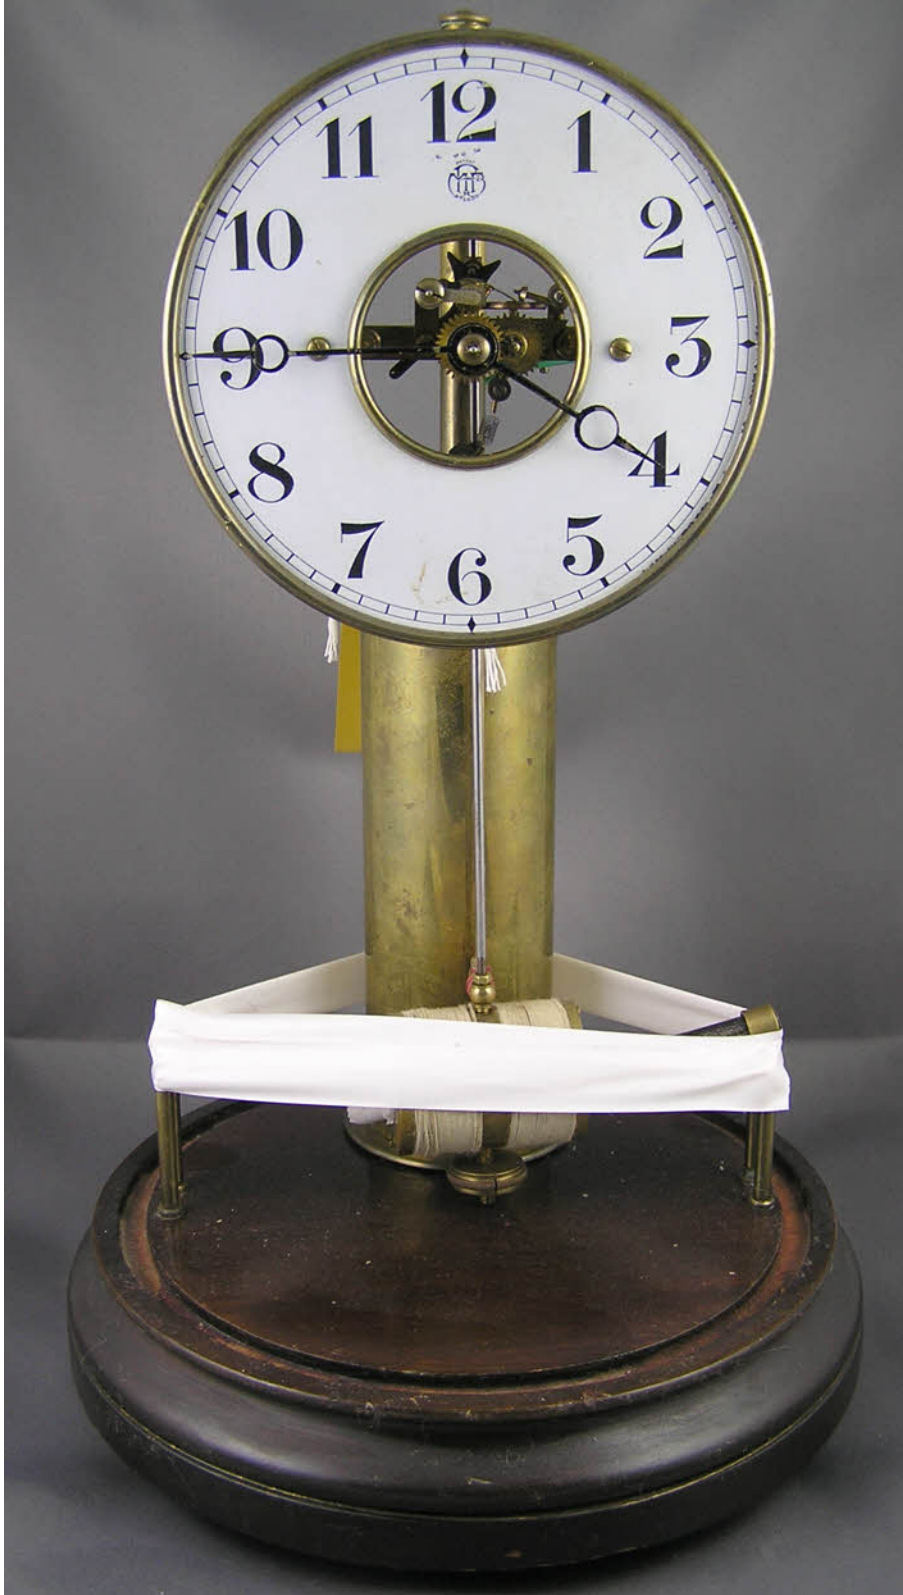
The clock as delivered.

This clock is a very early model and exhibits all the characteristics of a half plate movement which will be shown later. The dial is in good condition with just a few scrapes at the twelve o'clock position. The hands are original moon design. The base is a little tired but will be revived with a little wax polish and will not need French Polishing. Note that it carries a 1mm brass band around the circumference but the label is missing.

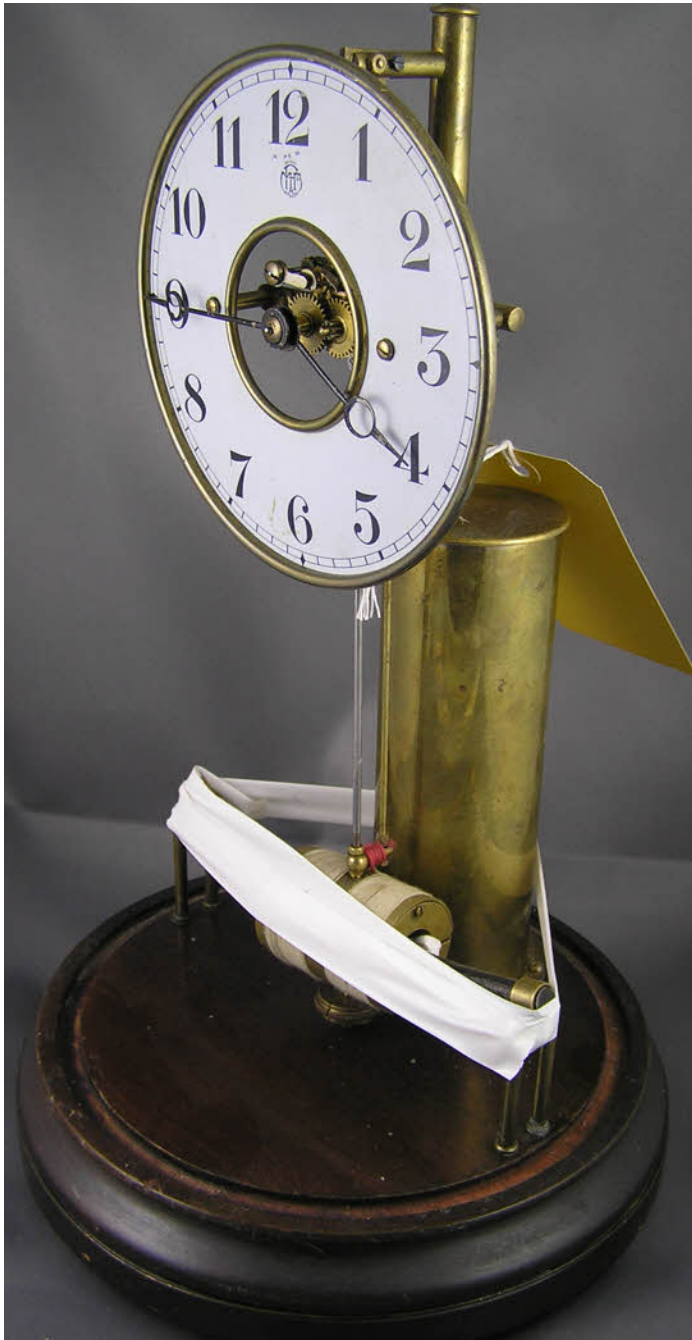
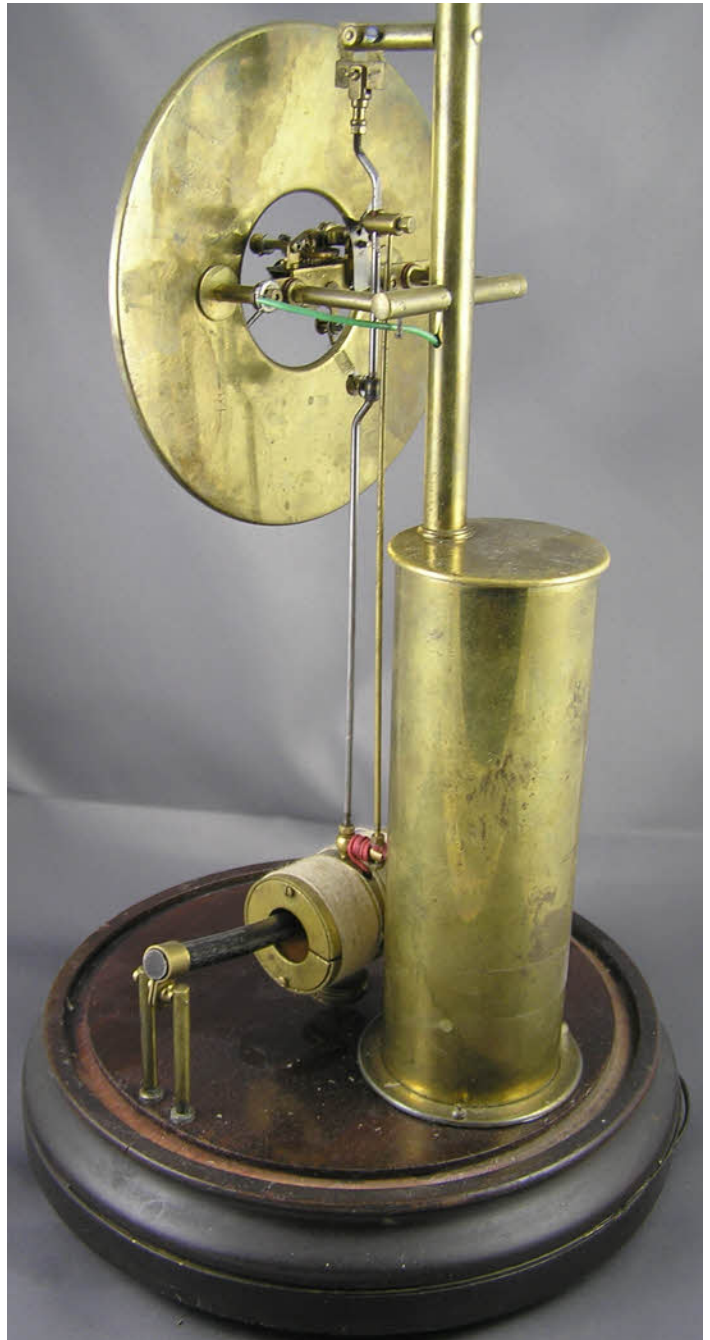
Side and rear views. The column looks to be solid with no major acid burns although there are some marks. Overall the clock look sto be in good original condition.

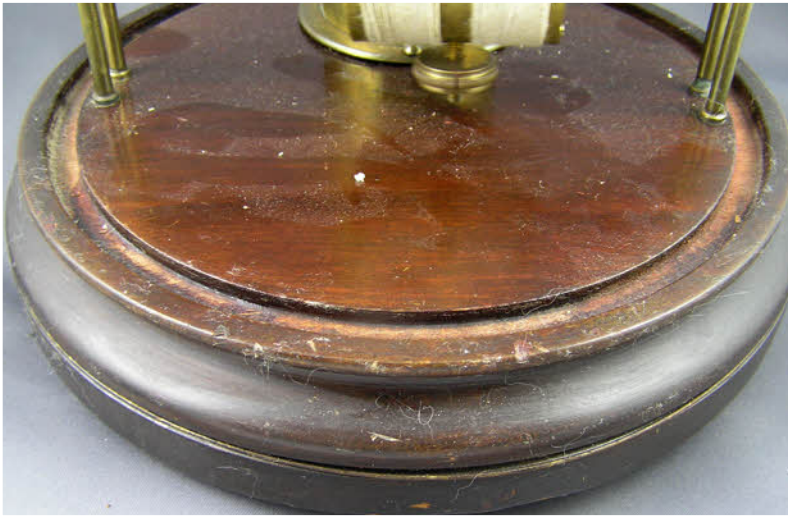
The base as shown above is a little tired but only need to be given a bit of colour and a good wax polish.

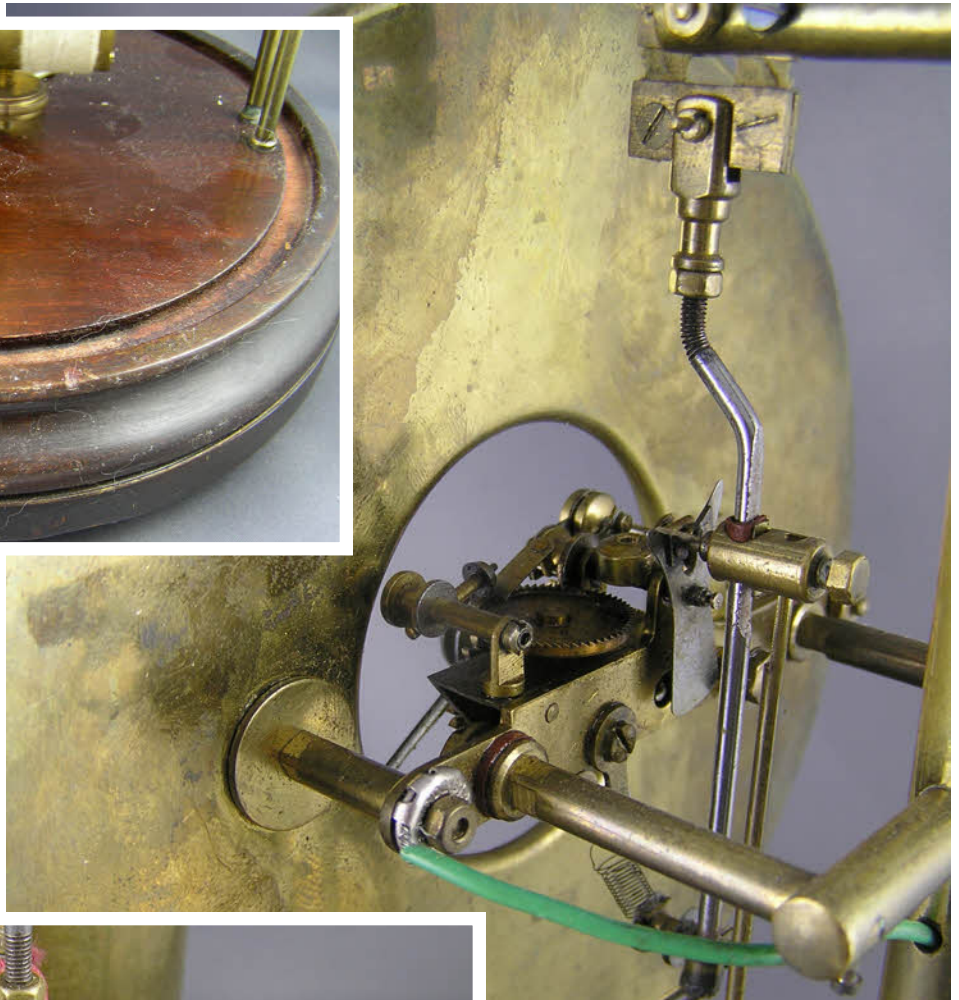
The photo at right shows the movement which seems to be in good order other than the dirt and oil.

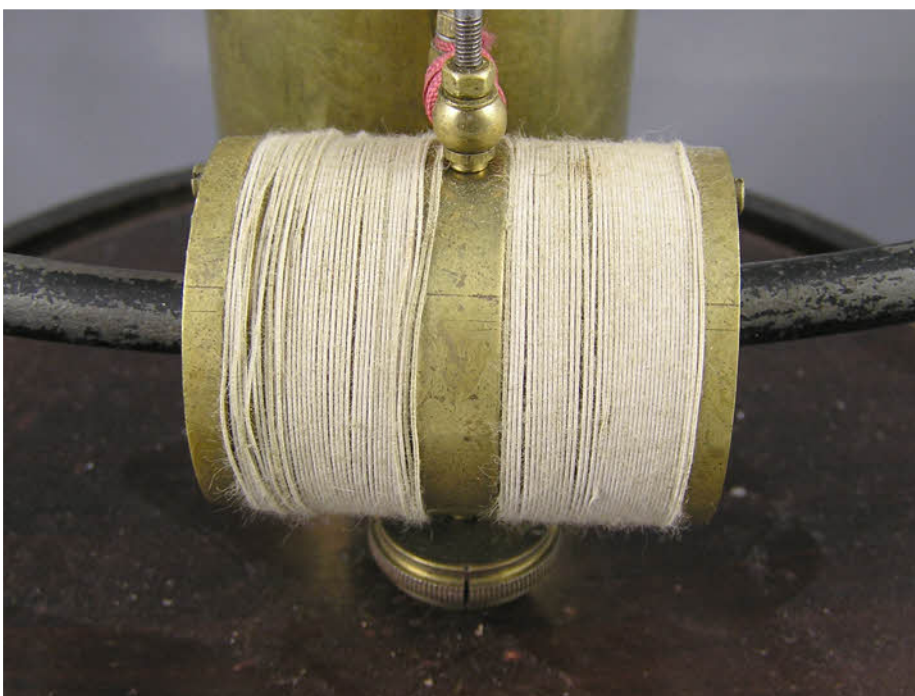
Coil looks to have been rewound with some cord at some time in its life, but is heavier than the original. It is also quite a light shade and shows no signs of fading as you would expect to see on protected areas of the cord. The lead out wire is also wrong and therefore we can suggest that the coil itself may have been tampered with.

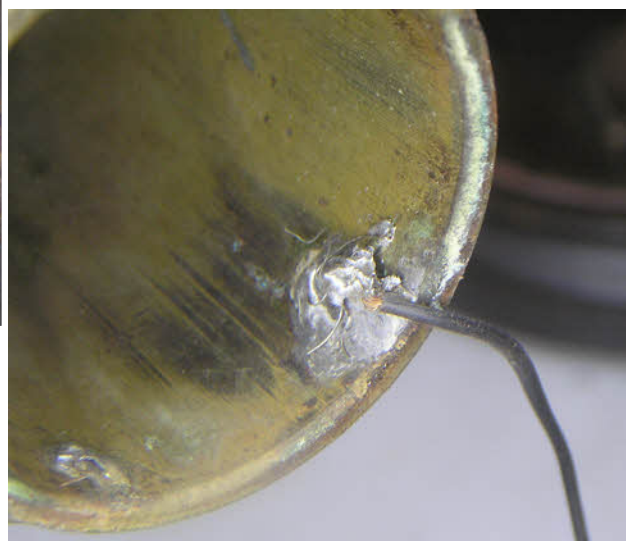
Below we see the inside of the battery column and other than the soldered negative lead it looks to be in a reasonable condition..

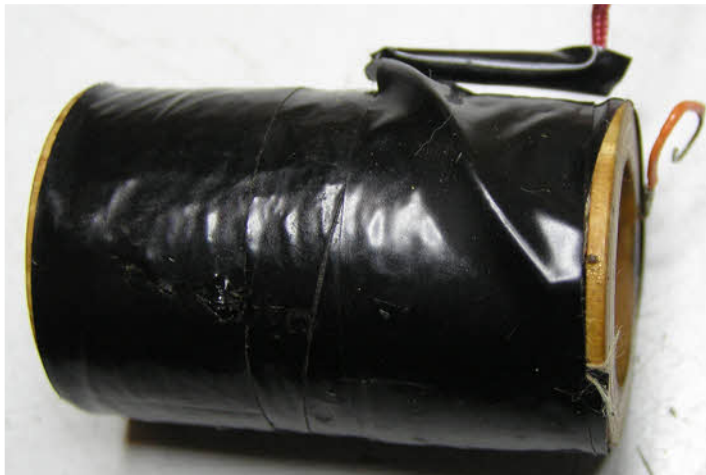
The movement was found to absolutely drenched in oil. The washers will need to be washed and dried, but are still usable

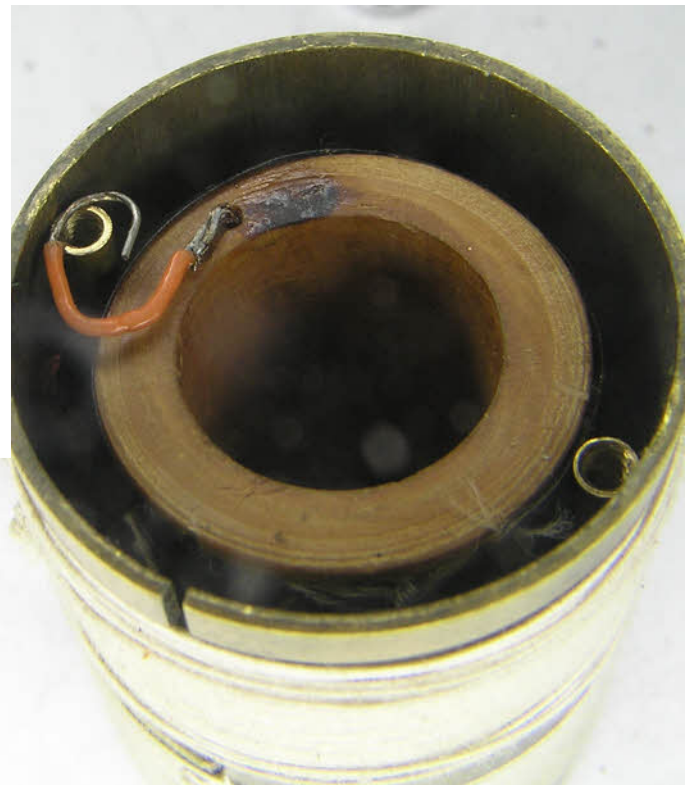
The coil is in a bit of a state. The first lead out from under the coil has obviously broken and has had a new hard single core wire soldered to it. We will try and replace this without damaging it further and necessitating a rewind. The coil itself is bound with modern insulation tape. The good news is that it still shows a good resistance

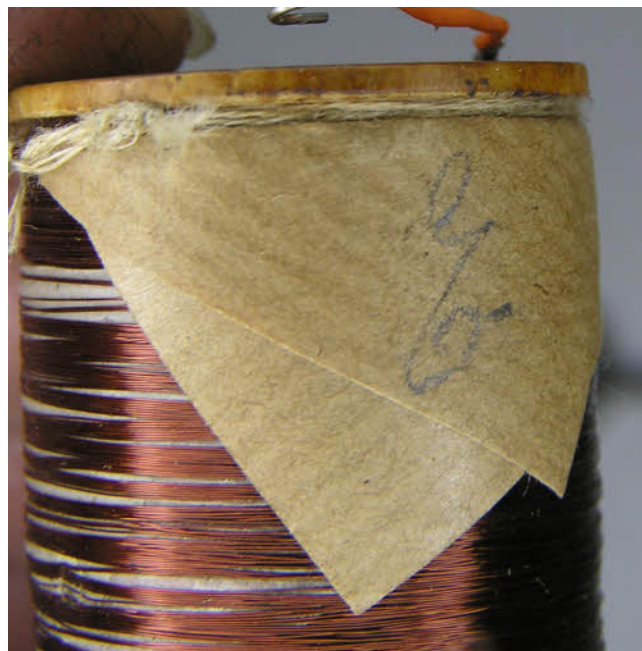
The second photo shows the brown paper sleeve used to protect the joint made with the coil and lead out wire. This particular example has the original signature of the worker who wound the coil in the early 1920's. As the coil was functioning OK, I made the decision not to touch the coil other than to replace the lead out wire coming from the side of the coil. This clock looks to be a transitional stage between the original 700 Ohm coil models that required a further 600 Ohms resistor added to the frame, and the later 1100 / 1200 Ohm models. The coil read 1300 Ohms and looks to be over wound and heavy in comparison to the normal 1100 Ohm coil. The serial number 1491 falls right on the cusp of the change and I suspect that this clock has had the coil extended rather than wasting existing stock.. I don't want to be the one to destroy a coil on , potentially so important a clock.

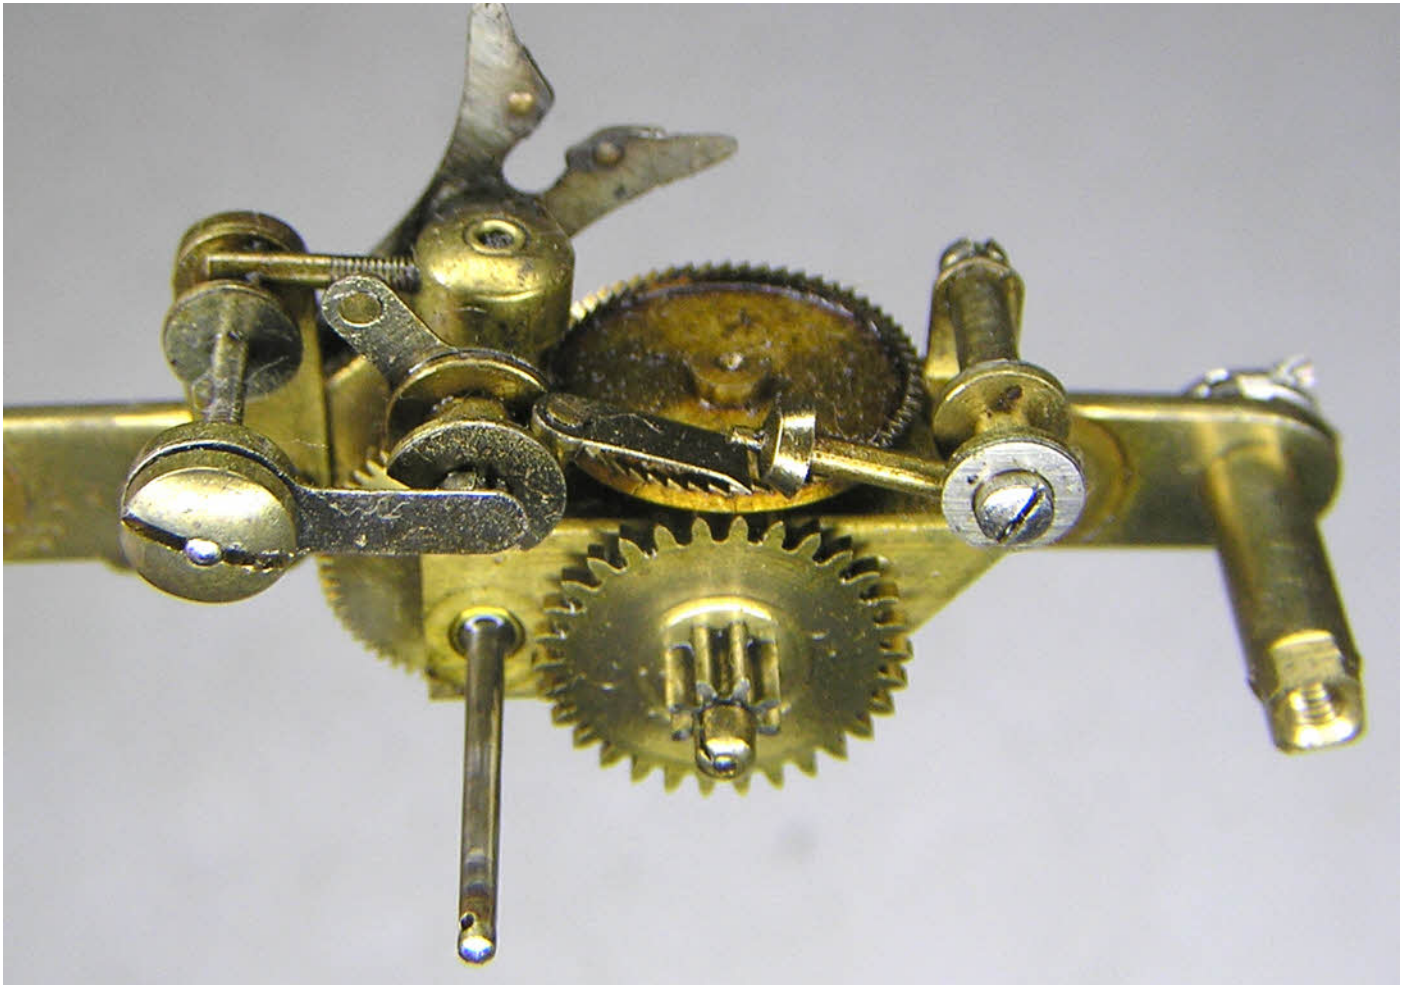
Below is another detail photo of the movement and the “gunge” covering the whole clock. You can just make out the wear on the silver contact of the fork. Both the fibre and silver contacts will need replacing.

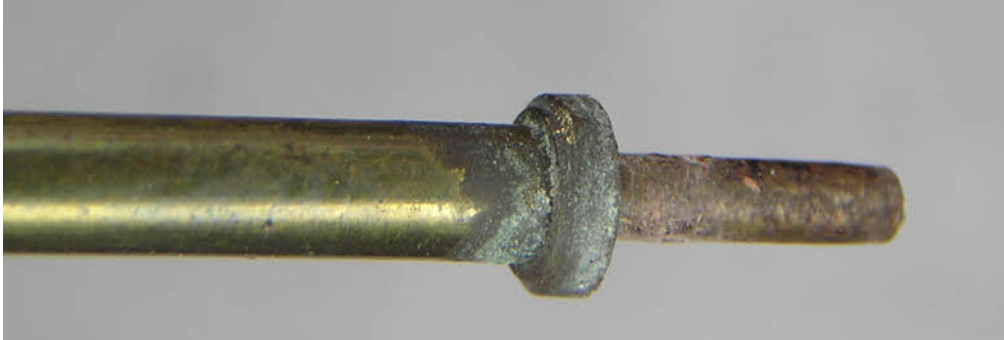
This photo shows the sort of corrosion that can occur with the brass on these battery clocks. There was no damage to the wood around the magnet support pillar and yet we see this corrosion? It may be from some old brass polish that was not cleaned off correctly.

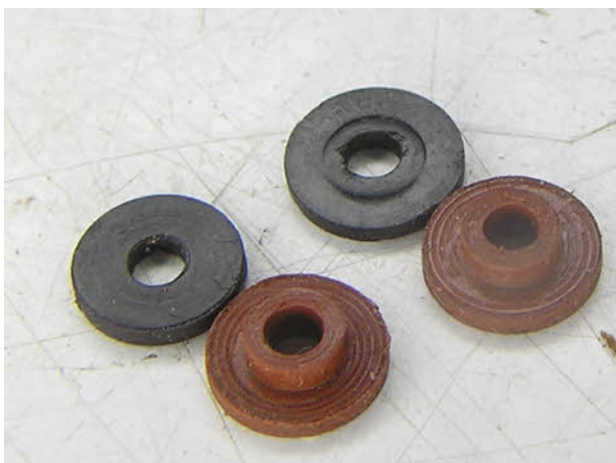
Below left we see the cleaned and dried insulating washer. The red and black colour scheme is not unusual on these early clocks.

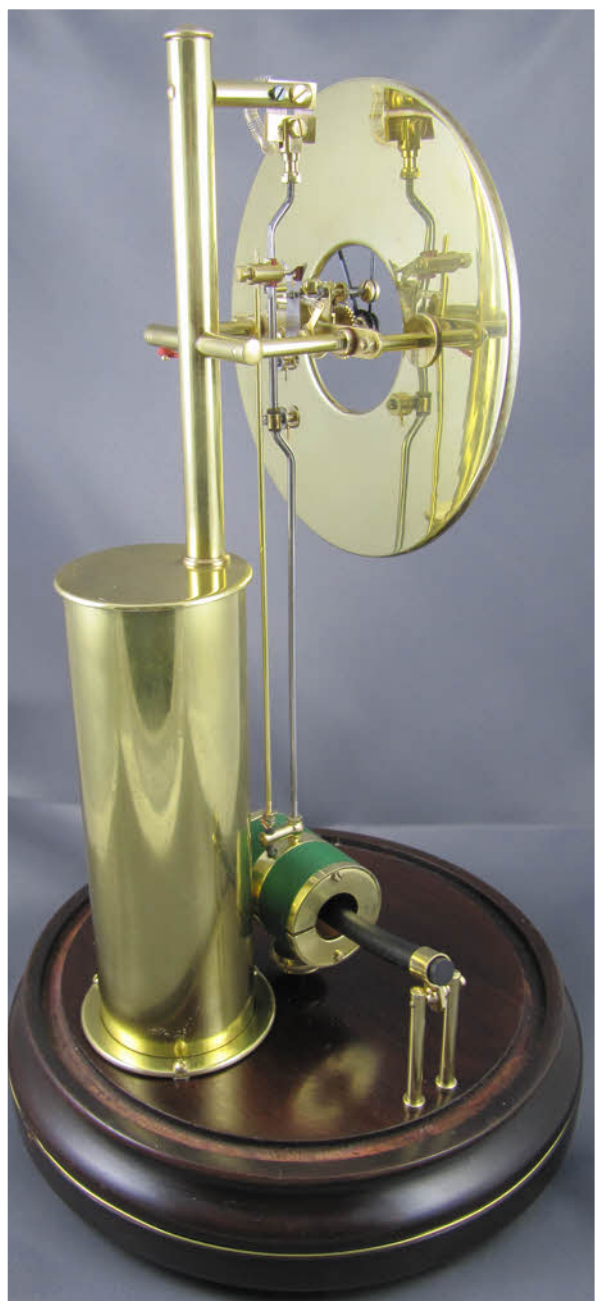
The finished clock.

*A nice early clock with what may be
an example of a 600 to 1100 Ohm
transitional type coil.*
