*Restoration of Bulle Clock
Serial Number 1583*

Bulle Clock Serial Number 1583

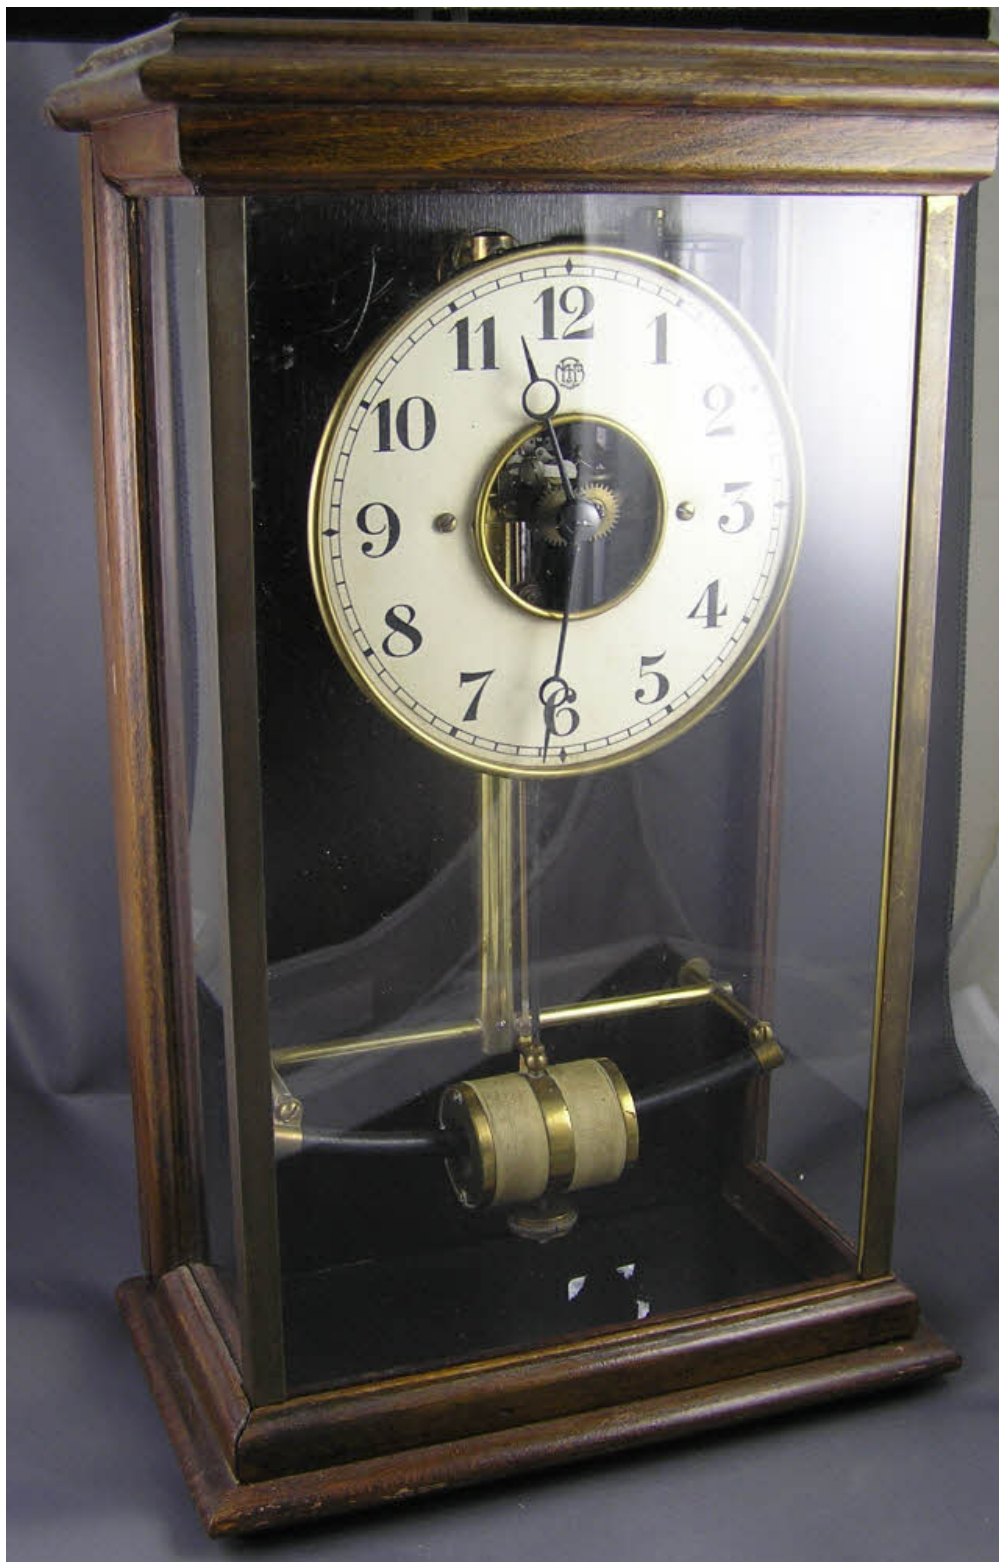
This is a very early and interesting Bulle clock dating from the first year of production. The full size movement is held in a front lifting glass framed wall case. The three glass panels are held in place by two angled brass strips. The dial is perfect as are the hands.

The case is unusual in that the two small hinges are at the top of the case meaning that the whole front and sides tilt up and backwards for access to the mechanism. The mechanism has an early half plate movement with box section, which is only seen on clocks with a serial number less than 2000.

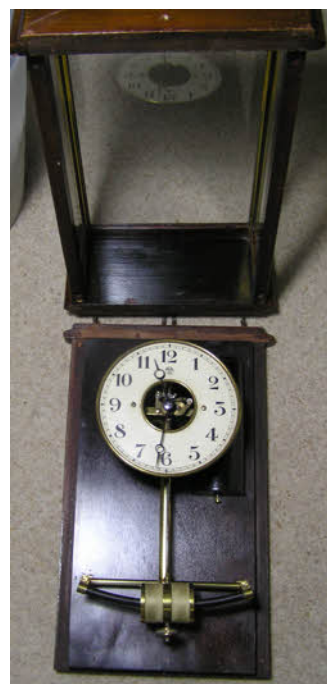
Not all of the later production methods have been ironed out yet and as such this clock has some unusual features not seen on later clocks.

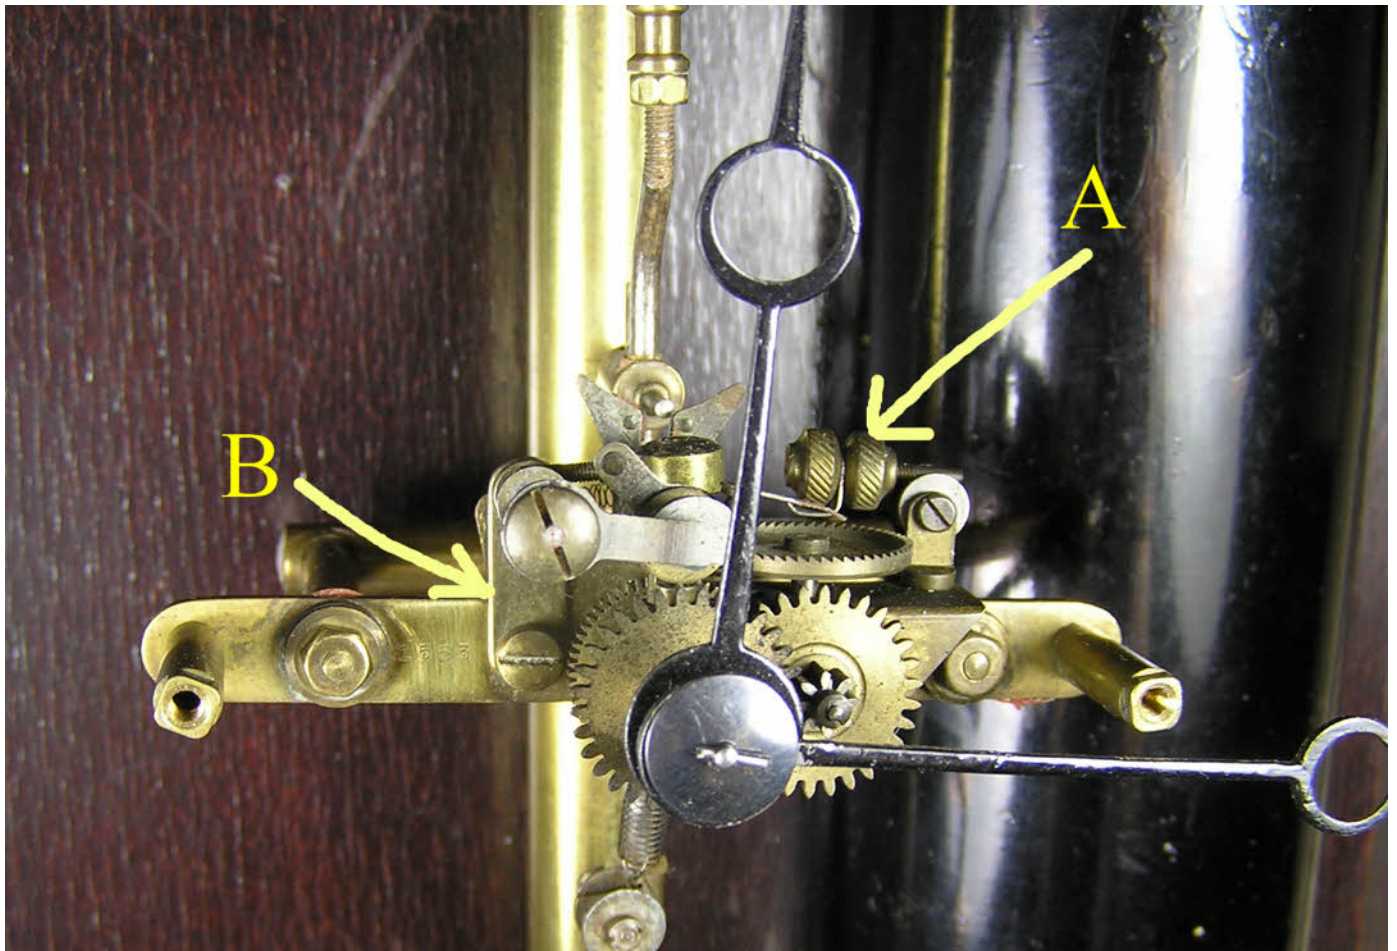
This clock has the early method of restraining the count wheel (A) from lifting and recoiling after impulse. Two knurled thumb nuts act as weights to stop the wheel lifting, while the piece of bent steel between them acts to prevent the wheel moving backward. The arbour that holds the dampening cup and fork arbour end shake plate is attached on a separate bracket (B). The later full plate mechanism no longer requires the bracket.

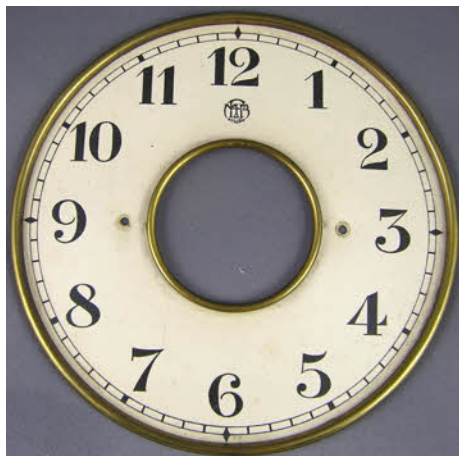
*The near perfect card insert dial and rear of the movement
The fork and both contacts are in fine condition and will only need a gentle cleaning*

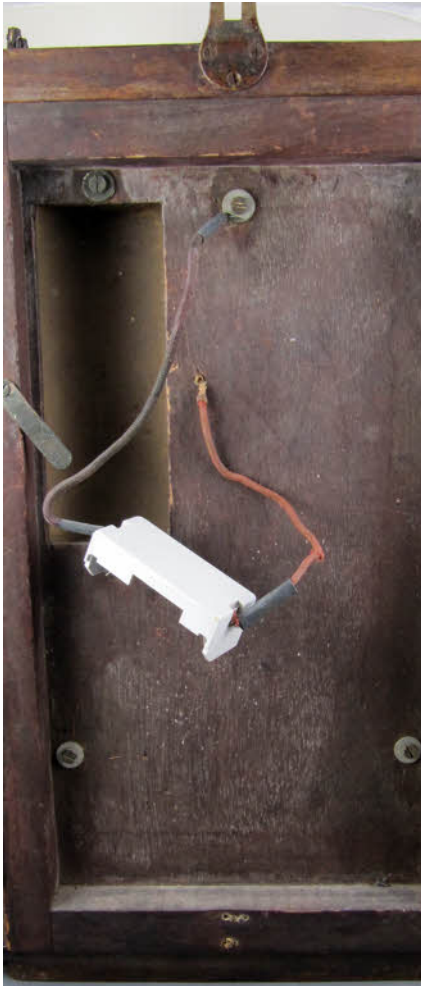
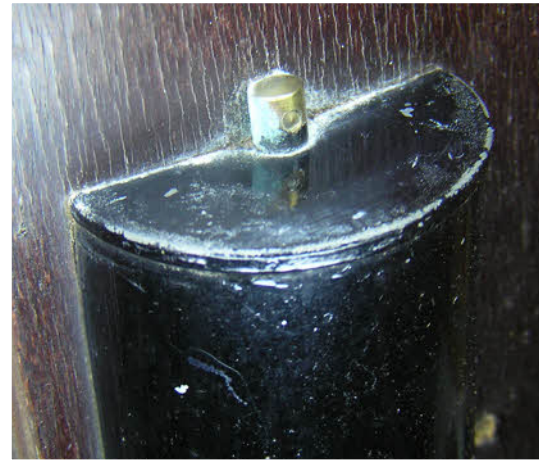
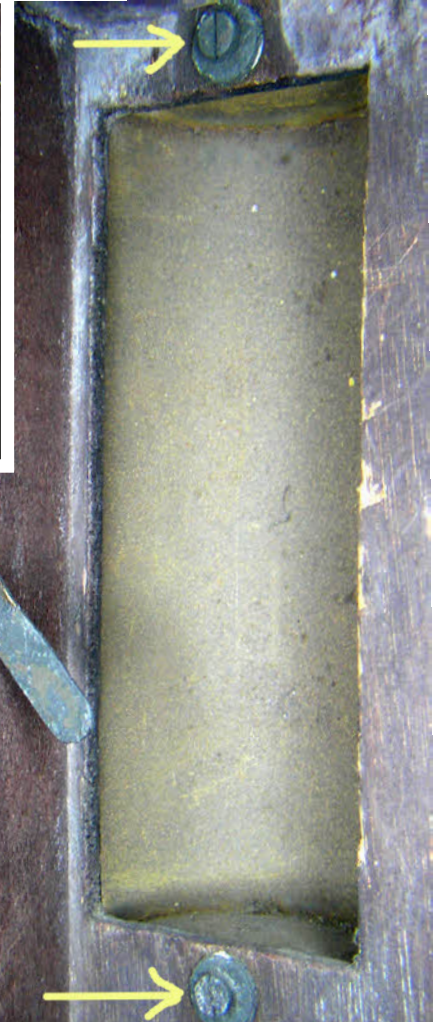
These three photos show the rear of the clock and the battery holder which is a little rusty and will need to be cleaned and painted. These holders are made from flat tinned steel with end plates which are peened over and soldered. Two brass rods with one flattened face, are then riveted into the ends and threaded to take the two screws as shown. arrowed

The rear of the clock with restored steel battery compartment.. The battery holder has long terminal leads to allow the battery to be changed easily when the clock is on the wall.

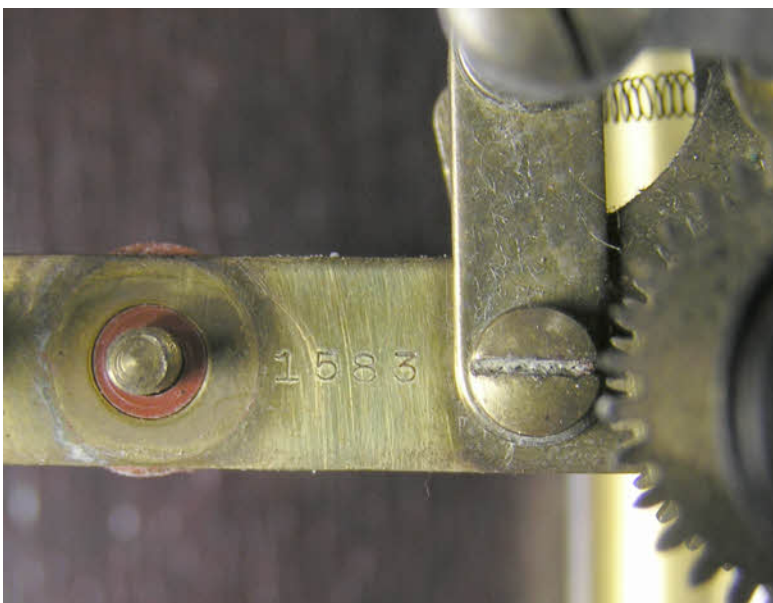
This last photo shows the early serial number. It is prudent to remove the nut and washer from the threaded arbour so that any hidden digits from the serial number can be seen. I have had quite a few people write in with incorrect serial numbers because there is a digit hidden beneath the fibre washer.

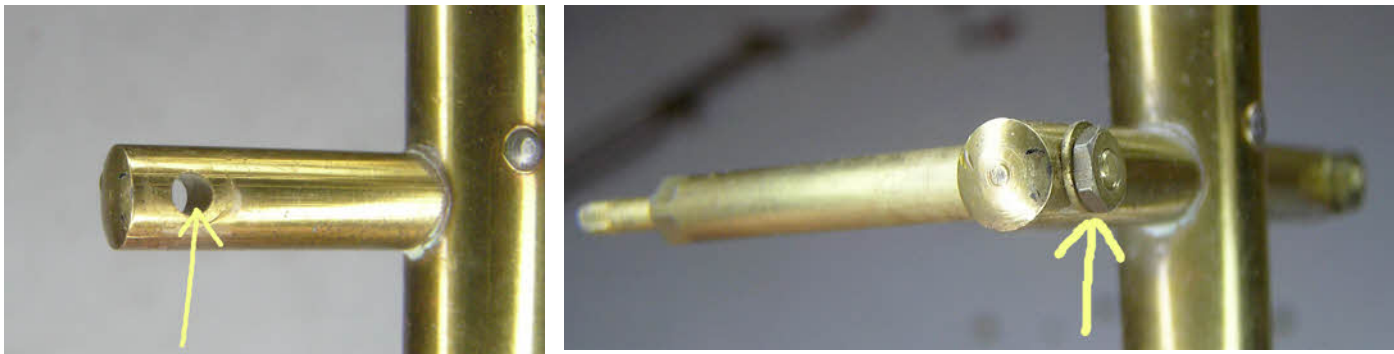
At first I thought that this movement had been damaged and nuts had been added to the arbours that hold the movement to the frame. But on closer inspection I think the modification is original. The hole is clean with no damage or any indication of being threaded. Also the arbours themselves have extended thread ends to suit the added nuts. If frame was originally threaded then the threaded end of the arbours would be shorter and not protrude through the frame. It must be remembered that methods changed quite quickly in these early production clocks and many new ideas were being tried out. I have seen many parts on these "half frame" clocks that have obviously been hand made while testing different techniques.

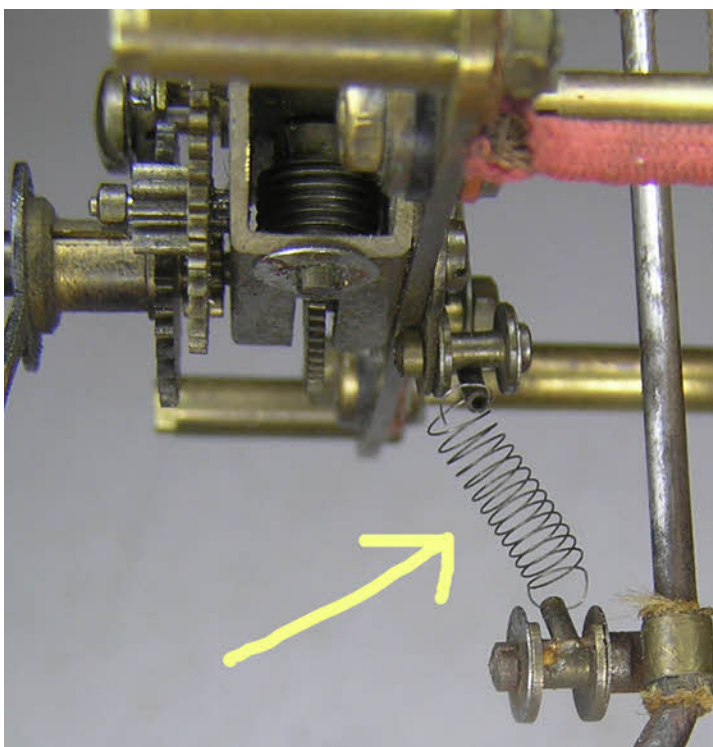
This photo shows the base of the movement and the rear. original Isochron spring and brackets.

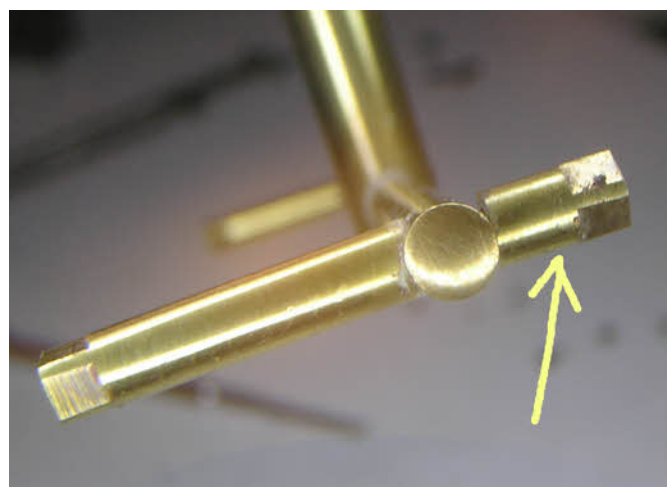
The photo above shows the extension to the arbour that holds the magnet. This extension is a method of standing the clock away from the case. There were two methods of securing these to the case. One is by the use of brass tags which are then screwed into the case from the front using wood screws, or in this case by machine screws through the case from the

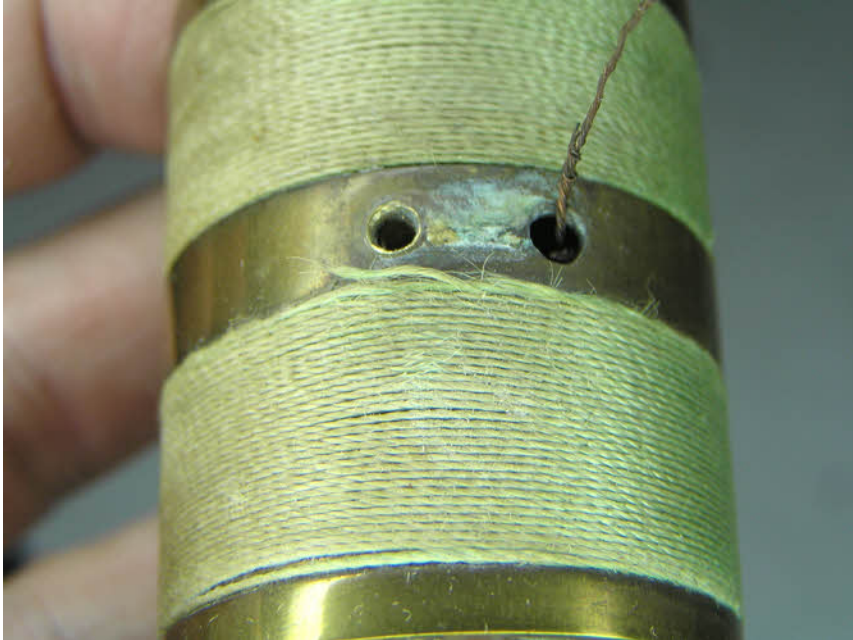
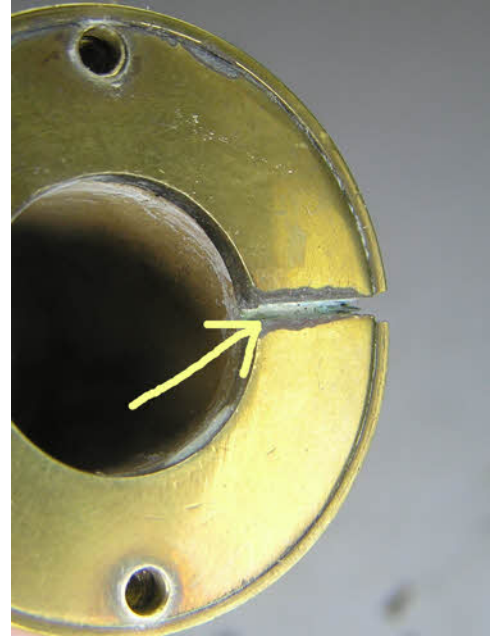
These photos shows the poor condition of the cord around the coil casing. The brass has been cleaned for many years with a brasso like substance which has eaten into the cord leaving dry, brittle and dusty. You can also see the deposits left in the joints.

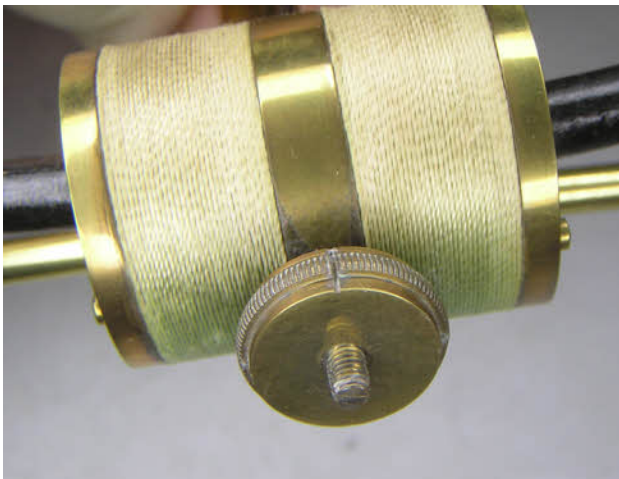
Thankfully the pendulum rating nut is complete and has not been drilled or turned down to lighten it.

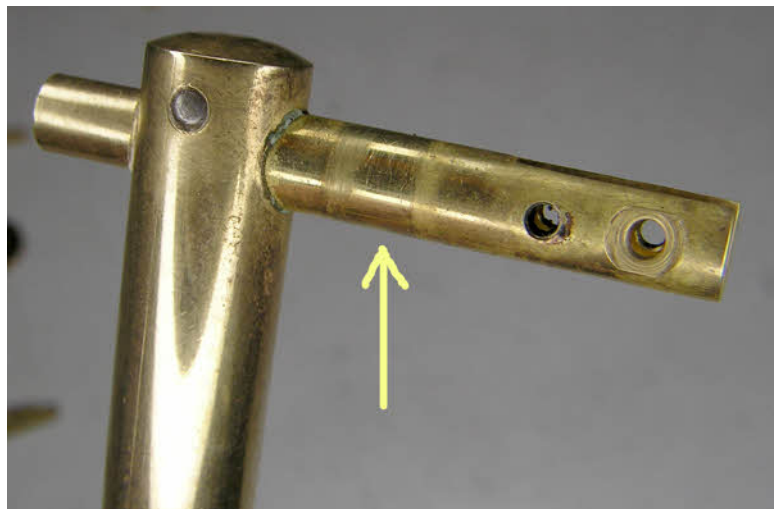
The mark on the frame shown here is where a resistor would have been located. These early clocks had low resistance coils of around 700 Ohms, whereas the later ones were around 1200 Ohms. It must have been realised that this was too low a resistance giving too great a swing of the pendulum and a shorter life for the battery. It was therefore decided to add an extra resistor between the battery and coil at a convenient point on the frame

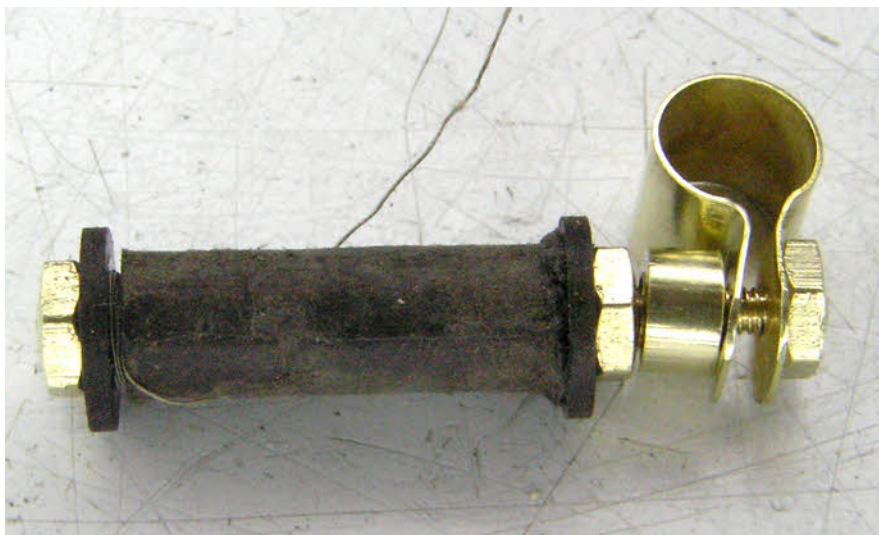
This photo shows an original resistor from another Bulle clock. It is simply made and has a resistance of 275 Ohms. It may be that the resistance varied slightly to match the main coil. I will use this as a template for making a new one for this clock. All the parts are simple turning and threading jobs. The coil itself is easy to wind on the lathe.

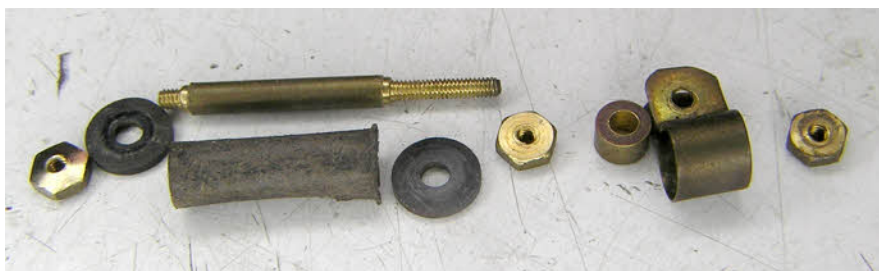
This photo shows the main components of the resistor. The body is a 3mm rod threaded to take 2mm nuts. The ends are capped with standard fibre washers found on Bulle clocks. The other two parts are a spacer and a loop to attach it to the clock frame.

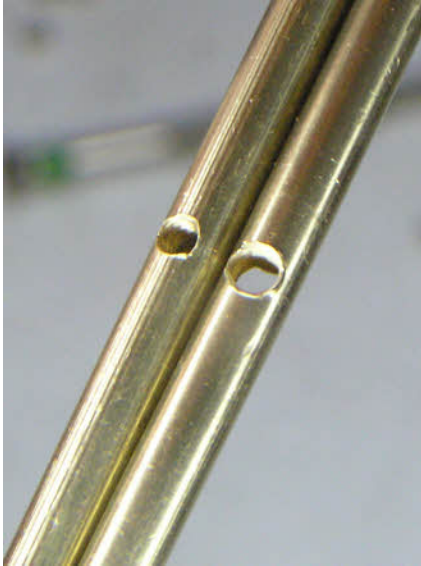
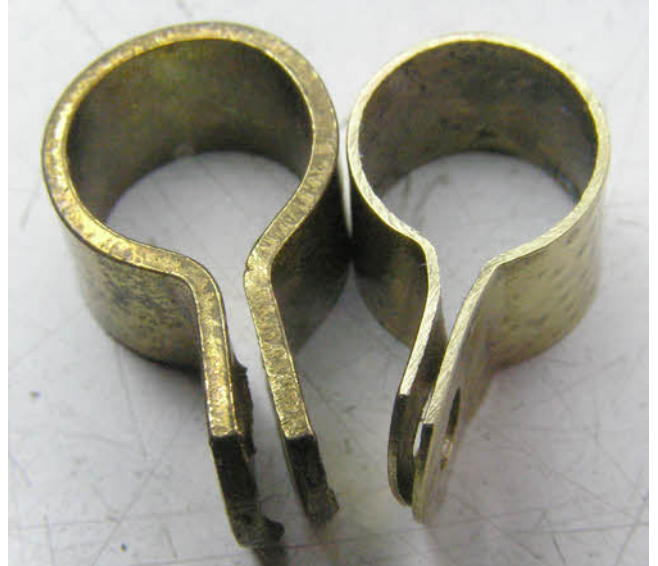
The photo at left shows the two coil cap spacer bars that have threaded holes to accept the pendulum rod and rating nut. Note that they are different sizes and that they are made from solid bar. Later ones are the same size and made from tube. The photo at right shows the early magnet brackets on the right and the much thicker ones from later clocks on the left.

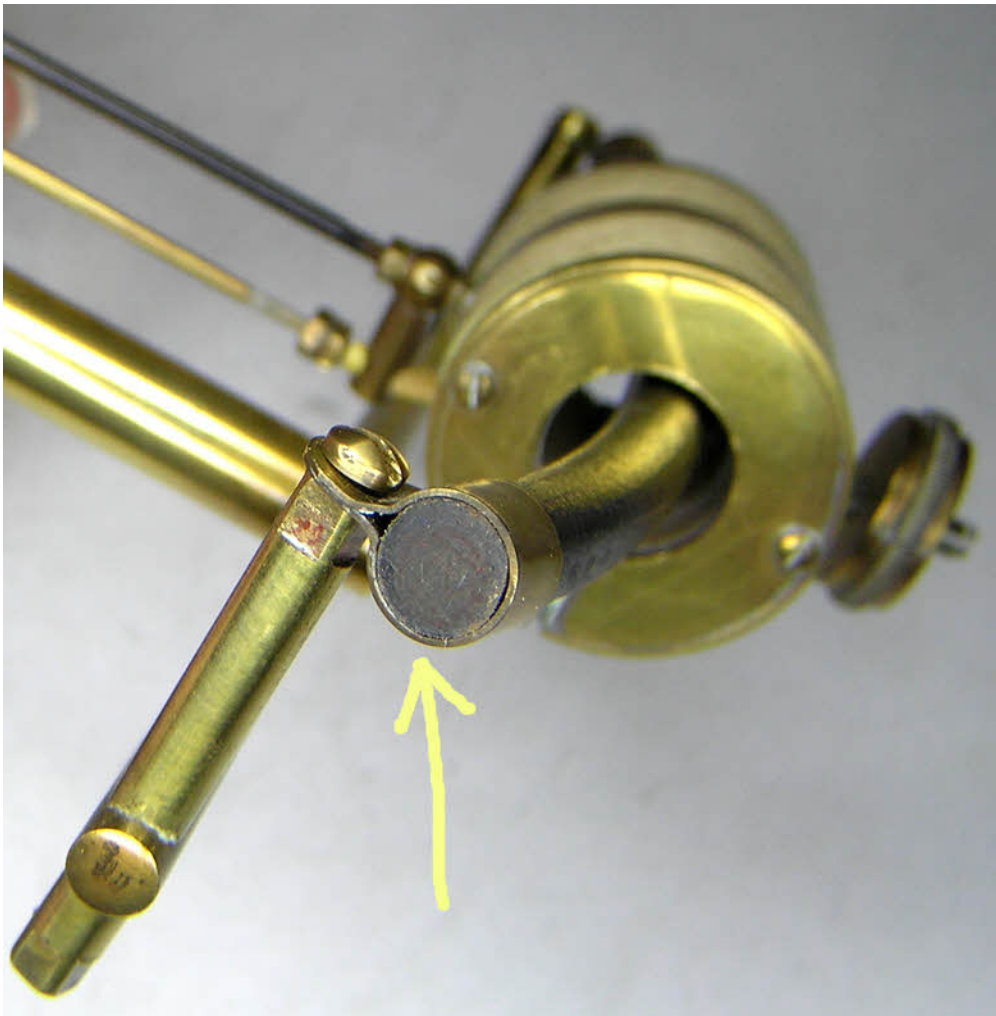
The early brackets in place. They need to be handled carefully as being quite thin, they can be easily snapped

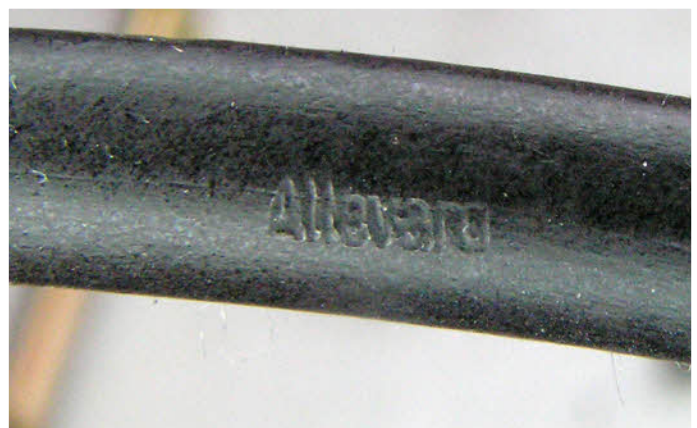
*Below is a detail of the magnet showing the word *Allevard* which is believed to refer to the town in souther France where the magnets were manufactured*
