Bulle Clock Serial Number 158805

*Restoration of Bulle Clock
Serial Number 158805*

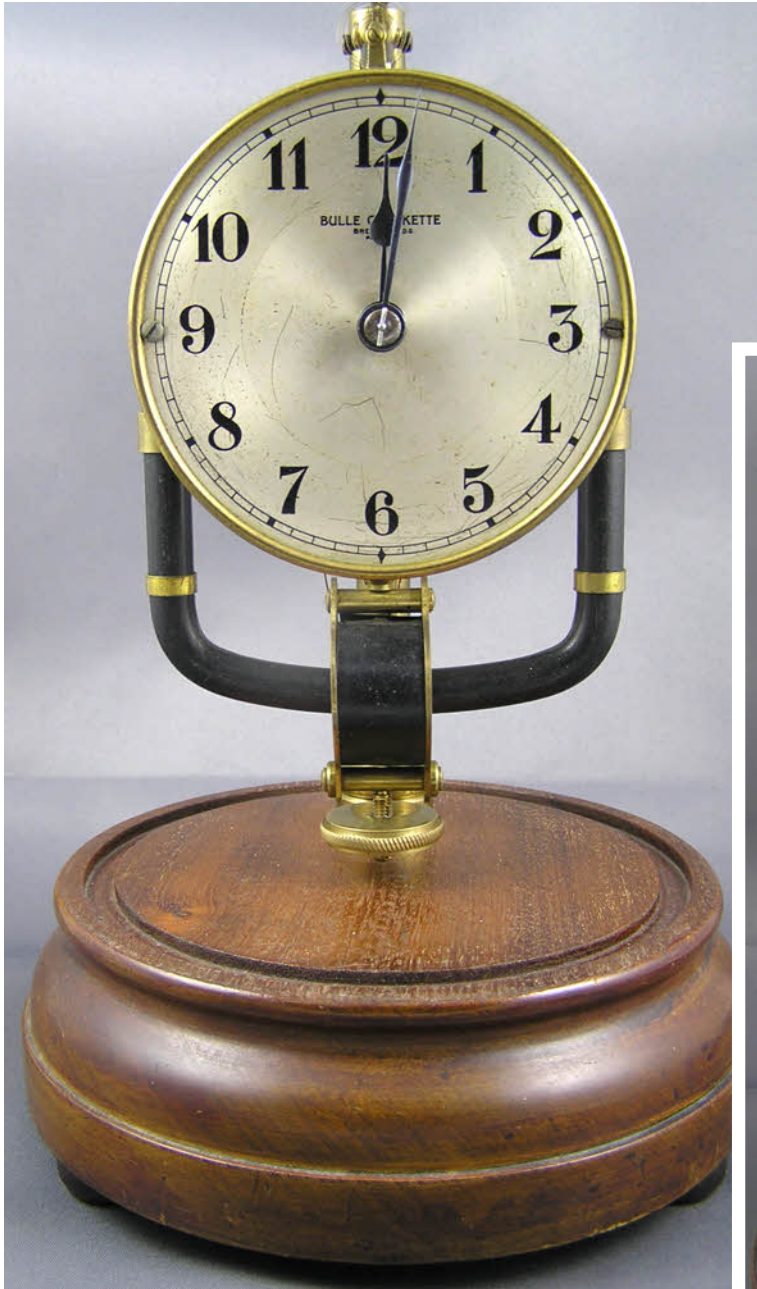
This clock is a standard clokette on a turned wood base. The base looks to be in good condition though a little tired. It will benefit from a cut back and wax polish. The dial is pretty good with just the usual scratches acquired in it's normal working life. Other than the base decoration the clock is nearly identical to 205535..

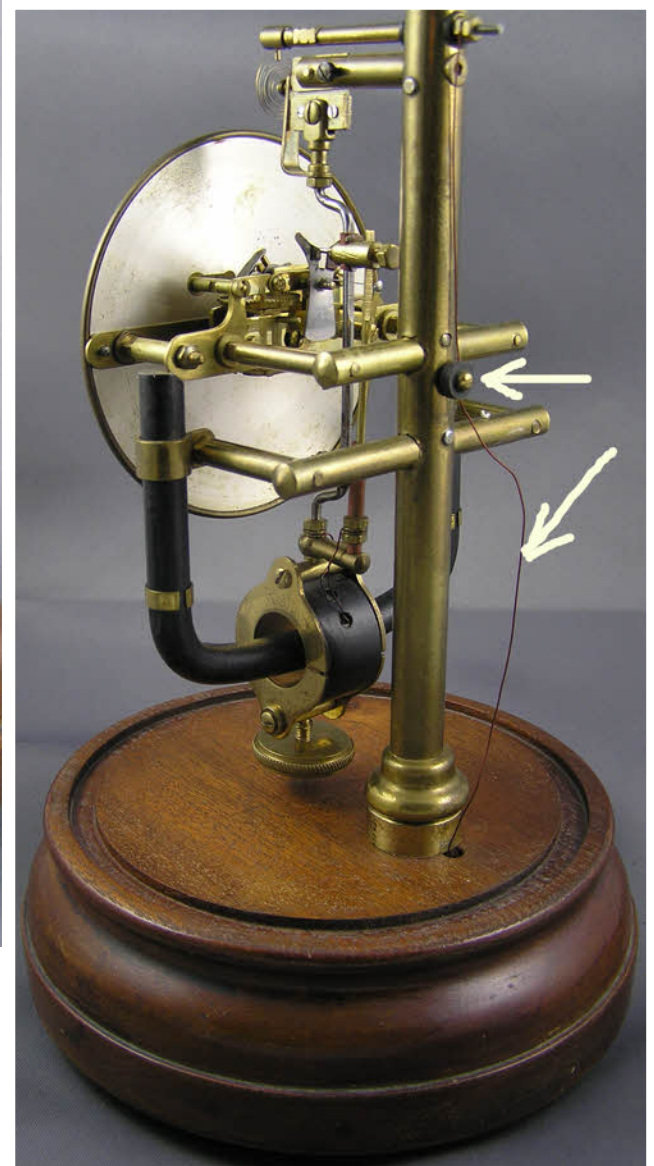
There are some initial signs though that this clock has had a difficult life and shows signs of bad repair practises. We will see more as the restoration progresses. Note the non standard wire and insulation (arrowed).

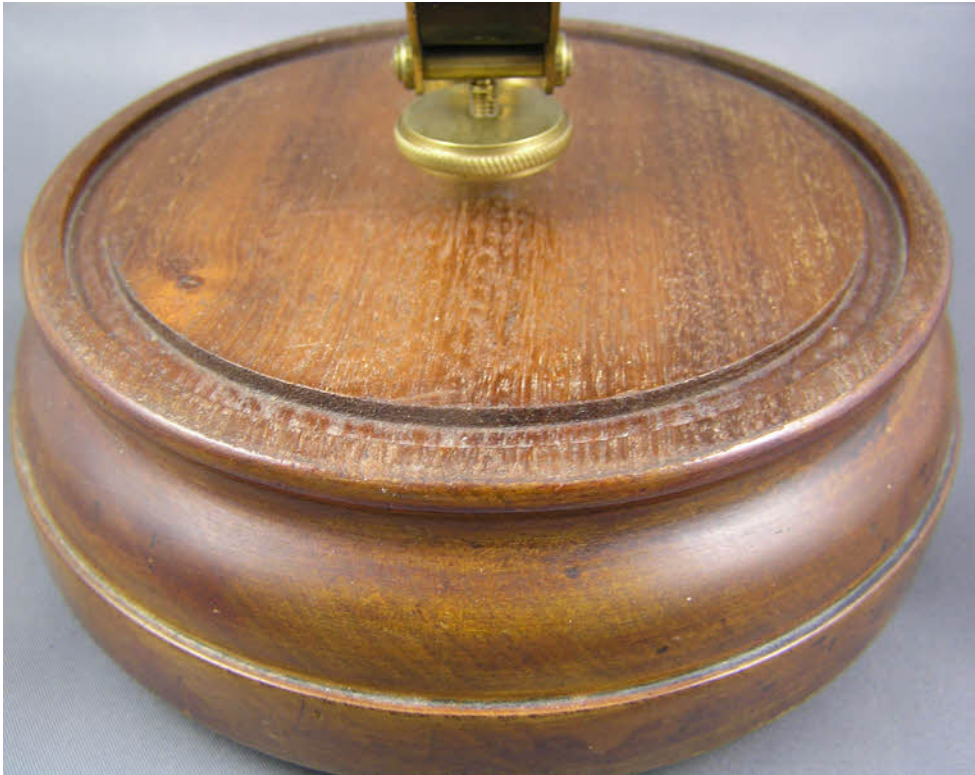
Detail of the base which is a little dull.

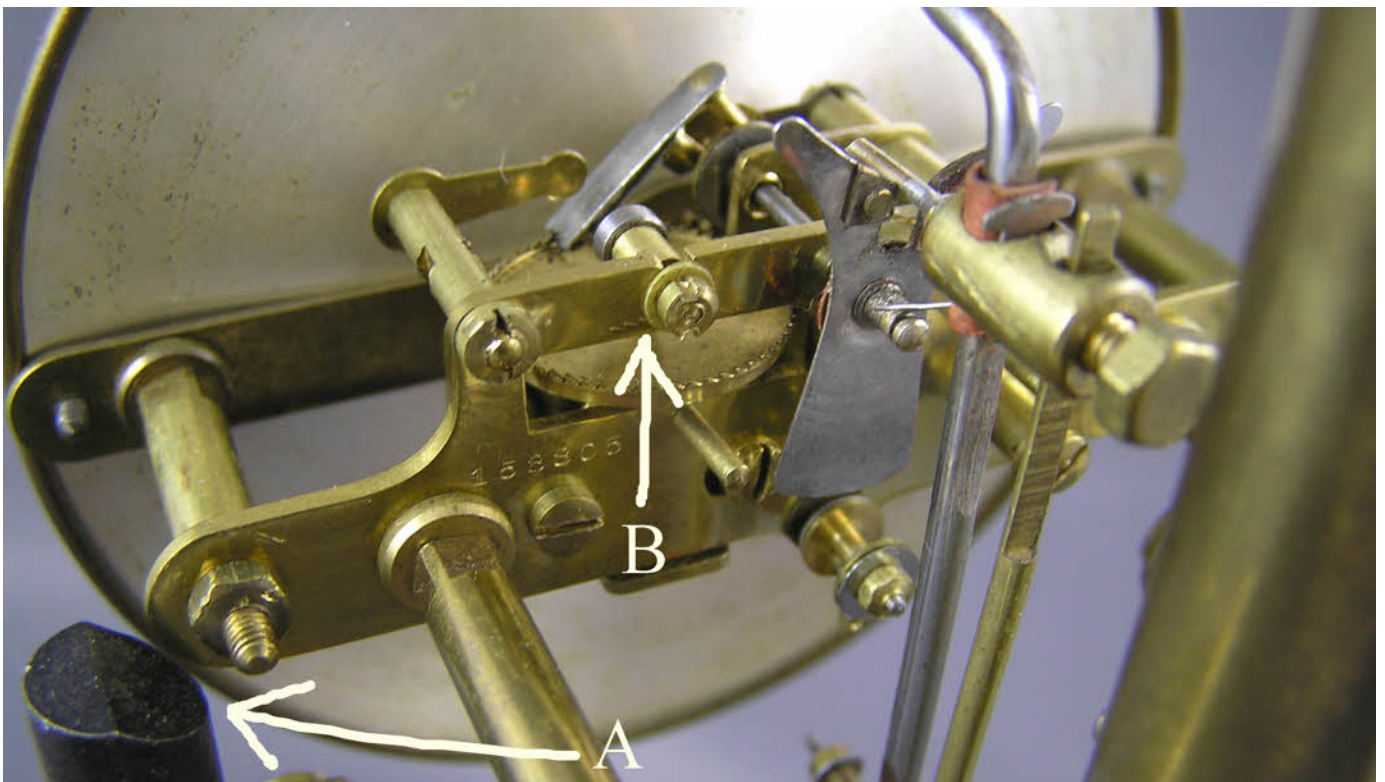
The photo below shows the movement with a couple of points to be noted. First notice the cut away (A on the magnet to allow it to be raised just a little closer to the movement. There seems to be an superfluous washer added to the count wheel free play adjuster (B).

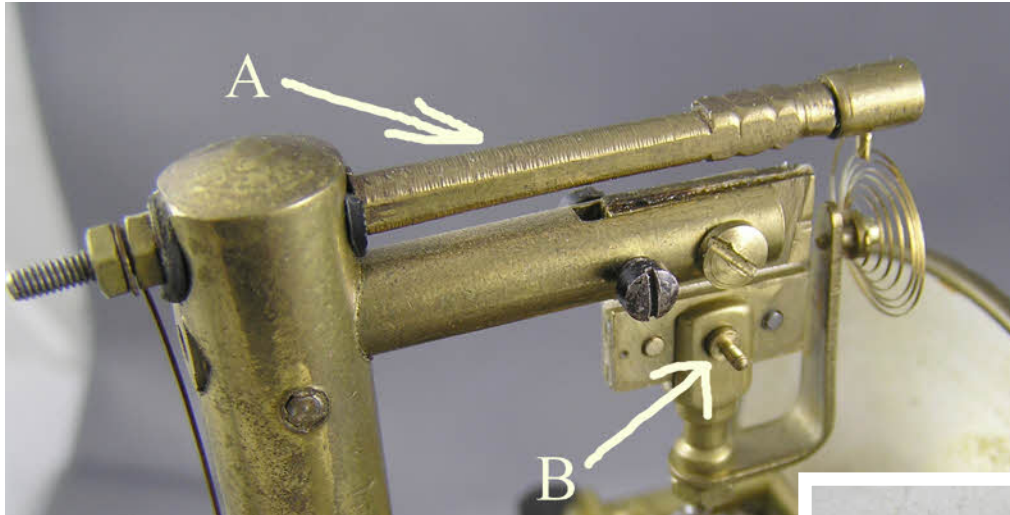
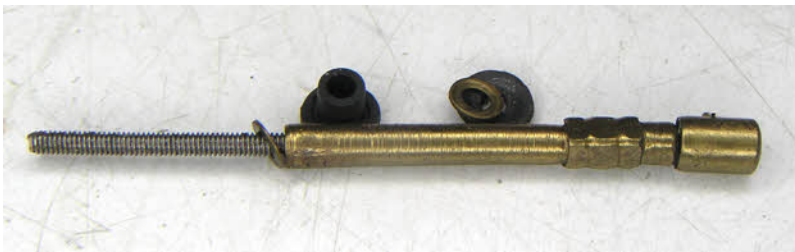
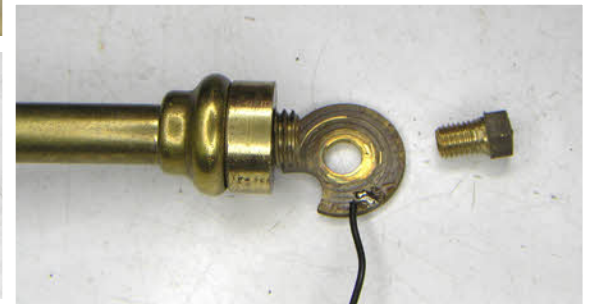
This photo shows the replacement arm that carries the supply to the hair spring. It is not original and seems to be made up from various scrap piece as seen below and left. This will be replaced with an original. The lower suspension assembly is also missing its nut (B).

This last photo shows the new arm that carries the power to the hair spring, along with new nuts fibre and brass washers.

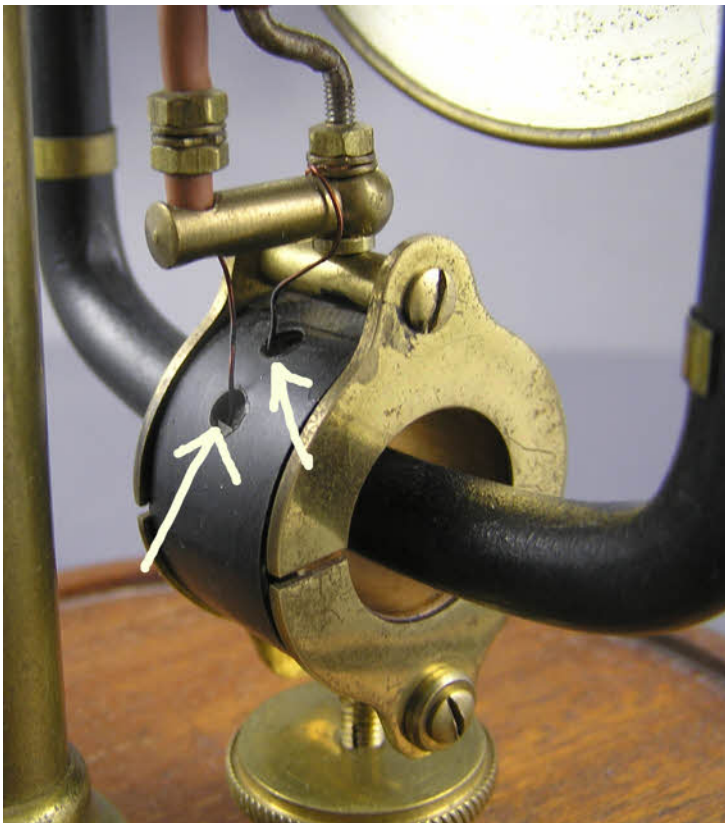
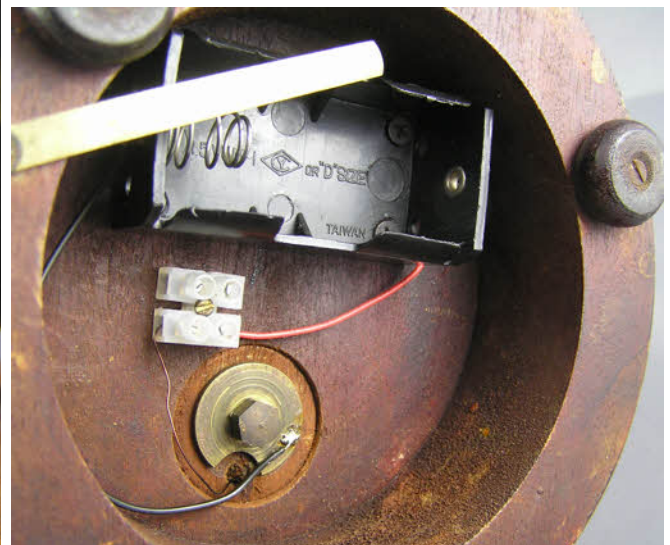
The photo bottom left shows the coil assembly. The bare wires suggest problems in the past and will need investigation. The photo below shows the underside of the base with the battery holder screwed on and the negative lead soldered to the base of the column. Both bad ideas.

The coil was bound in sticky tape and had single core wire replacing the original. The tape was removed and the coil tidied up and new lead out wire soldered on. The coil was then tested for a normal resistance range of between 1050 and 1250 Ohms.

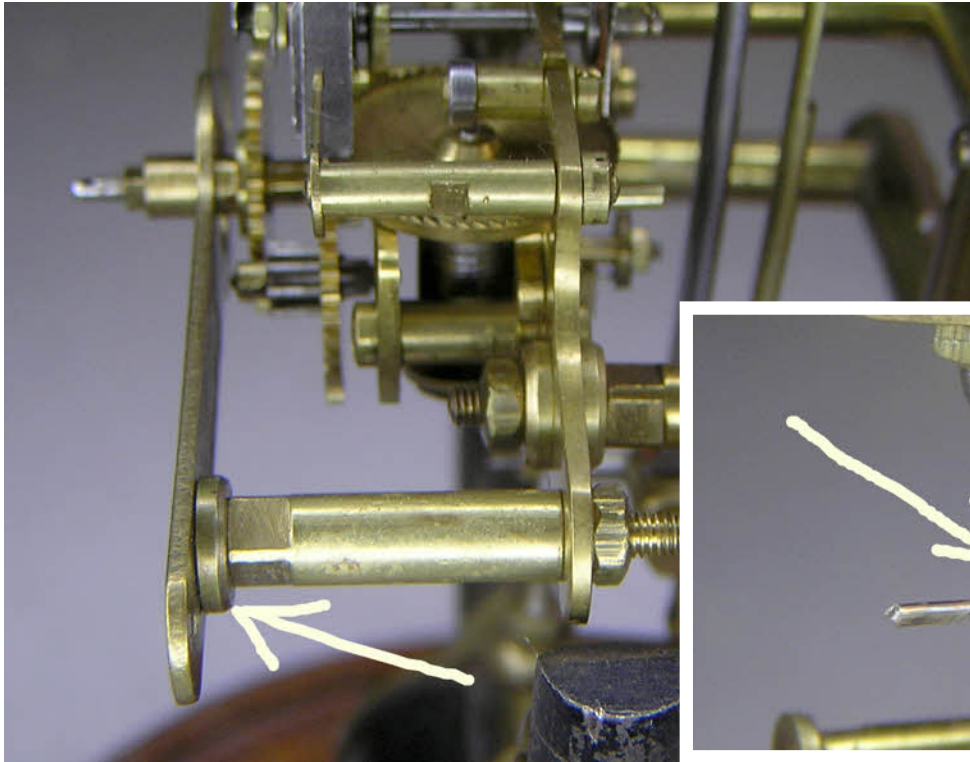
This photo shows the thick washer behind the dial support cross rib. It is far too thick and looks to be from another part of the clock. Two thinner washers will have to be made.

Right as the new dial step washers that were missing from the clock..

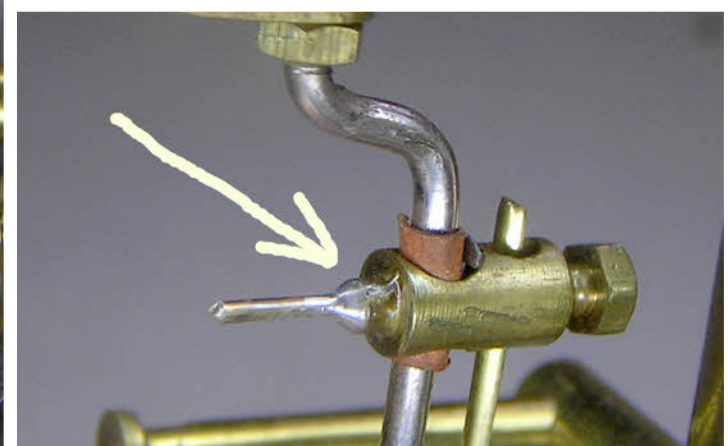
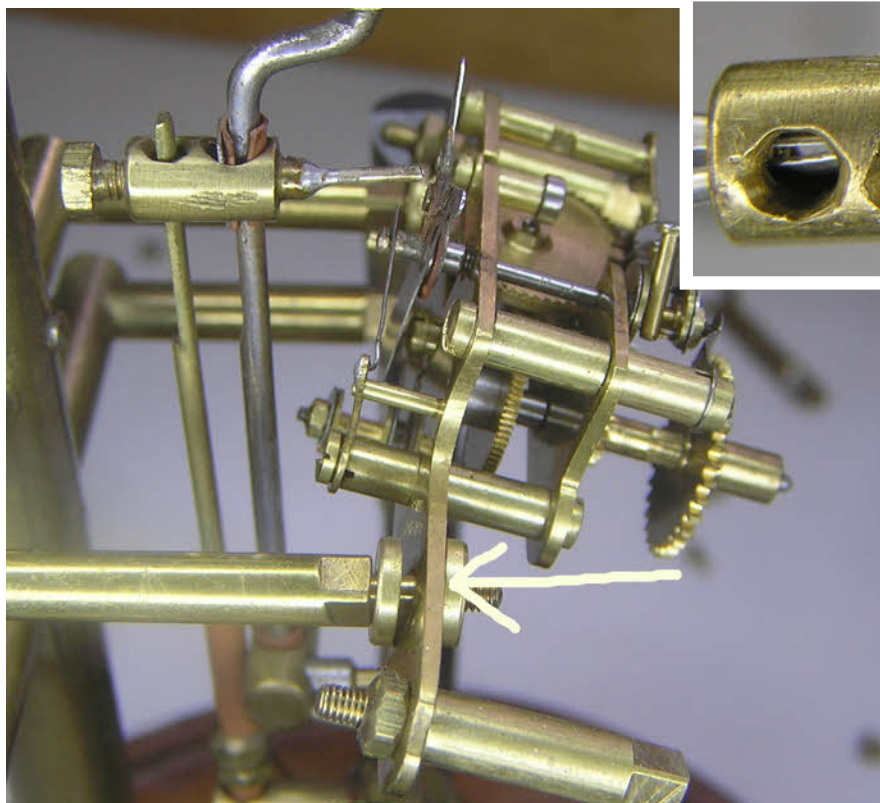
The photos above shows the replacement contact pin which besides being too thin is also soldered into the assembly instead of being screwed.

The old pin removed and the new threaded pin inserted.

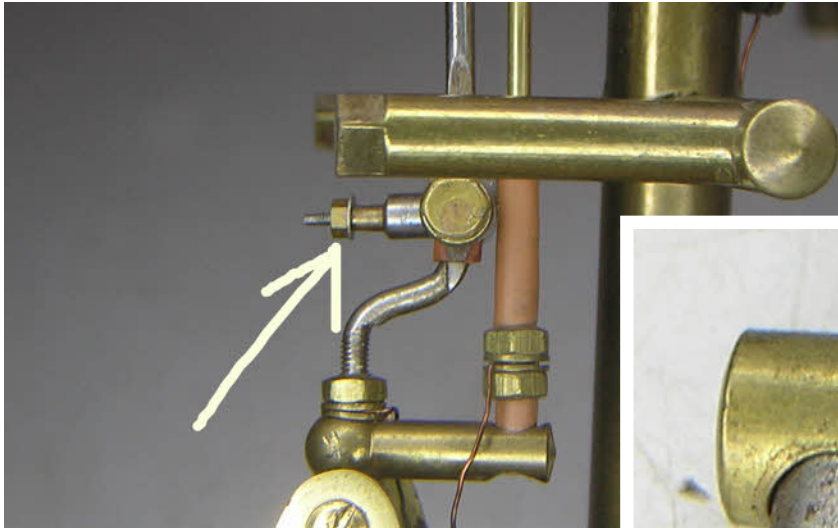
The lower Isochron bracket on the pendulum is missing all of the bobbin, washers and "T" piece. All will need to be replaced.

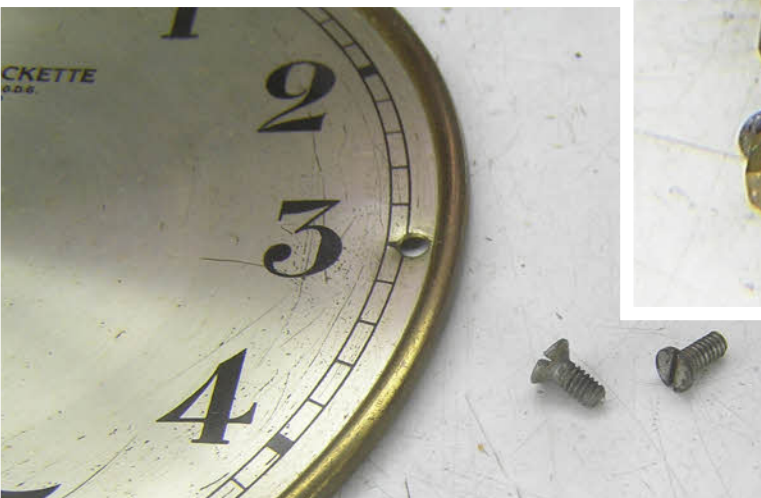
The dial, left, is held on by replacement countersunk screws. These are no original and should be brass with a slight dome head. There use has also damaged the thread inside the support arms. Slightly larger screws will be made and the support arms tapped to accept them.

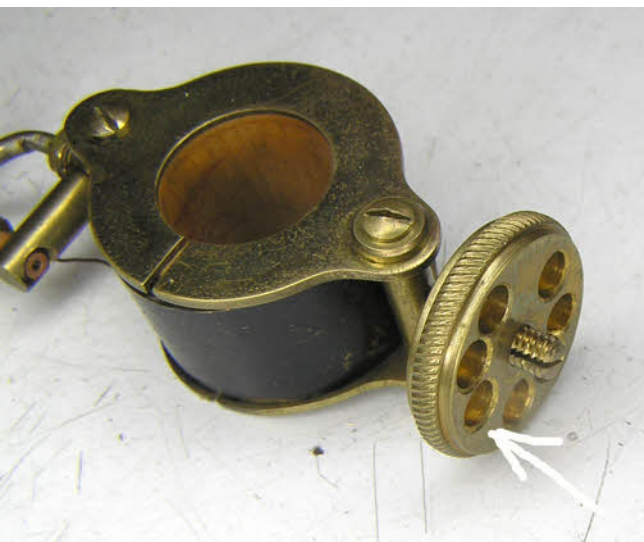
I'm almost afraid to look at the underside of Bulle rating nuts!!! You can see why in the photo at left. I would hazard a guess that 50% of clockettes have had the rating nut modified by drilling or cutting, to try and reduce weight. This will need to be machined aup and a new insert added.

The photos above and at left show the stages in correcting the rating nut damage. The nut has had most of the holes turned out on the lathe with a new solid piece of brass inserted and machined to fit. The only give away is the small ring. But this will be on the underside and will not be seen.

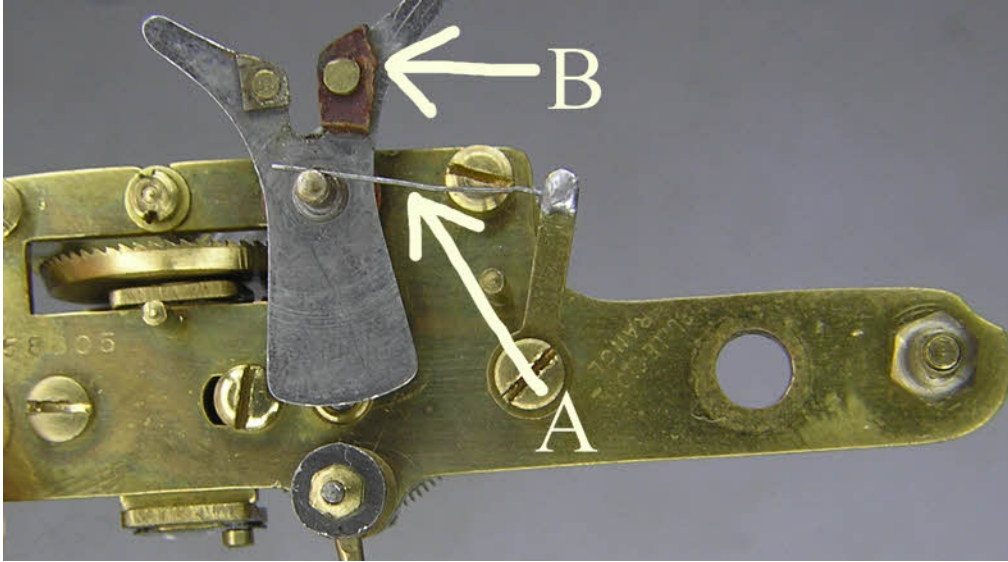
This is novel. A strong piece of spring wire has replaced the silver contact spring to try and maintain contact between the frame and fork arbour. It will be replaced and the solder removed.

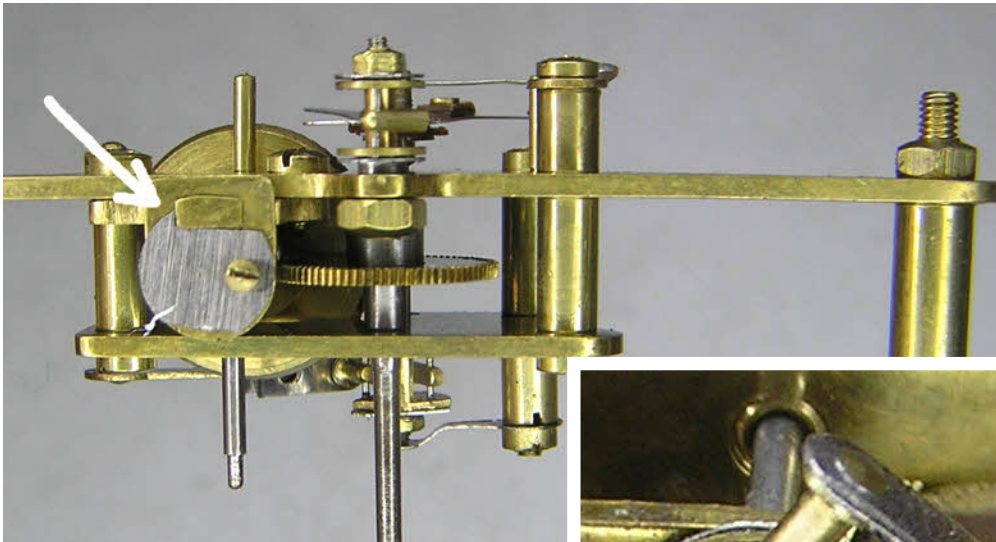
Although this looks wrong it may have been done at the factory! The steel washer that support the end of the count wheel arbour has been cut away to clear the protruding rivet. This will be reused on assembly.

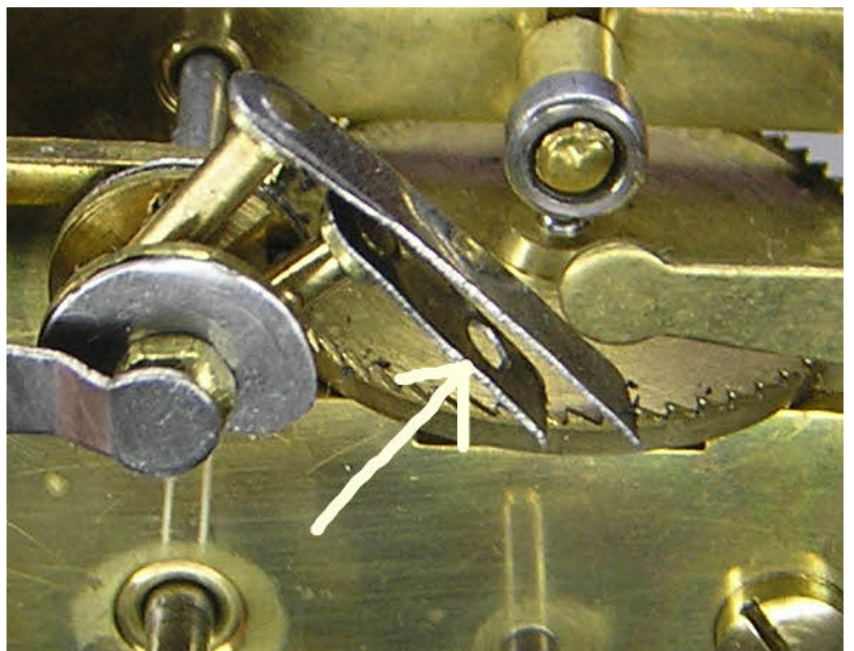
I thought the rest of the movement looked to be in good order until I noticed the driving pawl as shown in the photo at right. The small domed brass rivet which acts as a weight is missing completely and will need to be replaced. I have never come across one of these missing before. It also transpires that the 0.5mm piano wire that is riveted into the long stop pawl is loose and will need to be reset.

At left is the driving pawl with the new brass rivet.

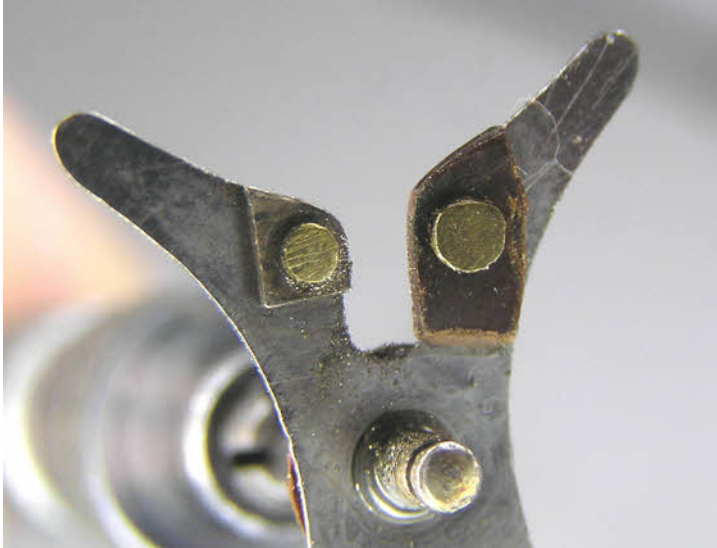
Both the silver and fibre contacts will need replacing.

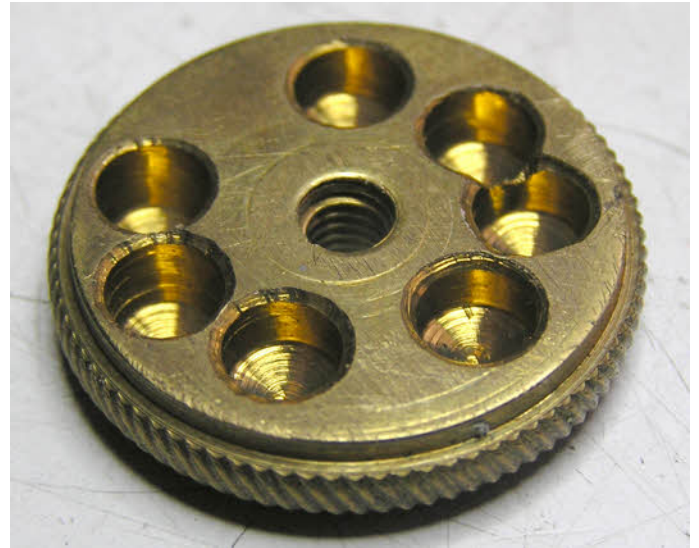
Here we see in more detail the drilled out rating nut.

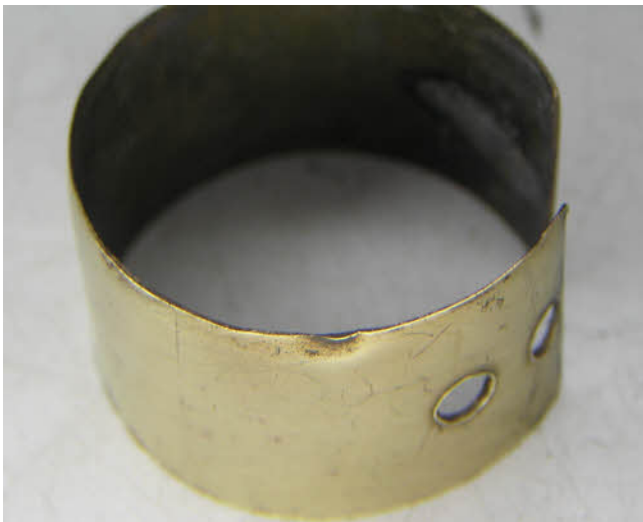
Above we see the slightly damaged coil casing which will be straightened as much as possible before re-spraying.

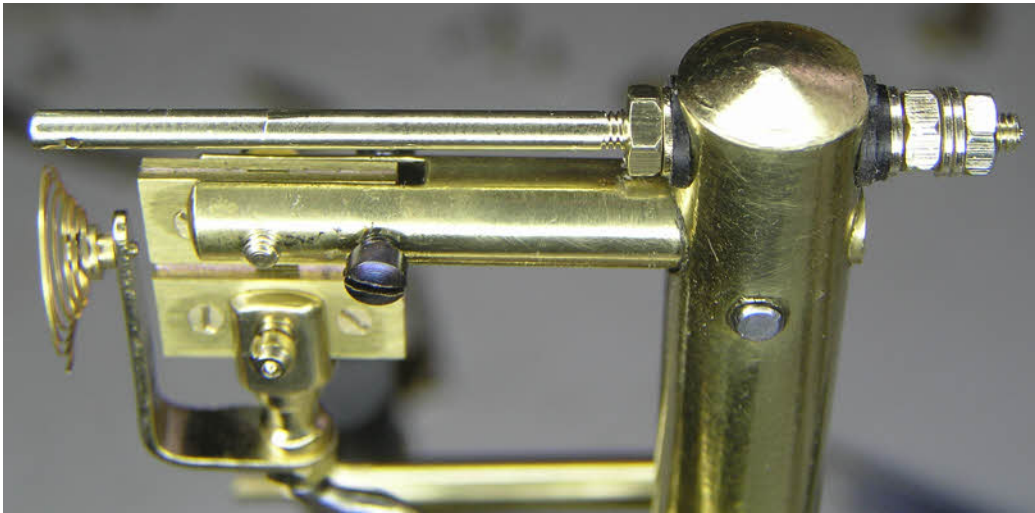
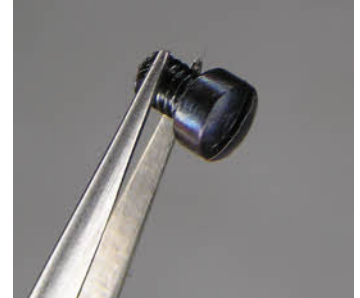
These two photos show the arm in place with the two steel suspension screws newly blued.

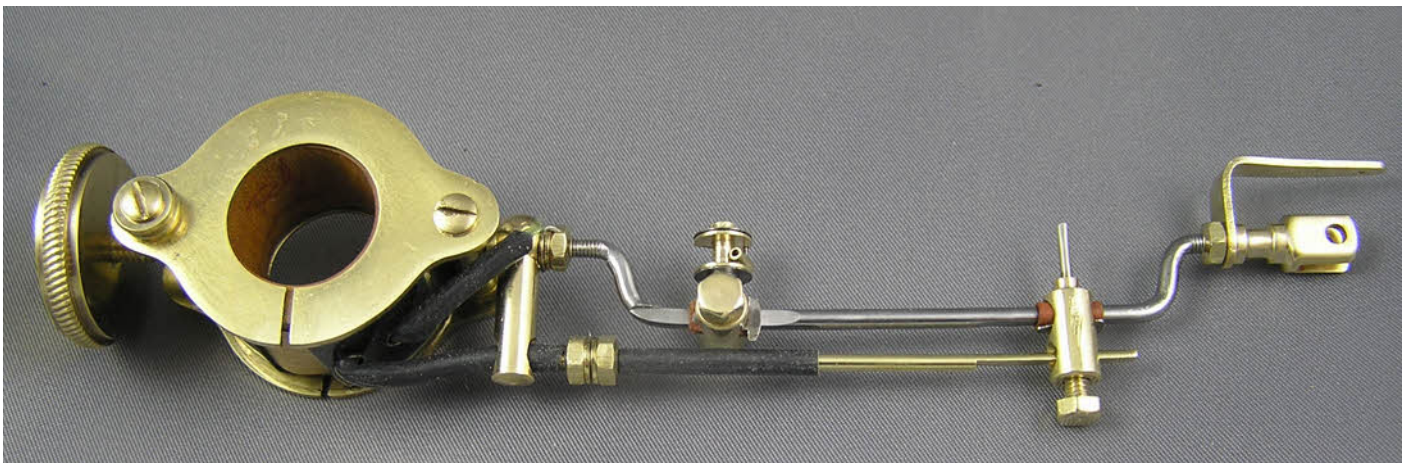
The re-assembled pendulum tested and ready to be inserted back in the frame. It is important at this stage, to check that the resistance is correct between the contact pin and the suspension bracket. It should be between 1050 and 1250 Ohms. Also make sure that the lower Isochron bracket assembly is insulated from the steel pendulum arm.

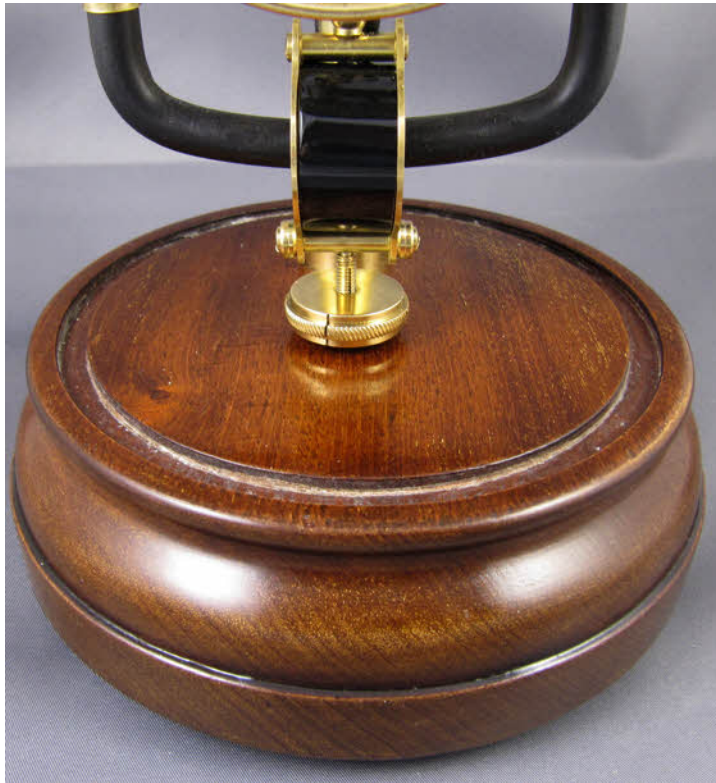
The base cut back and polished.

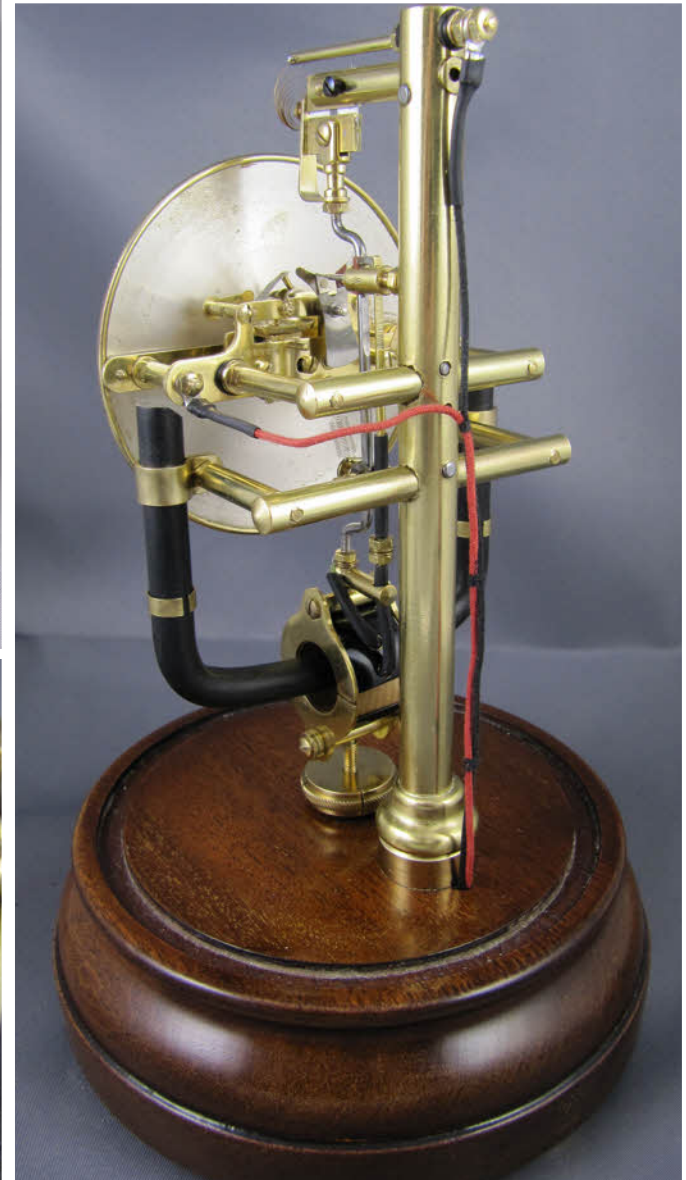
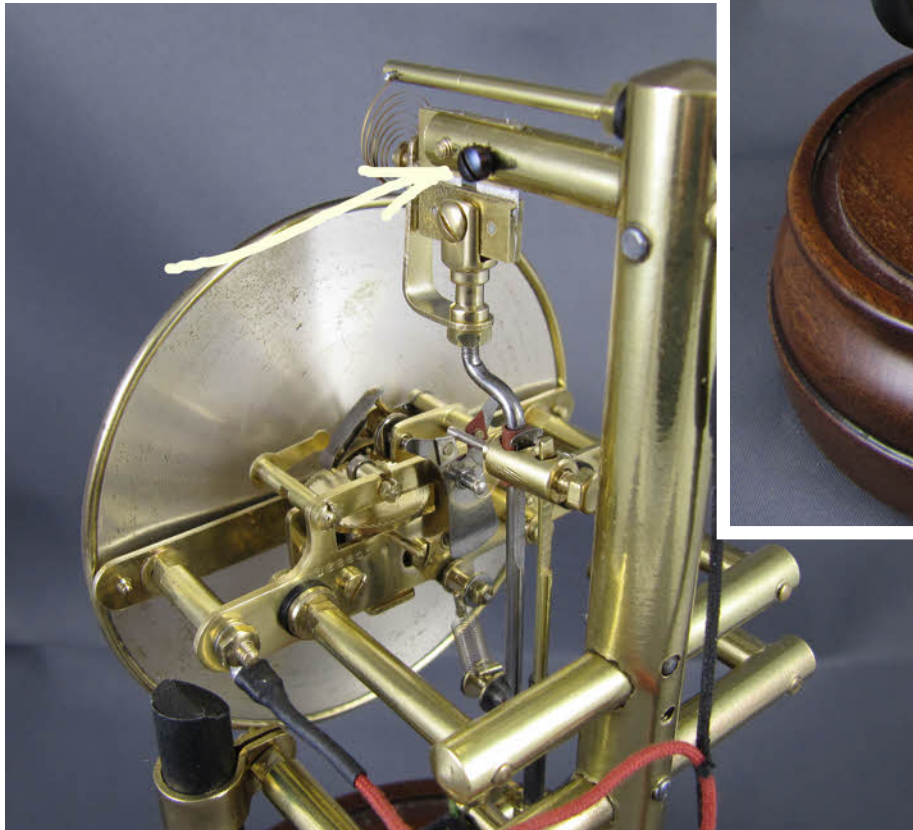
The movement and rear of the completed clock.

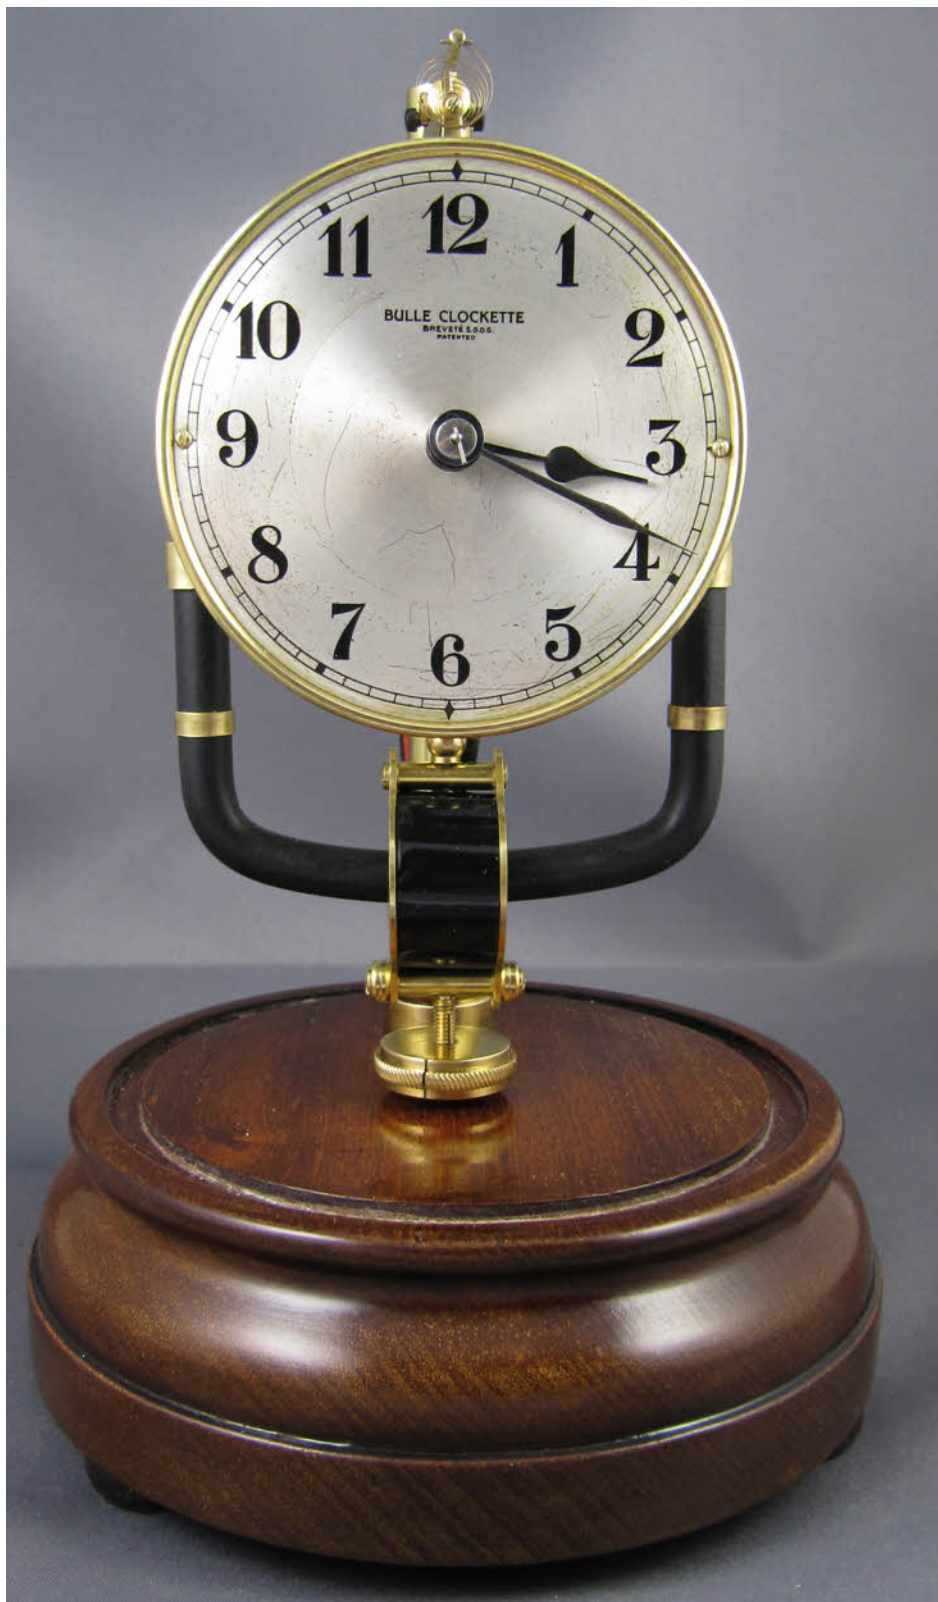
The completed clock.
