Bulle Clock Serial Number 190613

# Restoration of Bulle Clock Serial Number 190613

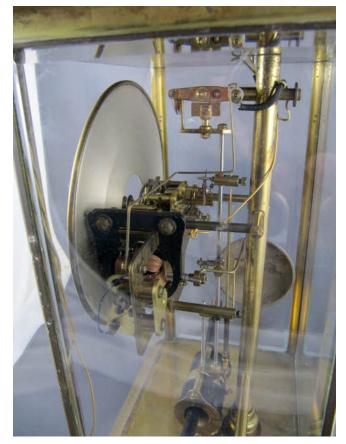
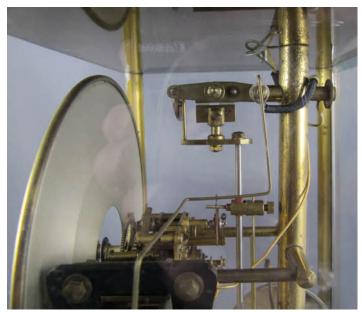
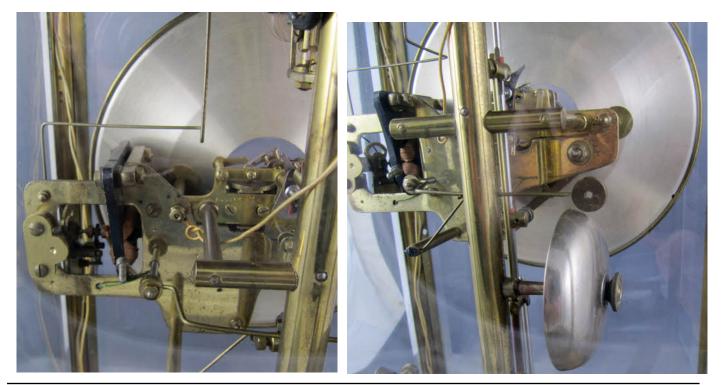
This group of photos show the movement before dismantling. Note that the strike mechanism is the same as s/n 255595. The bell is attached to the side of the frame and looks to be a typical bell from a French "Black Slate" clock.

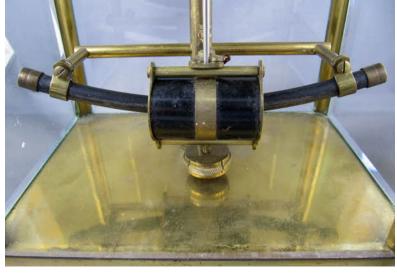
The base plate has no visible holes for screws so it can only be held in place via the four pillars which must be screwed in from below. Note the decorative brass end caps to the magnet. These are typical on four glass Bulle clocks.

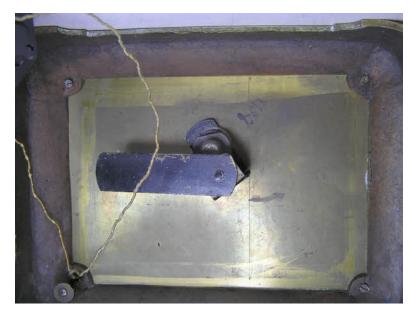
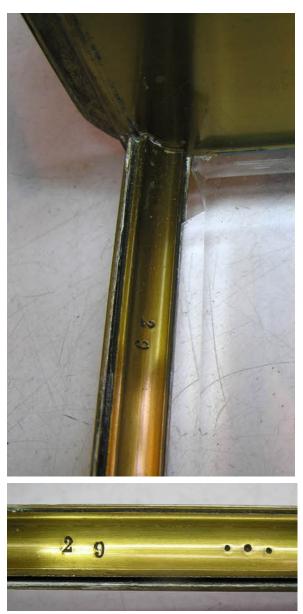
Each of the four pillars is numbered and punched with small dots to show their position in the case.

The case plinth and base plate are shown with screws in place which extend through both to sure each pillar in place. There is also an extra hole on the door hinge side which allows the wiring allows the wring to pass through to the battery holder underneath.

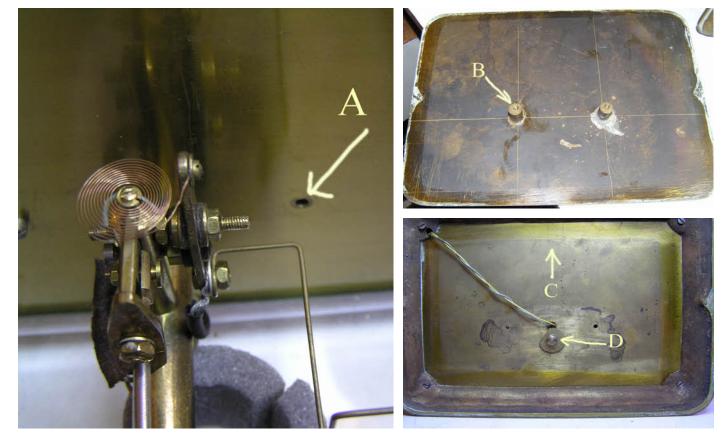
There are two brass plates and one casting that form the top of the clock. The photo on the left shows the polished underside of the first plate with a hole A) which holds the screw which passes up to the second plate B) and secures it to the top of the clock acting as a cover for the wiring. The casting is held in place by the four pillar screws. The final photo shows the the orientation of the clock with the arrow C) point to the front of the clock. The wiring can be seen coming from the rear of the mechanism across the top between the two plates and down the inside of the door frame via the hole in casting. Note the hex head screw D) that secures the movement frame to the top plate.

On the left is the movement and strike mechanism as seen after the dial is removed. On the right is a close up of one of the magnet end caps.

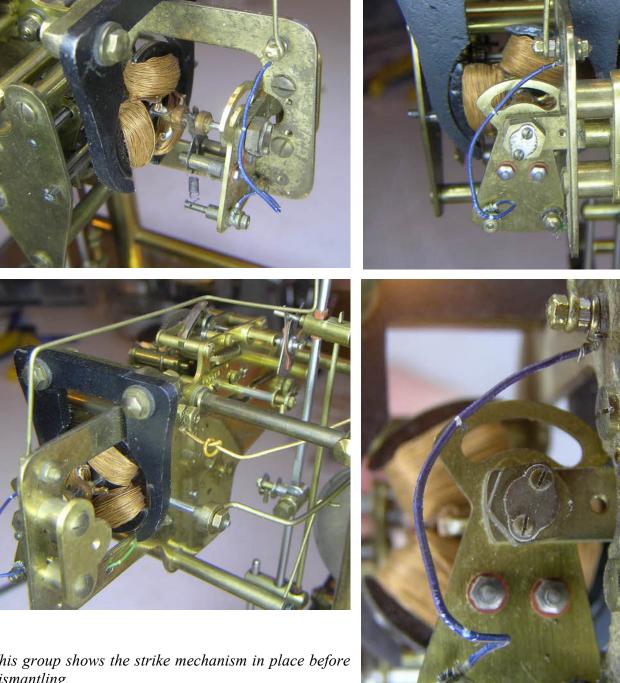
This group shows the strike mechanism in place before dismantling.

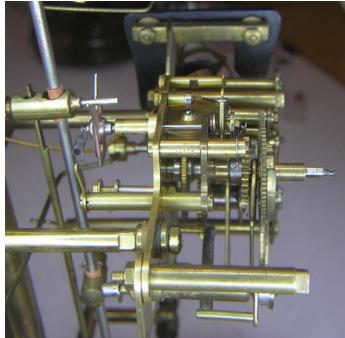
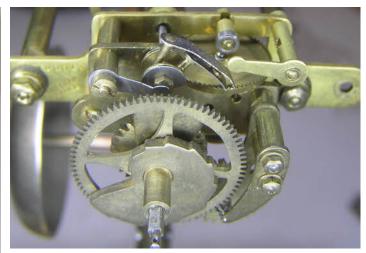
A side and front view of the movement showing the changes to the standard motion work to accommodate the rack strike.

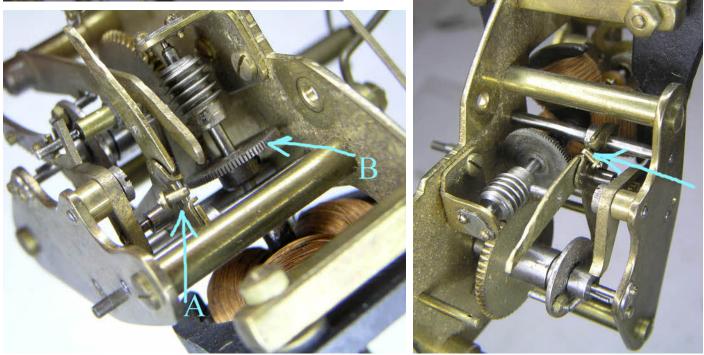
These two photos show the ratchet wheel B) an the remains of the ratchet pawl A). I can only assume that this ratchet was in contact with the wheel at all times and stopped the motor from running in reverse. The three striking clocks I have seen all have this ratchet removed or made ineffective. It must have caused a great deal of wear to the ratchet and proved to be useless after a short time. The ratchet wheel is therefore redundant and can only act as a small flywheel for the motor arbour.

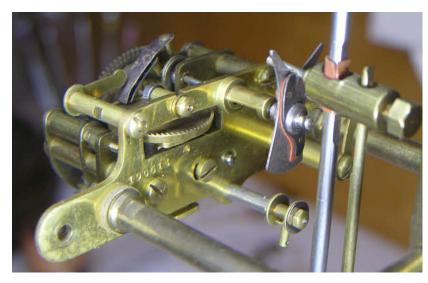
Rear view of the movement after the strike mechanism is removed.

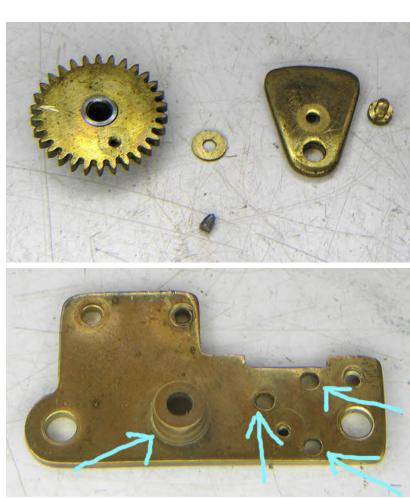
This group of photos shows the motion work and the changes to the movement plate to accommodate them.

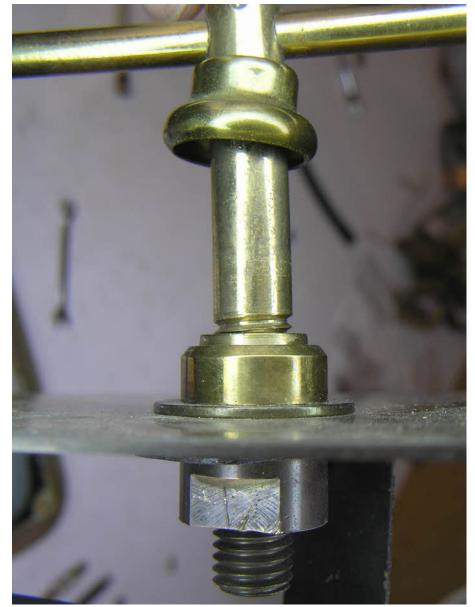
Here we can see the method of securing the frame to the base plate. A large nut and washer either side of the base plate allows the frame to be positioned as required between the top and bottom plate allowing for free pendulum swing and the securing screw at the top of the frame.

Above is the coil assembly which proved to be in good order with a good resistance.

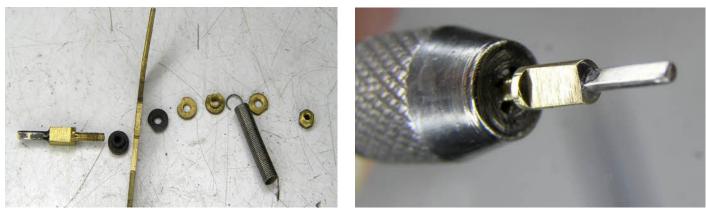
The two photos below show the silver contact pin assembly and a close up of the contact pin itself which is D shaped so that when disengaged at rest it does not make contact with the silver piece on the rack and therefore the motor is isolated and stops.

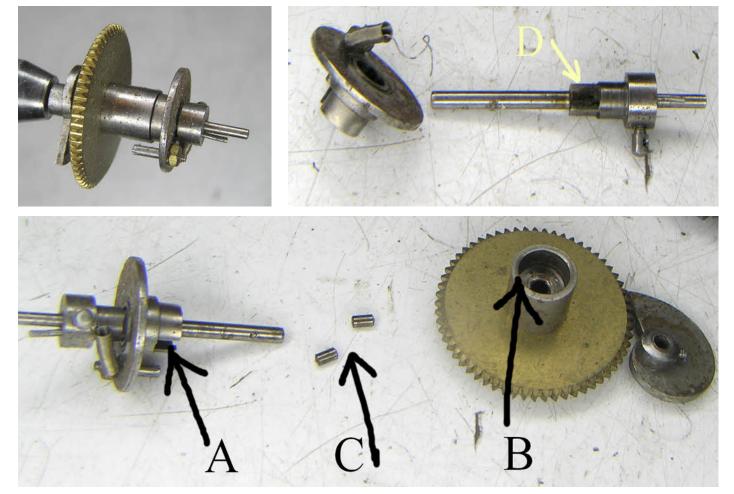
The hammer and rack lift arbour. The two rollers C) sit in the two recesses A) which are enclosed in the shell B) and engage with the square D). The wheel is driven directly by the motor worm wheel.

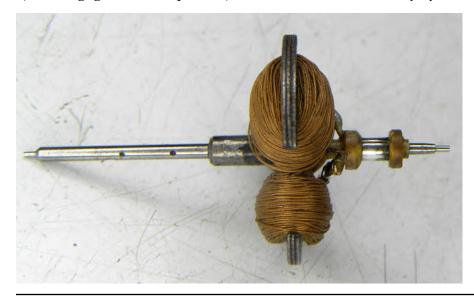
The motor arbour showing the two dimples for locating the grub screws which accurately position the ratchet wheel and worm.

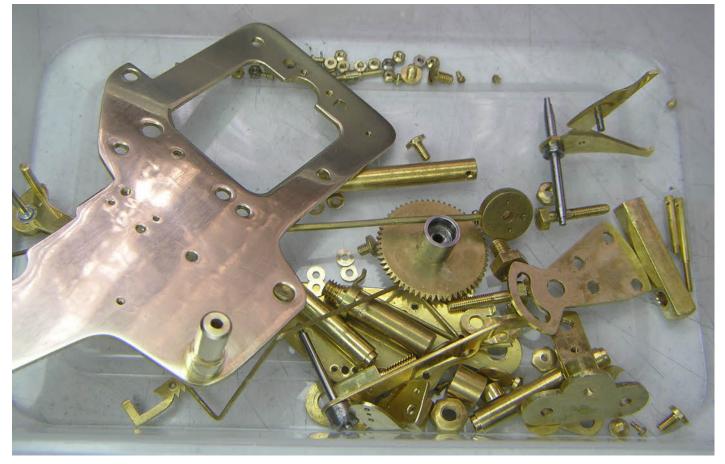
The strike mechanism which has now been completely stripped and cleaned in the ultrasonic tank ready for polishing.

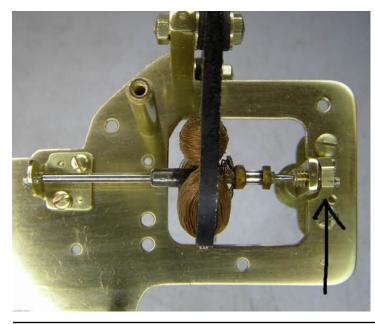
At left is the motor arbour being tested for end play via the hexagonal nut. When correct then the contact plate shown on the right can be added and the springs connected.

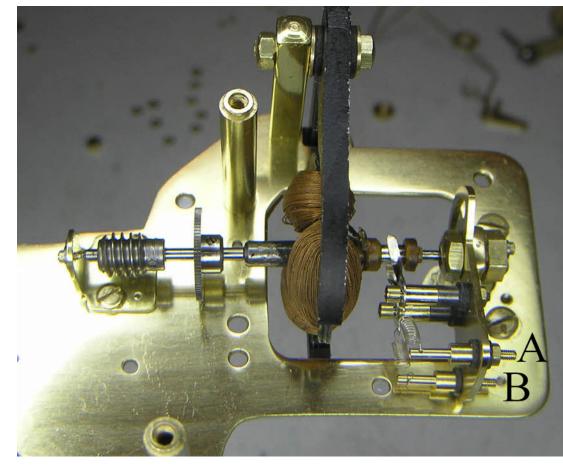
Here we see the striking mechanism main plate with just the motor added ready for running tests. A 1.5v battery is connected to terminals A and B and the motor should run easily. The end play is check for a small amount of movement before both the end pivots are oiled.

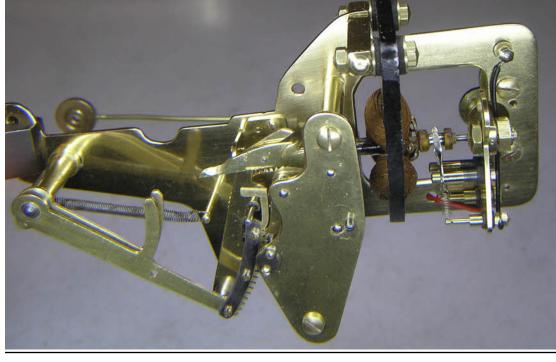
Here the strike mechanism is completed and further tested to make sure the silver contact pin operates correctly by engaging the silver strip on the rack thereby switching the motor on and off at the appropriate times.

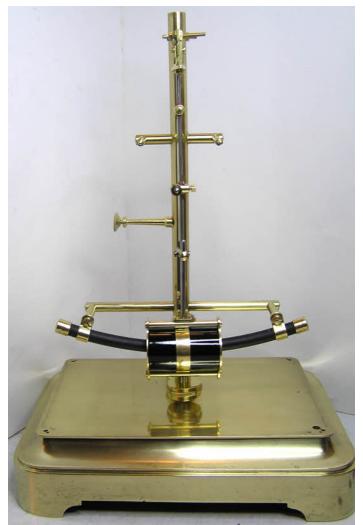
Above is the frame, pendulum and base plate reassembled to test height and freedom of pendulum movement. The pendulum and magnet can be tested at this point without the movement or strike mechanism.

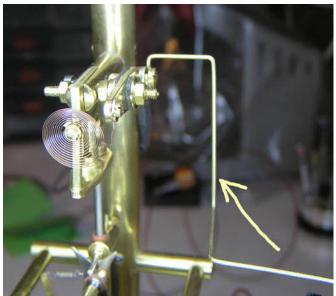
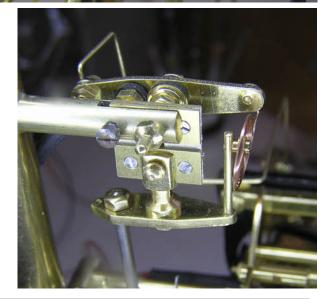
The three photos on the right show the completed movement and strike mechanism re-united for testing the rack drop. The arrow shows the strange method of joining the negative batter terminal to the strike mechanism.

The last photos shows the suspension assembly.

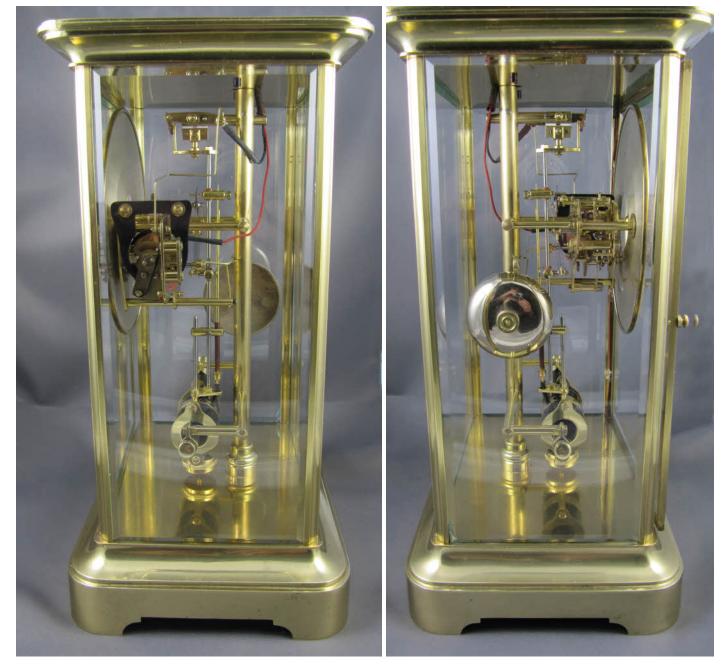
Two shots of the right and left sides of the completed clock.

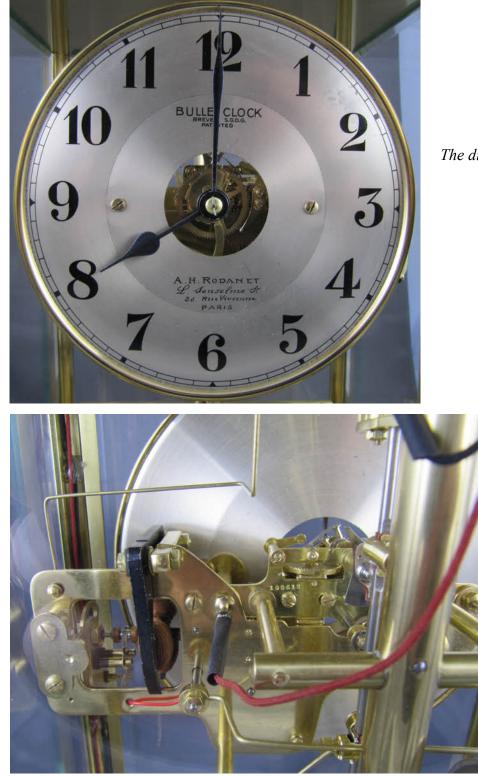
The dial and restored hands.

*The rear of the completed clock.*
