Bulle Clock Serial Number 19185

*Restoration of Bulle Clock
Serial Number 19185*

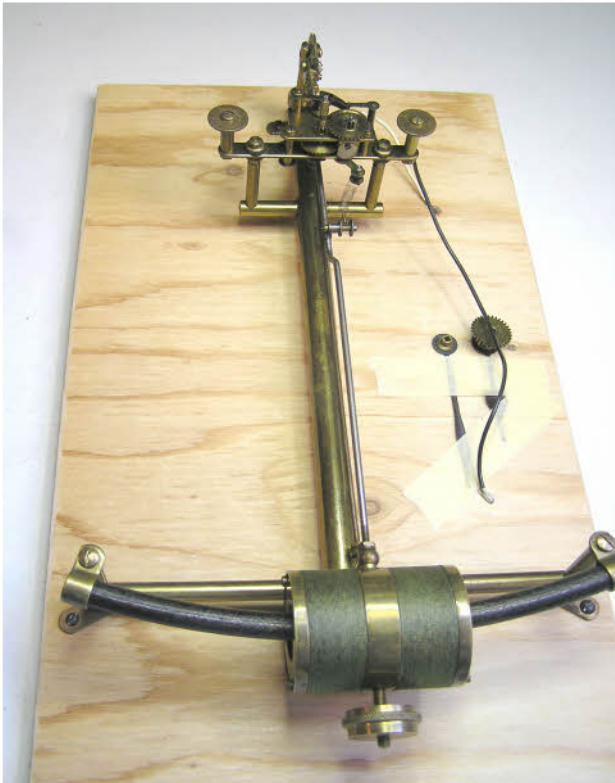
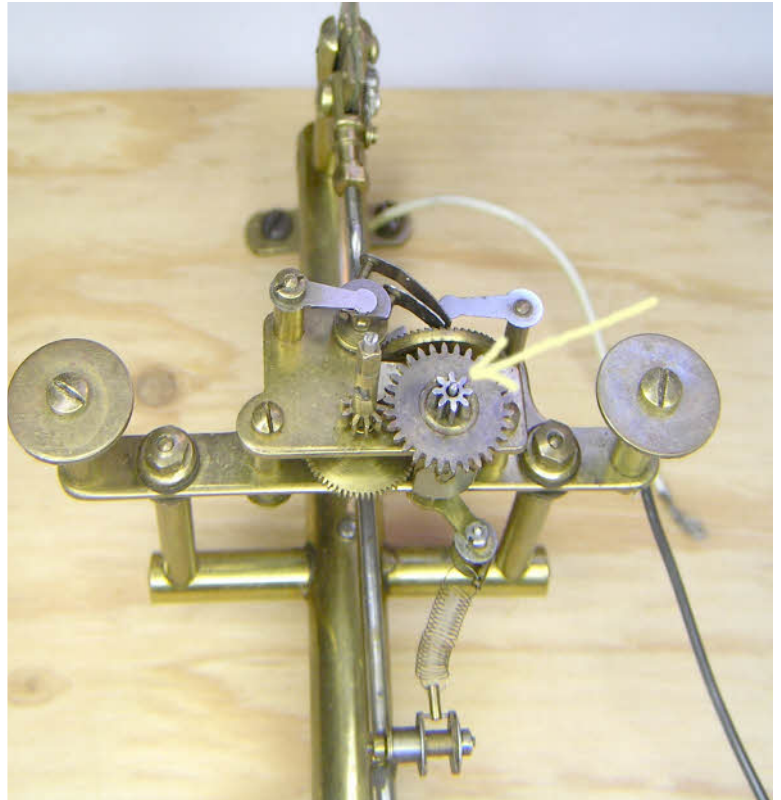
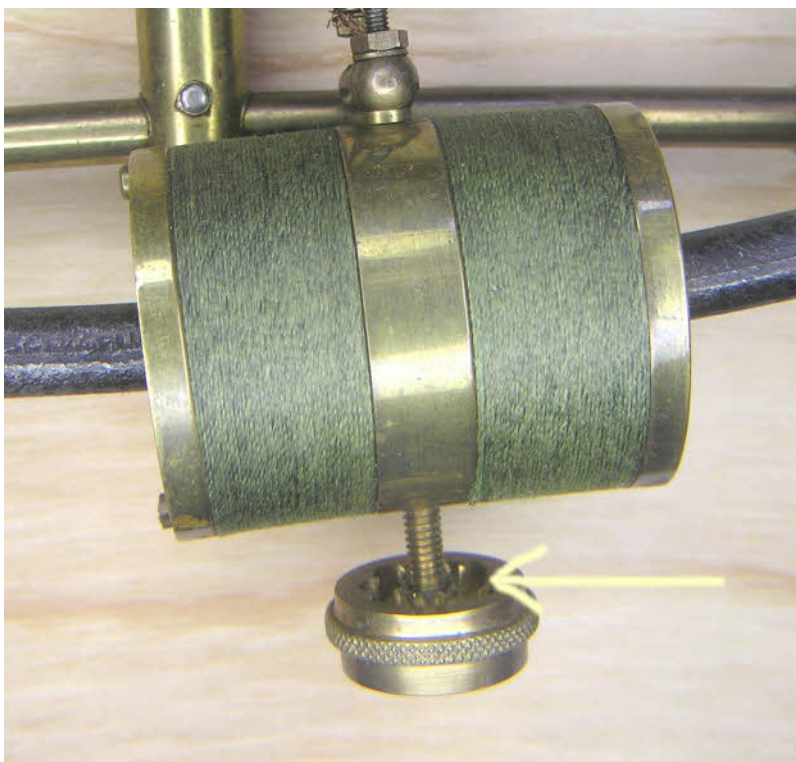
This clock has been delivered well secured to a plywood base. But without the case or dial. The first thing to note is the discolouration of the cord. This looks to be either oil contamination of some form of waxy substance. We'll remove this and rewind with new cord. The second thing is that the intermediate wheel arbour is missing it's retaining collar and it stands rather high near the end of the arbour. This will have to be investigated.

The last photo shows the rating nut has had the centre drilled out to try and reduce the weight. This means we need to investigate why this has been done (usually for no reason other than the clock could not be adjusted correctly due to dirt or bad contacts somewhere) and also we will have to repair the nut.

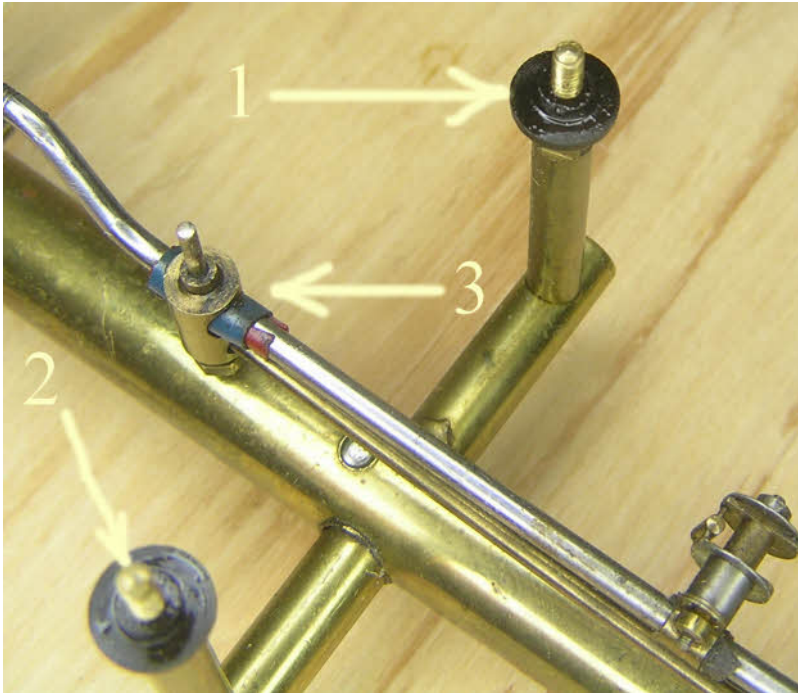
Note the oil saturated insulating washers at 1 and 2. These will be thrown away and replaced with new ones. The insulating fibre sleeve (3) which isolates the silver contact pins assembly is also missing and has been replaced with what looks like two pieces of blue and red plastic.

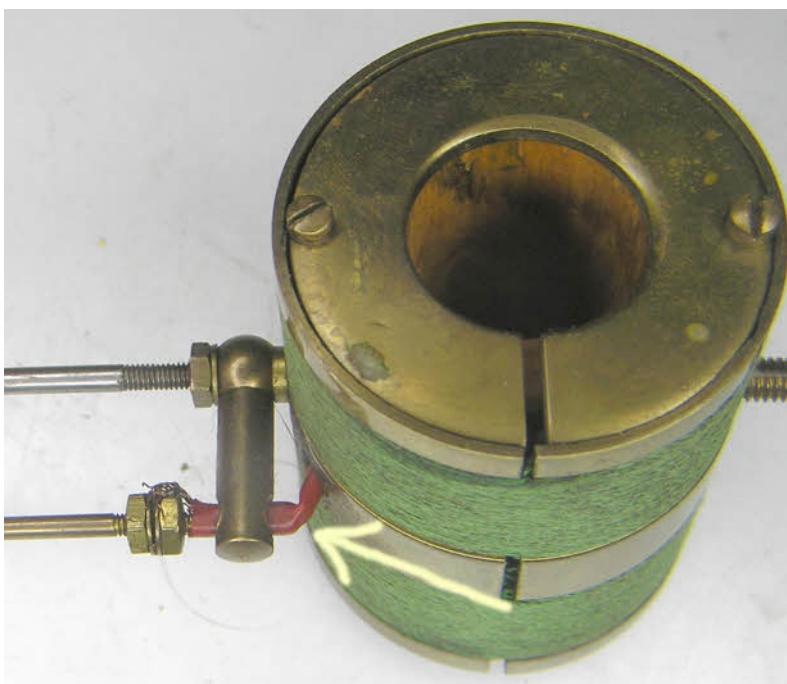
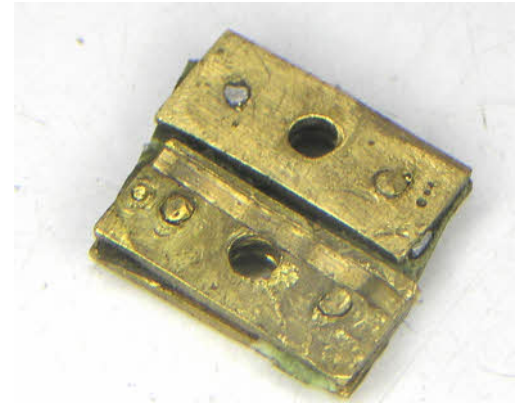
The photo above shows the mangled remains of the suspension which has been roughly riveted back together with one of the chops "inside out". You can see the slot where the strip of lead should be.

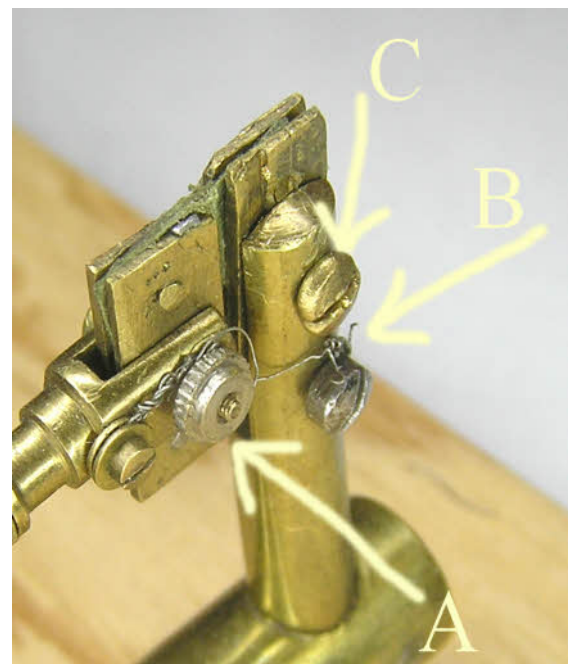
The suspension assembly is also in need of some "TLC". The screw and nut at "A" and "C" are wrong so I'll turn up new sets on the lathe. The contact wire is too short and attached to "B" instead of "C". The photo left shows evidence that the coil has been tampered with., but it still reads a good 1100 ohms. Hopefully only a minor repair required to the lead out wire.

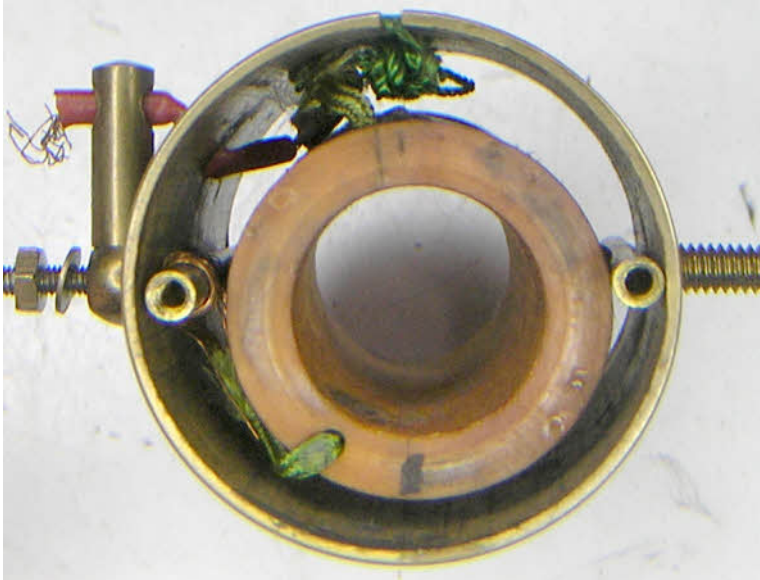
Although it is not clear in this photo the lead out wire to the rear brass pendulum rod is broken and the copper wire has the opportunity to short on the casing. The common wooden bobbin is quite clearly shown and looks to be in good condition. The rims can sometimes be cracked and splintered. The photo below shows that the original coil cover (2) is still in situ and looks undisturbed. The original lead out (3) has had a new piece badly joined to it under the plastic sleeve (1). This will all be replaced.

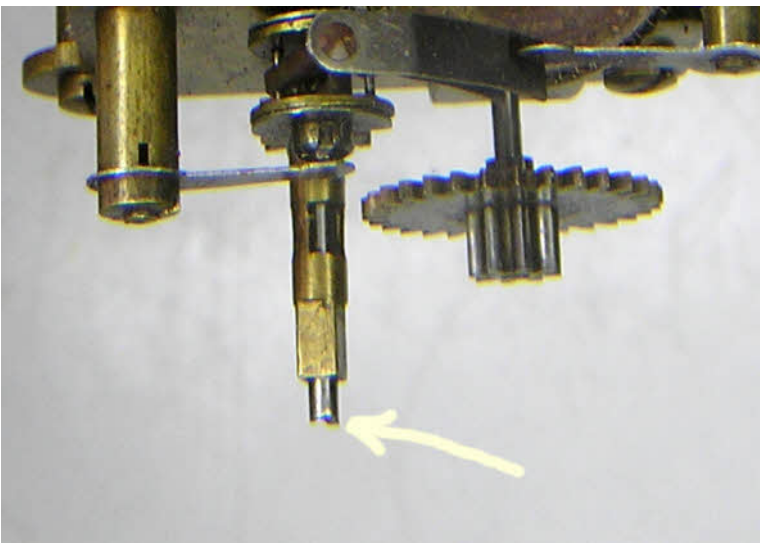
This photo above shows the centre minute arbour has broken off at the point where the pin hole has been drilled through. This has probably happened through excessive force being used to drive in a new pin. We will have to see if there is enough of the arbour left to clean it up and drill a new hole further down. It may necessitate removing a small amount of the collet behind the minute hand.

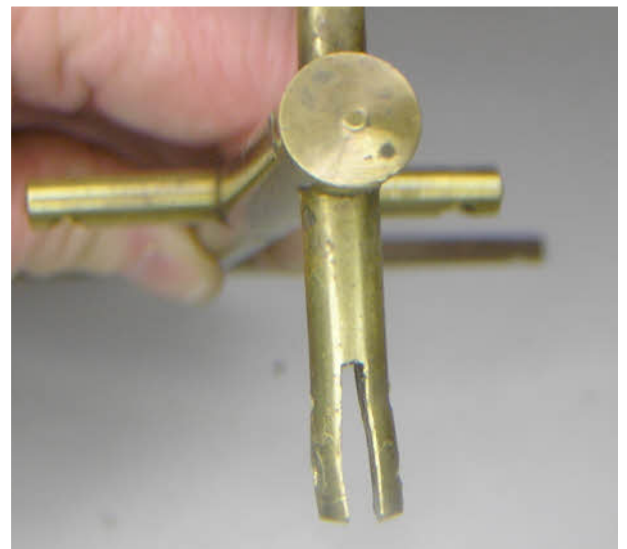
This last photo to the right shows the badly damaged top suspension slot. We'll need to straighten this to accept the new suspension unit.

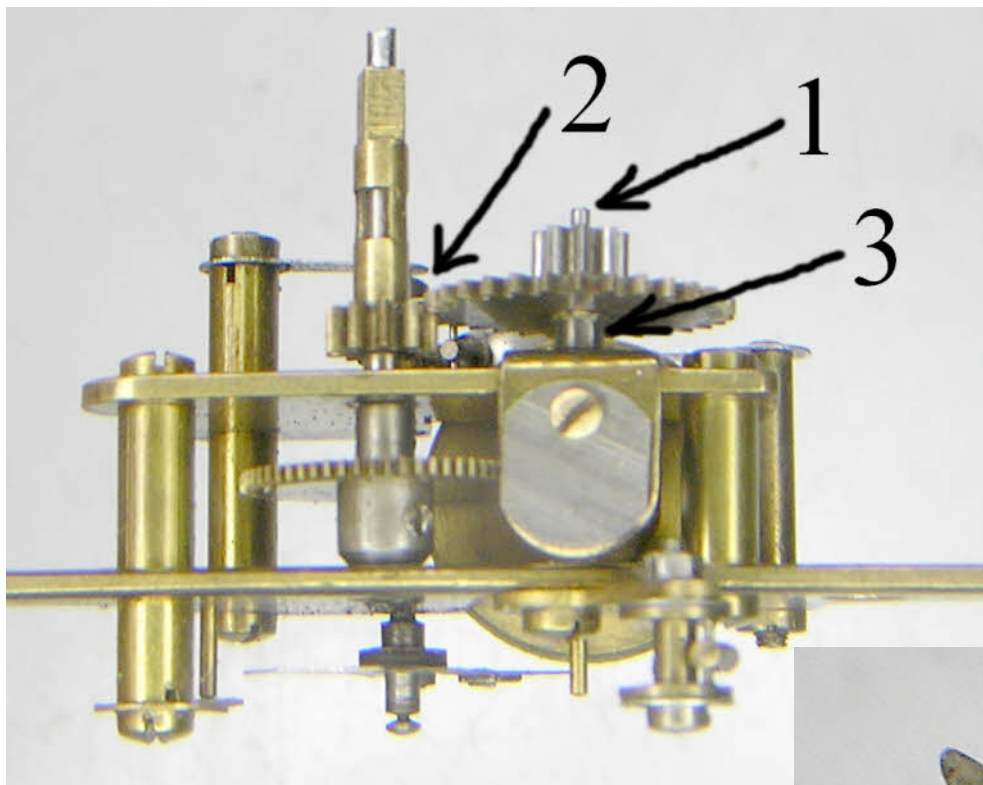
As seen earlier the intermediate motion wheel seen here is rather high on its arbour. There is hardly room left to fit the missing collar(1). At (2) you can see that the wheel is only just engaging the canon pinion. All this seems to be because a small steel collar (3) has been fitted on the arbour upon which the wheel sits. This looks rather dubious and we shall remove it and check how the wheel sits. The rest of the movement looks to be in good condition.

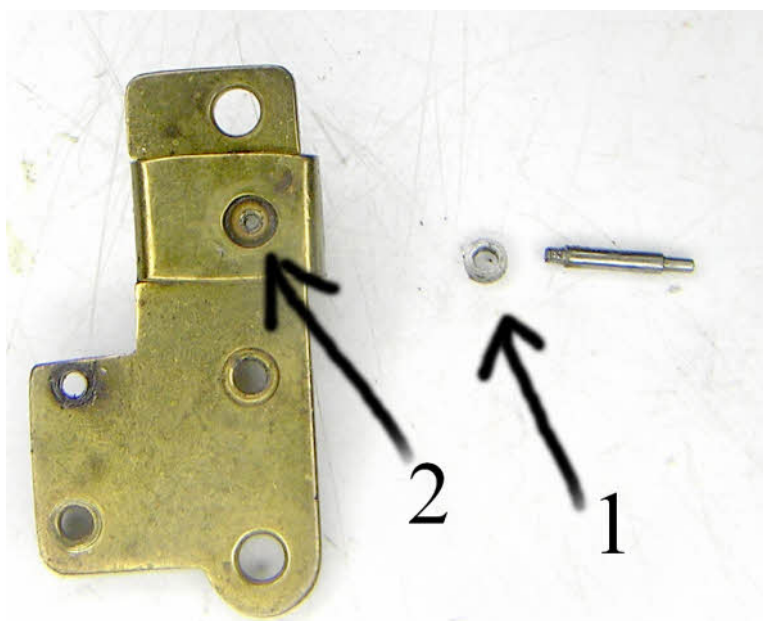
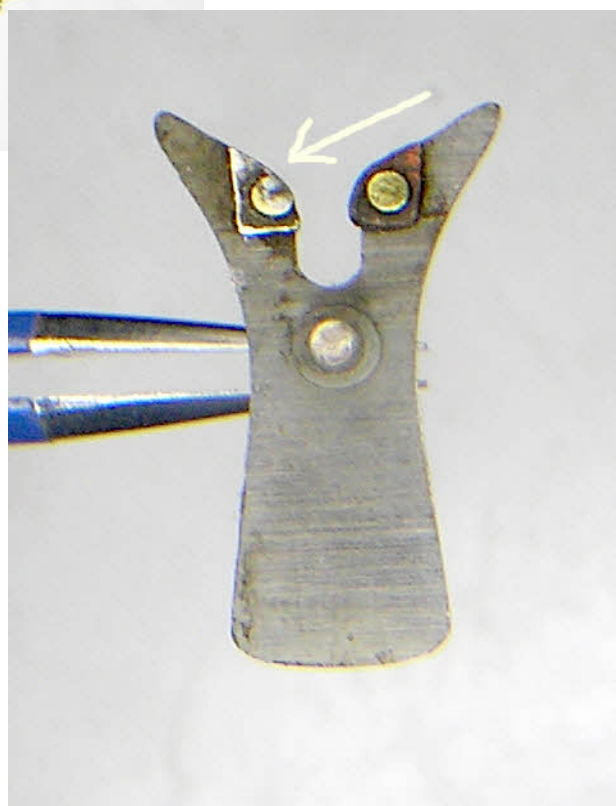
Once the movement has been stripped we can see the culprit. The small steel washer (1) was floating on the arbour (2) and I cannot see any reason for it.

The contacts on the fork are well worn. The silver contact has even worn down the rivet and the steel fork wing. The fork will be replaced.

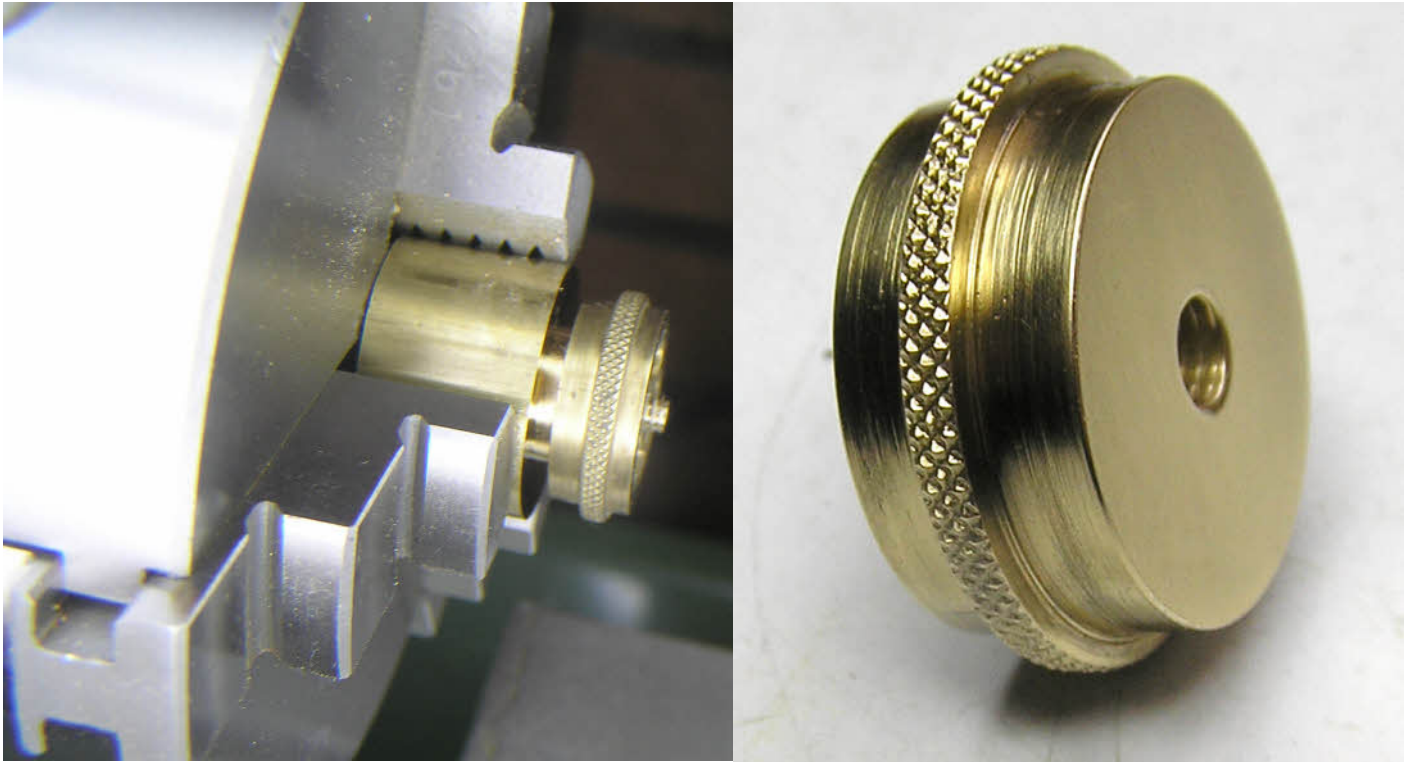
The rating nut mounted on an a brass threaded mandrel ready for turning down. The drill holes are slightly deeper than the knurled centre ring so I will extend the bottom half slightly to compensate. The photo top right shows the finished nut.

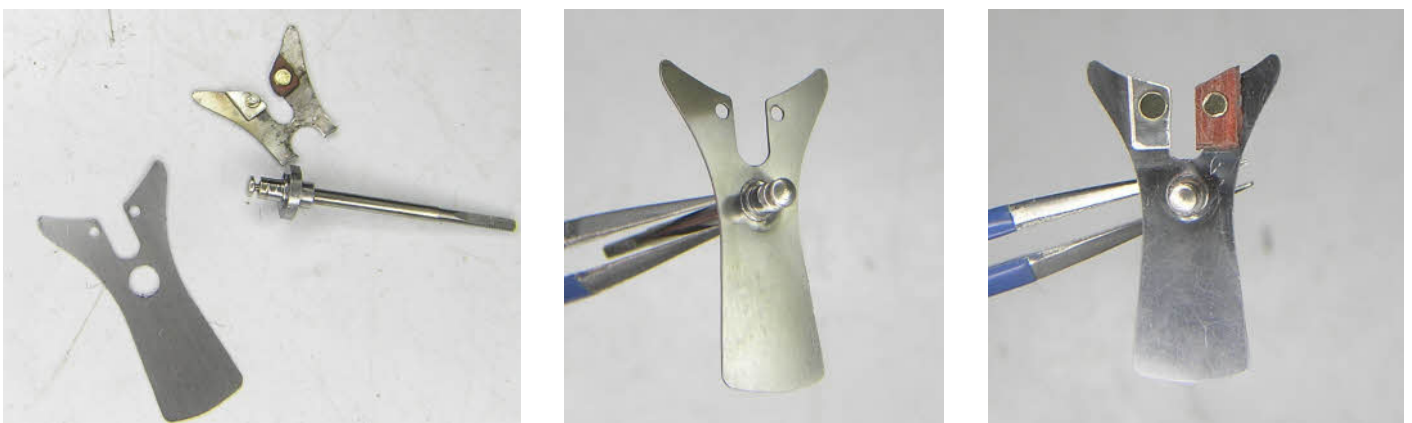
The stages in replacing the fork. The existing arbour is in good condition. It's just the fork that is badly worn, so the old fork is removed and the spigot on the arbour turned down to the diameter of hole in the new fork. The new fork is then riveted on and checked to be both secure and tight. The final photo shows the two new contacts, one of silver the other of fibre, riveted in place and ready to be filed down to their working size and shape.

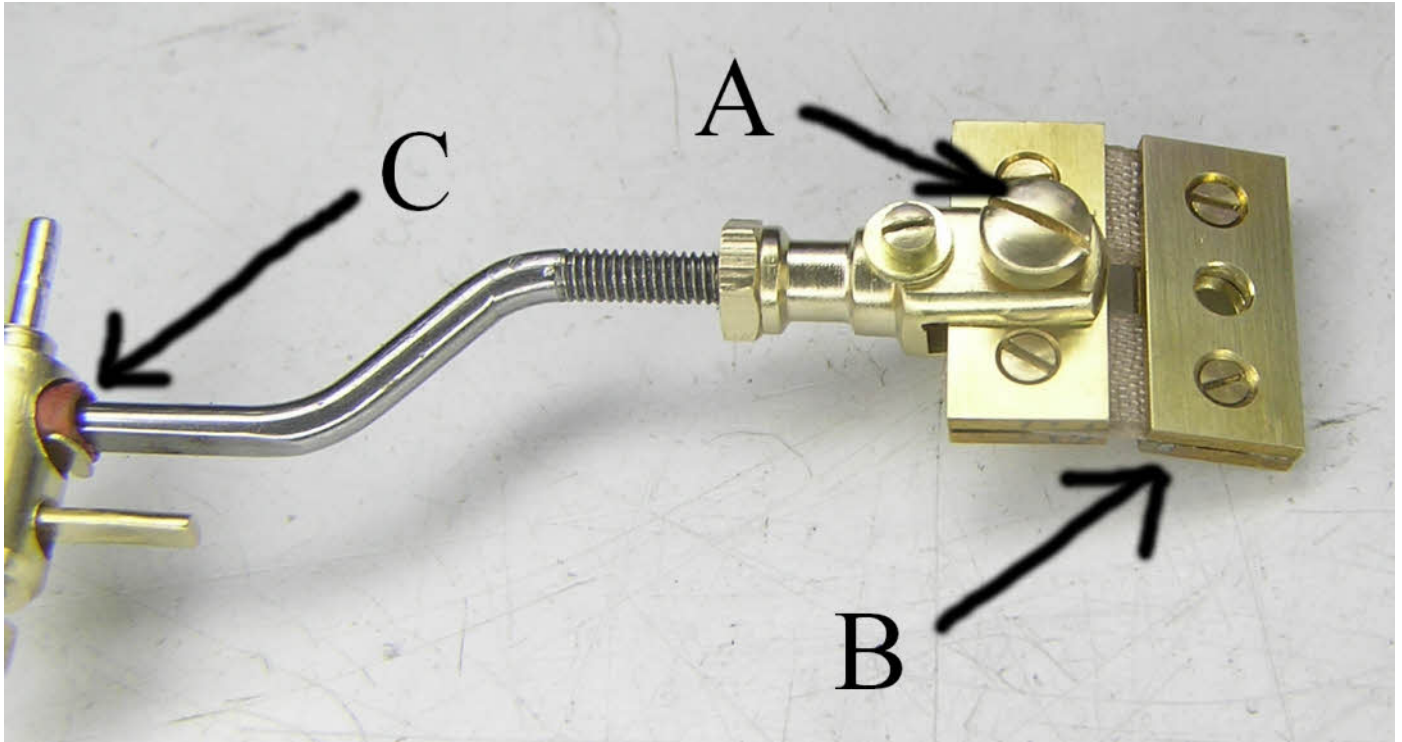
The new parts "A" and "C" fitted to the pendulum together with the new silk suspension "B".

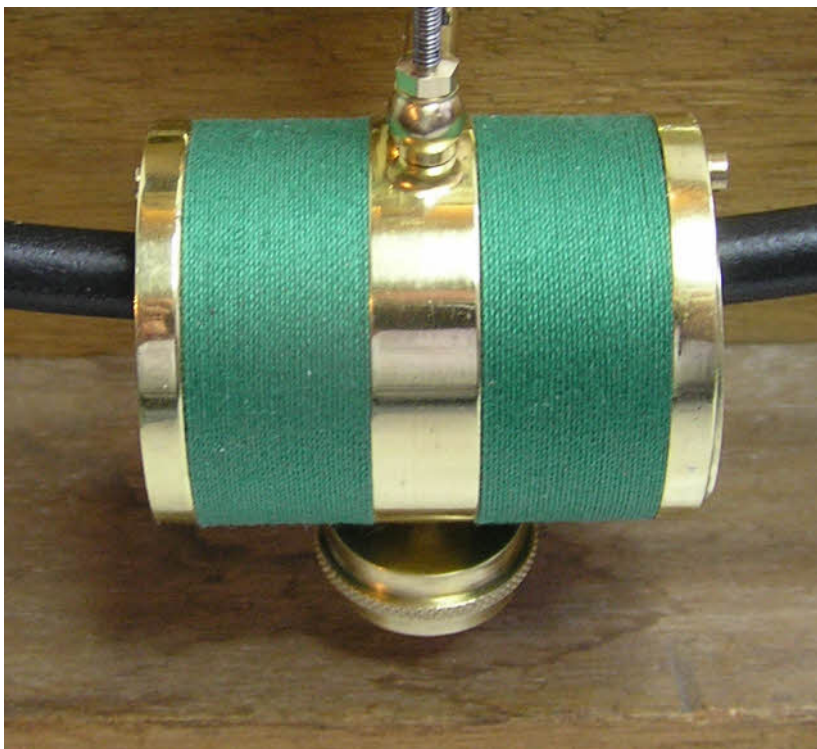
The pendulum coil casing rebound in cord with the rating nut in place. This nut is unusual in that it has no quarter cuts around the circumference. I have come across a few of these nuts with exactly the same size and characteristics so I see no reason to suggest that they are anything other than original.

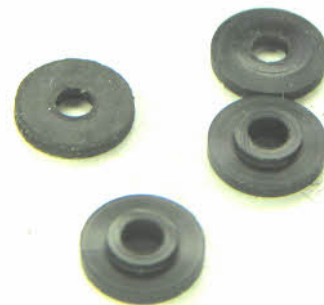
The new set of insulating washers ready to fit.

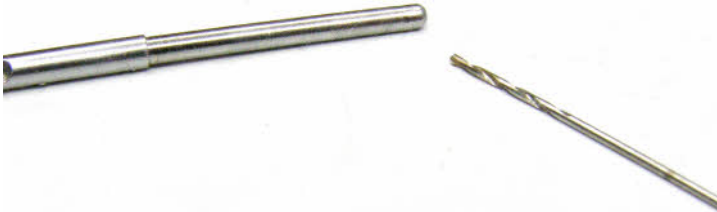
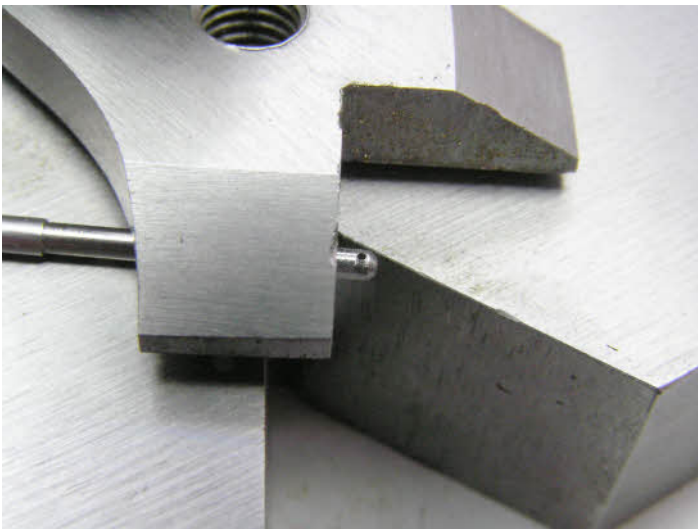
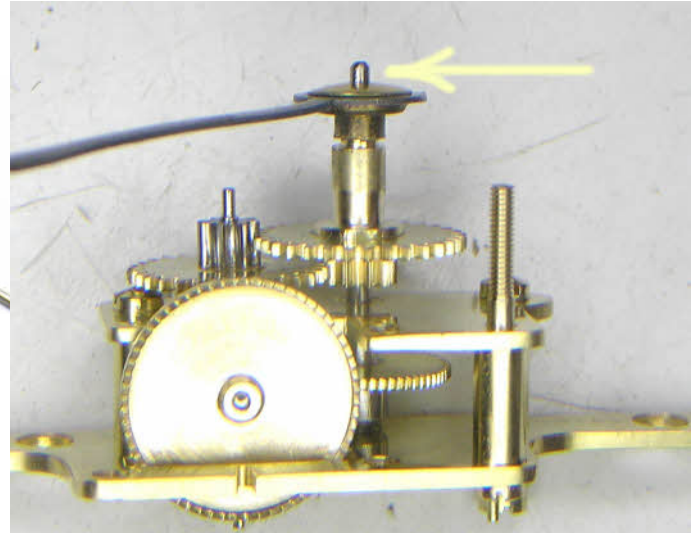
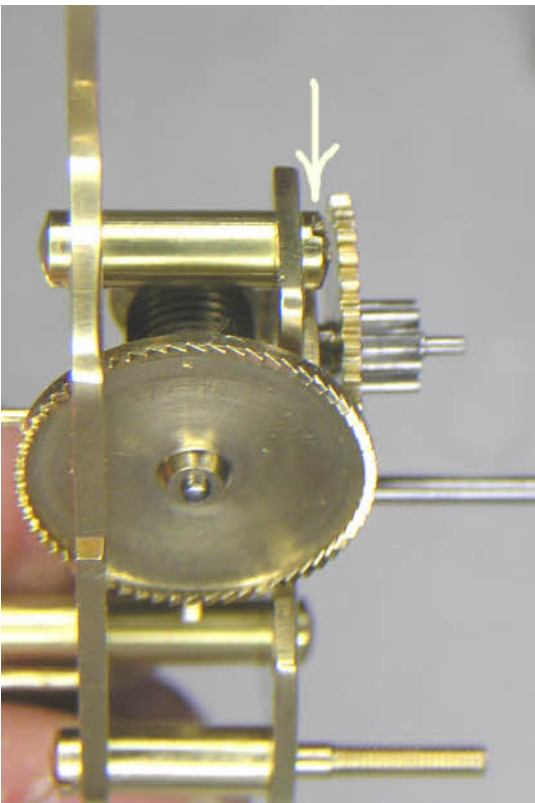
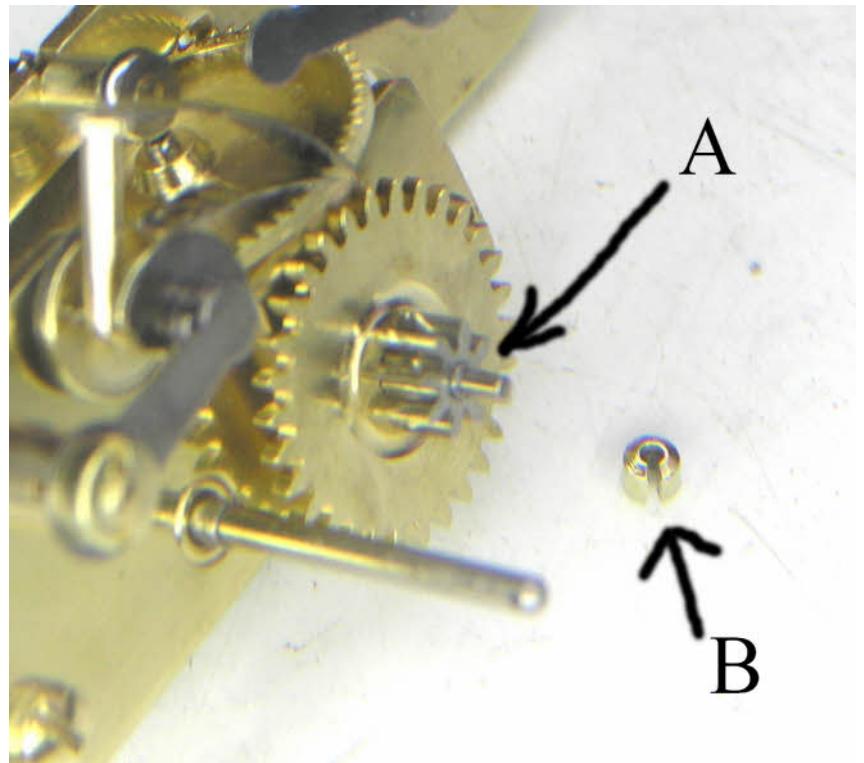
The photos above and left show the stages in drilling the new pin hole in the minute arbour. We had to reassemble the movement to check there was enough of the arbour left to accept the hole (arrowed above). Below we see the ample clearance for the intermediate wheel (arrowed bottom left) now the steel collar is removed The new brass retaining collar is shown "B" ready to locate on the arbour "A".

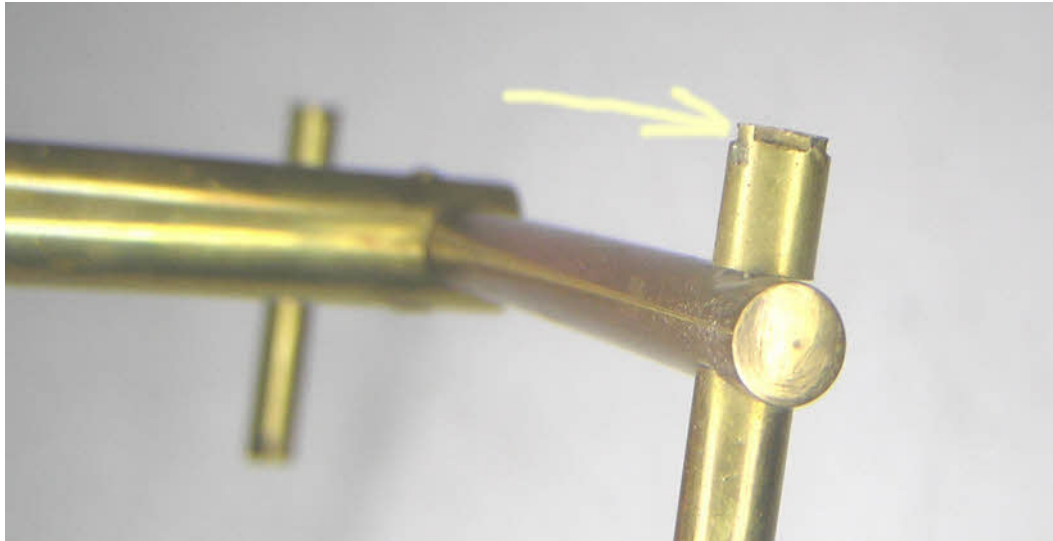
This clock is obviously meant to be case mounted as the rear of the frame has short extensions that carry short plates so that the whole clock can be screwed to a back board. The arrow shows that the extension have been filed down to allow the frame to fit the case with the dial positioned correctly to the front of the case.

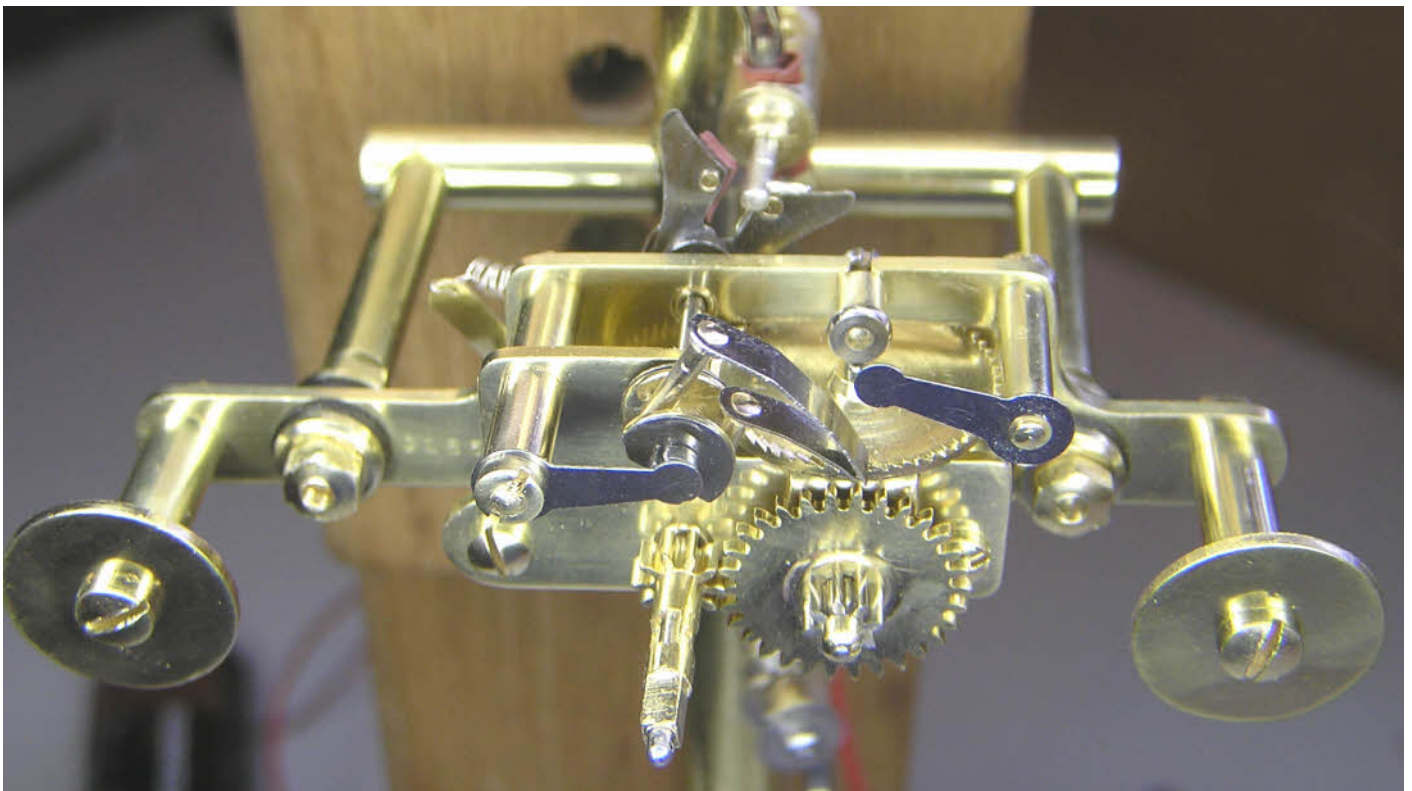
The movement and pendulum fitted back onto the frame for testing alignments and contact pin depths. Note that the depth and front to back positioning of the intermediate motion wheel is now correct. At the rear you can also see the new contacts on the fork arbour. Note the finished shape and height above the fork itself. They are only just sitting proud by approx 0.20 mm.

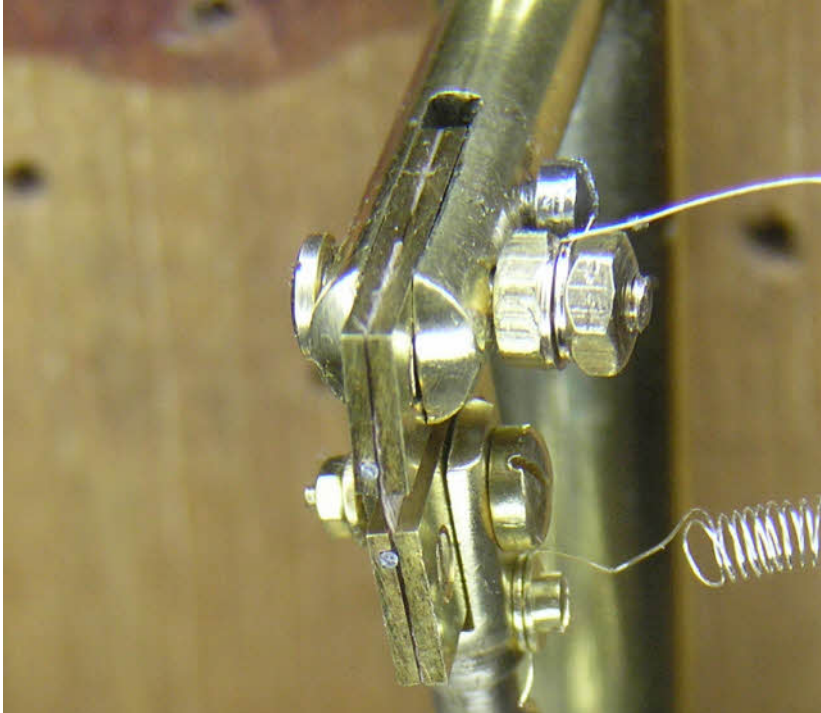
The suspension assembly in place with the correctly positioned contact wire. Note also the suspension mounting slot in the frame has been straightened and tidied up.

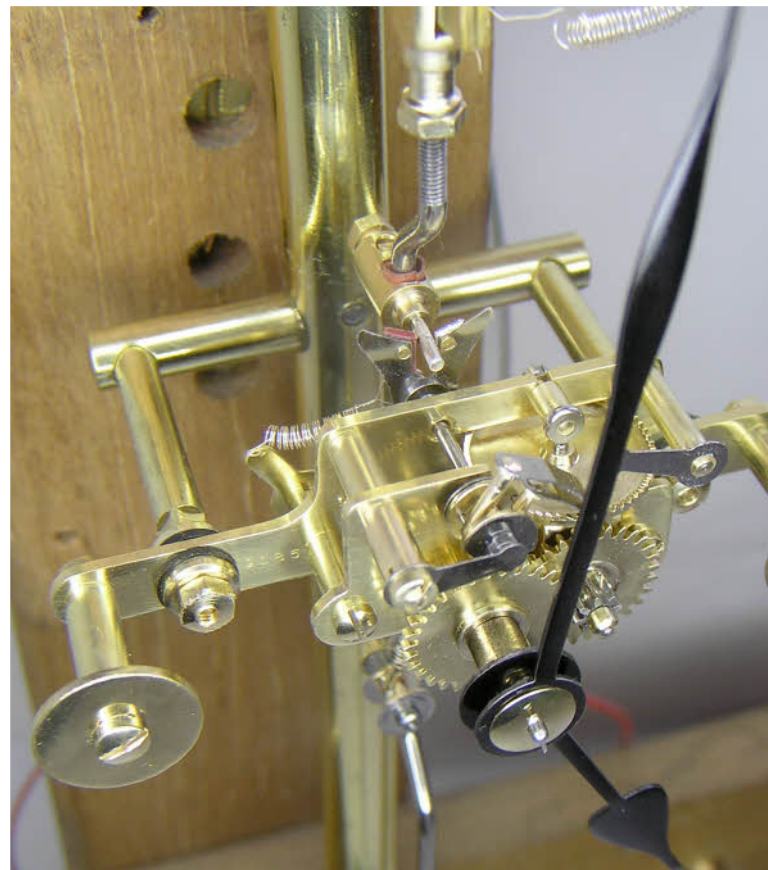
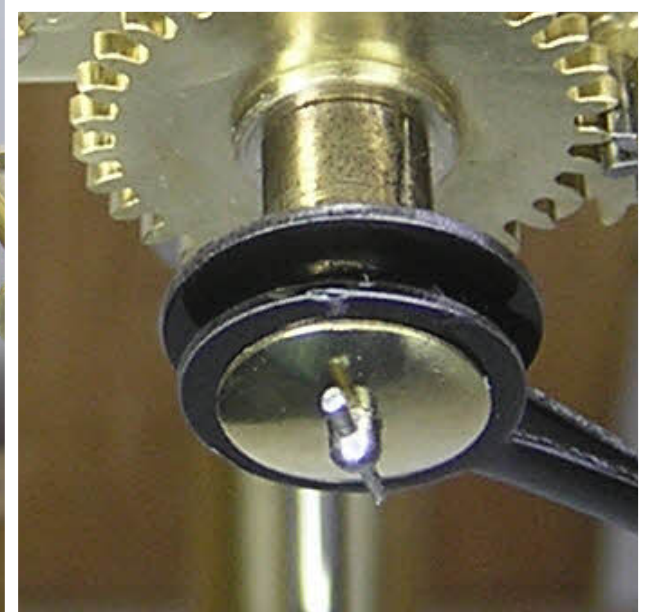
The photo at bottom left shows the movement with hands and collet in place ready for testing. The last photo shows the hand collet in more detail. The pin is centred and a snug fit leaving plenty of metal in the arbour for strength.

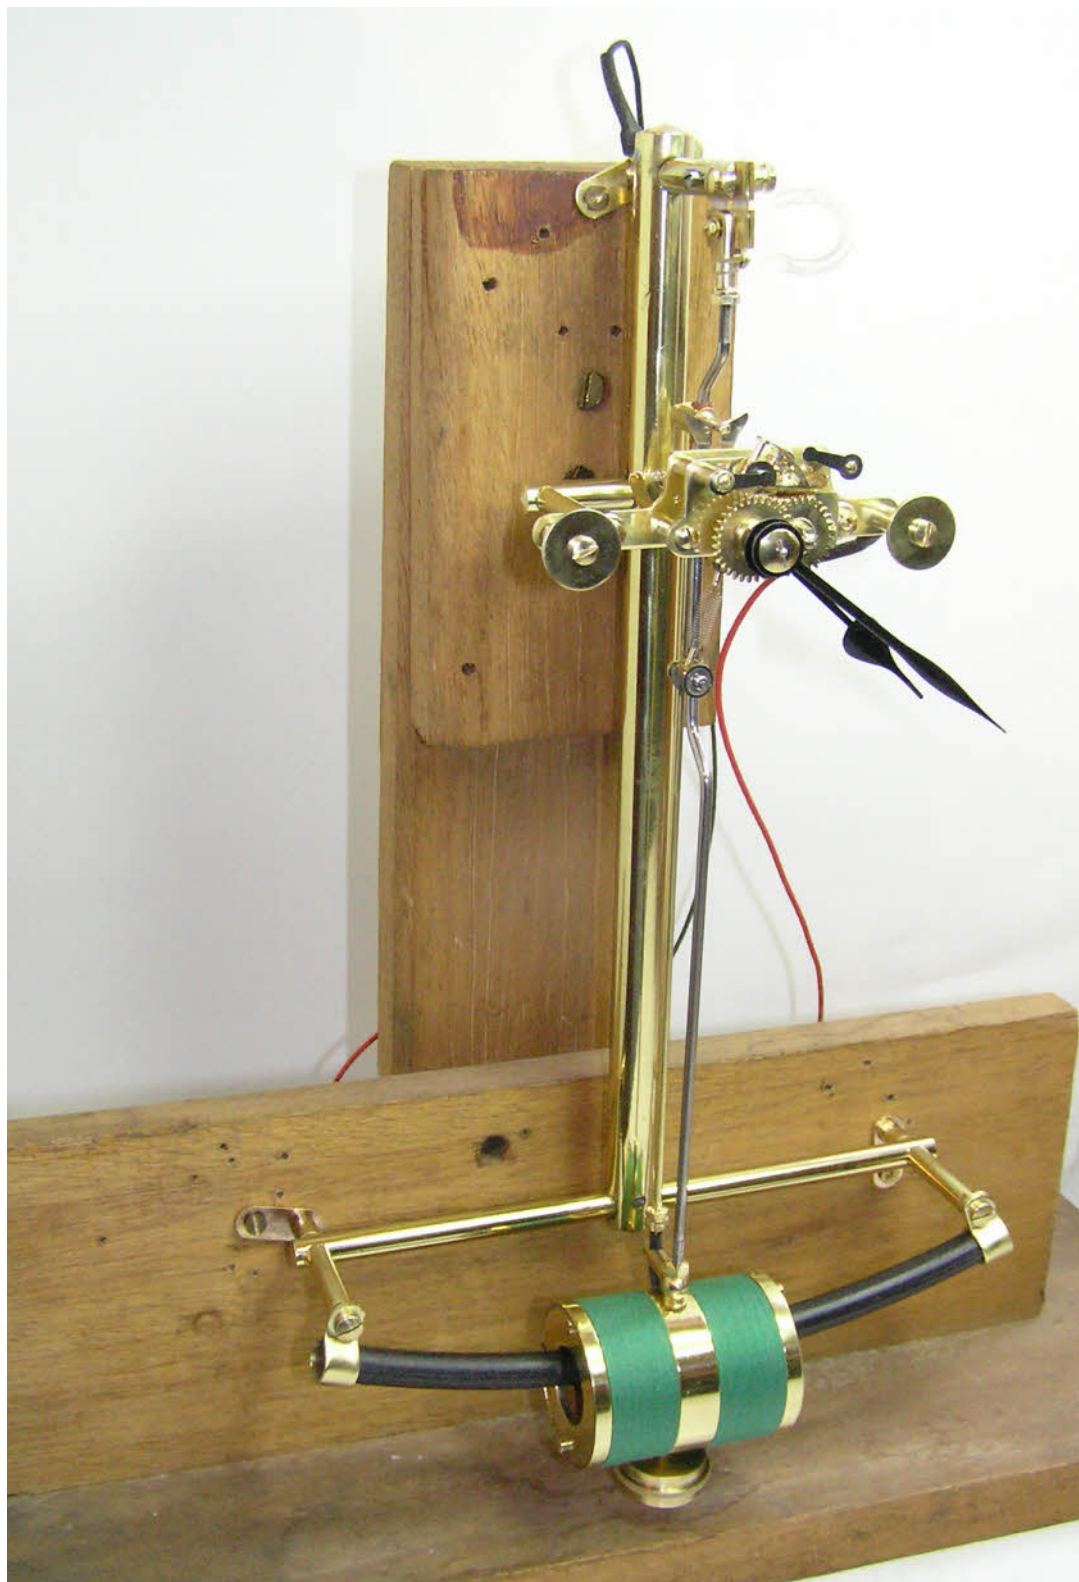
*The finished
clock on the
test stand.*
