Horologix

Bulle Clock Serial Number 192702

*Restoration of Bulle Clock
Serial Number 192702*

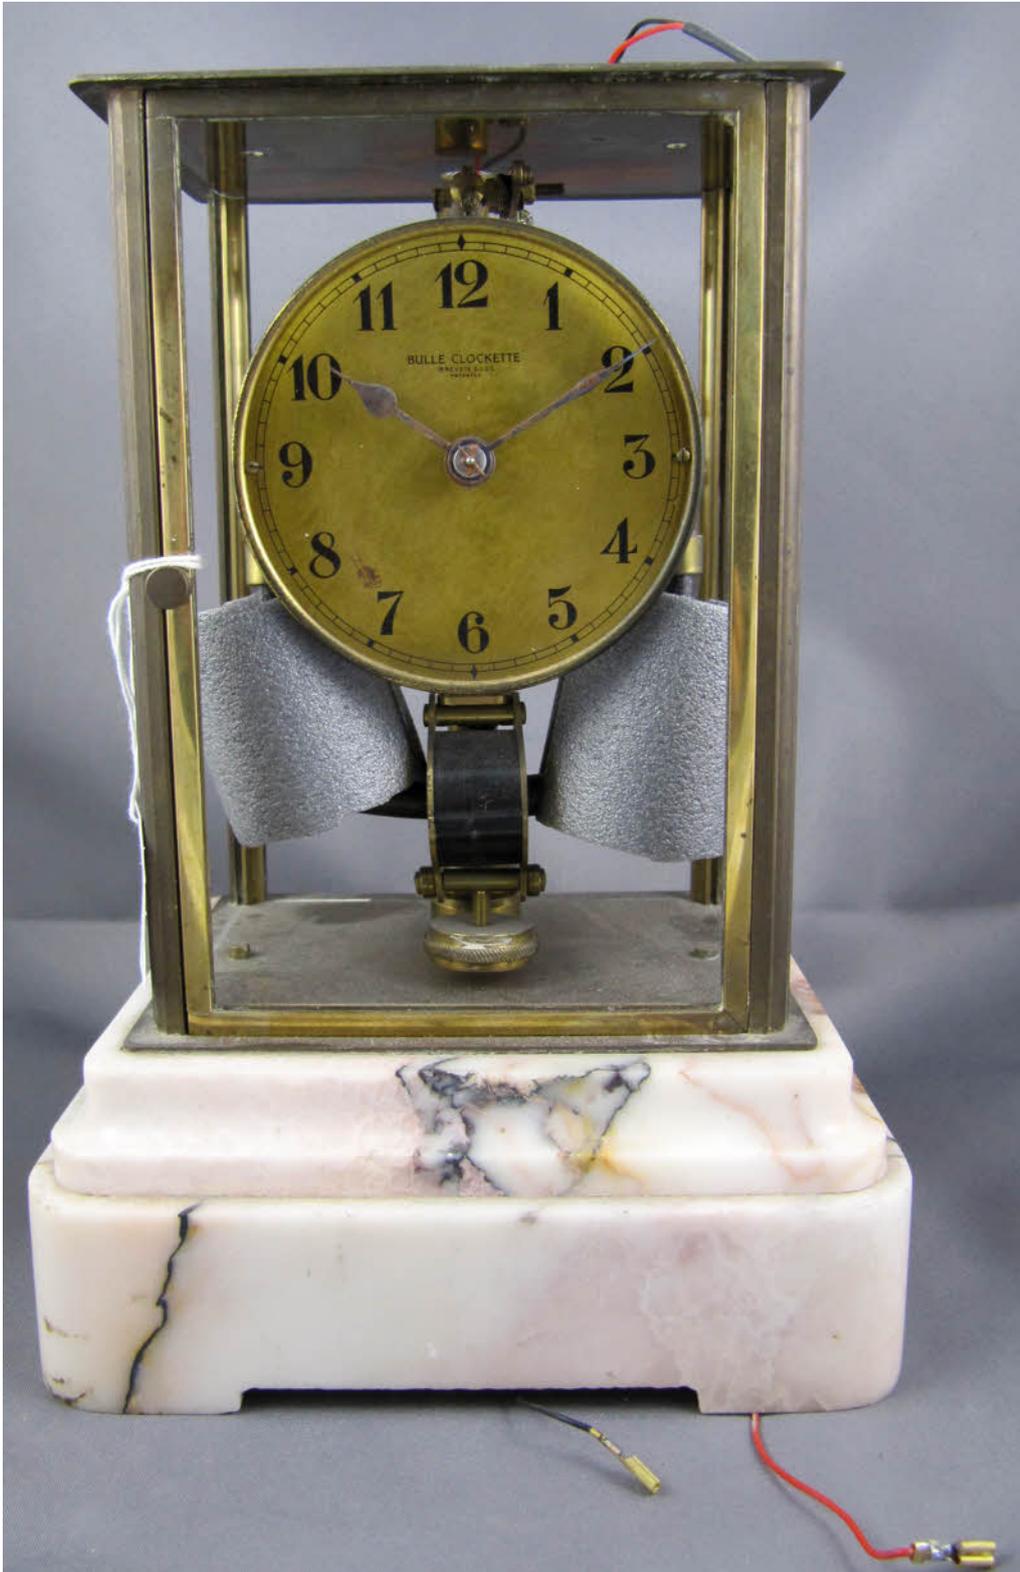
*The clock as delivered.
A short movement in
brass four glass case
with marble top and
bottom. The owner has
kep the top to save on
postage.*

*The glass is missing
and will be replaced by
the owner once the
clock has been re-
stored.*

*Most of the clock seems
intact with no parts
missing although there
seems to be some rust
on steel parts.*

*The hands are original
blued steel but again,
rusty. They may clean
up OK though.*

*The dial is very good
with just a mark be-
tween the 7 and 8
o'clock positions. We
shall see if we can re-
move it.*

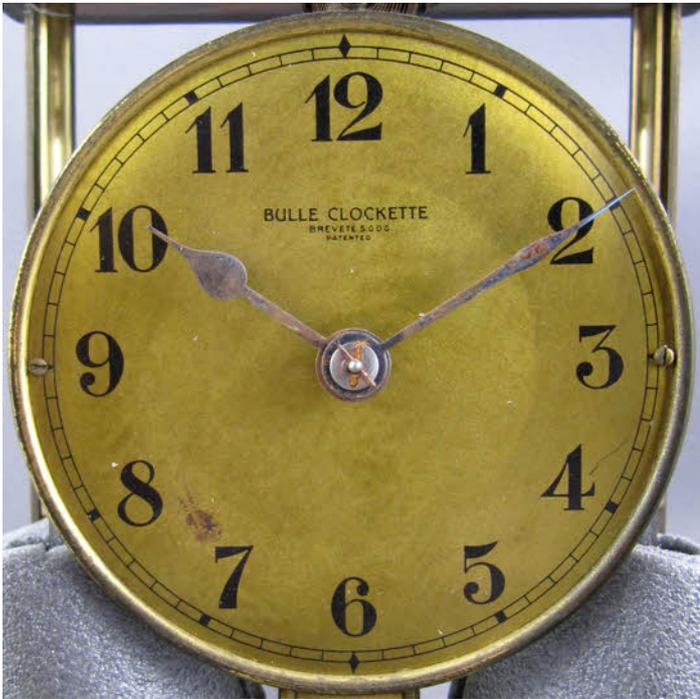
Above is seen the dial and hands in more detail. Note the rust. Below is a side view of the suspension and movement. All seems OK bar the suspension which has had the ribbon replaced at some time.

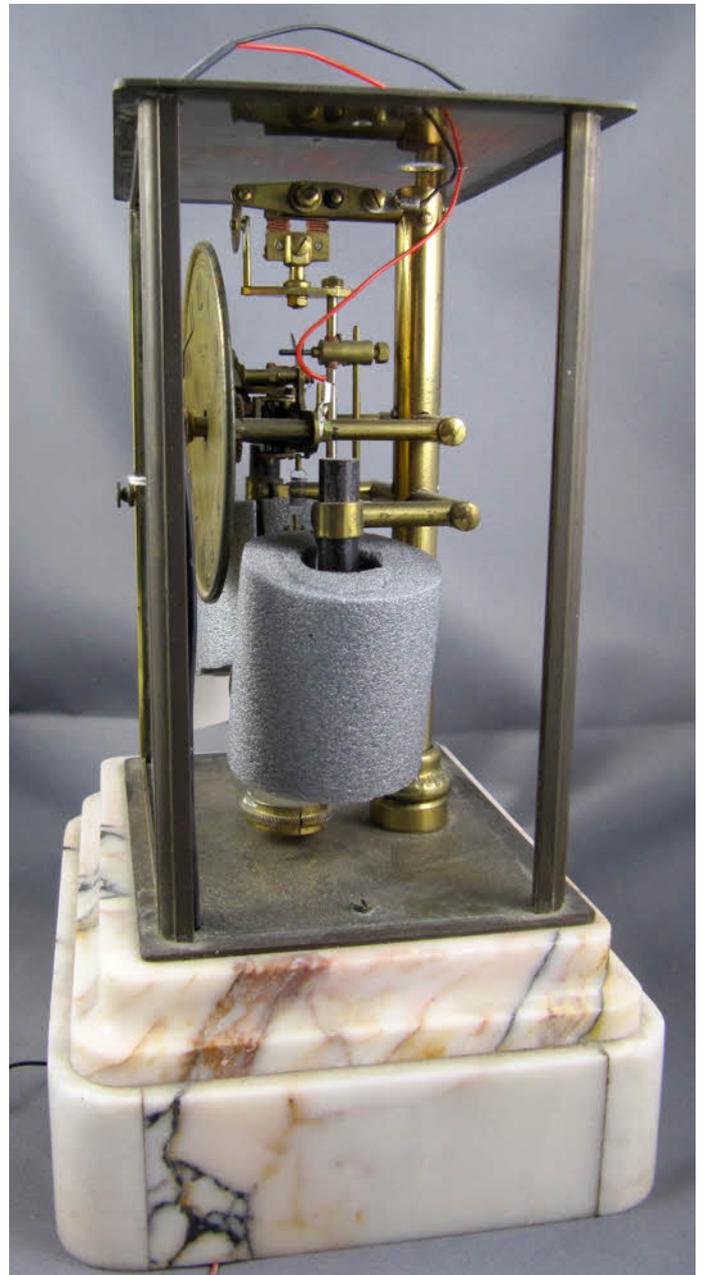
Above is a side view of the clock. Everything looks to be complete with no missing parts. Overall this clock seems to be in quite good condition bas the rust.

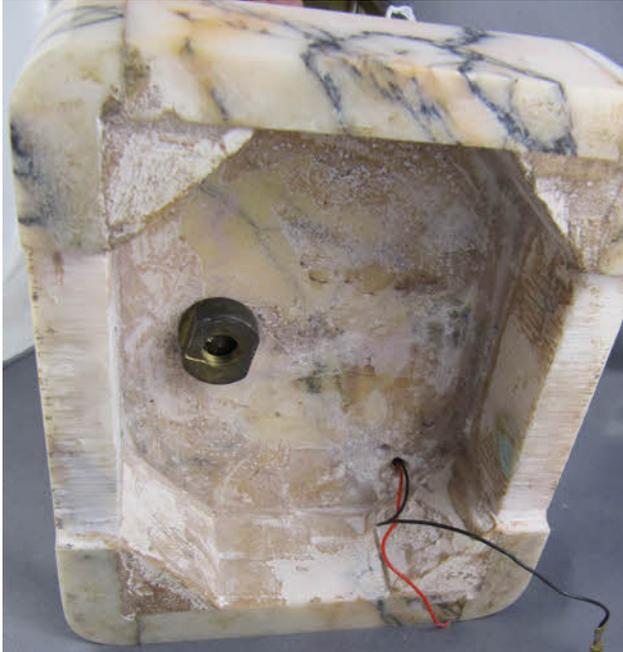
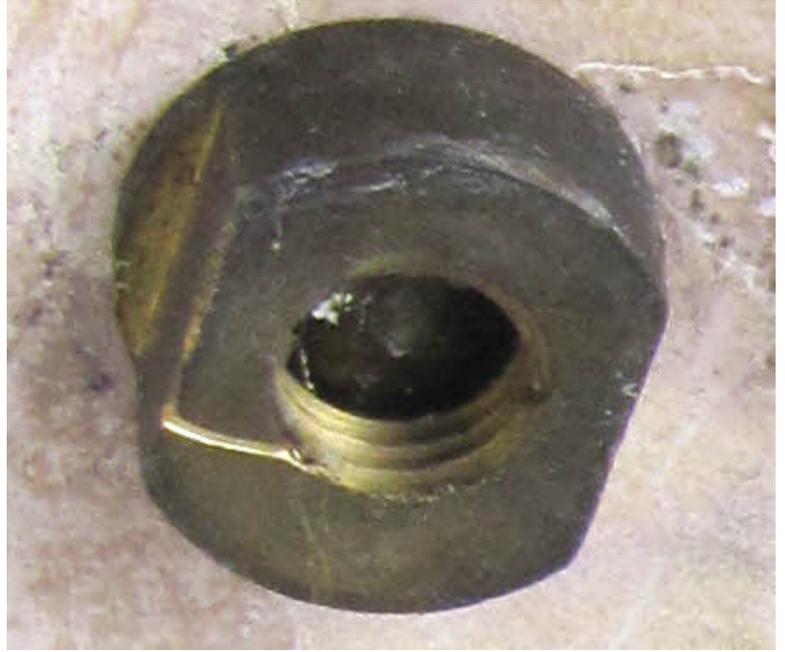
The underside of the base showing the large nut used to secure the column through the marble. The nut is only secured on a few threads of the column which means that we will have to be very careful when replacing the column to make sure we have enough thread protruding through the marble whilst also taking into consideration the height of the pendulum rating nut as it swings over the magnet. Allowing more thread through the base means less room for the pendulum to swing.

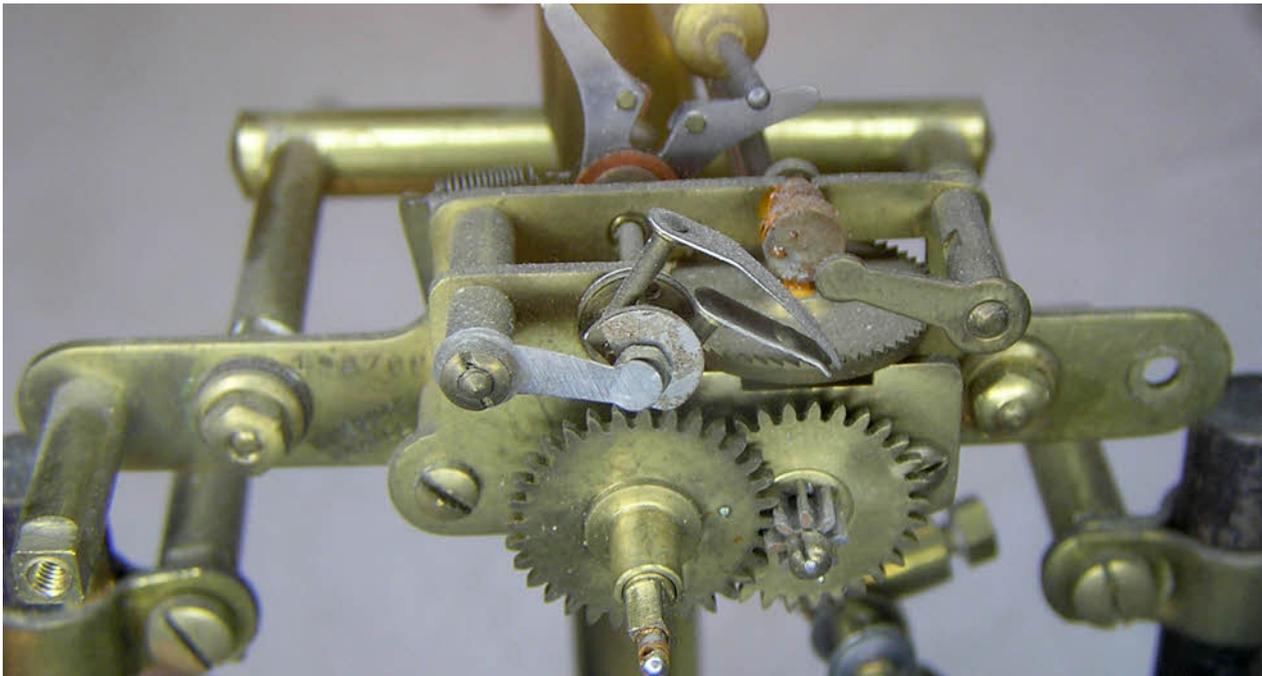
The movement showing the rust on the steel crown wheel end play boss.

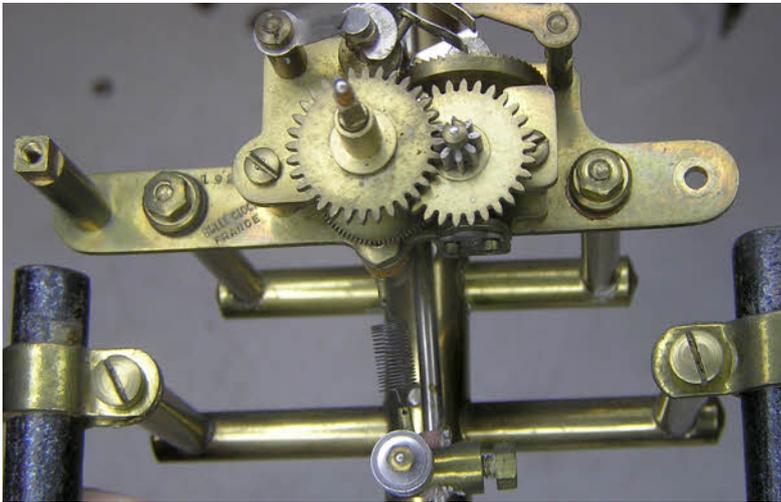
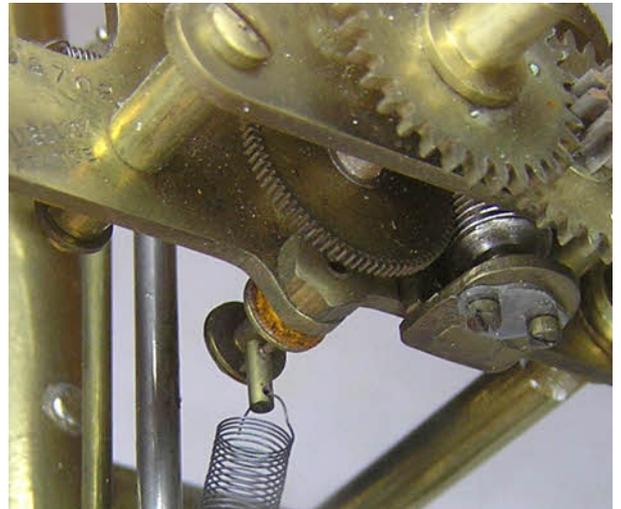
More views of the movement showing the original Isochron spring still in position and more rust on the upper Isochron bobbin assembly.

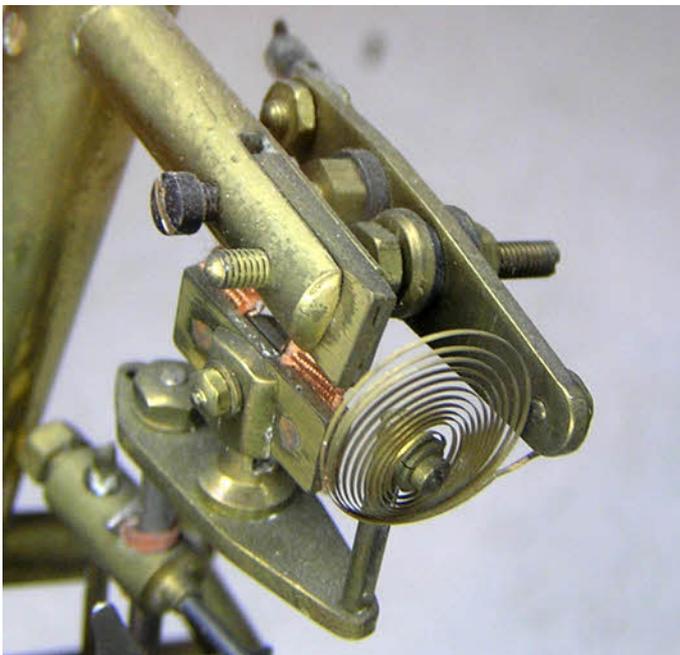
The photo above shows the hair spring used to provide continuity of current over the silk suspension. The photo on the right shows the method of attaching the negative terminal from the battery to the clock such that it is isolated from the frame before passing through the hair spring to the pendulum. The black spacers being made from insulating fibre.

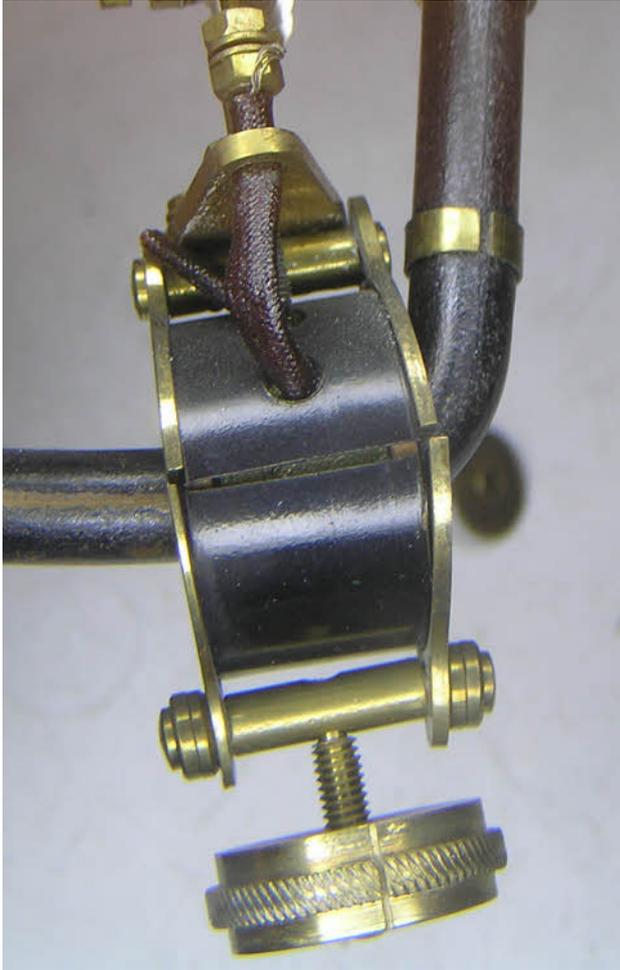
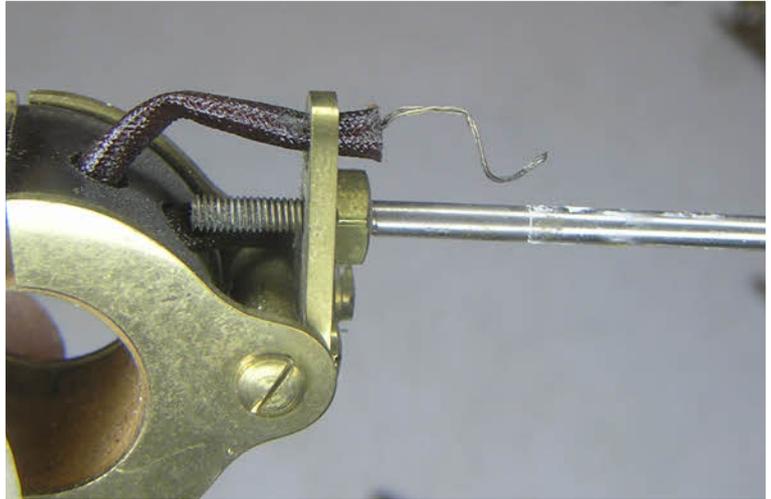
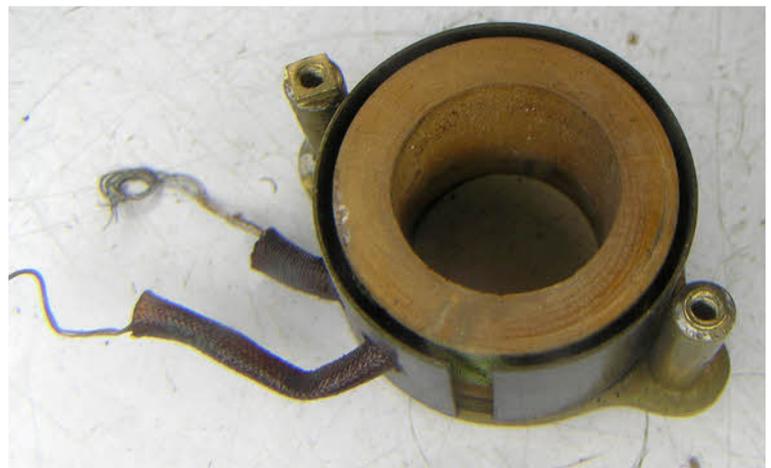
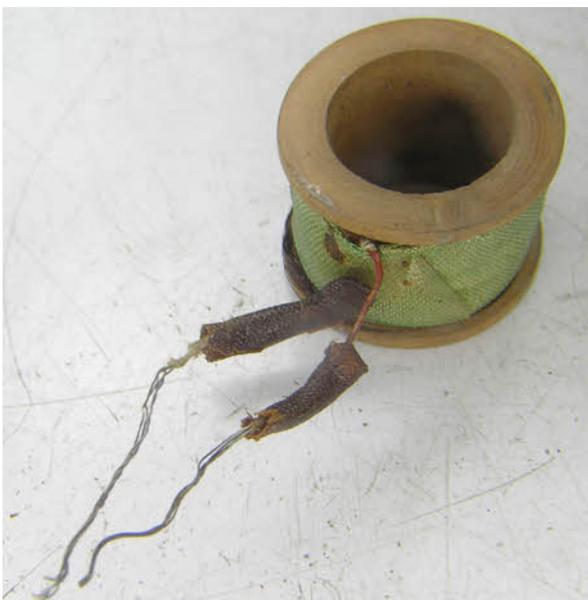
This group of photos shows the coil with its casing and wax lead wire covers. These wax covers are usually so brittle that they snap and crumble when handled (as in this case). But sometimes they can be reused if heated with a hair dryer every 10 seconds or so before they cool and turn solid.

The coil proved to be in good condition with a resistance of approx 1100 ohms.

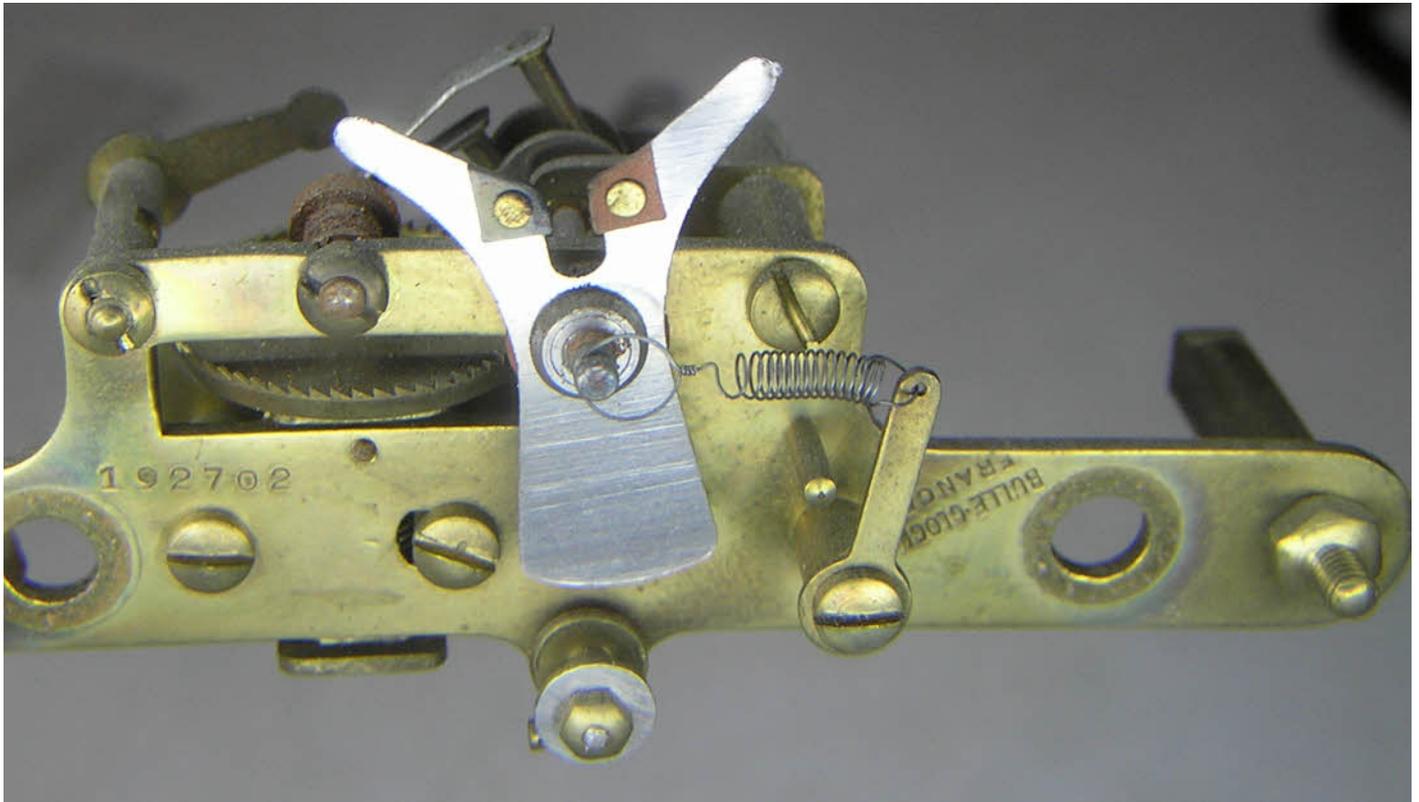
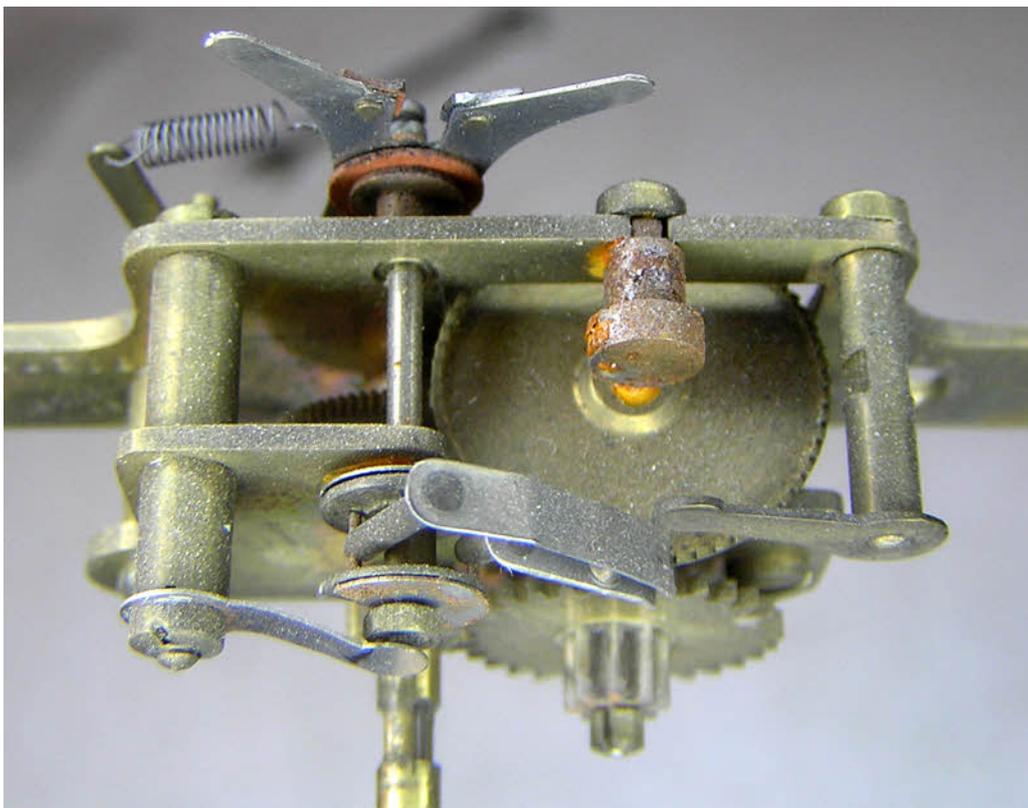
These two photos show the general state of the movement. The fork silver contact spring is still in position albeit a little tarnished. A soak in silver dip should see it brought back to a bright condition and reusable. The fork contacts though look worn and will be replaced.

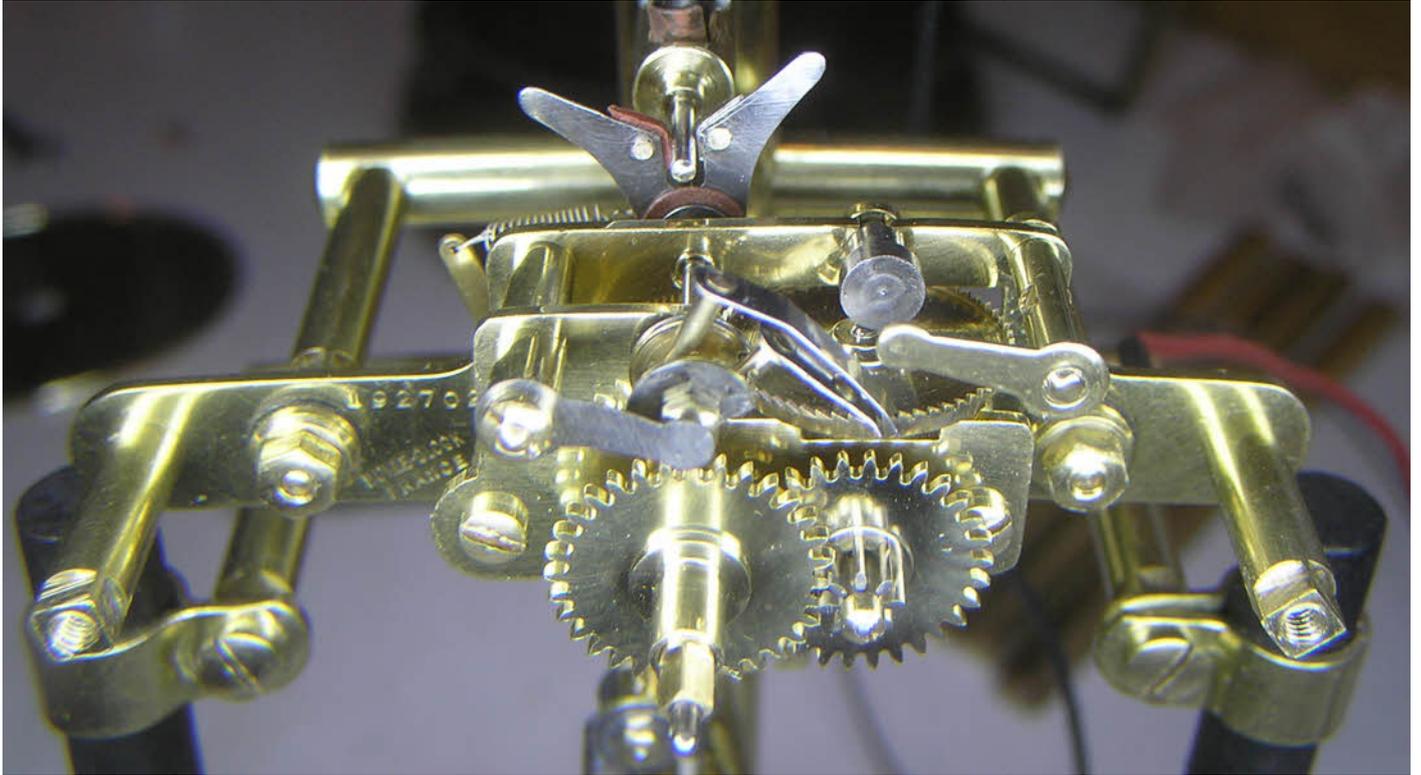
The movement after cleaning. Note that all the steel parts have cleaned up very well after the rust has been removed. The fork has had new silver and fibre contacts made.

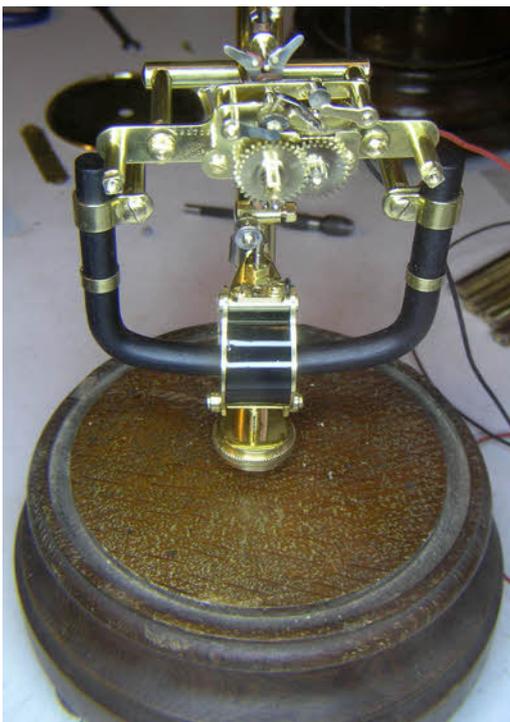
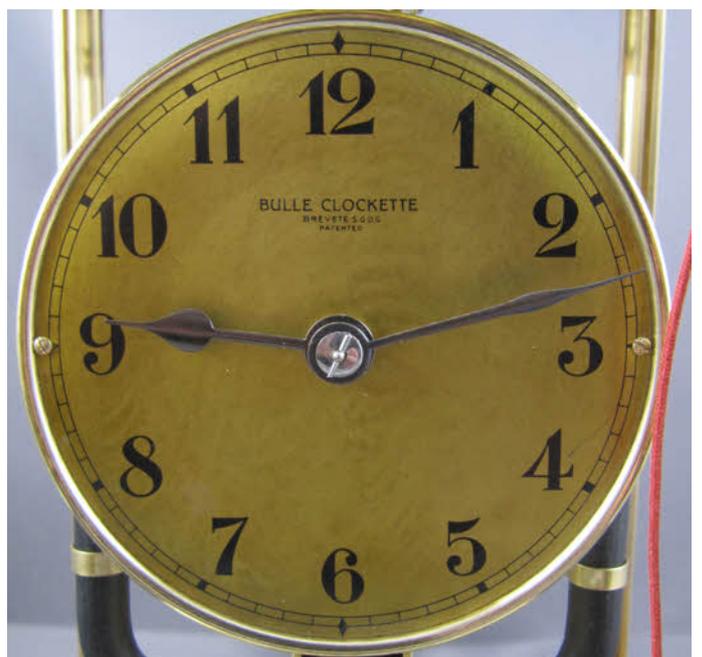
The photo on the left shows the clock on an old wooden base so that it can be rebuilt and tested without damaging the marble. On the right is the dial after cleaning. The mark is less visible and then hands have polished up well after rust removal..

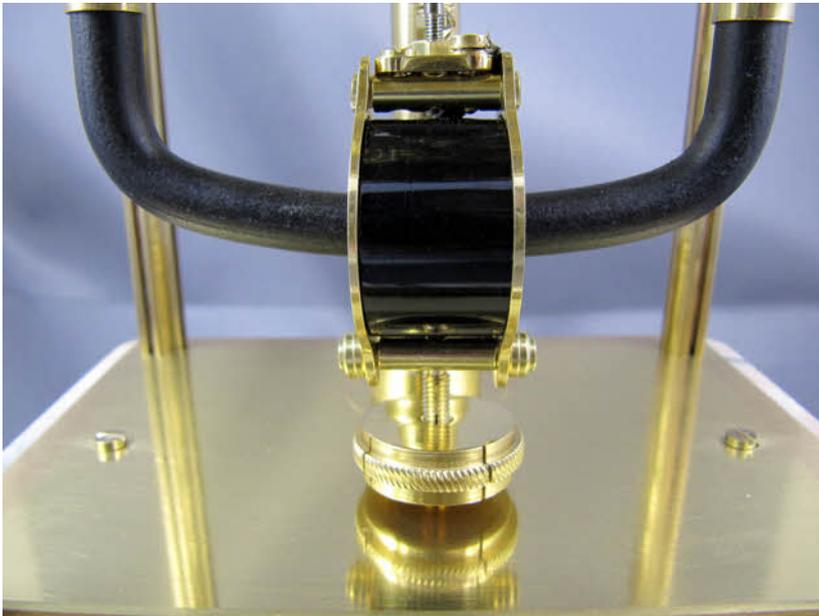
This photo shows the restored pendulum coil, rating nut and magnet back in position on the marble base.

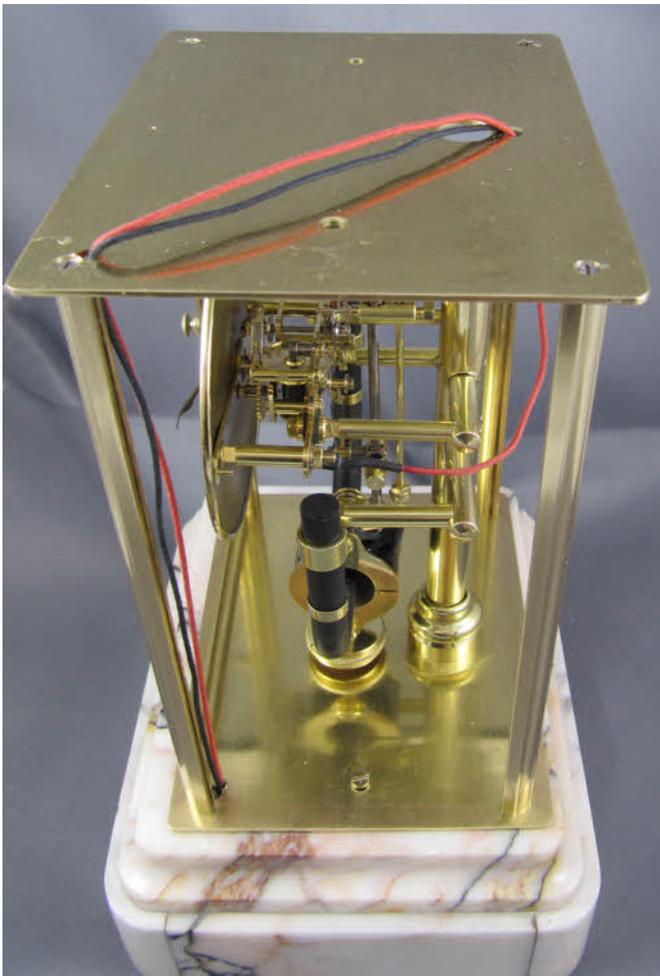
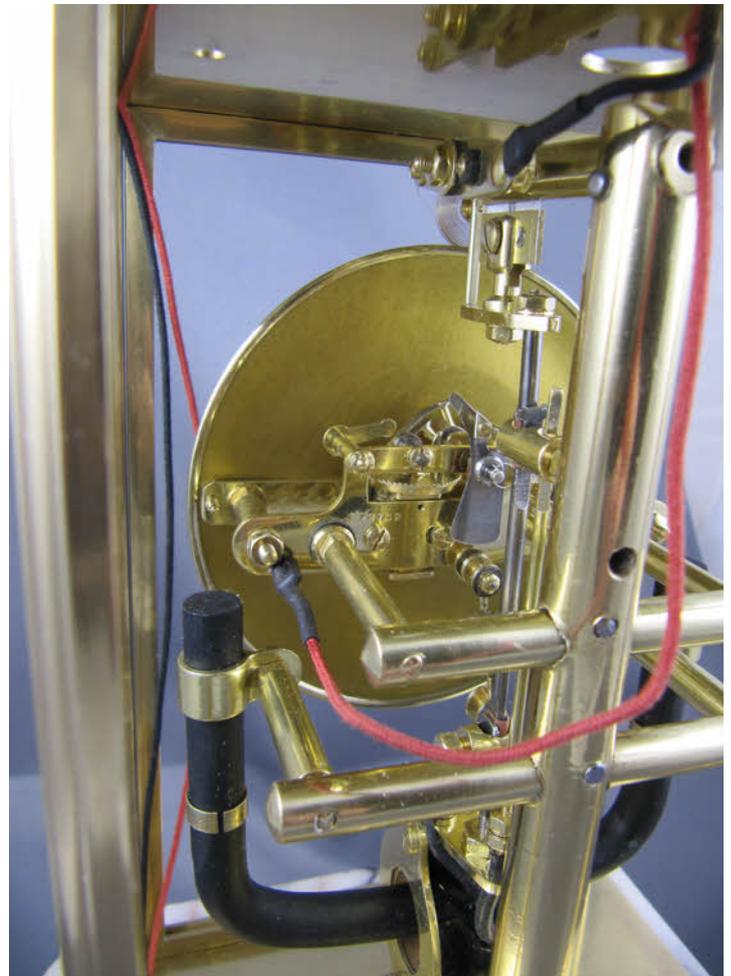
Below are two views of the side and rear of the restored clock.

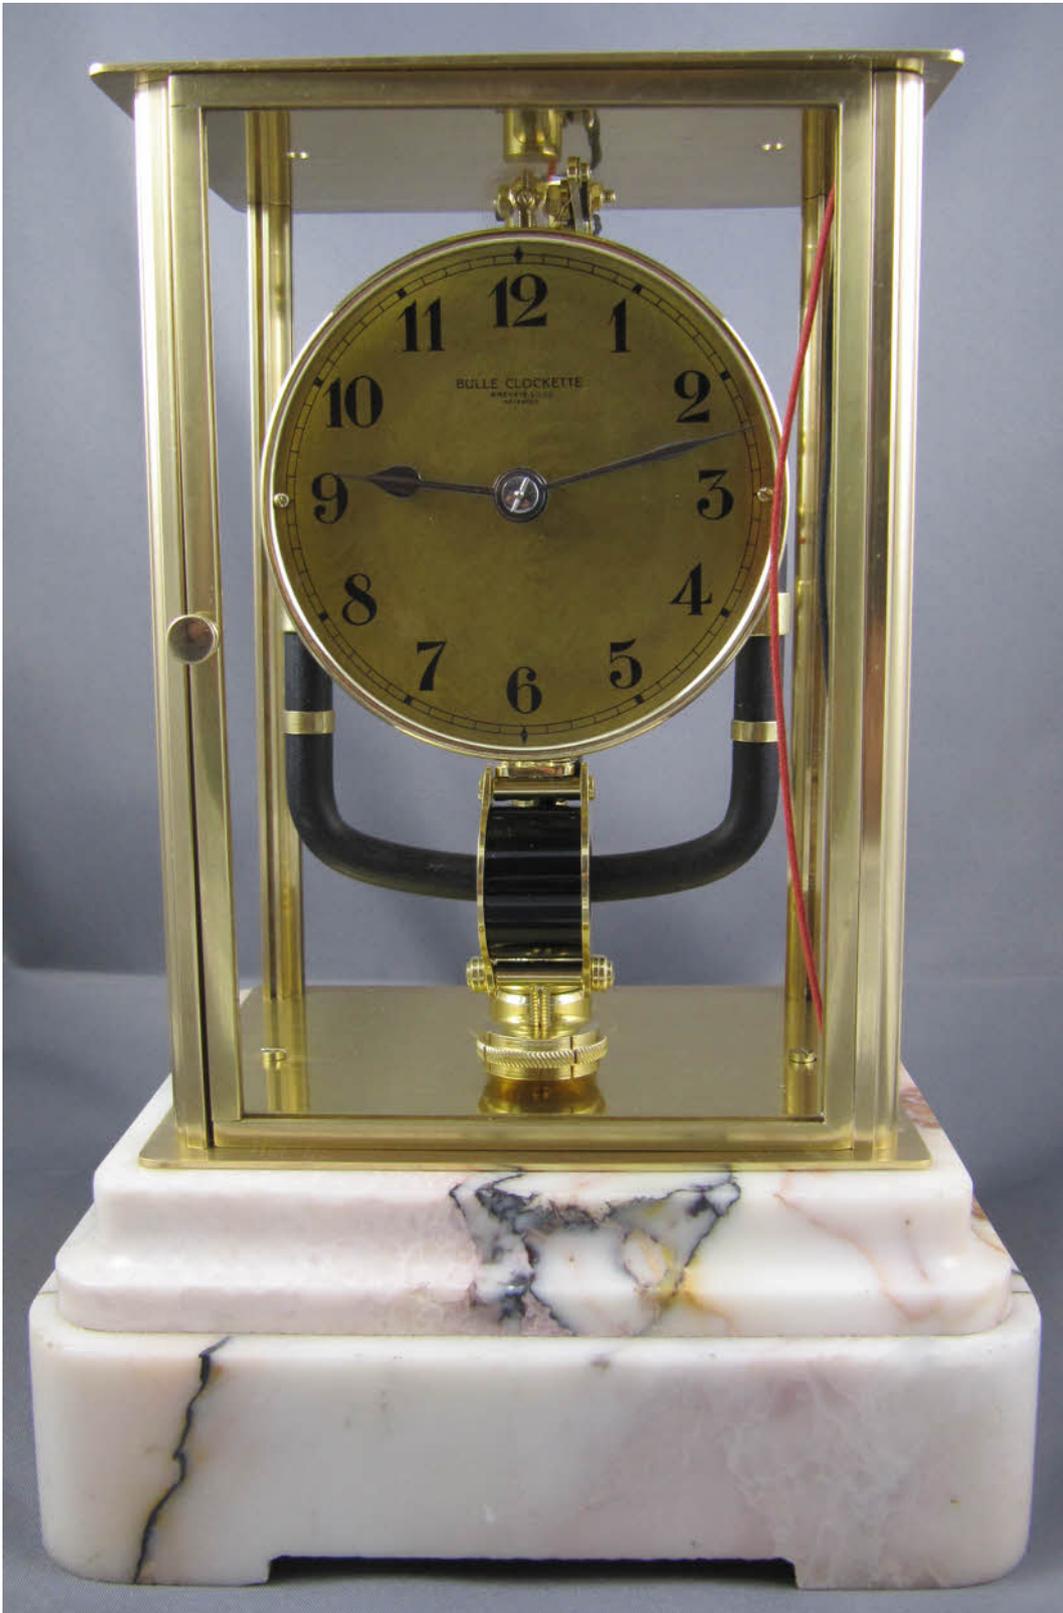
The finished clock.

The wiring is left loose so that the brass case can be unscrewed for fitting the new glass.

The wires would normally be secured behind the right hand side door pillar so that it wouldn't be seen from the front.
