Bulle Clock Serial Number 201051

*Restoration of Bulle Clock
Serial Number 201051*

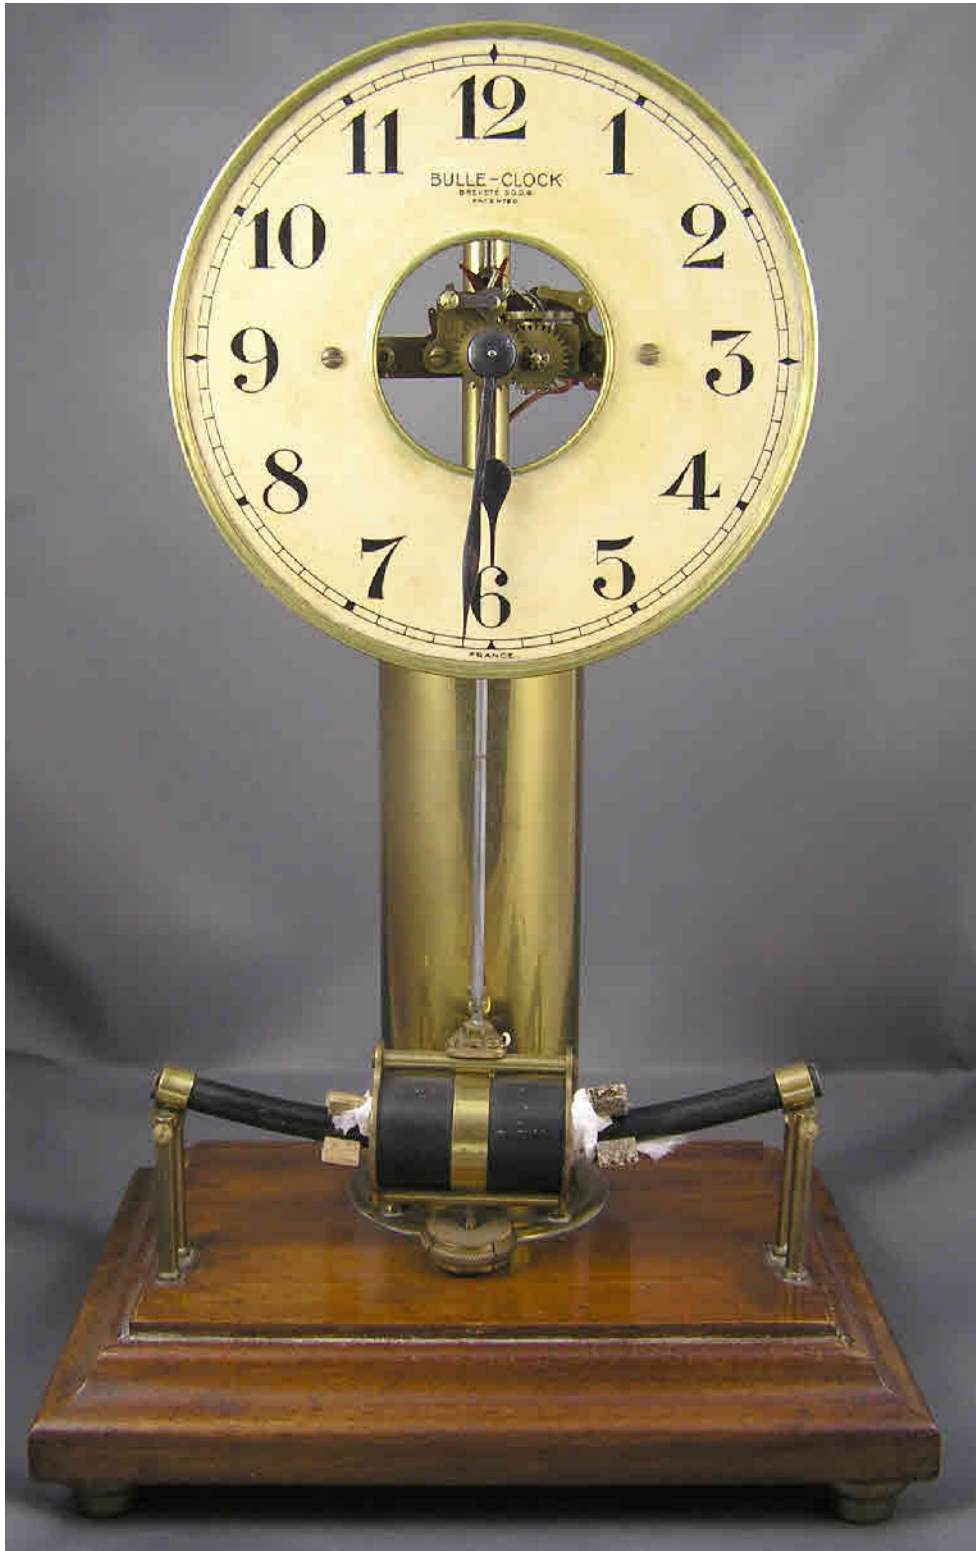
*This clock is a tall move-
ment in a four glass case ,
the top and bottom of which
are mahogany, while the
verticals are of brass. The
glass, verticals and top have
been retained by the owner.
The movement is a two plate
version dating from about
1929. The coil casing is a
brass shell painted black
with a brass central band.
On some clocks the band is
only infered by leaving the
central area clear of paint.
The hands are of the fine
spade type on a dial of
printed card.*

*First impressions are, that
the clock is complete in
good order. But first im-
pressions can sometimes de-
ceive you as we shall find
out later.*

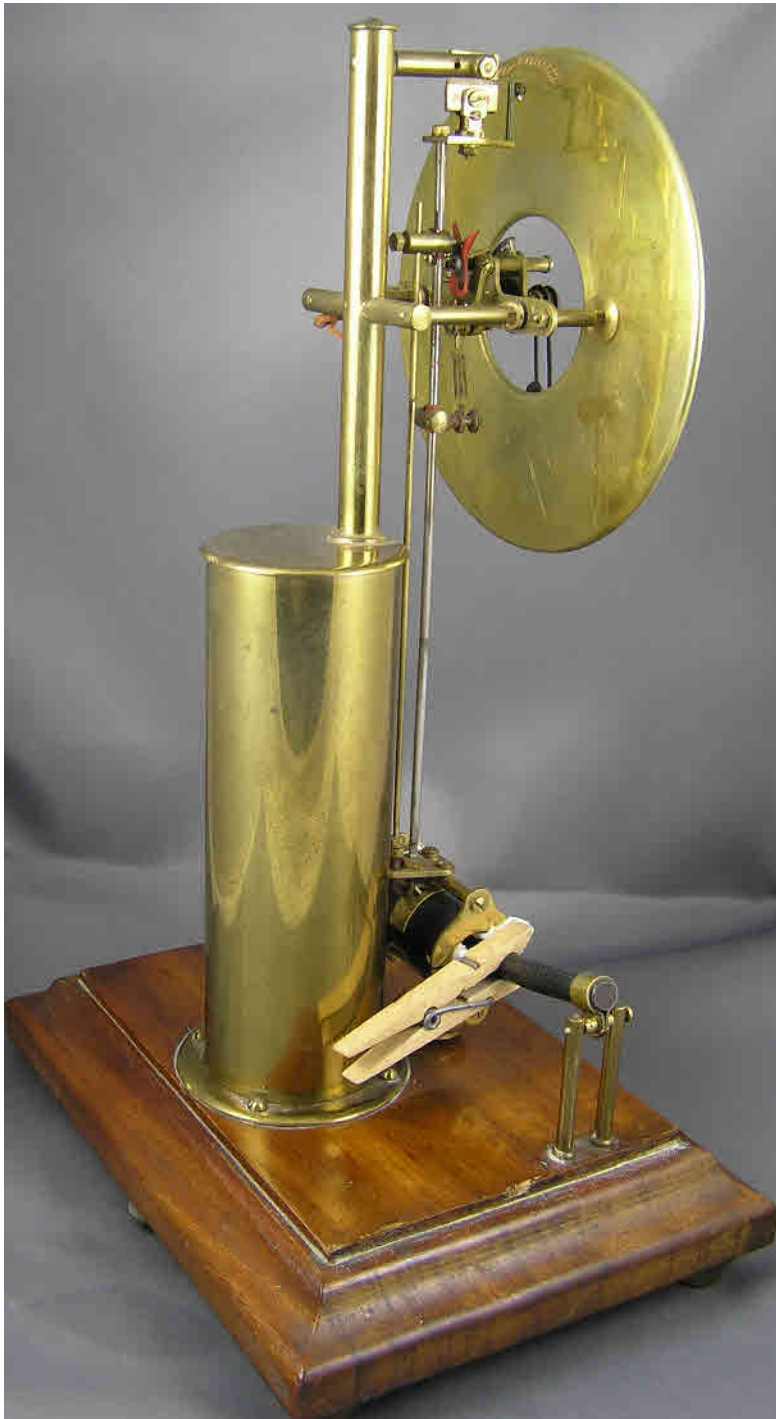
The rear of the clock showing that the tube looks to be free of any serious battery acid burn through.

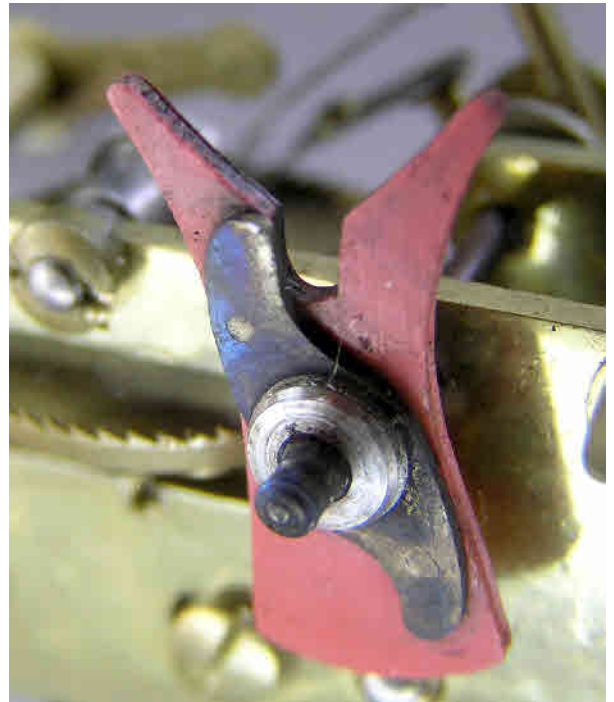
Some people ask about the seemingly modern fork that are found on some Bulle clocks. These are original and are some form of reinforced early plastic. They can come in a range of colours from clear through Blue and Red. I think the use of this material came about as an evolution from the simple early silver contact and fibre to the multiple insulated "S" silver forks initially found on clockettes. The latter were quite complicated affairs involving insulators on each rivet and arbour. This could be simplified if the fork was non conductive. And so this early plastic was used. But it was not as successful as hoped for two reasons:-

1. It wore down quicker than steel.
2. The whole assembly could not be riveted up so tightly for fear of damaging the plastic fork

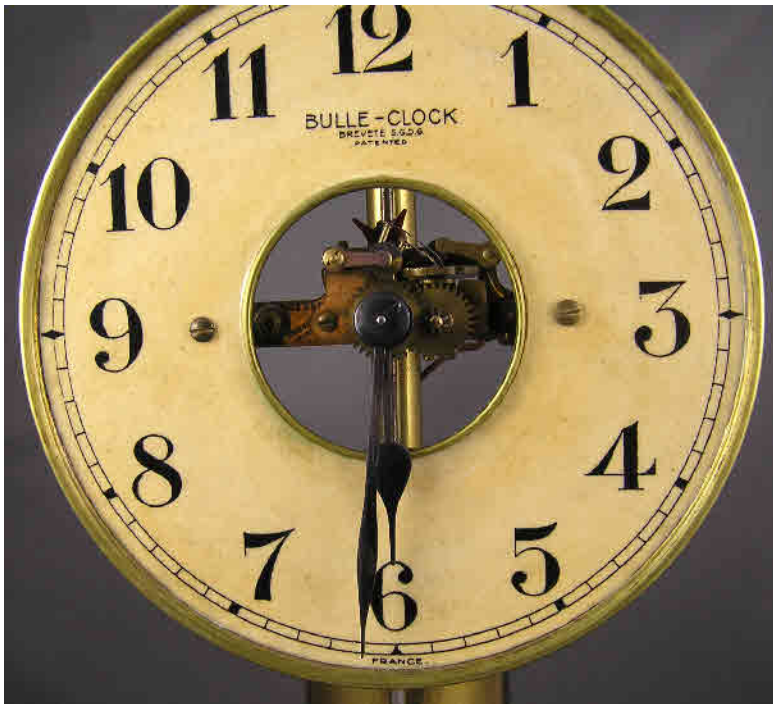
The first photo shows the dial in situ and all looks to be in order

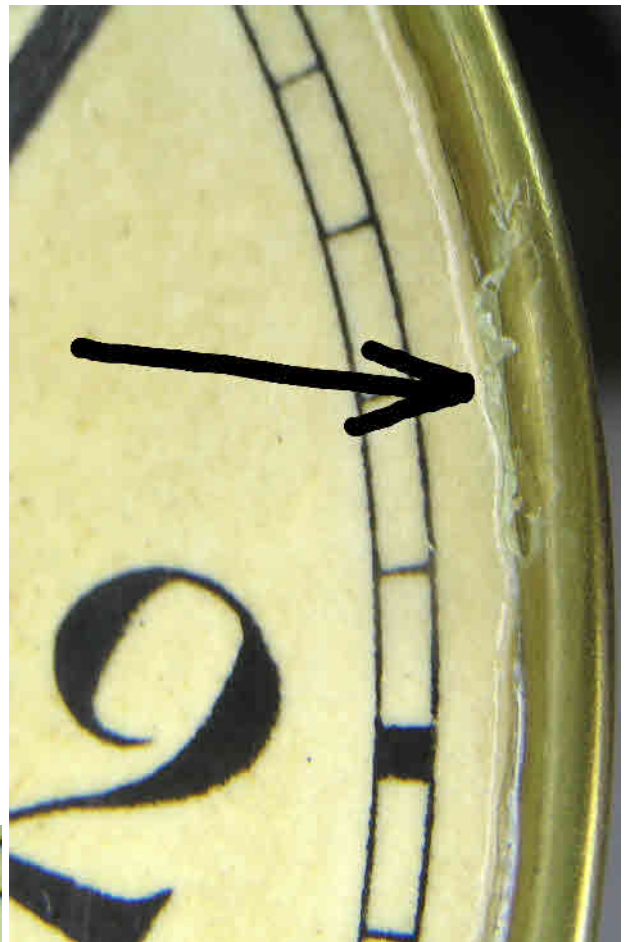
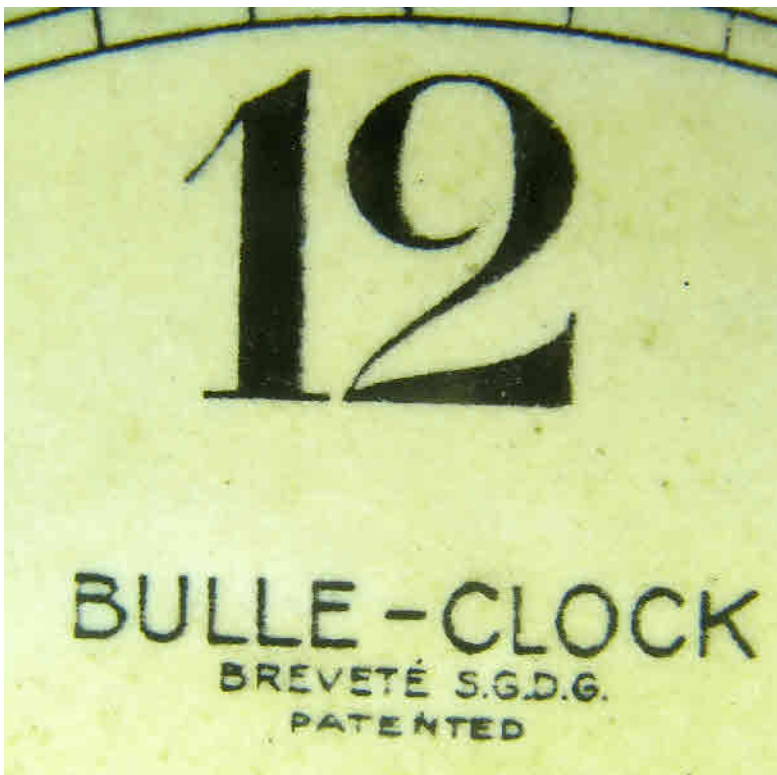
On closer inspection however there is found to be a film of a waxy plastic substance that covers the dial card and the rim of the brass surround. This may indicate that the dial is a later insert and has been sprayed over with a form of plastic protection. The surround itself looks as though it has been pressed in further than one would normally expect. The last photo shows that the print quality is not the normal standard of an original and may be a copy. Altogether I would suspect a card insert has been added to this dial albeit nicely done. All we need to do here is remove the waxy material from the brass surround so that it can be cleaned but leave the dial itself untouched. A sharp craft knife will be used around the edge of the card so that the covering will peel off the surround without damage to the dial.

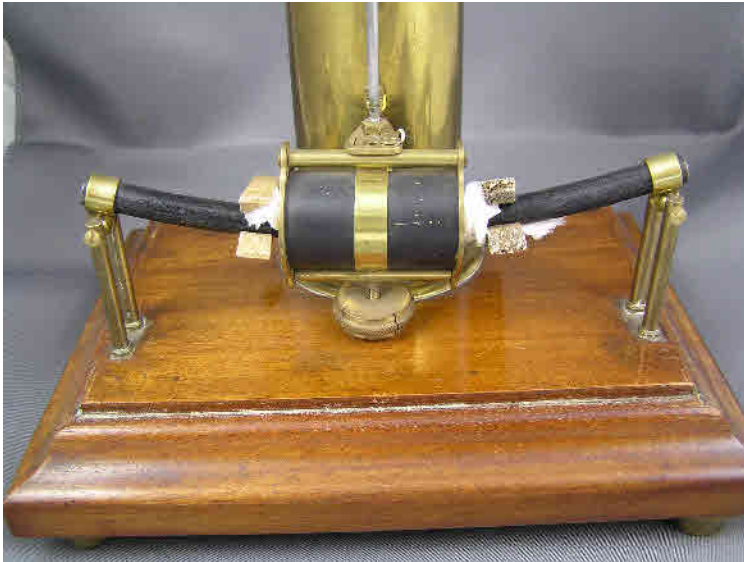
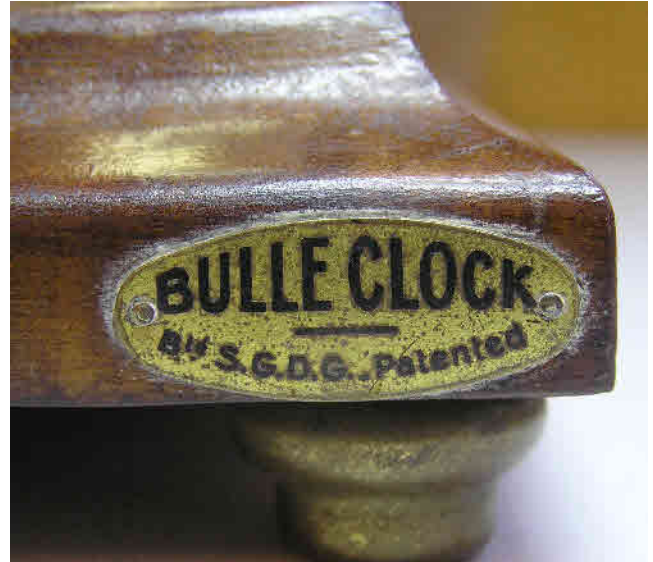
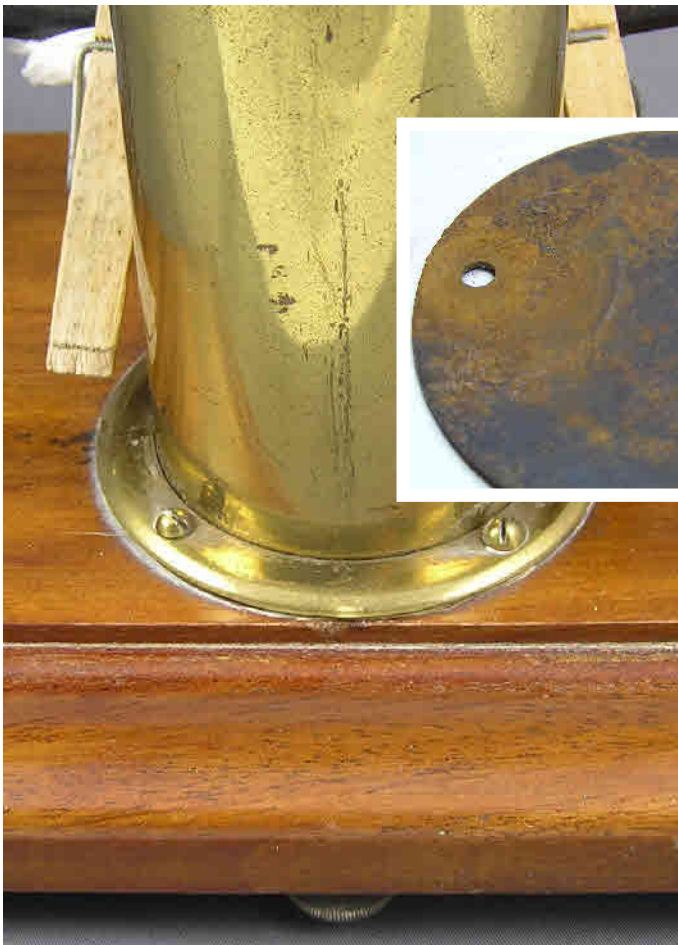
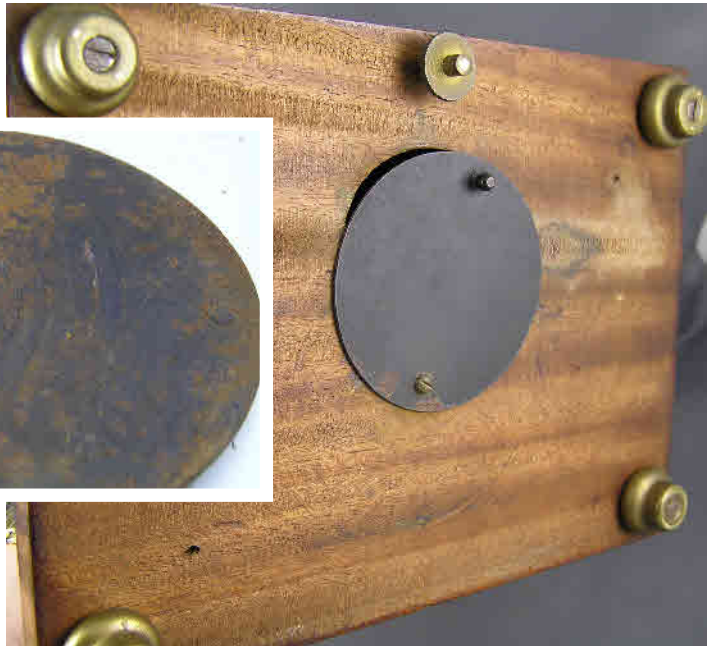
This set of photos shows the base which is in good condition and will only require a good polishing with wax polish. The battery compartment door however will need to be stripped and cleaned of all rust before re-spraying. All the feet and knurled height adjuster are in position and original.

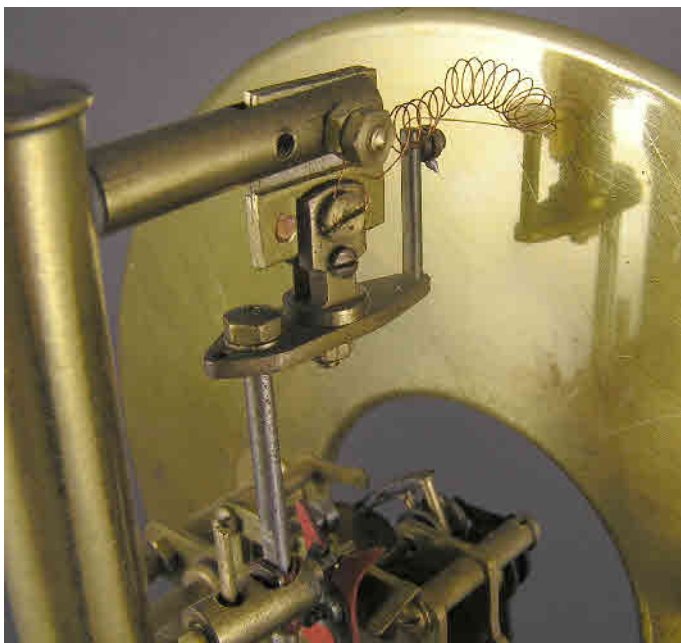
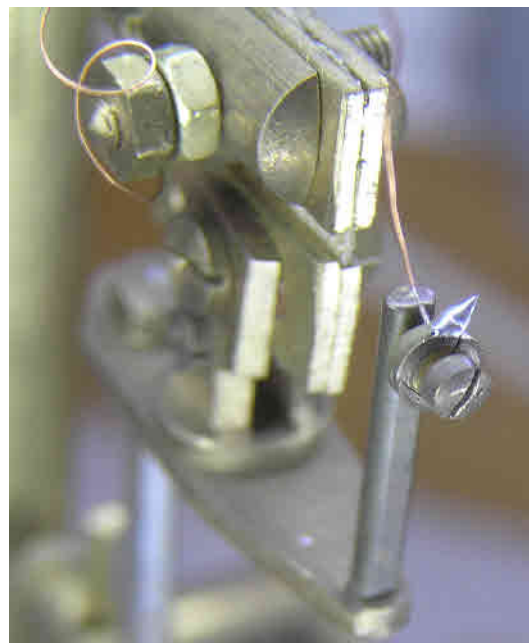
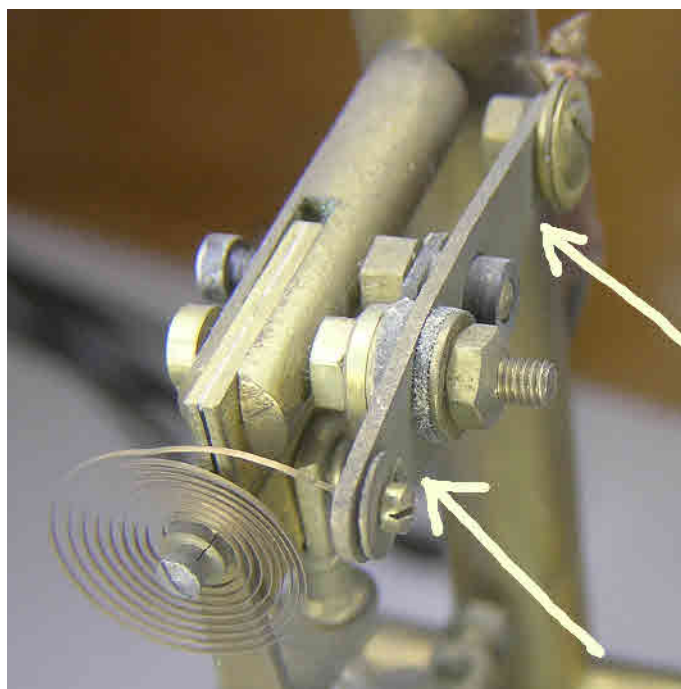
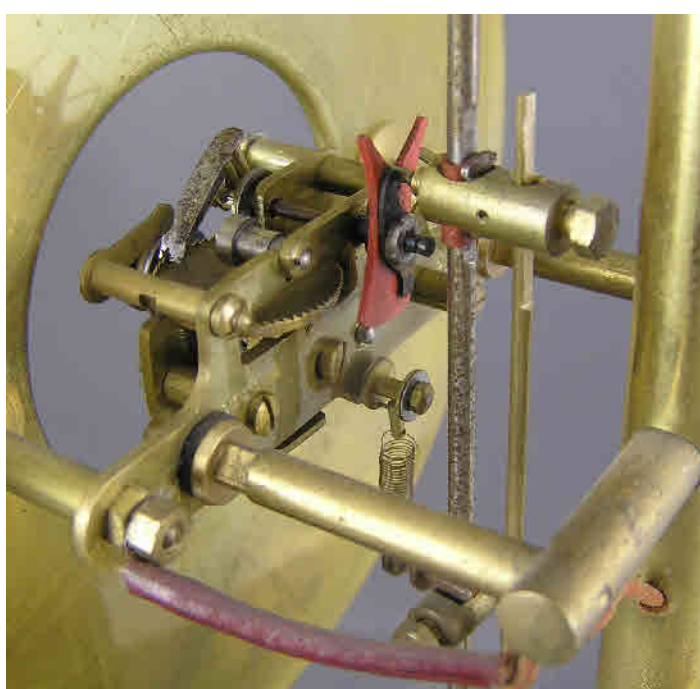
This is where the problems start. Note that the pendulum support has provision for a balance spring contact arrangement with the top of the frame column (two photos above). But the column does not have the matching assembly that would normally be seen, as in this photo of another clock below. (arrowed). Also note that in the photo at bottom right the Isochron spring is suspended from the main plate via a small lantern assembly. This should be hung on a small bracket that would allow the lantern to be raised or lowered thus providing extra adjustment for the Isochron Spring.. Both of these omissions add extra weight to the idea that this clock may be a marriage. I do emphasise “may”. We will look for other evidence.

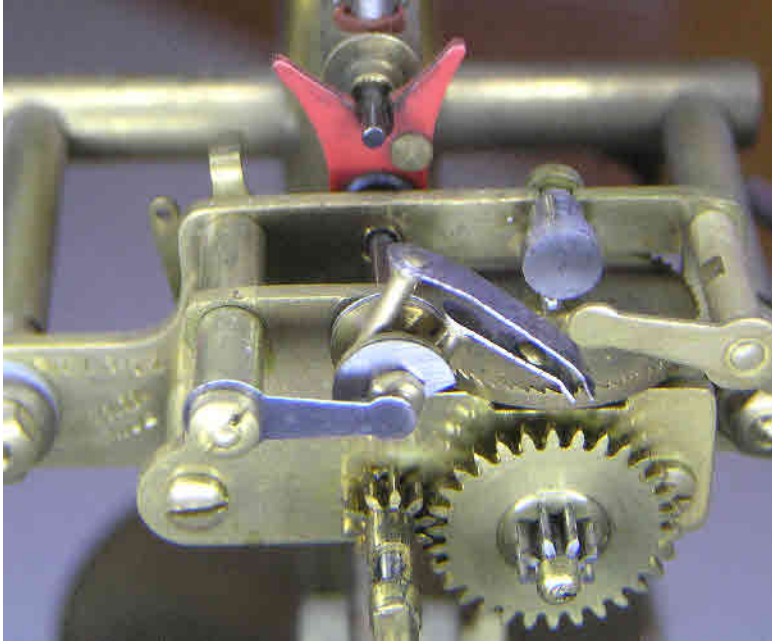
The rest of the movement looks to be OK and original. But the count wheel end shake plate looks to have some ominous signs of wear in the arbour if the detritus in the photo at bottom left is anything to go by. The photo below right shows where the plate normally sits and we need to disassemble this completely to investigate.

When this was investigated there proved to be a little wear in the button at the end of the arbour but this was negligible and the arbour end was re-polished. It was then checked to see if it provided enough clearance for the count wheel before reassembly. It was fine.

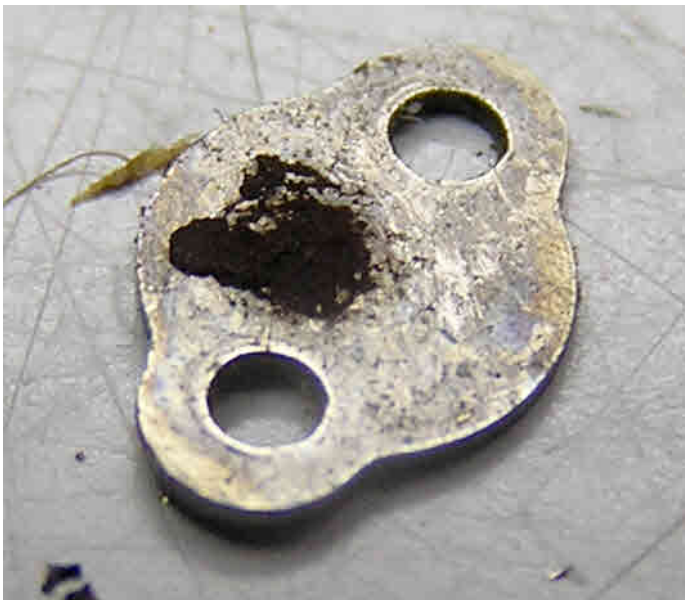
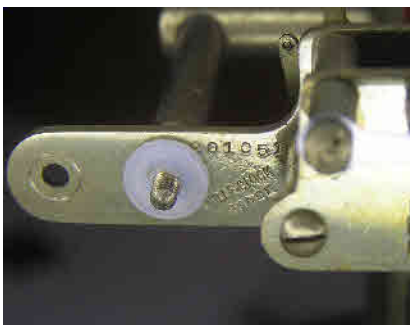
The photo at left shows the odd insulating washer made from nylon. The three other washer proved to be original. This just means that the last restorer probably dropped and lost the original and therefore made one from materials at hand.

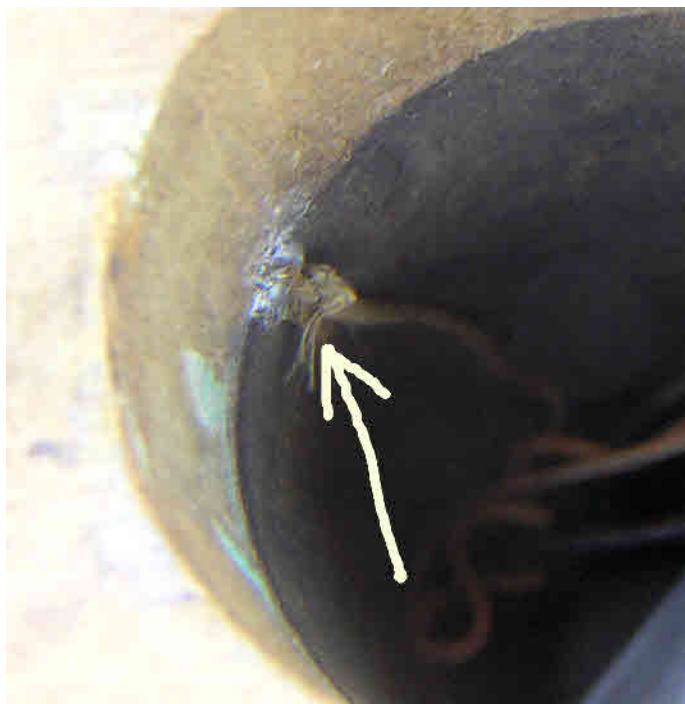
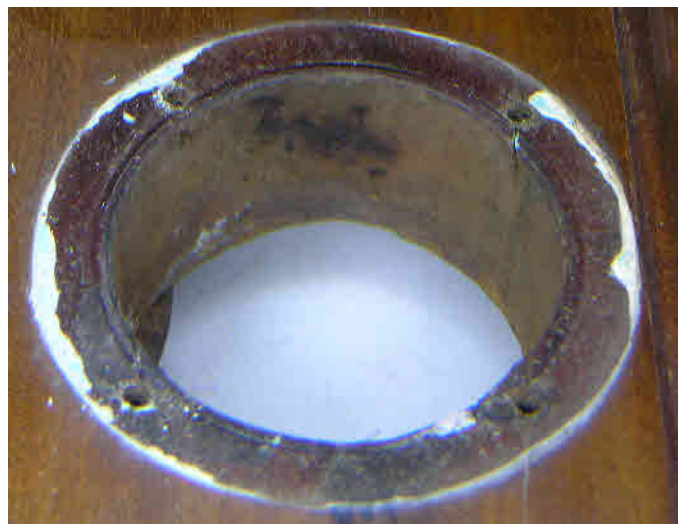
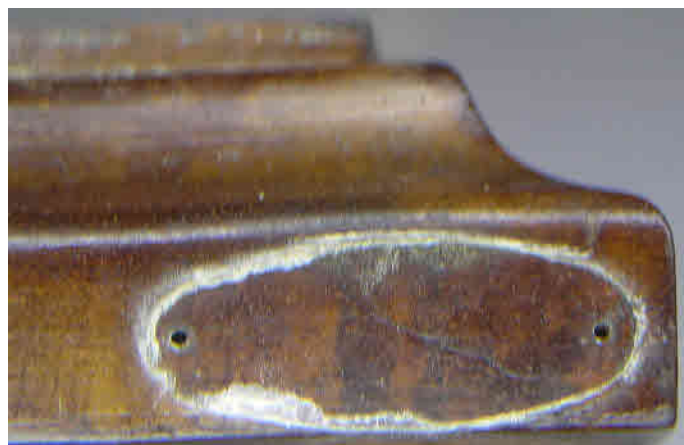
The negative connection from the battery was soldered to the inside of the tube. This is the wire that would have been projected through the top of the frame and been connected via the balance spring assembly if it had been original. Another little pointer to a made up clock.

These two photos above show that the column and label had been in position for some while as there has been a build of polish over the years. This is a good sign that the clock has probably not undergone any changes in recent years.

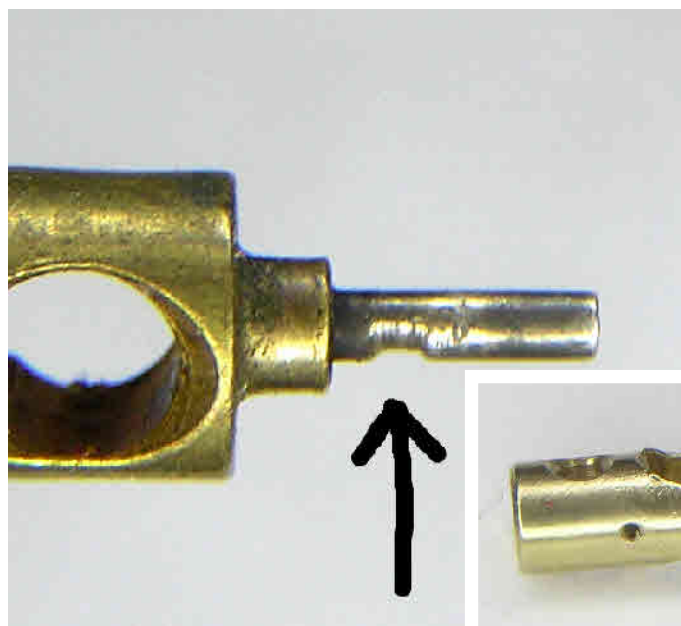
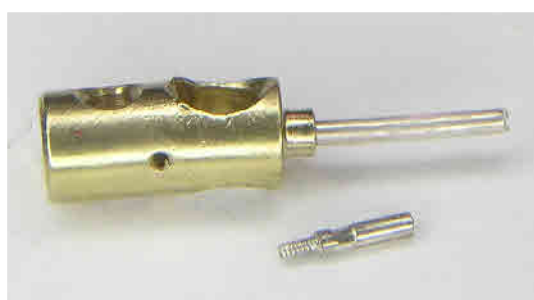
These last two photos at left show the wear in the silver contact pin. It is possible to turn the whole contact pin assembly upside down to use the fresh face of the pin. But I decided to make a new one as can be seen in it's embryonic stage before shortening.

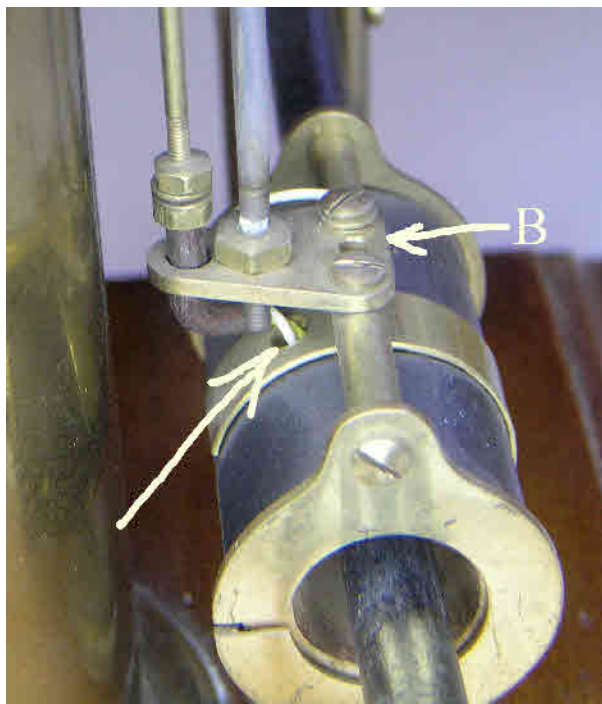
This photo shows the pendulum and coil cover. Note that the two wires protruding through the hole are plastic covered and therefore not original. Another sign that the clock has been heavily restored. Another odd point that if taken in isolation would probably not be noticed but with all the other variations, becomes more interesting, Note the amount of threaded steel pendulum rod protruding from under the triangular bracket (B). This is quite excessive and is impeding the exit of the wires. This part of this rod would normally have thread showing equally above and below the bracket. Another sign of tampering.

When the clock was eventually reassembled I changed the position of the bracket but this proved to lengthen the pendulum too much and the clock ran very slow and could not be corrected by the rating nut. So it was repositioned as above to correct the timekeeping. Perhaps this pendulum has been taken from another clock???

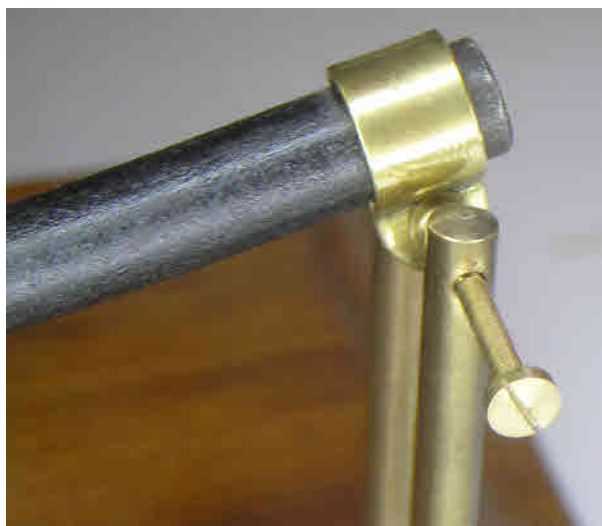
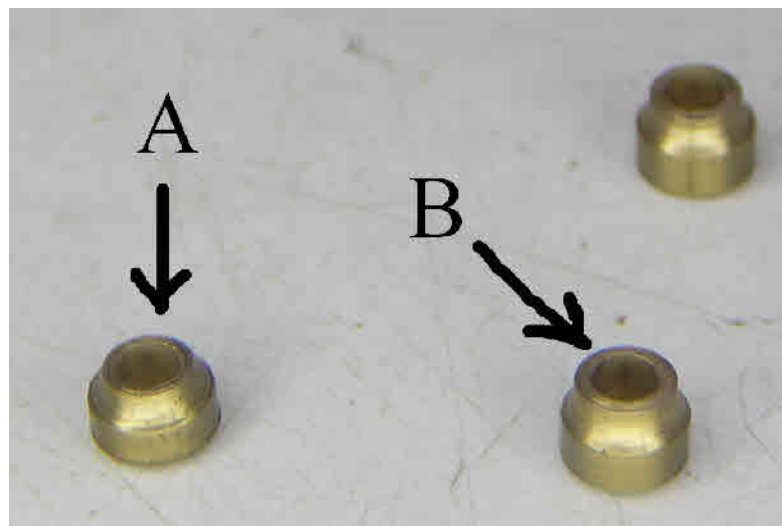
When the clock was disassembled it was found that a small number of the screws, nuts and washers were replacements. But they were well made and functional but not of the correct design or proportions as can be seen in the two examples above. The heads of the long screws in the photo at left are much larger than the originals and not polished. The washers in the photo at right are incorrectly shaped and inconsistent in profile. Look at the difference between A and B. There were other instances of odd nuts and screws. My impression was that they were made by an engineer and not a horologist. .

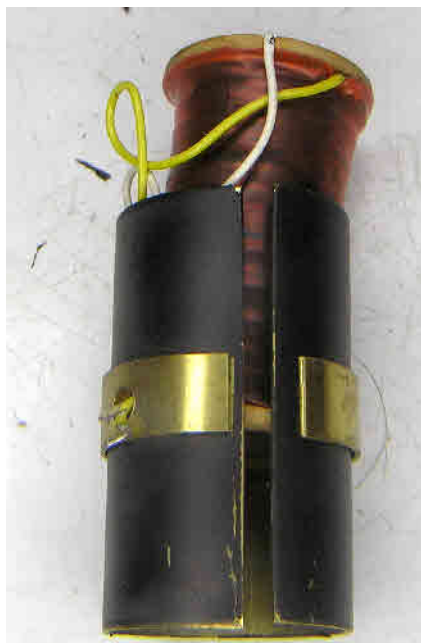
What finally clinched it for me was the state of the coil. As it was removed from the casing I saw this odd colour of the coil wrapping. It turned out to be a heat shrink material and is definitely not original. In fact I have never seen this done before on any Bulle clock. (But I do admit it; 's a good idea if you are making a new coil. It certainly keeps the wire in place).

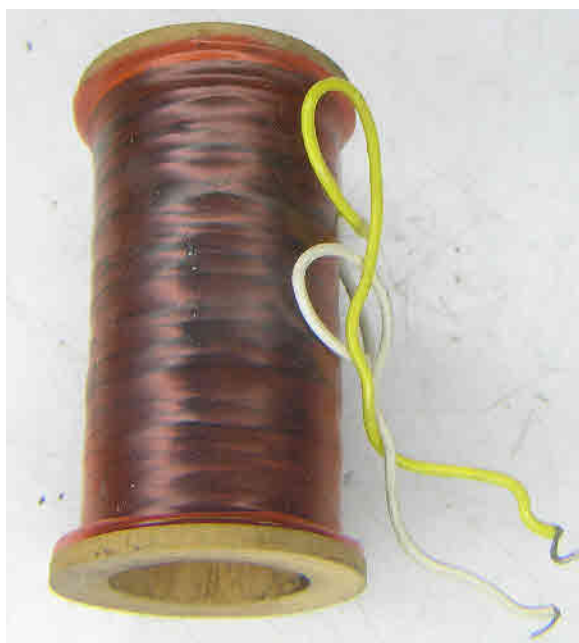
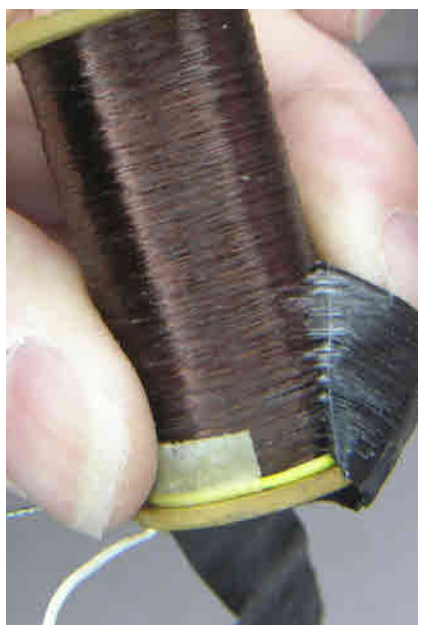
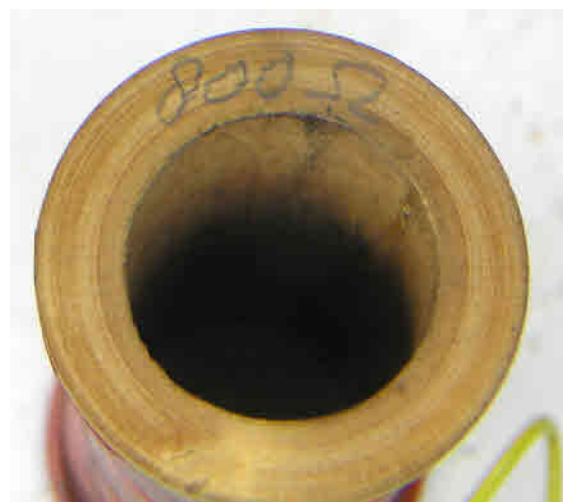
The photo of the end of the coil shows that someone has written 800 Ohms. This is about 300 Ohms less than it should be and will give one hell of a swing, but short battery life. The coil therefore had to be extended with a couple of thousand turns to make up for the shortfall. The photo at left shows what was found under the pink heat shrink! Not so good. This is insulation tape and it tends to degrade over the years and it proved difficult to remove carefully so as not to damage the coil itself.

The coil was extended so that it read approximately 1140 Ohms. The coil was then covered in brown paper and inserted back into the cleaned and painted cover.

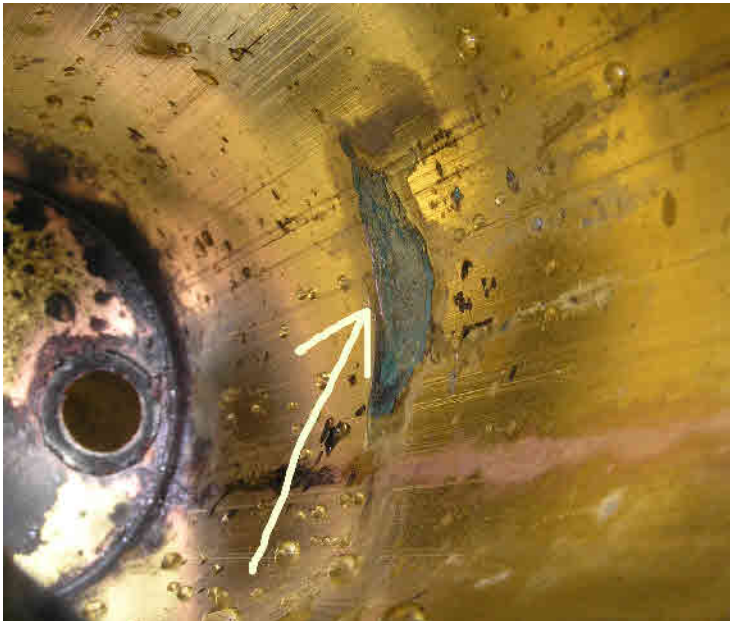
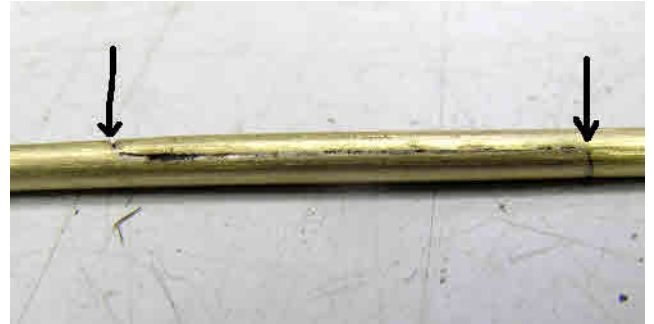
Another made up piece. This is the long brass bar that carries the current from the contact pin down to the coil. Note that it has been soldered in a half housing type joint.

There was some acid burning to the inside of the column but not enough to have eaten through to the outside. The column was immersed in horolene for 30 minutes before being immersed in white vinegar for a few hours. Finally it was left in Bicarbonate of soda for an hour. A long toothbrush was used to scrub the area every twenty minutes while in each solution. This cleaned any residual acid from the area and should prevent further deteri-

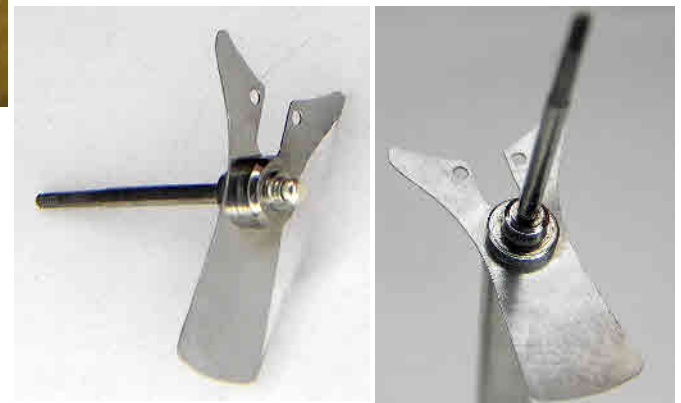
The new collet and fork on the old arbour. The old fork proved to be inconsistent in operation and it was decided to replace it with a more robust and electrically sound fork.

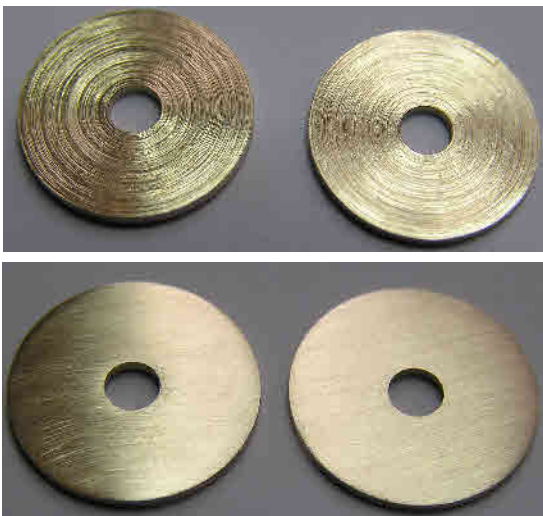
These two photos above show the “engineered” versions (another indicator of major rebuilding) of the dial support washers as found, and after a quick rub with 600 grit...

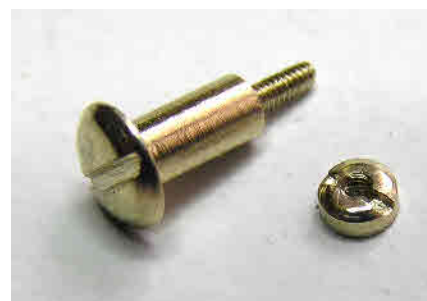
The photo above shows the new pendulum suspension screw and nut. This shouldered screw allows the pendulum to move slightly back and forward to enable it to swing clear of the magnet on a sloping surface.

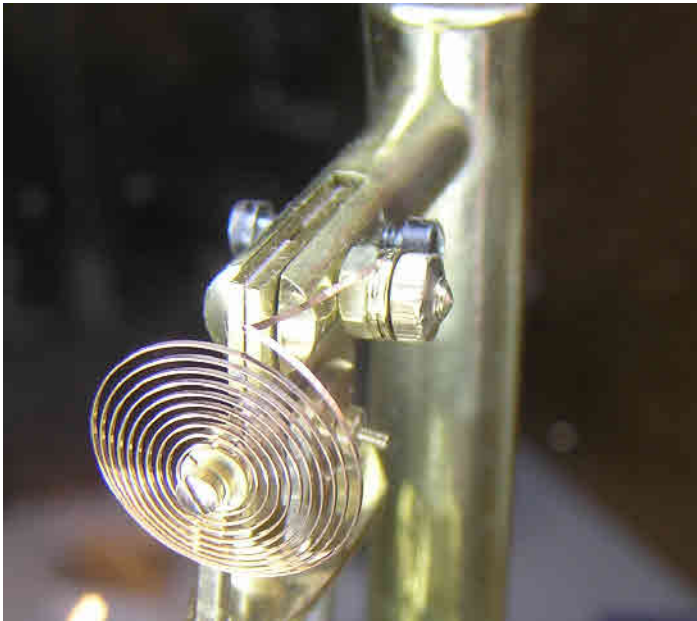
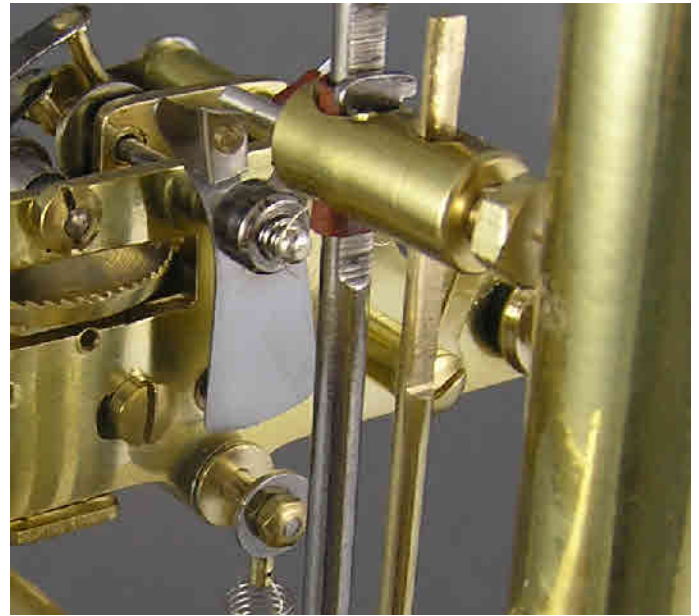
I finally decided to leave much of the clock as found.. It was electrically and mechanically sound, and to put it into a condition that it could be perceived as “original” would have required major additions that could be construed as “misleading”. Aesthetically speaking not many people would notice the difference anyway. I considered it best left as is.. The photo at top left shows the new balance spring linked using the existing frame and pendulum connection points. At right can be seen the new fork in position. Note the loop of the silver contact spring sitting comfortable in the groove of the silver arbour end. The action is one of rolling and not rubbing.

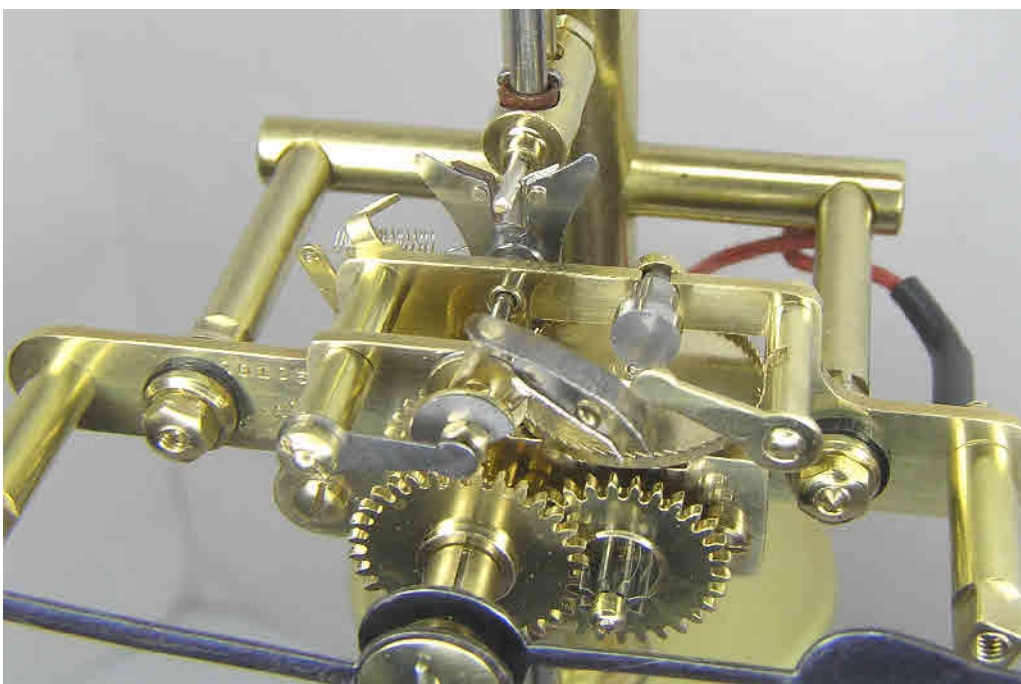
The movement back in place on the frame.

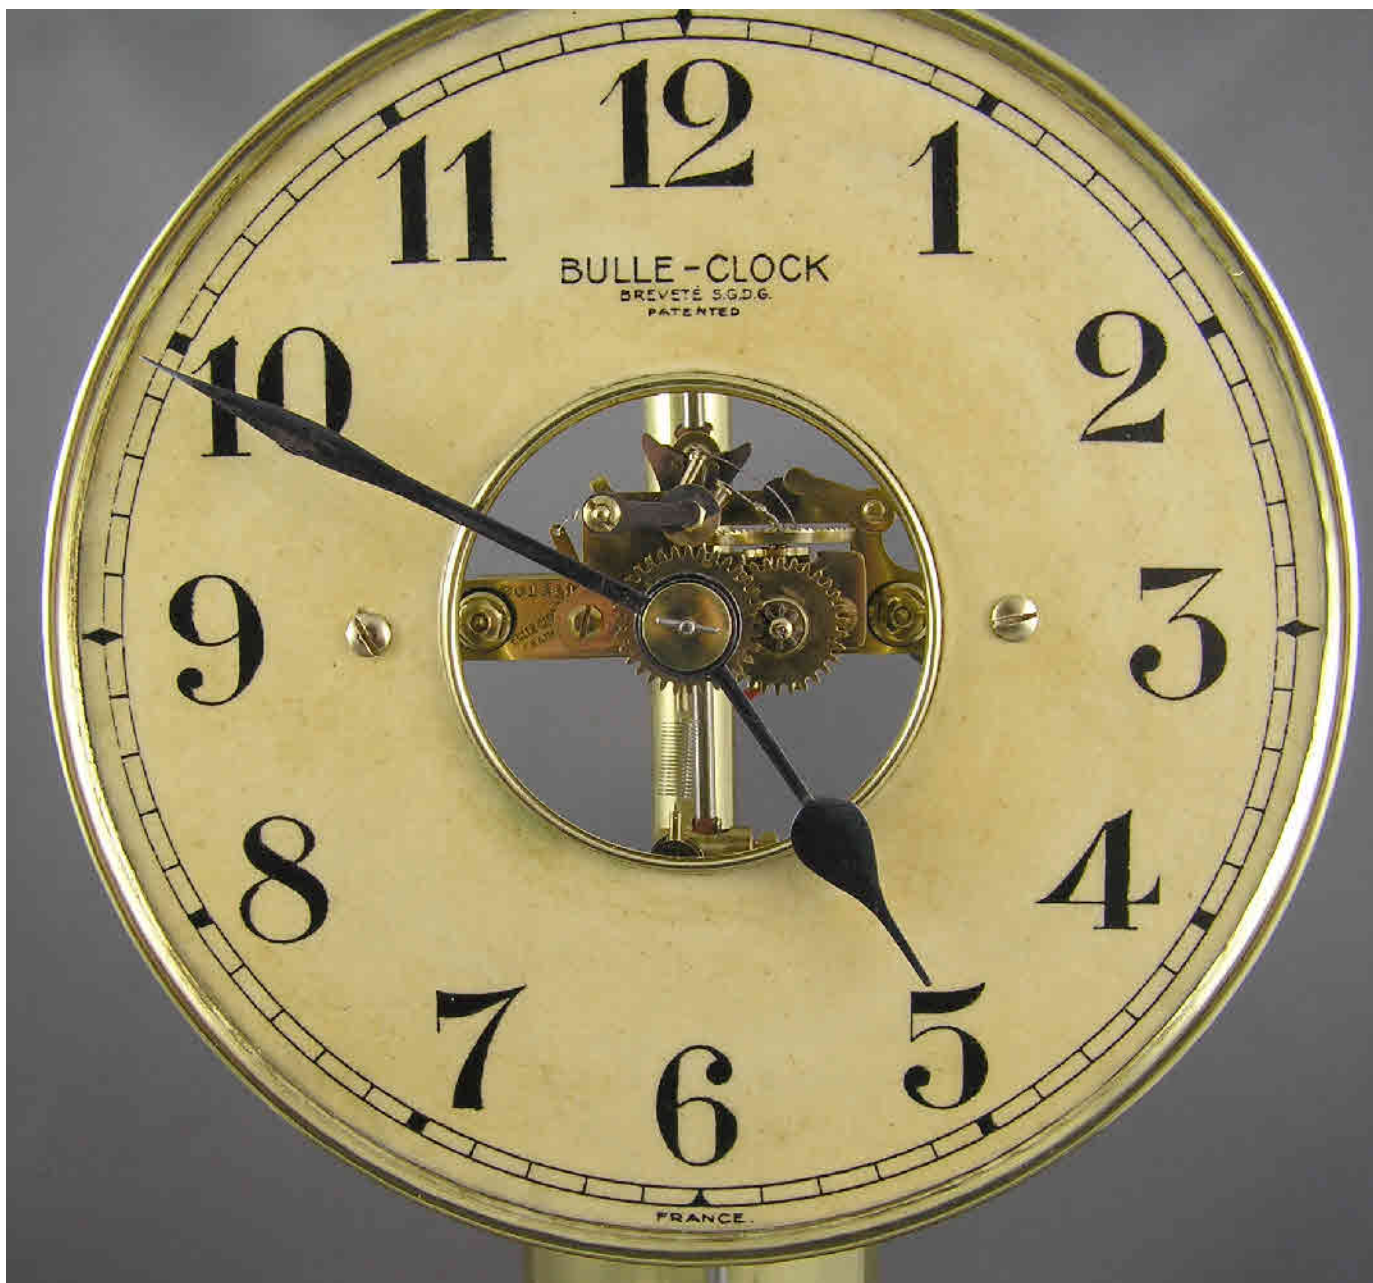
The dial with the excess waxy plastic removed and the brass cleaned and polished.

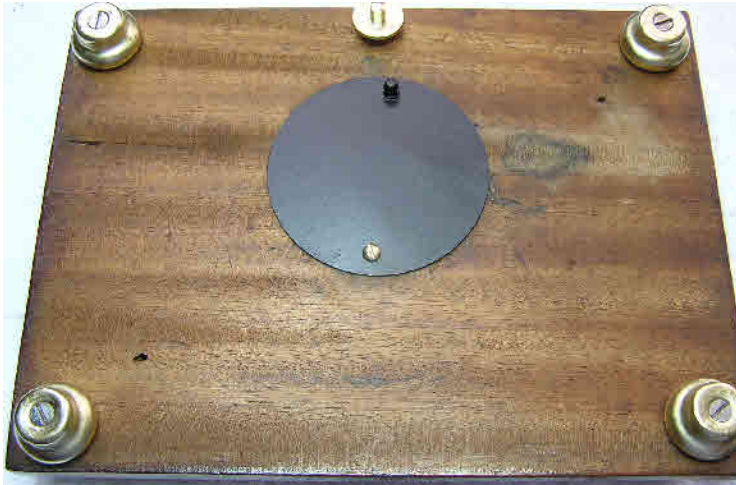
The underside of the base showing the cleaned and painted cover.

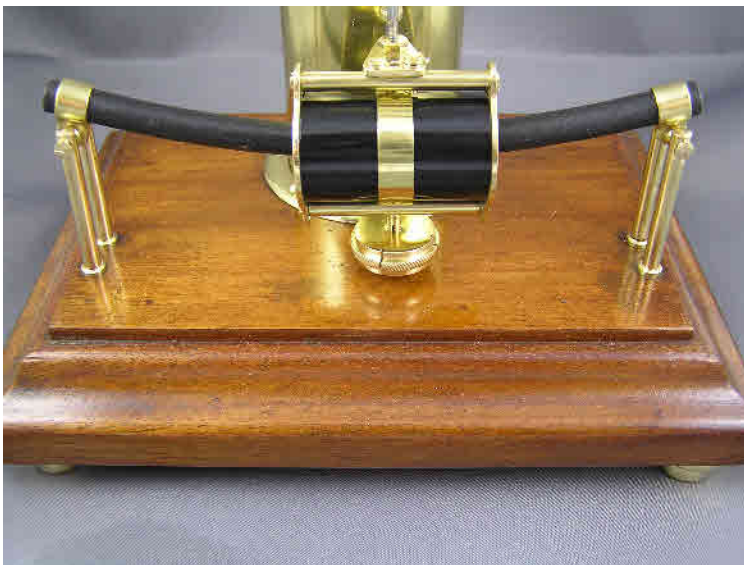
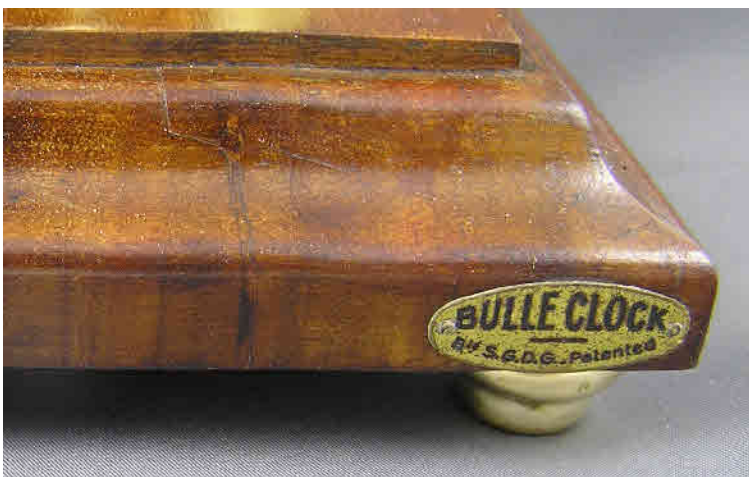
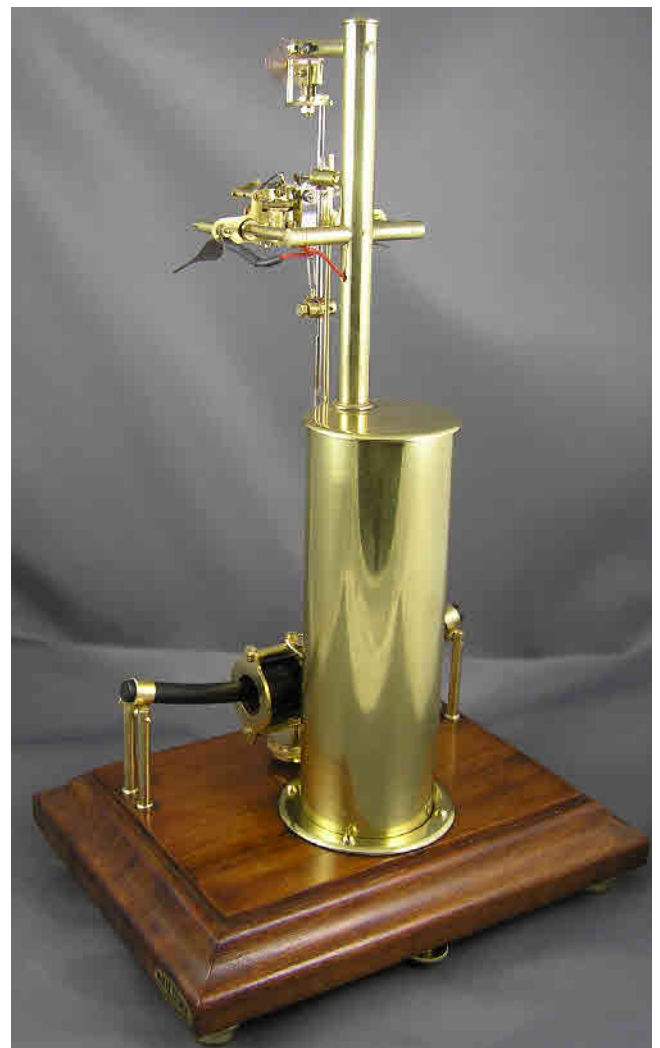
The photos below show the polished base, column, pendulum and movement back in position. The coil casing has been painted black.
