Bulle Clock Serial Number 201051

*Restoration of Bulle Clock
Serial Number 201051*

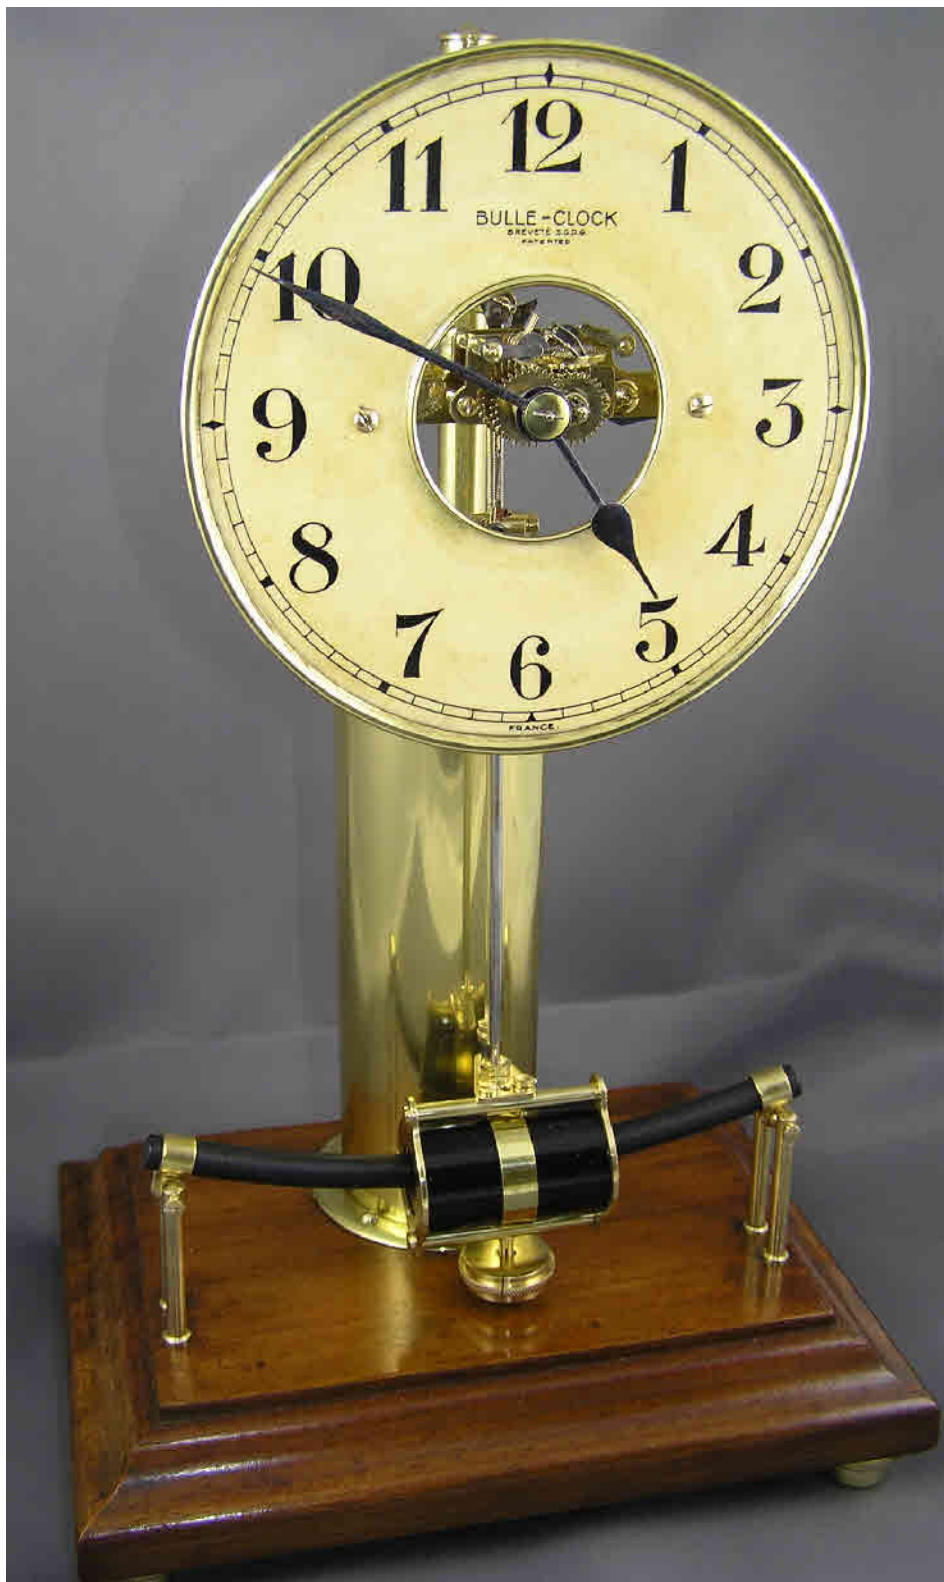
The completed Clock
