Bulle Clock Serial Number 2022

*Restoration of Bulle Clock
Serial Number 2022*

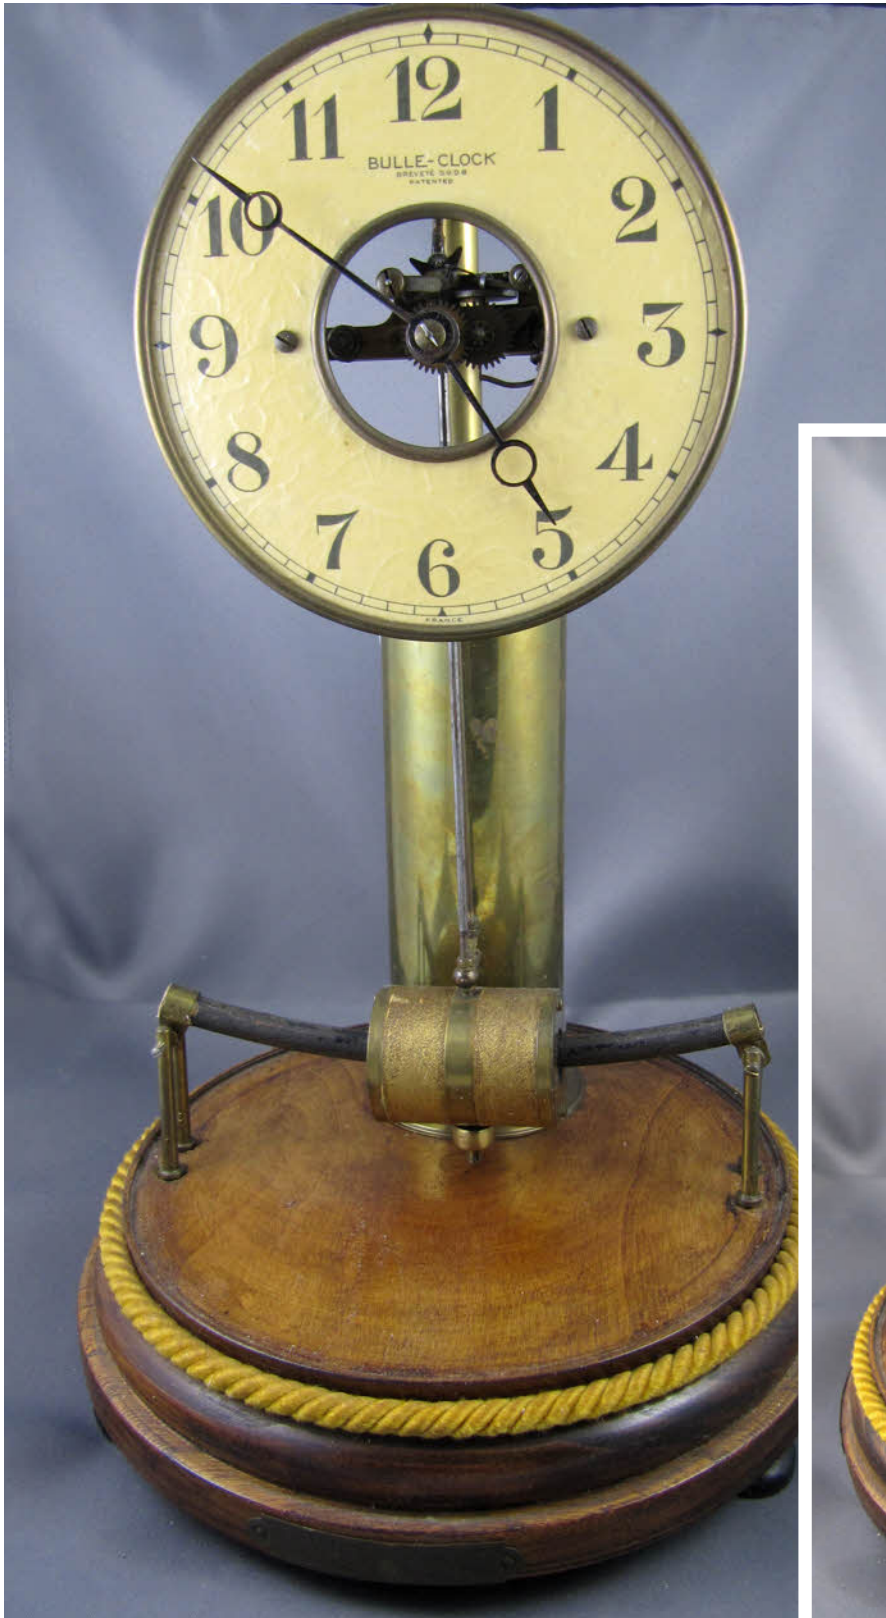
An early tall movement on a replacement round wood base. The dial is very crazed and fragile, but we should be able to clean the surround whilst protecting the face. The hands are original as is the cord around the coil cover.

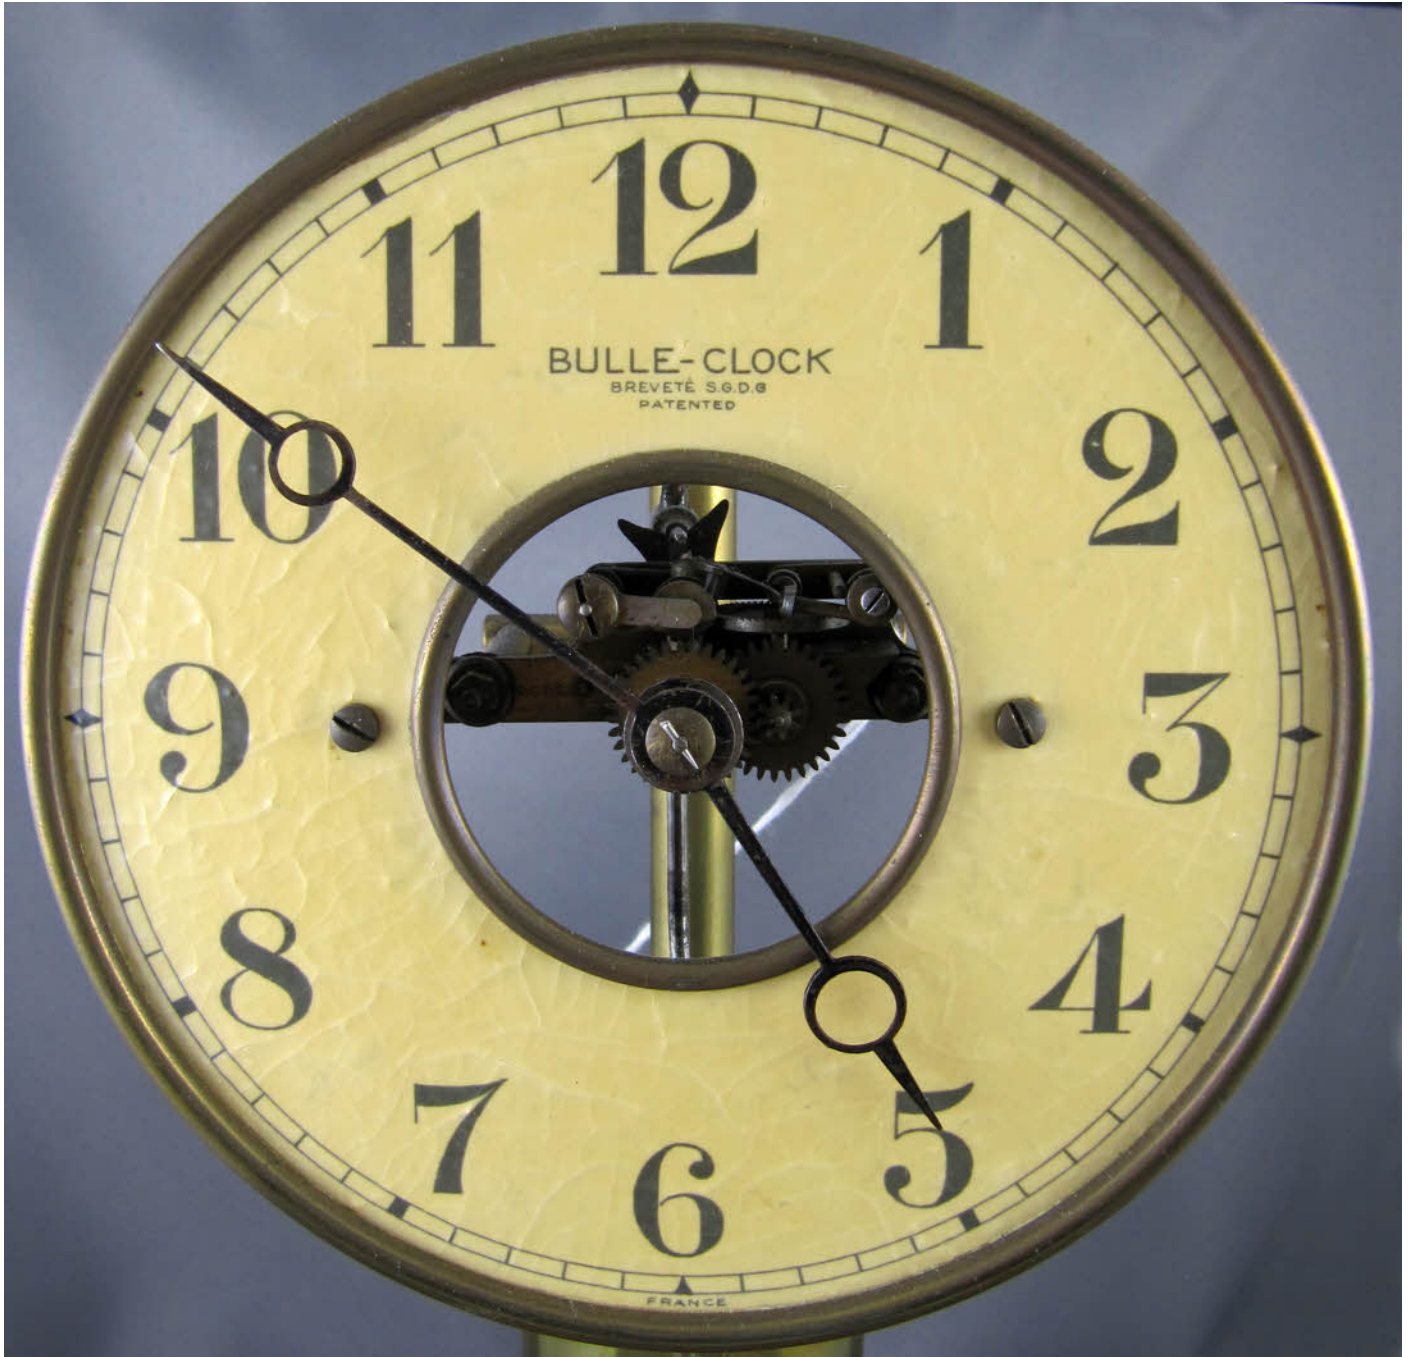
It's hard to see in this photo but you can make out the crazing of the face around the 9 o'clock position. It is all very fragile and will flake off easily. The dial will be put aside until the rest of the clock is restored and then some time spent carefully cleaning the brass without damaging the face.

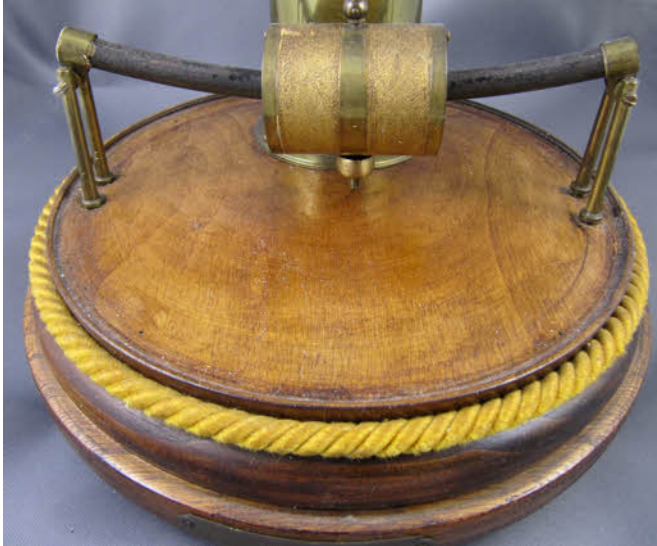
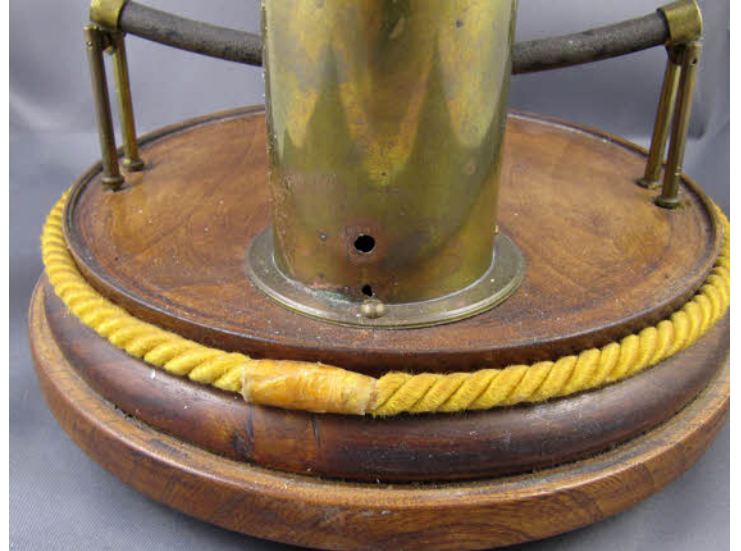
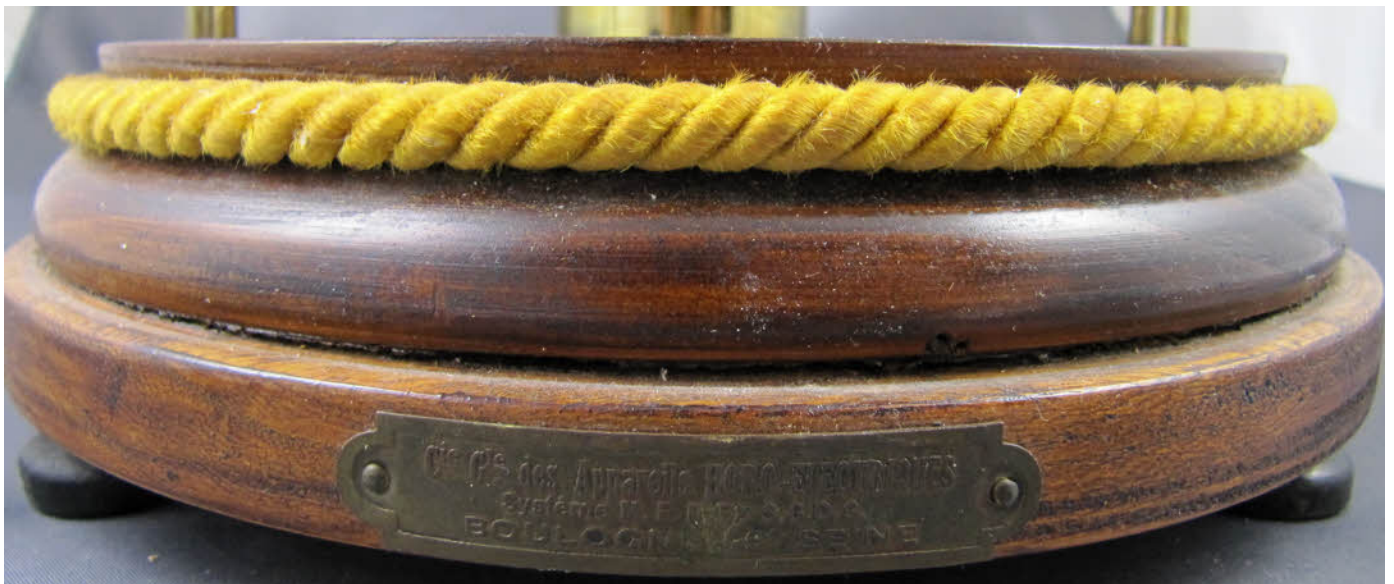
The base is not original and is in fact made up from two pieces of wood. It is all very warped and dry. The owner would like to keep it though as he no longer has the original and the glass dome fits this base. The whole clock it seems has recently been left to him and is therefore a family heirloom. He obviously wants to keep as much as possible of the clock as is. So I will try and restore the base as best I can. Note the standard French label on the front of the base. It has lost its definition and paint. The column is damaged with battery acid burns and has multiple holes the biggest of which is at the back and can be seen in the photo at top right.

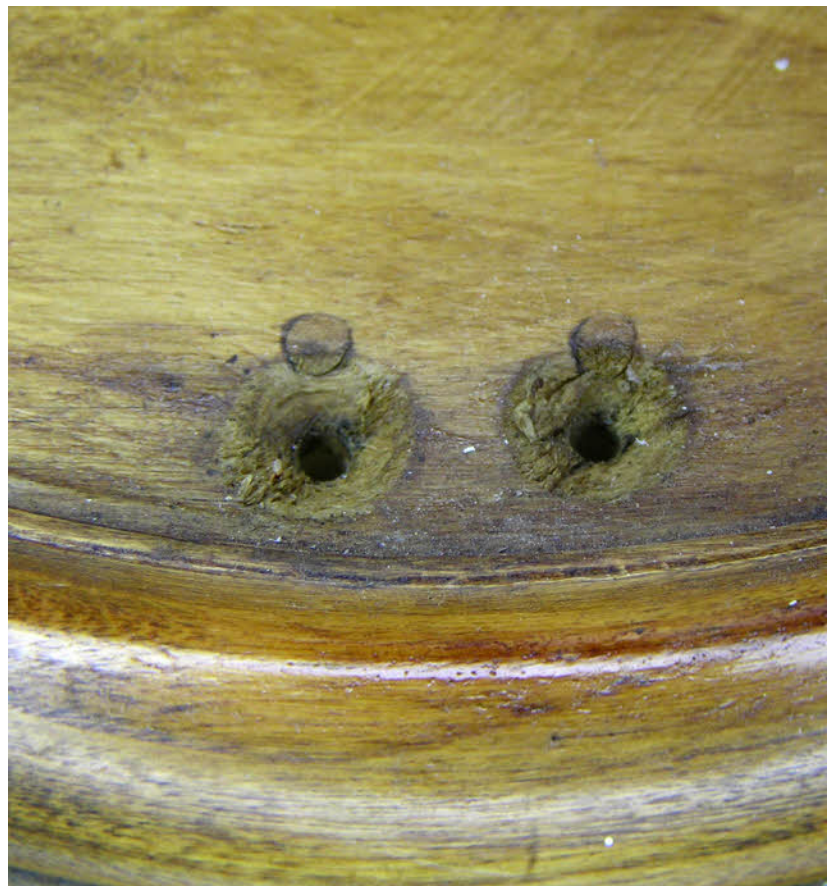
The photo above shows the packing inside the supports as they are too large to grip the magnet tightly. These will need replacing. The second arrow shows the badly drilled holes for the support pillars. Further detail is shown in the photo at left. You can also see where two holes had been misplaced and filled. I'll have to do something with these.

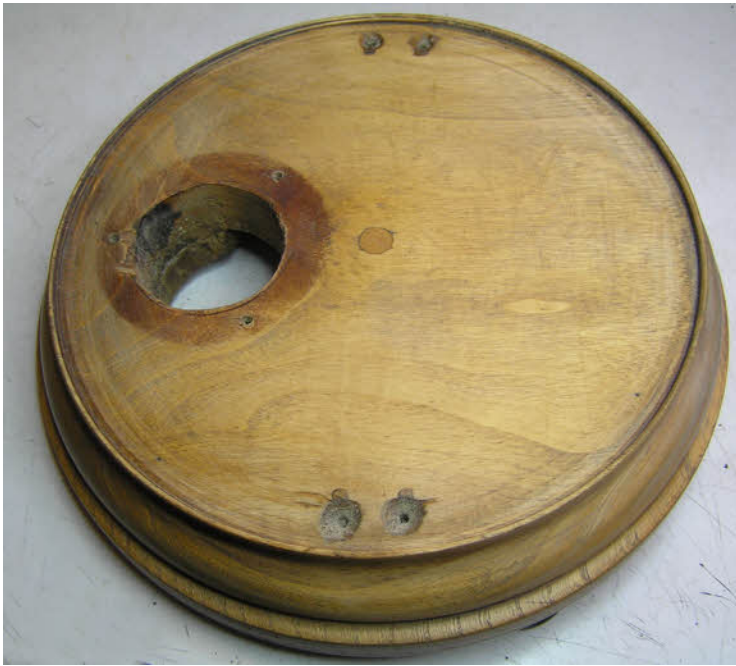
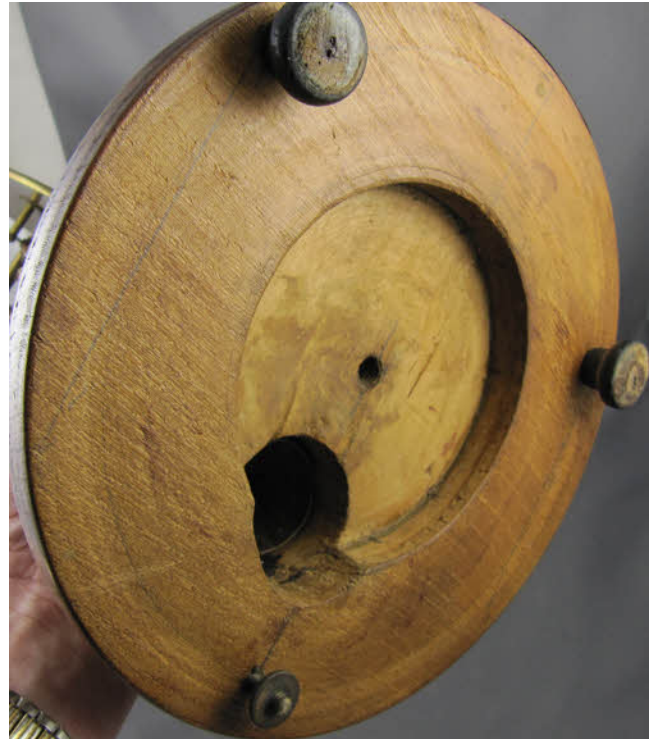
The photo above shows the misshapen hole for the battery holder. There is also no cover.

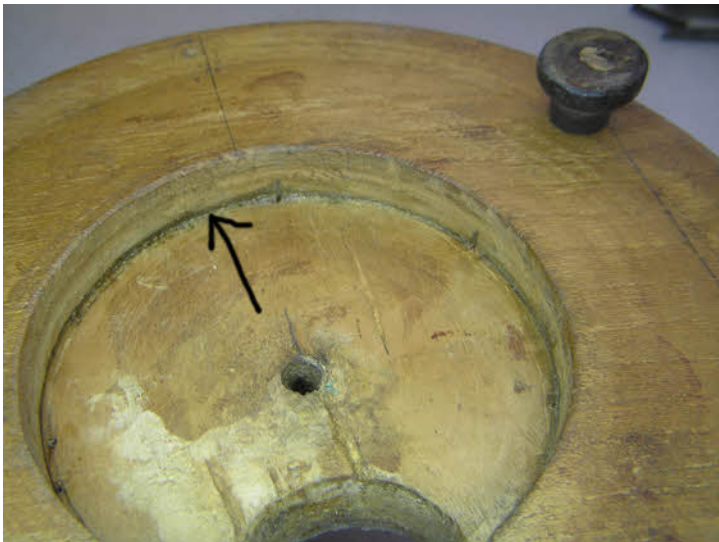
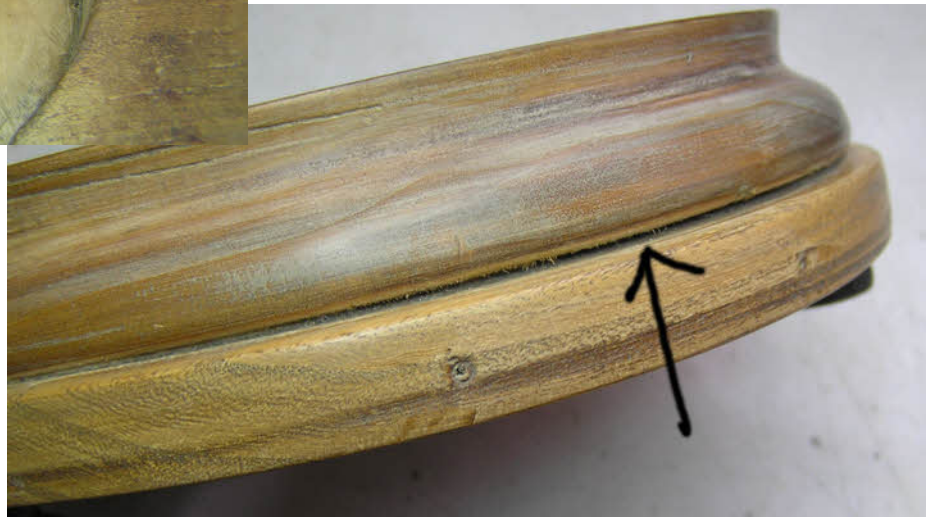
This group of photos shows the base after the column has been removed. The arrows show the two part base and how it has been glued together. Unfortunately the lower parts has warped slightly leaving a larger gap in places at the join.

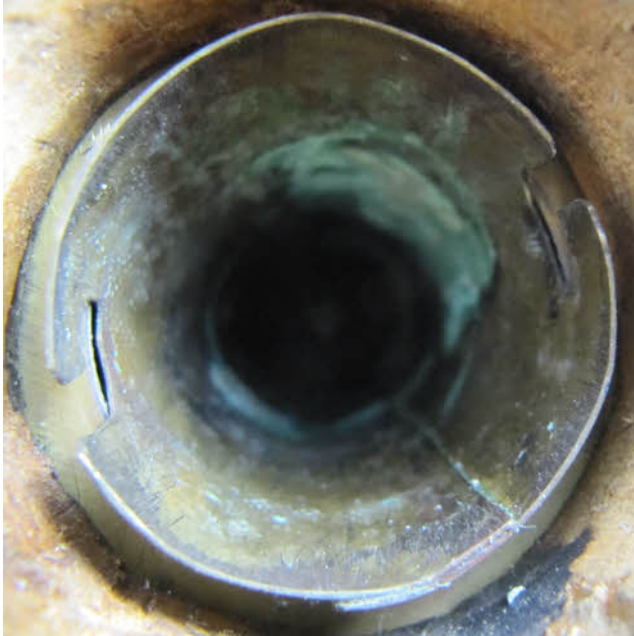
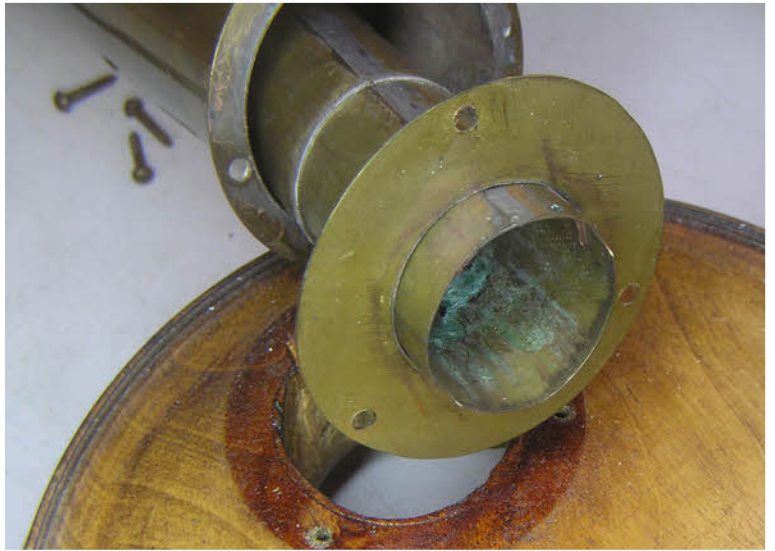
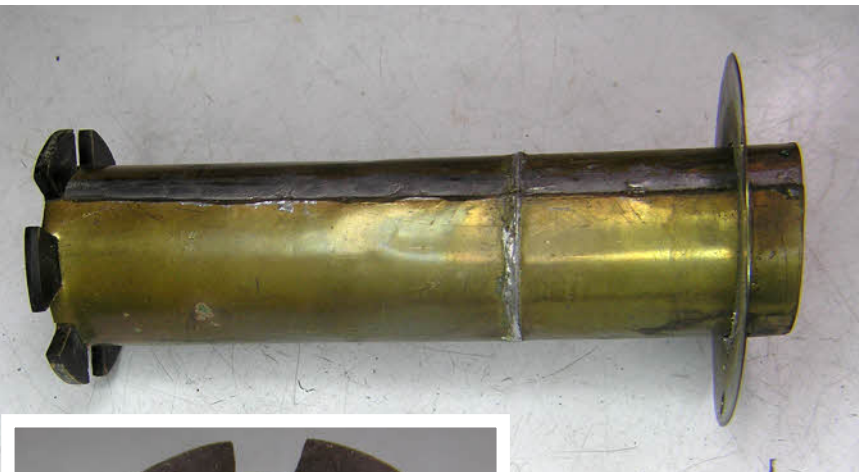
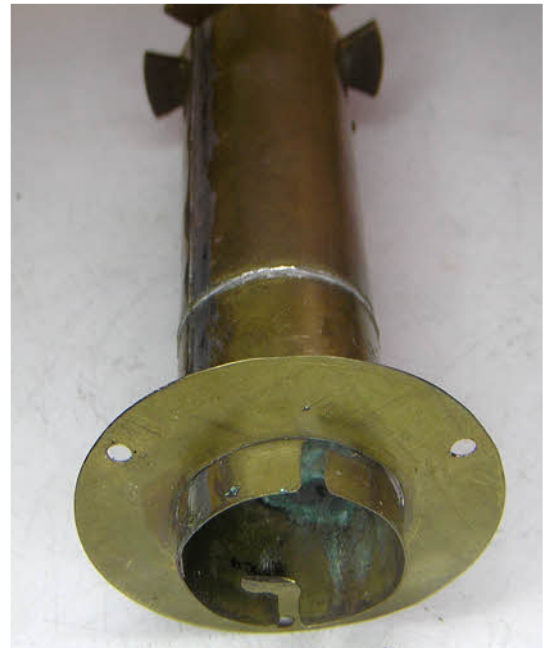
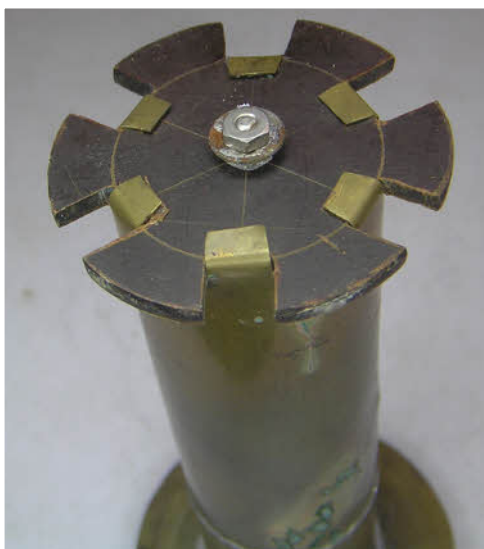
When the column was removed this “battery holder” was found inside. It was also damaged by acid burns. In the photo at top right you can see the colour the base was originally stained.

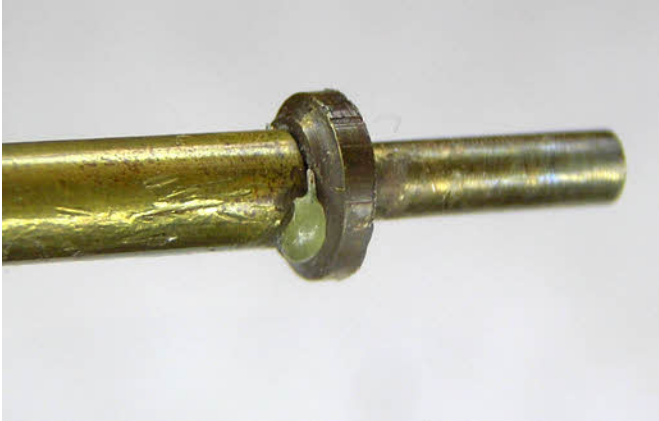
The magnet supports had the collars glued in place. Why? The magnet clamps are shown here in more details. They are badly damaged and cracked and will be replaced.. Also note the replacement securing screw which looks to be from a platform in a carriage clock. A new one will be made.

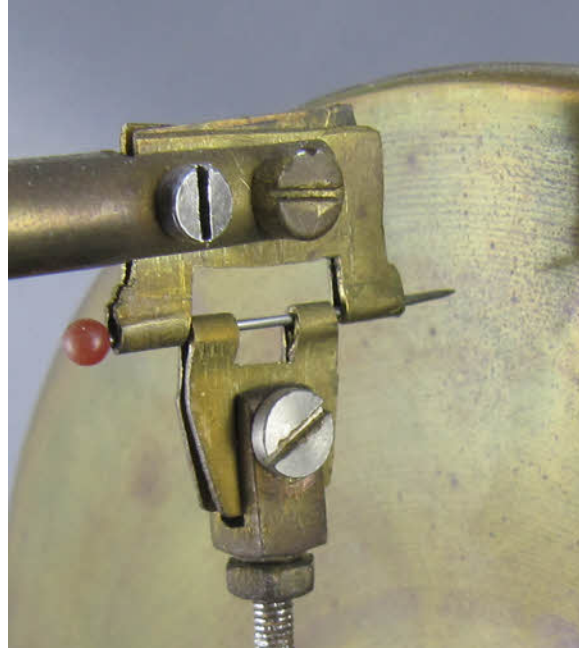
These two photos show the novel method of pendulum suspension. Whether it worked or not is debatable but it certainly would have made the pendulum too long and therefore the clock much too slow. I doubt if it could have been regulated. All of the screws and nuts will need replacing.

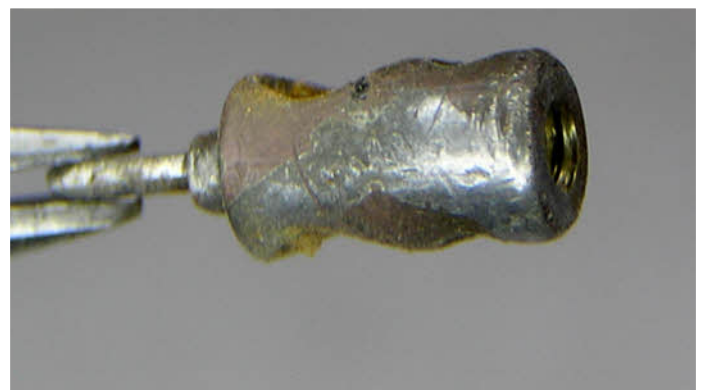
These photos show that the silver contact pin has been soldered in place. It seems from the corrosion that it was soldered in place while still in place in the clock. Hence all the burning and corrosion. Below is the contact pin assembly showing the excess solder.

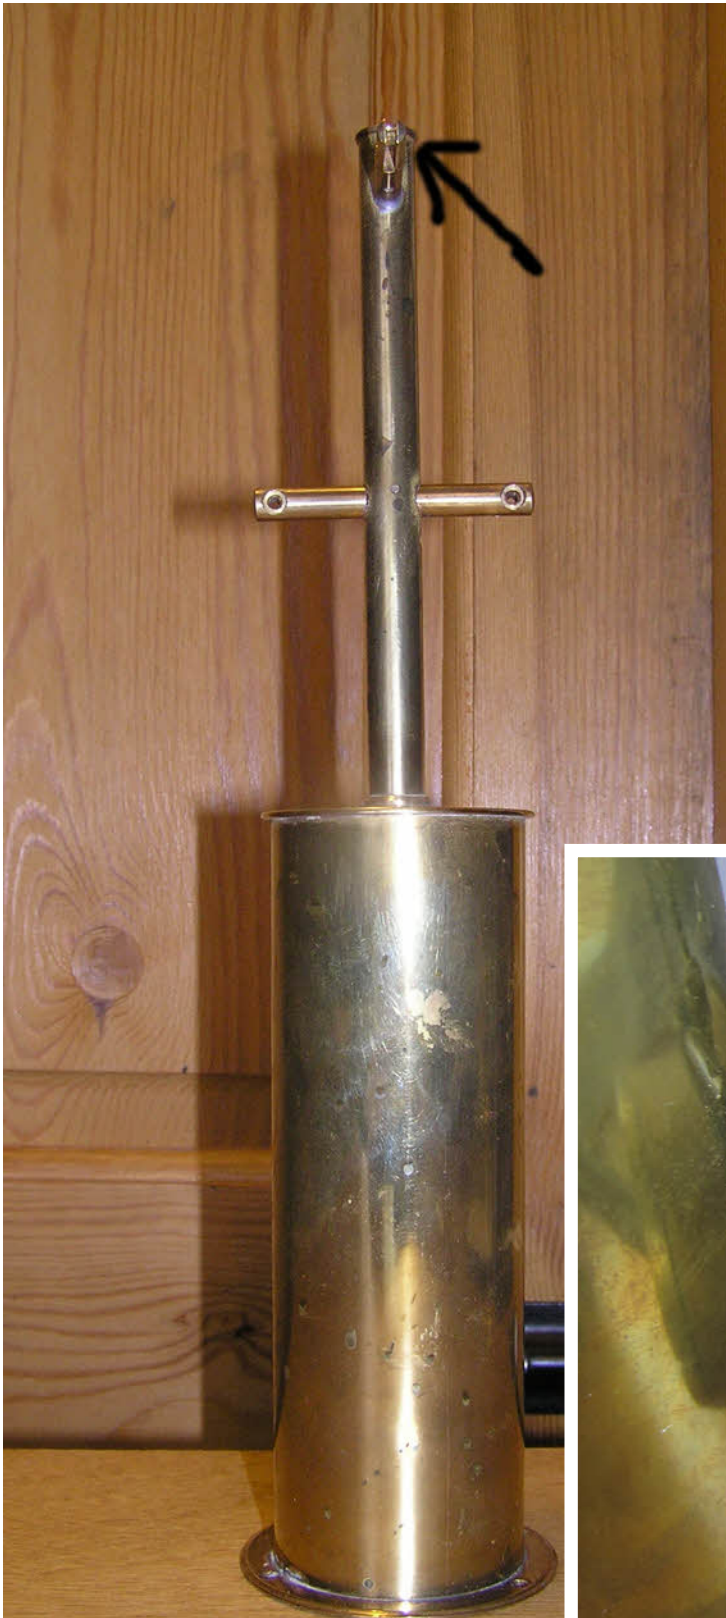
I have included this photo at left to show that the top frame has been soldered in place at an angle. The arrow shows the direction of the lean. It would not have made much difference to the running of the clock but it does show the errors in manufacture. Hopefully I will be able to get it a little straighter when I solder all the new parts back together.

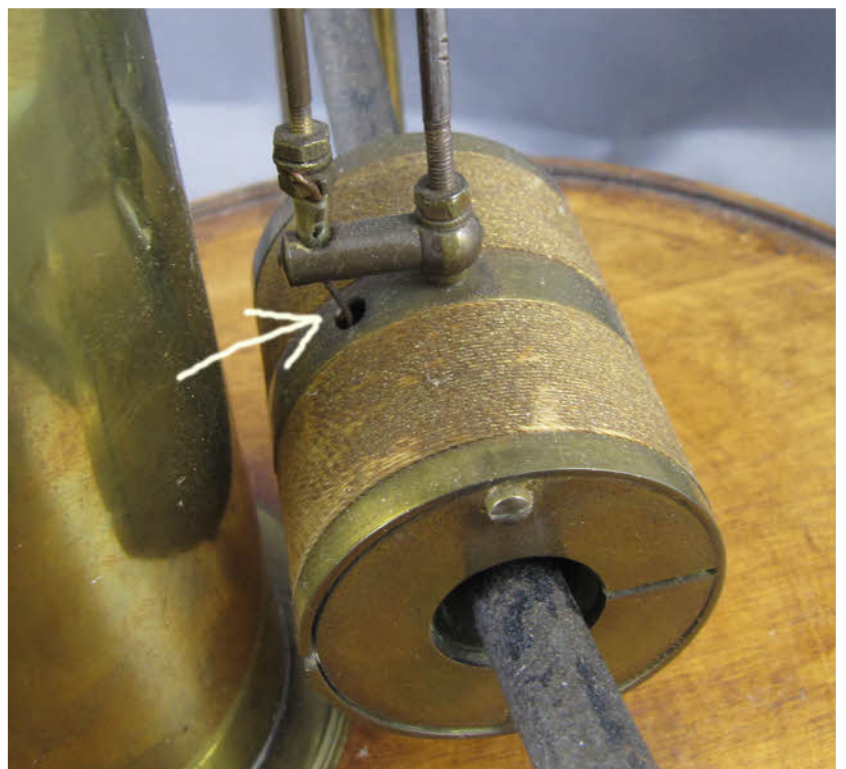
Below is the coil cover. Note the bare wire running through the cover. This would have caused major issues by shorting out the coil. The cord is brittle and in very bad condition. It will be replaced.

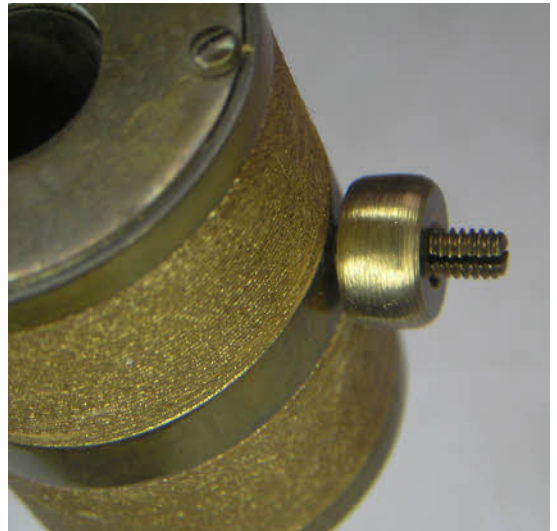
The original rating nut is missing and has a minute replacement. A new one will be made.

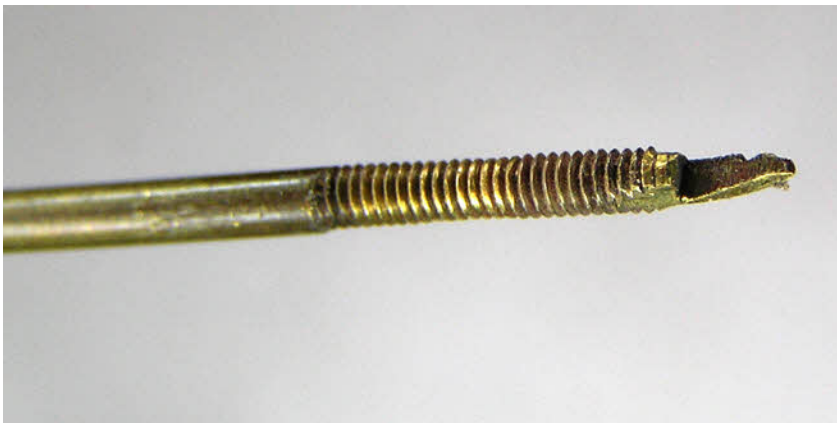
On the left is the brass coil connecting rod which has a damaged thread. This will be repaired.

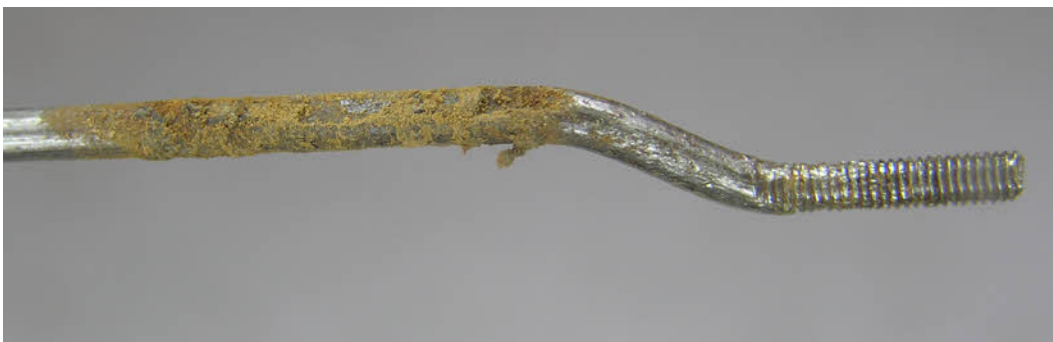
This last photo shows the damage to the steel pendulum rod where the contact pin assembly was heated when soldering the silver pin. It will easily clean up .

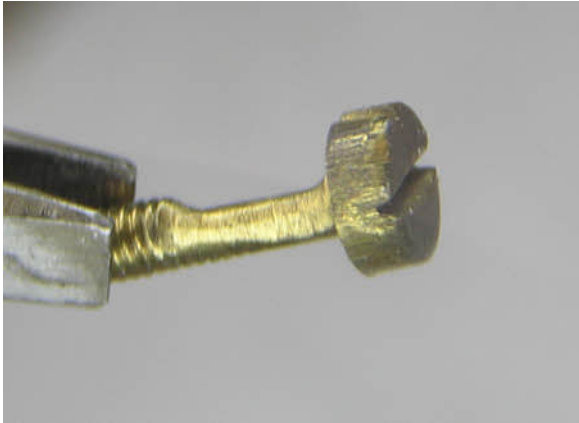
The screw which holds the top block of the suspension has been filed down to suite the "map pin" suspension. Another turning job.

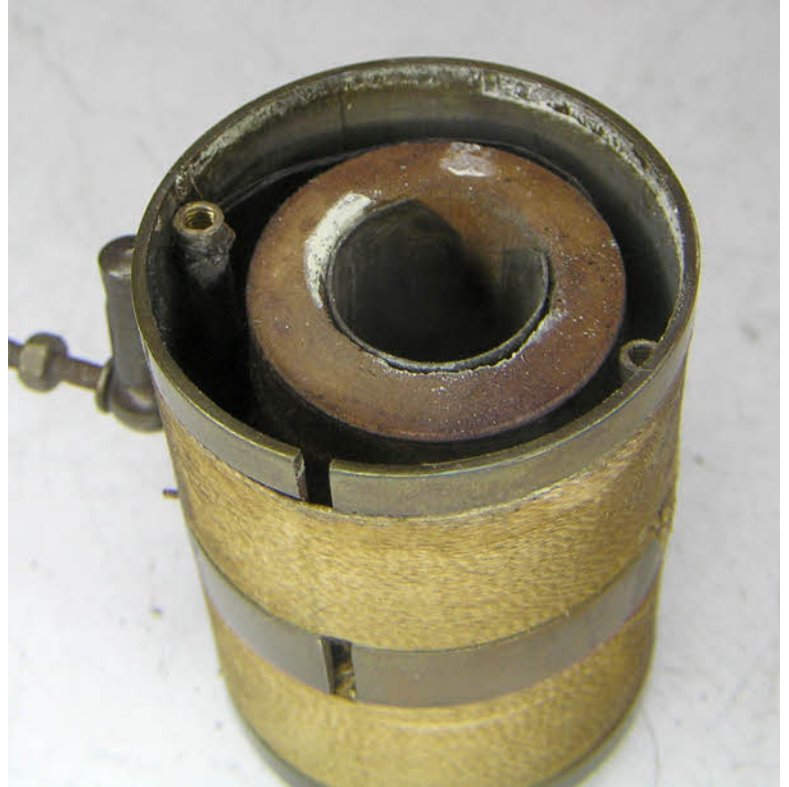
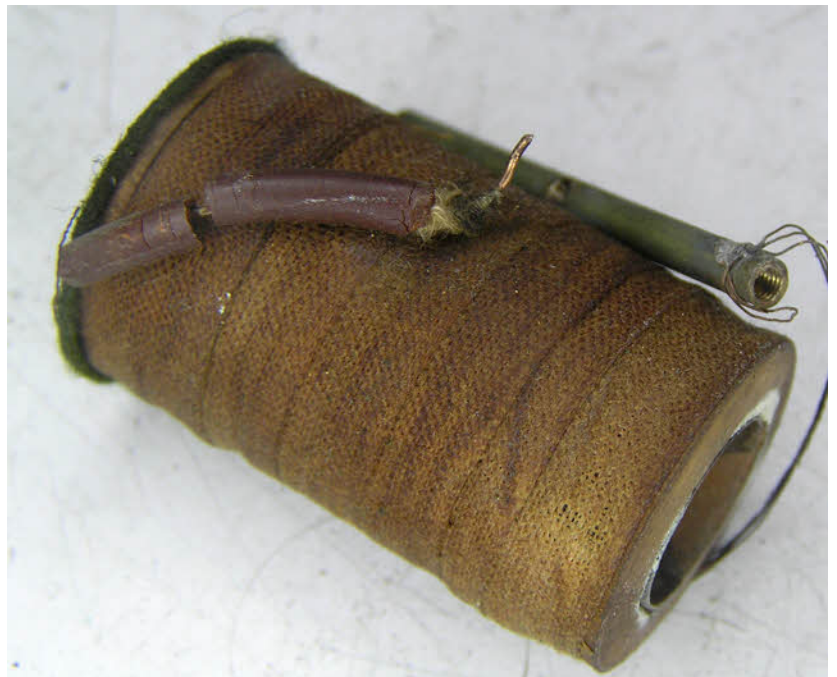
Although the lead out wires from the coil have been hacked about and new wire added to them the coil itself is still in good condition with its original binding and reads a about 720 Ohms. This clock is one of the earlier type with the lower resistance coils. These were found to be too low and the Bulle factory had to add a resistor to the frame to make up the total resistance nearer to the later 1100 ohms. This clock has a hole in the frame where the resistor once sat, but as with many other parts it is missing and will need to be made.

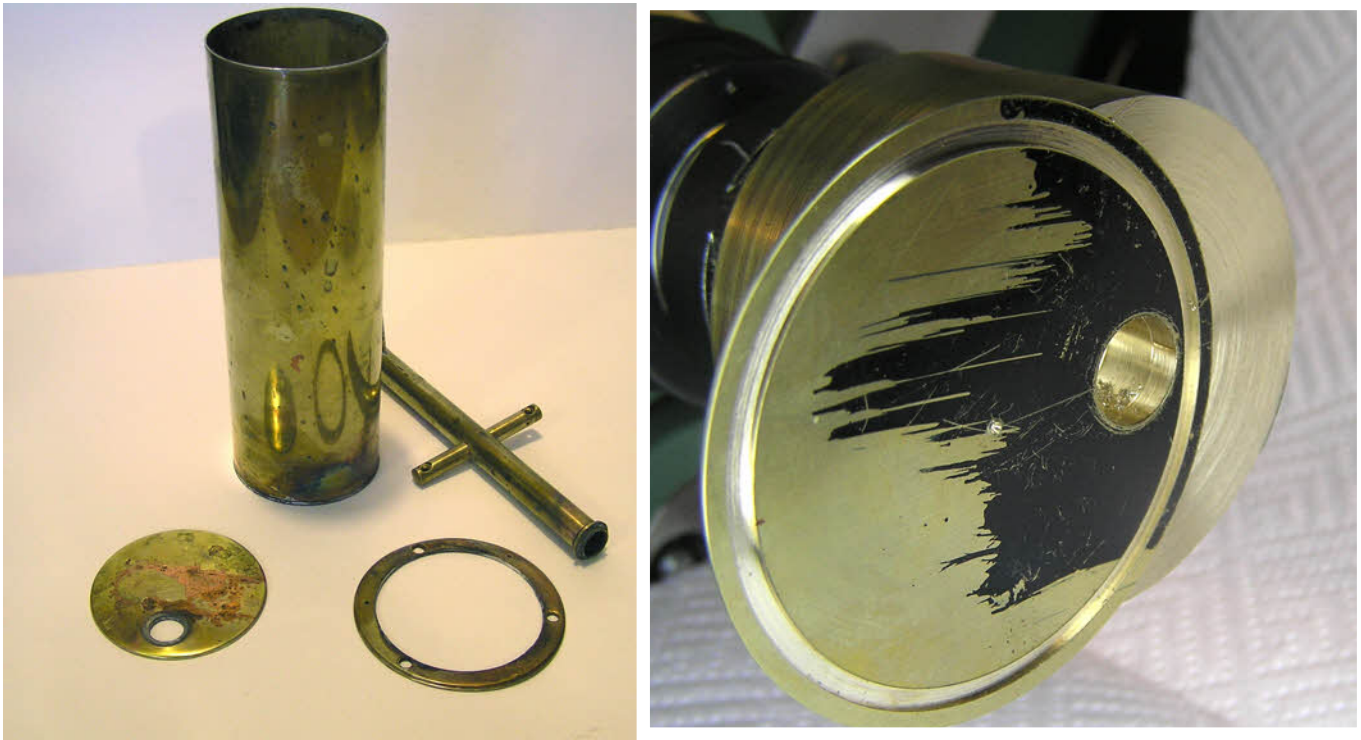
The column, cap and frame disassembled. The last photo shows the new column cap being turned up.

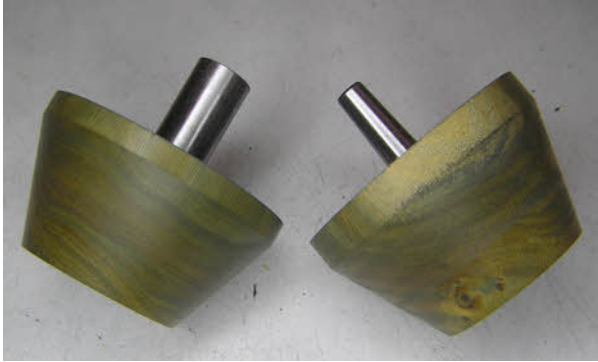
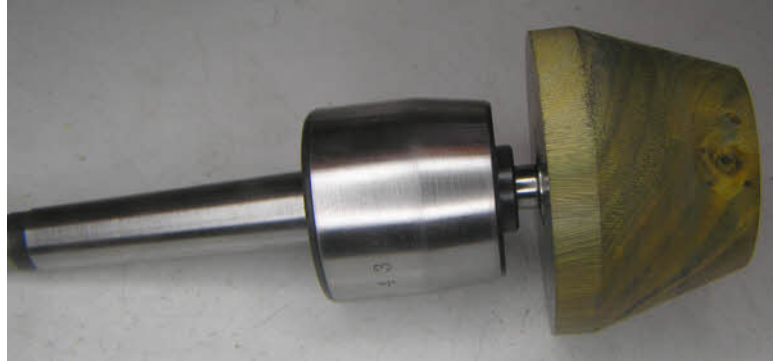
I made up these holders to carry the new tube in the lathe so that it could be machined and polished as shown below. They are made from pear wood. One was made to fit the revolving centre for the tail stock. The wood gave off a lovely aroma when being made. I kept the shavings in a box and it still provides a lingering fragrance.

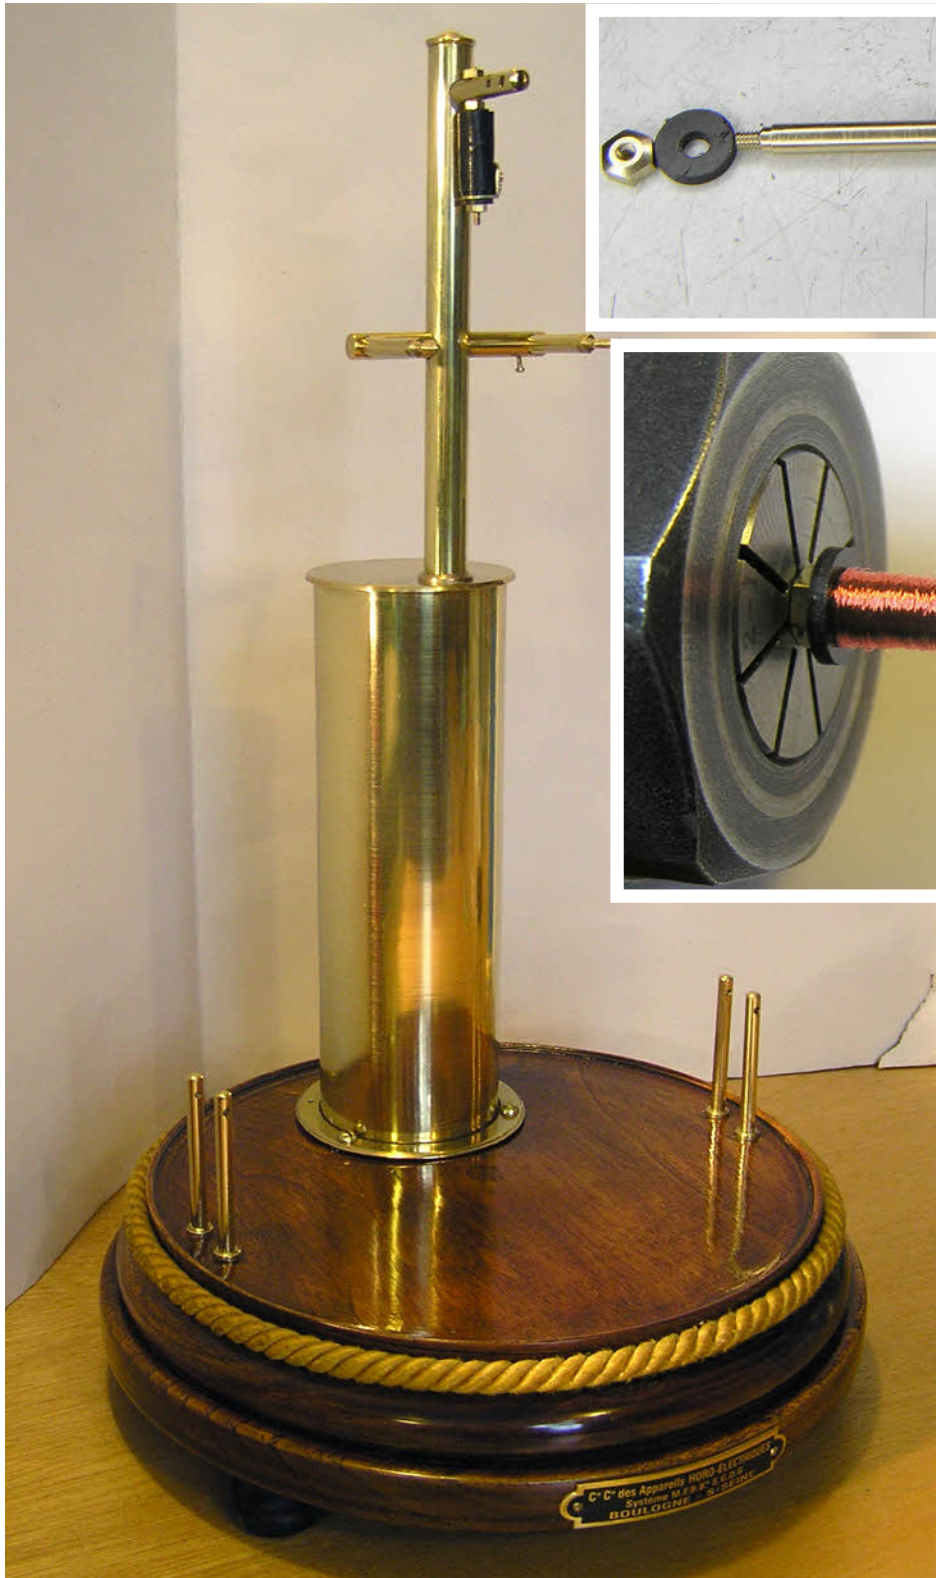
The column and base finished and back together. Note the new resistor in place at the top of the column. The two insert photos are of another one I built for another clock. The only difference is in the method of securing it to the frame. It has a loop of brass which secures it around the frame while on this clock it is secured through a hole in the frame.

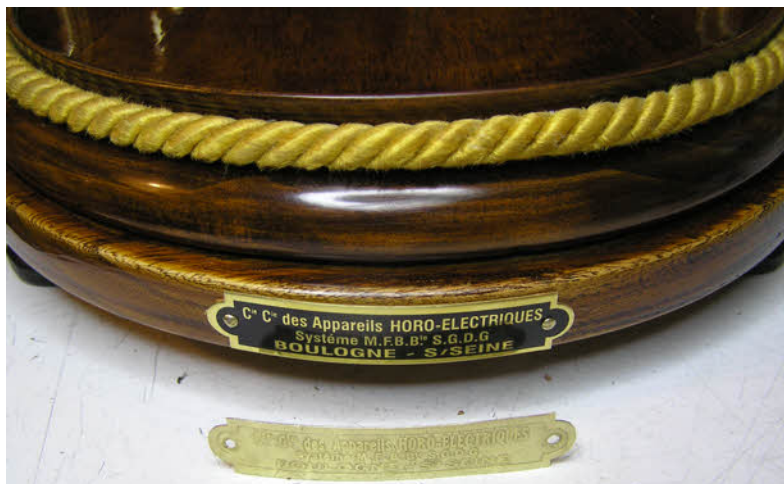
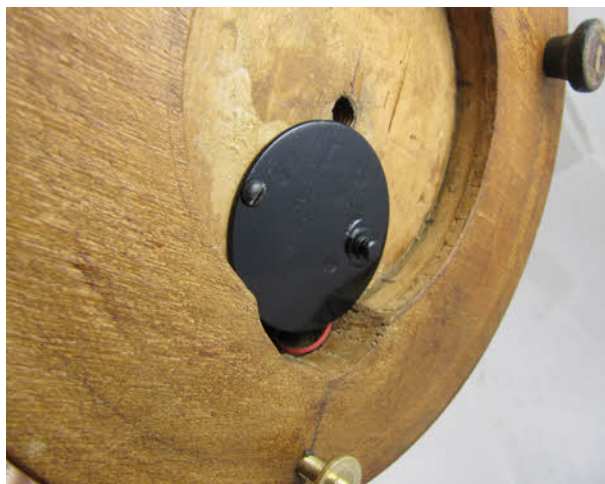
The base has been cleaned, stained and french polished. The photo at top left shows the new French label. The underside of the base needed a cover to keep the battery in place, so I thought it would be nice to use the damaged column cap which I replaced along with the column.

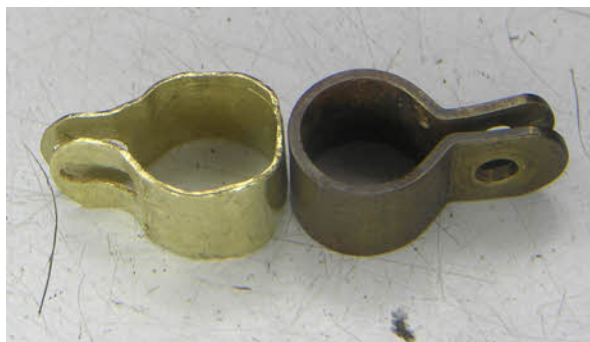
This photo shows the difference between the original and replacement magnet brackets. I happened to find a couple in the parts box.

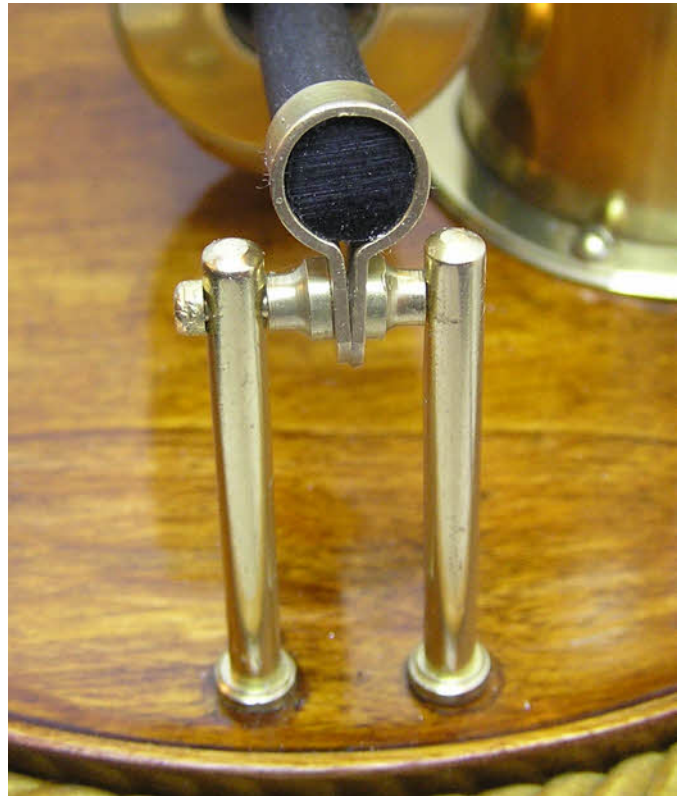
The replacement magnet brackets.

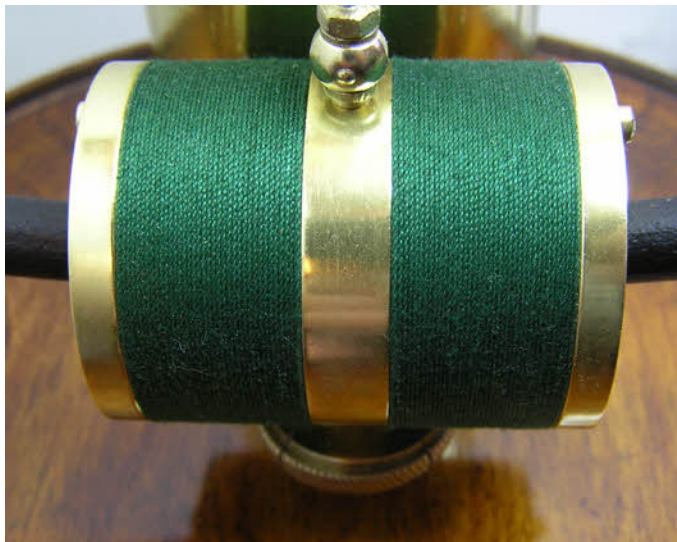
The rebound coil cover.

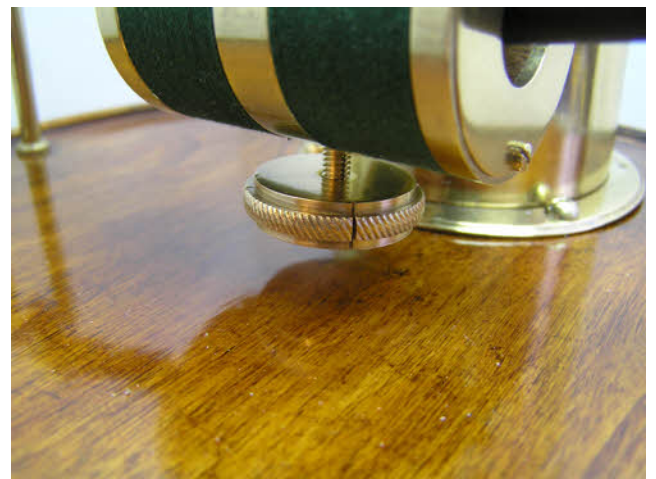
The new rating nut.

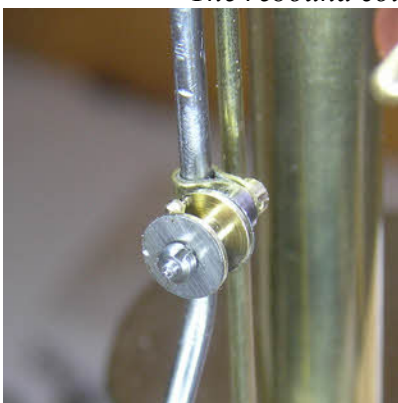
The new Isochron pendulum bracket assembly

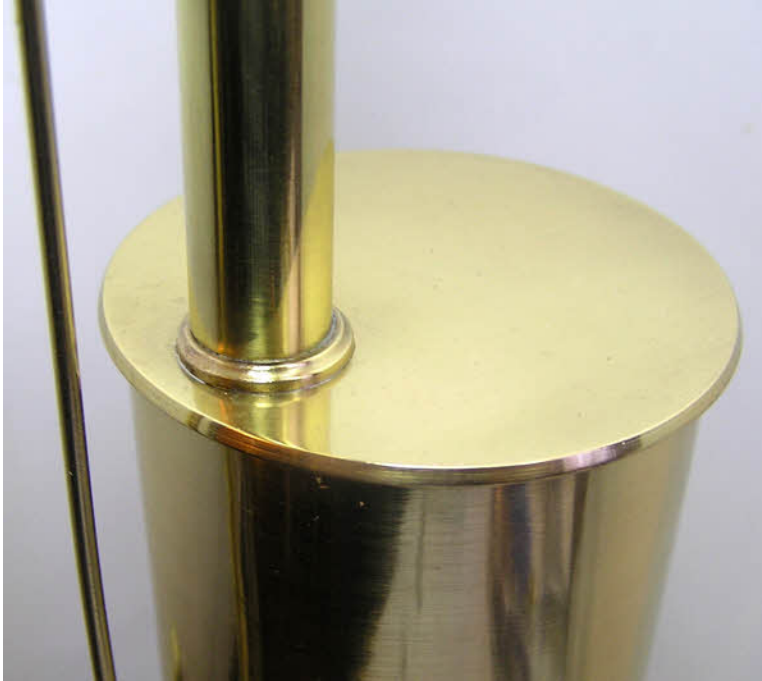
The new column cap.

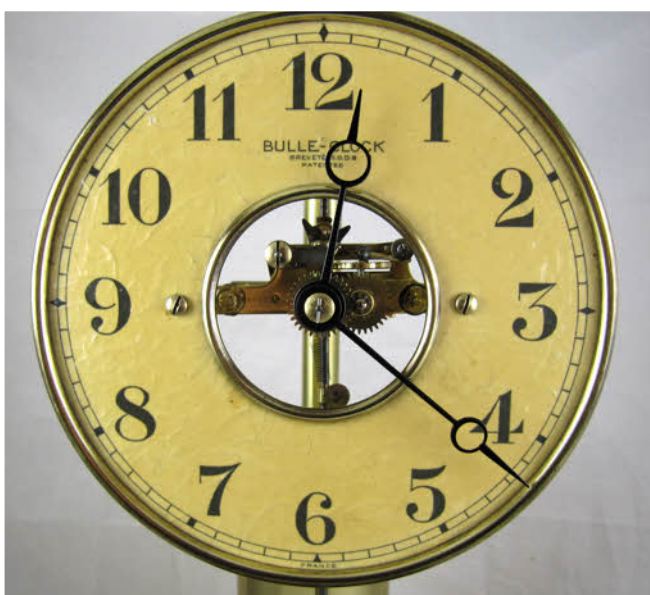
The dial with cleaned brass.
