Bulle Clock Serial Number 2022

*Restoration of Bulle Clock
Serial Number 2022*

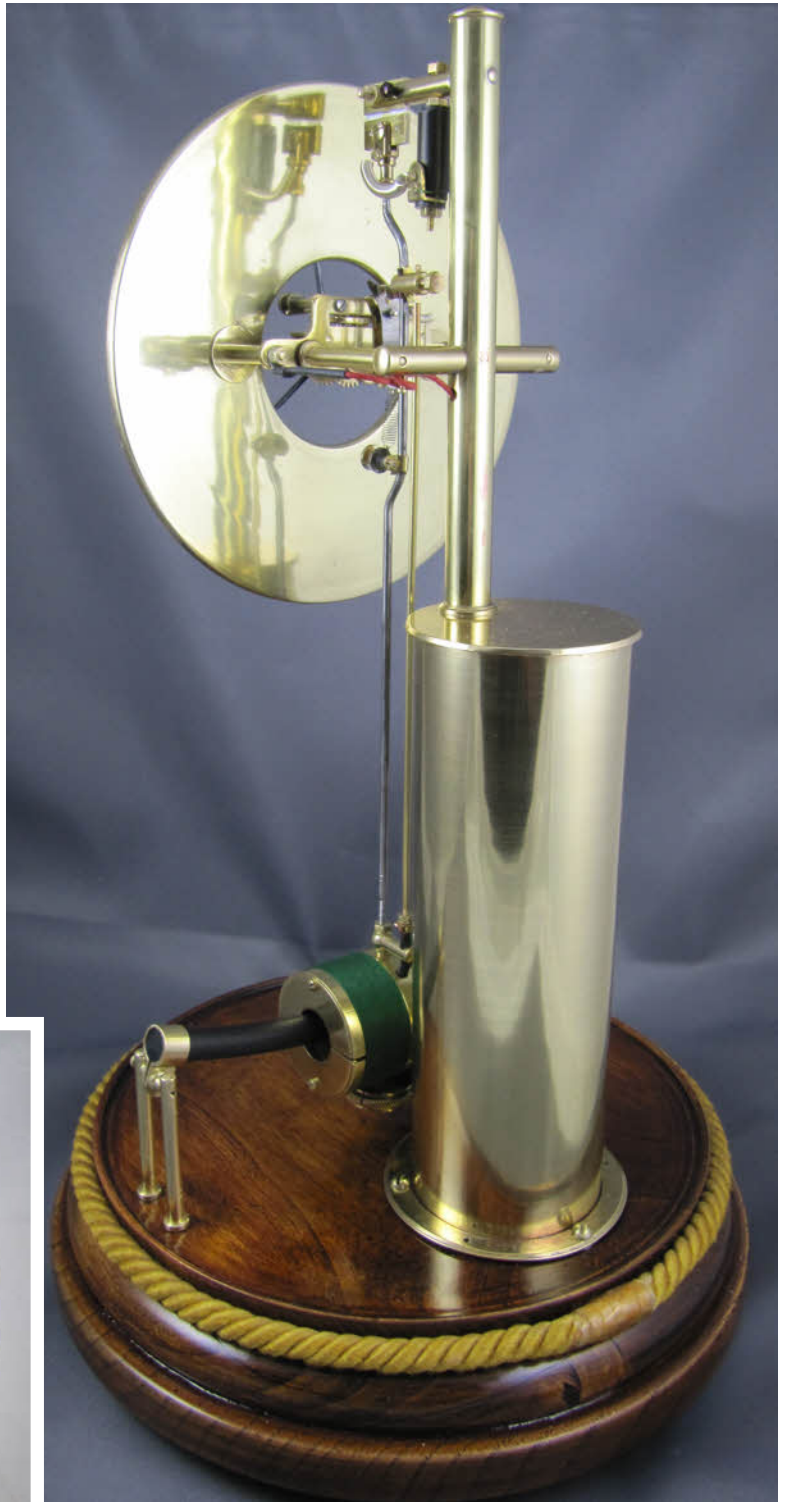
The finished clock from the rear

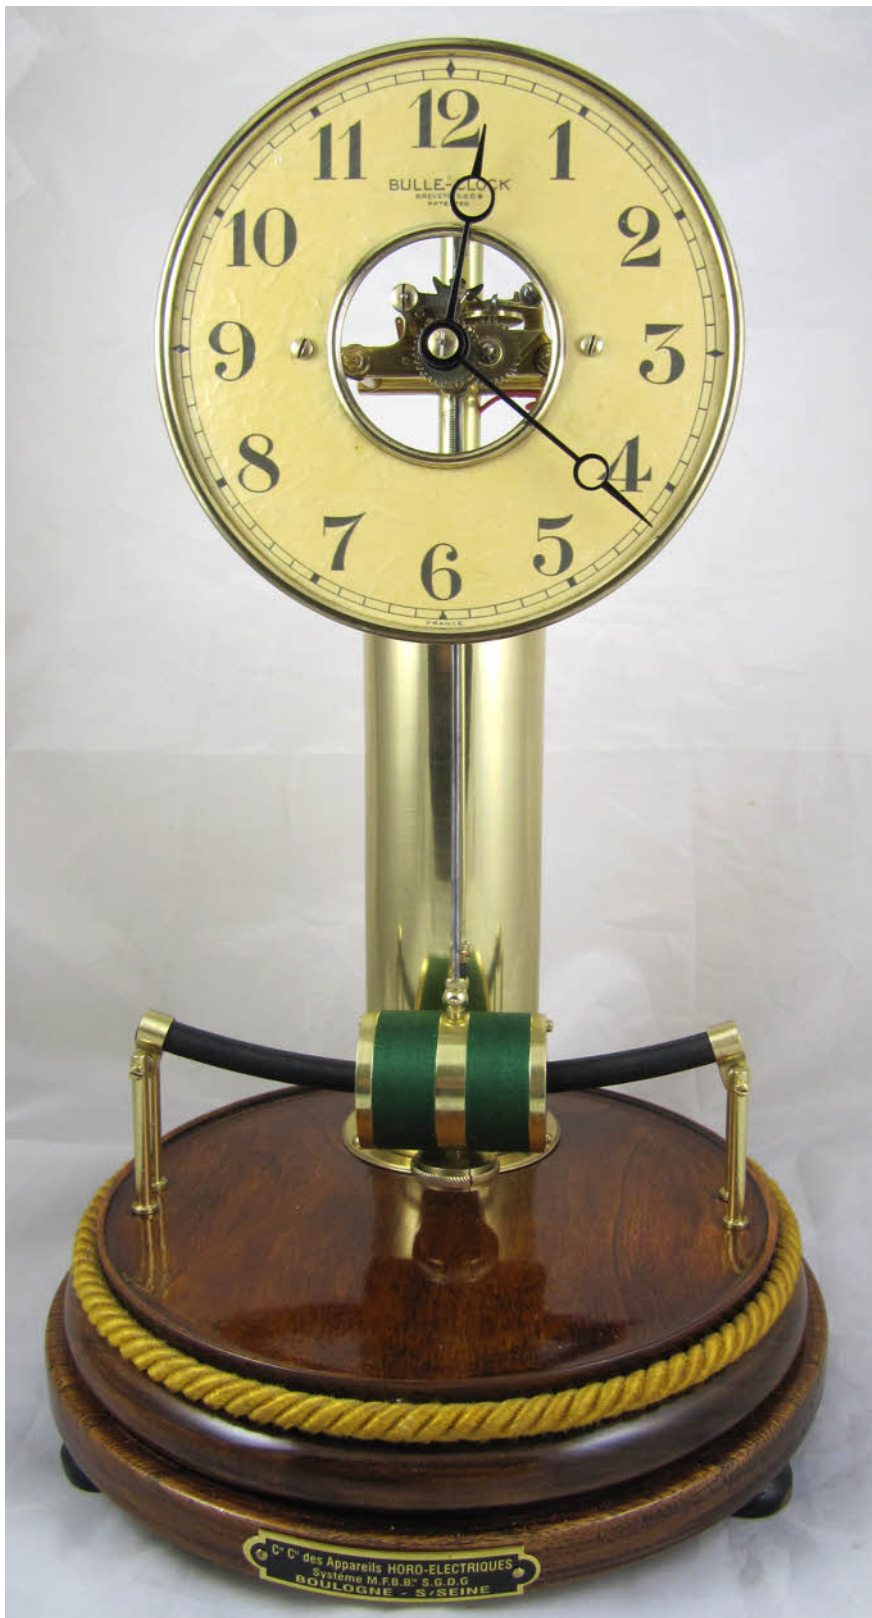
The finished clock
