Bulle Clock Serial Number 203860

Restoration of Bulle Clock Serial Number 203860

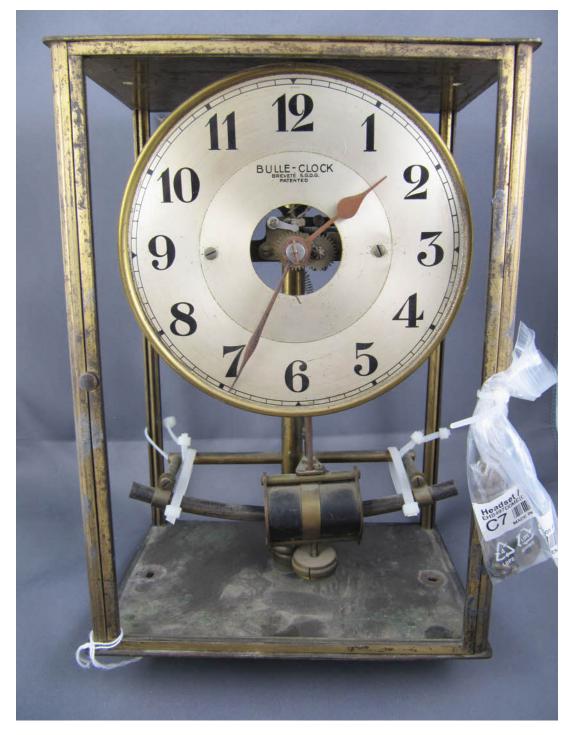
A medium Bulle clock in a brass four glass case. The owner has retained the marble top and bottom as well as the glass. The clock is not in good condition as can be seen. All the steel work looks rusted as well as the hands. There are also some deep stains in the brass.

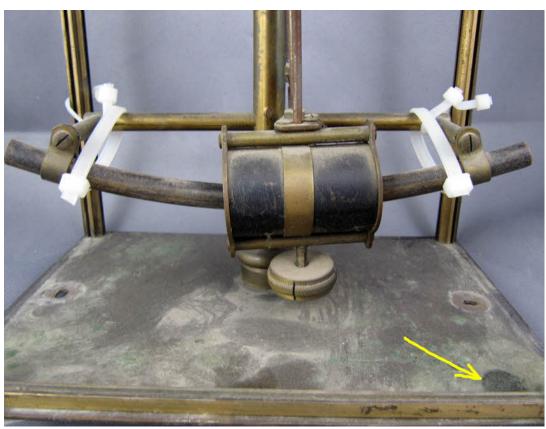
This photo shows the dark mark which is in fact a bad "burn" in the brass. I will clean it up as best I can but the mark will probably still be seen as it is quite deep. But at least it will be less noticeable.

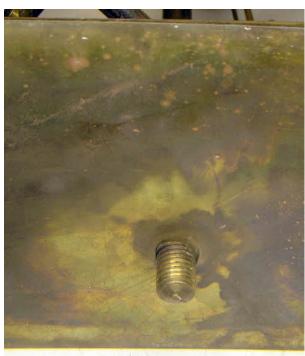
The frame is missing the large nut that secures it to the case.. This will have to be made

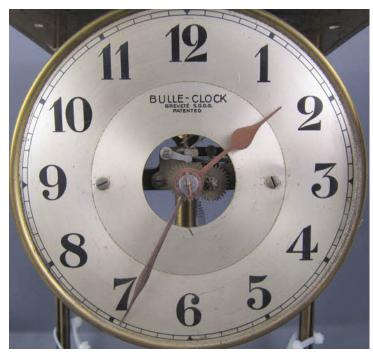
A closer shot of the dial and rusted hands. The hands will come up fine after cleaning and painting.

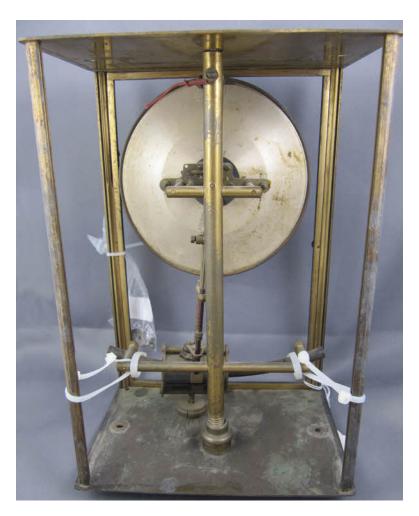
The photo on the left shows the rear of the clock. The back of the dial is badly marked and tarnished. Hopefully I shall be able to tidy it up a bit.

The photo below is useful as it shows the amount of thread protruding from the loose fitting cap which covers the round nut used to position the frame up and down such that it fits with enough clearance for the pendulum to swing freely but also low enough to fit the top of the case with the screw described below.

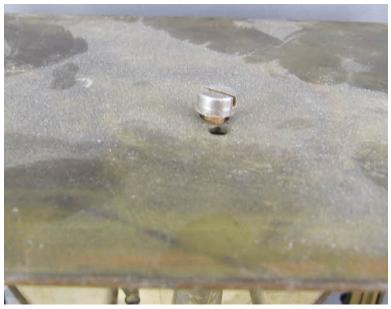
The photo lower left shows the top of the frame and the badly fitting screw holding it to the case. On disassembly it was found that the hole in the frame was stripped of thread and the screw was loose fitting. So I will have to tap the hole and make a new screw to fit.

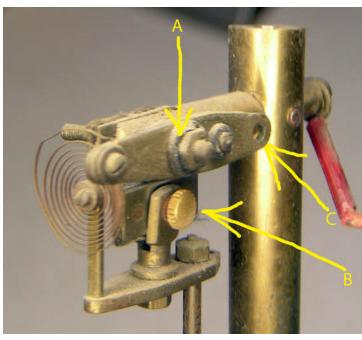
This photo shows the pendulum suspension with three problems A) shows the insulating washer which should have a brass backing washer. B) shows the lower suspension nut is missing and a quartz clock had nut used in replacement. C) shows the missing nut and screw that holds one of the battery leads. All will need to be made.

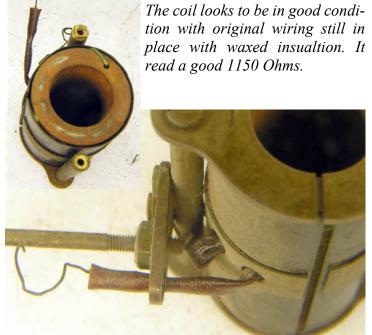
This photo shows a view from under the movement.

The pendulum casing looks in good condition as does the rating nut. Not the loose fitting cap on the main frame.

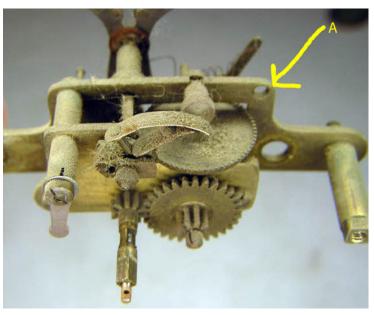
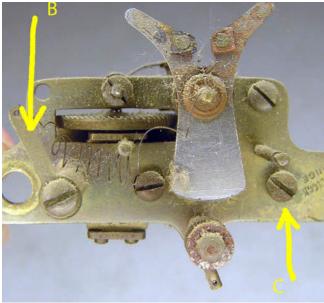
These two photos show the condition of the movement. A) shows the missing arm that stops the pawls from jumping vertically, B) shows the arm that holds the Silver contact spring in the wrong position. It should be at C). Note also the dirt and rust., The fork looks to be OK under neath the muck.

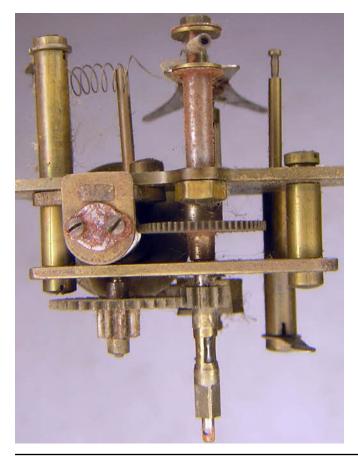
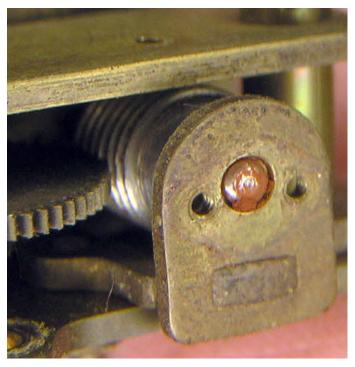
These two photos show the extent of the rust. The count wheel was jammed tight by the rust.

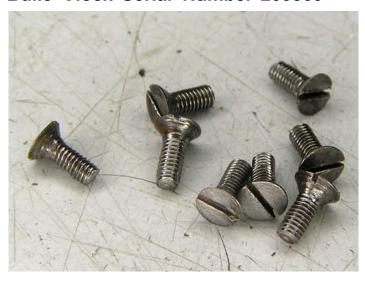
The group of screws that hold the brass case together after cleaning.

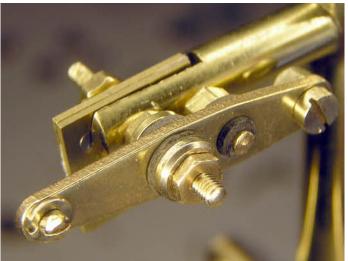
The isolation bar back in place with new screws, nuts and washers.

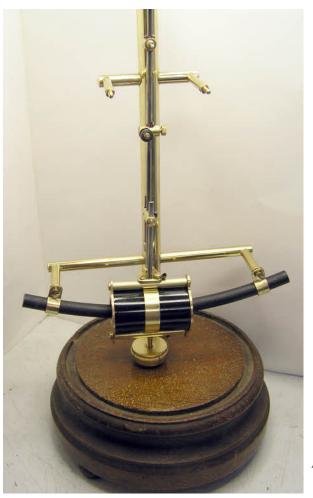
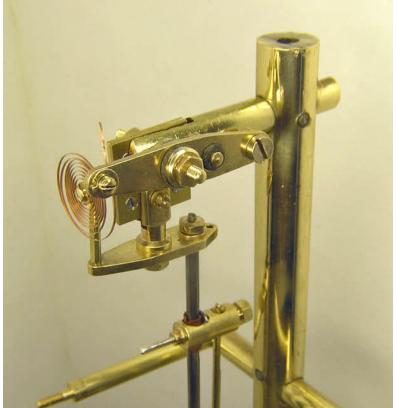
The pendulum, contact pin assembly and suspension back in place on a an old wood base used for testing the movement, which is not easy if put back in the four glass case.

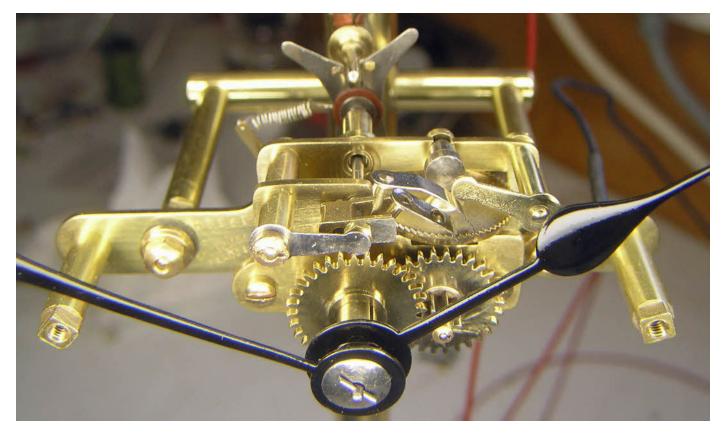
The movement back in place with the cleaned and painted hands. Not the new arm that restricts the vertical movement of the pawls.

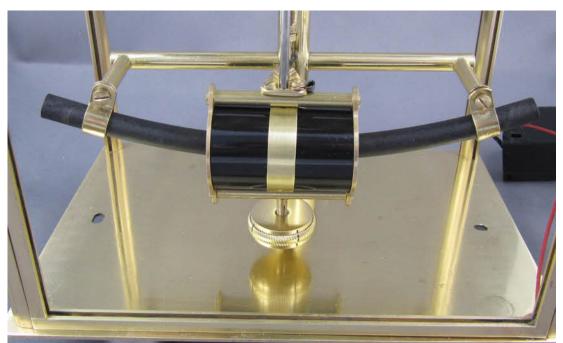
The repainted pendulum casing.

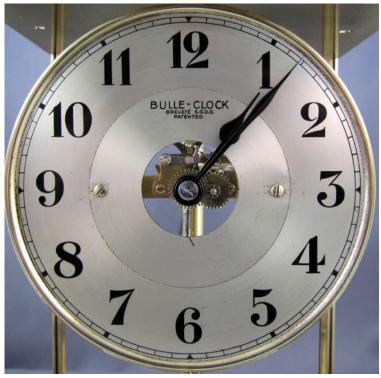
The cleaned dial back in place and a side view of the finished clock.

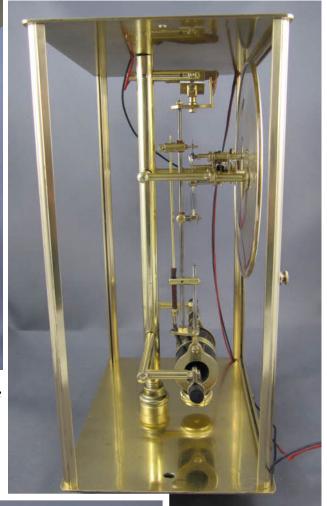
This last photo shows the new screw that holds the frame to the top of the case.

Note the wiring which has been left loose and long so as to facilitate an easy installation when the owner re-fits the glass and marble.

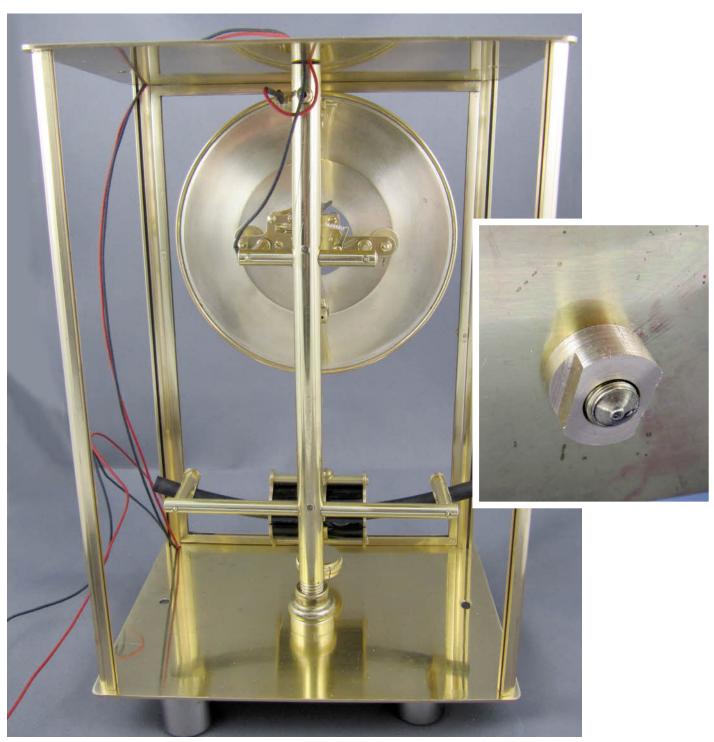
Rear view of the completed clock and an insert photo of the new nut that secures the frame to the lower case plate.
