Bulle Clock Serial Number 20441

*Restoration of Bulle Clock
Serial Number 20441*

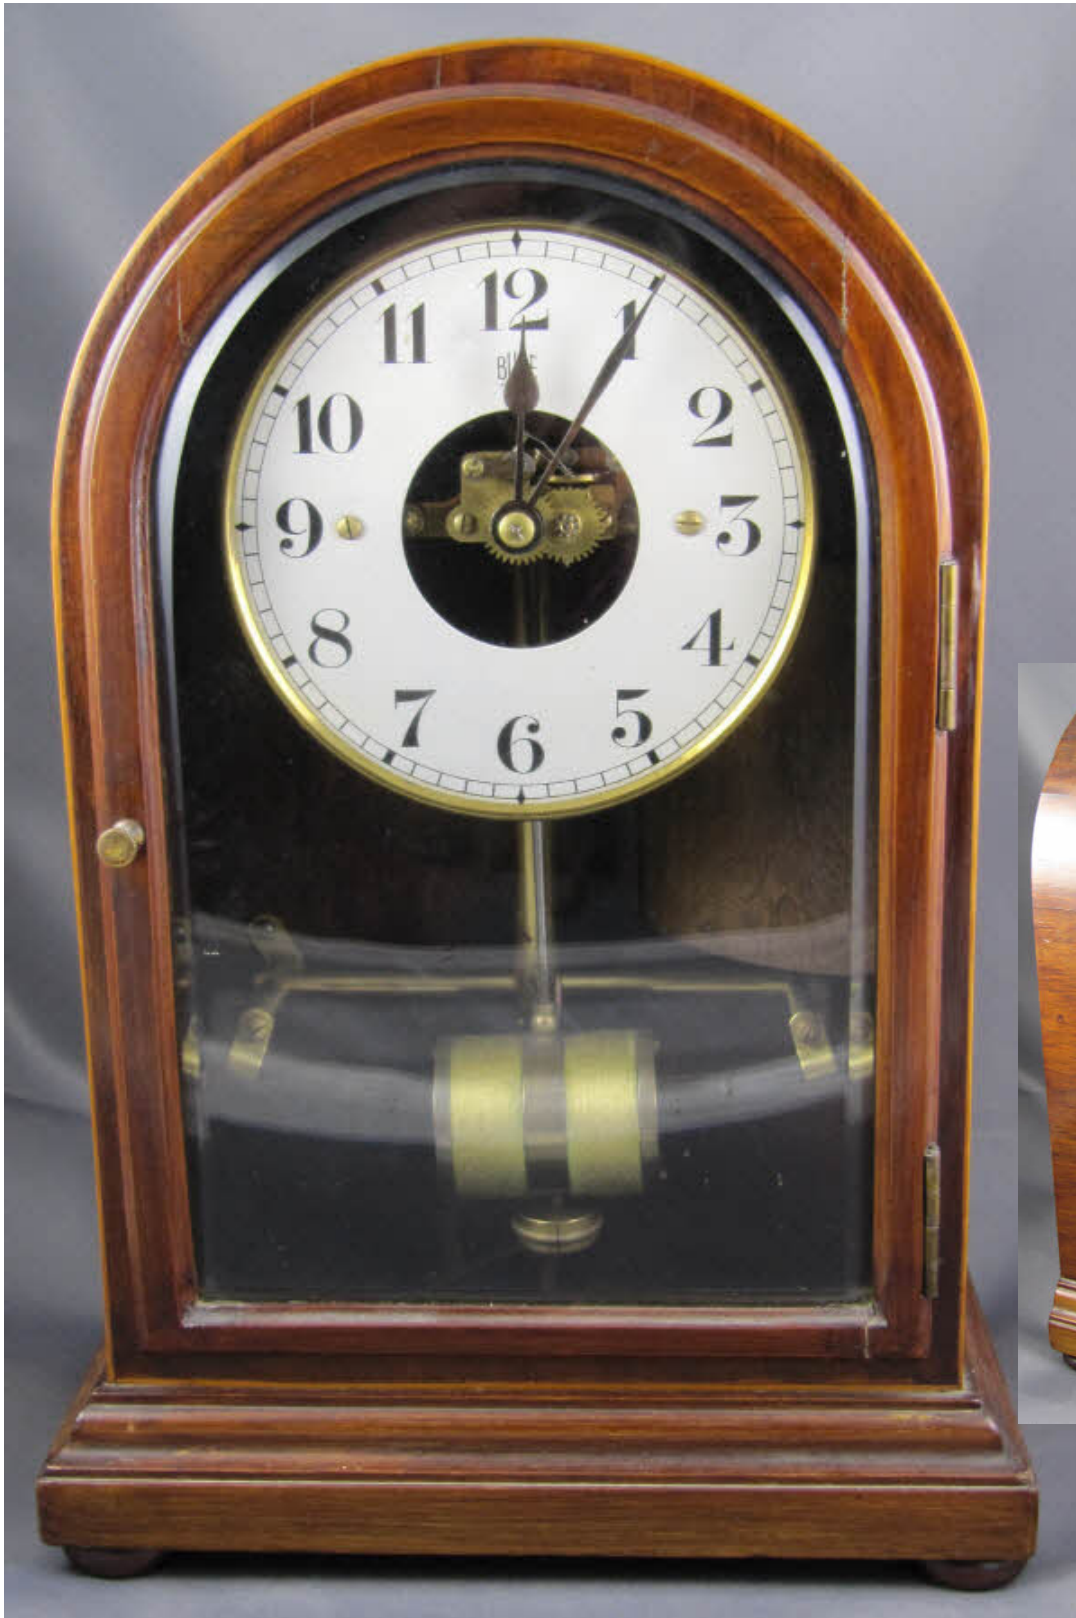
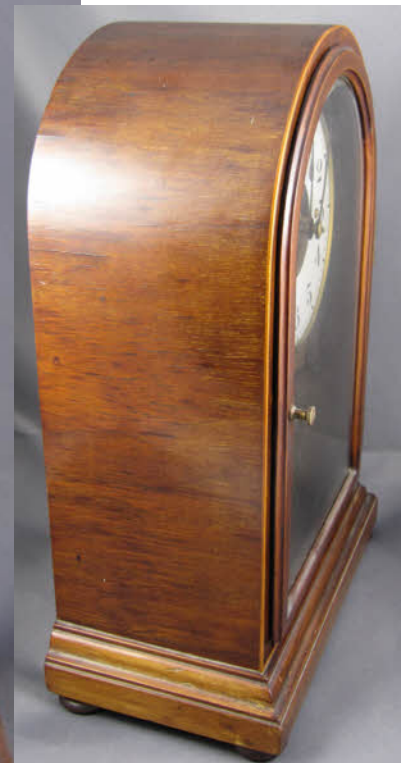
This clock is an early Bulle circa 1923. It has a medium size plated movement with bound cord pendulum in an arch top, mahogany case with full glass front.

The case looks to be in good condition and should only need a buff with good wax polish.

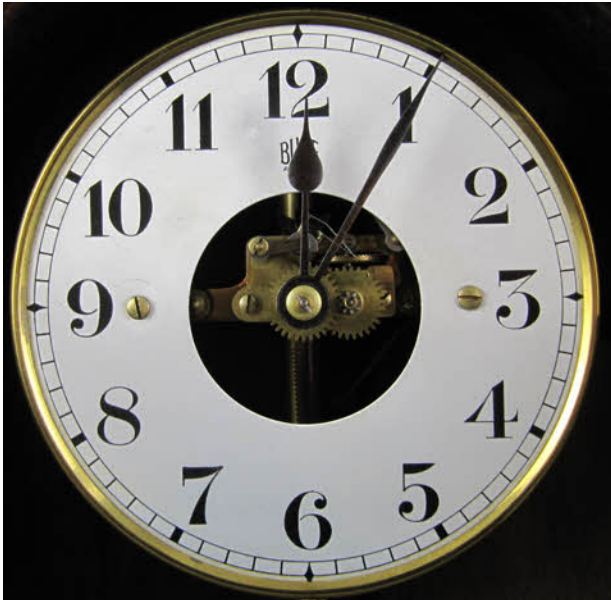
The dial is in excellent condition with no marks or gouges.

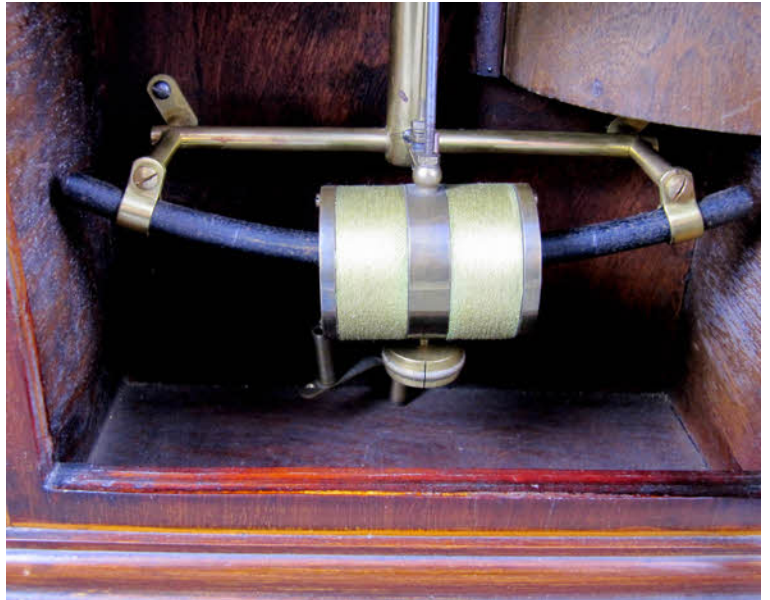
The cord around the pendulum case looks to be a little the worse for wear. On examination it was found to be glued down in places where it had frayed and separated from the casing.

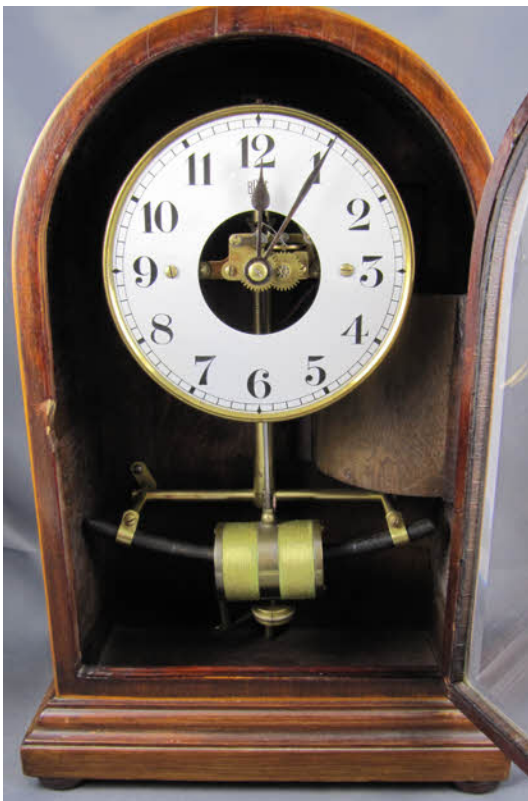
Inside, the movement and frame looks clean and tidy.

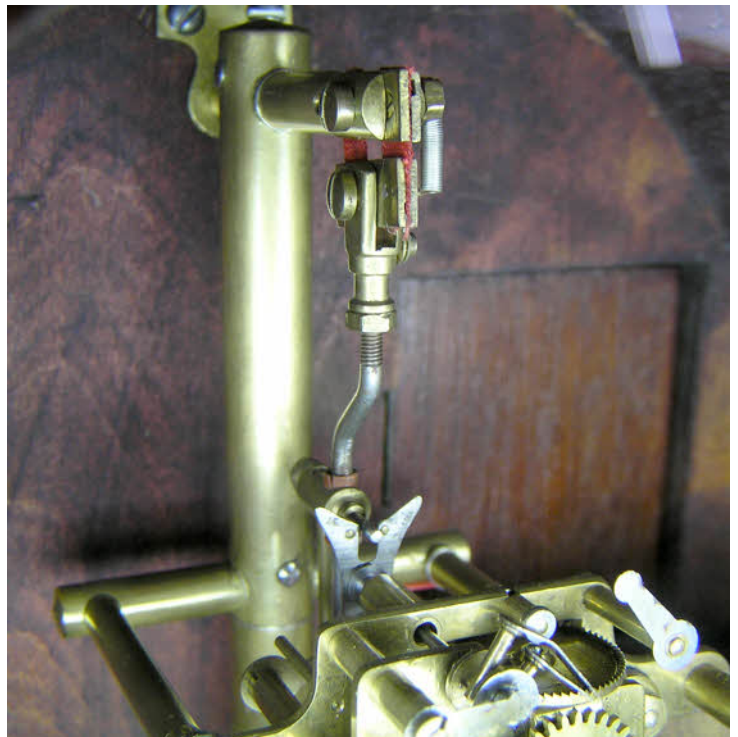
The only issue seems to be the suspension unit which will be replaced.

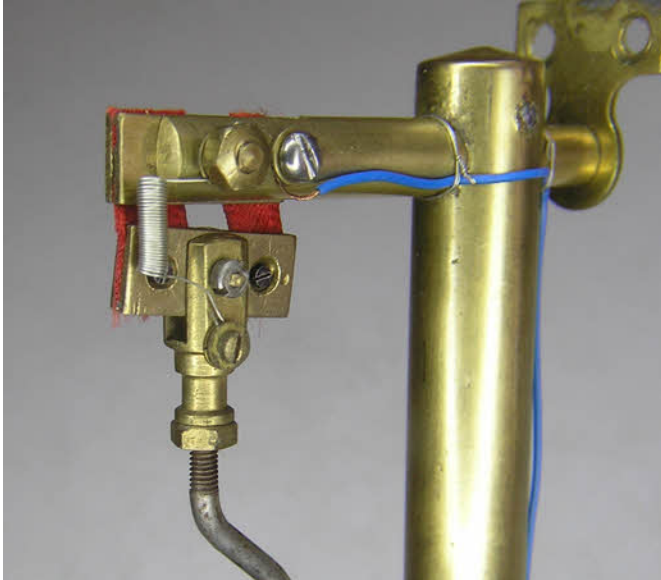
Someone had gone to a little trouble to tie the modern wiring in place. Note the small spring connecting the pendulum to the frame for electrical continuity over the non conductive cloth suspension. Although not original it would have performed adequately.

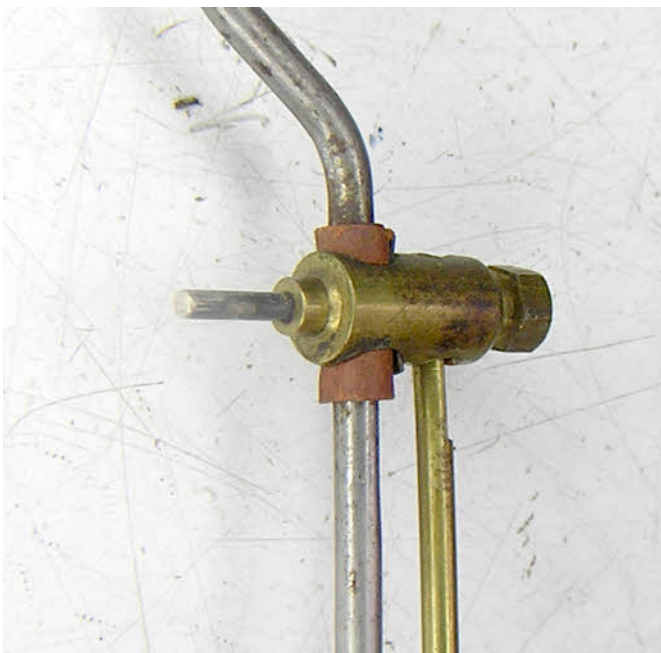
The contact pin looks to be in good order with no significant amount of wear.

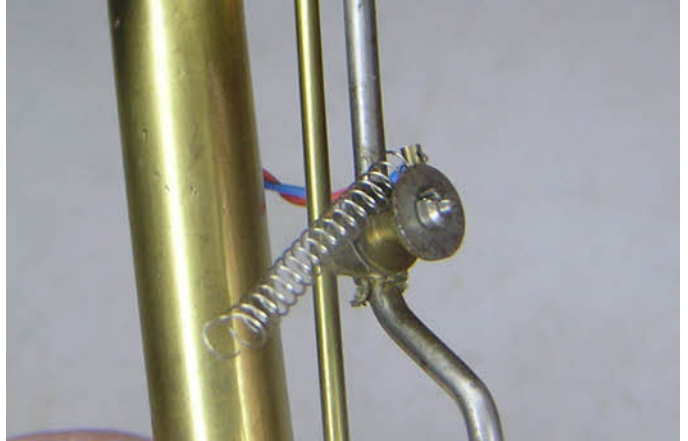
The isochron spring looks to be a replacement and made of mild steel wire. It will be replaced.

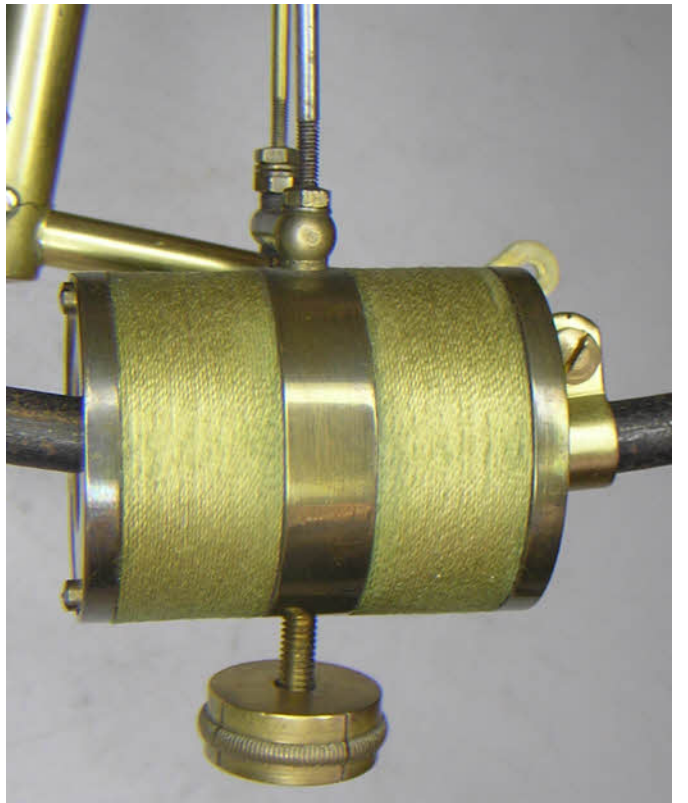
This rating nut has not been tampered with, unlike many I find that have had half the mass turned away on the lathe to try and correct a slow running clock.

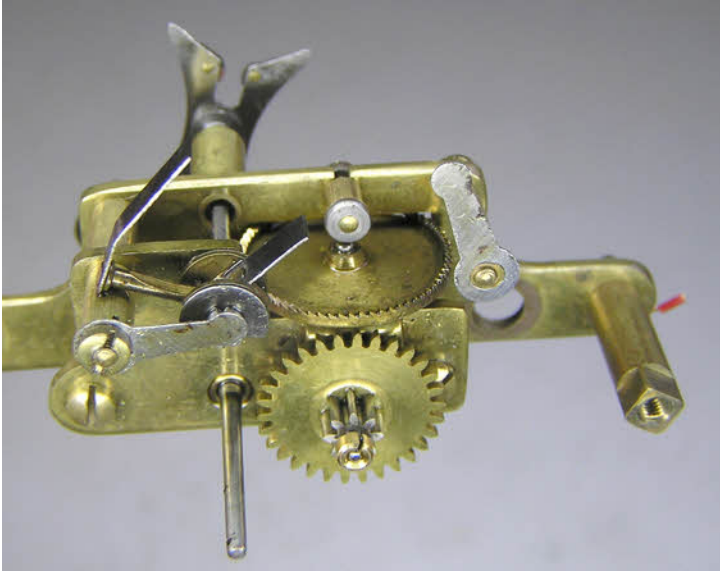
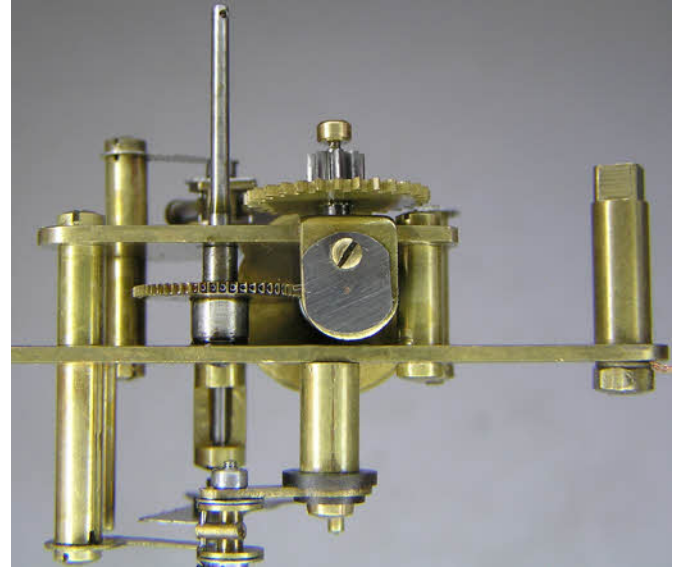
Top and bottom view of the movement which shows no damage or missing parts. The only issue seems to be a little oil contamination.

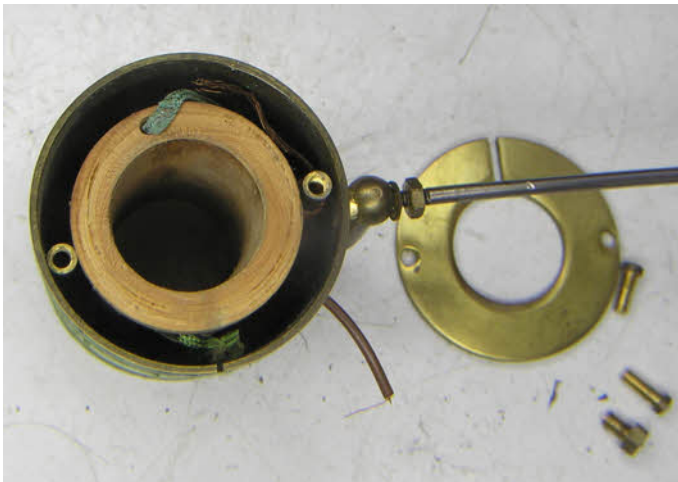
Inside the coil casing all seems well and the coil itself reads 1230 Ohms. There is just an extension to the lead out wire which will be removed.

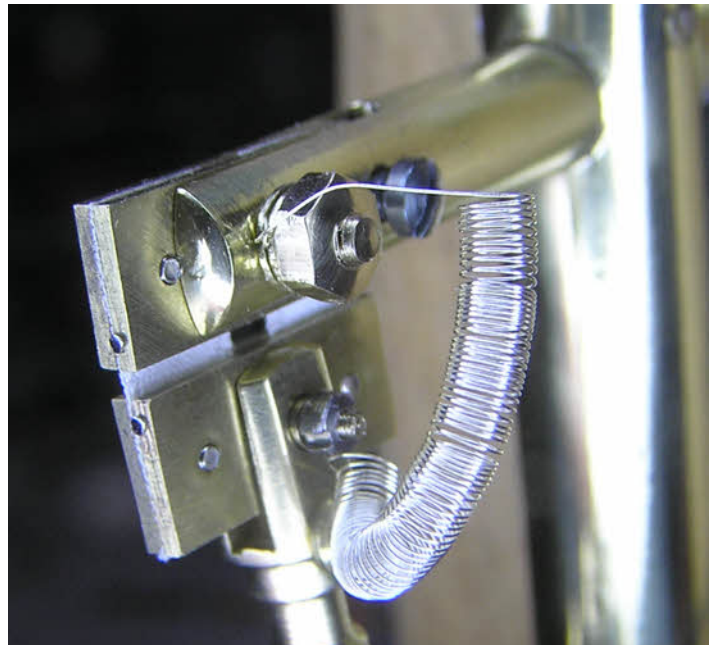
The photo above shows the new suspension unit and contact spring between the pendulum and frame.

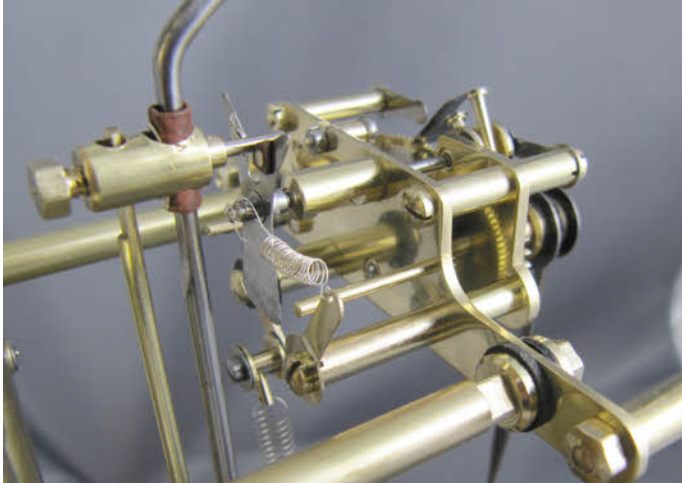
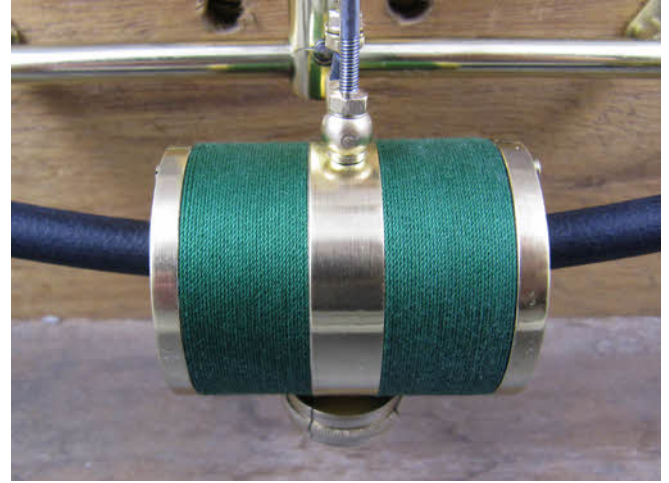
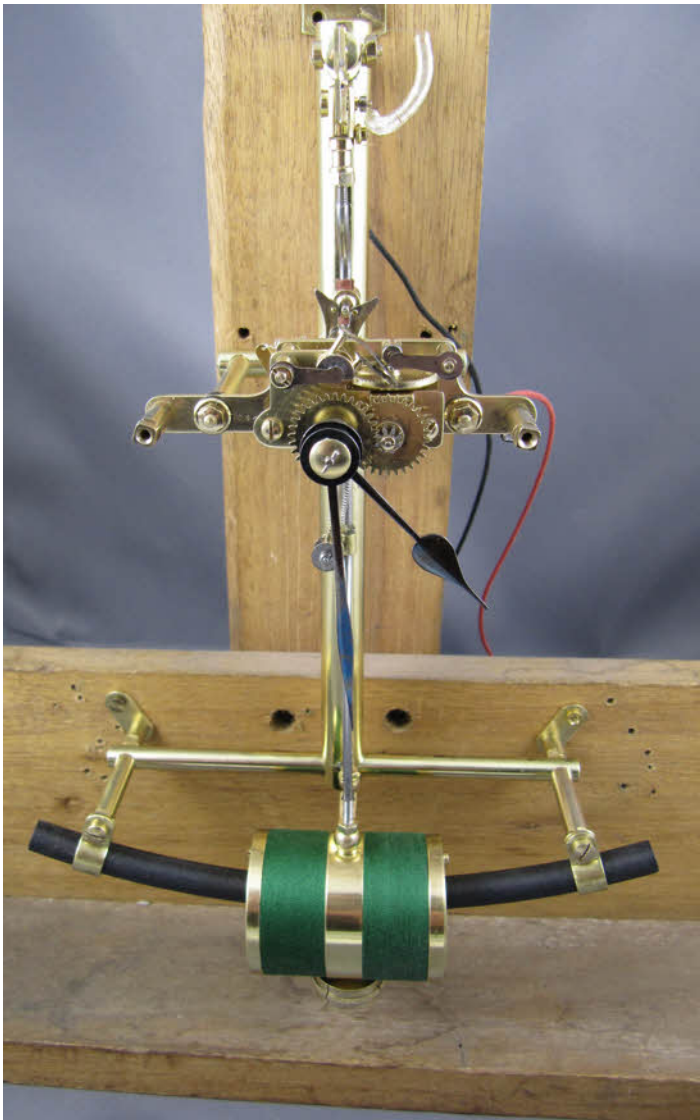
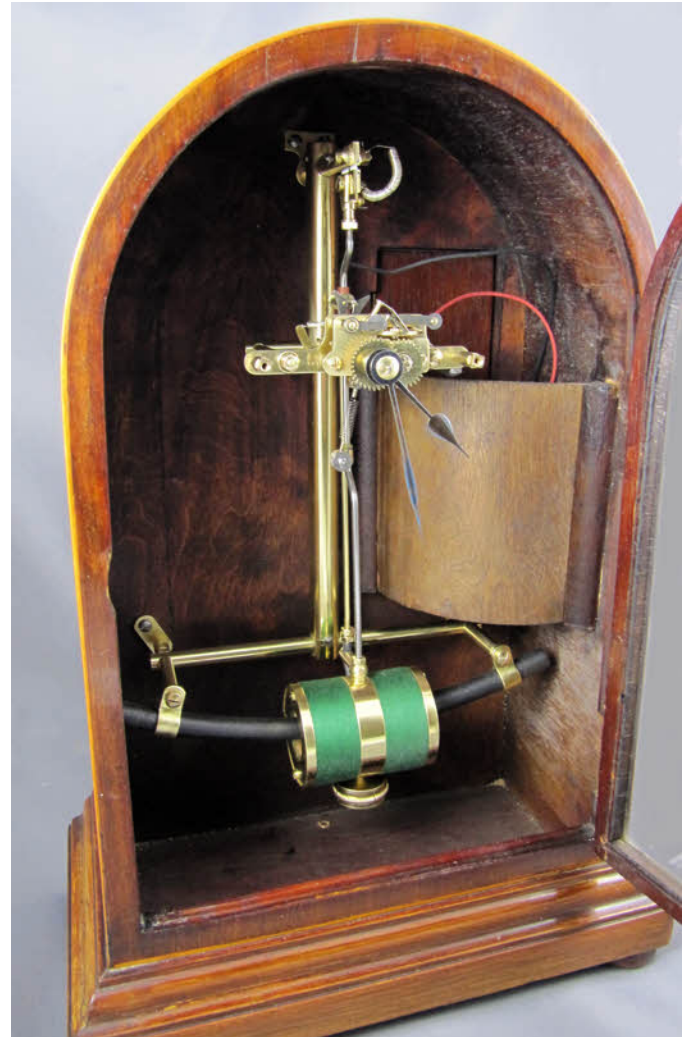
This group of photos shows the restored clock on a test frame and back in the case.

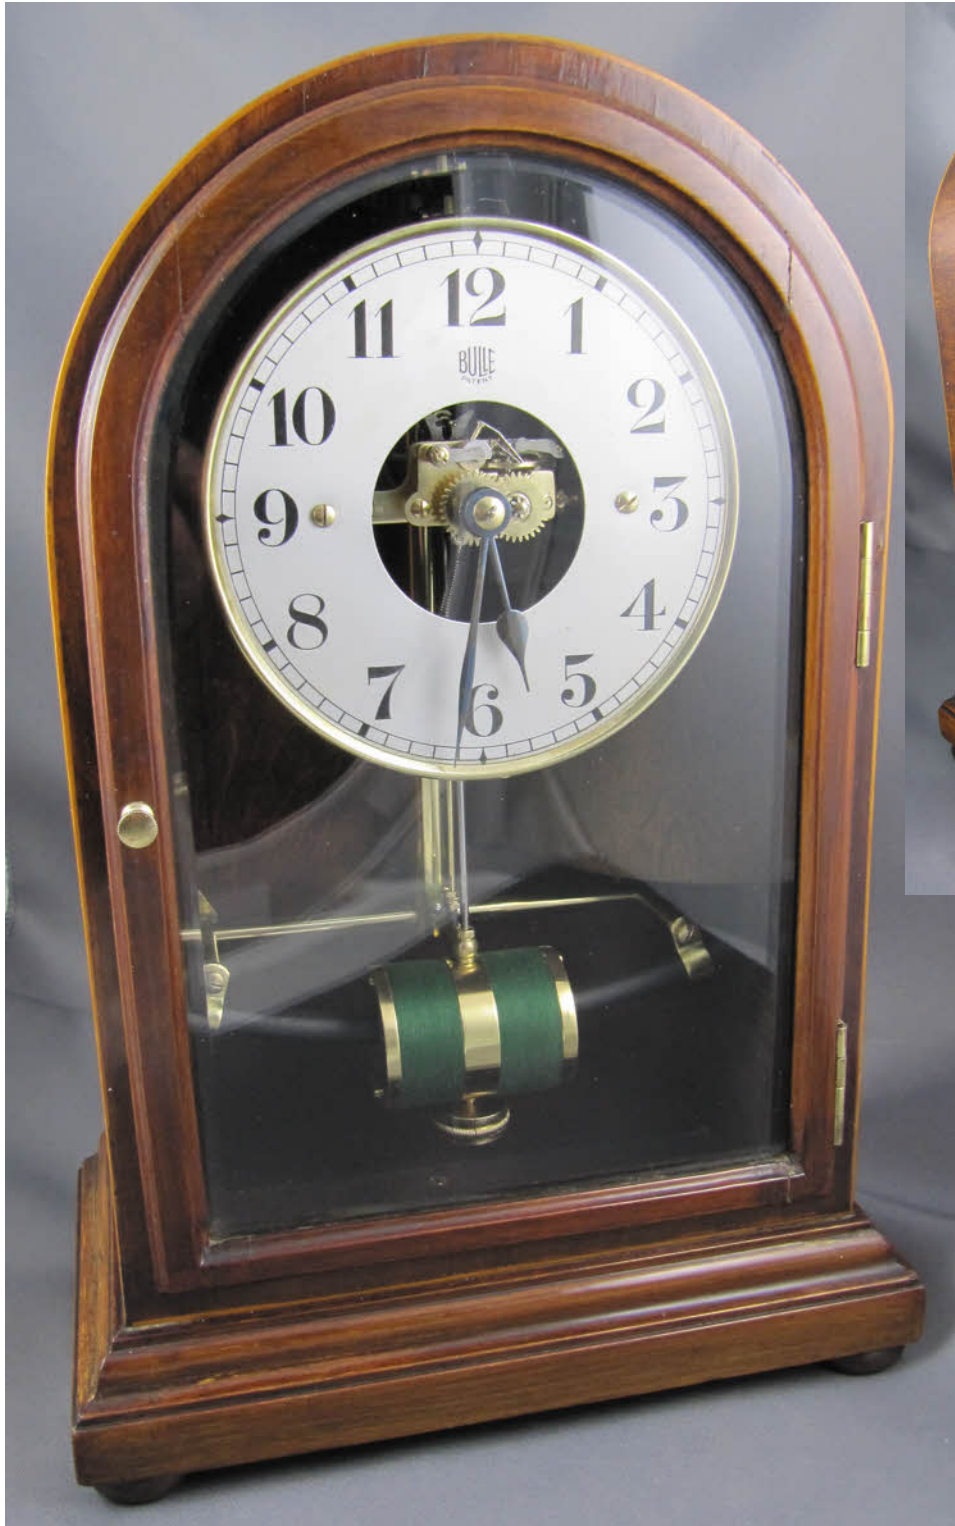
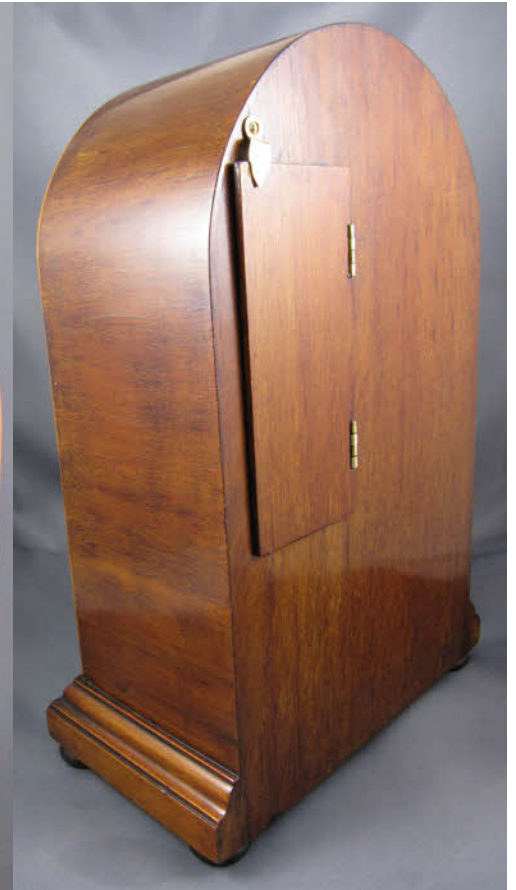
The finished clock

The case was a little dry with a few little cracks in the veneer. But it has improved with a good coat of wax and buffing. Repeating the procedure now and again should help it retain it's finish.

This was a pleasant restoration with the clock only needing cleaning and replacement of the usual springs and suspension.

It has been on test for about 3 week sand is keeping good time.
