**Bulle Clock Serial Number 205535**

*Restoration of Bulle Clock  
Serial Number 205535*

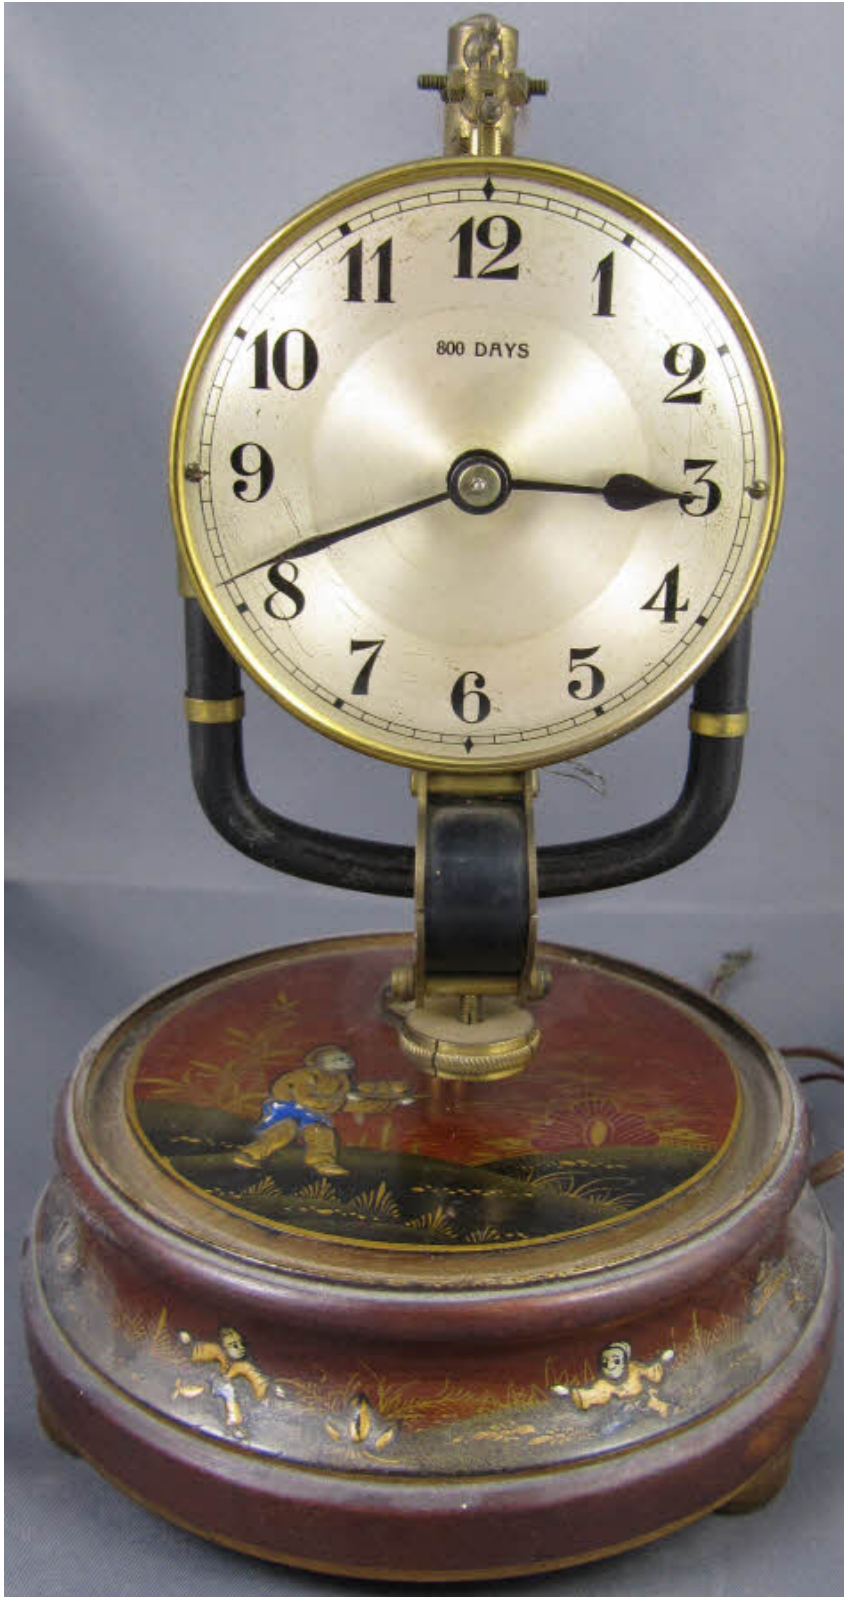
*This short clockette has a beautiful Chinese design base which has survived intact with no major damage. It will clean up very well.*

*The clock itself is of the standard design and all looks to be complete again with no major damage or missing parts. It should be a pleasure to restore.*

*The dial is pretty good although it has a few small scratches.*

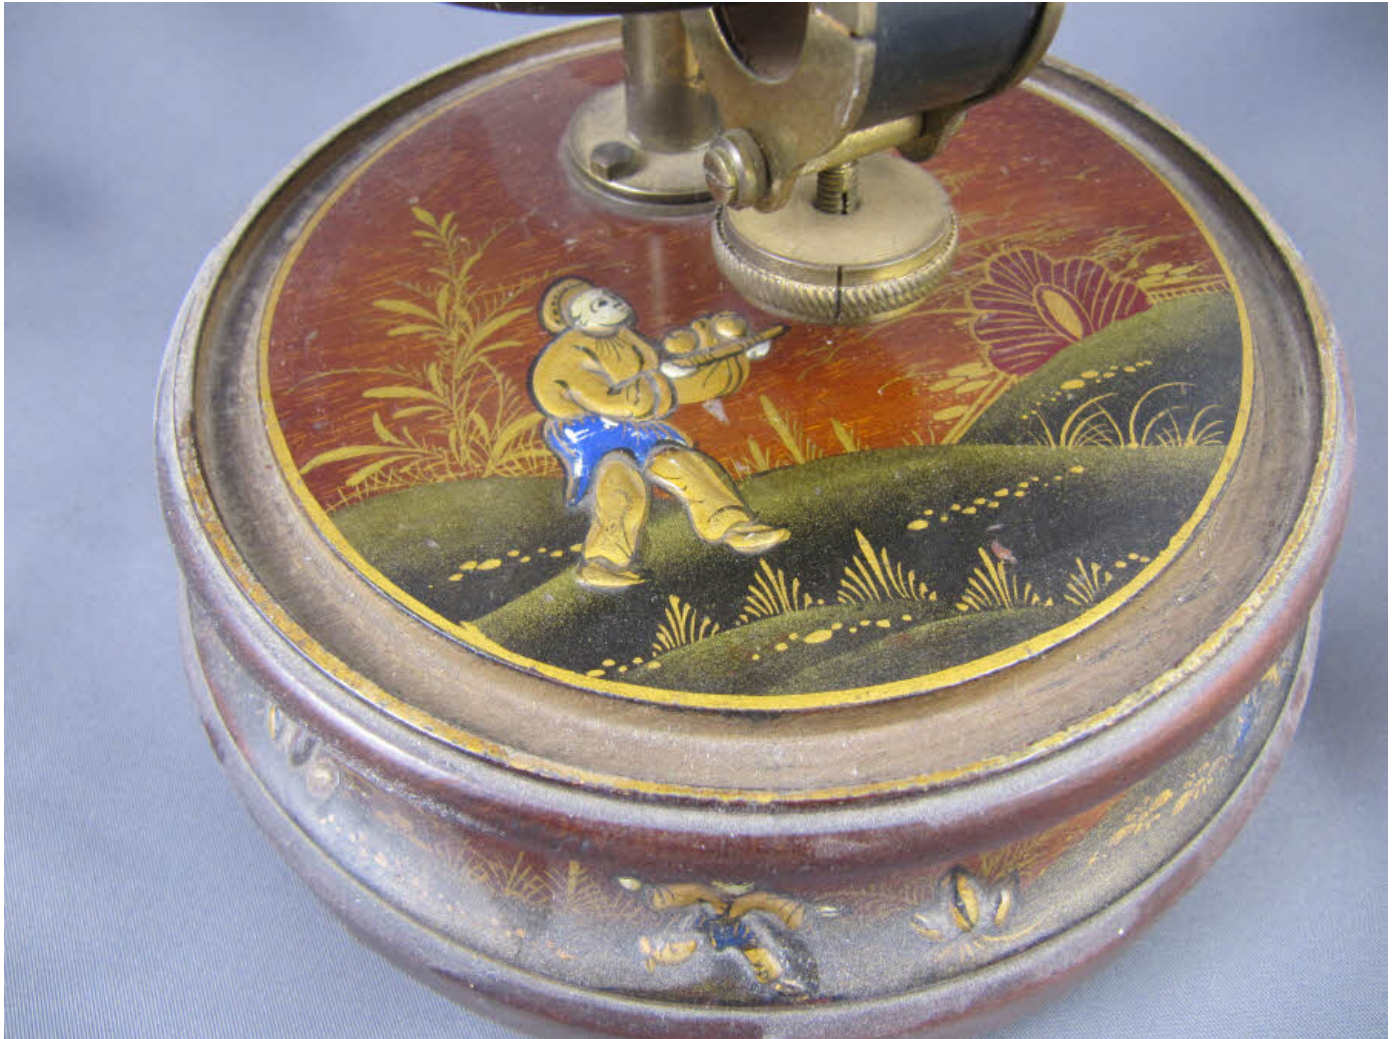
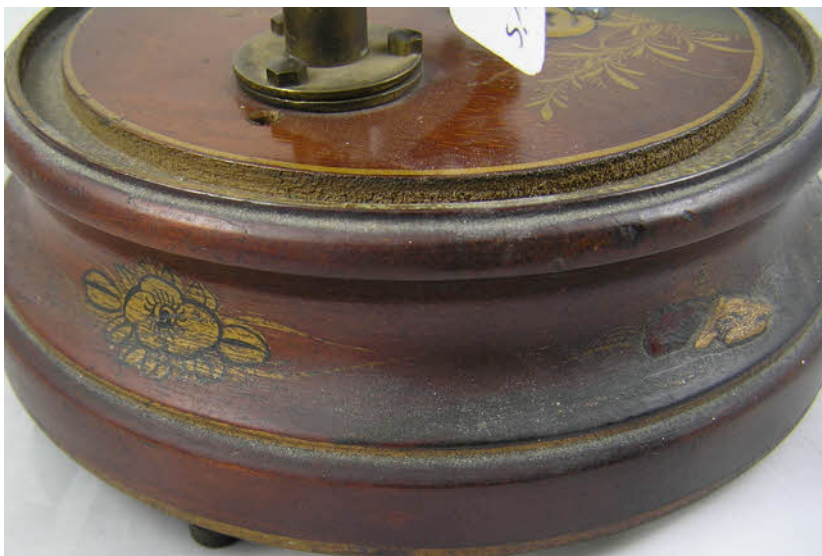
*These two photos show the wonderful base and it's figures. The only issue seems to be ingrained dirt hiding parts of the design around the side of the base. This should all clean up quite well.*

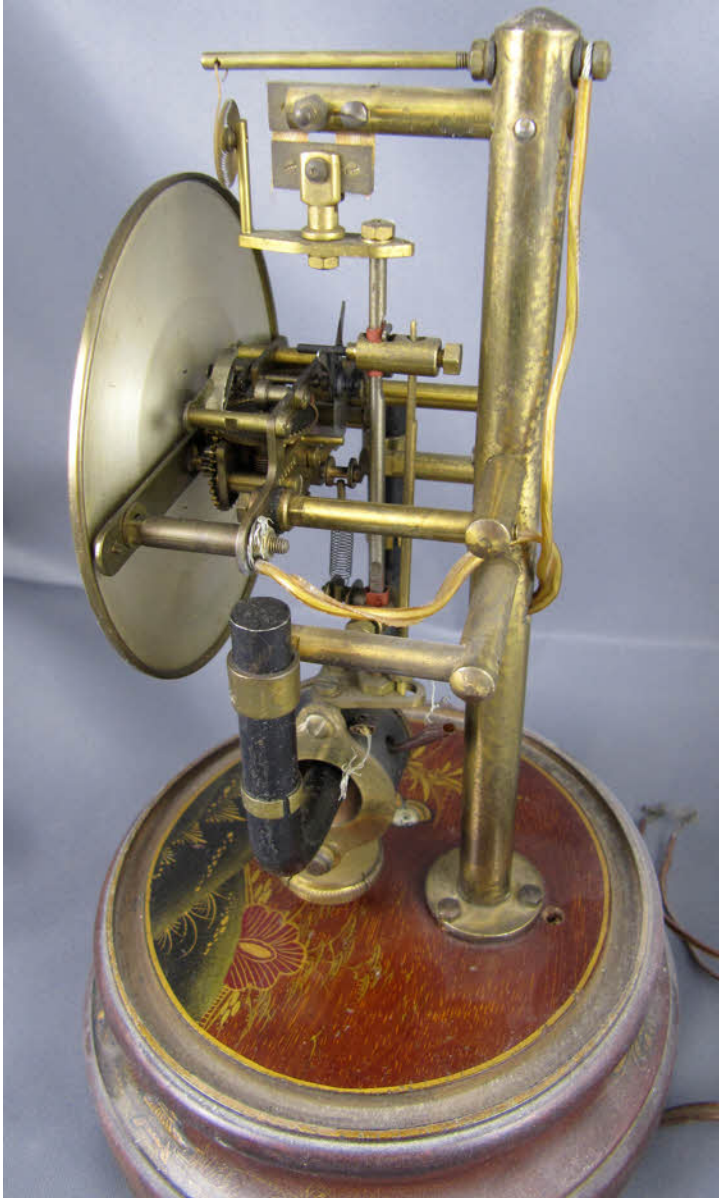
Above we see the rear of the clock with an extra hole in the base behind the column. It was probably added at some time to facilitate new wires from the battery. This was quite common as it is sometimes difficult to push the wires through the hole and down the column. Those without the knowledge or tools would sometimes opt for a new hole. It is quite small and out of the way so we shall leave it rather than do any more damage.

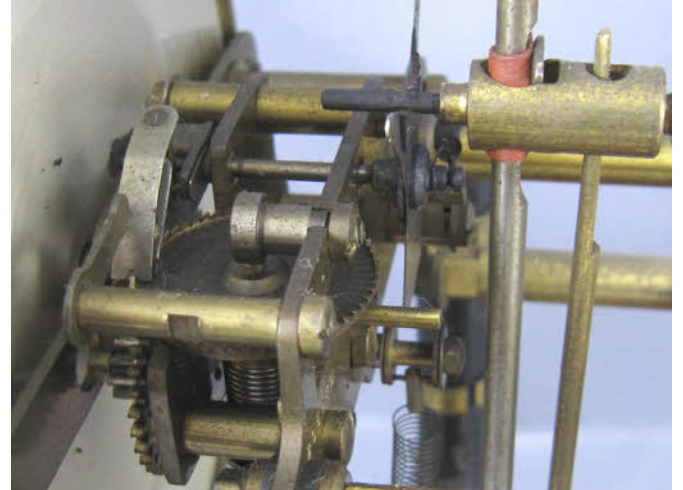
Above is a detail of the movement which although dirty is in good condition.

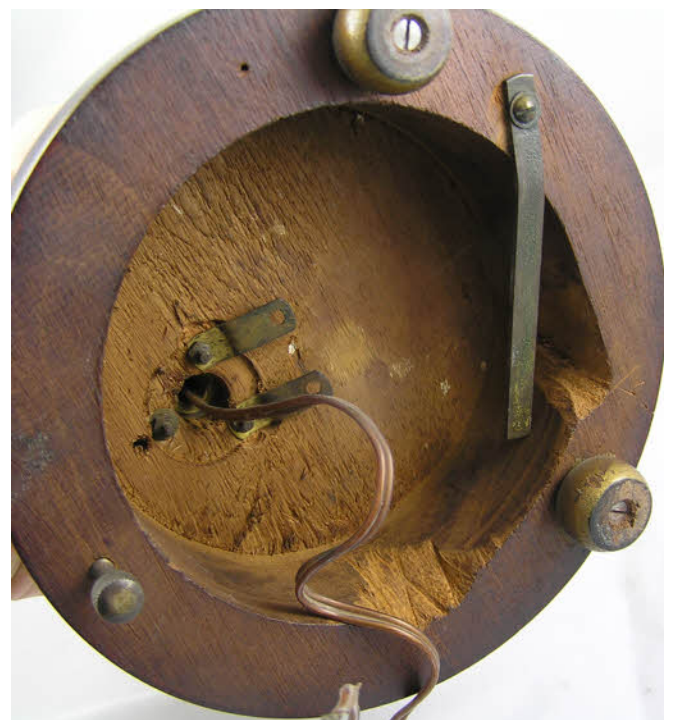
Below we see the bottom of the base which again looks OK and will not be touched other than cleaned..

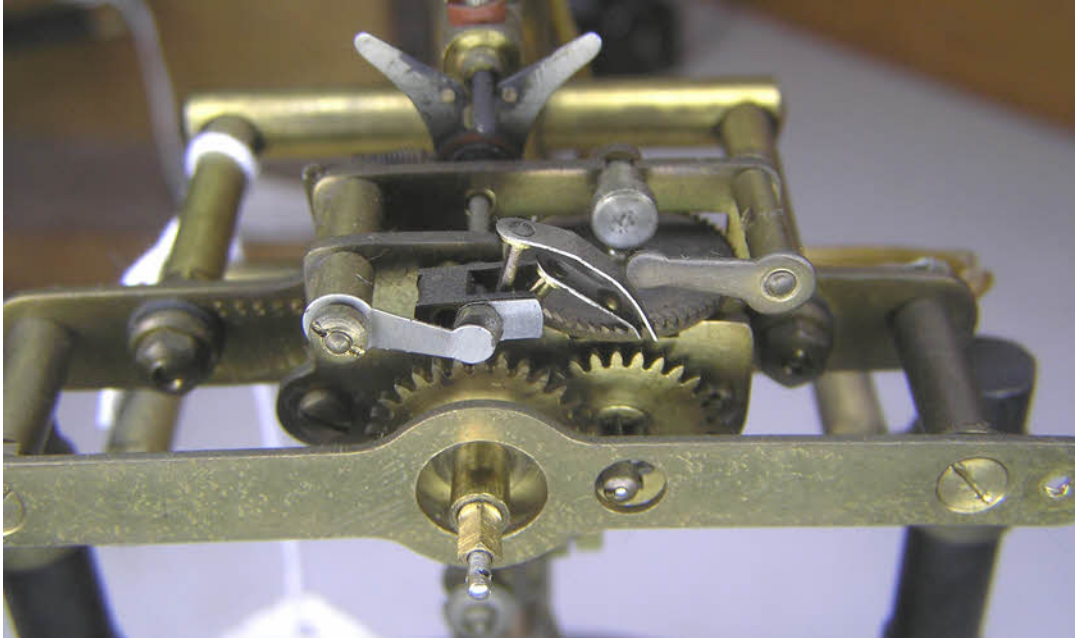
*The movement before disassembly. No missing or damaged parts yet.*

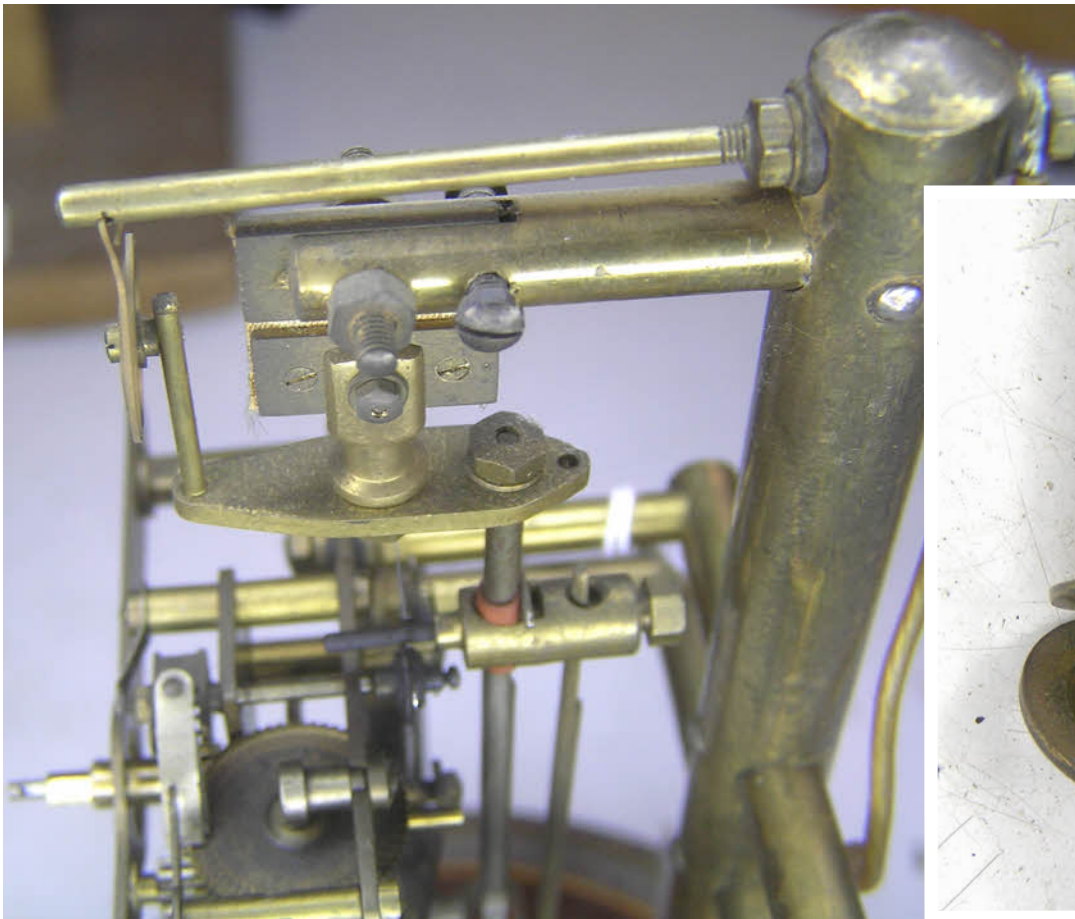
*Below left we see the top of the frame and suspension unit. The only new item here will be the suspension.*

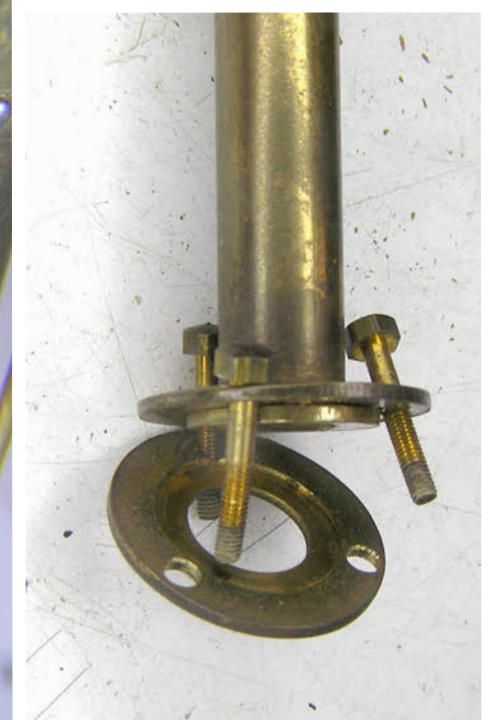
*Below can be seen the method used to attach the frame to the base. Three long bolts pass through a brass collar and then through the base. The collar is permanently fitted to the column but free to travel up and down or turn 360 degrees.*

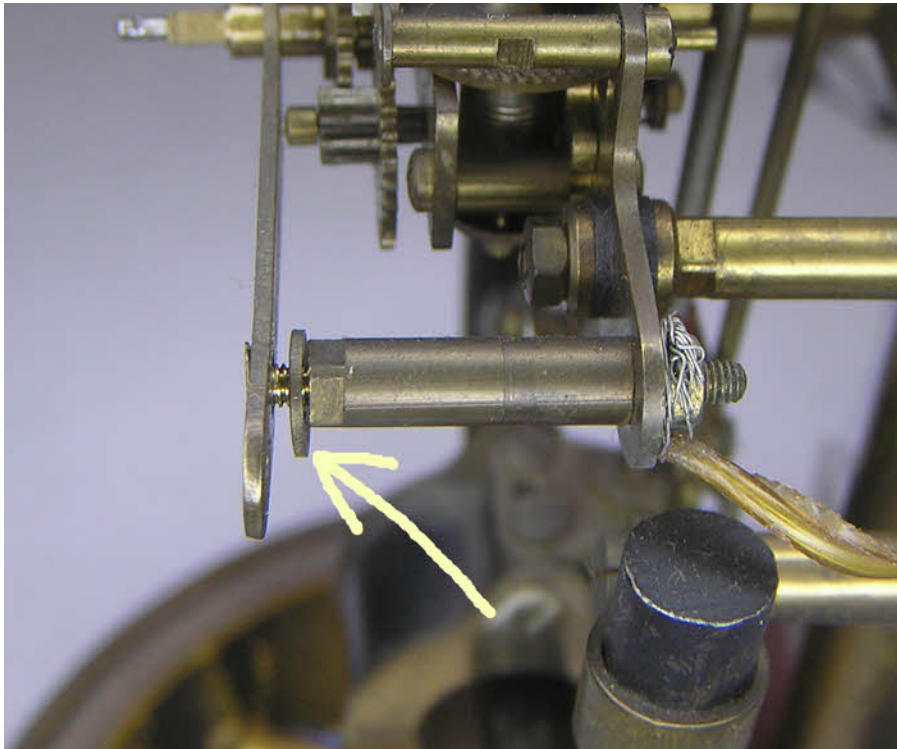
*I include this photo to show the spacer between the dial support pillar and the dial cross rib. It the clock needs these spacers because the screws have counter sunk heads that are a little too deep for the cross rib such that the rib cannot be screwed down tight and will wobble. Once the spacers are in place then the screws will pull up tight.*

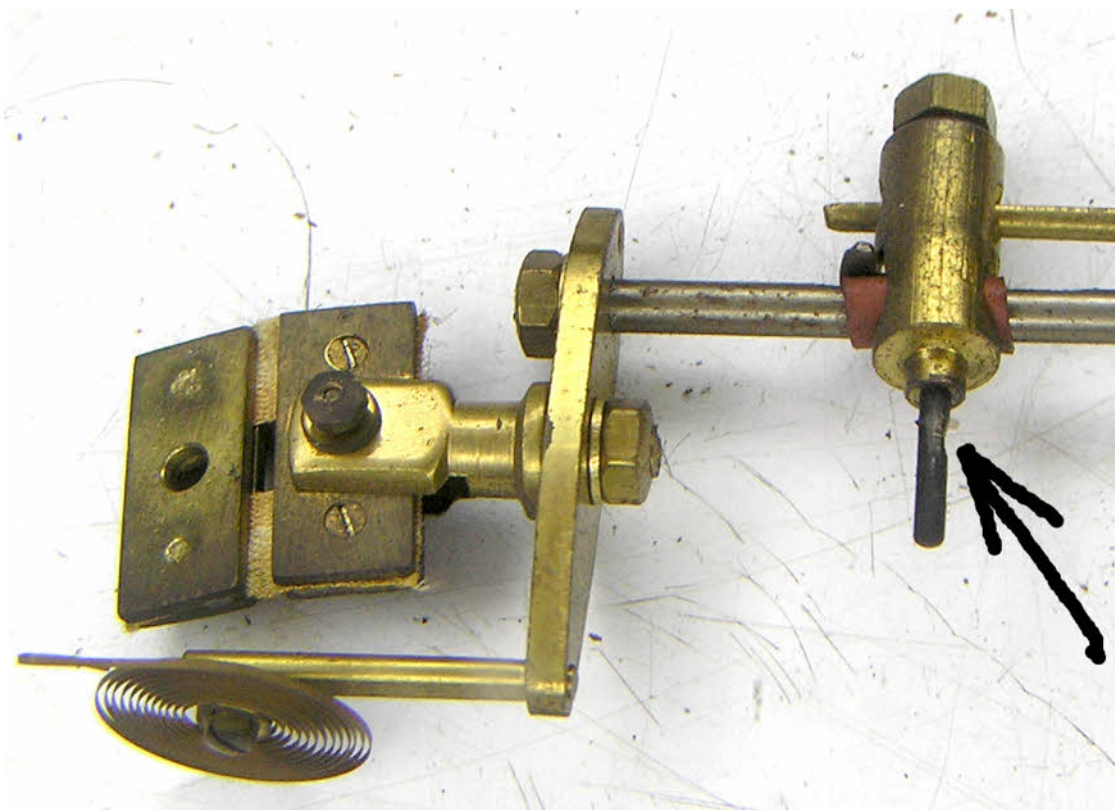
*This photo shows the top of the pendulum and suspension together with the contact pin assembly. You can just see that the pin has some wear with a pronounced gully where it makes contact with the fork. This amount of wear is usually associated with excessive wear of the silver and fibre contacts, when the steel of the fork actually cuts into the soft silver pin. The groove will be removed and the pin turned upside down to present a new working face.*

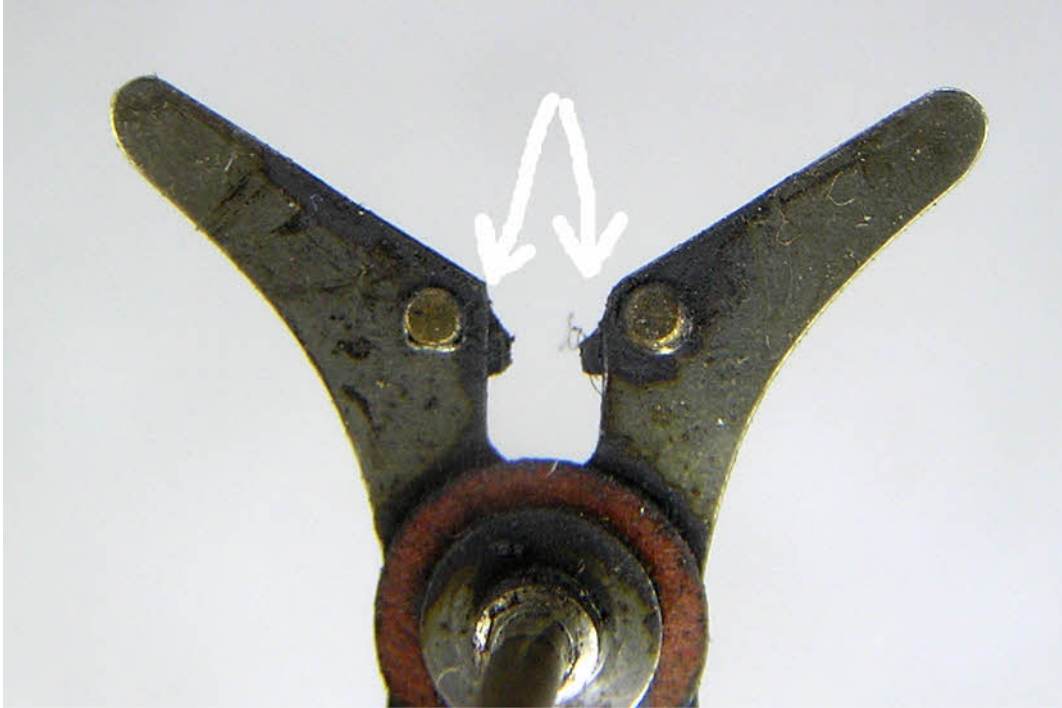
Here we have the fork arbour showing the wear suggested by the pin. Both the silver and fibre contacts have worn away completely at the heel of the fork. These will both be replaced.

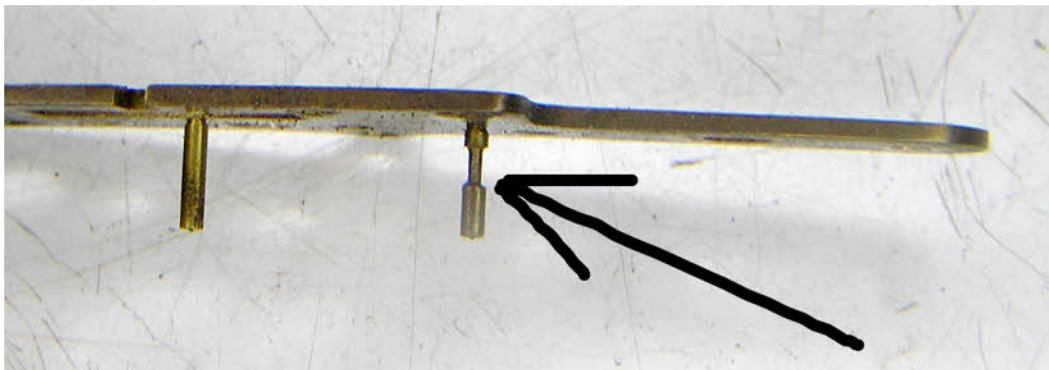
This cut away on the right hand banking pin is unusual but not uncommon. It has been turned down to allow just a little more swing to the right of the fork.

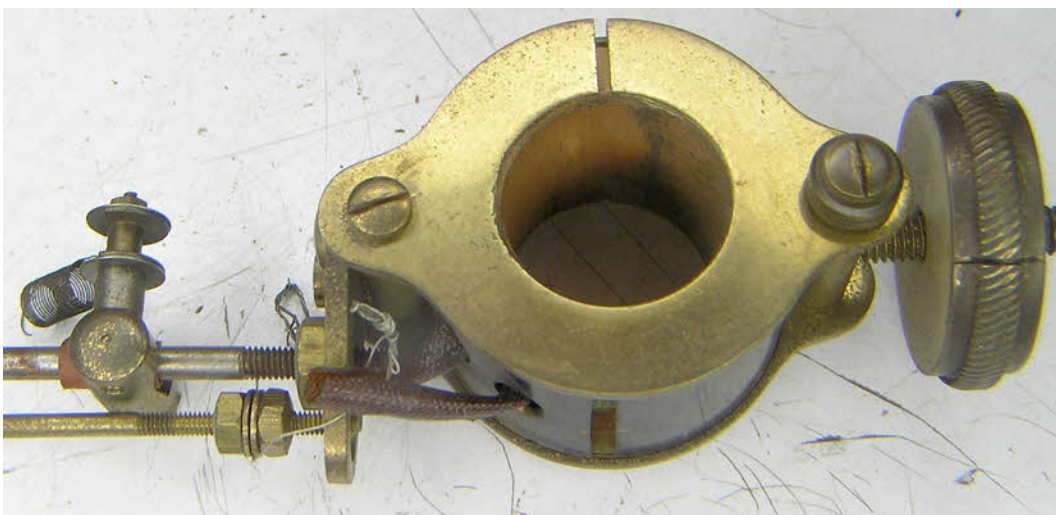
This last photo shows the coil and its casing at the bottom of the pendulum. The wiring looks a bit ragged but intact. We will cheque the condition of the coil when we take the casing caps off. (Since finishing the clock, it proved to be somewhat temperamental and I had to revisit the coil and change the top lead out wire which seemed to give an intermittent contact).

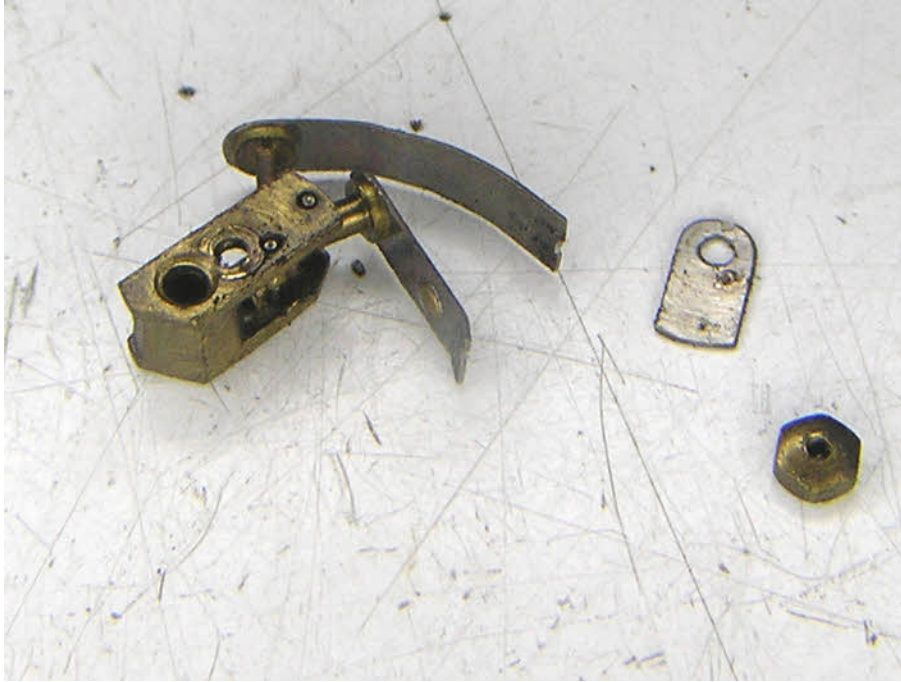
*The pawl assembly. This type of rectangular bobbin is again unusual but not rare. The bobbin is normally round with matching steel washers. In this case the washers are rectangular the same as the bobbin. I find these a little more difficult to re-assemble and position correctly than the round ones. The washers keep falling into a vertical position when trying to tighten them.*

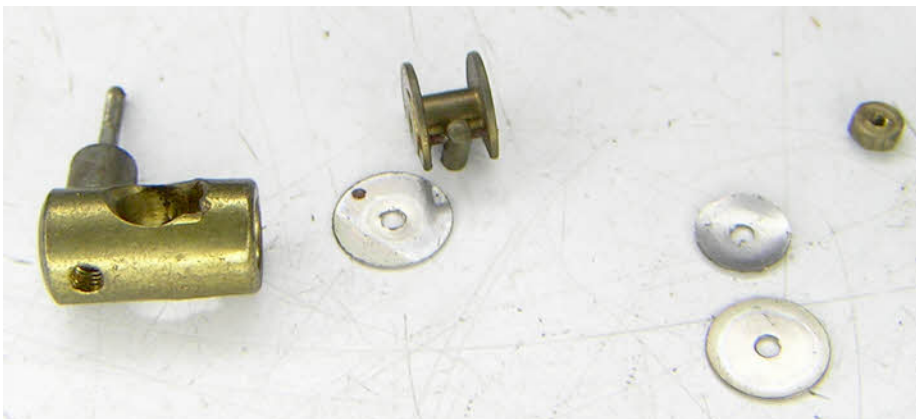
*This photo shows the lower Isochron attachment assembly with its steel washers. Note the wear pip on the inside of the first washer. This is caused by the continual rocking of the "T" pin. It is of no consequence as it is just a case of turning the washer a few degrees to present a new face.*

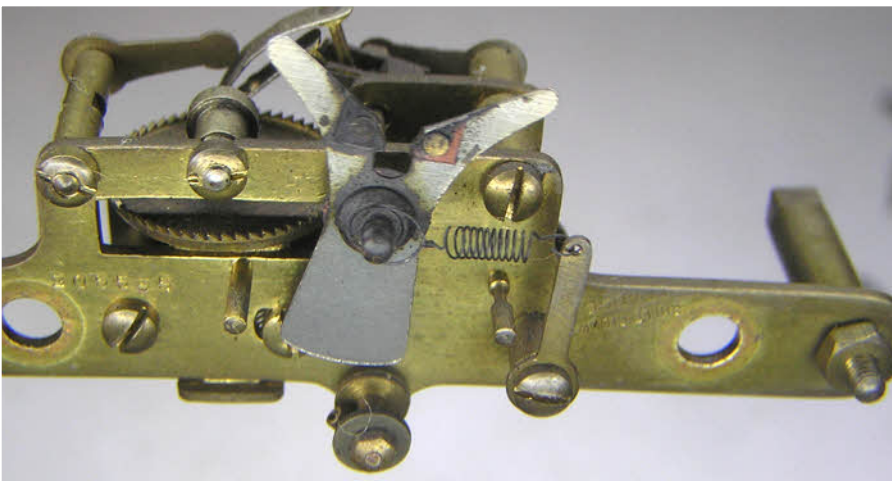
*The rear of the movement before disassembly.*

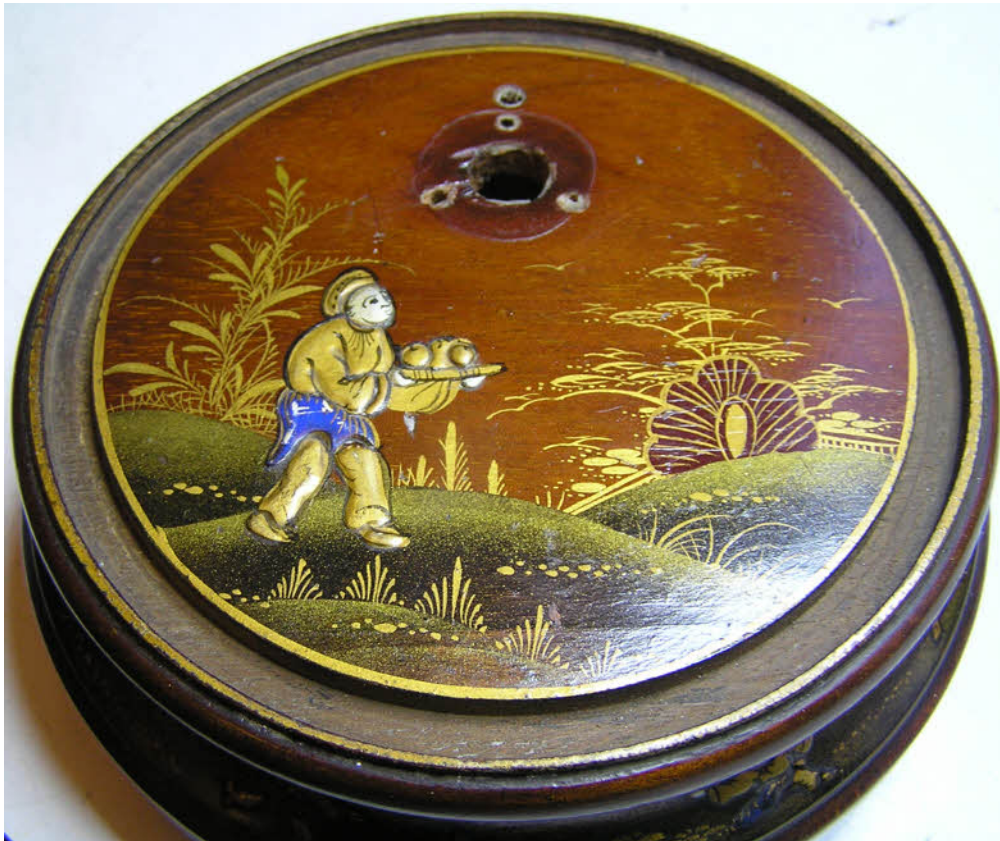
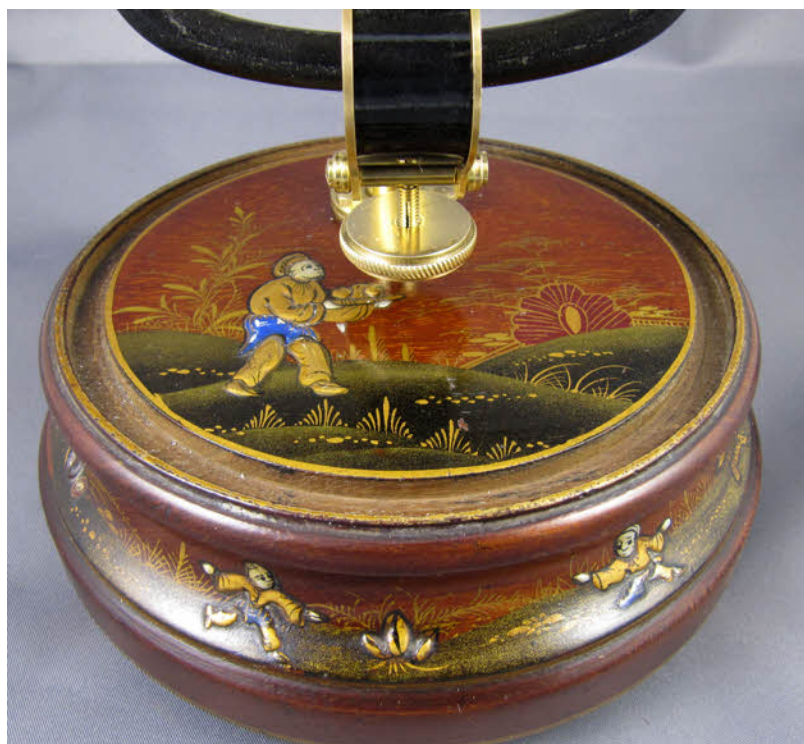
*The base after a light clean and wax polish.*

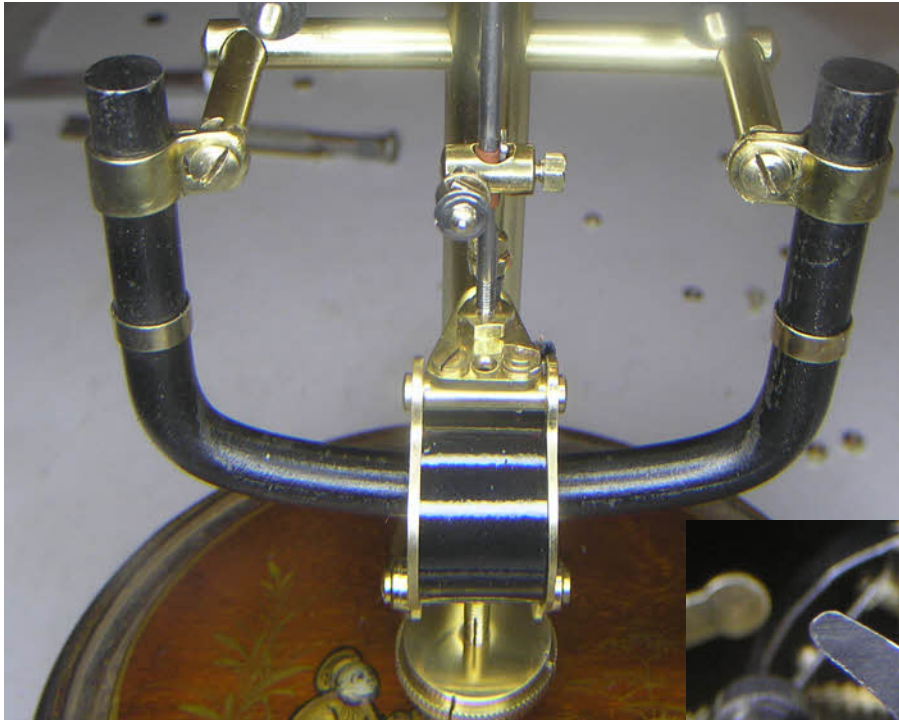
*The pendulum, magnet and frame back in position of the base.*

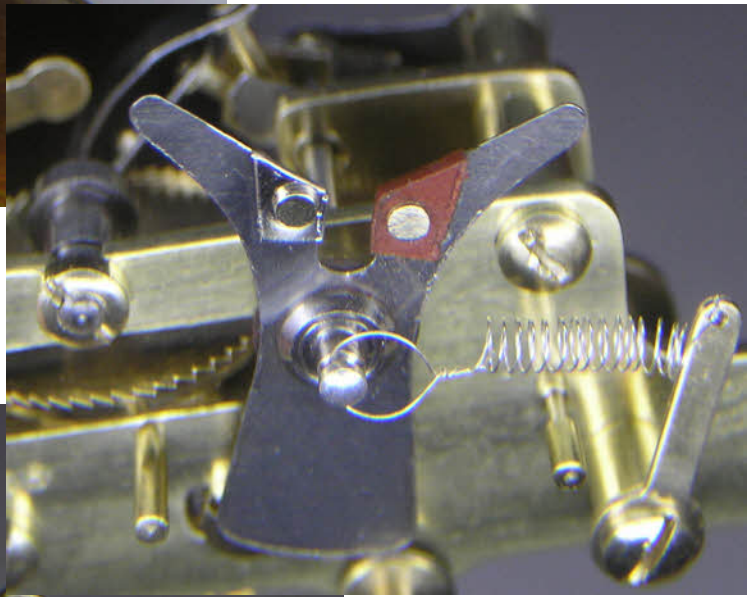
*At right is the fork arbour back in place with the new silver and fibre contacts. Note the position of the Silver Contact Wire. This loops runs in the groove of the silver stub at the rear of the arbour.*

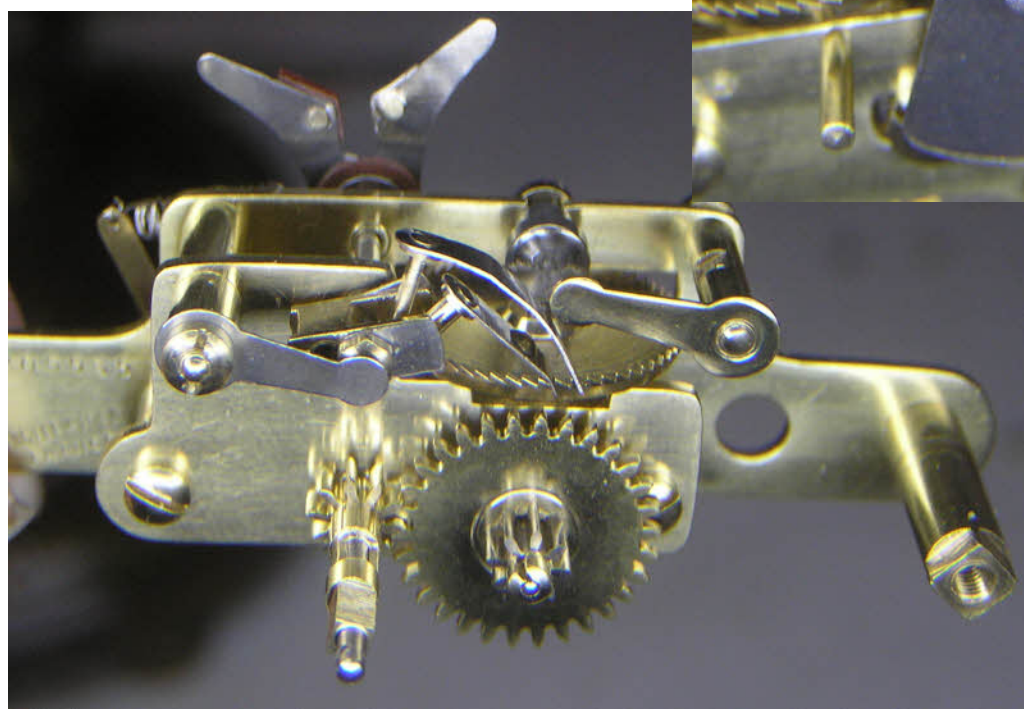
*The front of the cleaned movement.*

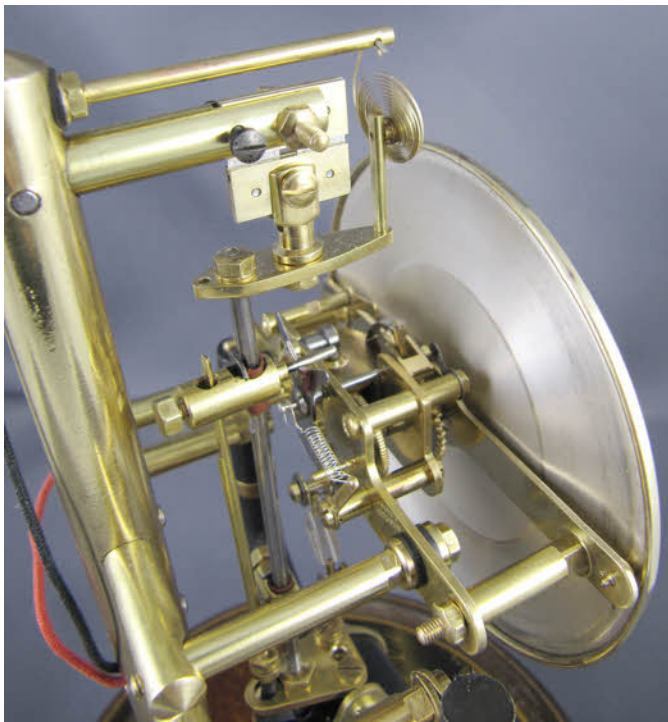
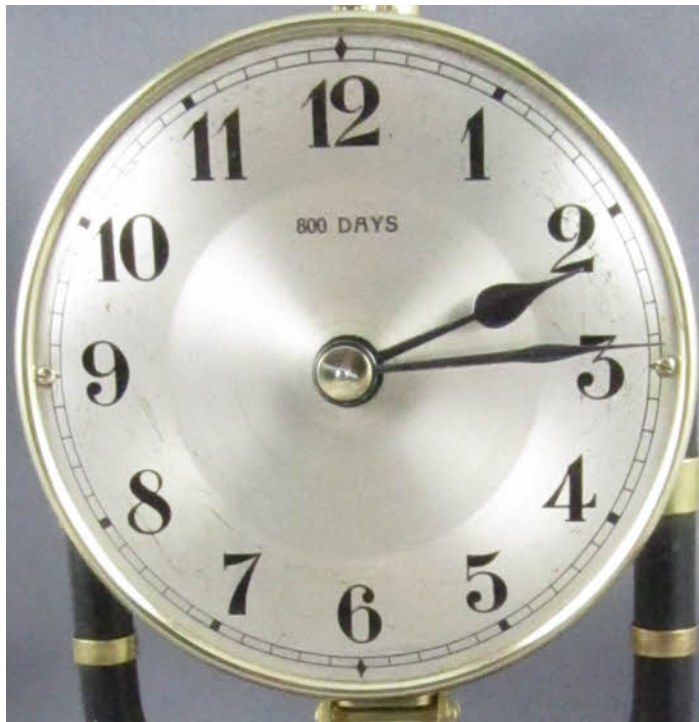
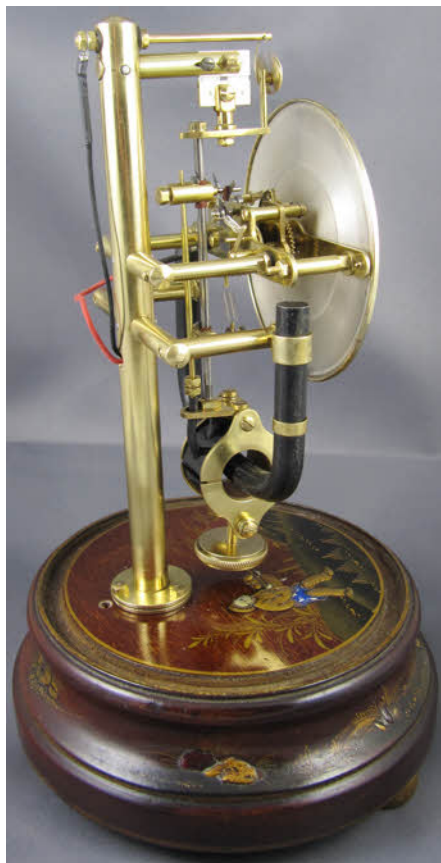
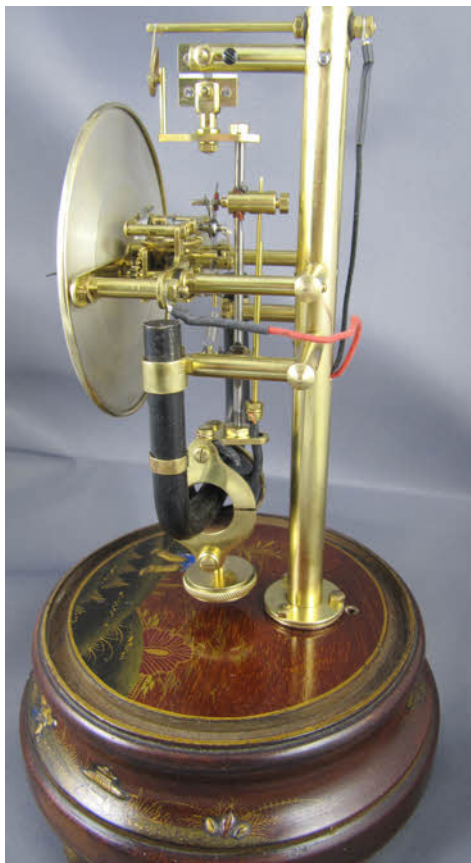
*The clock in restored condition.*

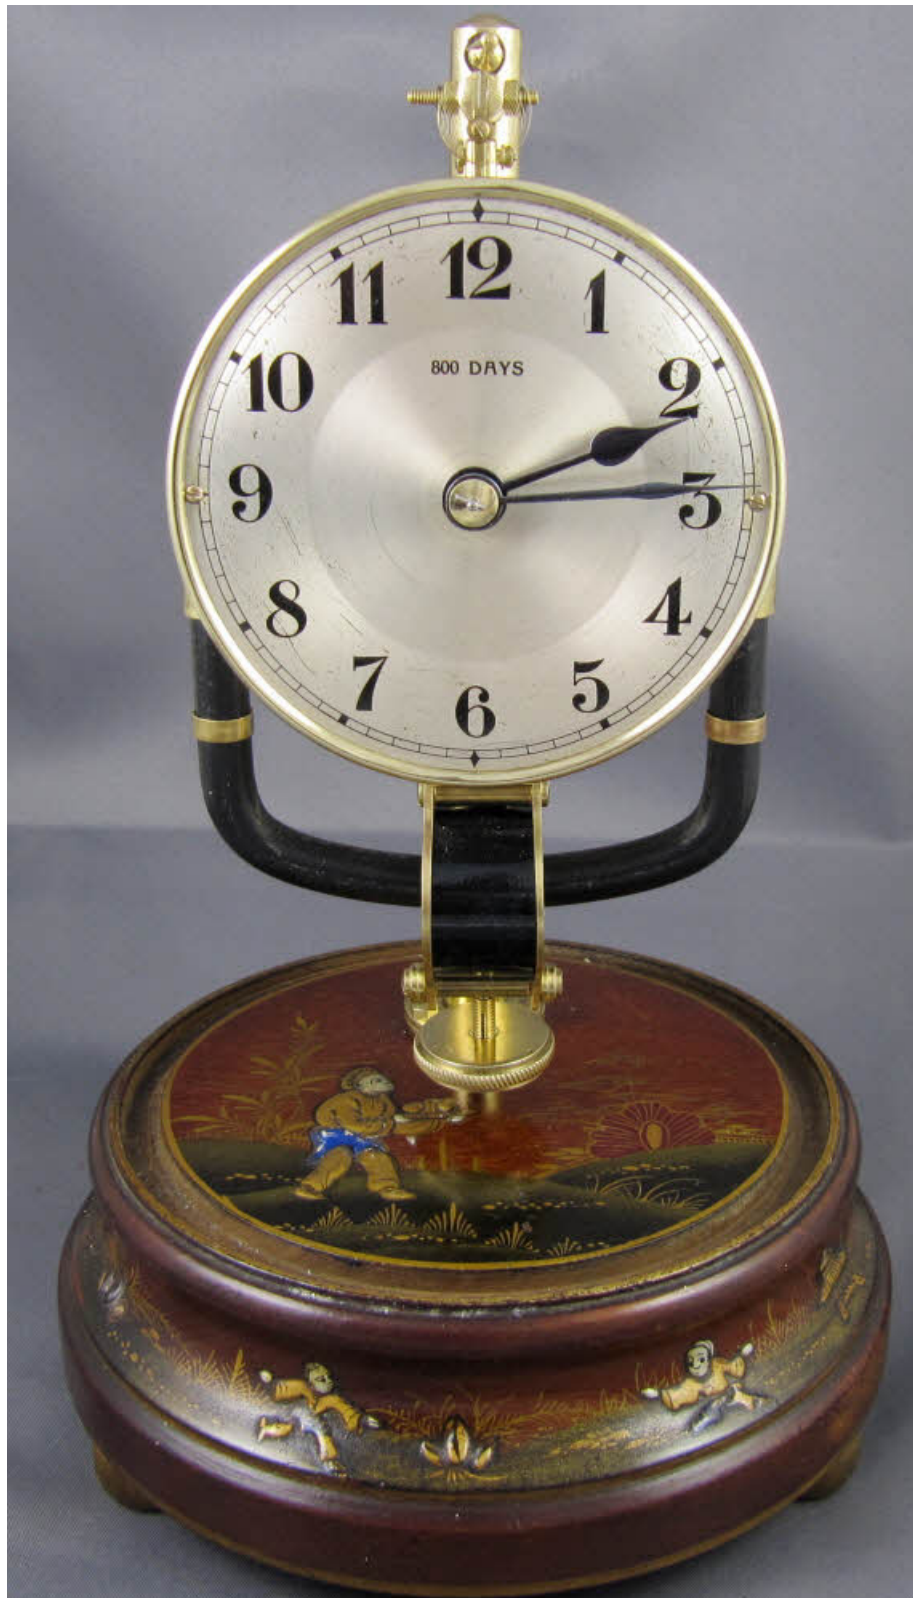
*The finished clock.*
