**Bulle Clock Serial Number 205826**

*Restoration of Bulle Clock  
Serial Number 205826*

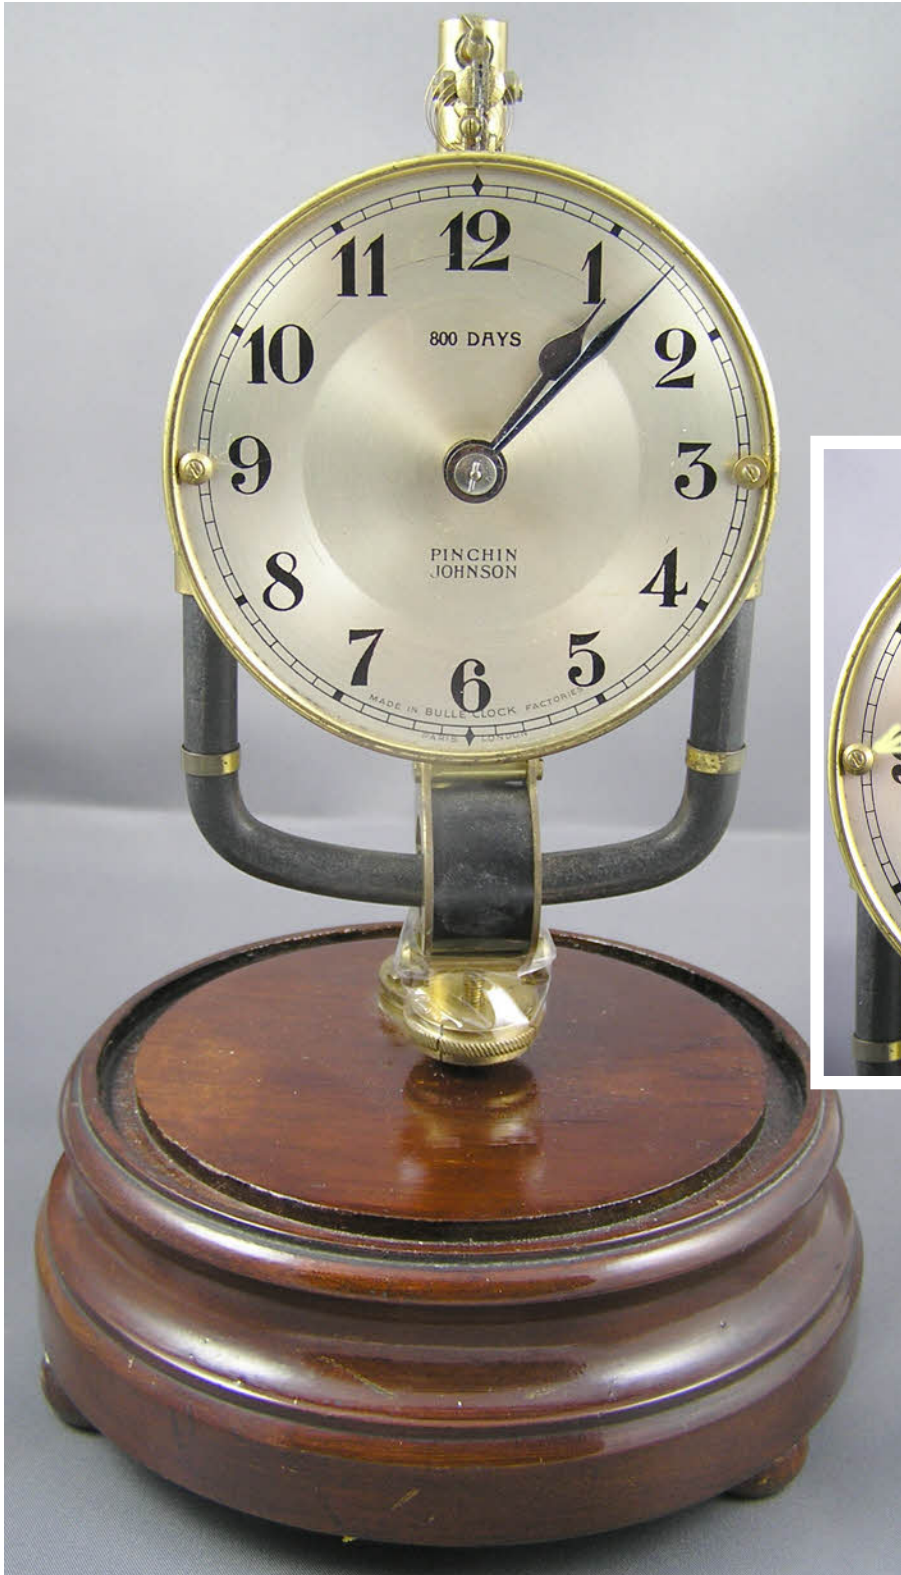
*This short movement clockette sits on a round mahogany base which houses the 1.5 volt battery underneath. Overall the clock looks to be in good condition with nothing missing other than the glass dome which has been retained for safety by the owner.*

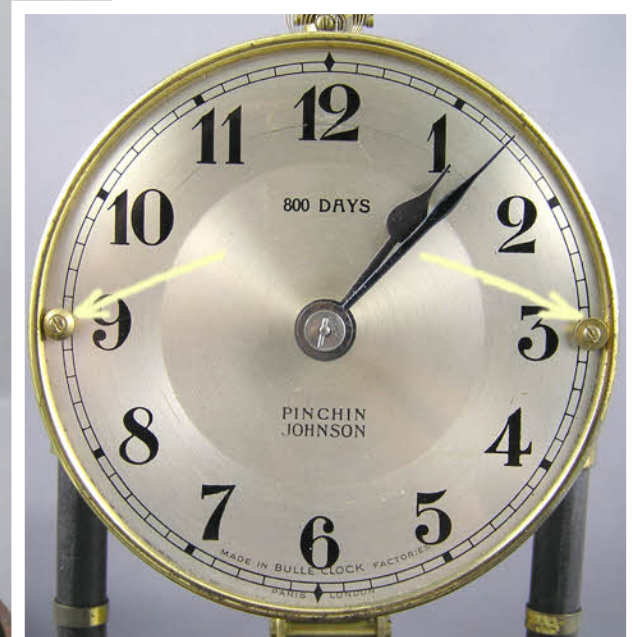
*One thing that's rather obvious though are the two shaped spacing washers on the outside of the dial (arrowed). These should in fact be immediately behind the dial to space the brass rim of the dial away from the cross bar which holds the dial to them movement. This will be shown in the correct place in later photos of the restoration .*

The photo at left shows the correct positioning of the shaped dial spacer washers behind the dial. You can see here that the angle is included to miss the brass rim of the dial yet still allow the dial to sit squarely on the frame.

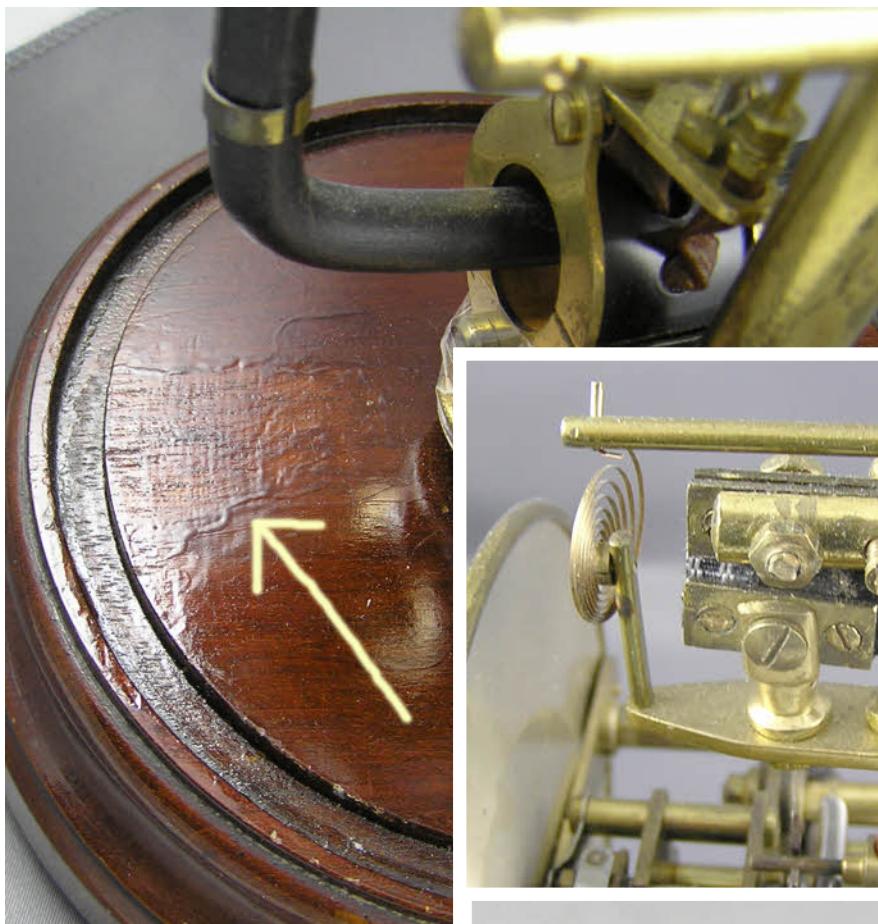
*The base has been disfigured at some time in the past . It may be a solvent has been spilt or perhaps an attempt to re polish the top. Either way I'll try and cut it back and see whether we can get away without a complete re-polish of the whole base.*

At left we now see the base that has been cut back and some polish applied. It has worked out OK and the rest of the base which is in good order did not need to be re-polished. It is always better to try and retain as much of the original clock as possible.

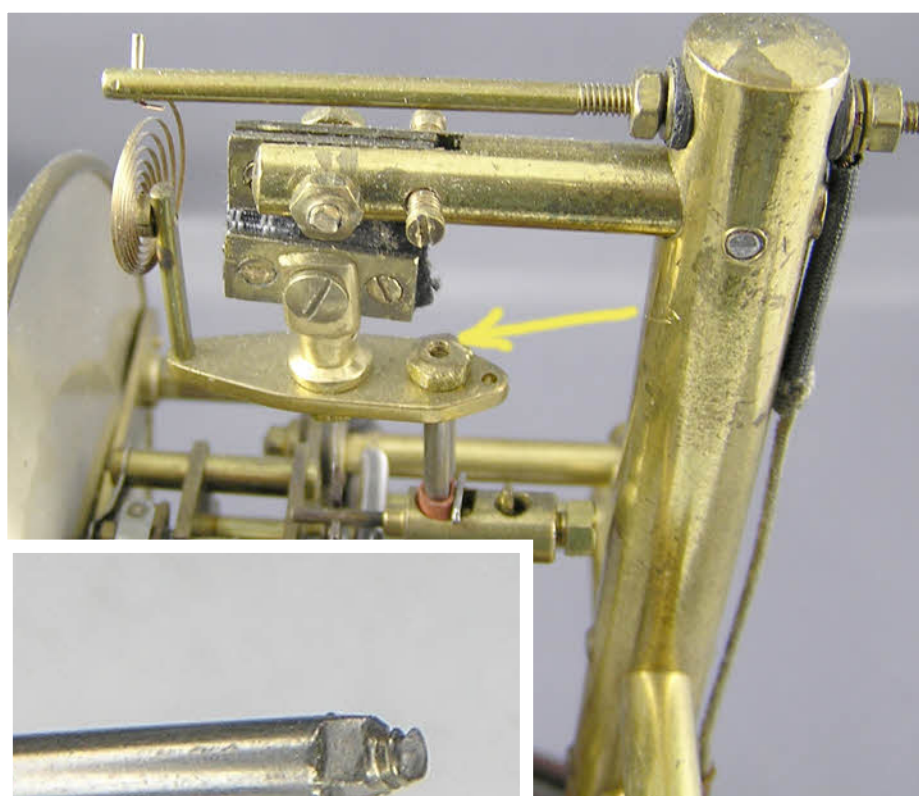
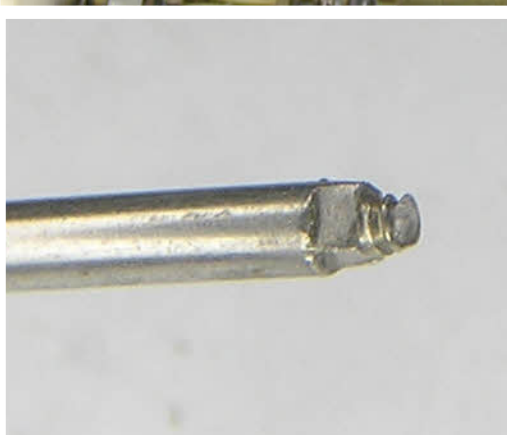
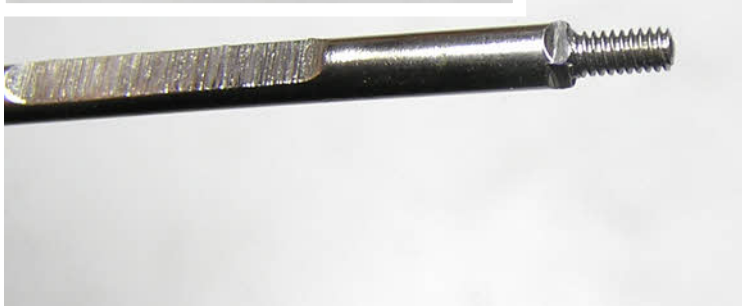
*This is interesting. The main photo on the right shows that the top of the steel pendulum rod has been cut short. Or perhaps badly damaged when taken apart some time. The insert photo right shows the rod removed from the clock. There is not enough thread to secure the suspension assembly effectively.*

*Note also in the centre photo, that the suspension unit needs replacing as usual.*

*The final photo shows the replacement rod with the correct length of thread..*

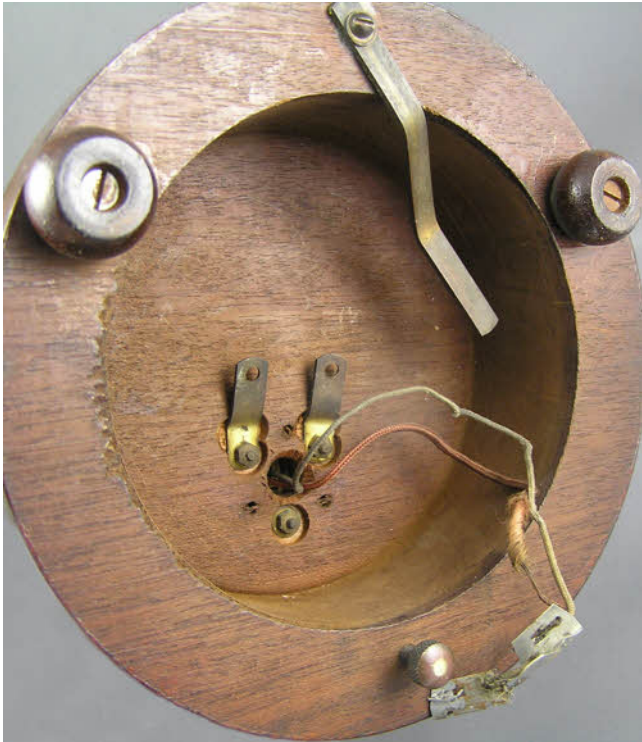
The bottom of the base showing the old wiring which proved to have at least two breaks in the copper wire. This will need replacing.

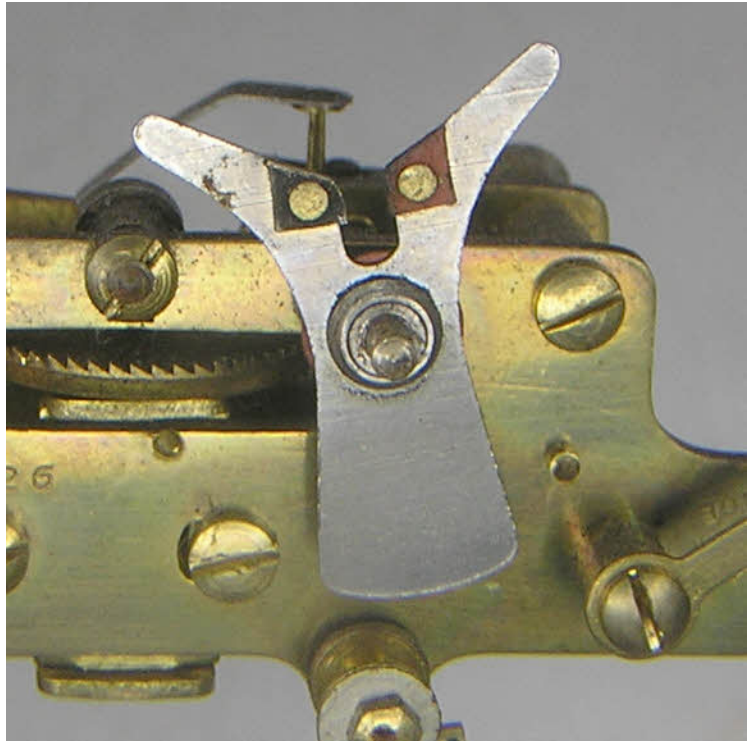
The rear of the movement showing the fork in some detail. Other than the dirt and tarnish it is in very good condition and will only need to be cleaned to extend it's life another twenty or so years.

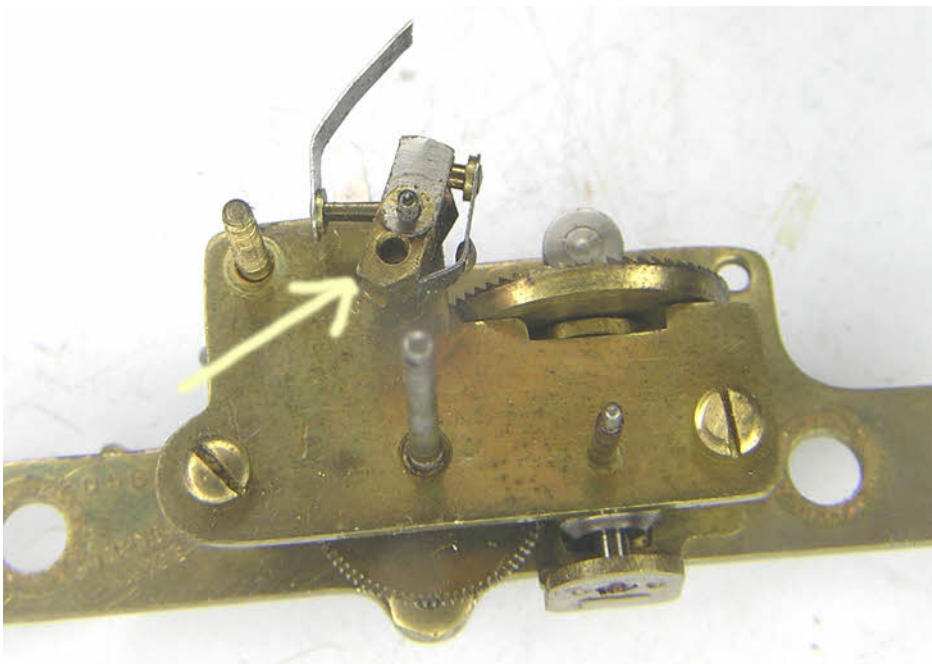
I've included the photo at left, not to highlight any faults, but to show the more unusual form of the pawl assembly. In the majority of cases you'll normally find a round lantern type assembly. But in this case we see the rectangular type with similarly shaped end caps. The methods for disassembly are the same though.

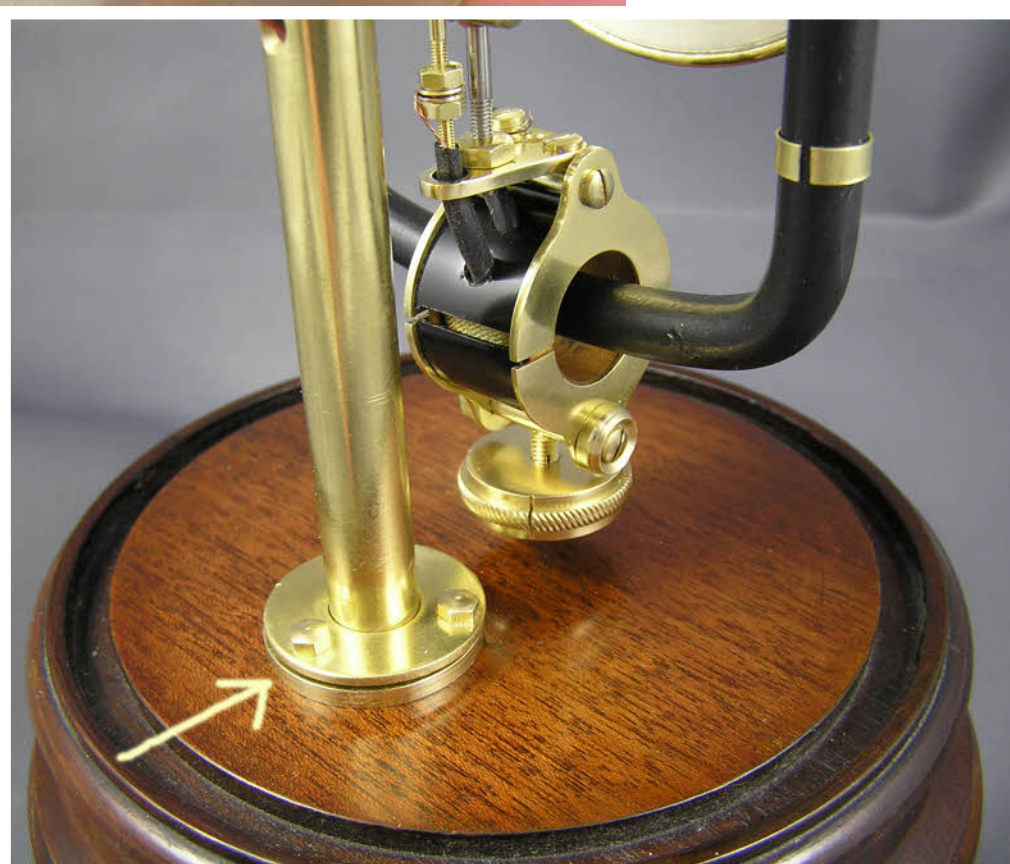
It is interesting to note the original large spacer between the column and the base. I wonder if somebody miscalculated the clearance needed by the pendulum at design stage?

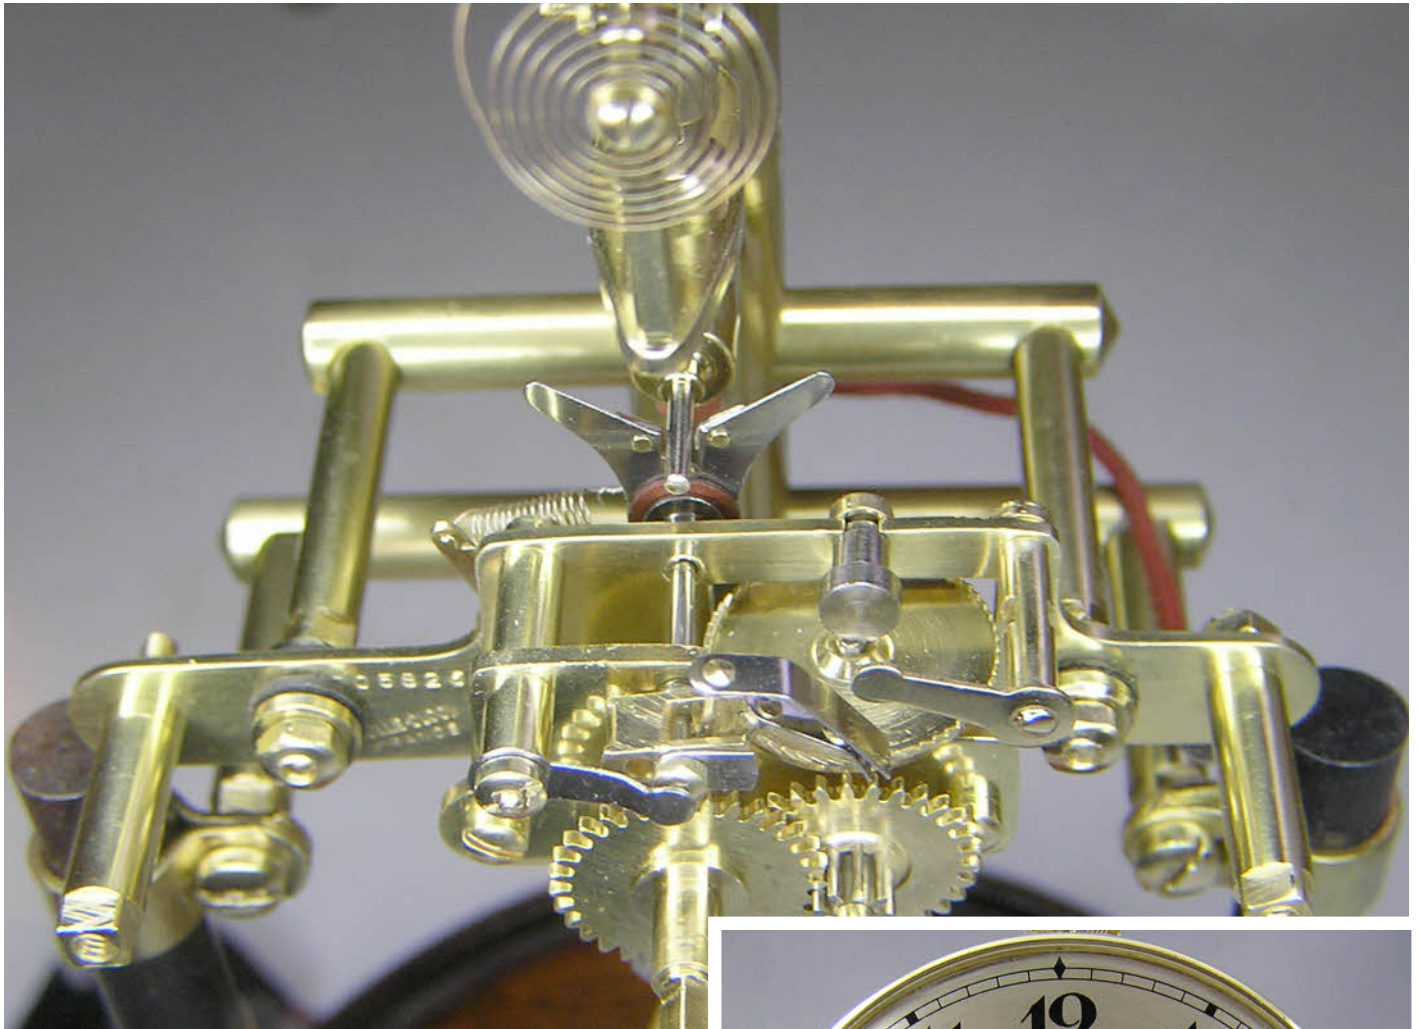
*Above; the movement restored and back in position on the frame.*

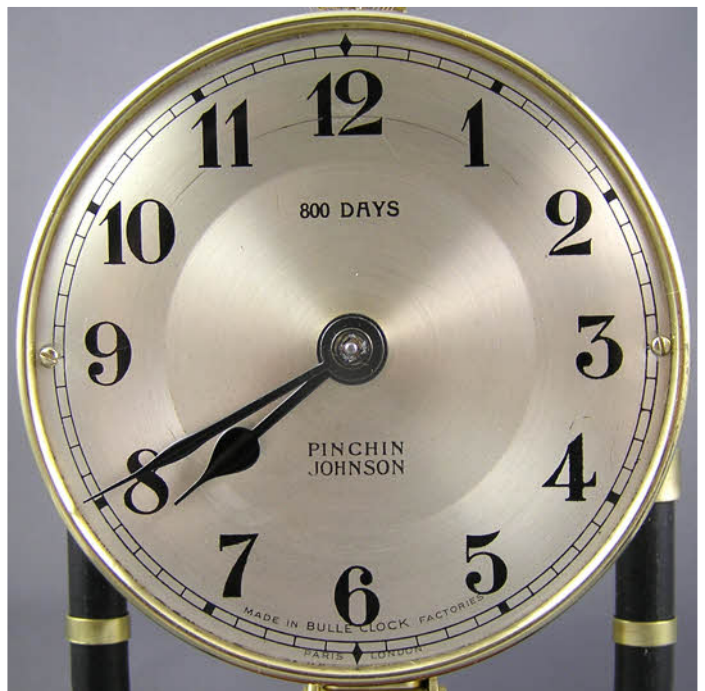
*At right the cleaned dial and hands in position ready for hand collet.*

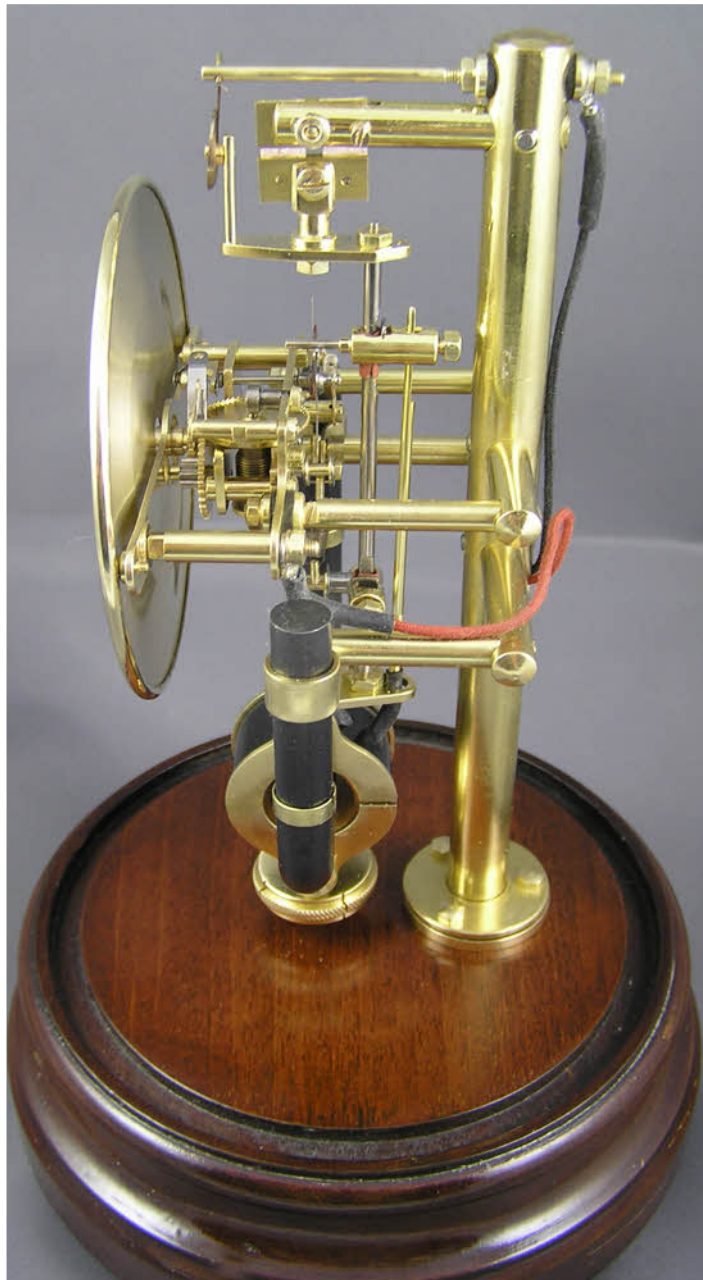
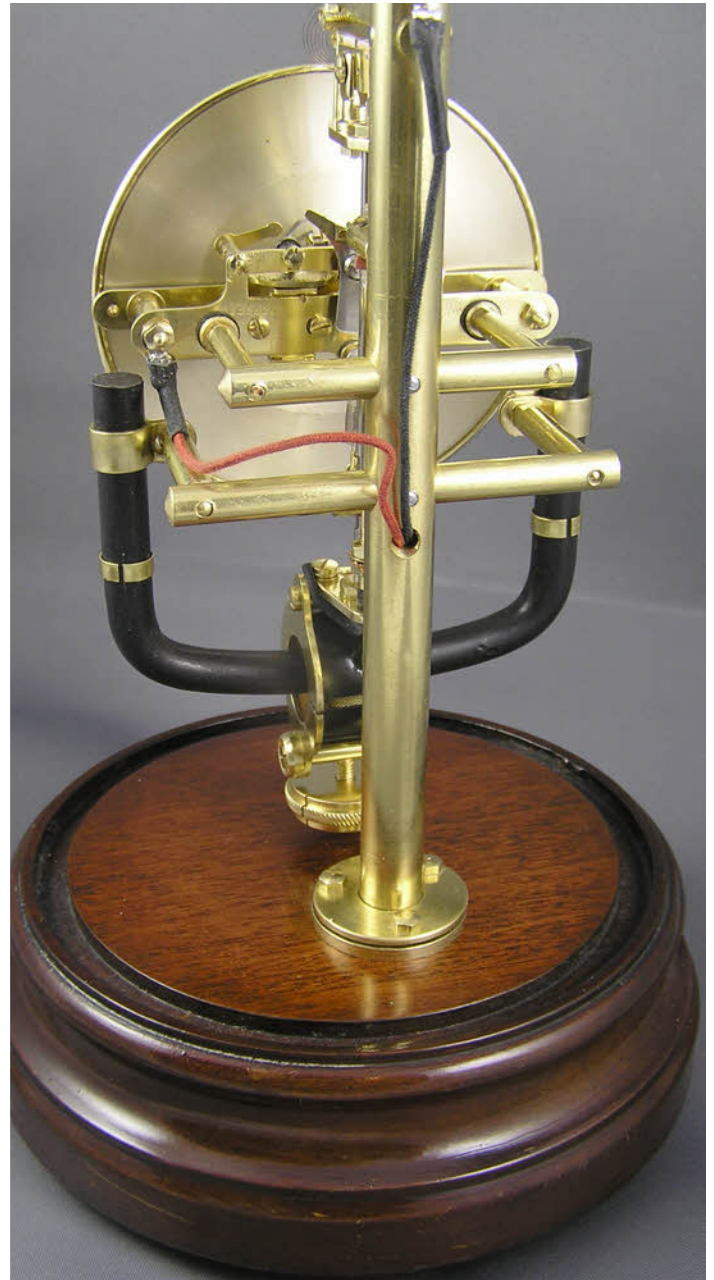
*Side and rear view of the completed clock.*

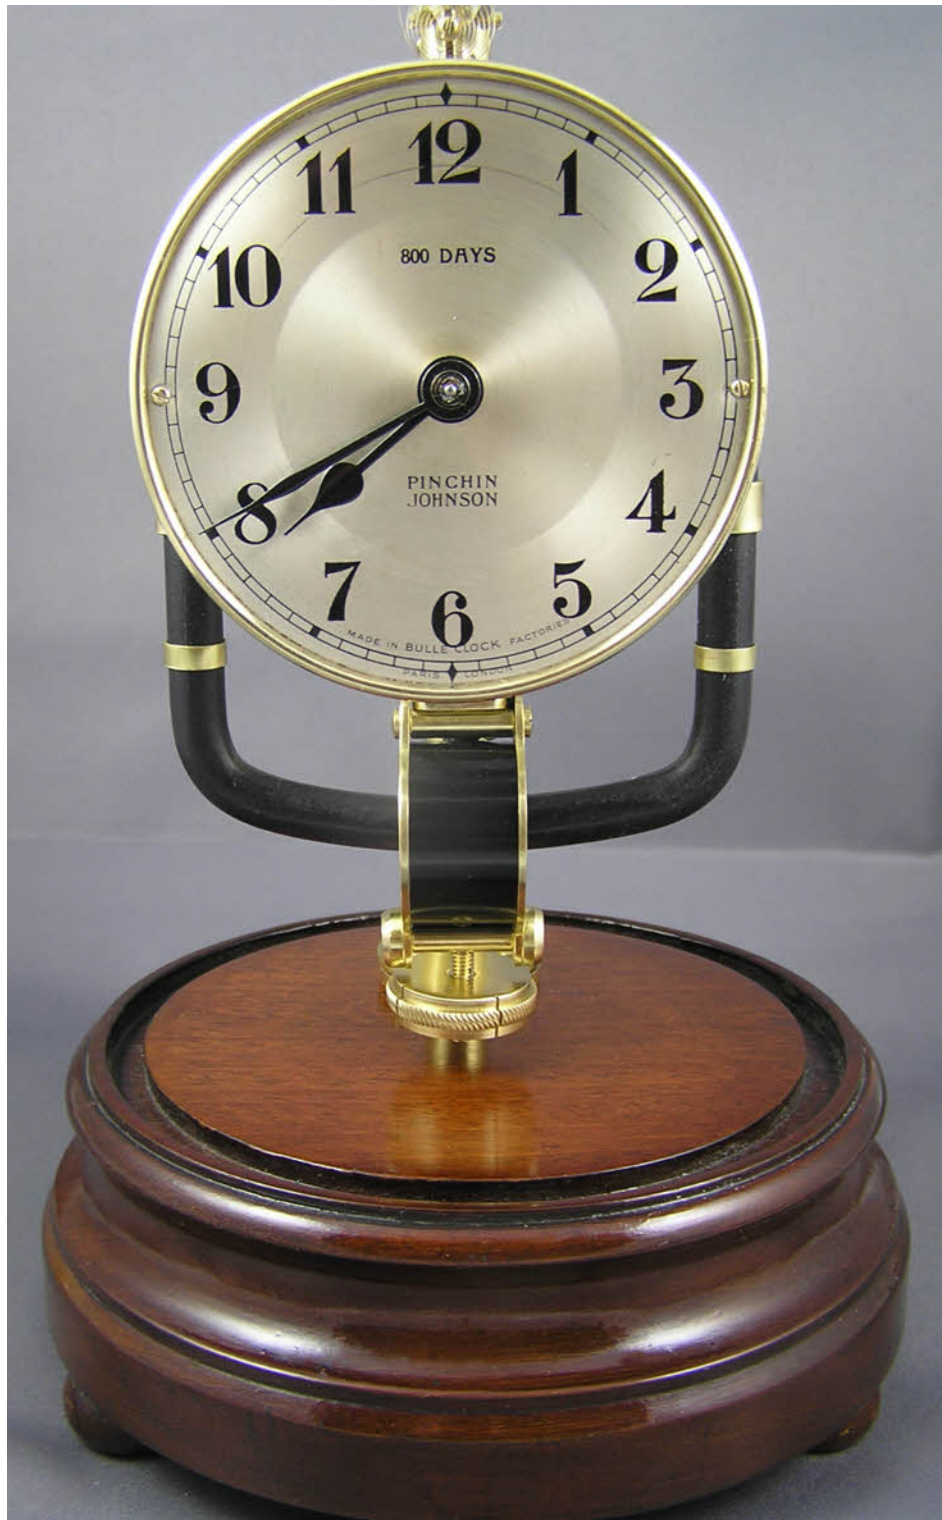
*The finished clock*
