Bulle Clock Serial Number 24834

Restoration of Bulle Clock Serial Number 24834

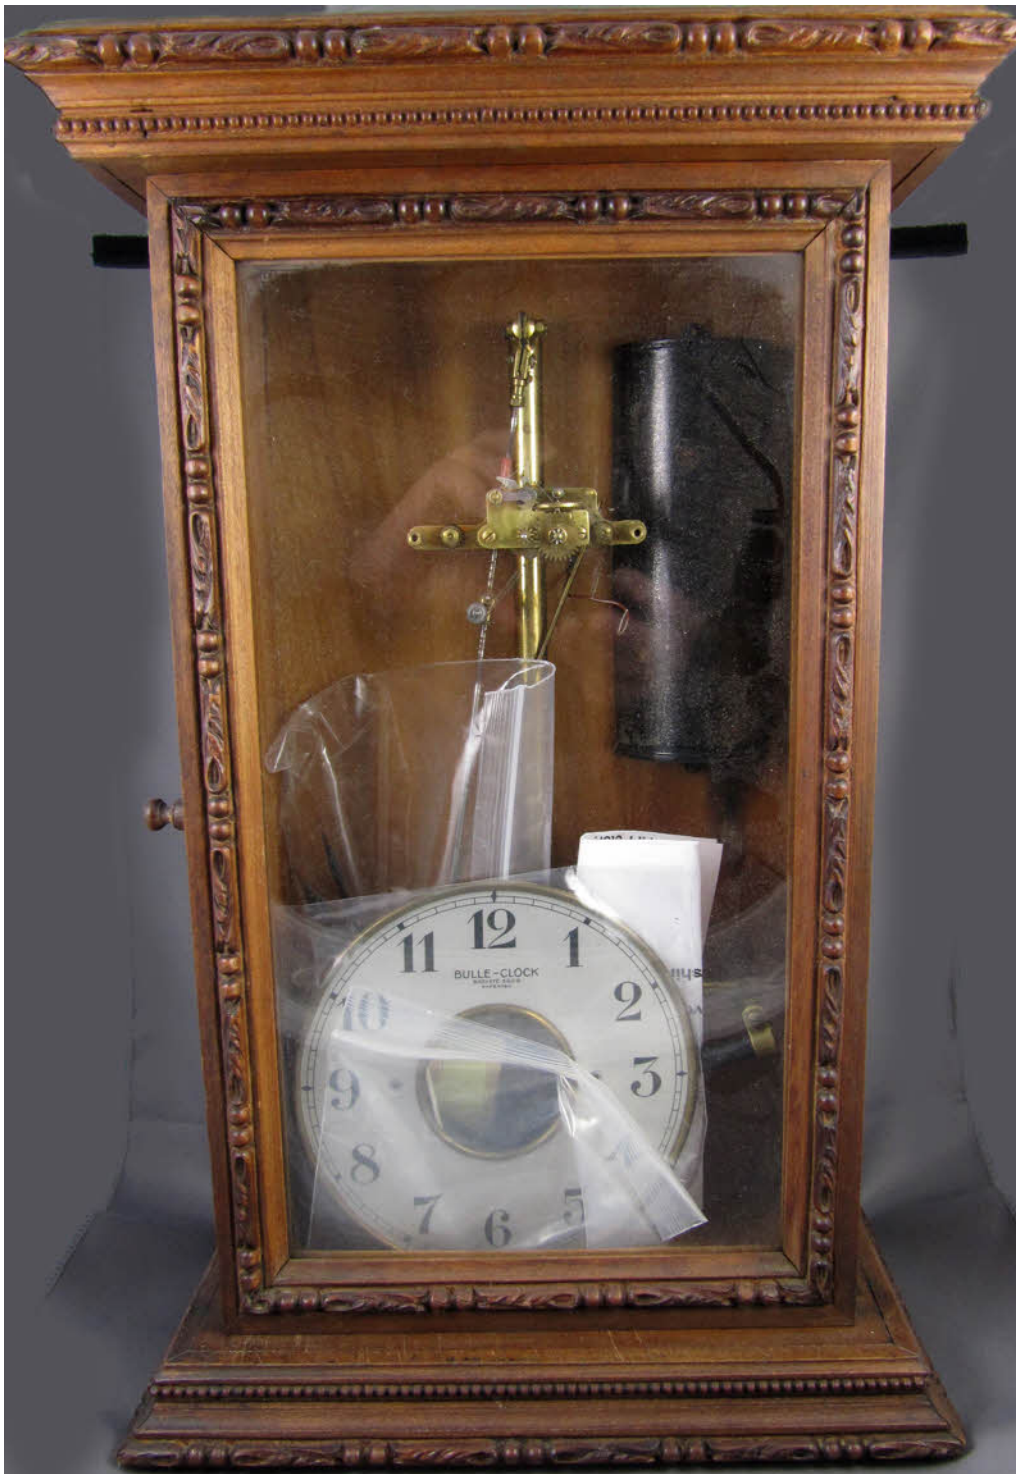
The clock as delivered.

*A tall movement in a
carved wall, case with
glazed front opening door.
The dial and some other
bits and pieces were in
plastic bags inside the
case.*

*The case itself looks to be
in very good condition ,
just needing a good wax-
ing. Although it proved
very difficult to open the
door as it seemed to be
jammed tight. The carcass
may have shrunk over the
years leaving the door
slightly oversize. We will
need to inspect and if nec-
essary shave a smidgen of
the top and / or bottom.
The glass is also loose and
will need securing.*

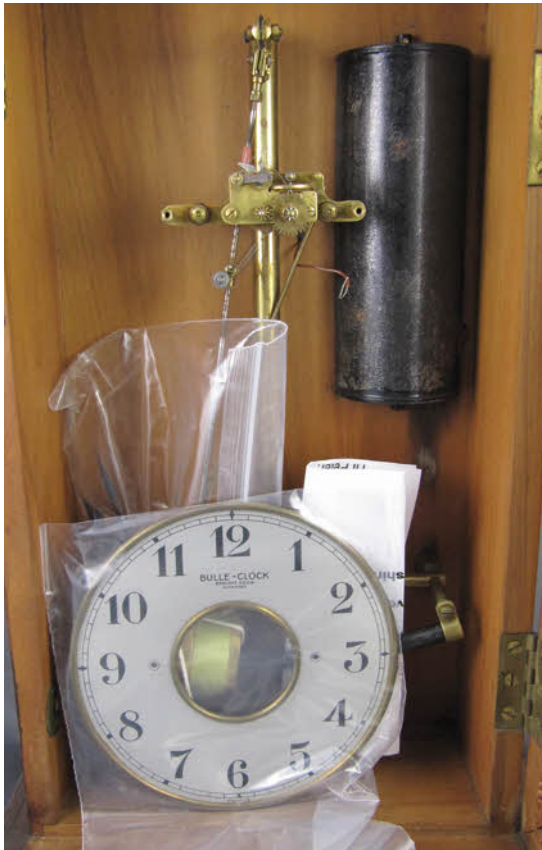
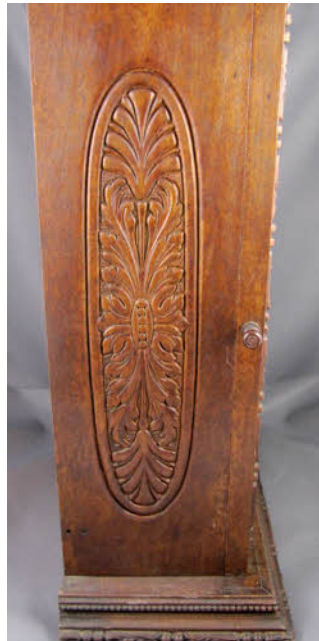
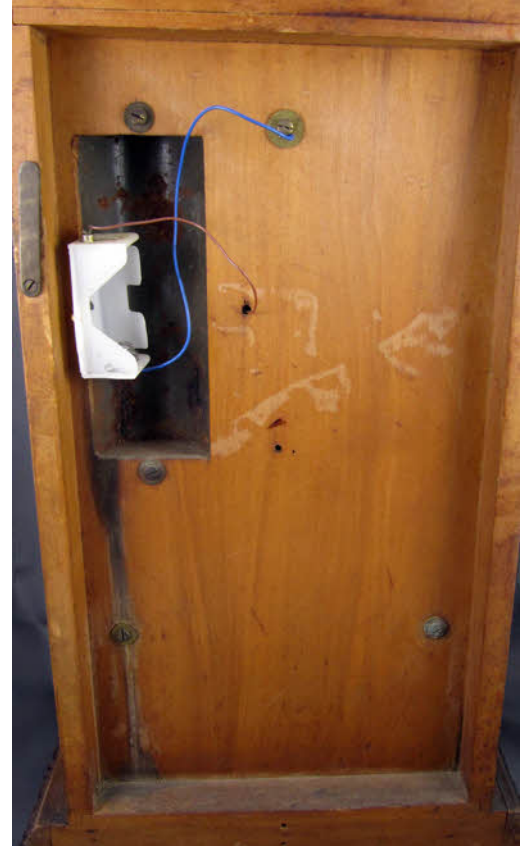
Note the lovely carving on the side of the case. The battery compartment looks rusted through in places.

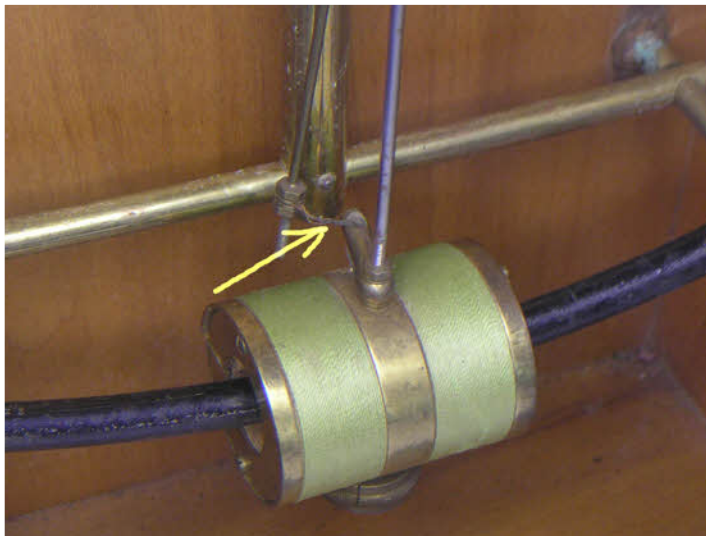
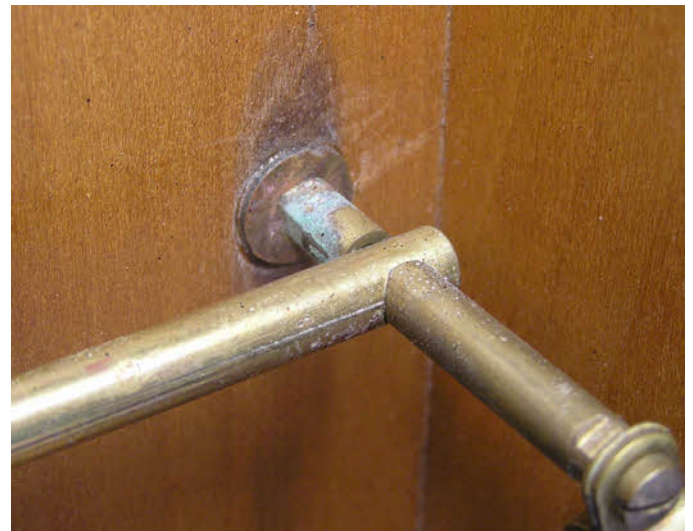
The photo above shows the lead out wire from the pendulum has no insulation and will short out on the brass. The insulation is old and dried right out. It crumbles when touched. The last photo shows the corrosion on one of the stand off pillars.

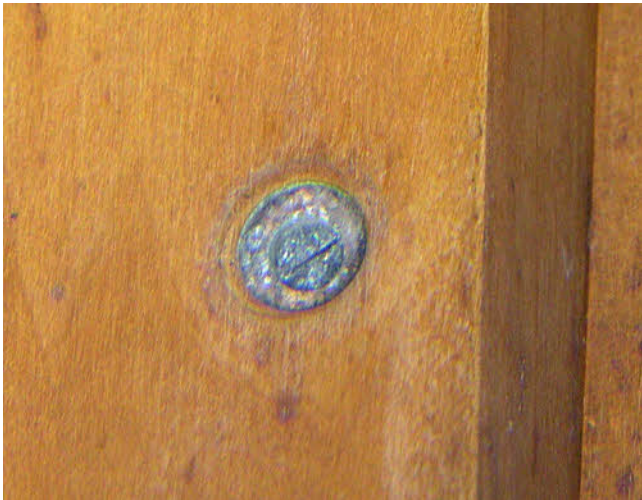
The corroded pillar securing screw from the rear.

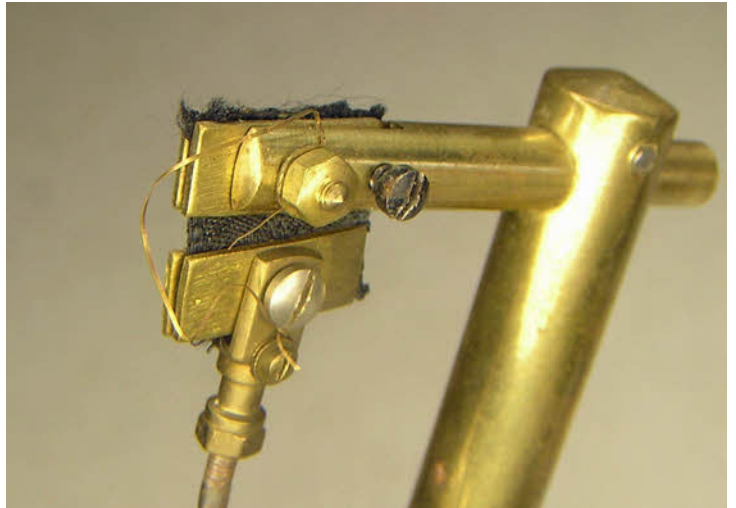
The replaced suspension and contact wire. Both will need to be made.

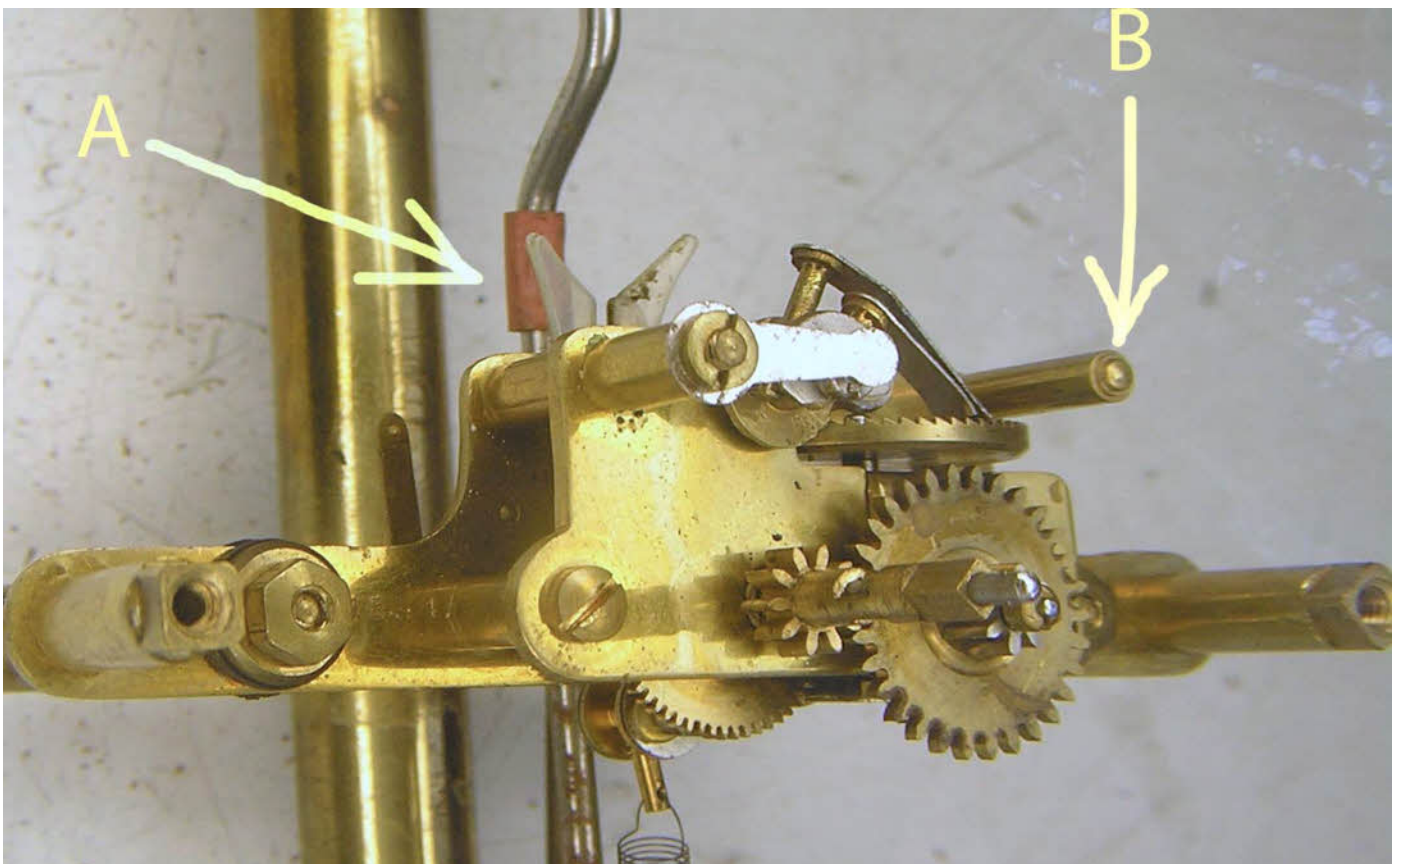
A) shows the missing contact pin assembly some of which is in the plastic bags, while the body itself has slipped down the pendulum rod and is shown in later photos. B) shows the arm which limits the pawls from jumping out of the count wheel whilst the clock is in transit.

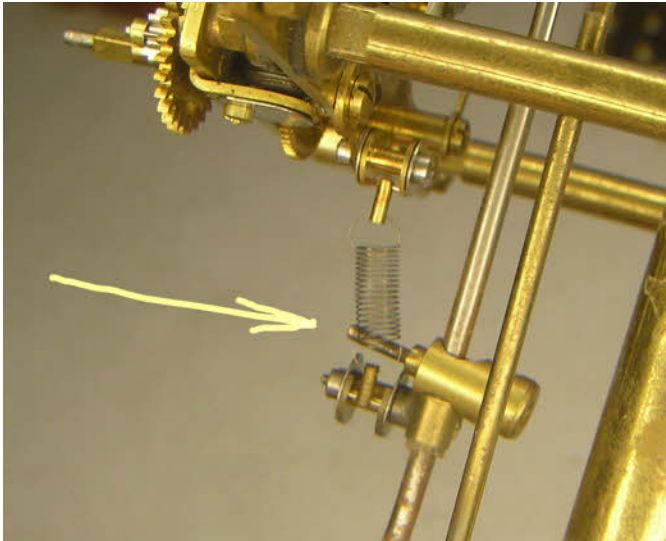
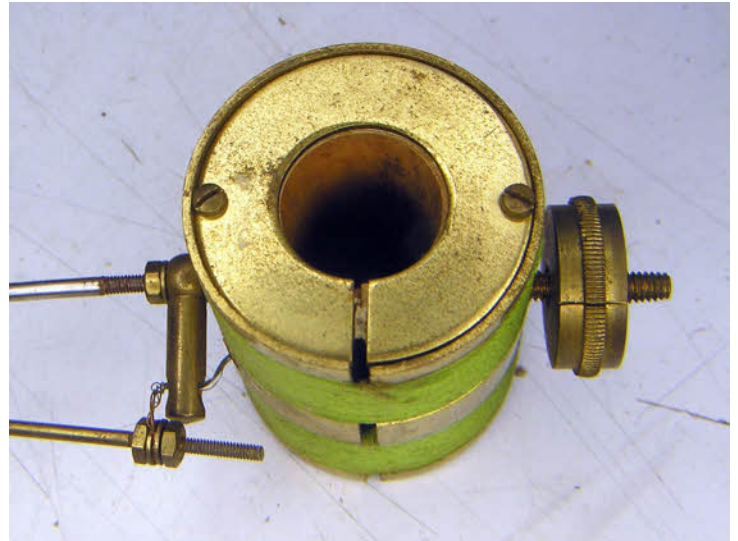
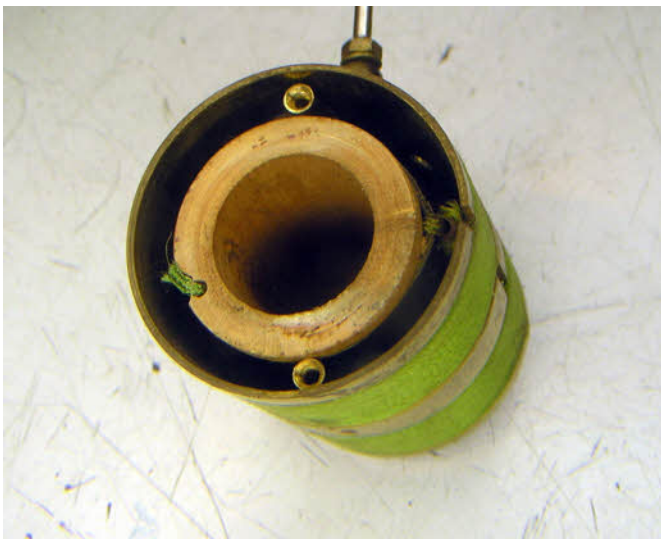
The arrow shows that the contact pin assembly has dropped down the pendulum rod because the hexagon head screw has been removed. The parts were supplied in the plastic bags. The other photos show the coil housing and orientation of the coil in the housing. The orientation is important to get right on assembly otherwise it will not match the magnet with its South-North-South orientation and the clock will fail to run. Some clocks are seen with magnets polarised North-South-North probably because the coil has been inserted the wrong way round and it's easier to re-polarise the magnets rather than take the pendulum apart again and re-orientate the coil.

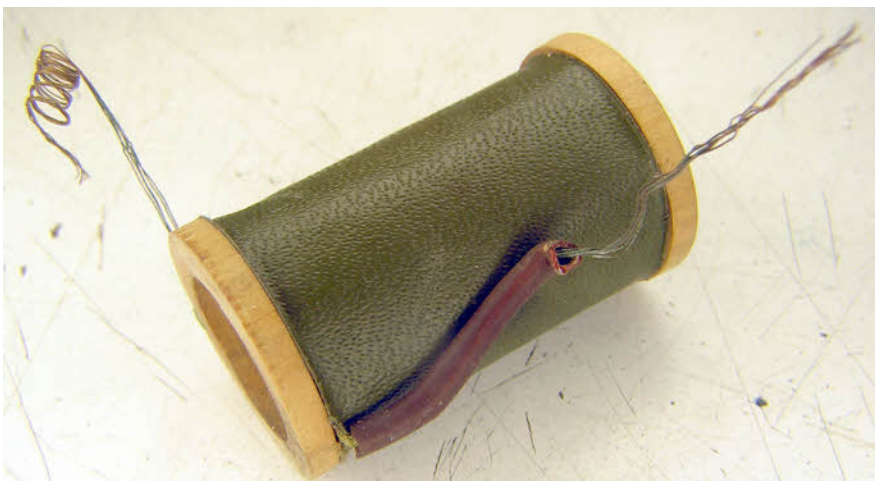
This last photo shows one of the coil lead out wires. The insulation is as hard as rock and crumbles when touched.

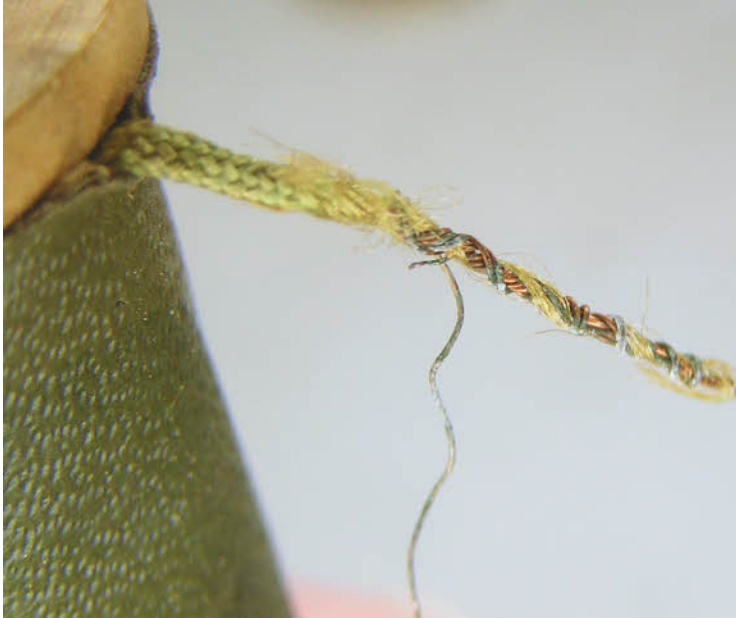
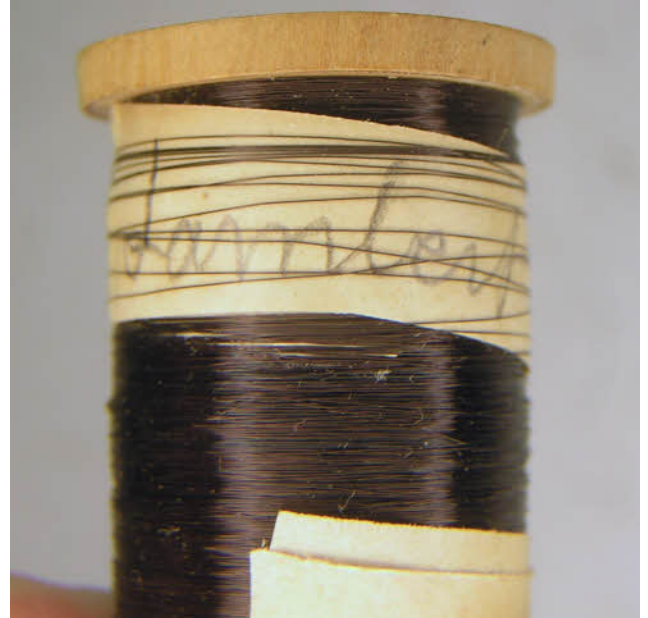
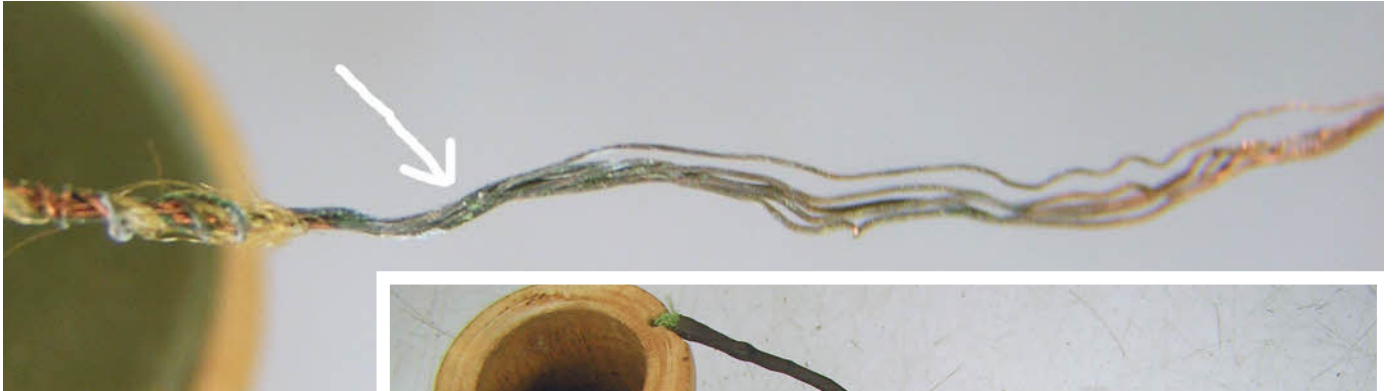
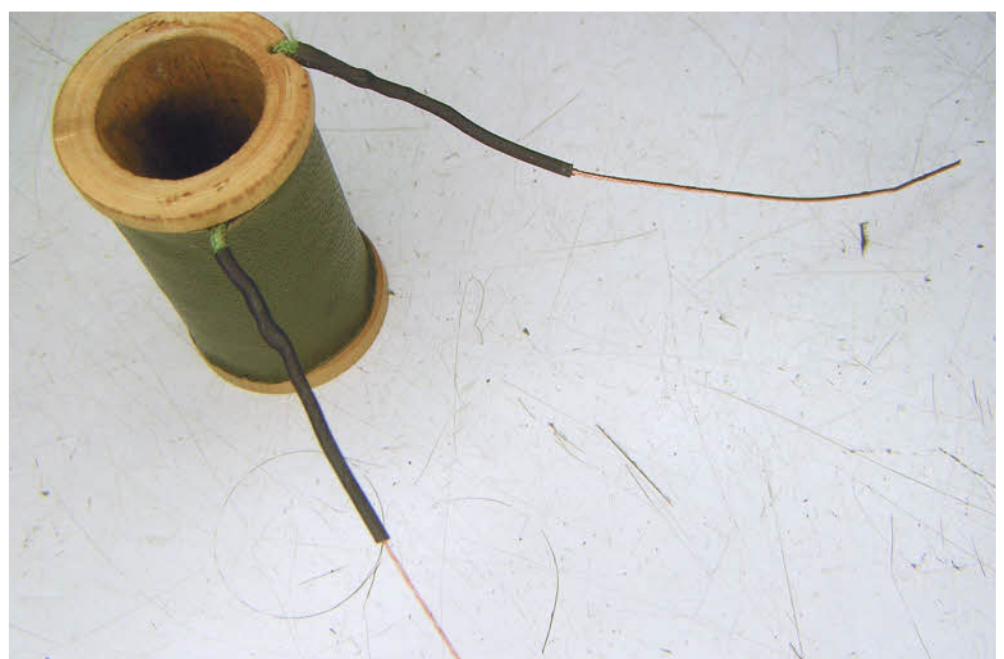
The first photo shows the lead out wire has been replaced at some point. The arrowed photo shows the bad corrosion of the wire which need to be replaced. When the paper covering was removed I found the name of the factory worker who wound the coil, a Monsieur Lambert. I bet he didn't think his name would be seen 80 years later! Last photo shows the new lead out wires

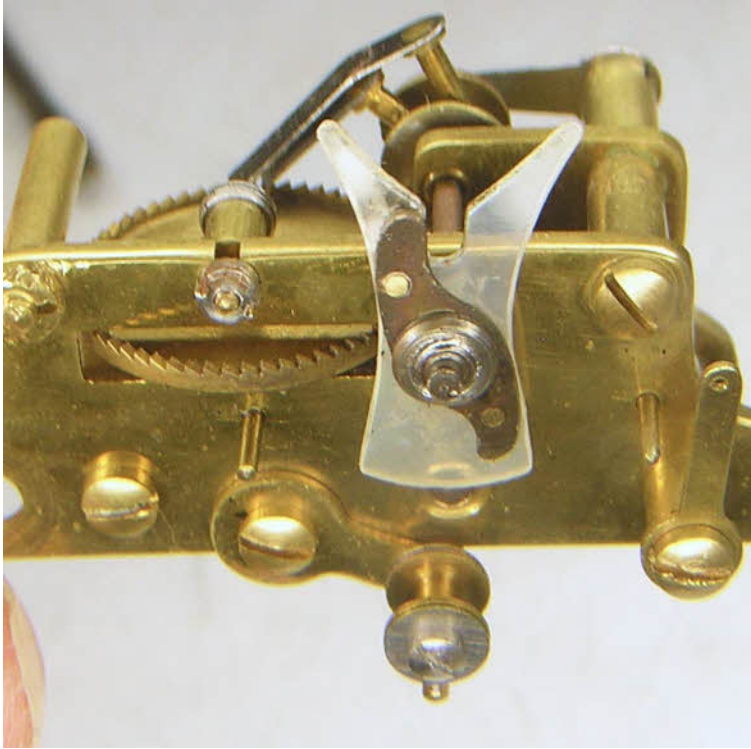
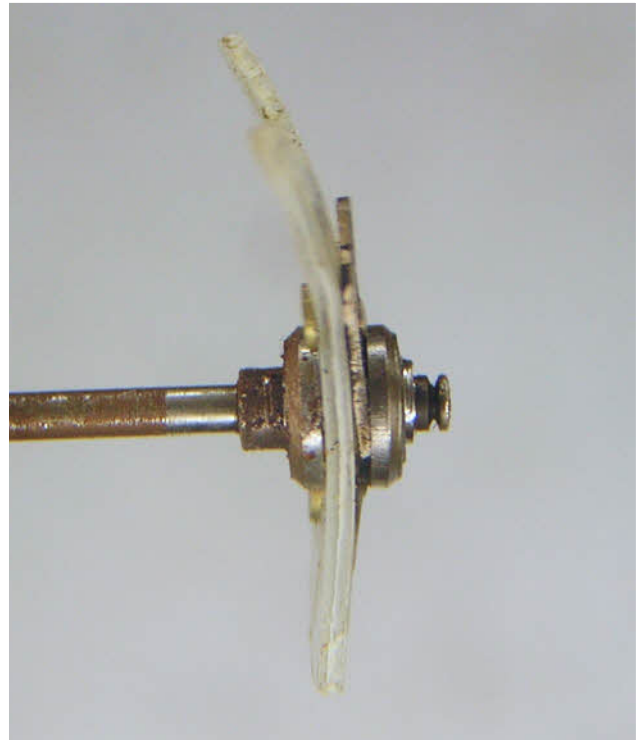
The fork is one of those early plastic types and must have been subject to damp at some time (notice the rusted arbour) as it is quite bent out of shape. They are relatively easy to straighten with the application of a little steam and steady pressure. In this case though there were problems with continuity so I had to replace the fork. The photo below shows a badly mauled nut that will need replacing.

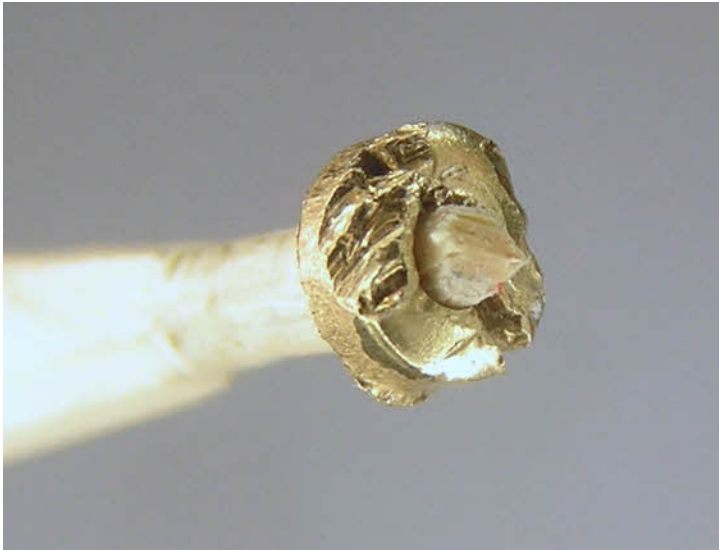
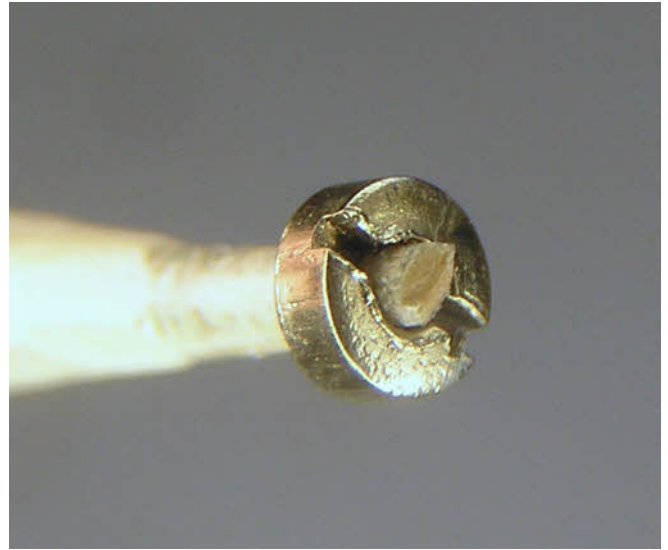
The photos at the top shows the mauled nut and another from the same clock, showing what it should look like.

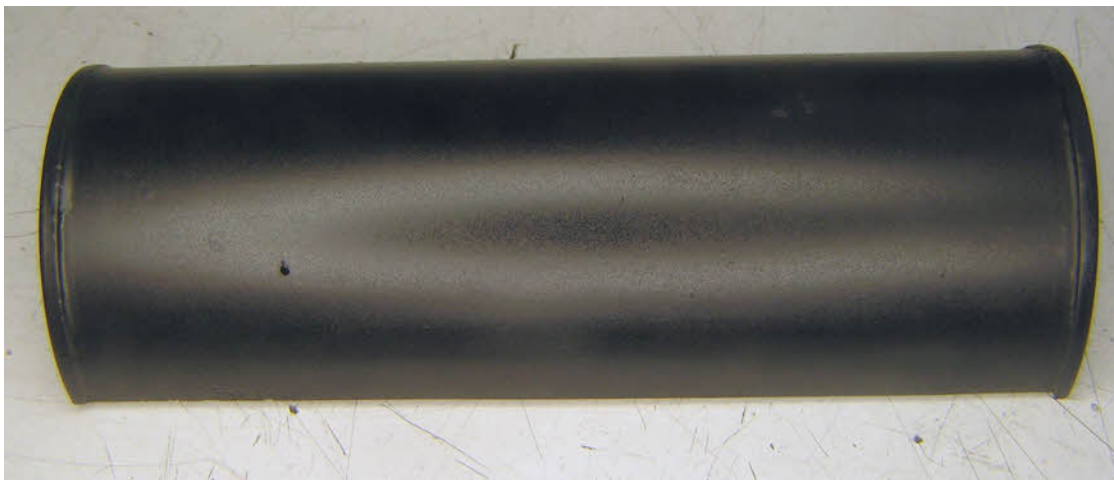
The photo at left shows the cleaned and painted battery housing. But it does have a few small holes as a result of the acid burns.

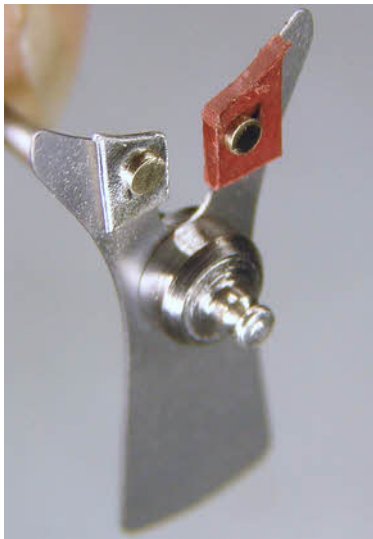
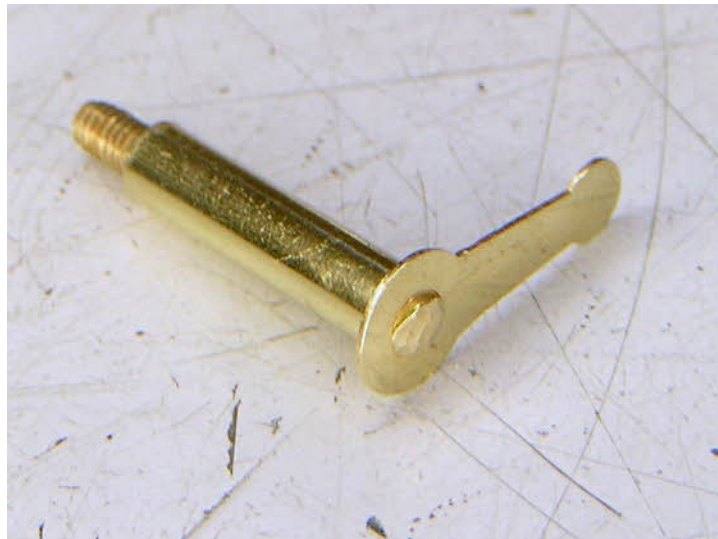
The photo on the far left shows the new fork and contacts. The last photo shows the repaired pawl limiting arm.

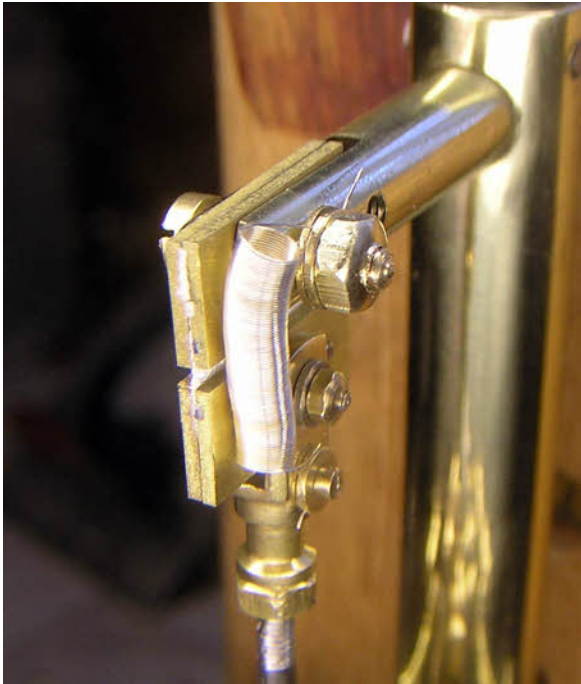
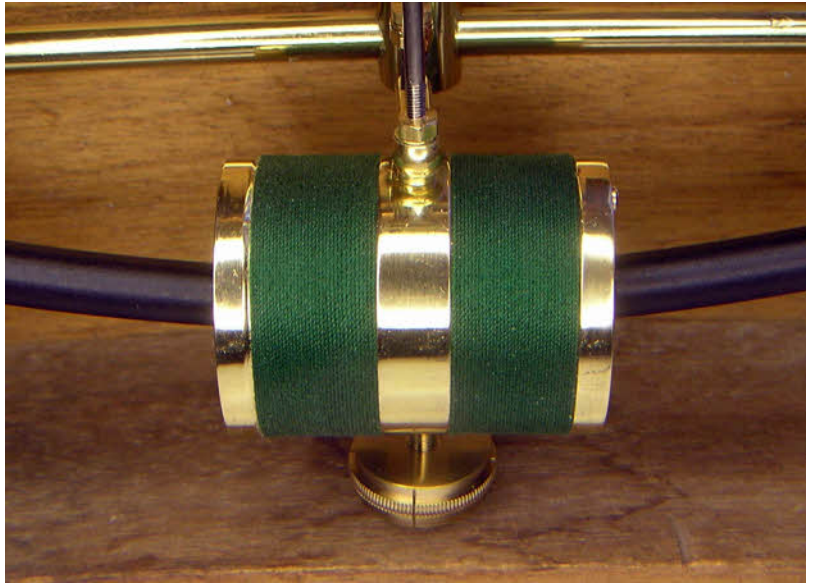
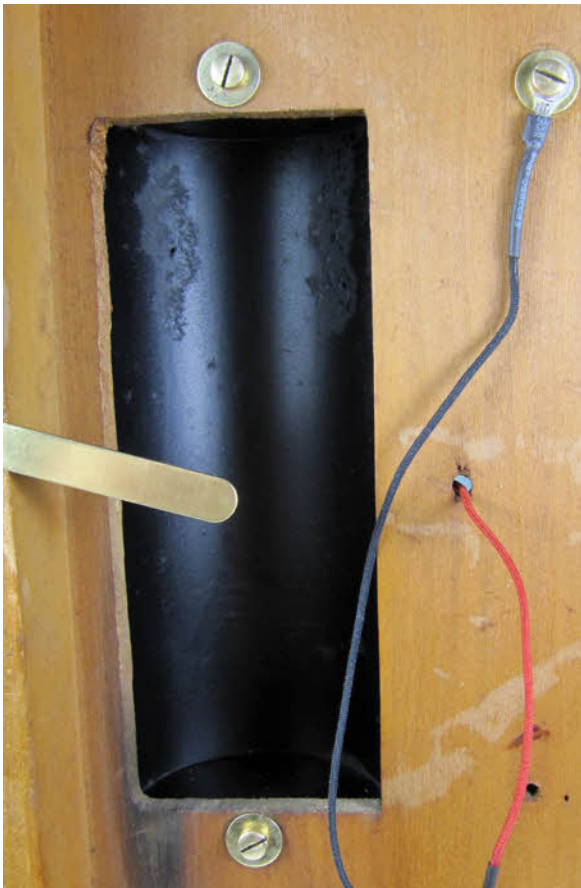
These photos shows the clock back in the case with new coil binding. Note that the battery housing has been damaged through acid leakage, although it shouldn't get any worse after I cleaned away all the acid and gave it a protective coat of paint.

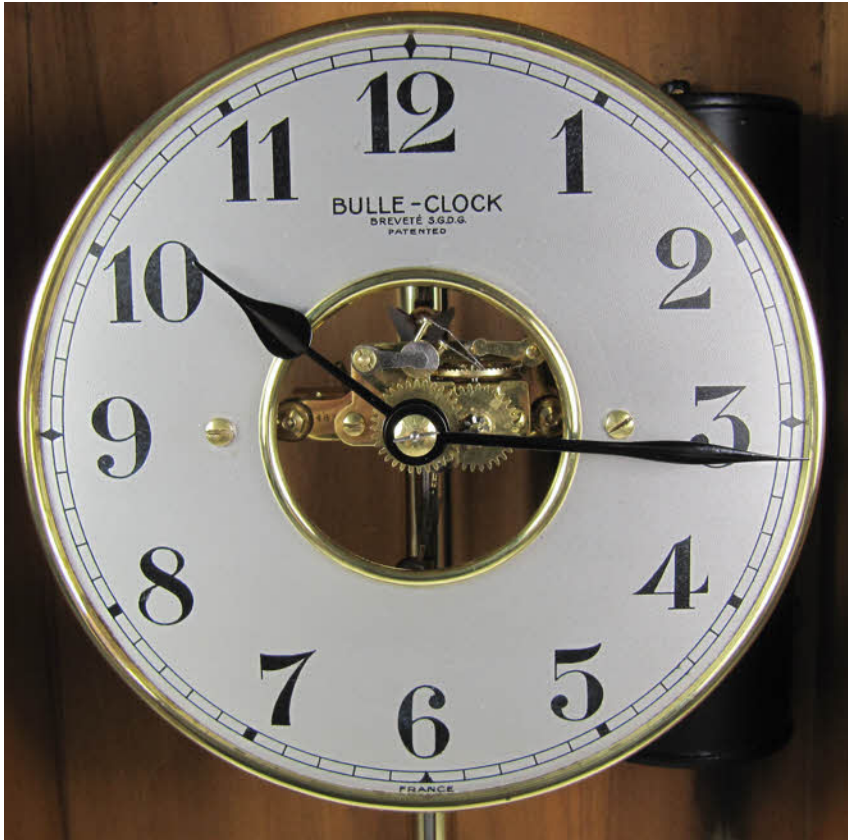
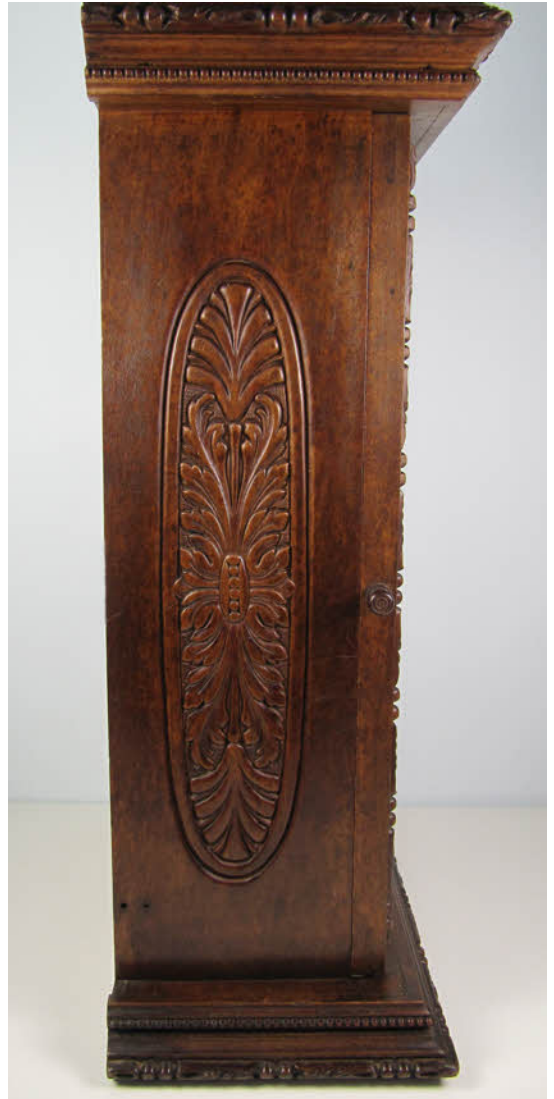
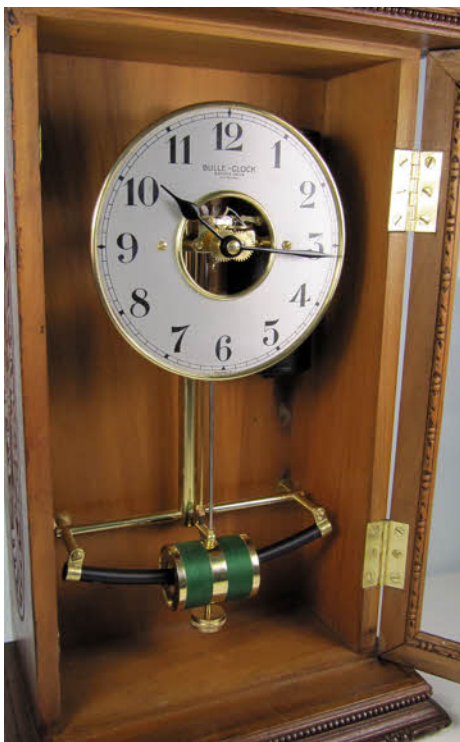
The dial is still in very good condition and only needed washing in soapy water. The brass rim was then cleaned and polished. Note that this dial is made from printed aluminium and was therefore safe to wash. Card dial are obviously a different matter and should not be cleaned at all.

The wooden case has only had a polish with wax.

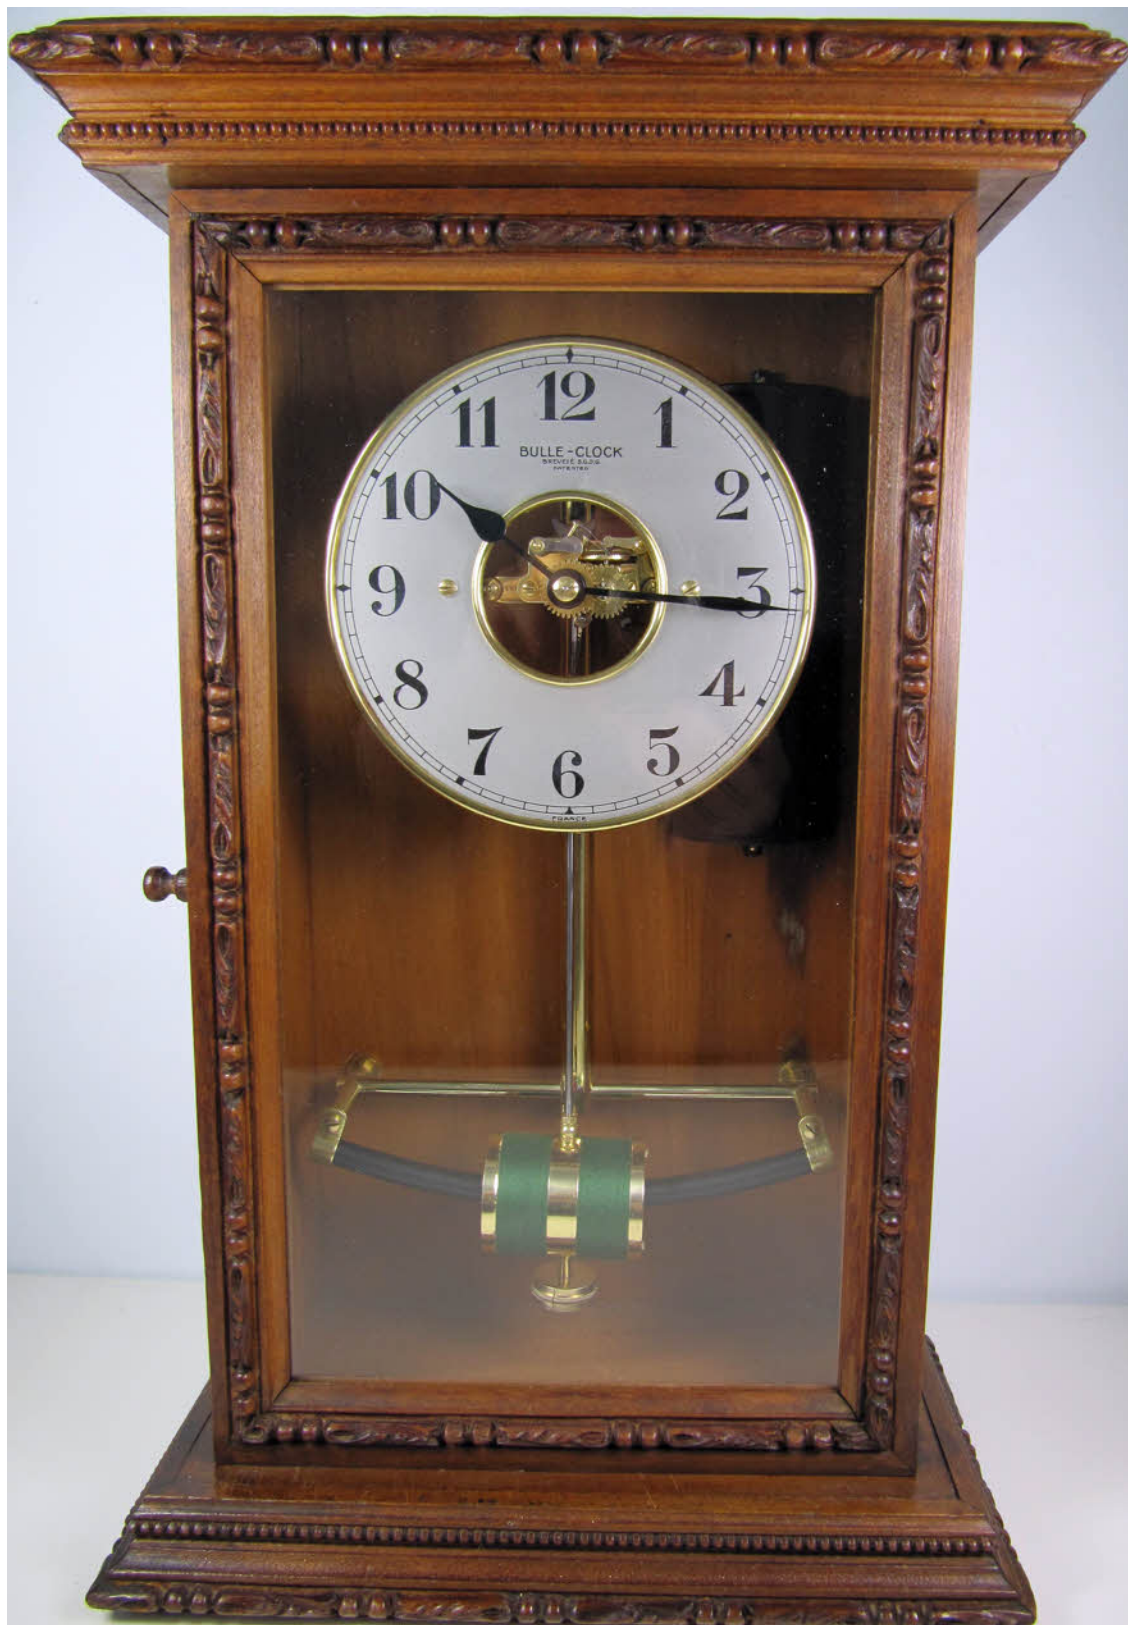
The finished clock
