**Bulle Clock Serial Number 255595**

*Restoration of Bulle Clock  
Serial Number 255595*

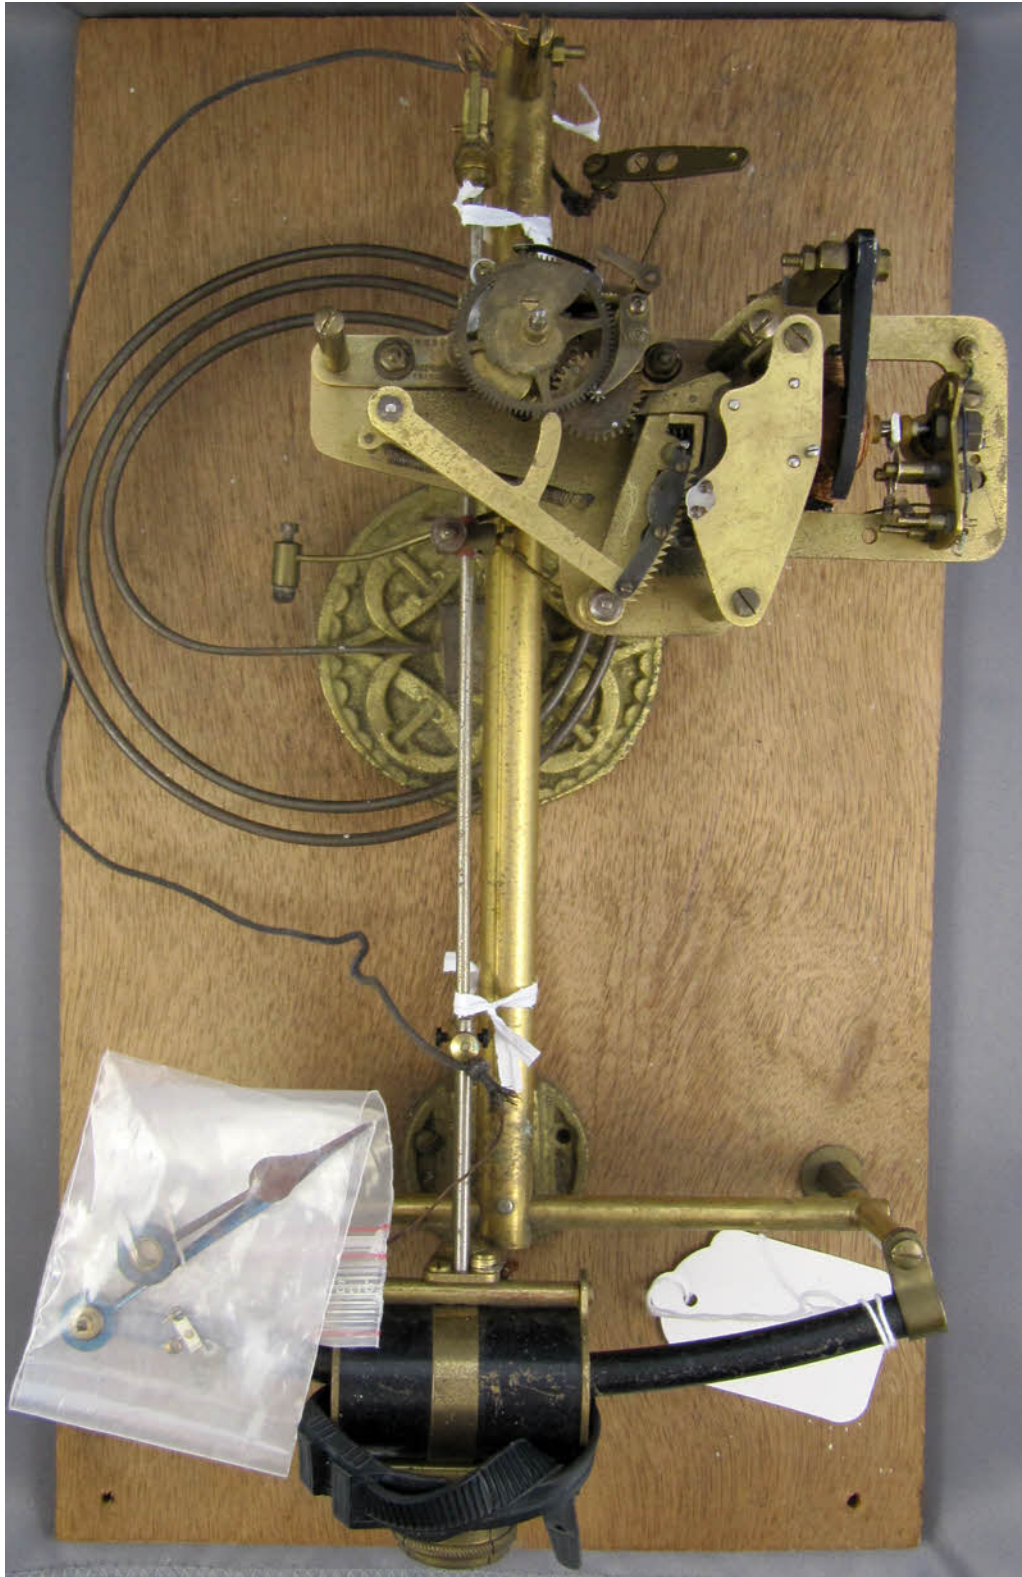
*This is an interesting clock. It is a Striking Bulle with a ½ second pendulum. The striking mechanism can be seen clearly at the right hand side of the movement with the additional rack, snail, hour & minute wheel modifications to the main movement. This version strikes on a gong although there is no difference in the mechanism to a bell striking version also in the workshop at the same time.*

*It's interesting that the strike mechanism is completely separate from the main movement and can be removed and tested very easily. But I am surprised that the small motor is still driven by the same 1.5v battery used for the main movement. The early batteries though were bigger and had more capacity and would still have lasted at least 6 months. If a modern "D" cell is too small to last long then the battery carrier will need to be modified to accept 2 or three cells in parallel. But so far my testing indicates at least 3 months running can be achieved with a good "D" cell.*

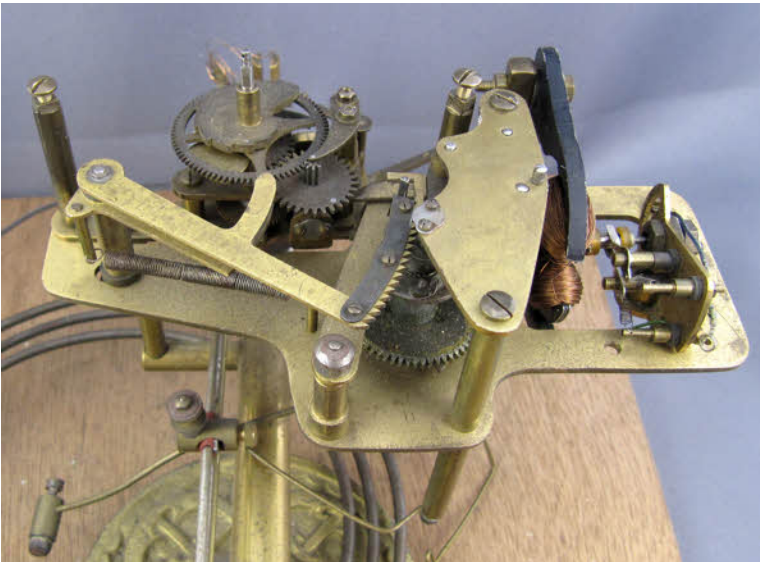
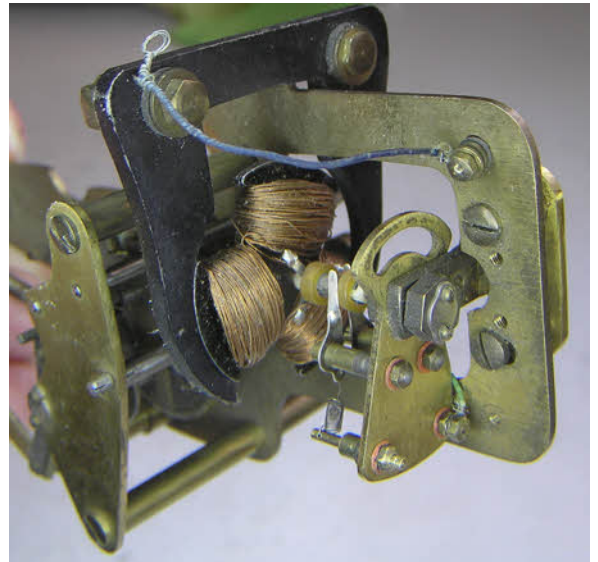
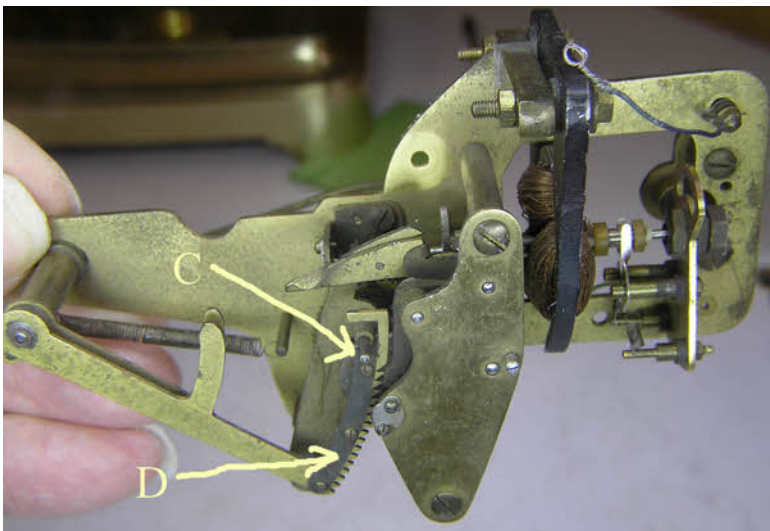
*The three windings were each measured and averaged between 10 and 15 Ohm resistance. One side of the motor is directly connected to the negative terminal of the battery through a fixed brass wire which runs from an insulated post on the striking mechanism B) to the insulated negative carrier at the top of the movement frame A) (as shown below). The other side of the motor is connected to the positive terminal through the silver rack pin as shown at C) in the photo on the left. When the silver pin is in contact with the silver strip on the rack D) then the motor runs. When completed the pin falls in the slot and disengages.*

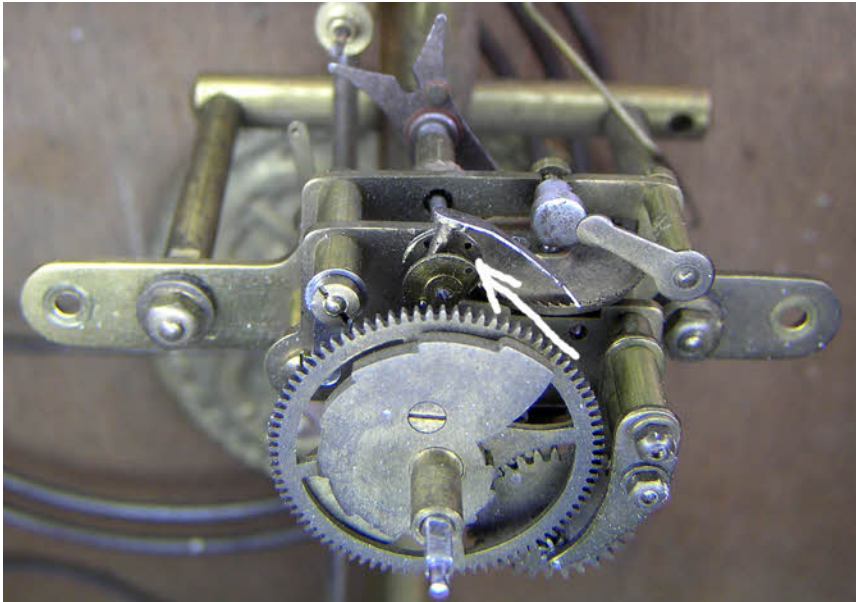
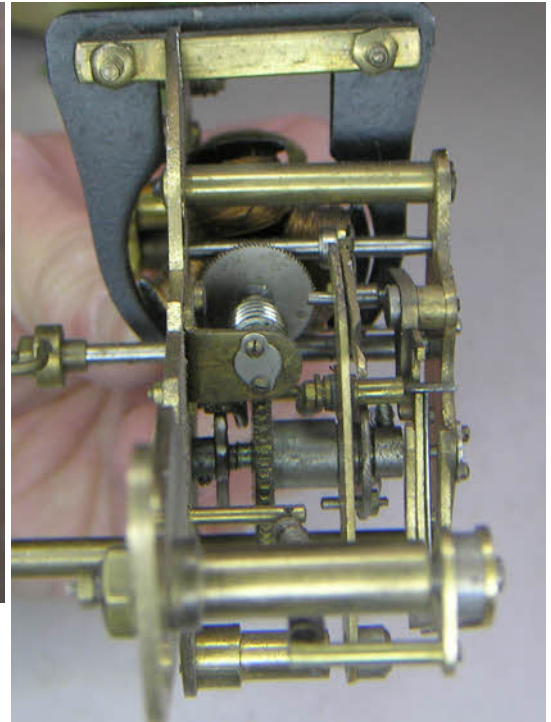
*The plastic bag that came with the movement contained some parts including the missing pawl shown above.*

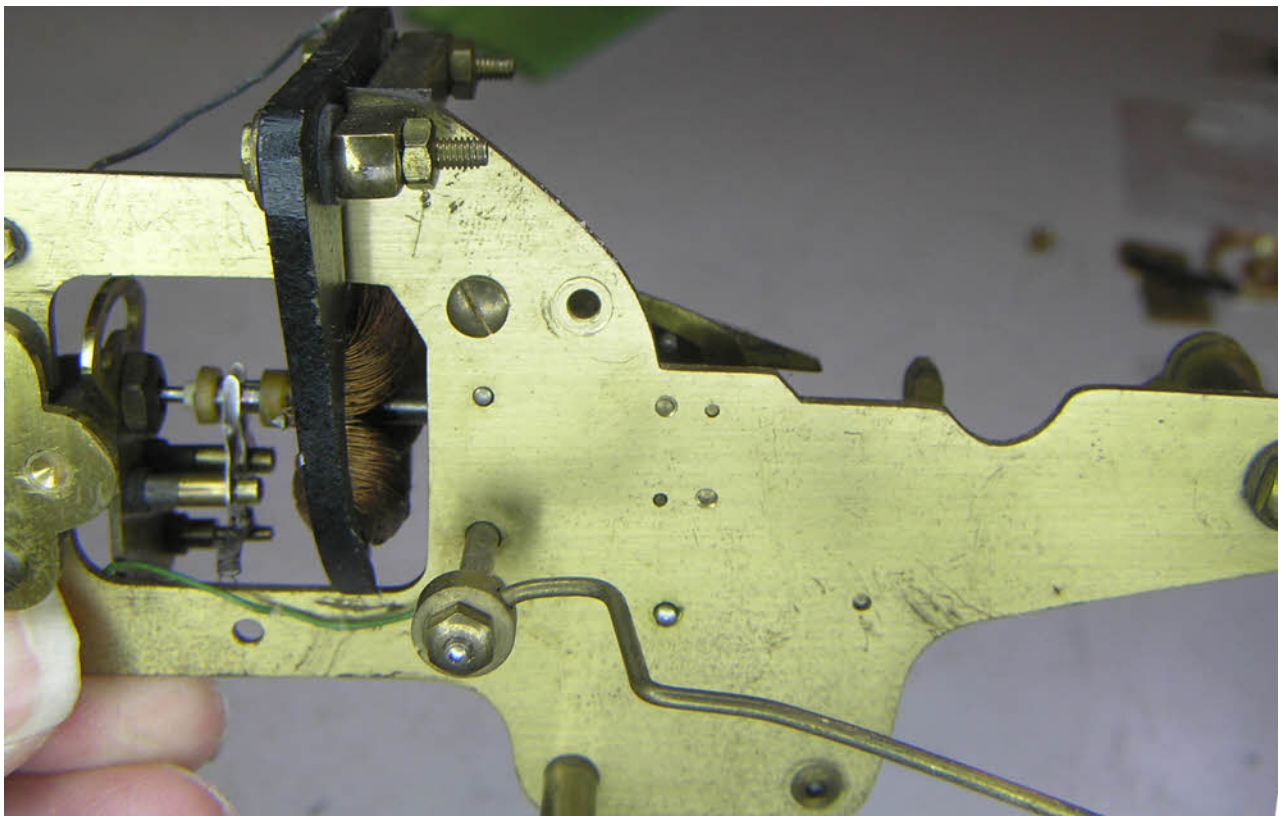
*Rear view of the strike mechanism*

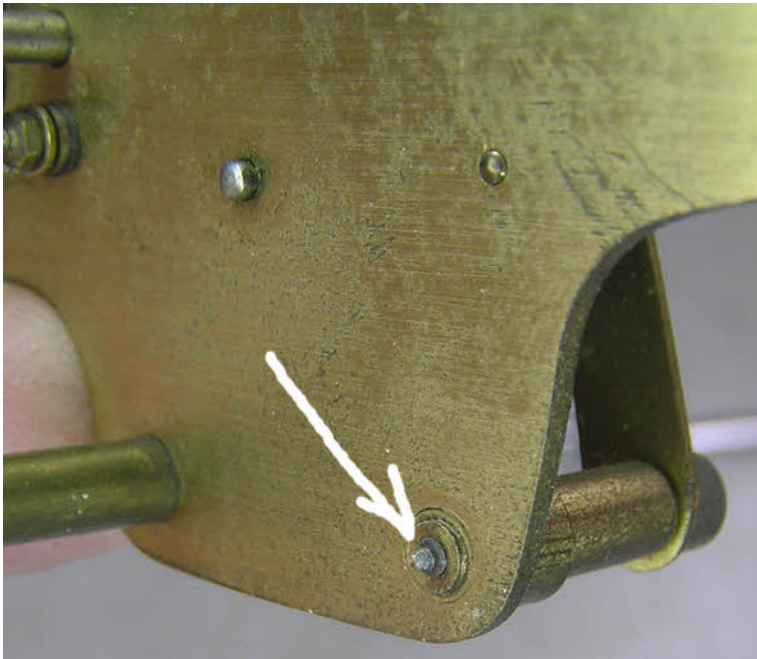
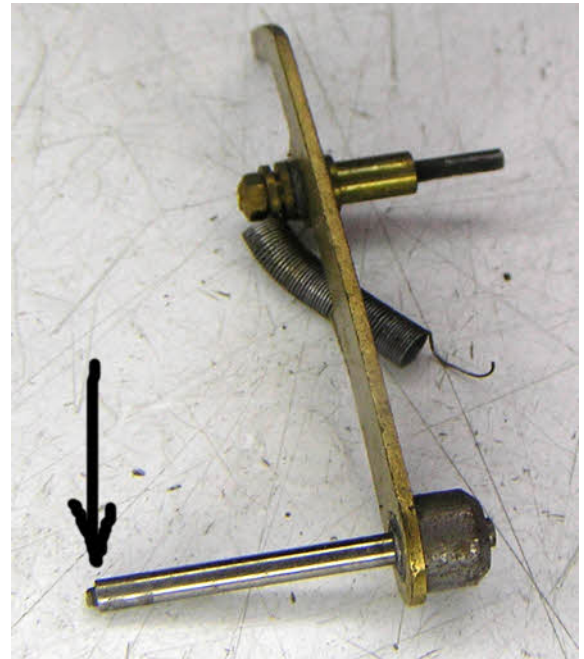
*The rack arbour was snapped and the thread missing, as seen in these two photos above. A new one will be made and threaded with a new nut.*

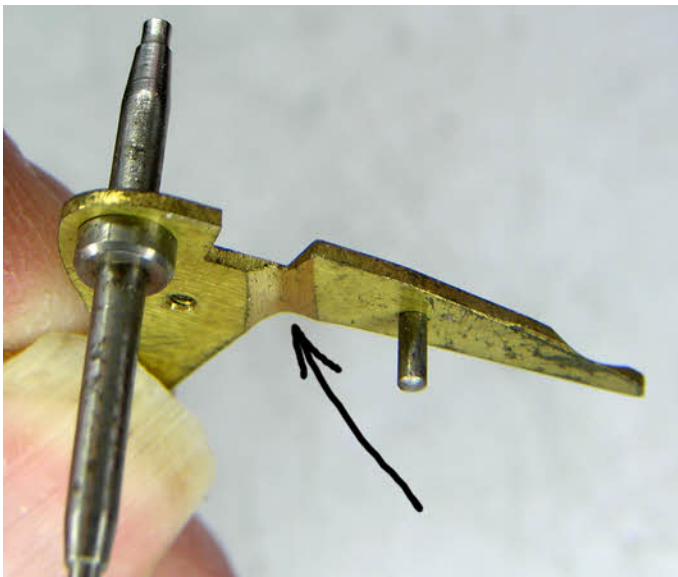
*The warning piece has a very pronounced groove in the arm but there is nothing in the vicinity that could have caused it. It may have been done deliberately but I cannot see a reason why.*

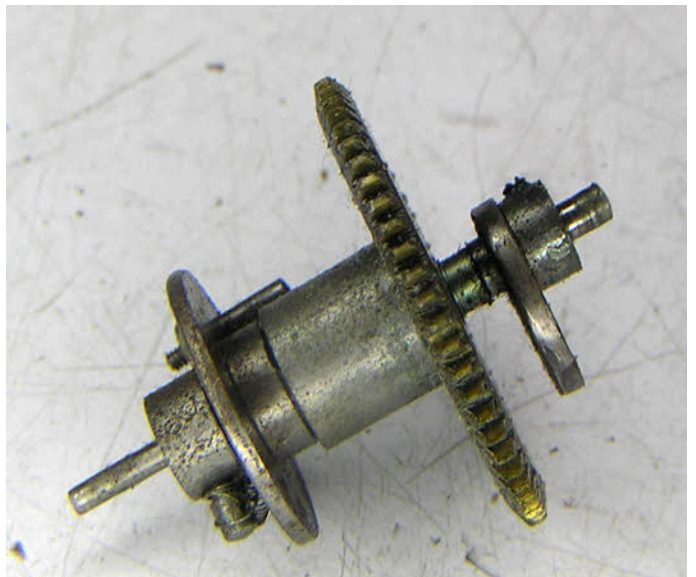
*The hammer lift arbour. The wheel is driven by the worm wheel on the motor arbour.*

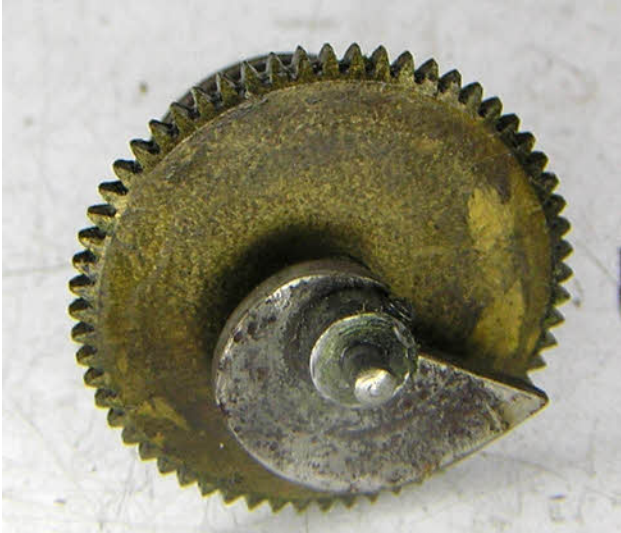
*Another view of the hammer lift arbour.*

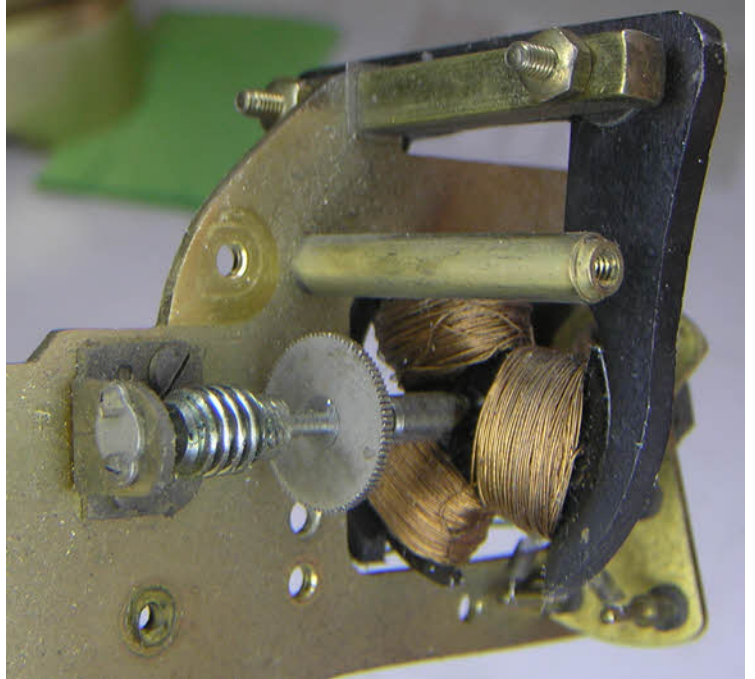
*The motor arbour. (above and left) The steel ratchet wheel is redundant as the ratchet pawl has been disconnected and removed This is the same on three striking mechanisms I have seen. I guess it was originally there to make sure the motor could not be reversed. But may have worn to quickly and became ineffective.*

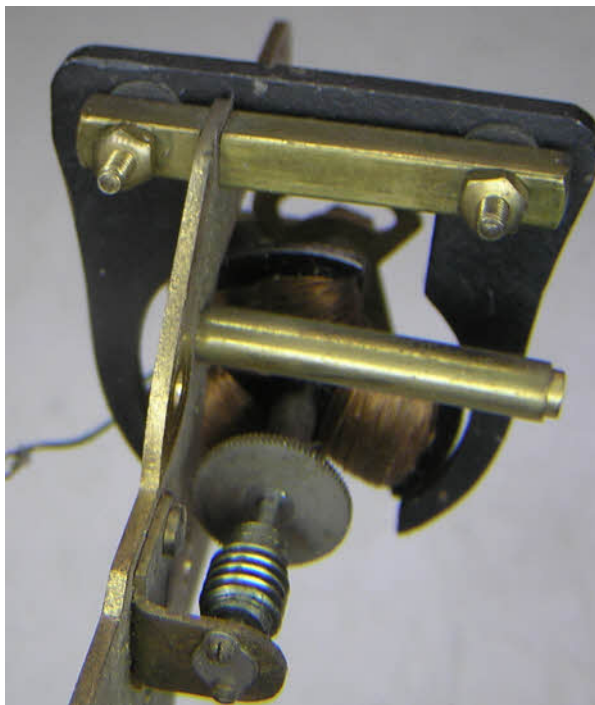
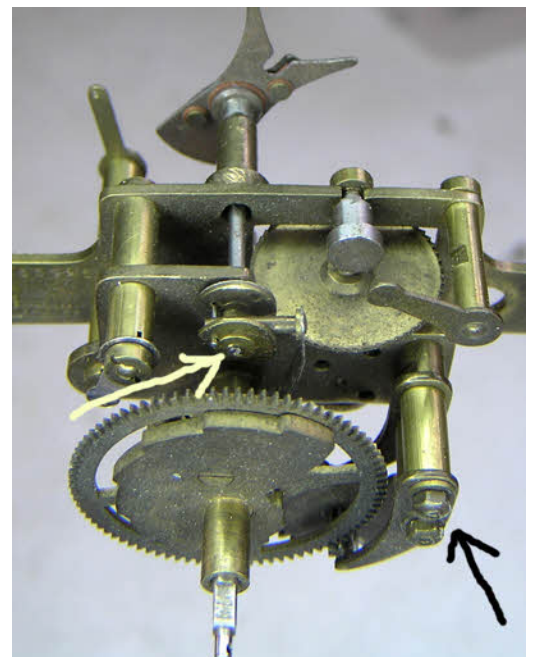
*The photo on the right shows the broken fork arbour and the extra parts needed to hold the intermediate motion wheel that carries the half hour and hour lifting pins.*

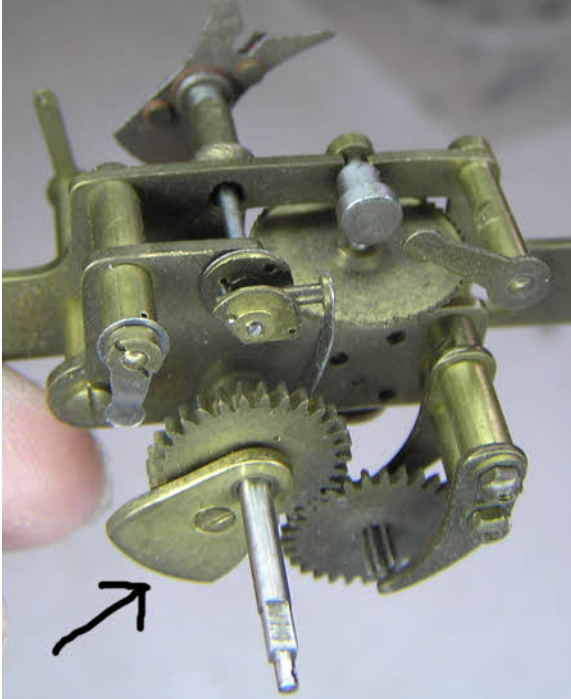
*The rack arm has a second extension at the rear which falls onto this brass section for half hour striking. It limits the fall of the rack so that the hammer strikes only once.*

*The photo on the right shows the two pillars that support the intermediate wheel. These pillars in conjunction with the small plates allow the intermediate wheel to be depthed in any position with the centre arbour.*

*The small washer shown is a spacer between the centre arbour and the half hour section arrowed above.*

*The two scratch marks seem to be markers for lining up the the intermediate wheel.*

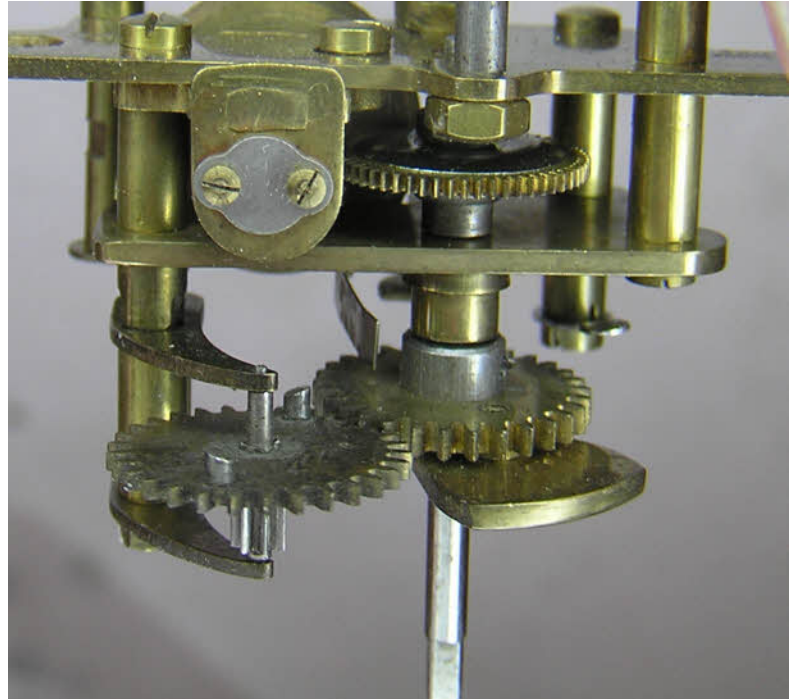
*The view from below showing the intermediate motion wheel.*

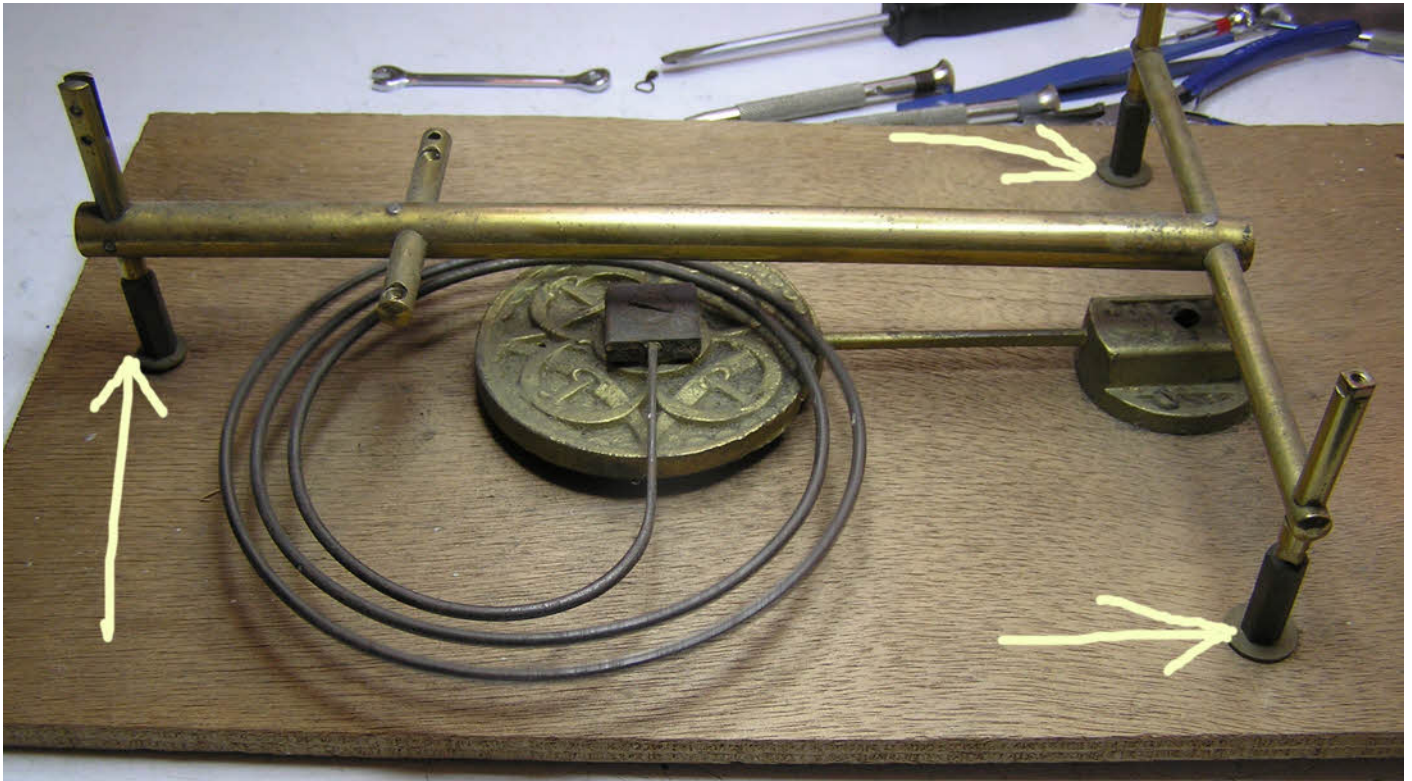
*These extensions do not look original being of hexagonal section and space the frame well away from the back board and gong frame.*

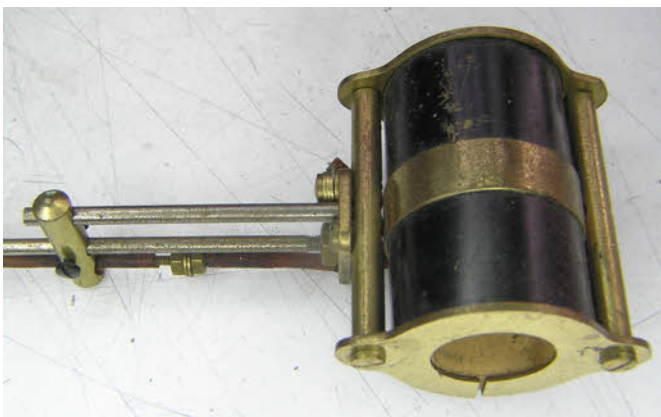
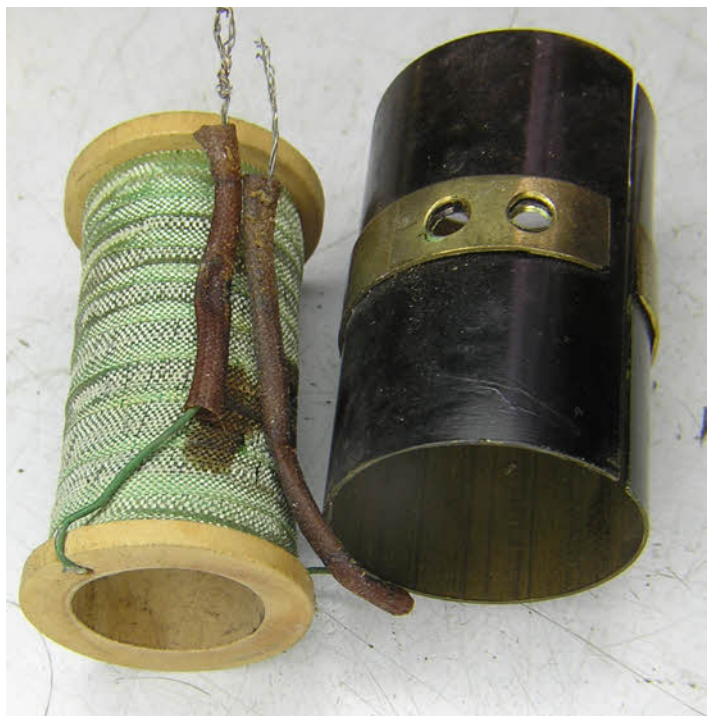
*These last two photos show the coil assembly . All the parts look original and untouched. The coil gives a respectable 1200 Ohms resistance.*

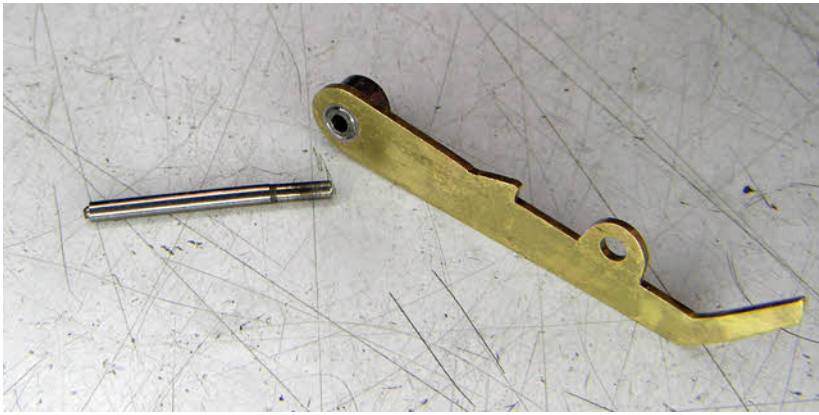
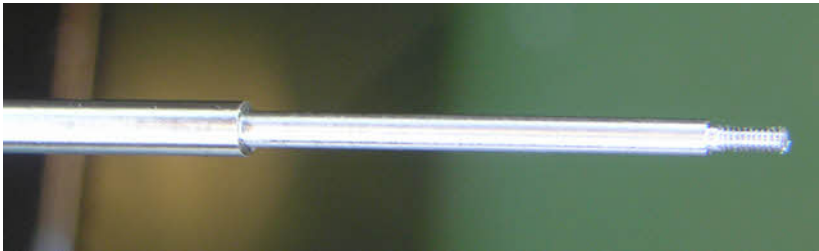
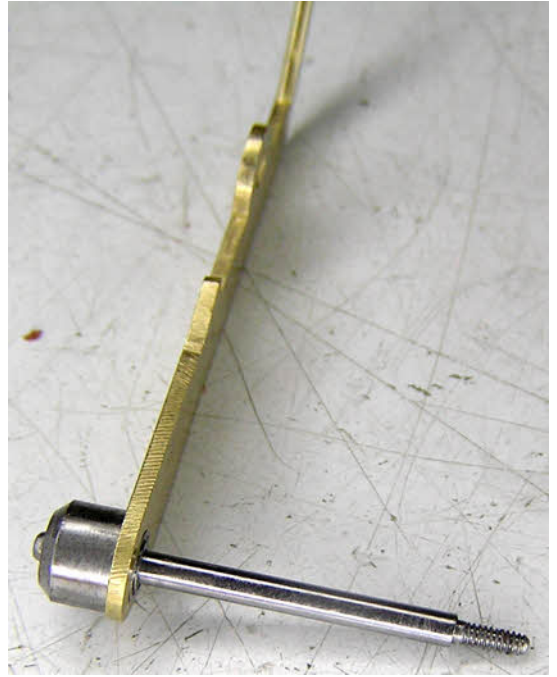
*This group of photos above show the damaged arbour and new replacement.*

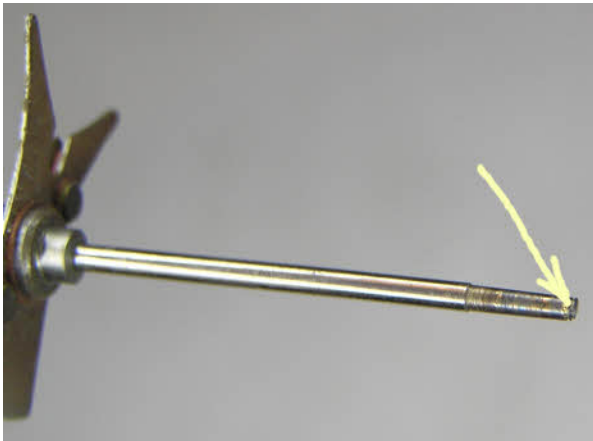
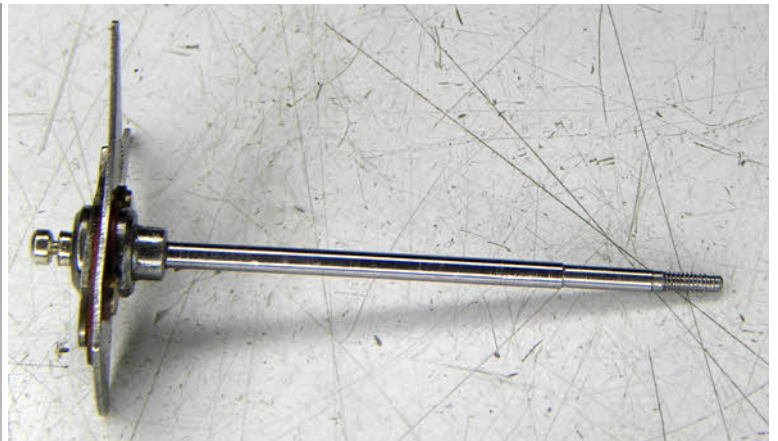
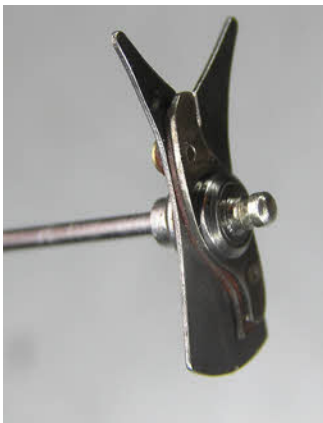
*Above and left are photos showing the broken fork arbour and its new replacement.*

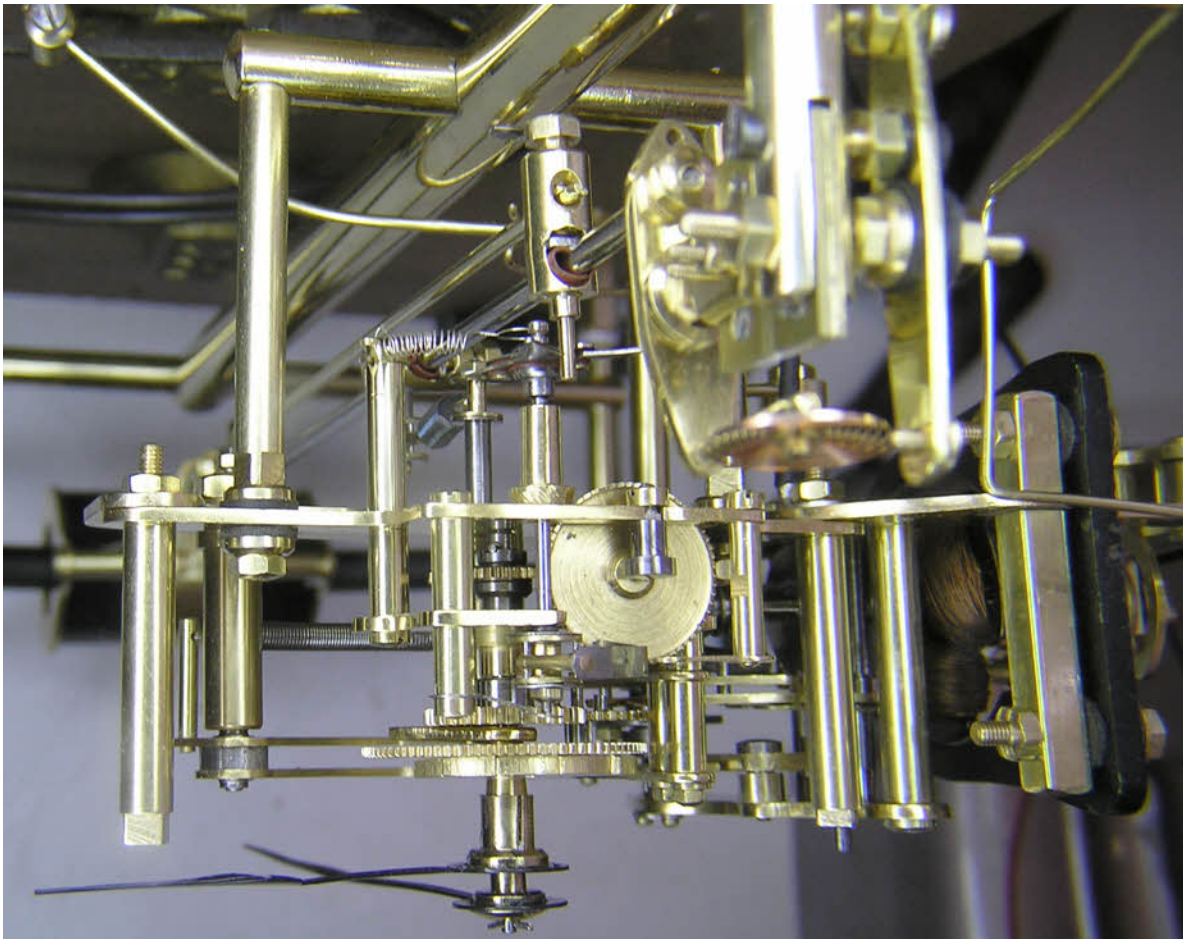
*View looking down on the clock. It may look complicated but remember that the both movement and striking assembly can easily be separated for testing.*

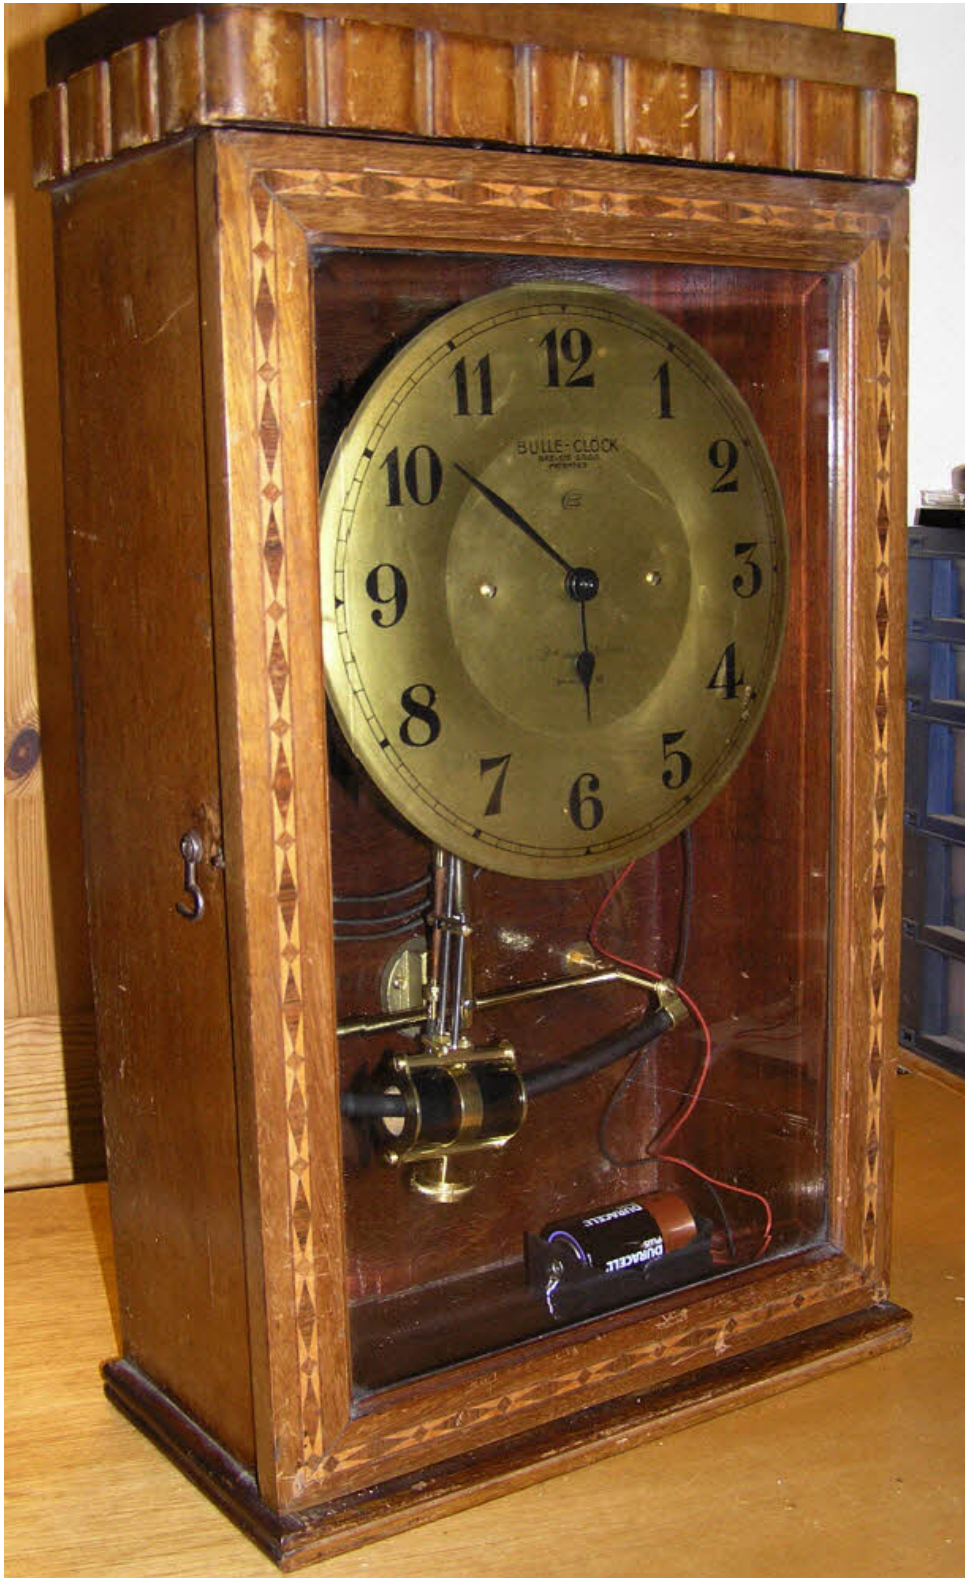
*The clock nearly completed. The case is a replacement but is exactly the type in which this particular striking movement was originally housed in. See the 1925 Bulle catalogue, [page 13, type B9](#). The only problem is the missing bottom section which housed the battery and hands. A new pair of hands is being manufactured and I will add a photo of the completed clock when they are ready. The owner intends to have the case restored at a later date*
