Bulle Clock Serial Number 258493.

A short movement clockette, s/n 258493. The case is a four glass design with wood base and top and four pillars of brass. The top has been retained by the owner to reduce possible damage in transit. The clock appears to be in good condition although it does not work at all on a 1.5 volt battery.

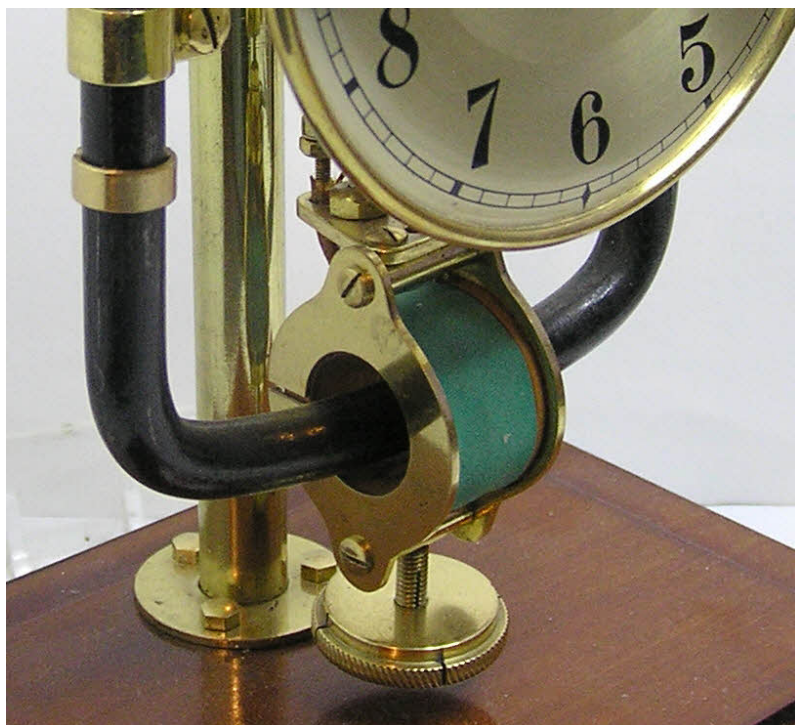
The other odd point about this clock is the pendulum coil assembly. On a clockette that has the pendulum visible under a dome or four glass case etc, the coil would normally be covered with a black painted brass shell to make it more appealing to the eye. This example has the type of assembly normally associated with an enclosed case where the swinging pendulum would not be visible. The coil cover would then not be important and manufacturing costs could be lowered by not encasing it. The coil would therefore be bound in green silk ribbon. This clock has had the ribbon replaced by a piece of green material. It may be that, given the replacement magnet collars and the coil cover, this movement may not have started with this case.

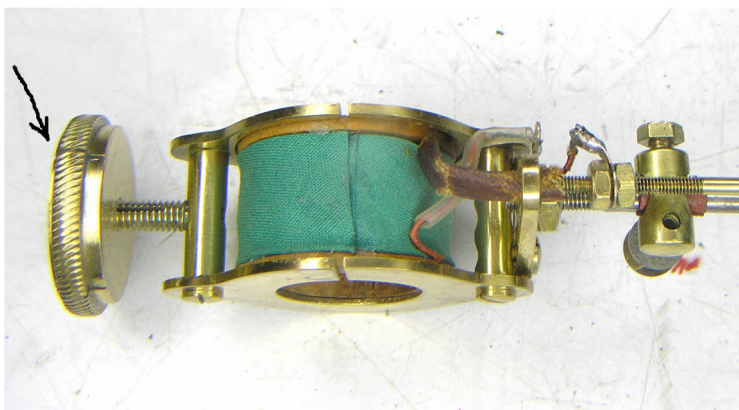
These last two photos show the hollowed out rating nut. This has been done to lighten it and in effect shorten the pendulum, thereby speeding up the clock. There is never a case for doing this. If the clock is slow and cannot be speeded up by raising the nut then obviously something else is wrong. This nut will be replaced.

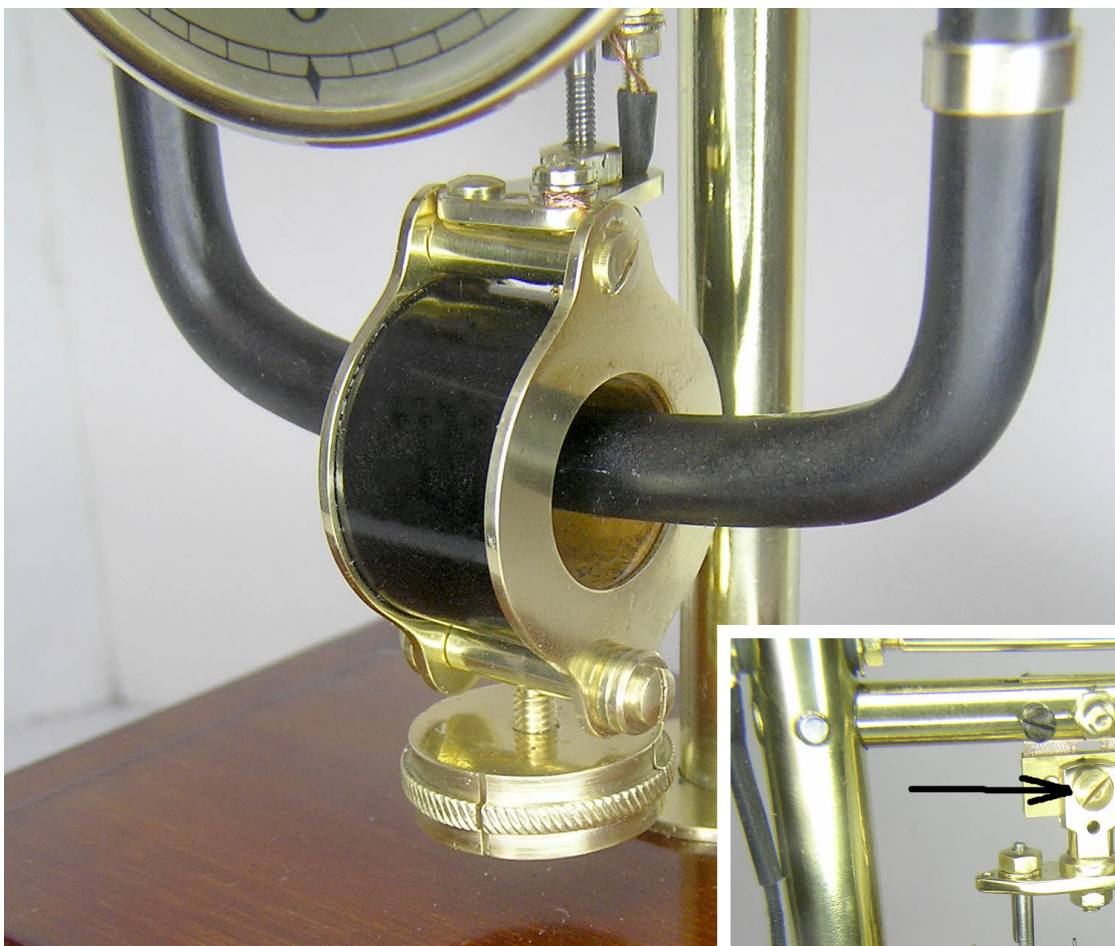
The new rating nut and coil shell.

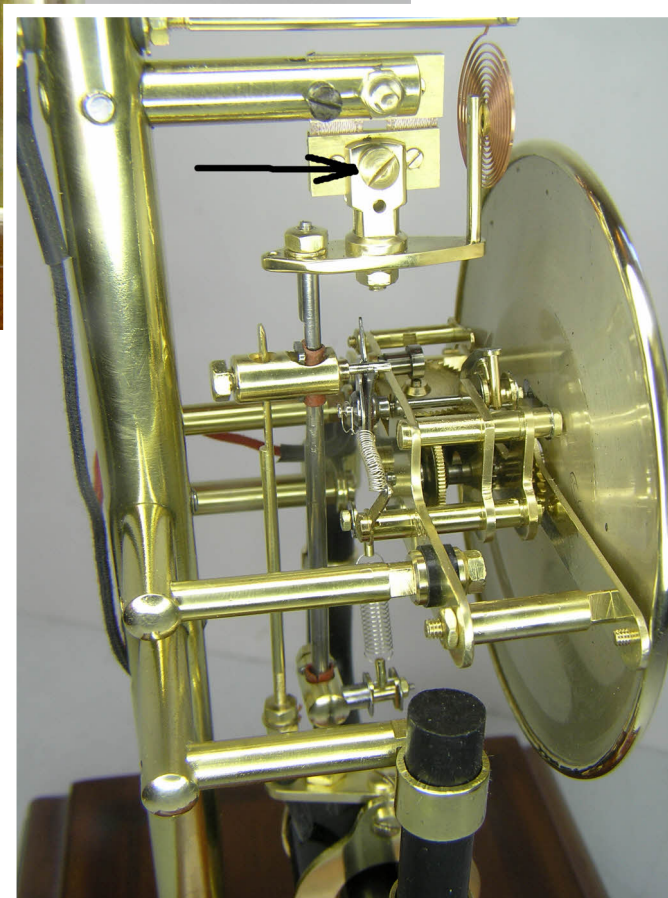
The clock on test. The arrow shows the lower suspension assembly and the washer removed. This allows freedom for the pendulum to swing forward and back to find it's own level. The top assembly in contrast should be tight and positioned such that the pendulum swings easily and does not wobble and touch the magnet.

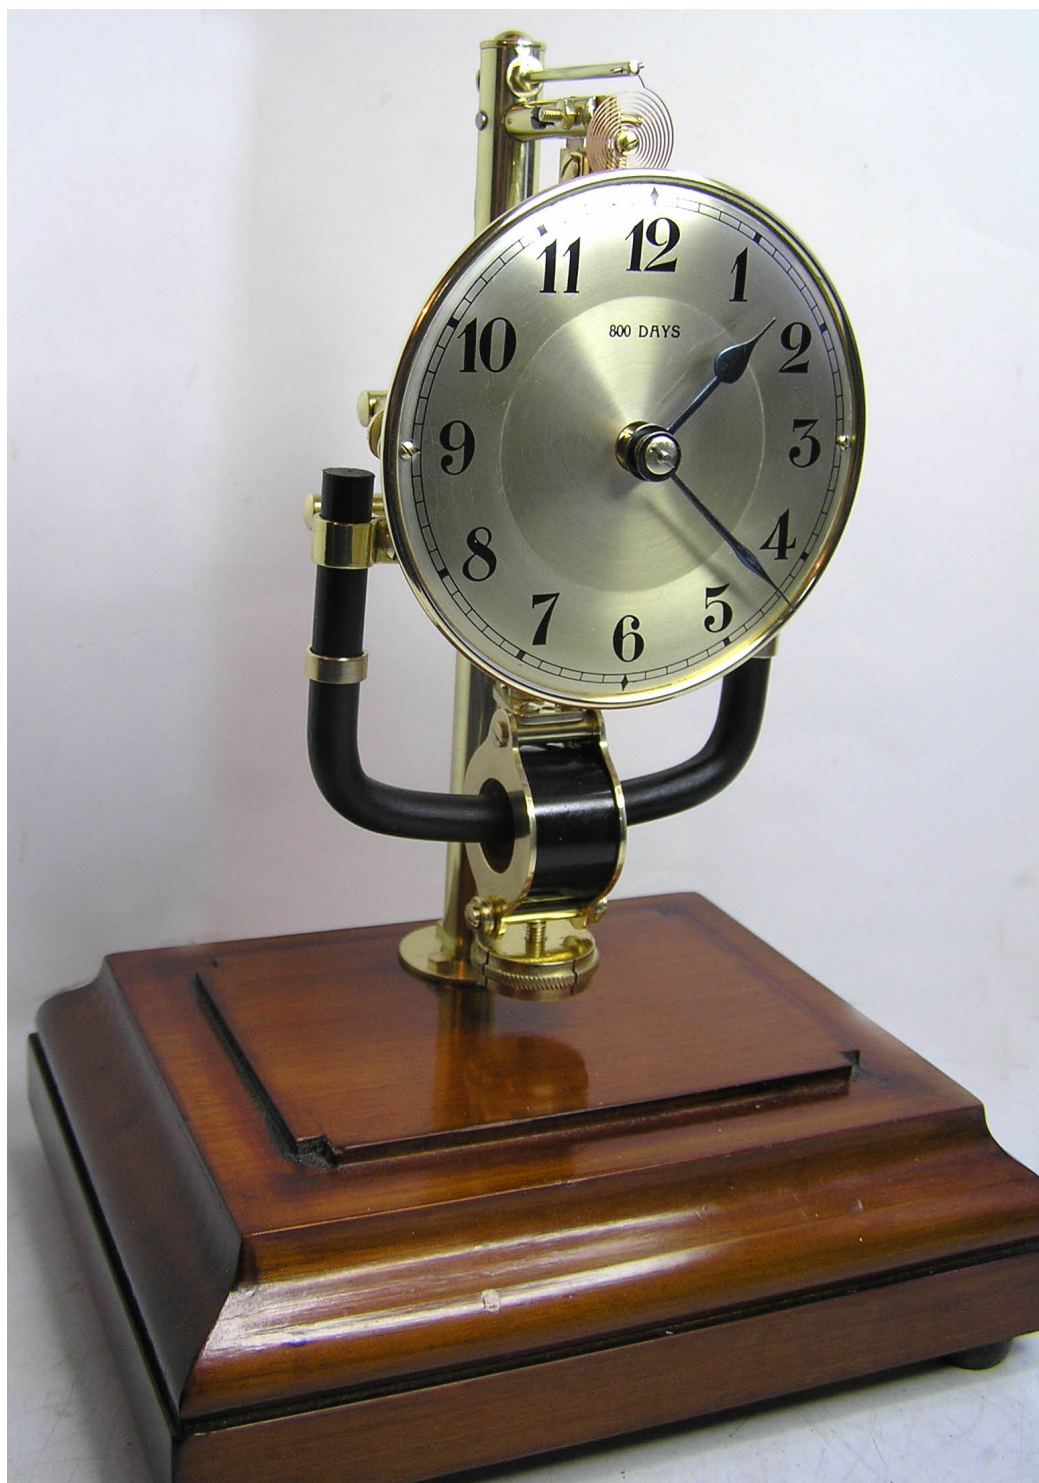
The completed clock.
