**Bulle Clock Serial Number 26443**

*Restoration of Bulle Clock  
Serial Number 26443*

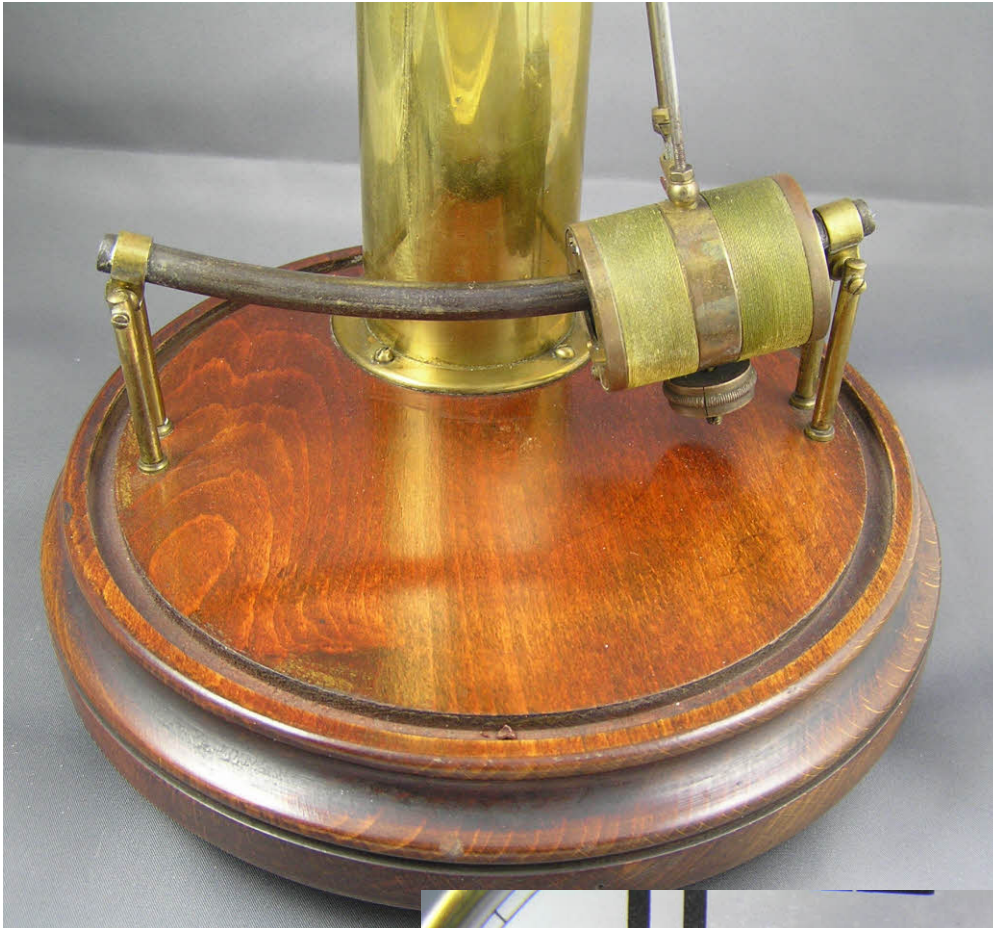
*The base shows some in-grained dirt around the waist but this will easily be removed with a good wax polish and some elbow grease*

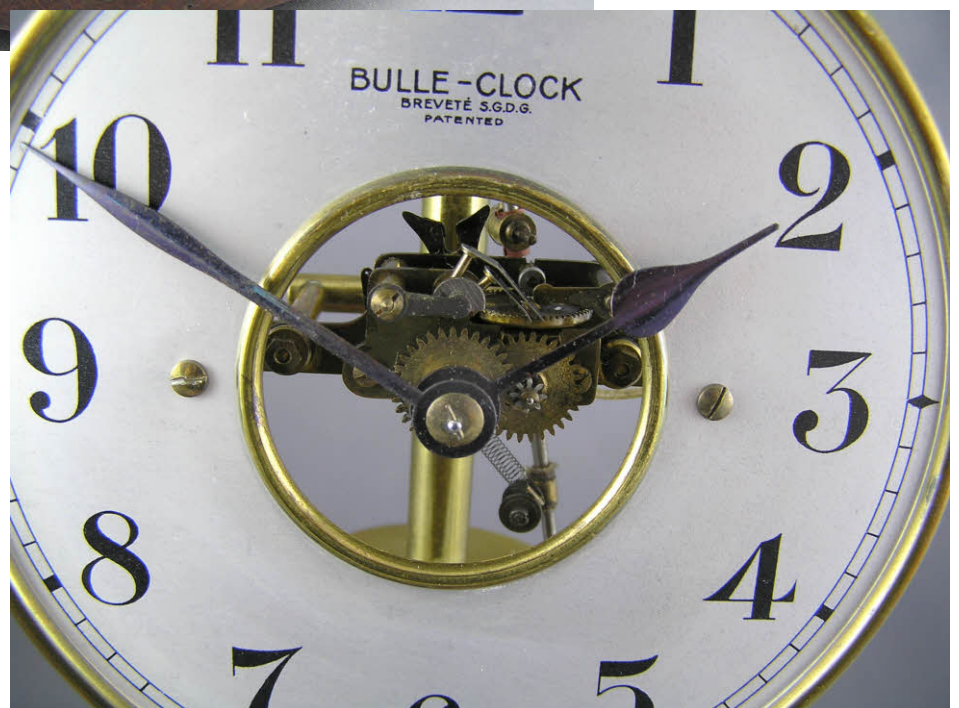
*The dial in good condition, but the movement looks quite dirty and oily. The hands are fine and will need to light waxing.*

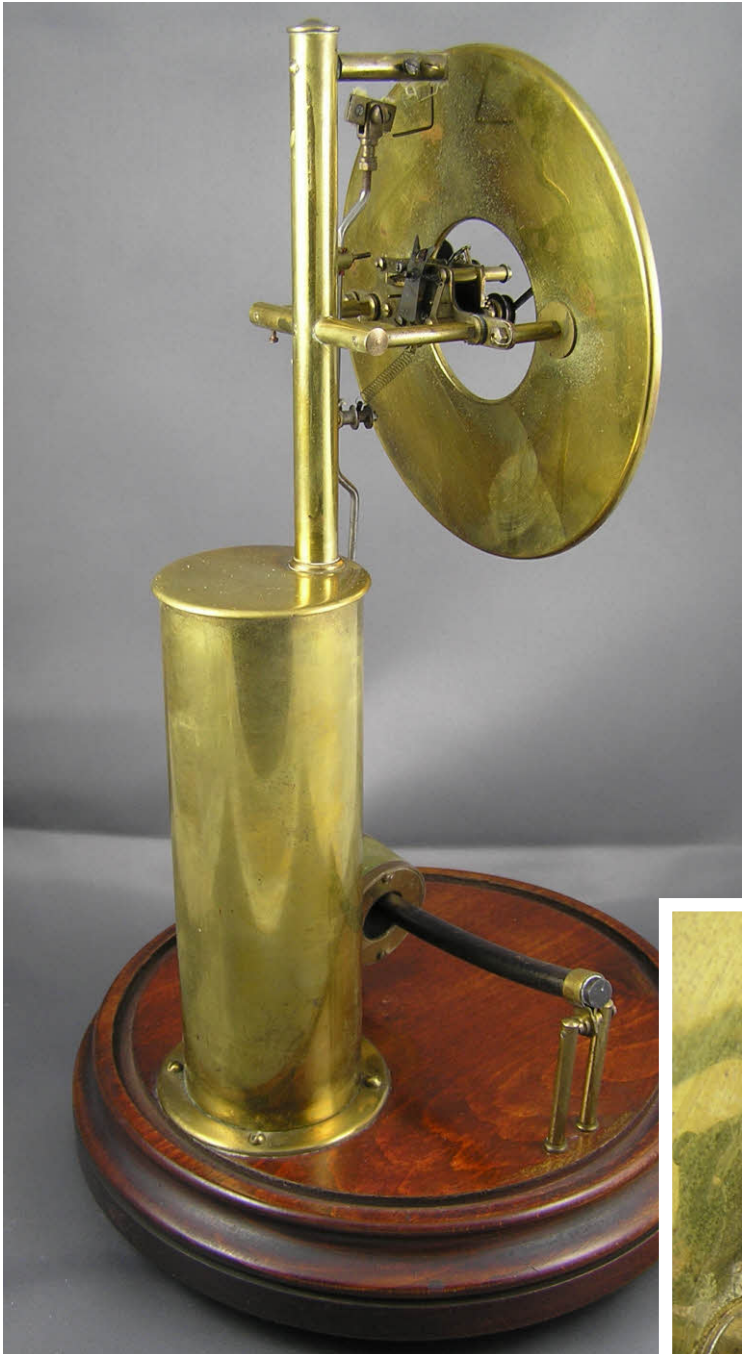
*The clock from the rear shows no major distress to the brass tube as may usually be expected from battery corrosion. But there may still be some evidence on the inside.*

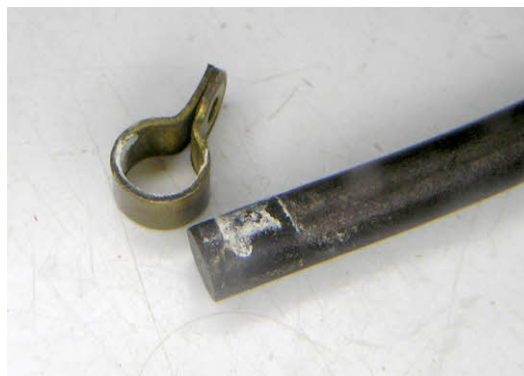
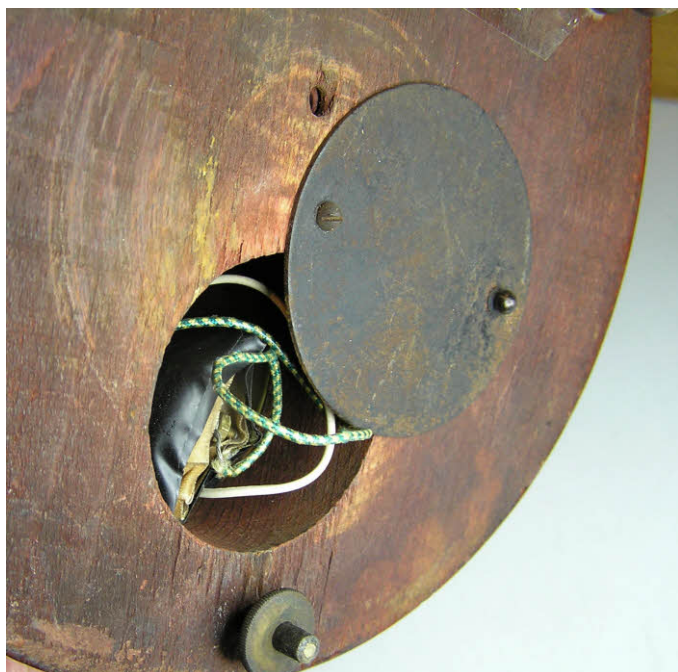
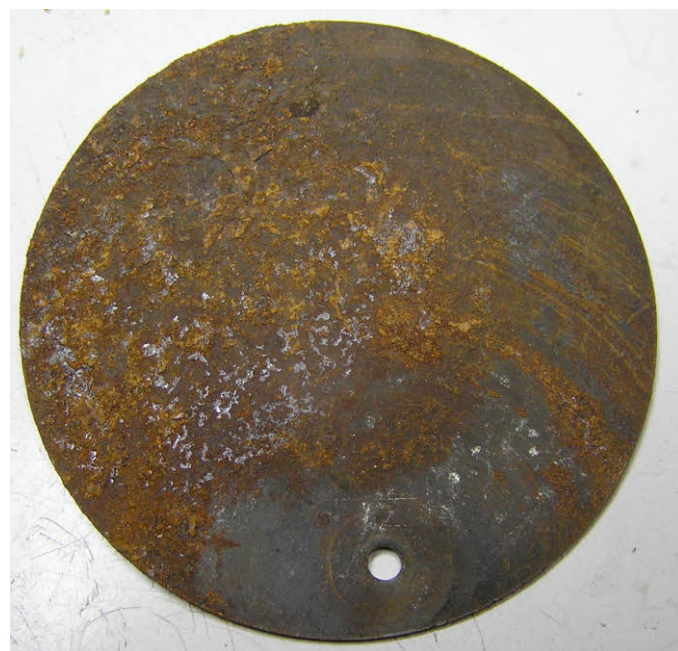
The photos above and to the left show the battery cover under the base. It is corroded from battery acid and will need to be stripped and cleaned before a coat or two of paint.

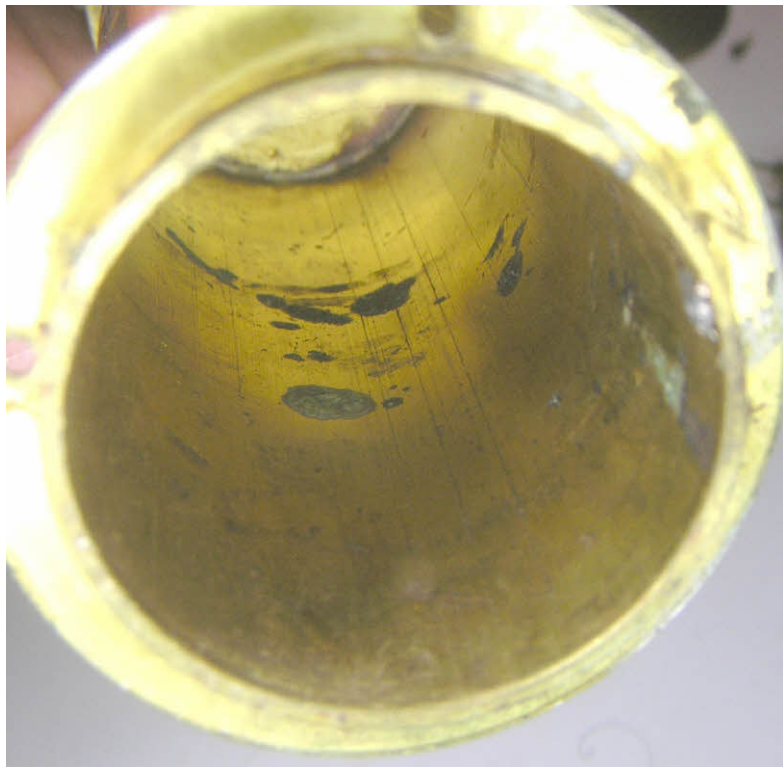
*The inside of the battery tube shows some signs of battery acid corrosion although it doesn't seem to have eaten it's way to the outside yet. This will be cleaned and neutralised.*

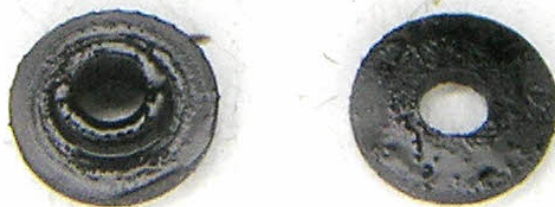
*The insulating washers show that the clock has been well oiled in the past. This was also manifest in the fibre of the fork. This will need to be cleaned and dried out. The Bulle clock should not be oiled at all.*

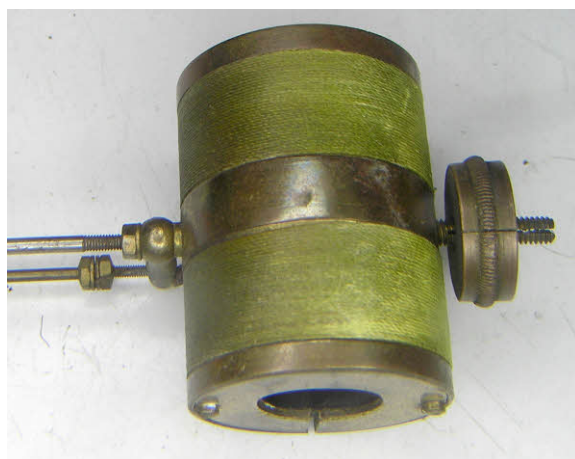
*Although the cord around the bob is discoloured in a few places, the owner of the clock would like to try and keep it in situ. We will try and accommodate this, but if the cord is too fragile it will disintegrate quickly if roughly handled especially after corrosive effect of the Brasso cleaner.*

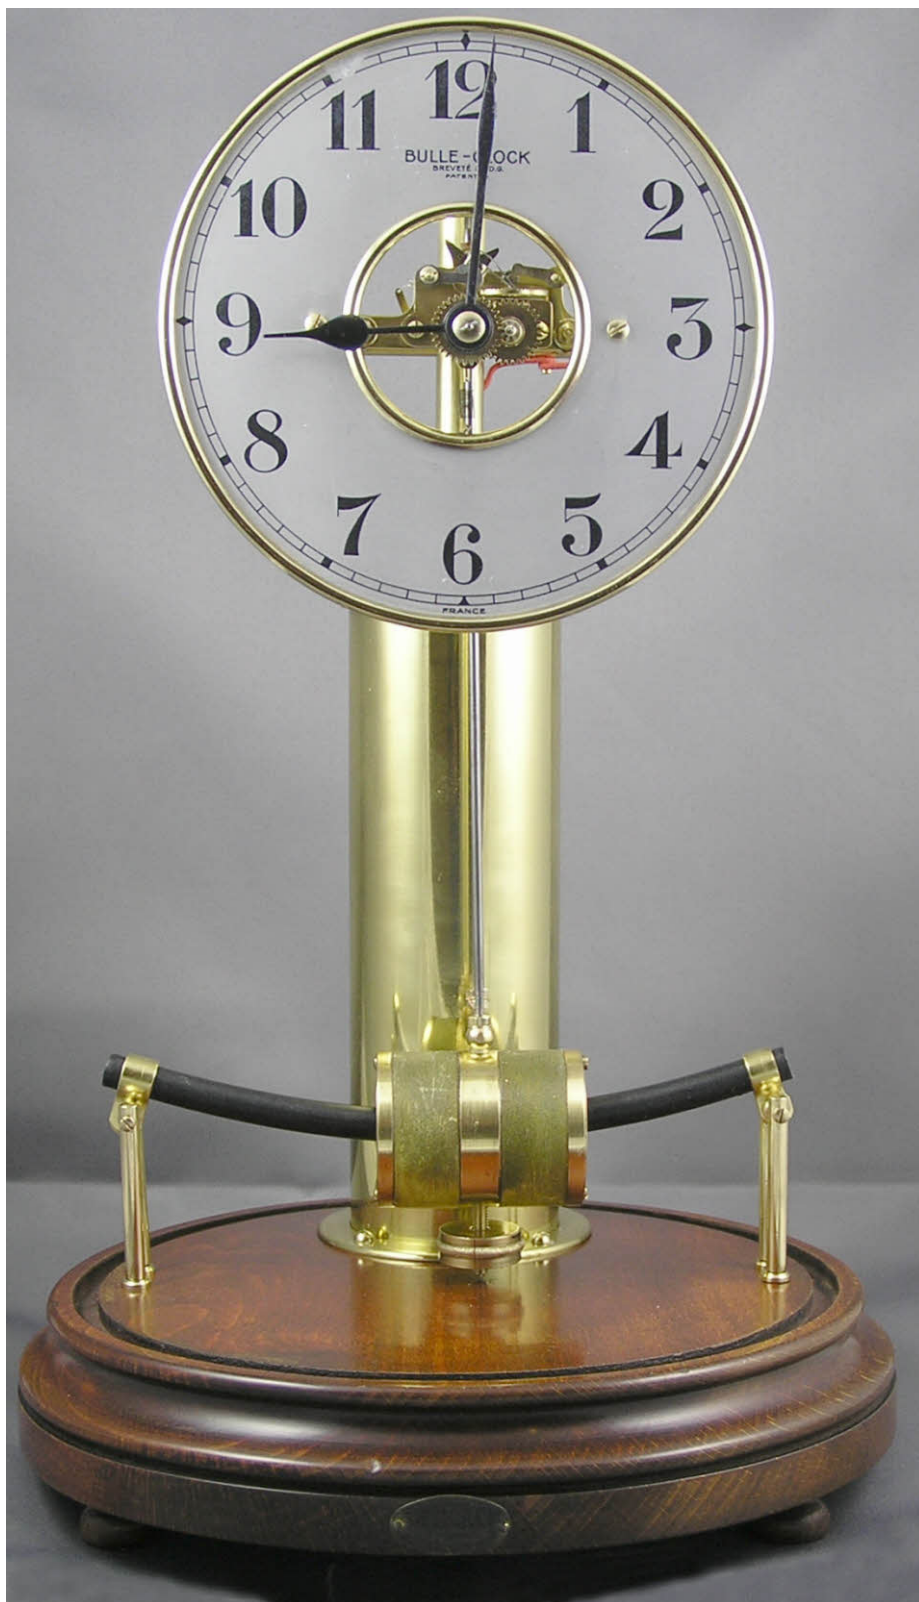
*The completed clock on test.*
