Bulle Clock Serial Number 265148

Restoration of Bulle Clock Serial Number 265148

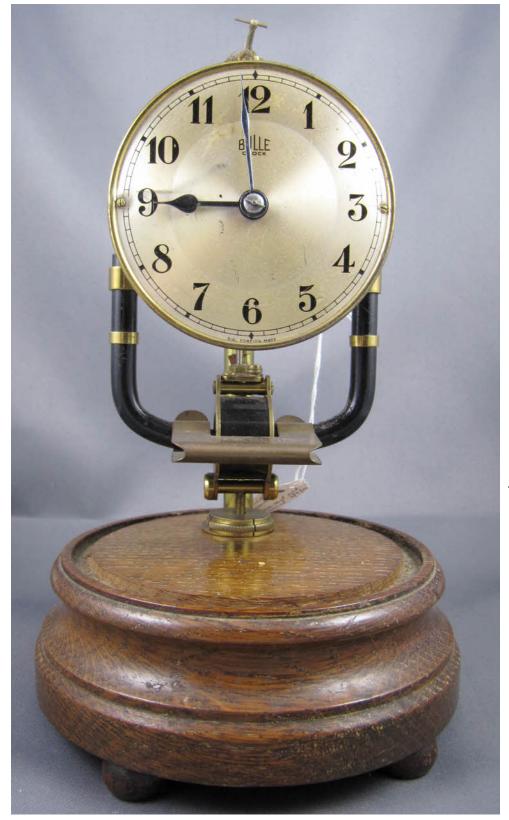
This clockette sits on a round Oak base under a glass dome (not supplied). The nice addition to this one that you don't often see is the magnet retainer clamp that originally came with all these clockettes. It keeps the pendulum in place while in transit.

The rest of the clock looks reasonable at this stage with no major damage or repairs.

There is a problem though with the dial as will be seen on the following page.

The oak base will need just a good wax polishing..

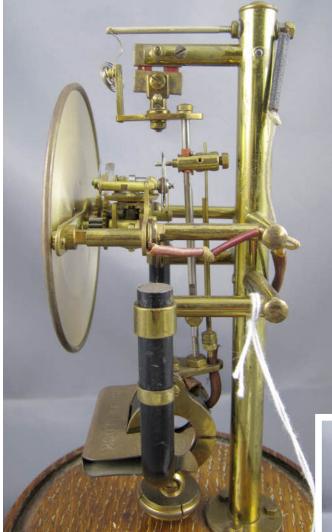
A side view of the clock

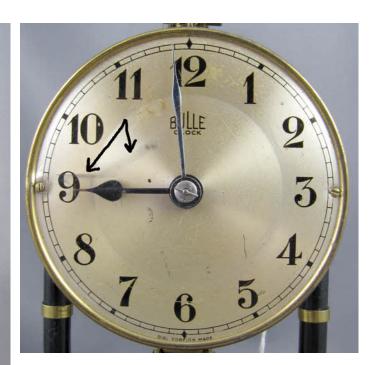
The dial has a buckle shown by the arrows. There's not much that can be done about this and it will be left as is. Once the brass is cleaned though it will look better.

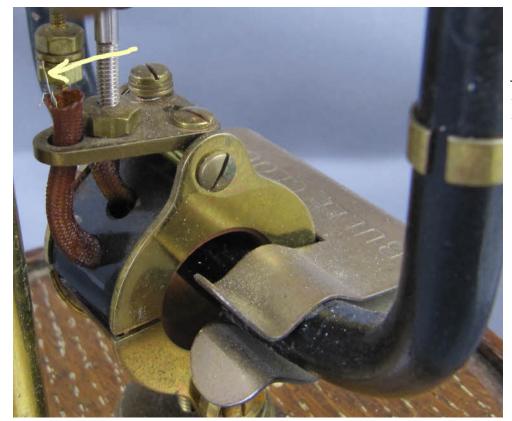
A view of the rear of the coil showing the single strand of wire left carrying the current from the coil. Also note the pendulum clamp and how it positions around the magnet. The clamp is a good idea but does tend to scratch the magnet. It would have been nice if the base had a position underneath where the clamp could have been stored after transit. Ninety nine percent of them goe missing once the clock is is use.

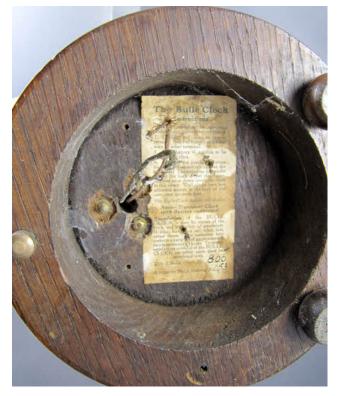
At left is the underside of the base with the label still in position.

Although well made the arbour carrying the current to the hair spring is a replacement and made of steel. This will be replaced with a new one in brass turned up on the lathe. Note the hair spring will also need replacing.

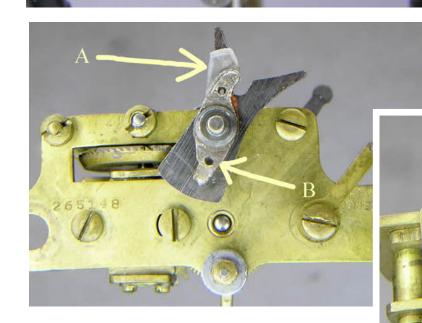
The movement from the front. Nothing much amiss here other than the badly positioned stop for the fork arbour. This should be in the three o'clock position acting as a stop to allow adjustment of the end play of the fork arbour.

Below left we see the terrible state of the fork which has been damaged. The rivets have been removed (B) and a piece of plastic added (A). This will have to be replaced.

On the right we see the underside of the movement. The arbour carrying the minute hand is arrowed and the following couple of photos show how it is assembled.

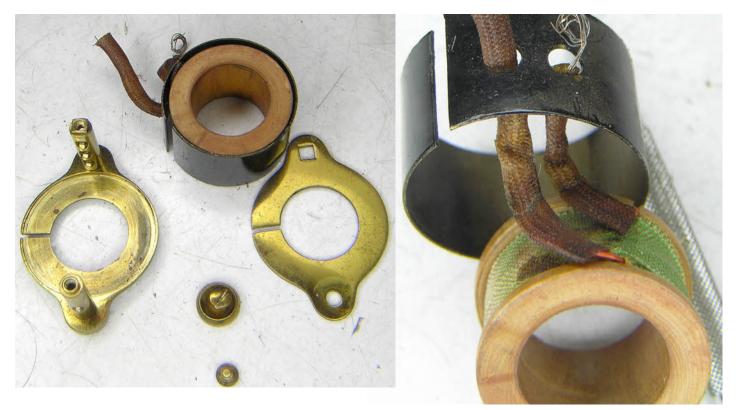
The minute arbour (centre arbour in mechanical clocks) is assembled with a spring steel friction disc retaining the brass wheel with a collar and pin. The disc is compressed and the pin removed.

These two photos show the coil in it's painted brass sleeve. The waxed insulation is dry and cracks easily. Sometimes you can get away with heating the insulation with a hair drier which softens the wax enough for the sleeve to be reused. Note also that the decorative dish washers are only used on the lower screws that hold the end caps in place.

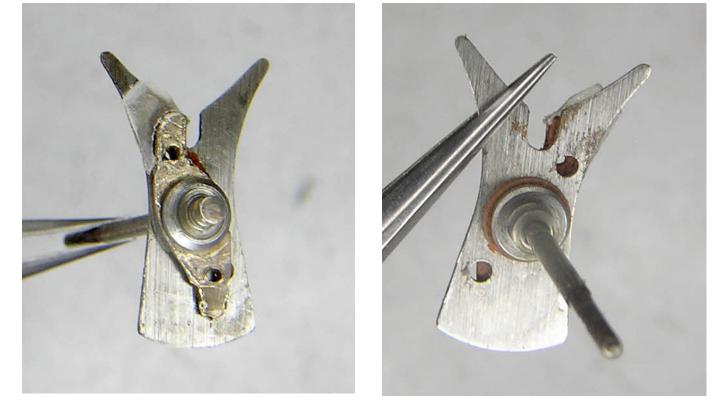
Here we see the detail of the damaged fork. The photo below shows the fork removed

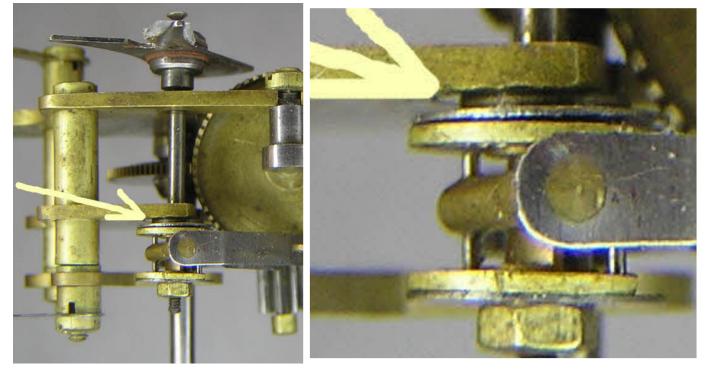
It is difficult to see in the photo above (magnified on the right) but there is a small washer that has been replaced with a large one behind the pawl bobbin. It should be much smaller and made of steel. It buts against a step in the fork arbour and should be about 2.0 mm in diameter. A new one has been manufactured and is show below.

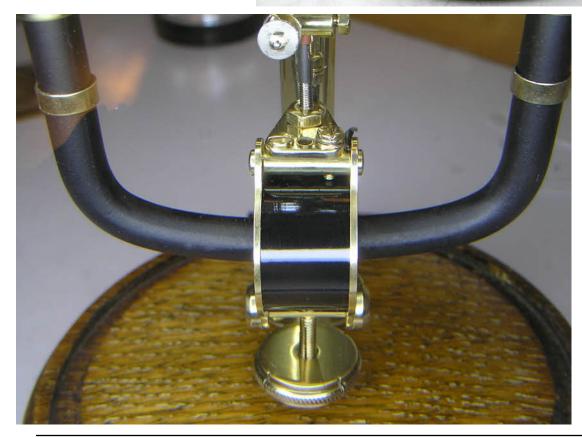
The base has been polished and the coil cover painted and back in place on the pendulum

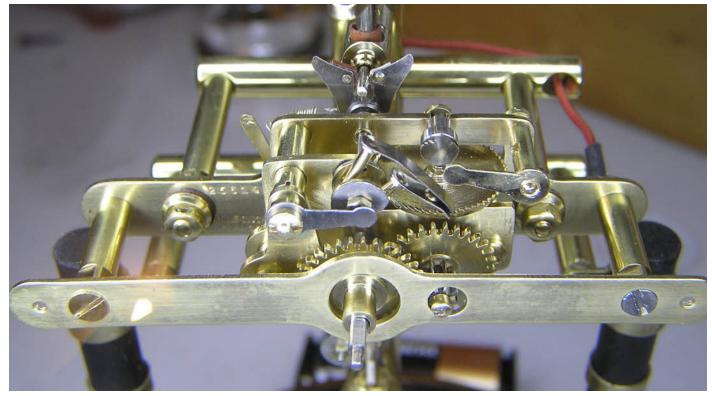
The movement cleaned and back in position. Note the position of the fork arbour stop.

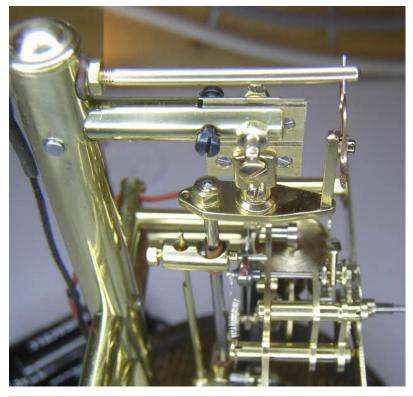
The new arbour carrying the current to the hair spring and the new spring itself.

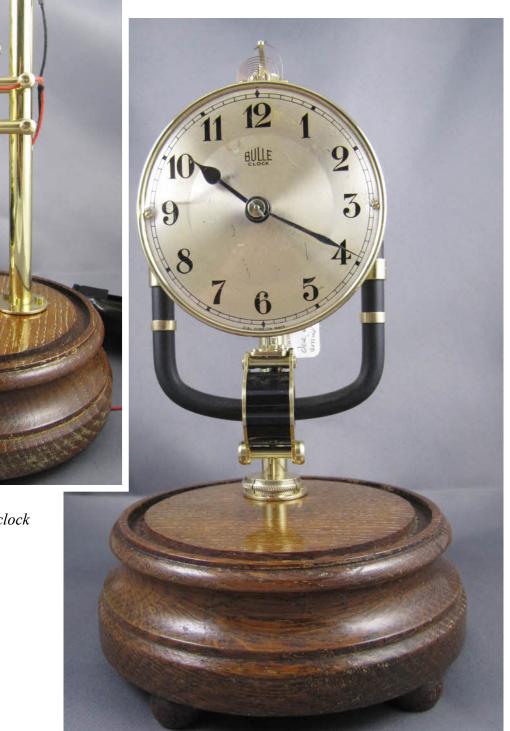
The finished clock.
