**Bulle Clock Serial Number 274481.**

*A Bulle Clockette on a round mahogany base with a rare pendulum spring steel retaining clamp. The base is in very good condition and will only need a polish with some good wax. The most obvious problems areas are the suspension and the battery compartment. The suspension will be replaced as per usual and the battery holder removed to reveal the Bulle label.*

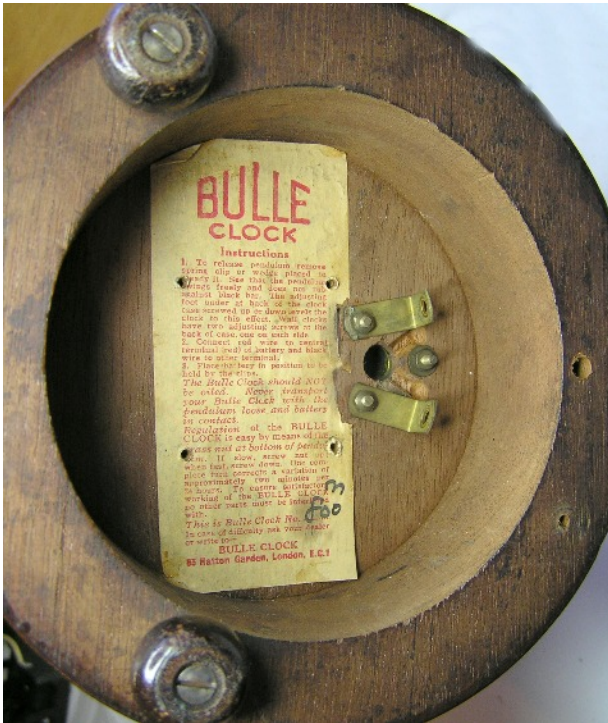
The photo above shows the battery compartment below the base with the carrier removed. The brass strips are also not original and will be removed,. The label can now be seen in full.
