Bulle Clock Serial Number 276016

*Restoration of Bulle Clock
Serial Number 276016*

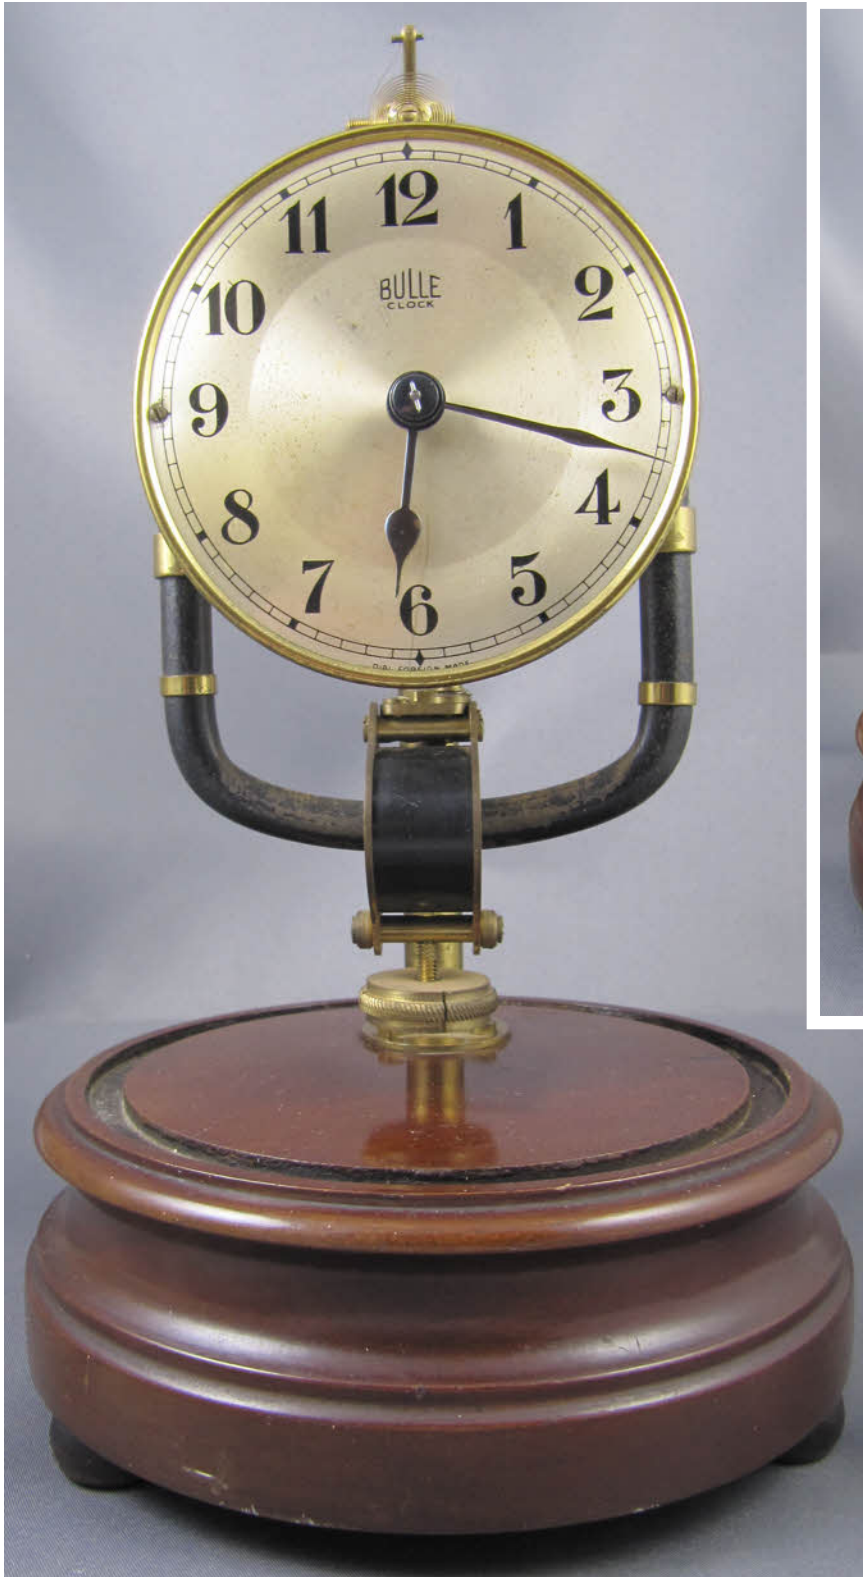
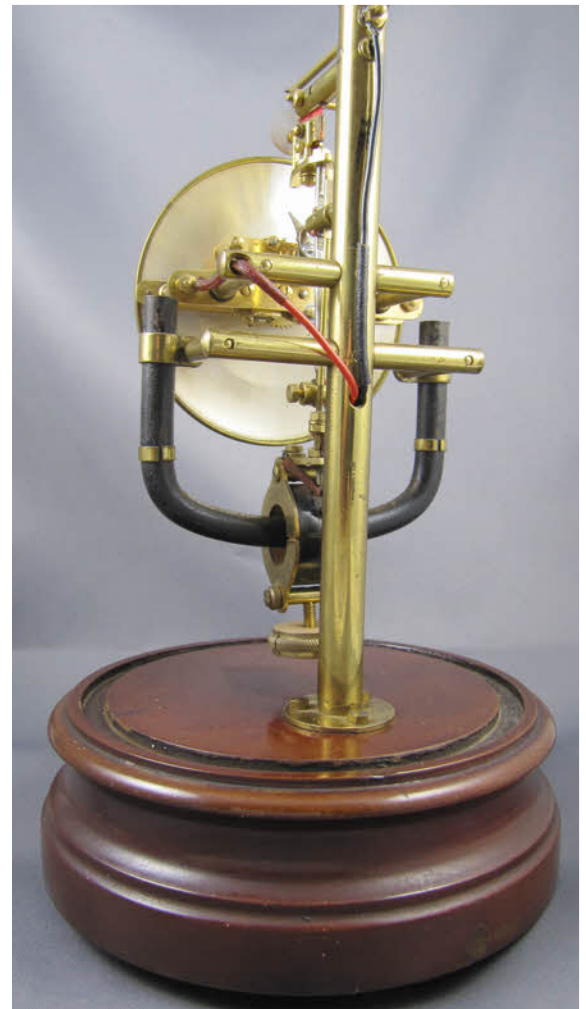
This clockette sits on a round mahogany base under a glass dome (not supplied). The dial and hands are in good condition as is the base. The magnet looks a little distressed with rust but it should clean up nicely and look good after a coat of grate black.

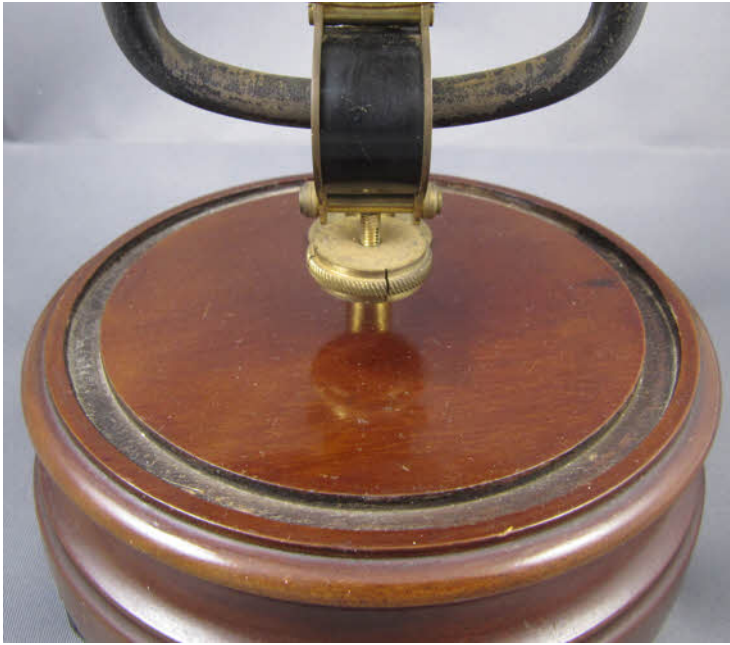
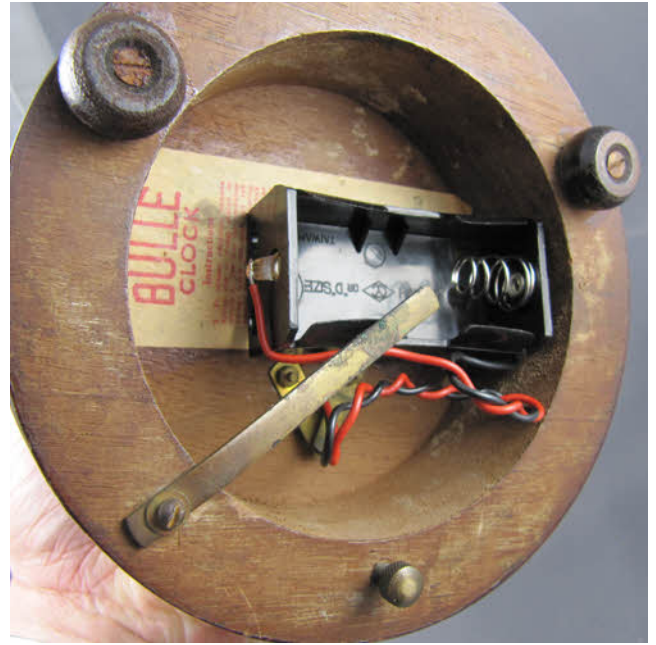
The photos above show the top and underside of the base which is in very good condition. It will only require a wax polish which should revive the existing finish to a nice sheen. There are no major chips or scratches. The underside retains its original label.

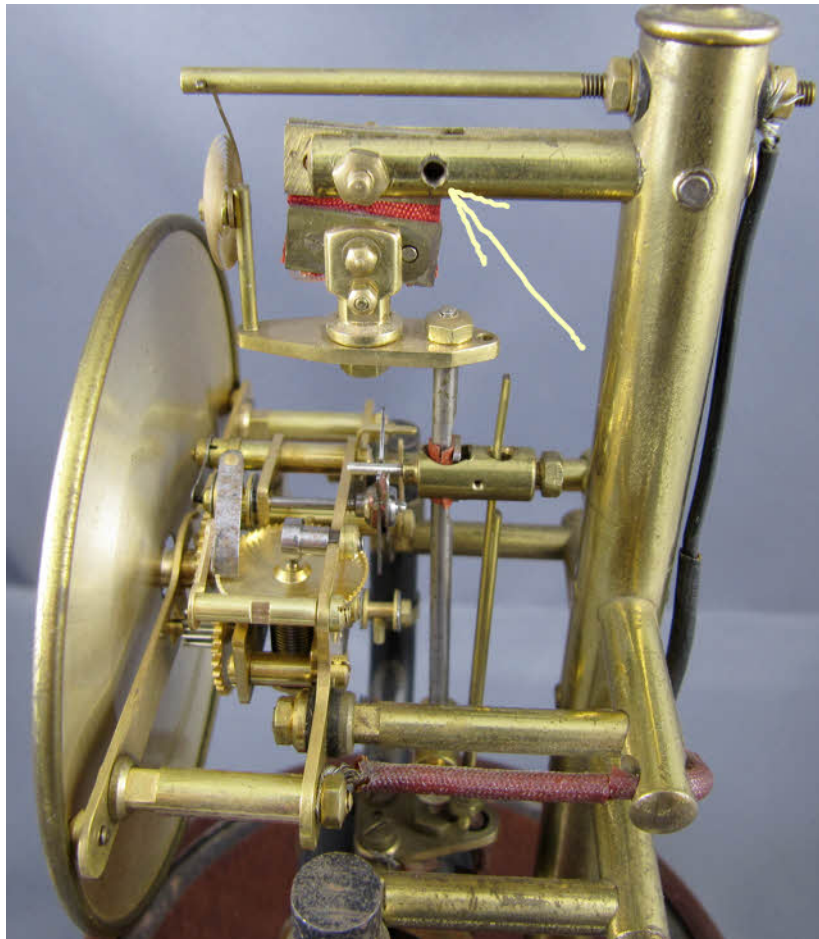
The photo on the left shows the movement and suspension. Note that the two blued steel suspension adjusting screws are missing and will need to be manufactured. The suspension itself will also need replacing.. The rest of the clock looks to be in good condition with no major damage or missing parts.

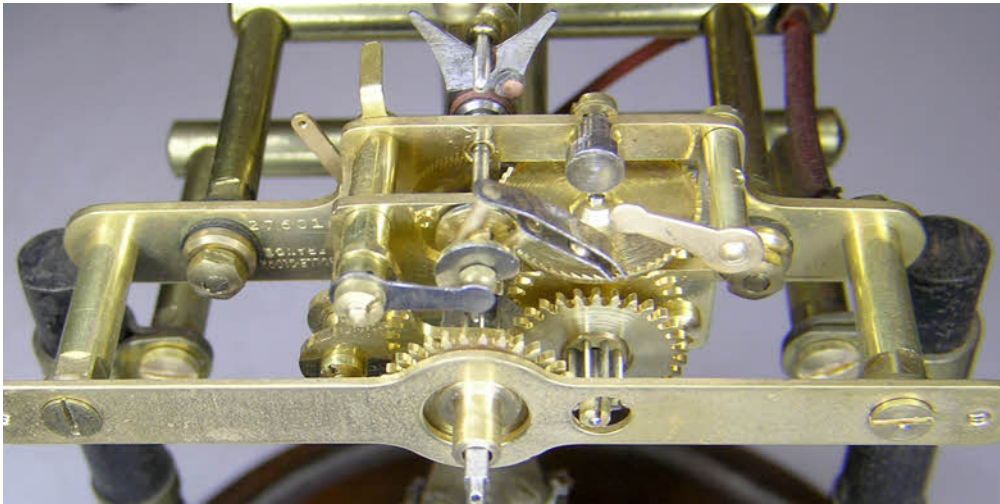
A shot of the front of the movement. All seems OK except for the missing silver contact spring

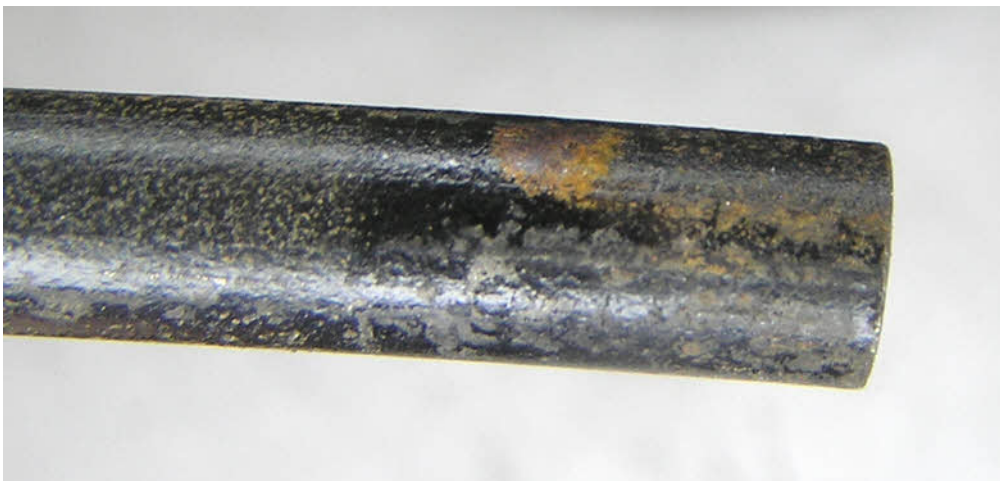
The magnet is just showing signs of rust which will easily be removed.

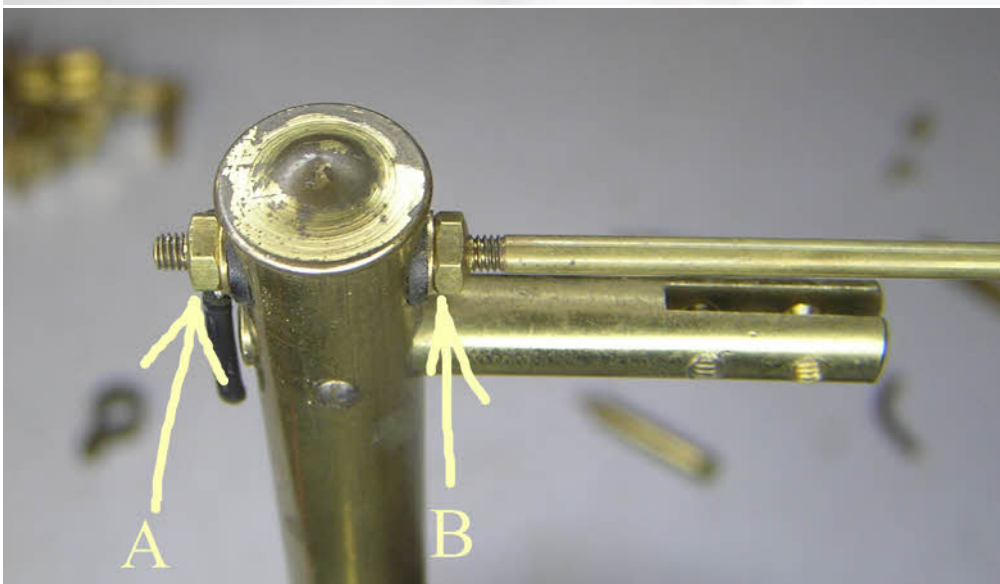
In this photo we see the standard method of retaining the arbour that carries the power to the hair spring over the pendulum. It is not satisfactory as it is impossible to tighten the nut (A) enough to grip the power wire from the battery without damaging the insulating washers through the column., It is better to have two nuts at (A), one which is tightened against (B) to hold the arbour and the other to tighten fully to hold the wire. (See later photo).

The photo above shows the extra nut (A) added that allows the power wire to be tightened against the second nut (B) instead of pulling against the nut (C) and damaging the insulating washers. This ensures a good electrical contact.

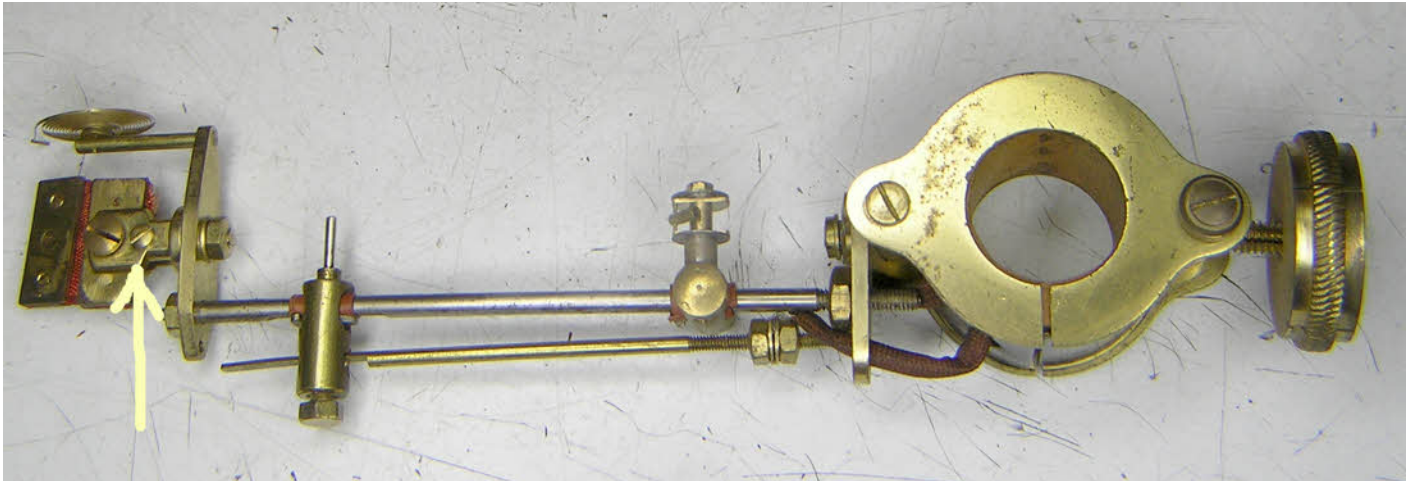
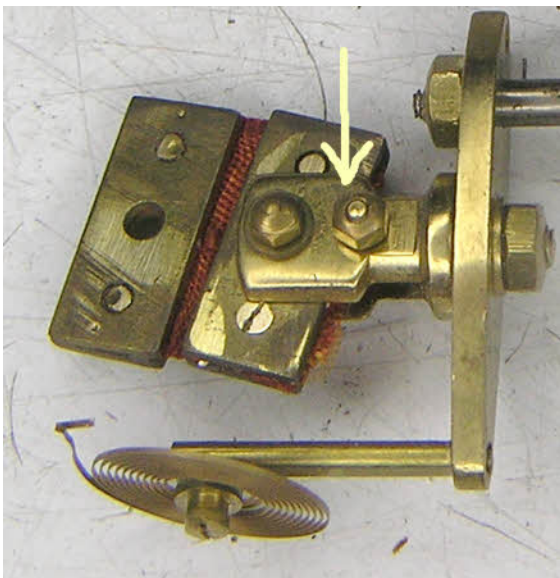
Above we see the full pendulum. It's interesting to note that some clockette pendulums have the extra screw and nut (arrowed) which exist to pull together the two cheeks of the lower suspension assembly. This was found to be necessary because if the cheeks were too loose and left a gap between the cheeks and the suspension itself then there was a tendency for the pendulum to twist as it oscillated side to side. The pendulum would then have a pronounced wiggle at one or both ends of its swing. The screw allowed the gap to be minimised and locked.

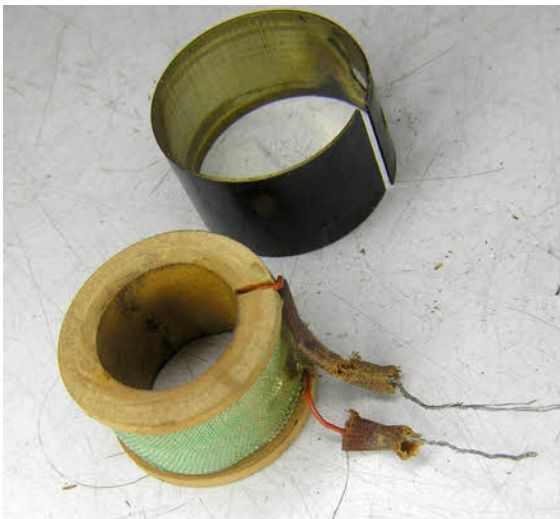
Here we see the coil with the damaged and weakened was insulating sleeves. These will be replaced. The coil though is in good condition reading 1190 Ohms.

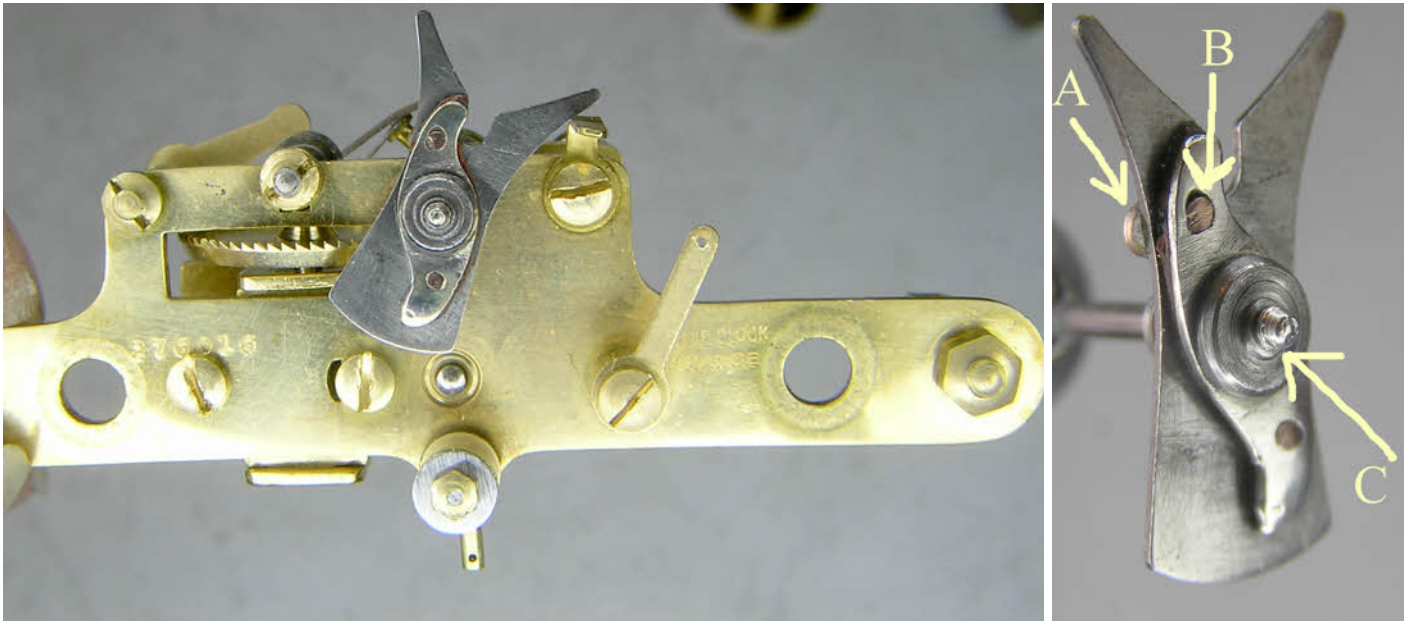
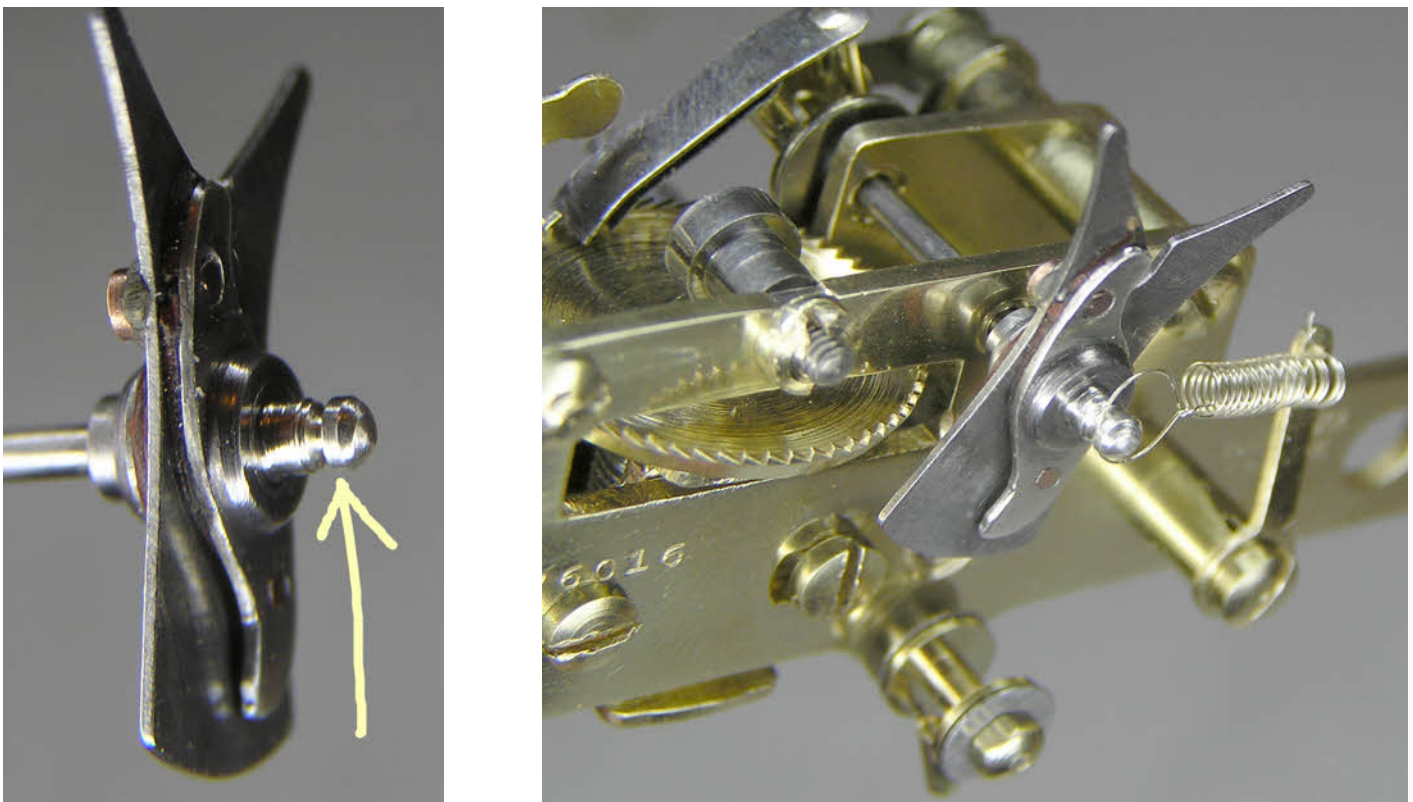
Above we see the fork arbour which has been repaired at some point. The repair itself is good and has been successful in that the silver is in good condition and is electrically sound. Note the copper rivets (A & B) which are not original but work well. But the silver contact at the end of the arbour which carries the loop of the contact spring is broken. This I have removed and replaced with new silver as shown below. Note how the groove in the silver accepts the loop in the wire for a rolling action.

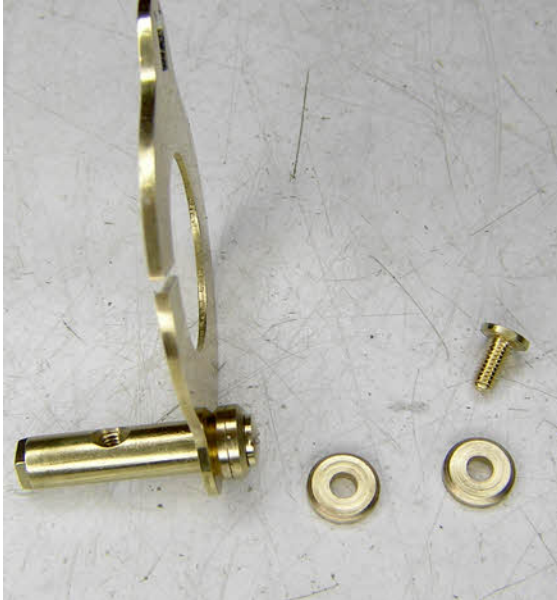
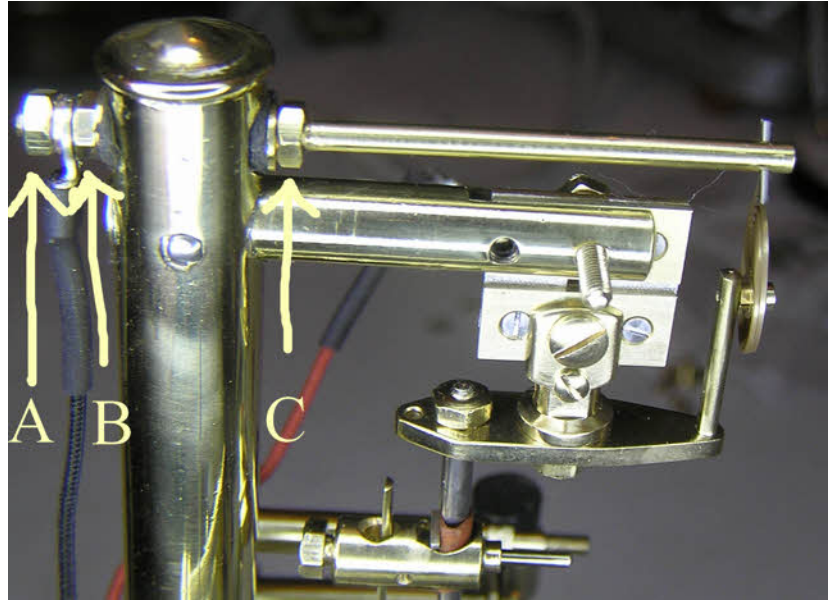
In this particular clock the decorative rings used for the two lower screws of the coil are in fact the same as the spacing washers used to space the movement with the insulating washers on the frame.

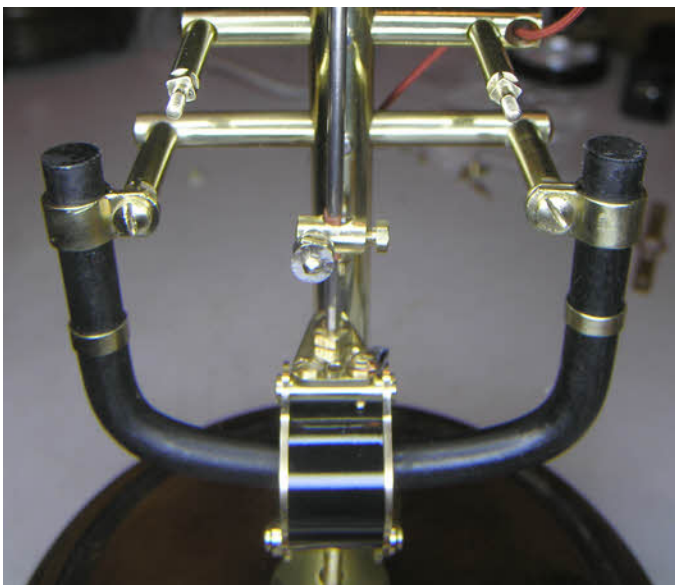
The pendulum re-assembled with the painted coil cover, back in place on the frame ready to accept the movement.

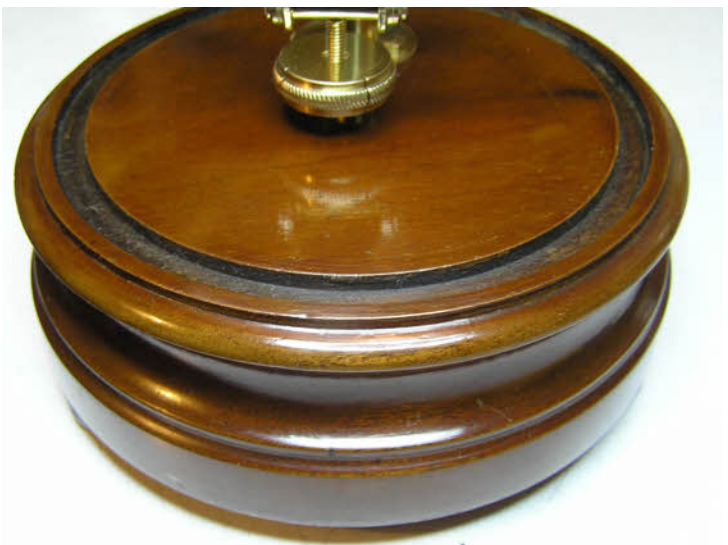
The base after a couple of minutes polishing with beeswax.

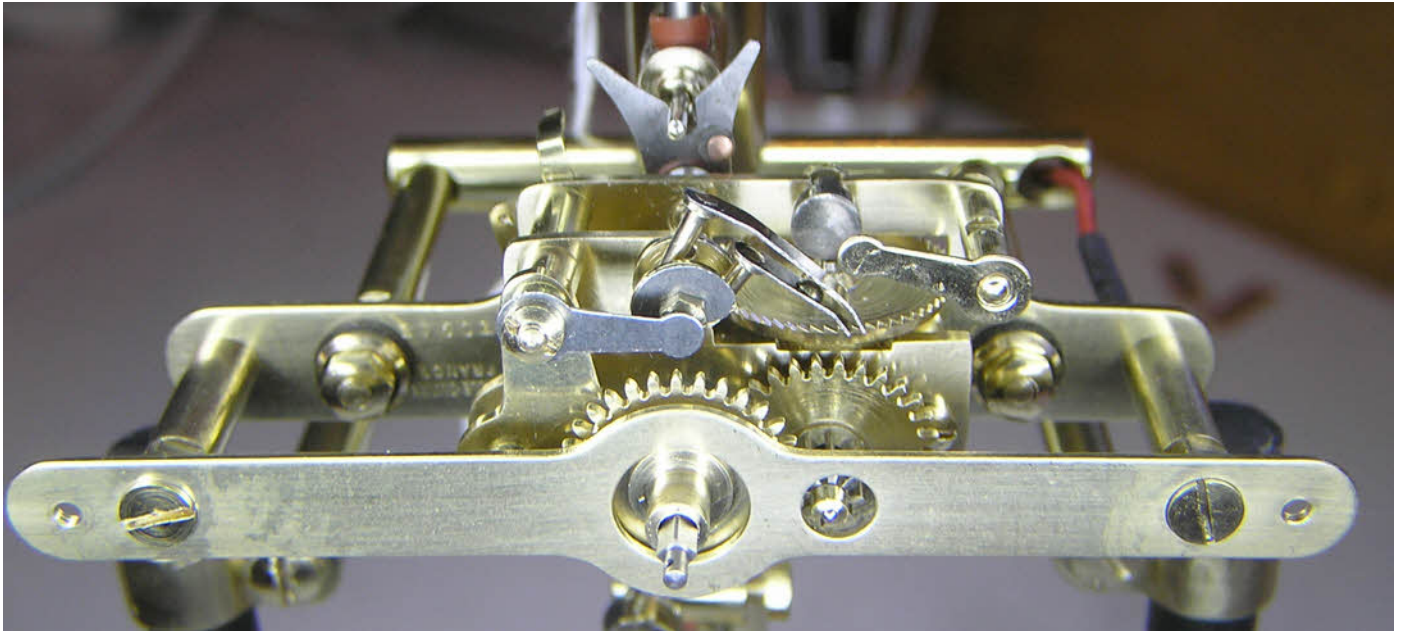
The movement cleaned and back in place on the frame.

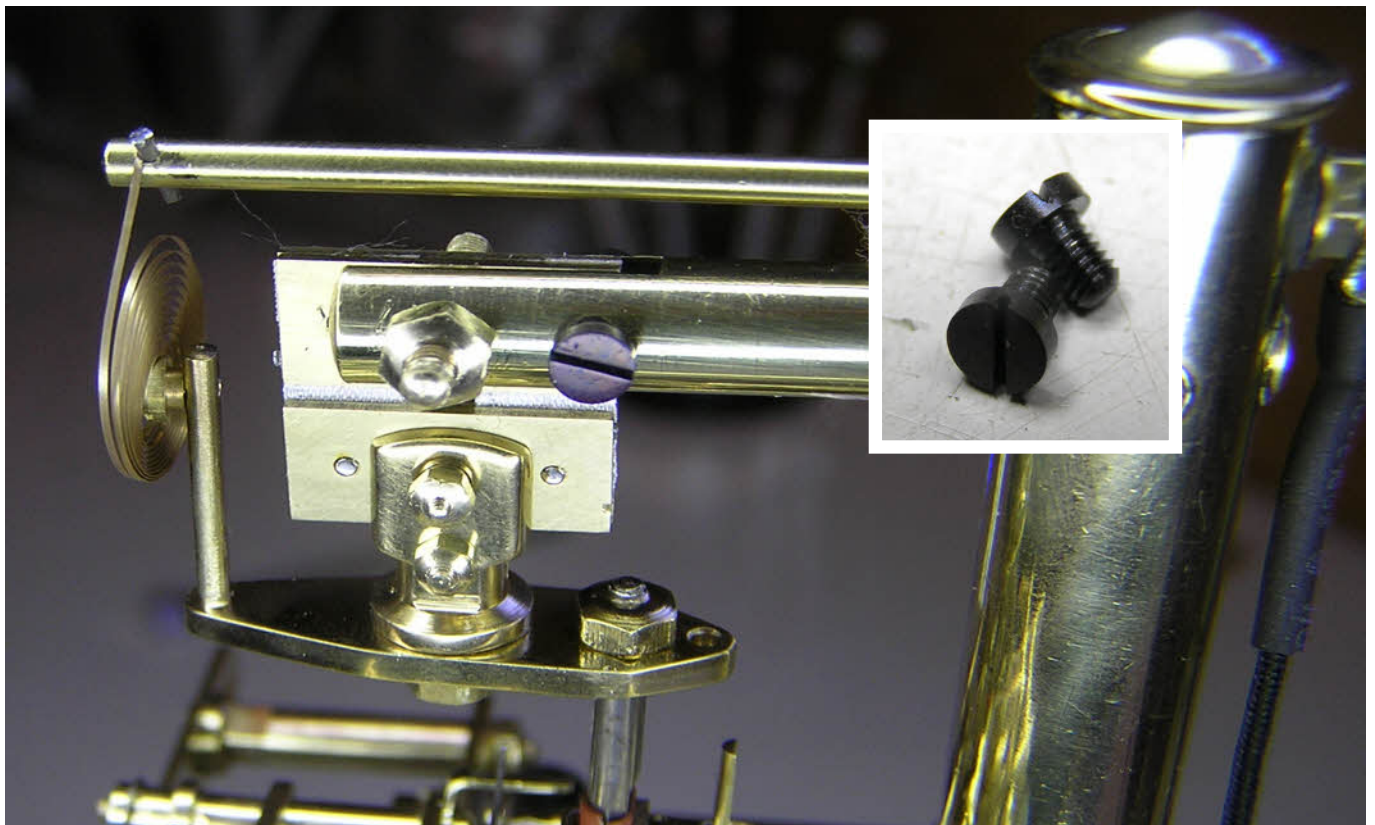
The blued steel replacement screws back in place on the frame.

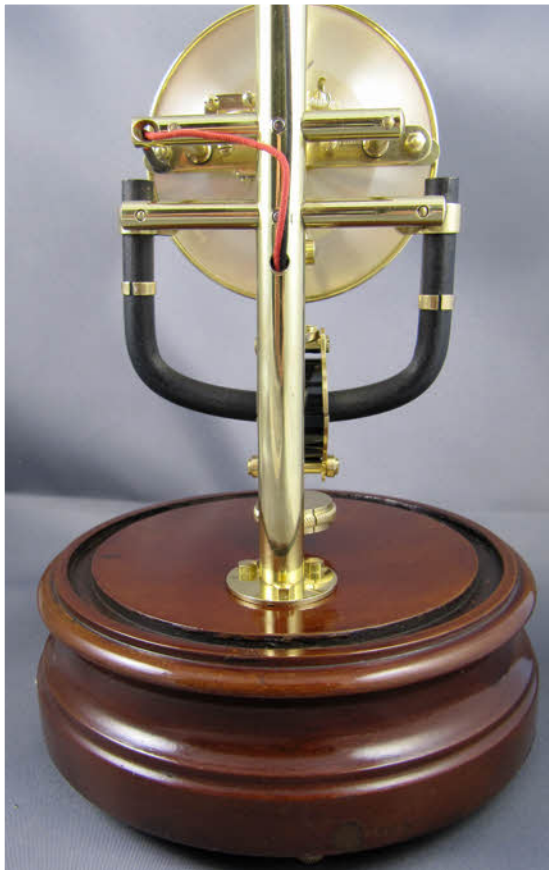
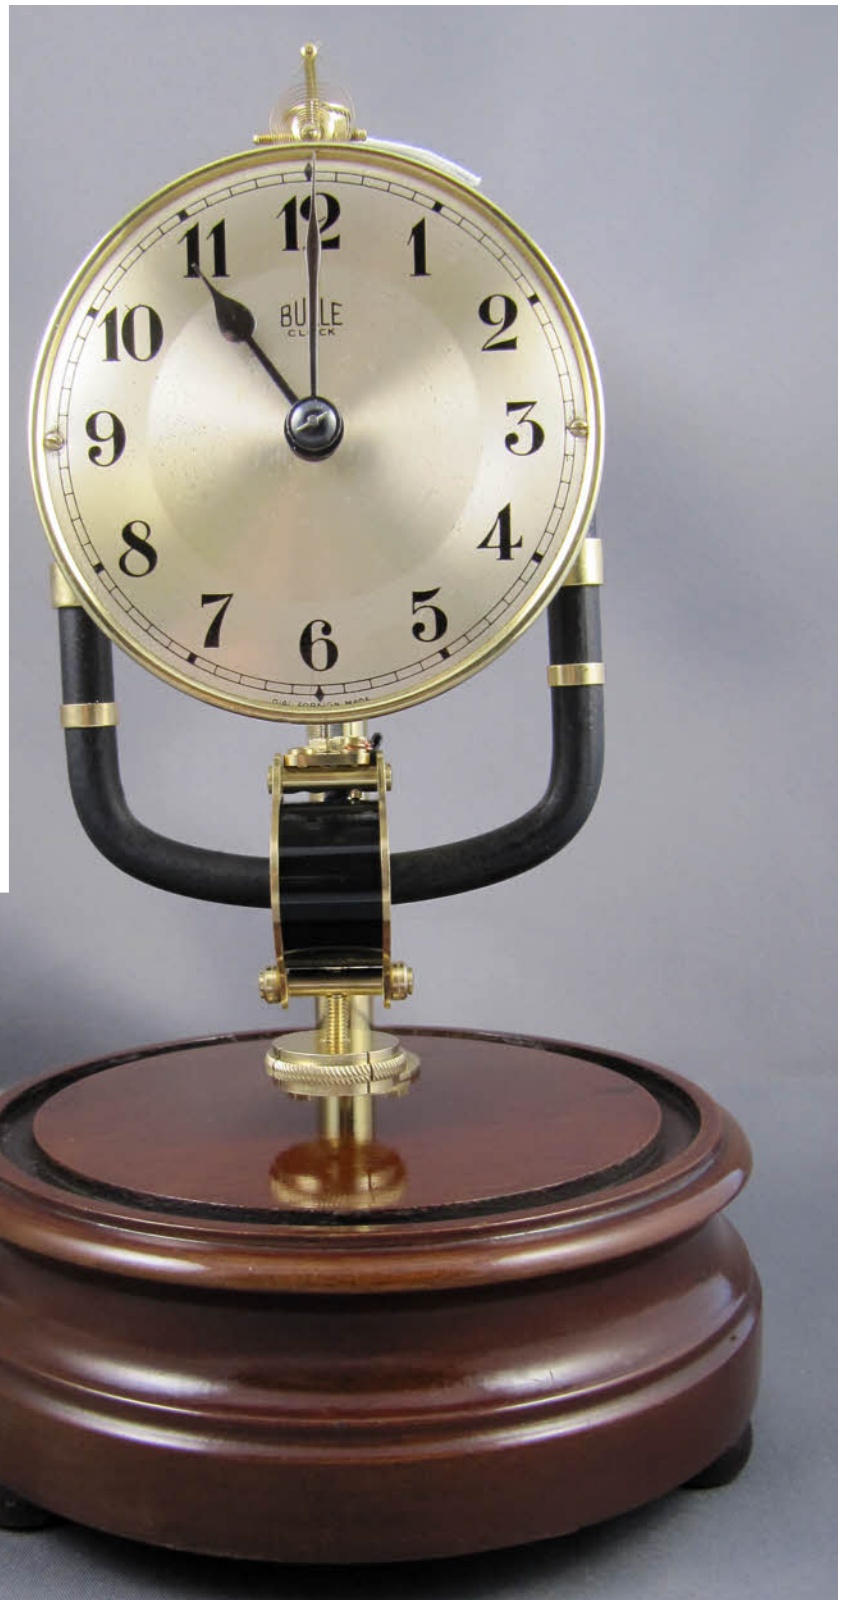
The finished clock.
