**Bulle Clock Serial Number 27993**

*Restoration of Bulle Clock  
Serial Number 27993*

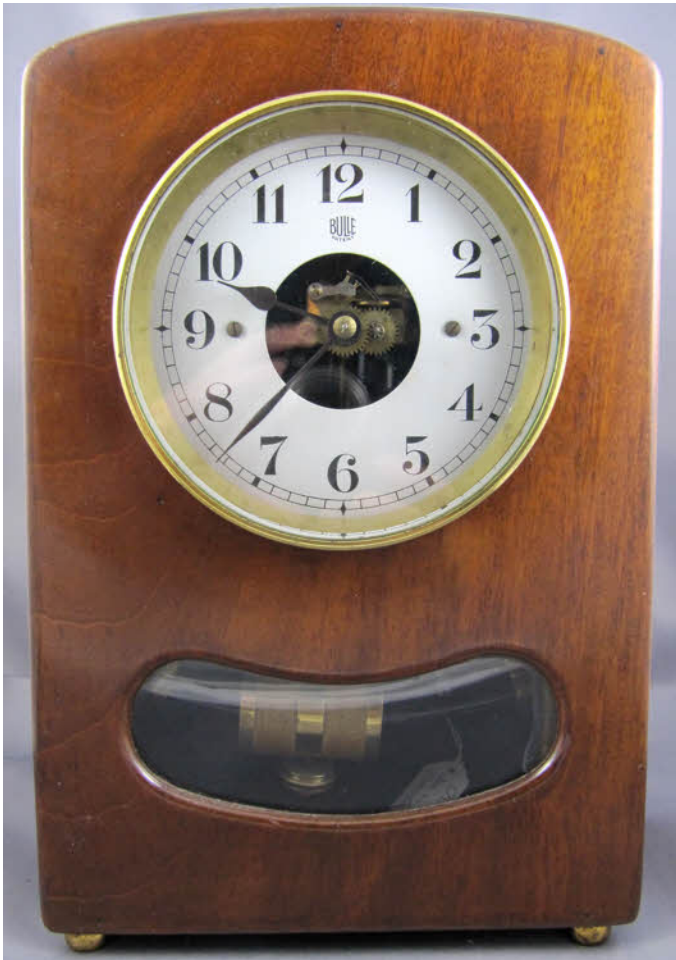
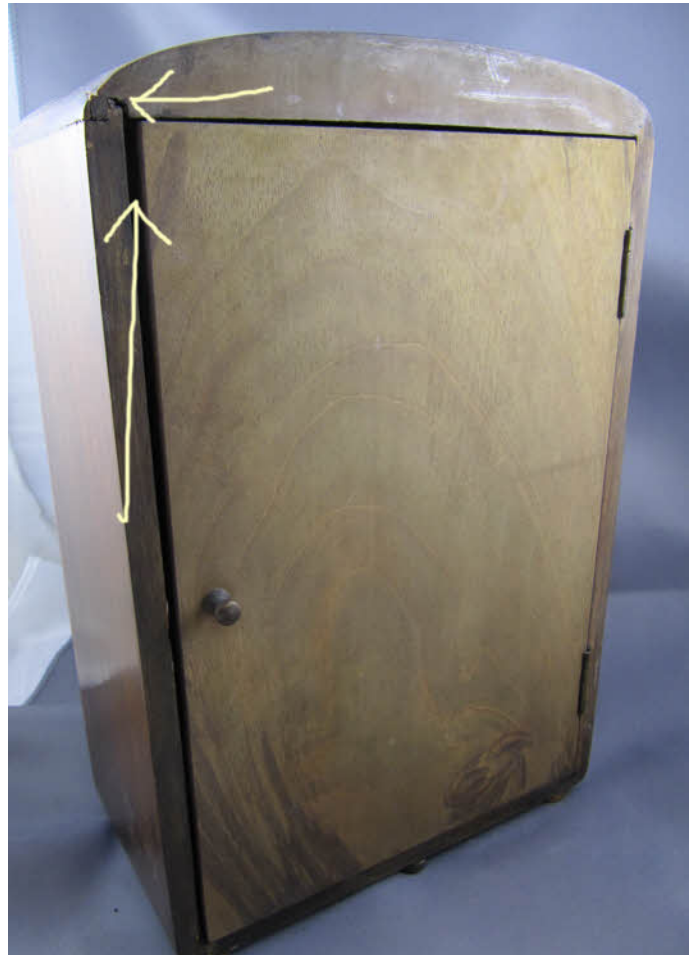
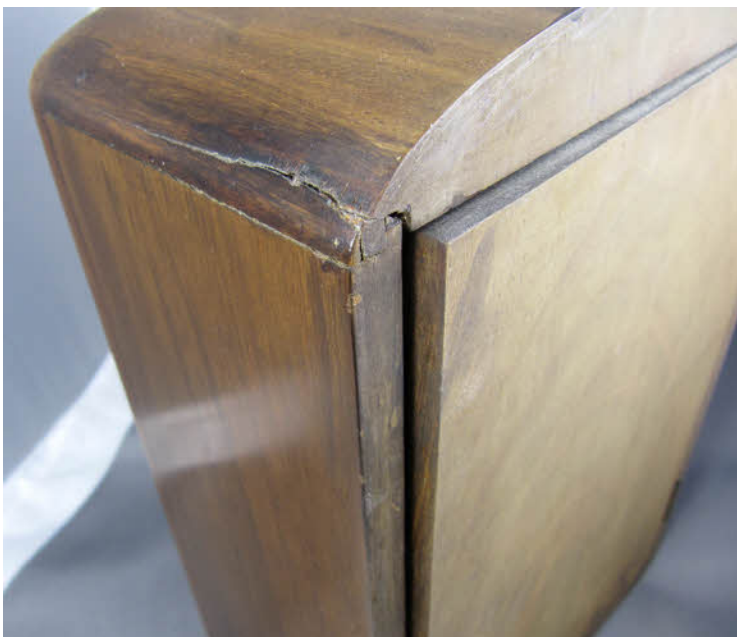
*This Bulle has a three quarter movement in a full wooden case with glass aperture for the pendulum. Unfortunately the clock has been left in the sun and the case has suffered both from bleaching and shrinkage. The shrinkage has cracked the top and separated the side such that the gap around the door has increased. The door itself is dry and bleached. I'll try to fix the top and close the crack.. I'll also try restore some colour to the top and door, and then apply some french polish. As the tops, sides and front are all different colours I will try and match the top with the front. The bezel was only held in position with friction as the hinge pin was missing!! A new one to be made.*

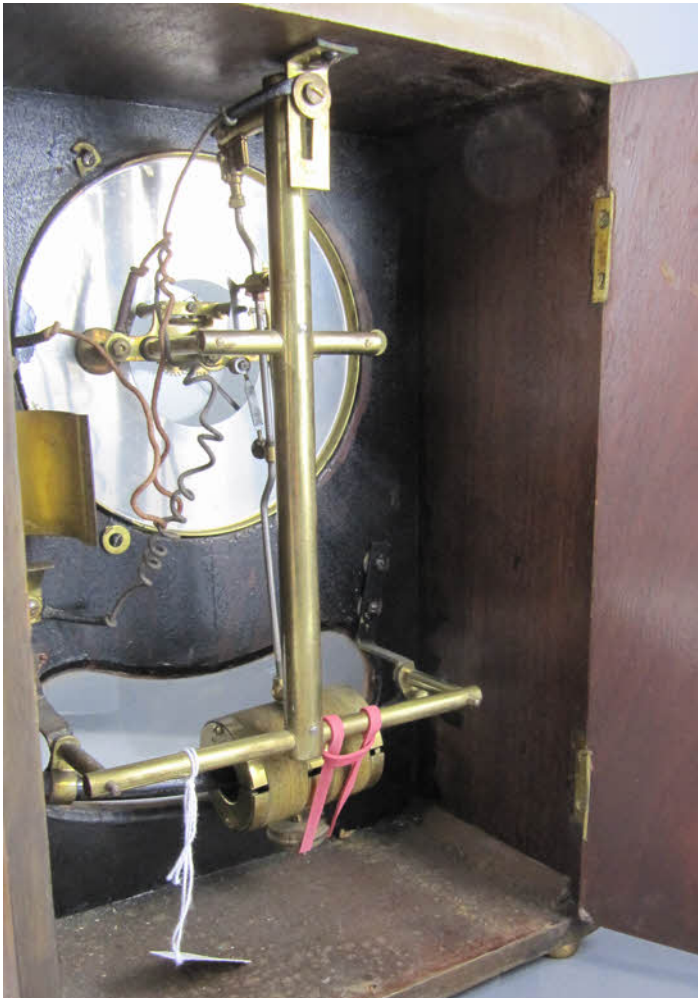
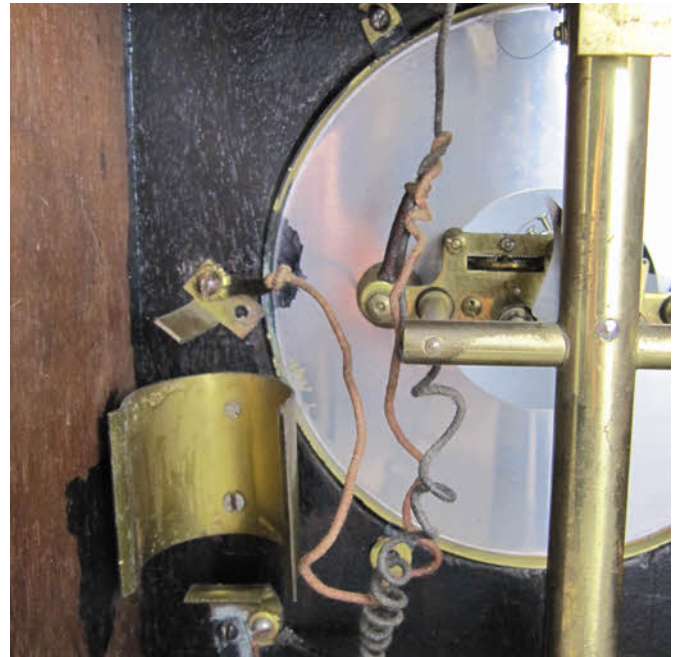
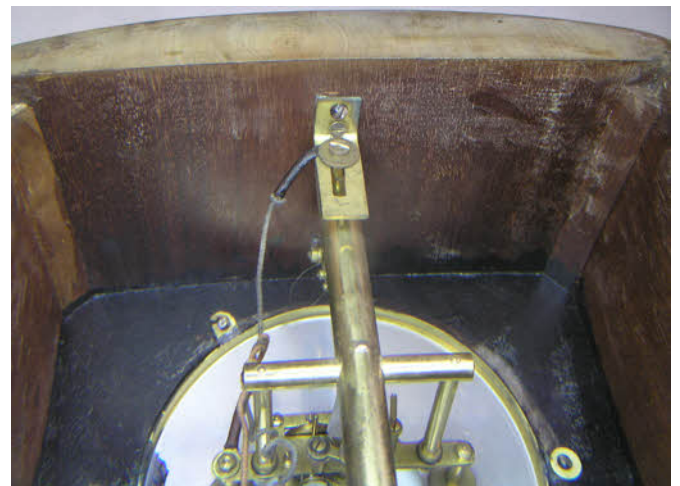
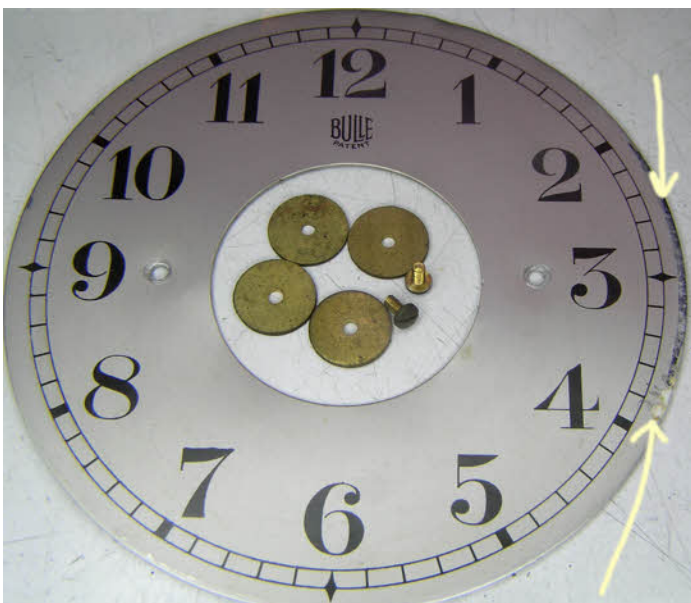
The movement looks to be in good order and complete, although the dial has suffered at some point and has some corrosion on the outer edge between 2 o'clock and 4 o'clock. It is minor and will be left alone. Movements in wooden cases are sometimes difficult to line up with sufficient accuracy to align the dial with the aperture and you will often find extra shims here and there to try and affect a good fit. In this case there are two extra spacing washers behind the dial to help push it forward into the dial pan.

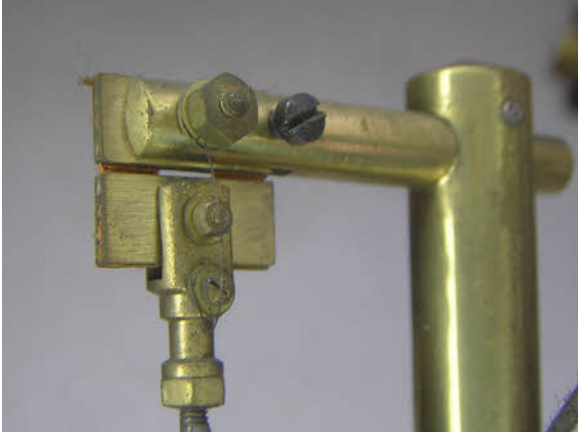
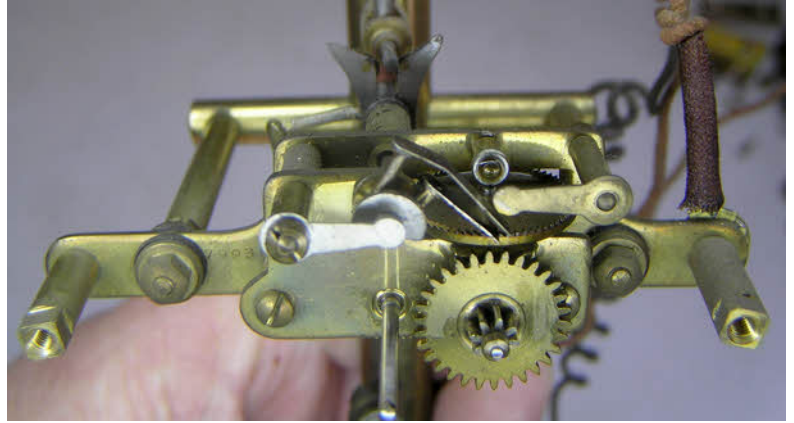
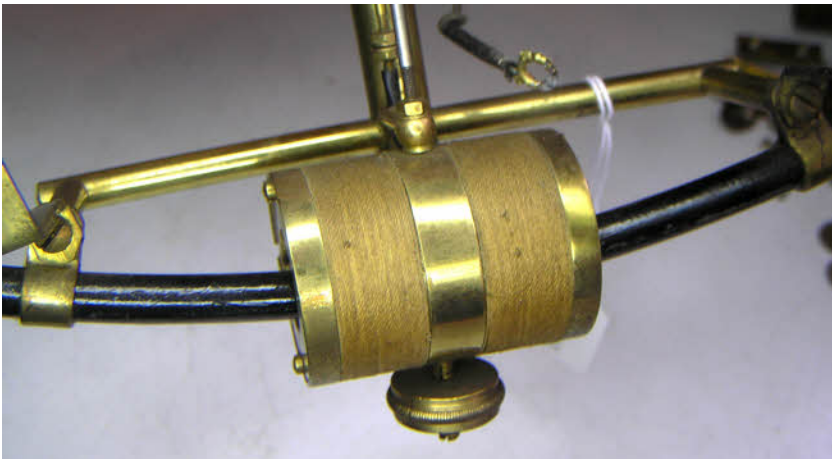
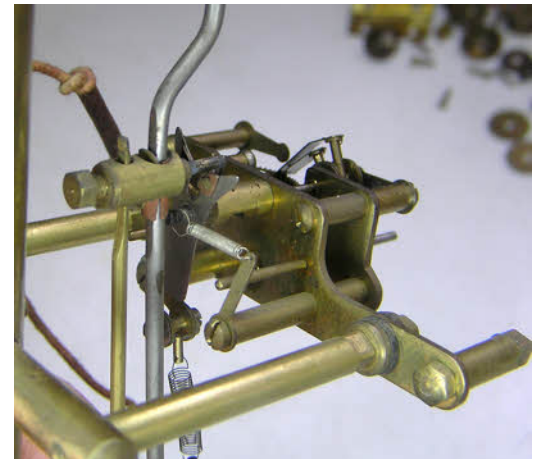
*This group of four photos shows some general views of the movement which appears to be in almost original condition although the cord is dry and brittle (as usual). It will need to be replaced.*

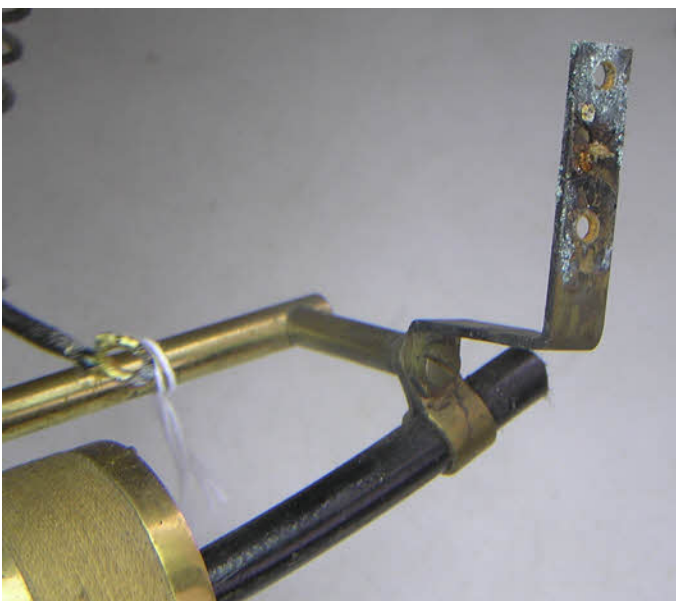
*This last photo shows one of the movement support arms that holds the movement in position in the case. It has suffered a little with corrosion but it will clean up well enough. There are still traces of black paint which was applied to hide the supports when viewing the swinging pendulum through the front glass aperture. The rating nuts can often be found with drill holes or even hollowed right out. This was an attempt to lighten the nut and therefore speed the clock up when a previous repairer hadn't cleaned and repaired the mechanism correctly. Fortunately in this case the nut has not been tampered with, which also indicates the clock was running well.*

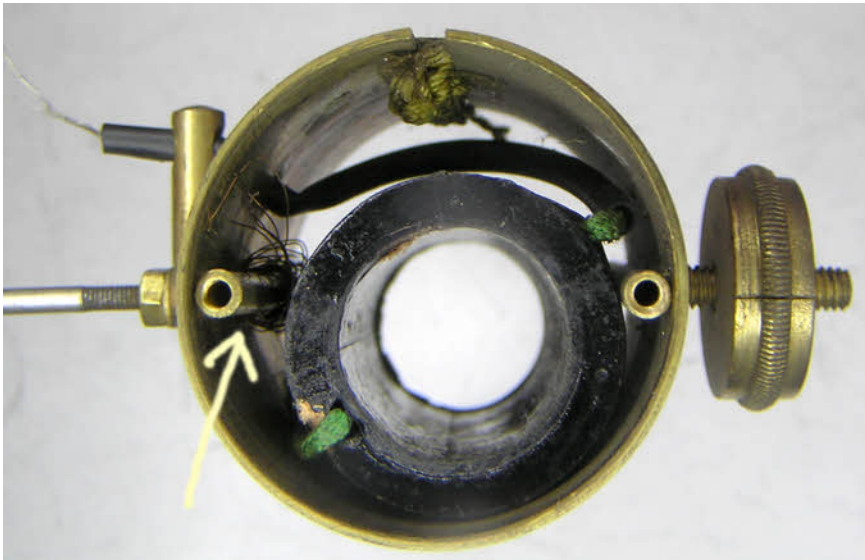
The inside of the coil casing showing the two lead out wires. One is wrapped around the top cap spacing rod while the other is led out through the casing. The wire may look frayed but it is just the loose ends after being wrapped about five times around the rod. Note that this coil is wound onto a cardboard bobbin and not a wooden one as used on earlier clocks.

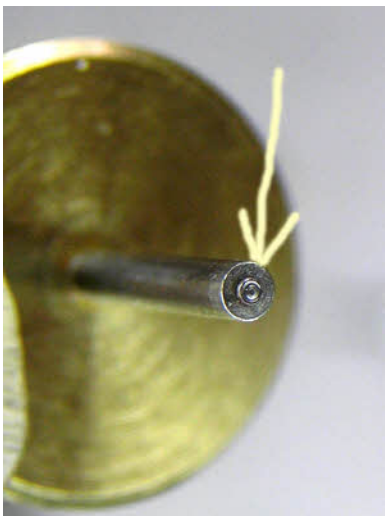
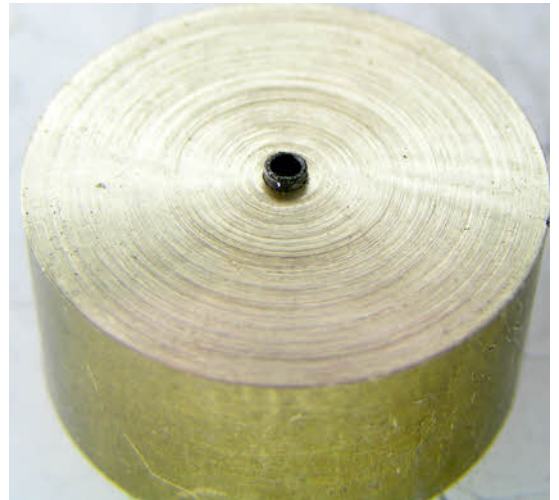
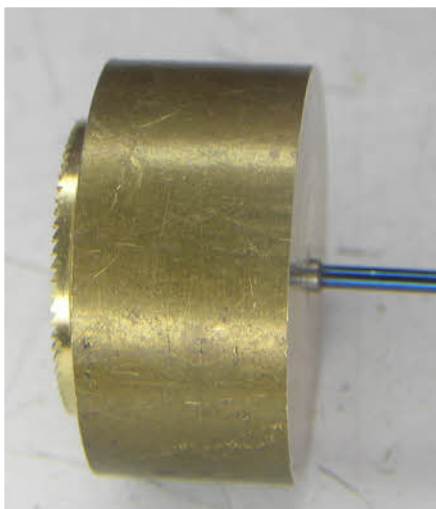
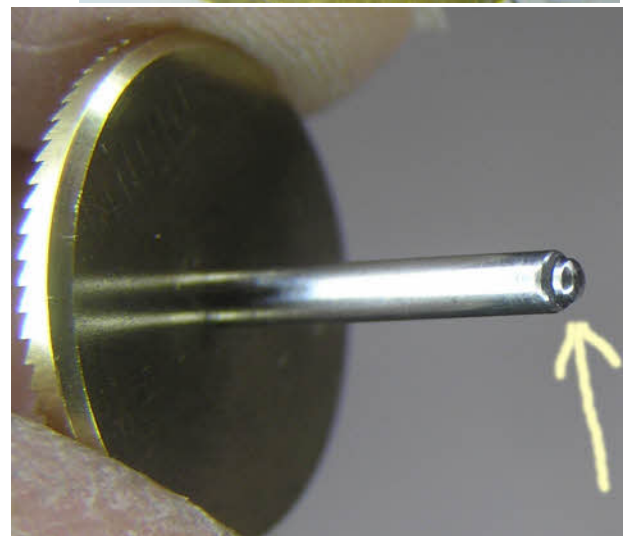
Whilst examining the parts before cleaning I noticed that the hardened nipple on the end of the count wheel was badly worn. This would mean the worm wheel would rub against the housing and create friction in the movement. The only option is to grind the nipple off, drill the end of the arbour and fit a length of blued pivot steel as shown in these photos. The nipple is then sized and polished.

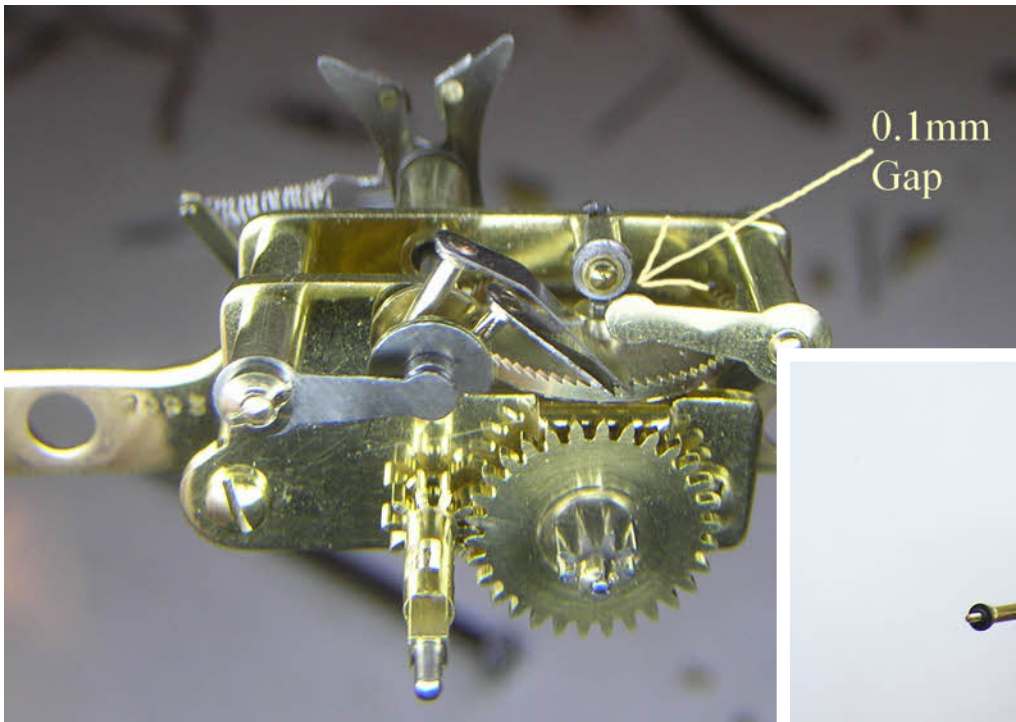
0.1mm Gap

*The count wheel was then checked to see that it was at the correct working height and that the whole assembly ran free with no friction. There should be a gap of approx 0.1mm between the wheel and the end stop.*

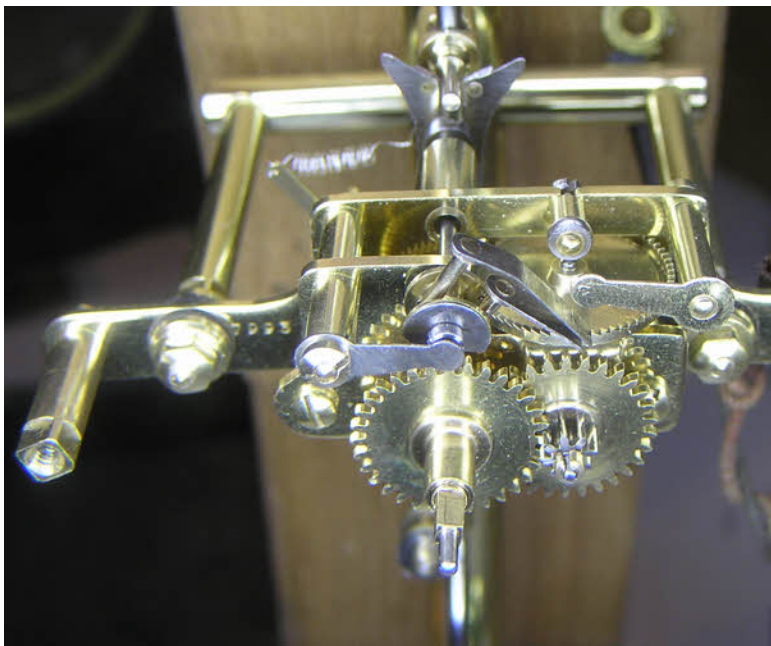
*The movement reunited with the frame and pendulum and set running for the first time.*

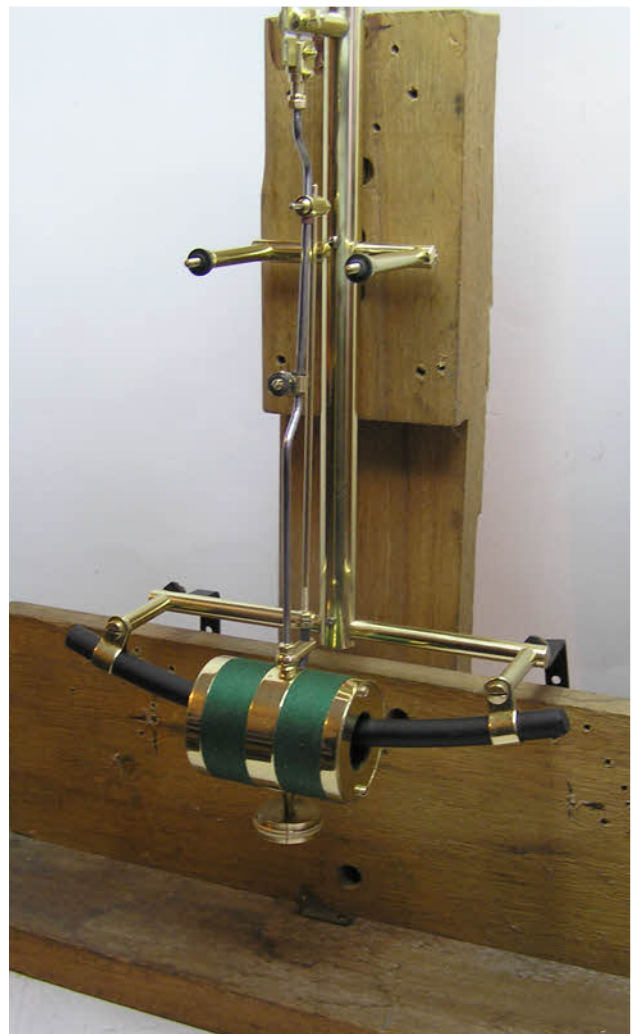
*The frame and pendulum on the test stand while checking the length of the pendulum.*

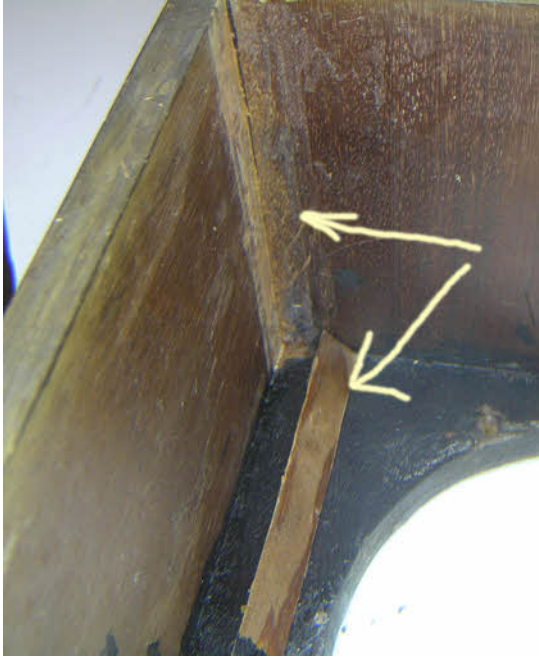
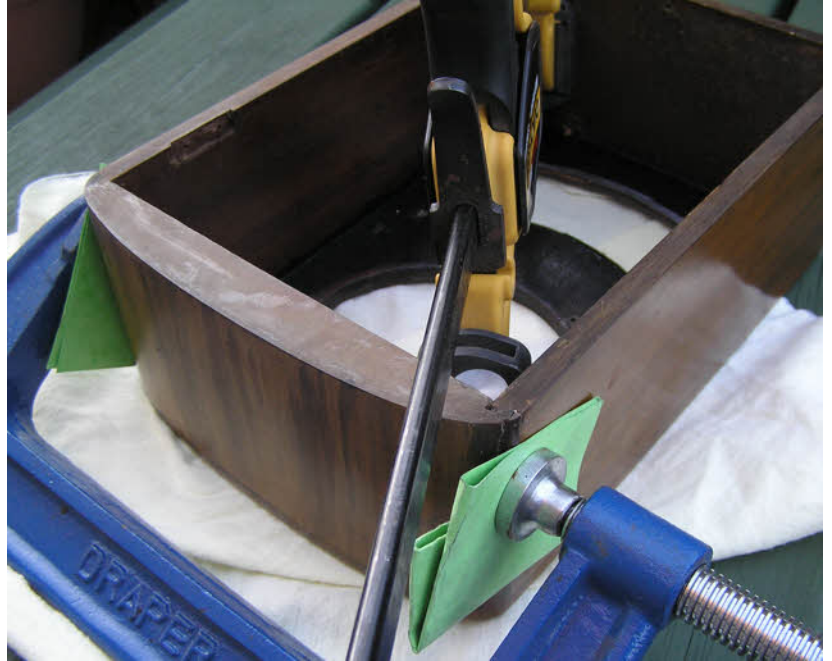
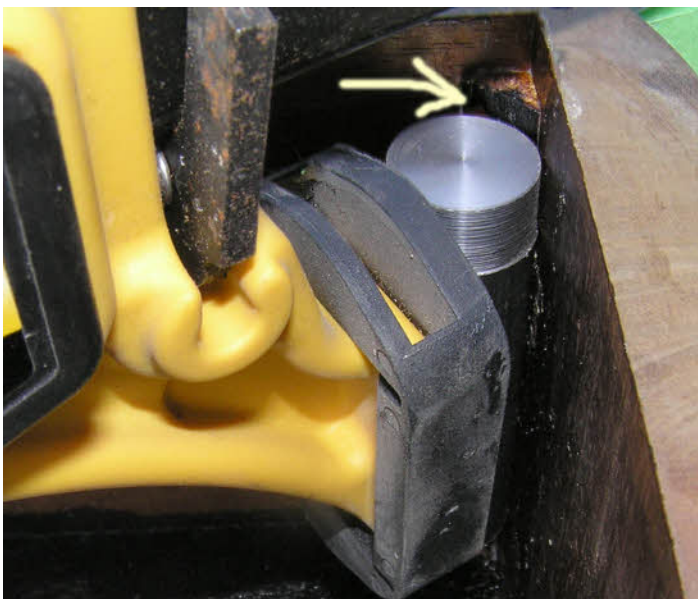
*These photos show the case being repaired. The corner wedge is removed to allow the corner to be cleaned and glued in position. The wedge is then replaced and also glued into position. Note that a round steel bar is used to allow the clamp to apply pressure to the wedge.*

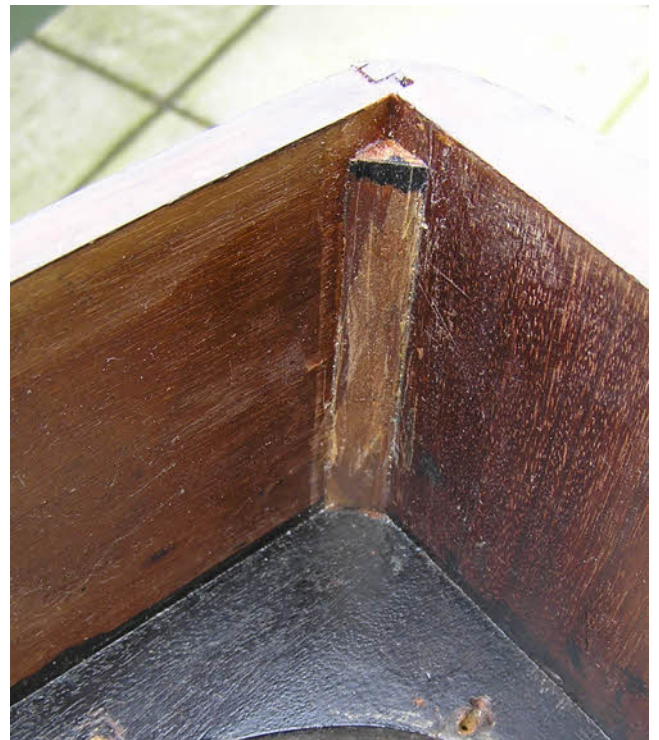
*This last photo on the right shows the finished repair. The joint has been pulled up and the wedge back in position holding the joint.*

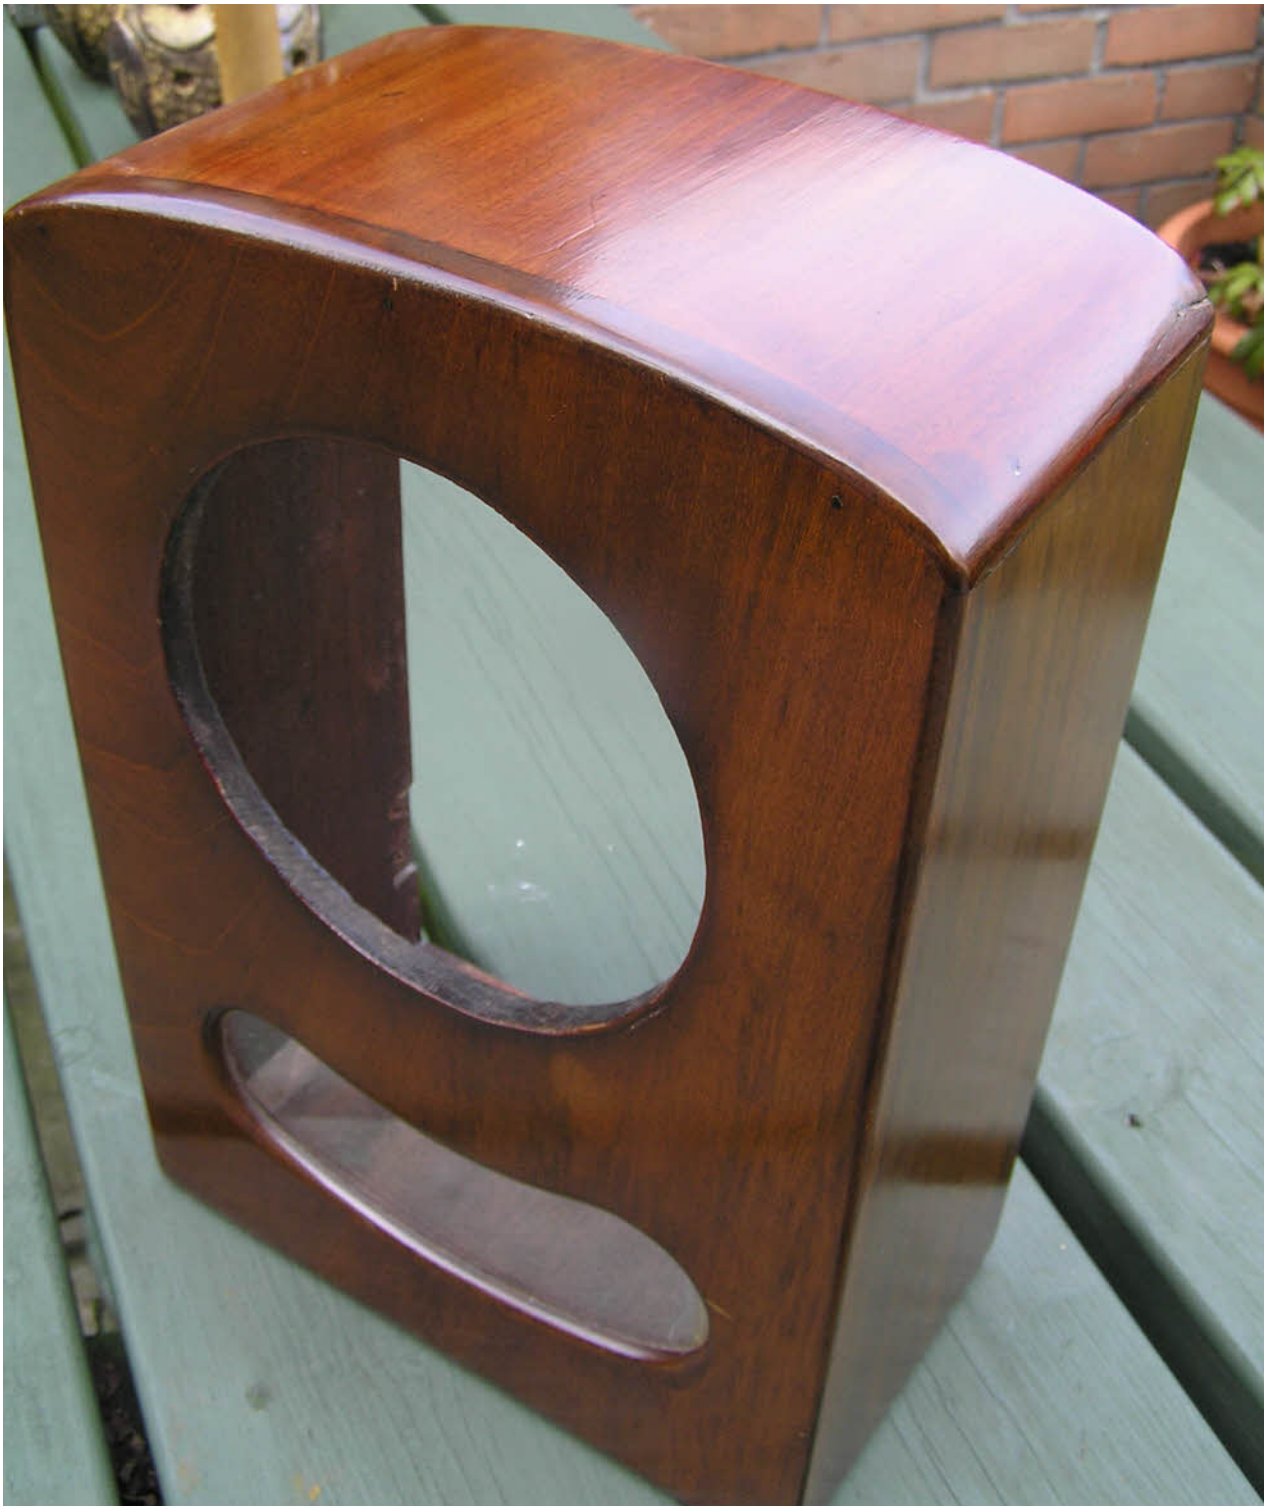
*The case after gluing, cleaning, staining and polishing the top. I haven't gone overboard in trying to hide the repair. I didn't want it all to look brand new.*

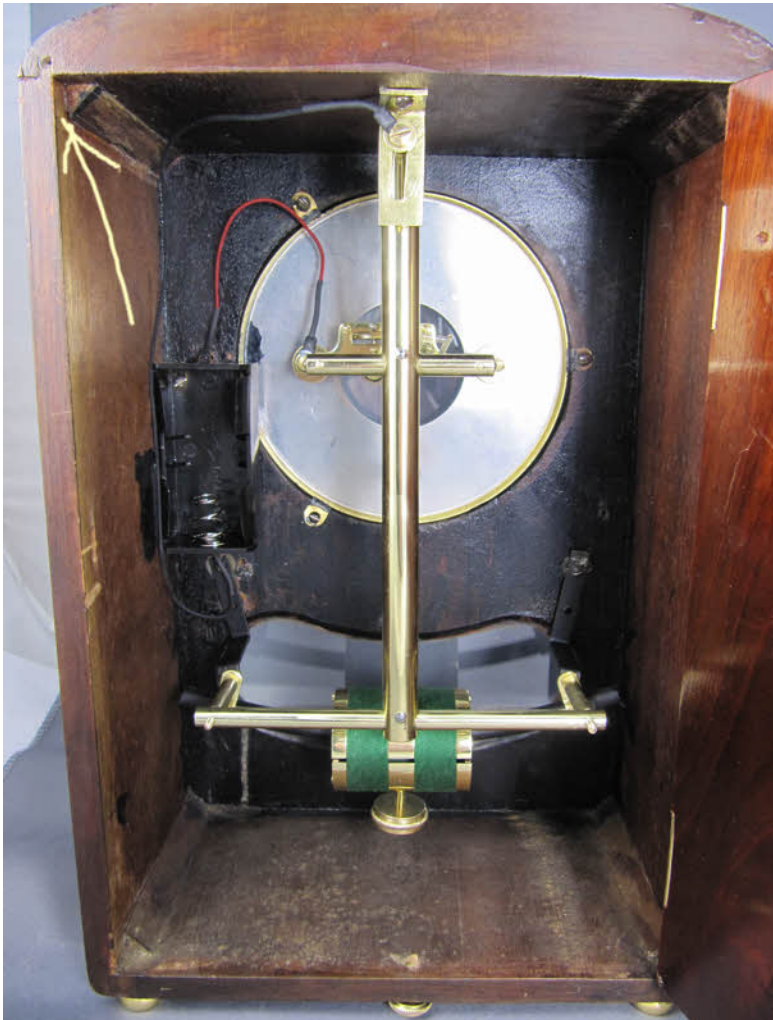
*The movement installed. Note the repair arrowed*

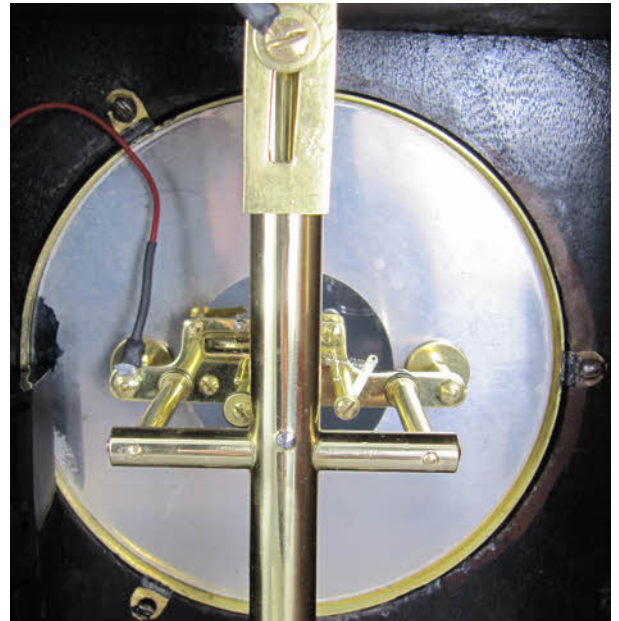
*Rear of the dial showing spacing washers.*

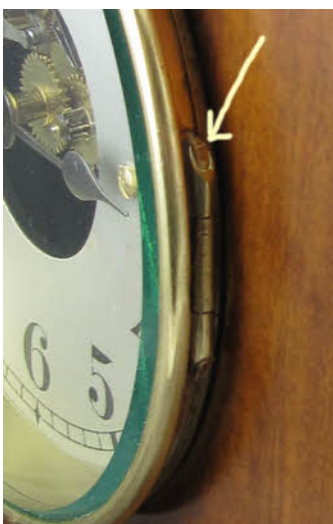
*A new hinge pin was fitted as the original was missing*
