Horologix   *The place to come for all your Bulle and Eureka restoration parts.* [Contact Peter Smith](mailto:peter_smith@horologix.com)
[Telephone 01454-880825](tel:01454-880825)
[Or Mobile 07969-773480](tel:07969-773480)
[Email peter_smith@horologix.com](mailto:peter_smith@horologix.com)

Bulle Clock Serial Number 28105.

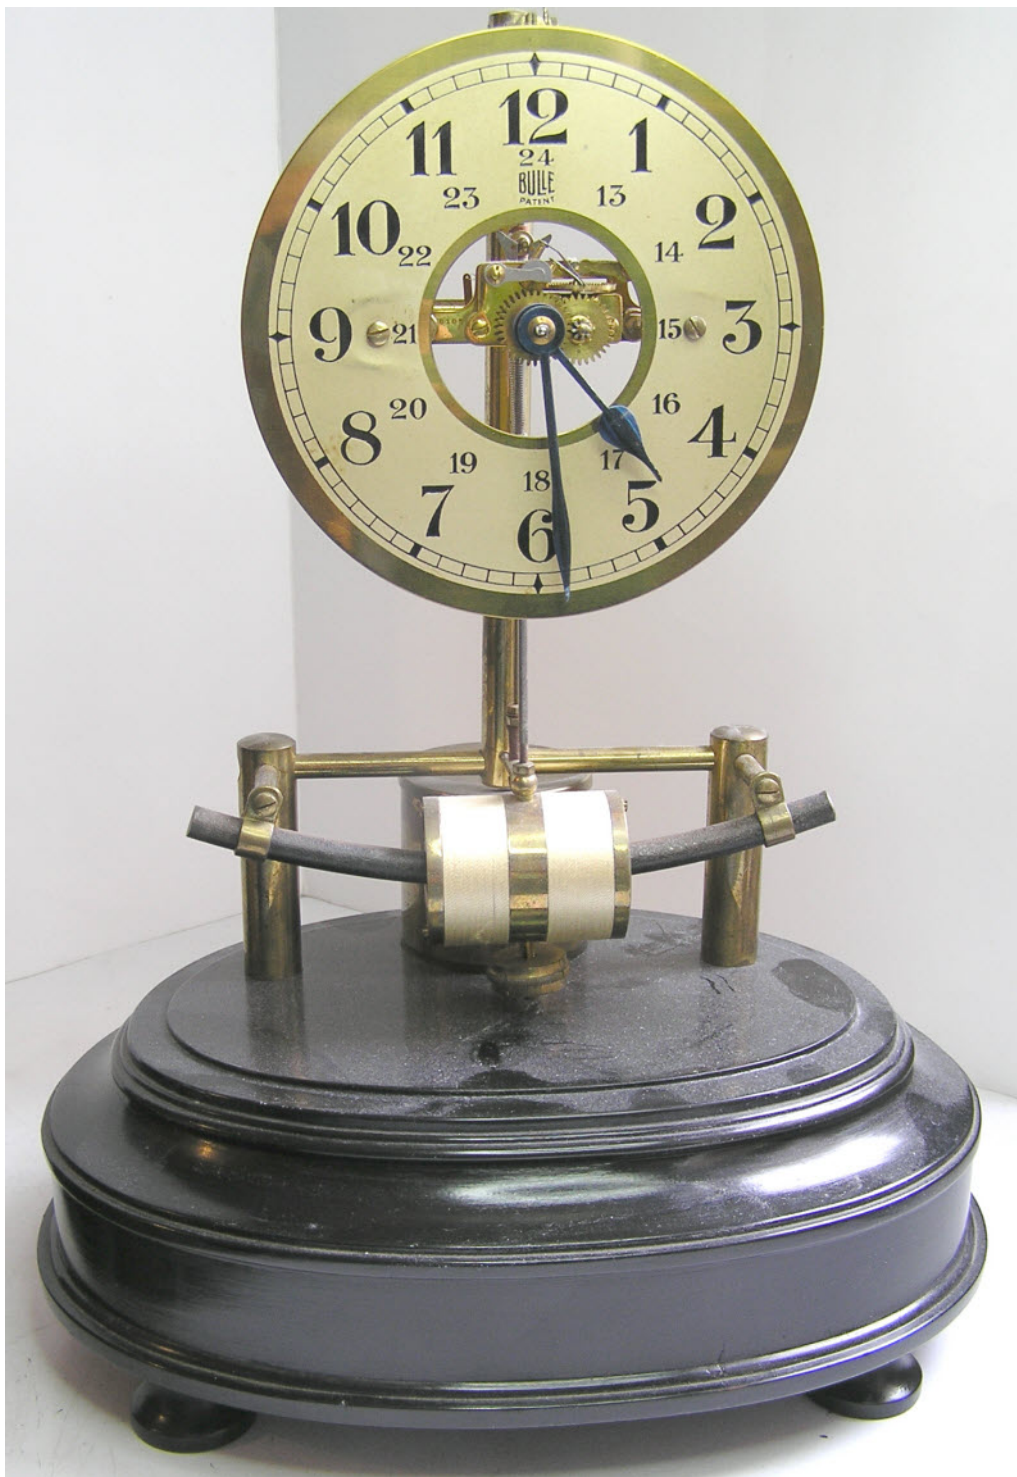
Restoration photos by kind permission of the owner. The clock as delivered. It is Crystal dome clock on an ebonised wooden base. This model has a half tube of 53mm at the back which protrudes up from the base by about 50mm. It is capped with a spun brass cap. Two grooves are cut into the tube just under the cap to allow the positive and negative leads to pass from the battery to the movement. The dial is partly silvered and displays the usual crimps and buckles where the dial has been twisted against the screws and large washers securing it the the frame. Other than that it has no major blemishes. There seems to be some damage to the battery tube and cap. The cap will need replacing, while the tube will need a bit of beating out. The tube cannot be removed easily without damage. They are thin walled and are extremely tight in the wooden base.. Consequently they will fold and buckle if removed.. I'll concentrate on the tube repairs in the following pages as most of the other work has been covered many times on other clocks .

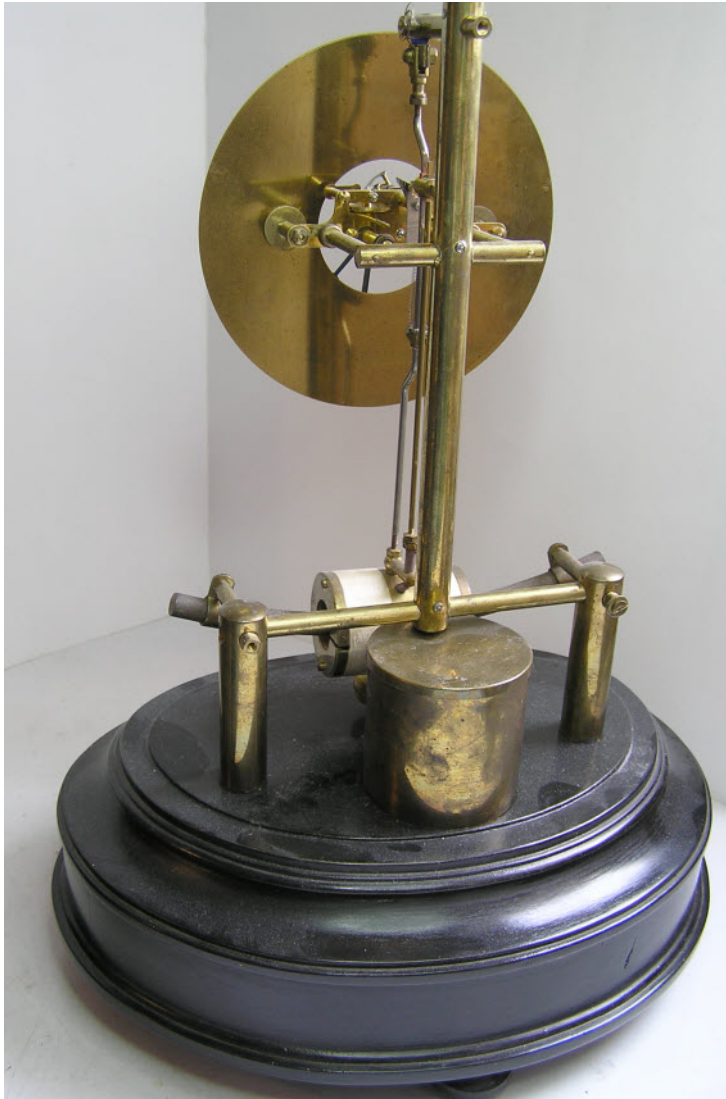
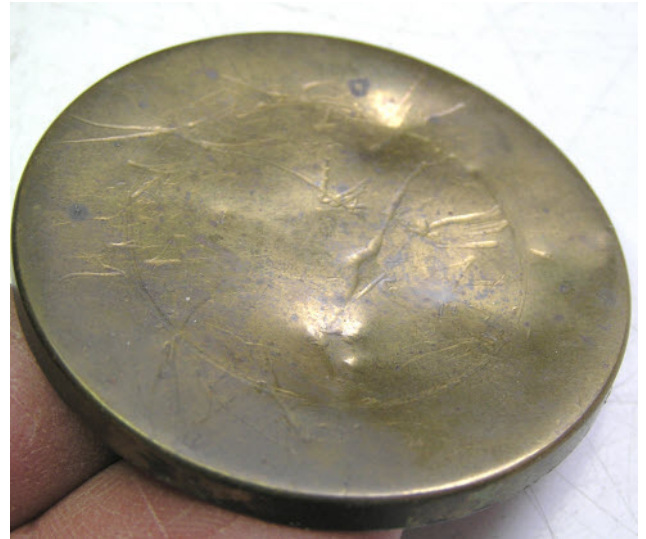
The cap has seen better days. It will be high on impossible to knock all the dents out and still keep its shape. It's much easier to spin another on the lathe.

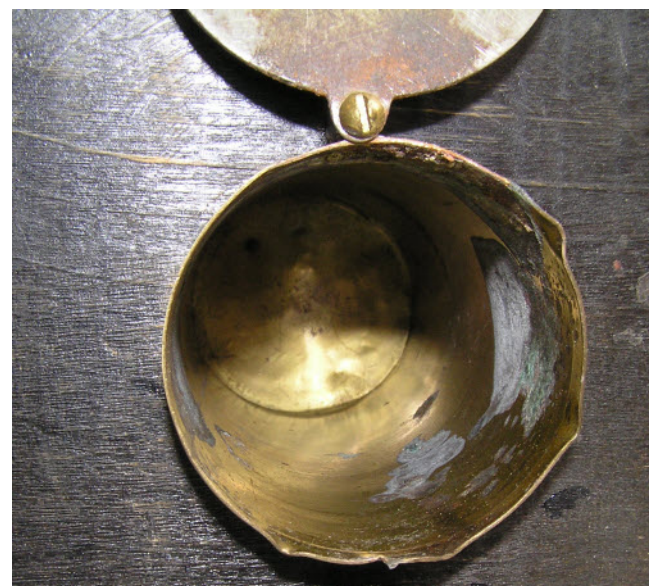
The photo above shows the rear of the clock, which seems to be complete and in reasonable condition other than the cap and tube. The photo at right shows the condition of the battery tube under the base. It has been heavily dented and abused by a previous repairer trying to remove it probably to try and clean the battery acid from the inside. They have tried to knock it through the base but it is much too tight. We will have to do all repairs in situ including removing the acid. We'll also try to knock out some of the dents

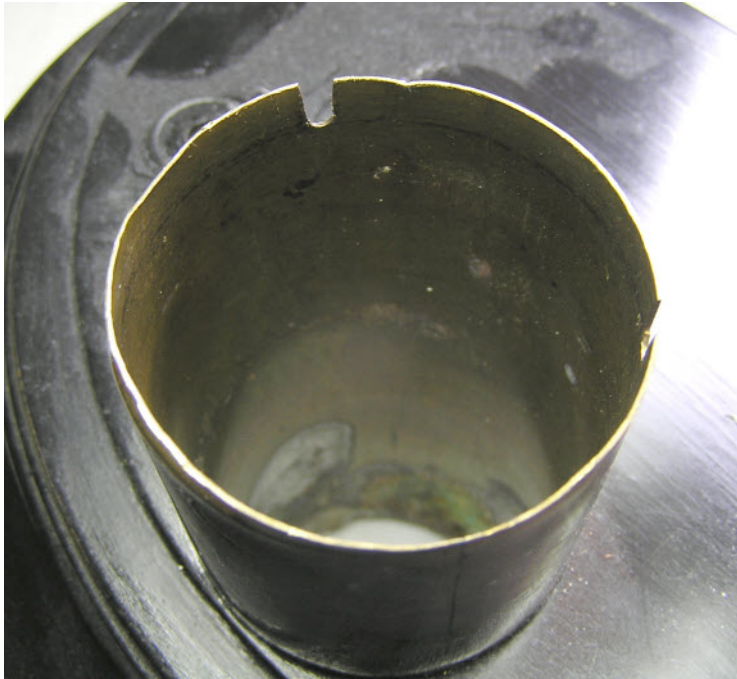
The top of the tube is also disfigured and we'll have to try and smooth it out whilst trying to regain a clean round shape. Note the two slots in the top for the two wires.

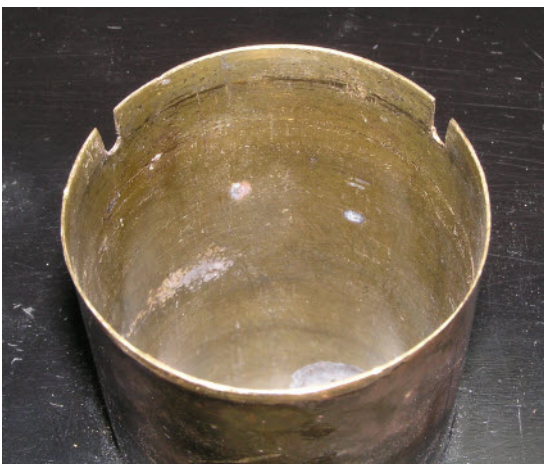
An old Gudgeon pin from a lorry engine is just the right size to use as a stake while hammering the tube walls into shape. The last photos show the tube top and bottom after this treatment. The new cap will now fit securely.

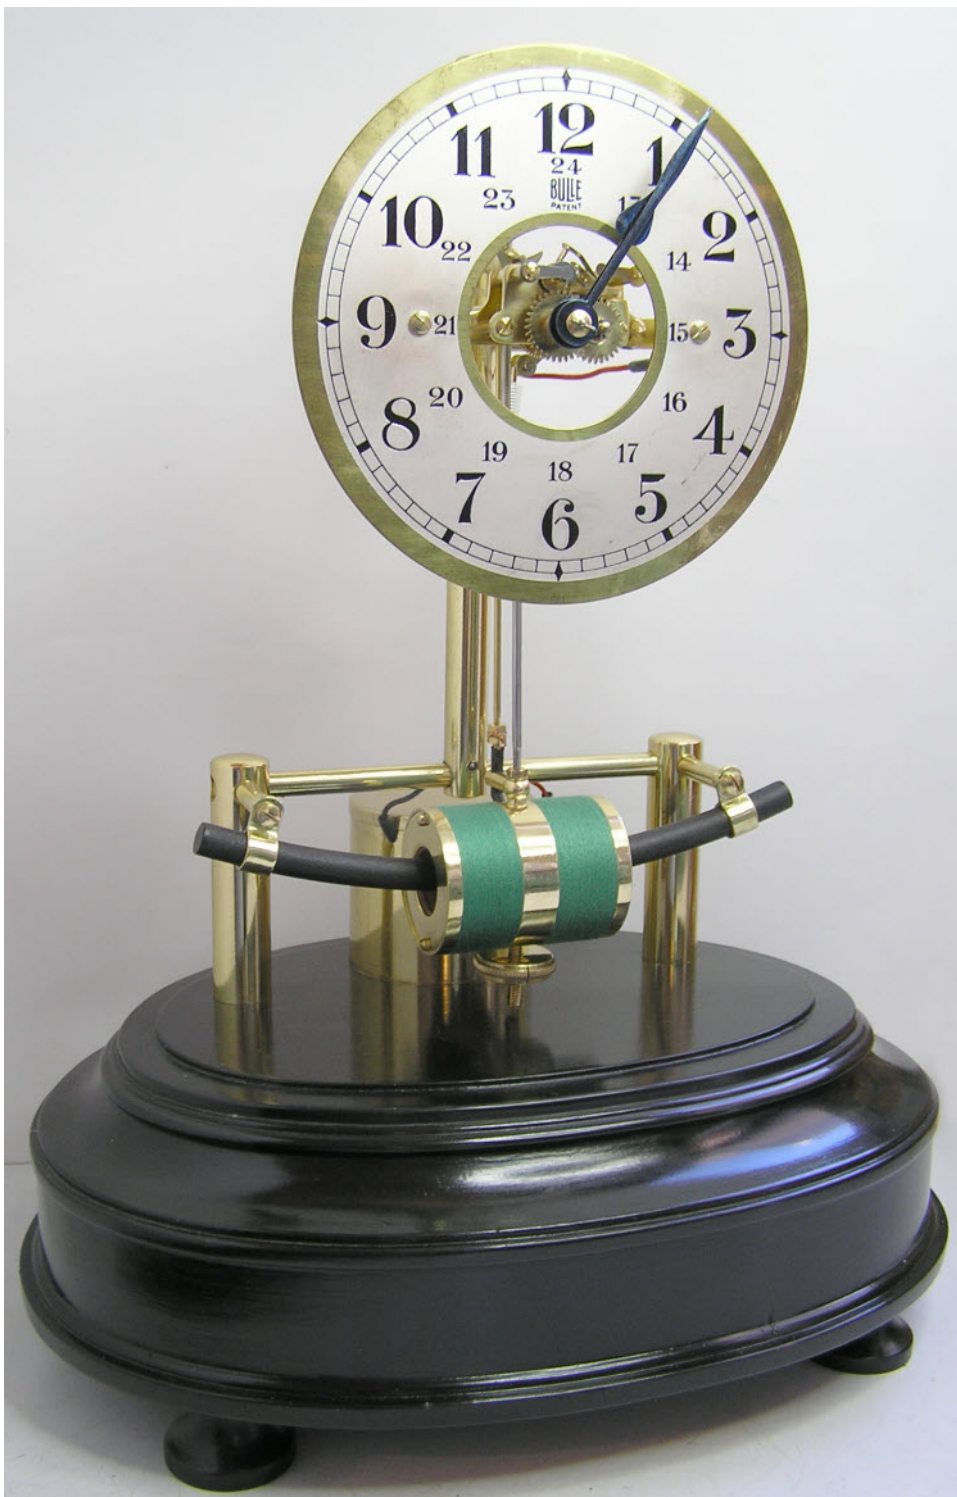
The finished clock
