Bulle Clock Serial Number 284391

The place to come for all your Bulle and Eureka restoration parts. Contact Peter Smith
Telephone 01454-880825
Or Mobile 07969-773480
Email peter smith@horologix.com

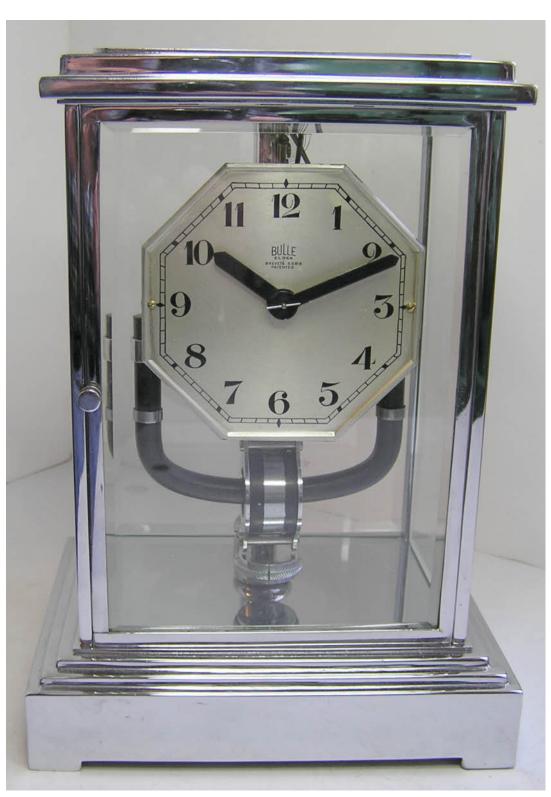
This little clockette looks to be in perfect condition. The case is a four glass model which has been chrome plated. The condition is excellent with no wear on the chrome at all. I would suspect that it has been re-chromed at some point in recent years. The dial is also in good condition with no obvious signs of wear or damage. These chrome examples are unusual in that not all of the parts have been plated. You will notice later that some screws. nuts and other small components have been left as unplated brass. The glass shows no chips or cracks although they are rather short in the frame which tends to leave them to rattle around when being handled.

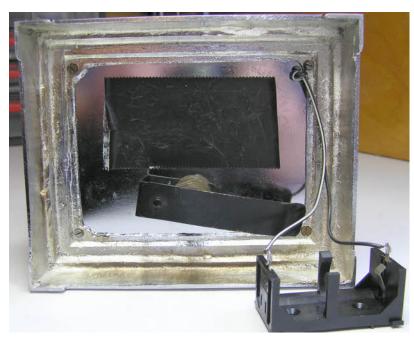
The underside shows clearly that the whole case has definitely been re-chromed. The battery holder and wiring are also new..

Overall it looks as though this clock has been completely restored in the last ten years or so. Consequently there are no signs of battery acid or any other damage.

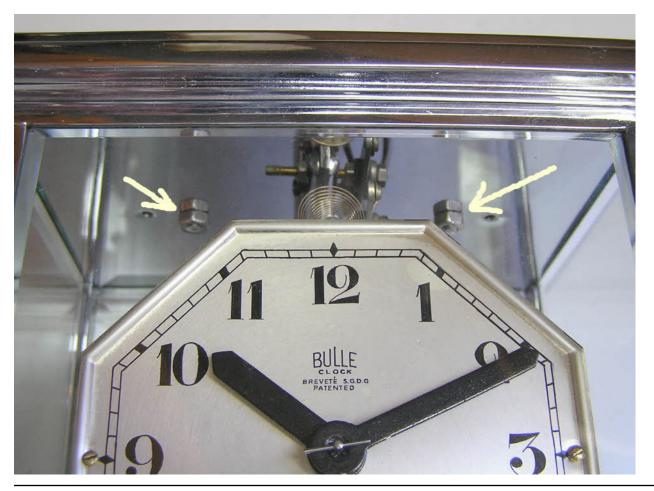
To start dismantling the case we need to remove the two nuts hidden up under the top of the case. These are a little difficult to get at and require no little amount of patience and care to undo.

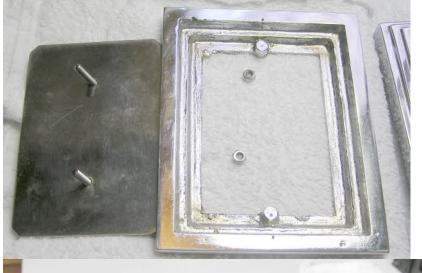
Once the nuts are removed we see that the top is actually two parts. The top plate and top frame..

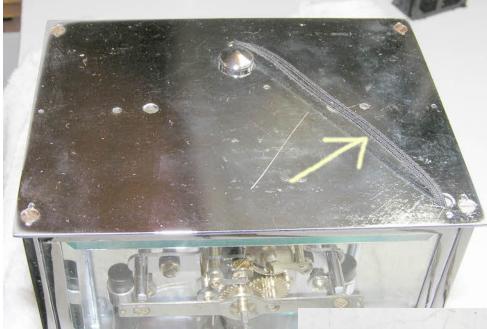
In the photo below we can now see how the wiring reaches the top of the movement. It comes through a hole in the bottom plate, up along the right hand side door pillar, through a hole in the top frame plate. It then leads across the top of the clock and down behind the movement frame. It may be tidy but it is pain to reassemble. Note how the top of the movement frame protrudes through the plate.

The depth of the intrusion is adjusted by screwing up or down the large chromed nut at the base of the movement frame. The cap shown at the left of the photo, is left loose to fall and cover the nut.

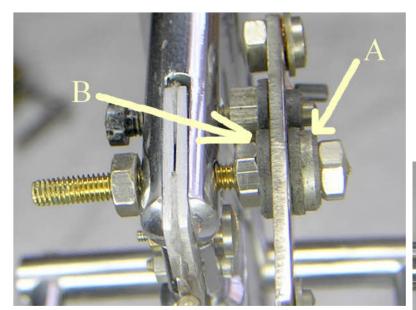
This photo shows the top of the movement frame and the assembly which receives the negative wire from the battery. At point "A" you can see a disc washer which should have an equivalent at "B". This will have to be replaced.

The photo on the right right shows the attempt at repairing the suspension. This will also be replaced.

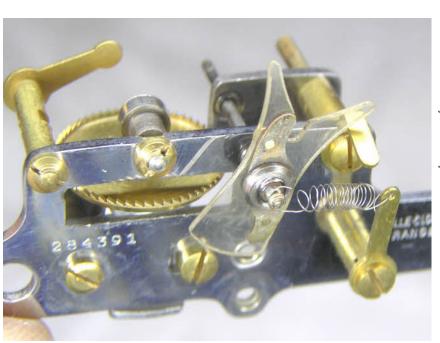
This last photo shows the movement and the odd but original mix of chromed and brass parts. Note also that the fork is in good condition and made from a clear form of plastic and only has the silver contact. There is no need for a fibre insulation piece on the right side of the fork. There has been much conjecture on the shape of the silver piece. Some believe it is "S" shaped so that it can be turned upside down to present a new face after wear. But it will not fit upside down. It is that shape to reach the centre arbour for electrical contact, with a tail to counter balance the top. The contact spring is misshaped and is missing a loop end.

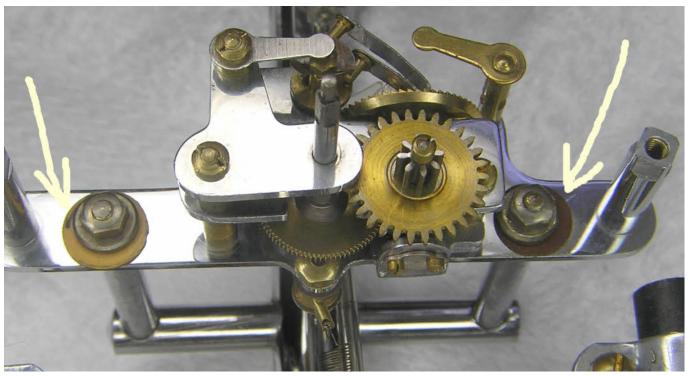
This photo shows the movement and how it is attached to the frame. The two washers arrowed are not original and are two thin to provide a guaranteed electrical insulation between the frame and movement. These will have to be replaced.

The magnet clamps have small nuts behind them which are not original. The screws pass through the clamp and tighten up within the frame. So the nuts in this case are purely acting as spacers with will push the magnet further to the front of the clock. Why they are here I have no idea. The magnet and pendulum coil alignment are better without them. They will be removed. The last photo shows the decorative magnet collars. The last photo shows that decorative magnet collars which have been glued in place. These collars can be quite thin and easily bent so I suspect that they may have been weakened when the clock was last repaired. It will leave them in place.

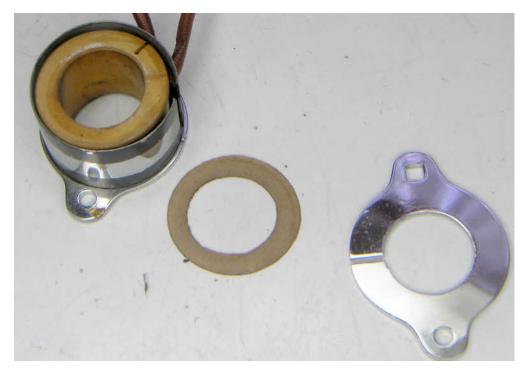
The coil halfway disassembled. Note the paper washer to provide extra thickness to the assembly so that the screws would pull up tight and clamp the coil between the chromed end plates.

The coil proved to be in good condition with a solid reading of 1200 Ohms. But the insulation on the lead out wires is cracked and brittle. This will be replaced.

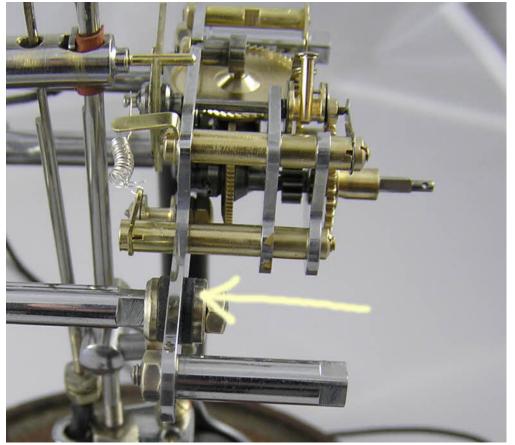
The movement being refitted to the frame. Note the new insulating washers in place. The frame and movement are checked at this point to make sure that they are electrically insulated.

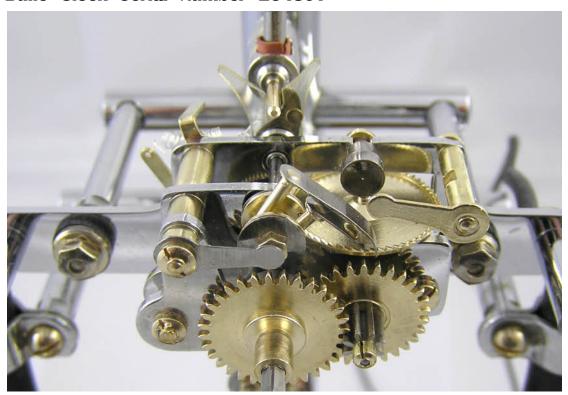
The restored and cleaned movement back in place.

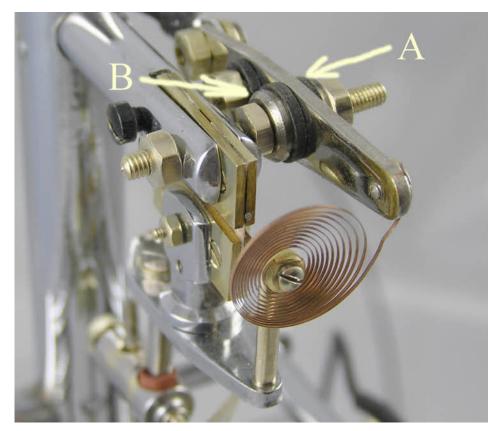
The negative battery wire assembly back in place with the new disc washer.

If the frame of the clock is not positioned correctly by adjustment of the large nut at the base of the frame then this assembly may touch the top plate and cause a short.

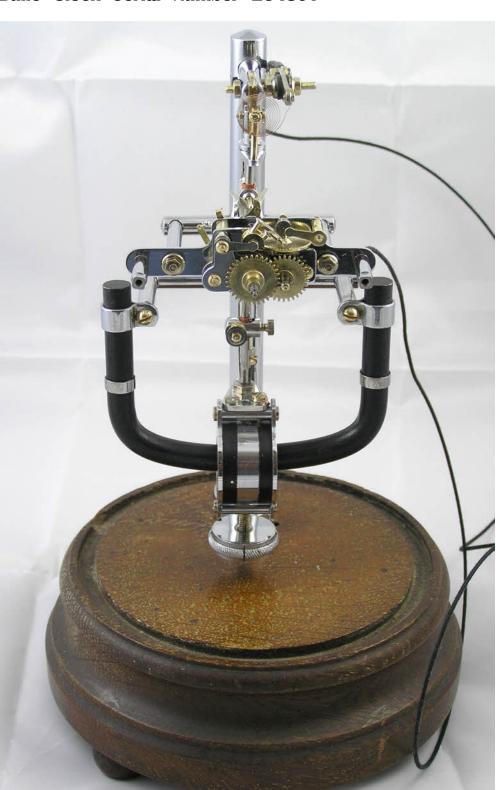
The clock reassembled on an old Bulle base for testing. Once the clock is back in its four glass case it is nigh on impossible to reach the parts if testing shows up any issues. So I had an old oak base from a similar clock which is now utilised as a test stand.

It doesn't look quite so impressive on this base as it does in its four glass!!

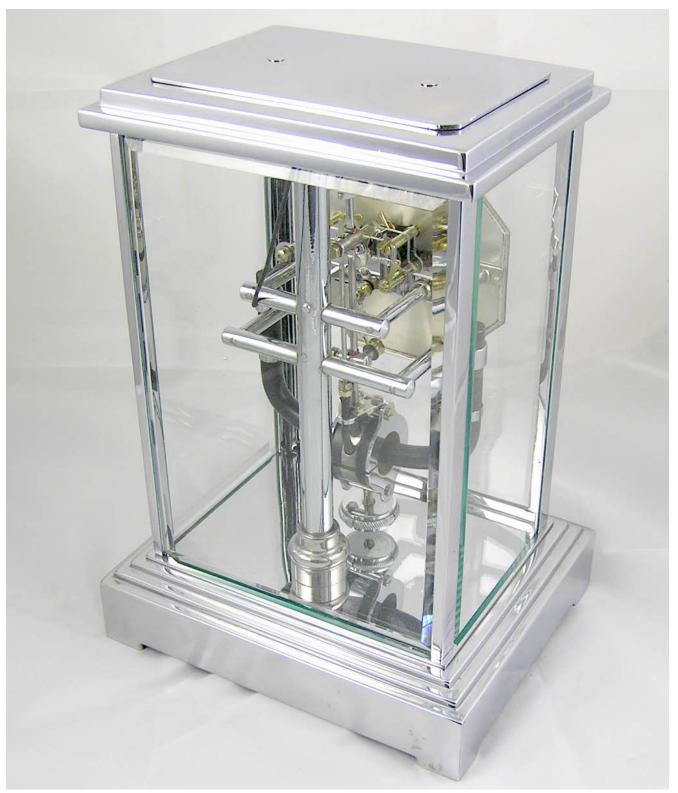
The rear of the completed clock
