Bulle Clock Serial Number 342201

Restoration of Bulle Clock Serial Number 342201

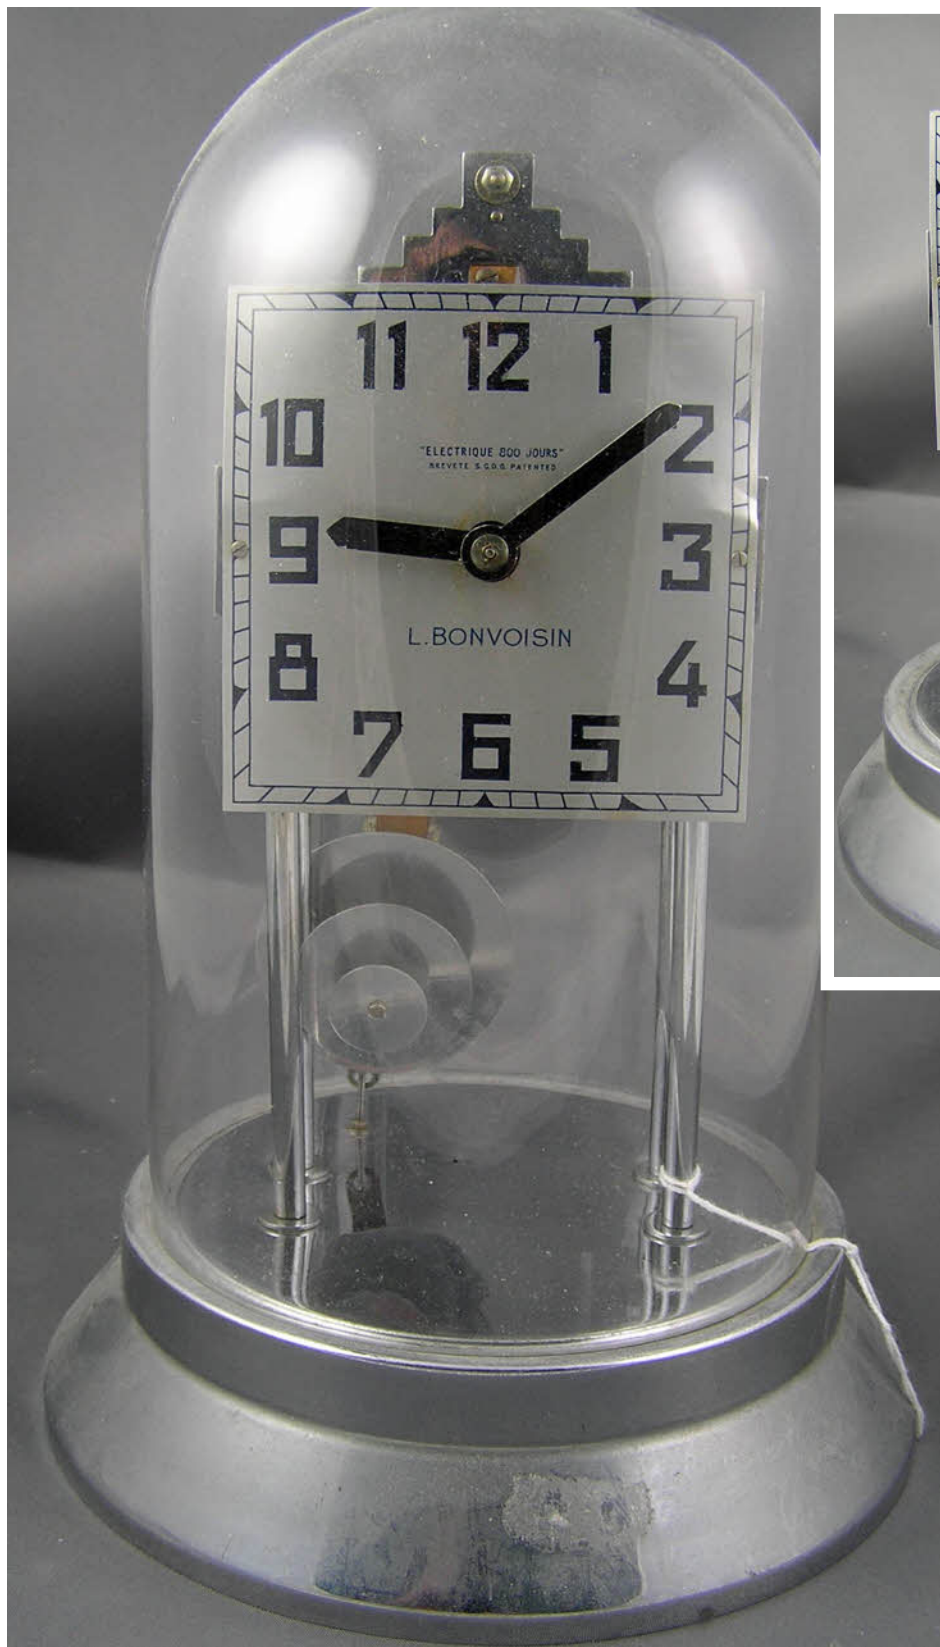
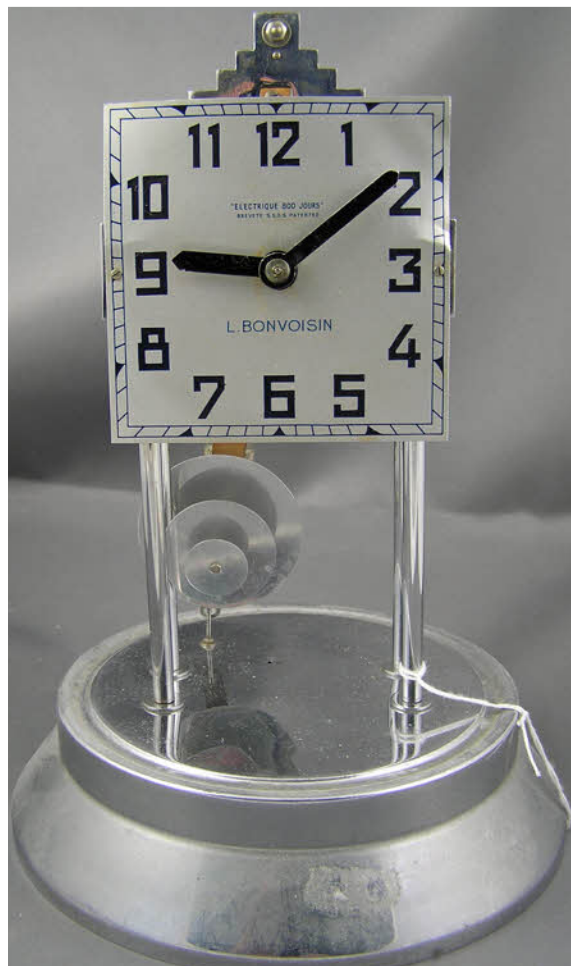
This clock sits on a thin polished aluminium base under a glass dome. The s/n shows it to be a very late model probably into the 1940's.. The pendulum is some sort of flat fibre rod with large decorative aluminium disks at the end. The regulation weight is hidden at the back of the clock. The suspension consists of a pivoted arbour completely unlike the early versions. The clock looks complete but is quite dirty.

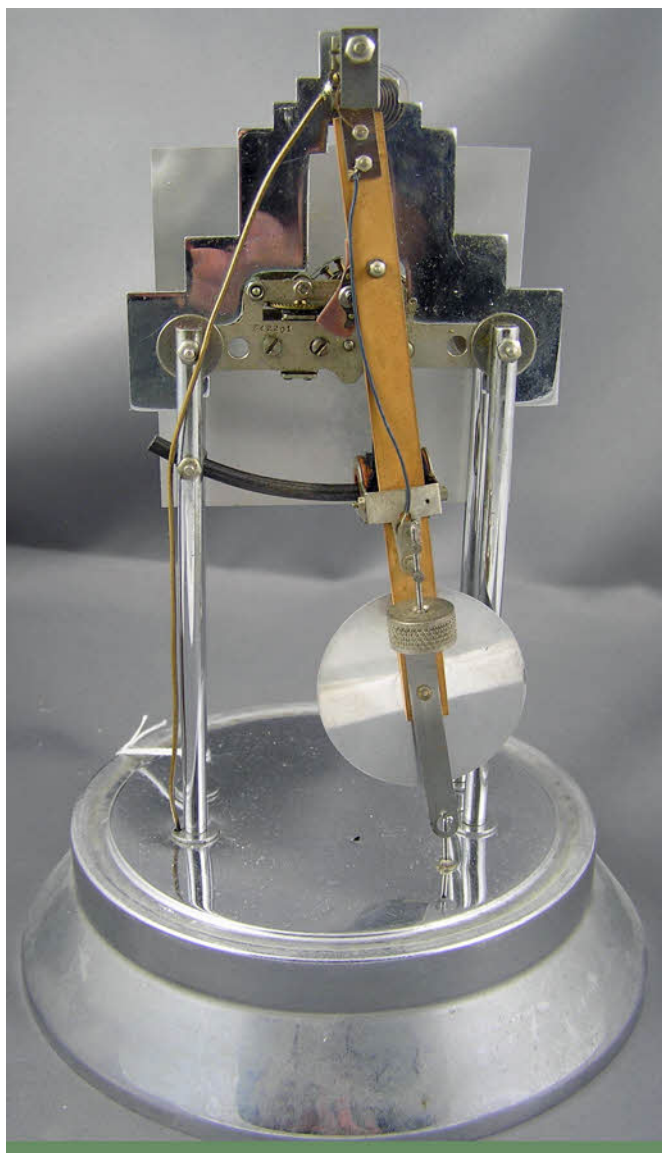
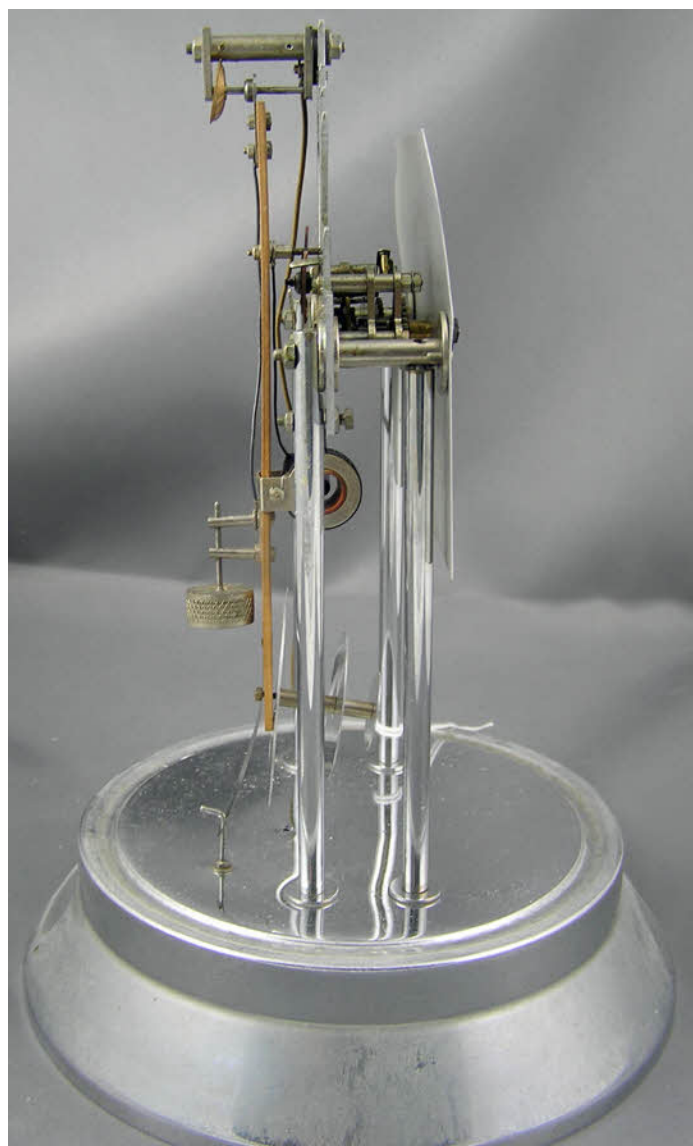
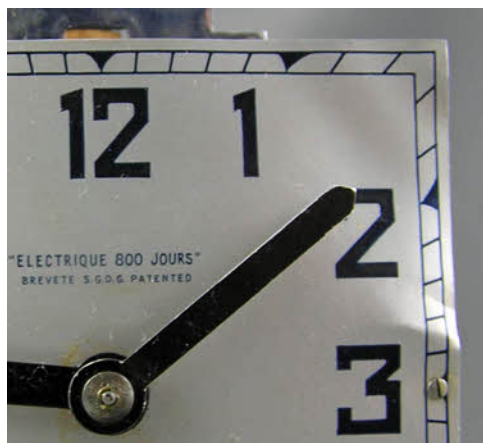
The large magnets on earlier clocks have now been replaced with these much smaller cobalt magnets which are only fixed on one side leaving a large gap on the other. Some clocks have the arc of swing completely closed with a dummy magnet of brass or other non magnetic material secured to the other side of the frame. This example could allow the coil on the pendulum to be completely disengaged from the magnet and swing free. But the suspension does tend to hold the pendulum in a rigid arc. For travel the pendulum is secured by a simple hook and eye as seen in the first photo above. The photo at left shows some damage to the thin aluminium dial. These dials being so thin are very prone to damage at the slightest knock. I should be able to straighten it better than what it is now though.

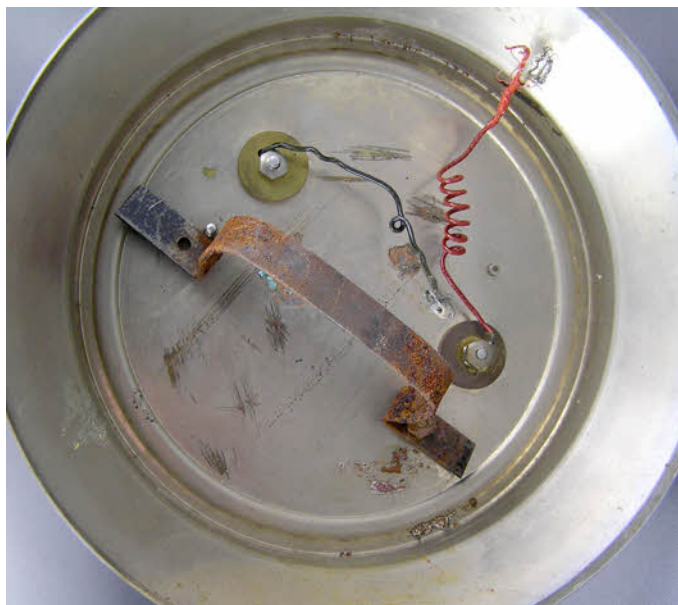
The underside shows the badly corroded battery strap. I shall see how much steels is left after cleaning and decide whether it is worth keeping.

The strap has been cleaned as best I can. The rust has been removed and there is just enough metal left to make it serviceable. The base itself has some bad corrosion marks which have thinned and holed the base in places. But they should not be that noticeable

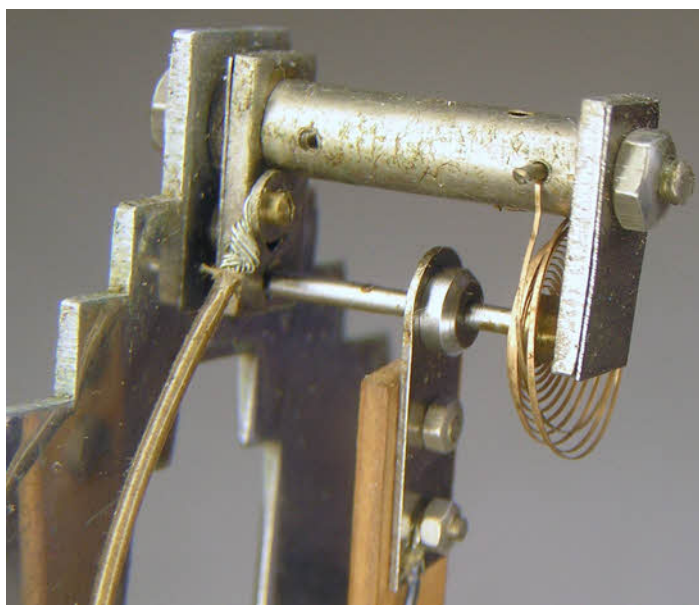
The suspension with hair spring to maintain electrical contact. The suspension is isolated from the frame by fibre washers.

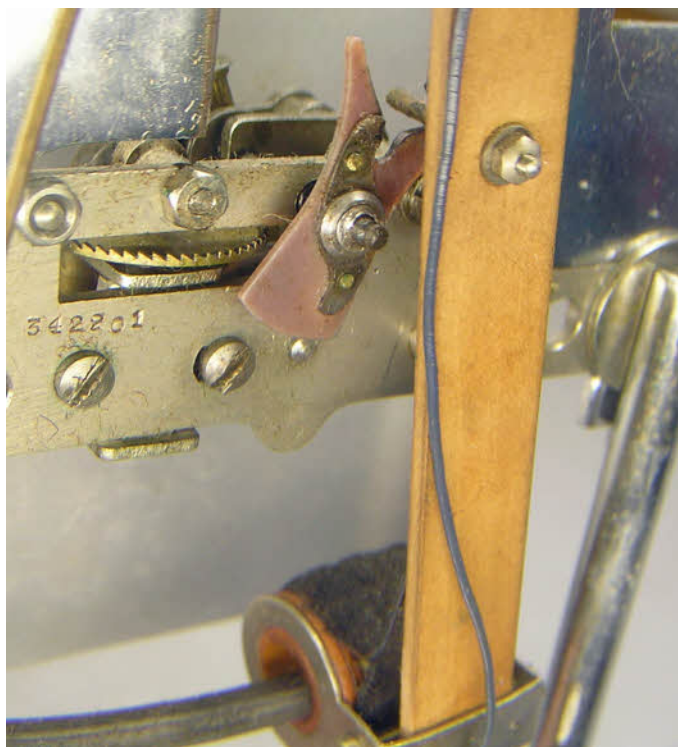
The rear of the movement showing the fork and non adjustable contact pin. Its height is fixed which can make it difficult to regulate the clock.

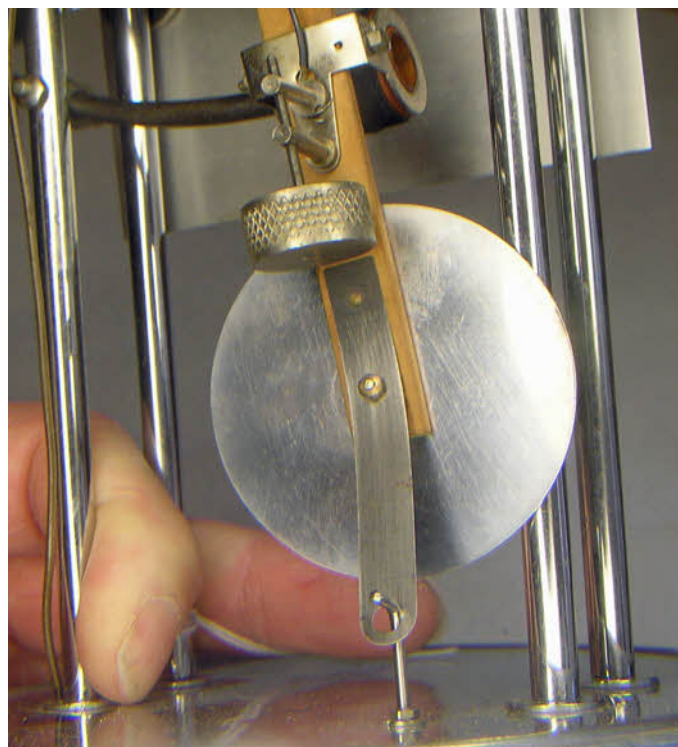
The hook and eye of the pendulum. Note the small aluminium rating nut.

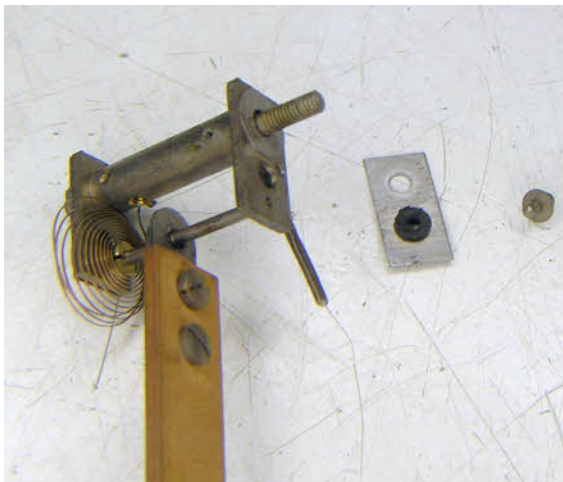
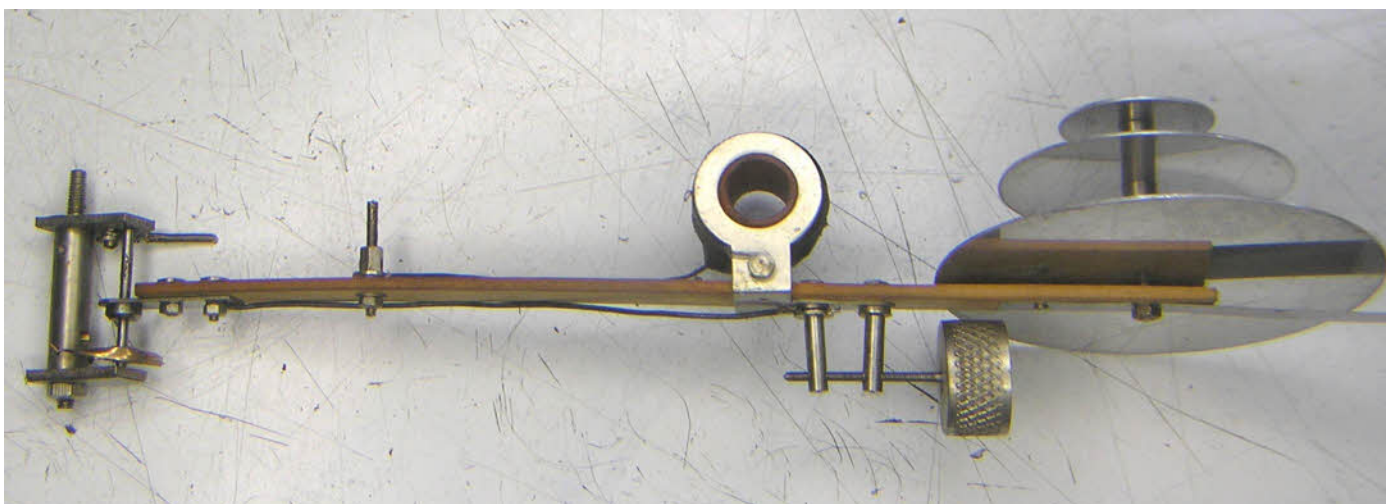
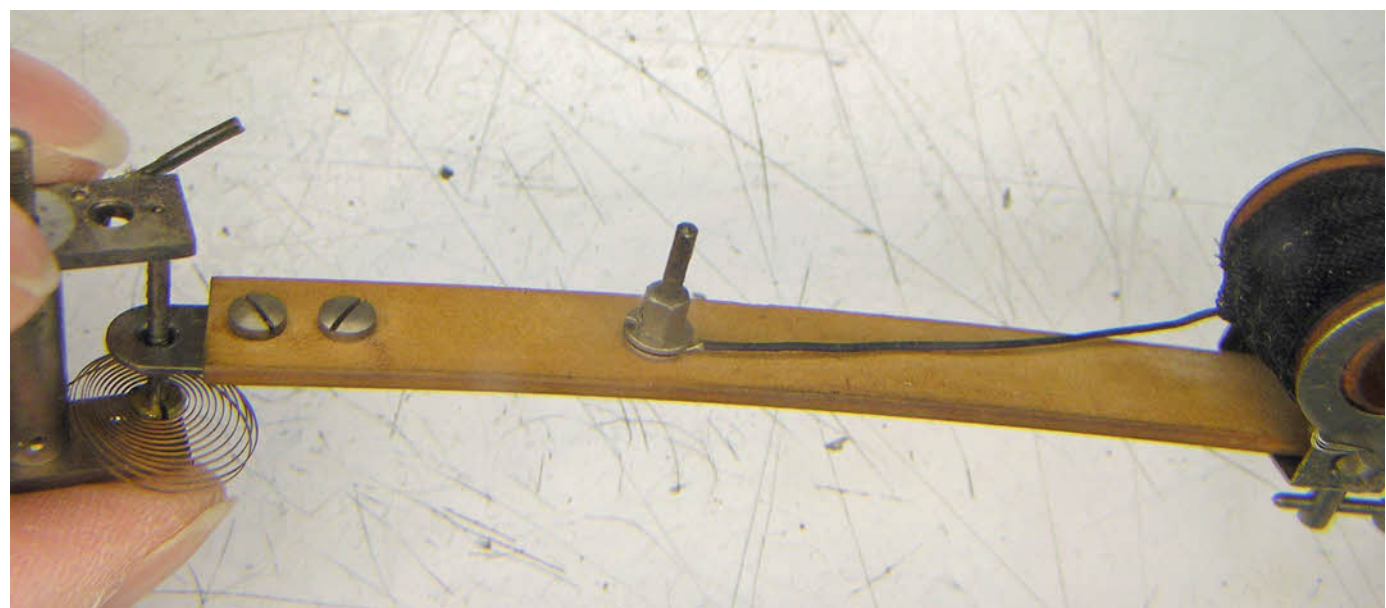
Some more detail photos of the pendulum and suspension. These later clocks were made with cheaper materials and although they were probably easier to manufacture they are more difficult to restore than earlier clocks. As you can see the pendulum rod is slightly bent, but the material it's made of, makes it very difficult to straighten successfully. Note also that there is no adjustment possible with the contact pin. Its fixed position means that it cannot be adjusted up or down in the fork. The cobalt magnet is also a problem in that it cannot always be re-magnetised to the same strength as when first manufactures.

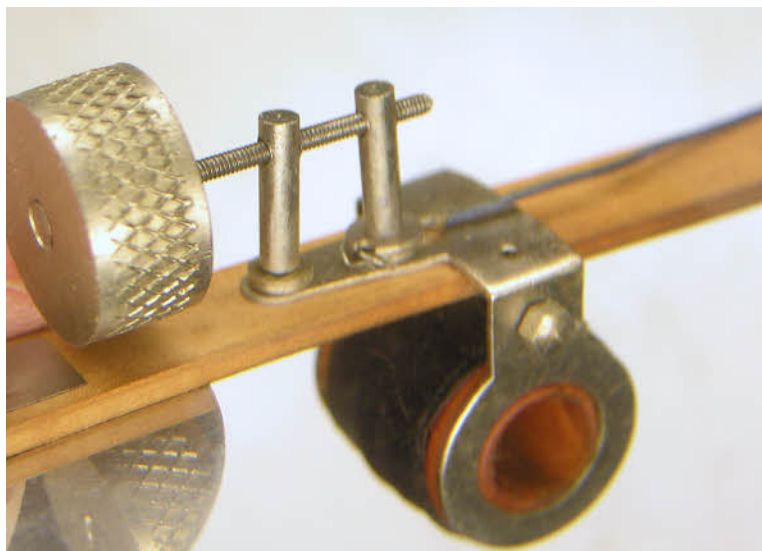
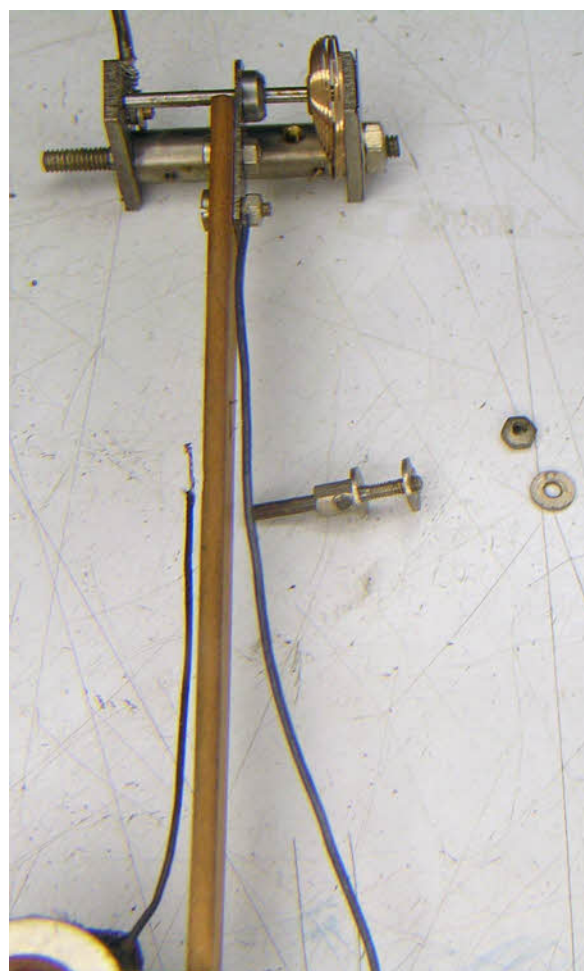
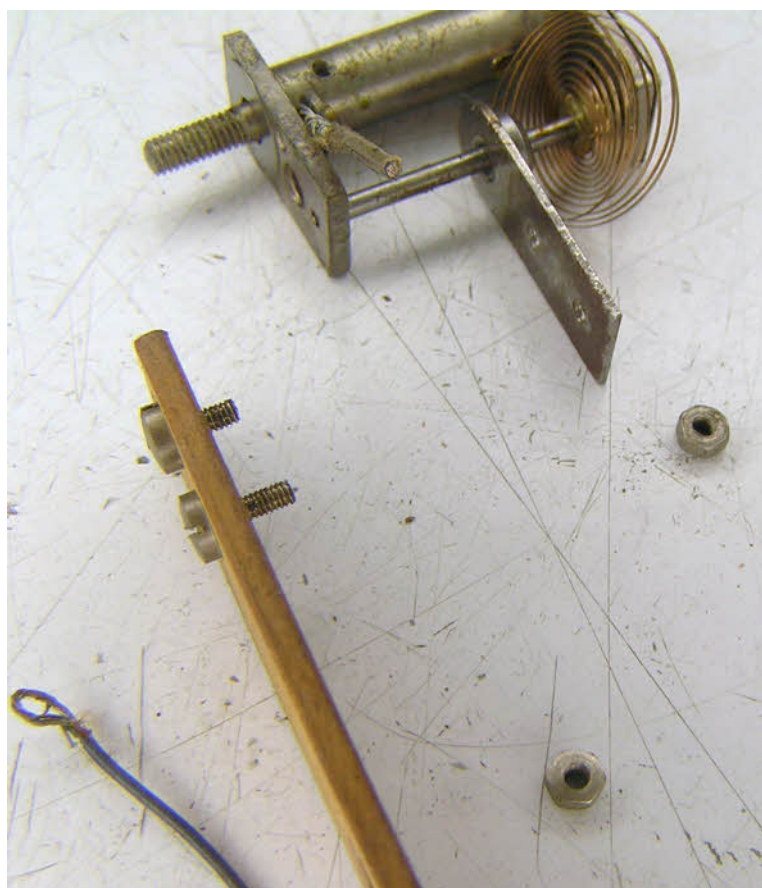
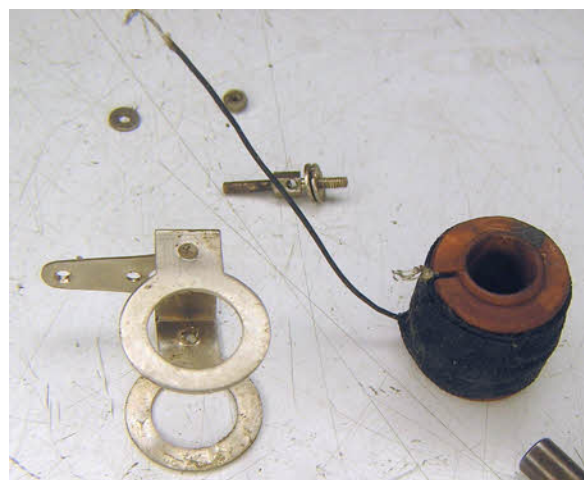
I thought it may be useful to show a few more photos of the pendulum assemblies as they are a little more unusual than most I see in the workshop. Another area where manufacturing has changed is in the makeup and material of the contact pin itself,. In this model the pin is made from brass and not silver.

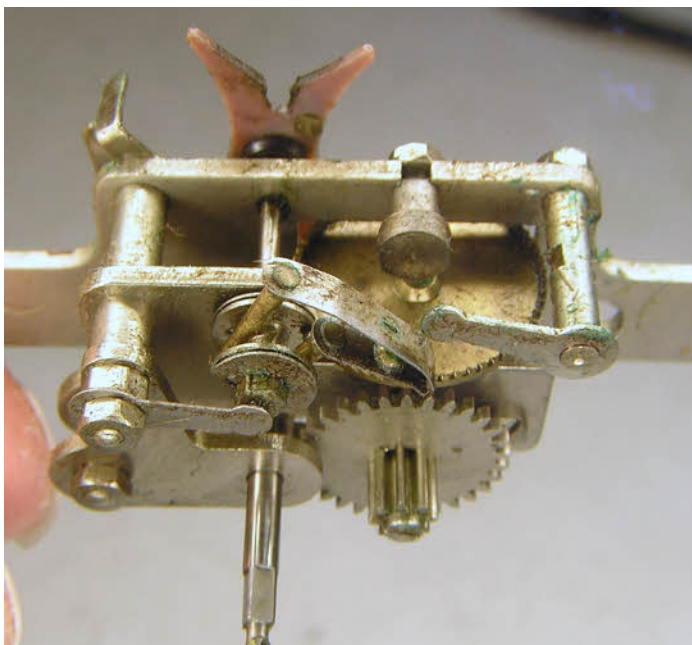
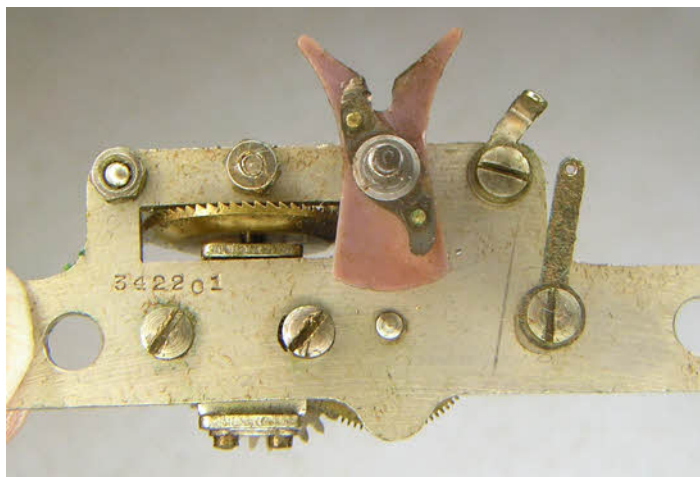
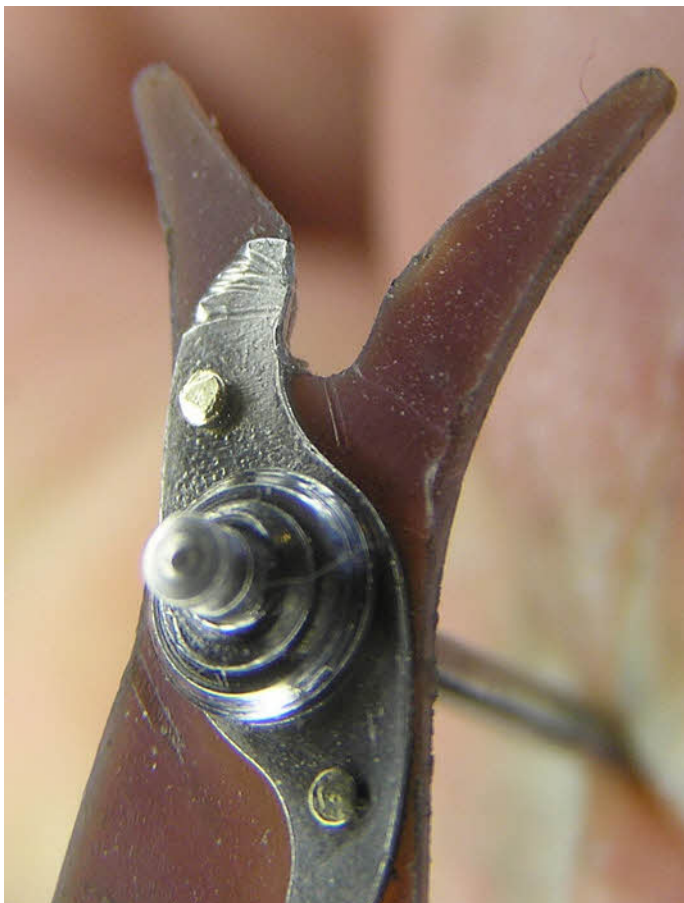
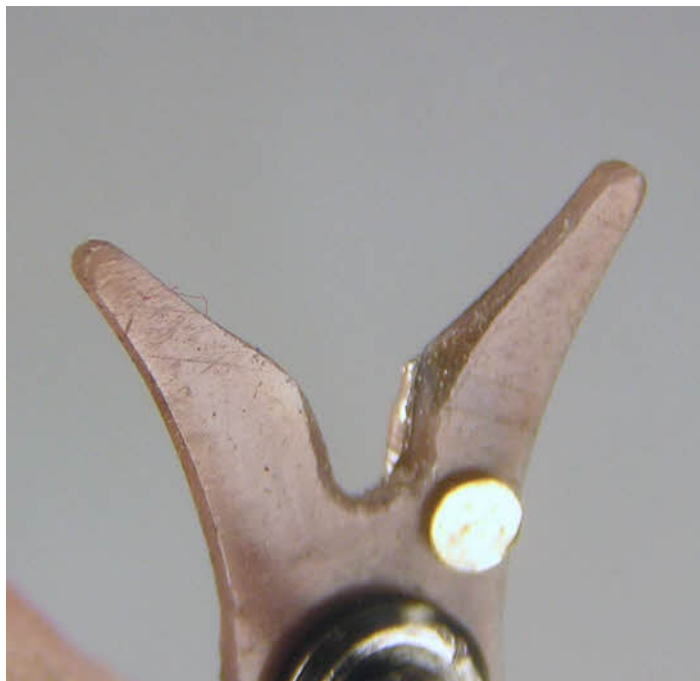
This type of fork is not uncommon on later clocks. Bulle seemed to use many colours of this plastic type material. I have seen black, blue, red, pink and clear. There were probably others as well. I guess it must have made manufacturing easier because no insulator was necessary if the fork itself is an insulator. But note the wear in the fork canyon and the damaged silver contact. I will have to replace the fork completely. The photo at top left shows the dirty nickel plated movement.

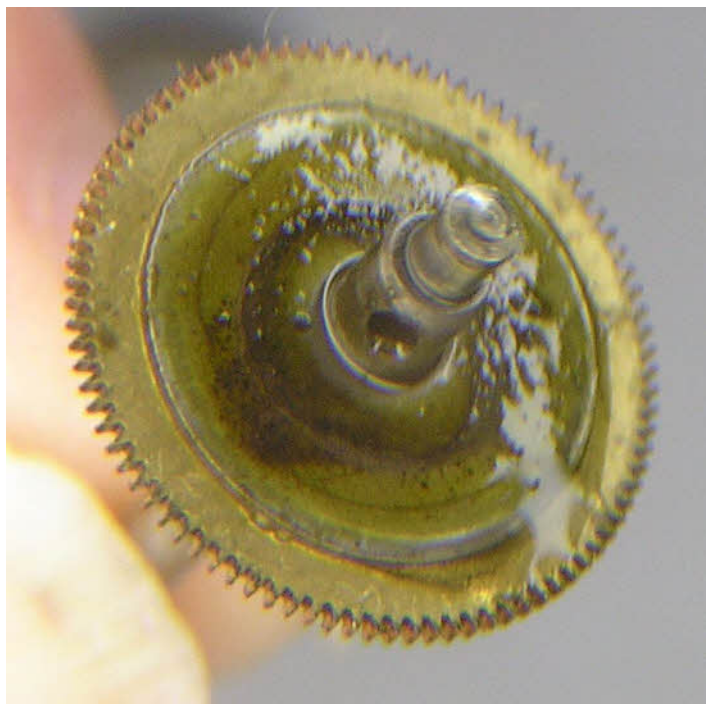
The clock seems to have been well oiled!!!

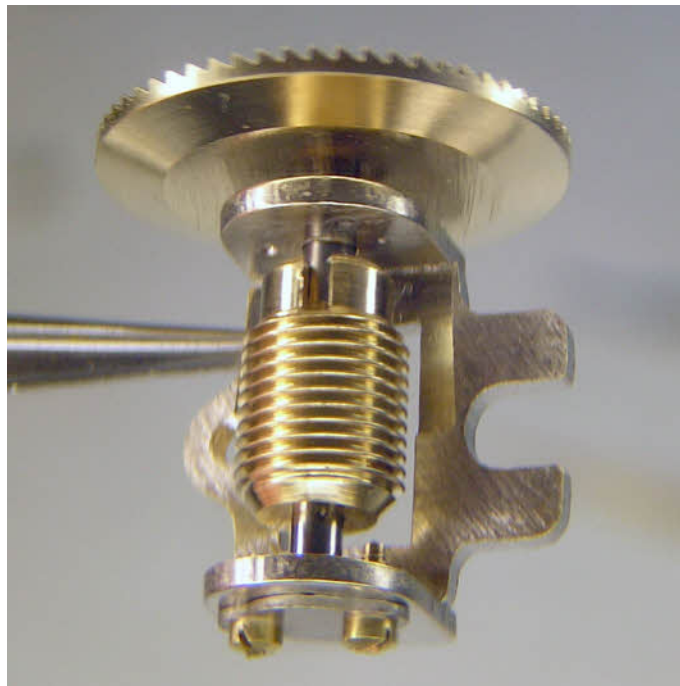
The cleaned worm wheel assembly.

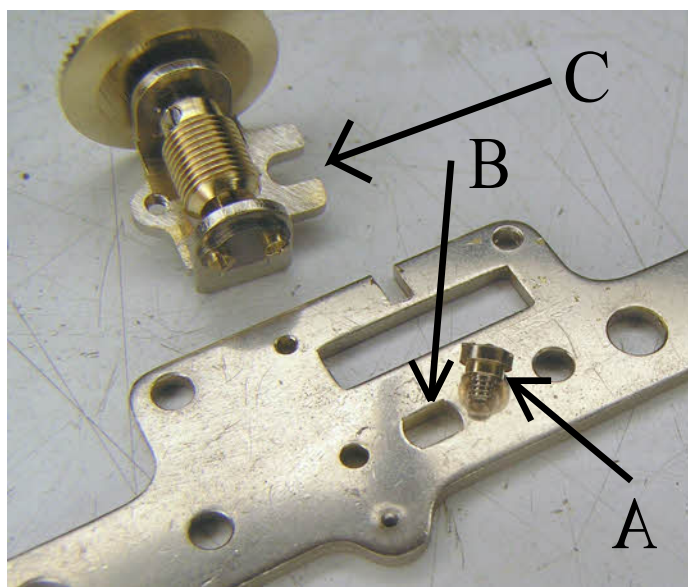
The worm wheel assembly ready to be mounted back on the main movement plate. Always make sure that shouldered screw "A" runs back and forth easily in the slot made for it "B" before securing the worm wheel assembly "C". It makes it much easier to adjust the depth of the worm and centre wheel later on.

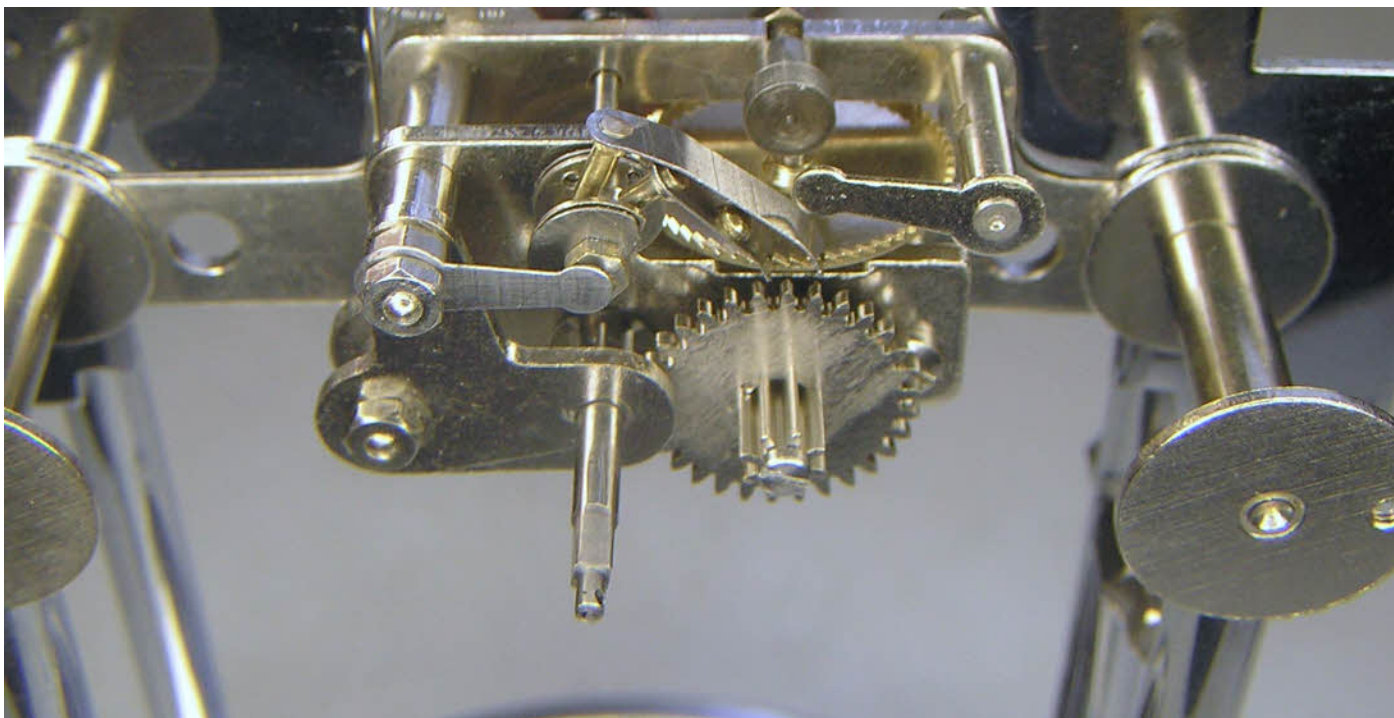
The cleaned movement back in place. The method of mounting the movement on the frame makes it very difficult to make adjustments when testing.

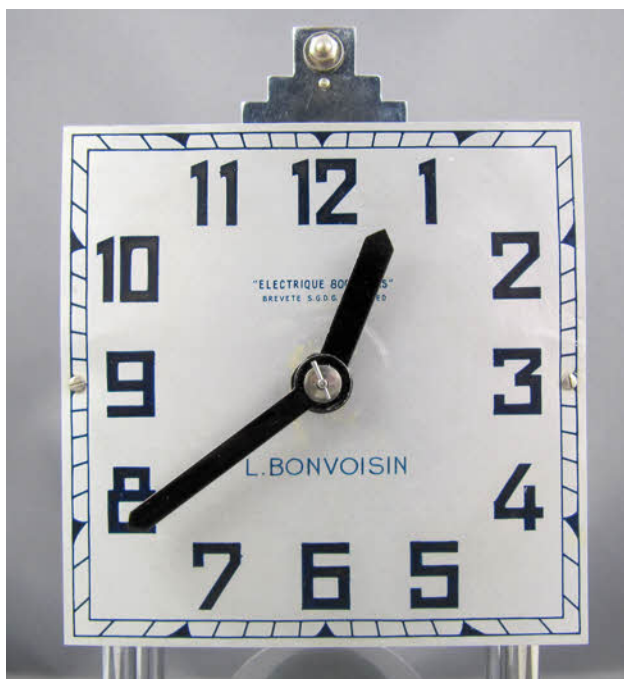
The dial has straightened out quite well.

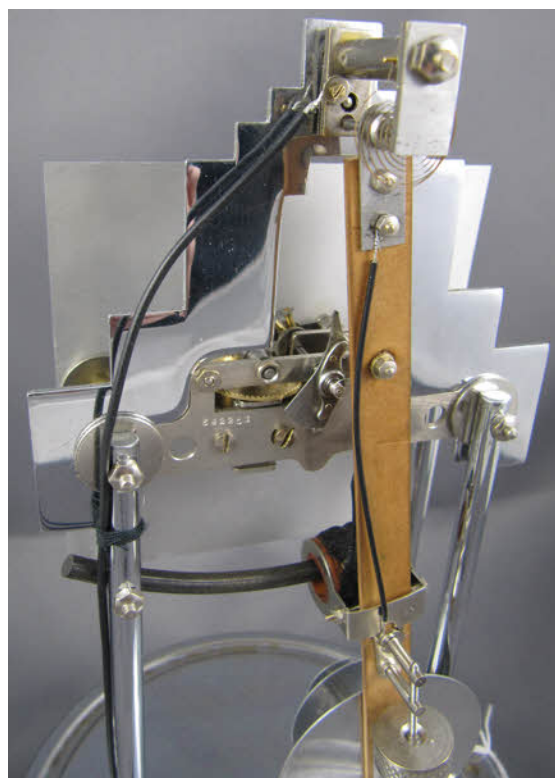
The photo on the right shows the movement and pendulum back in place

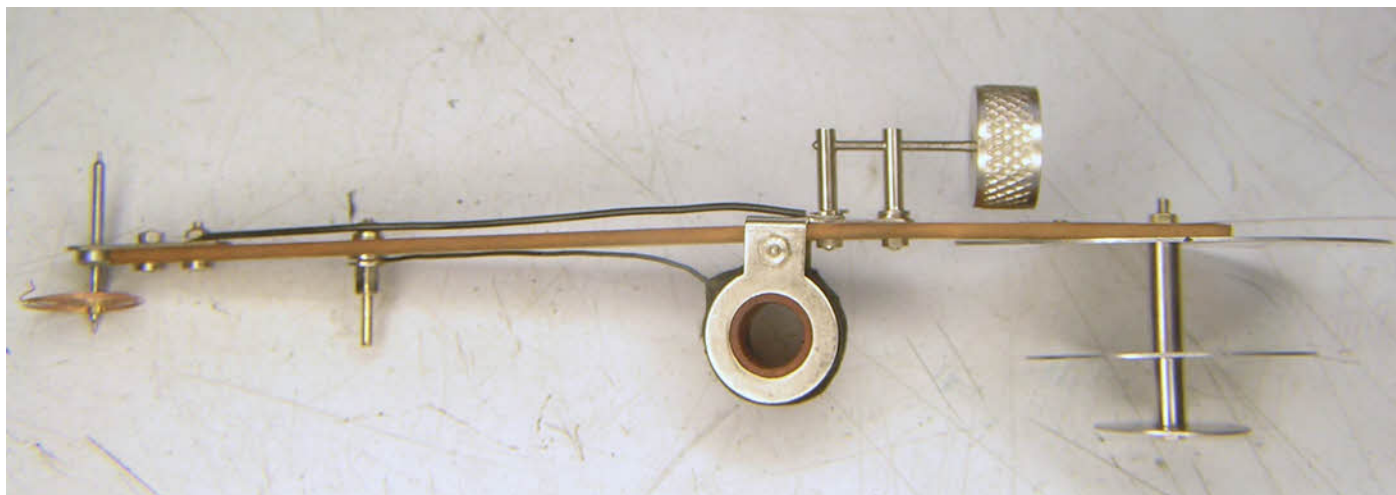
The pendulum restored and straightened as much as I dare.

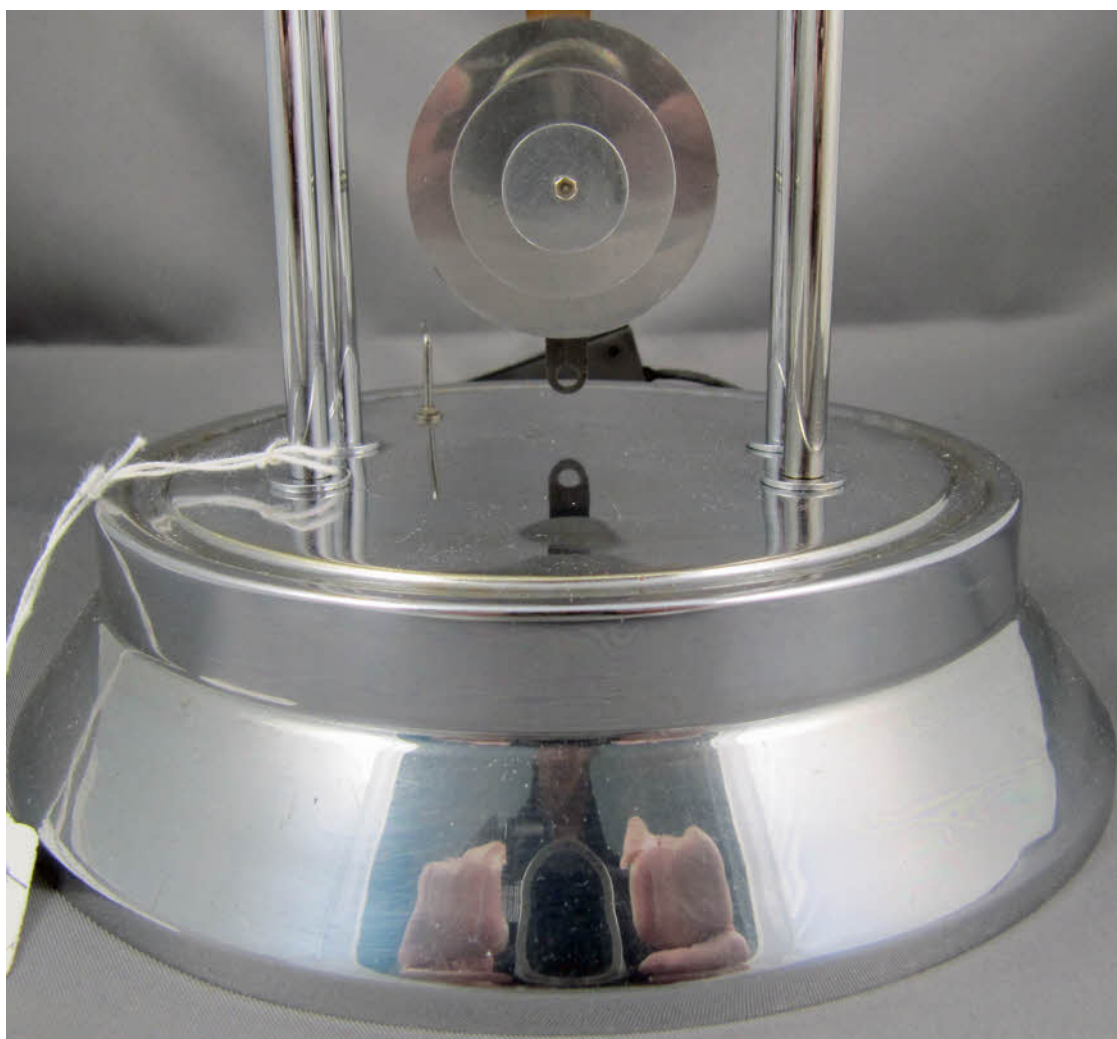
*The base cleaned
and lacquered.*

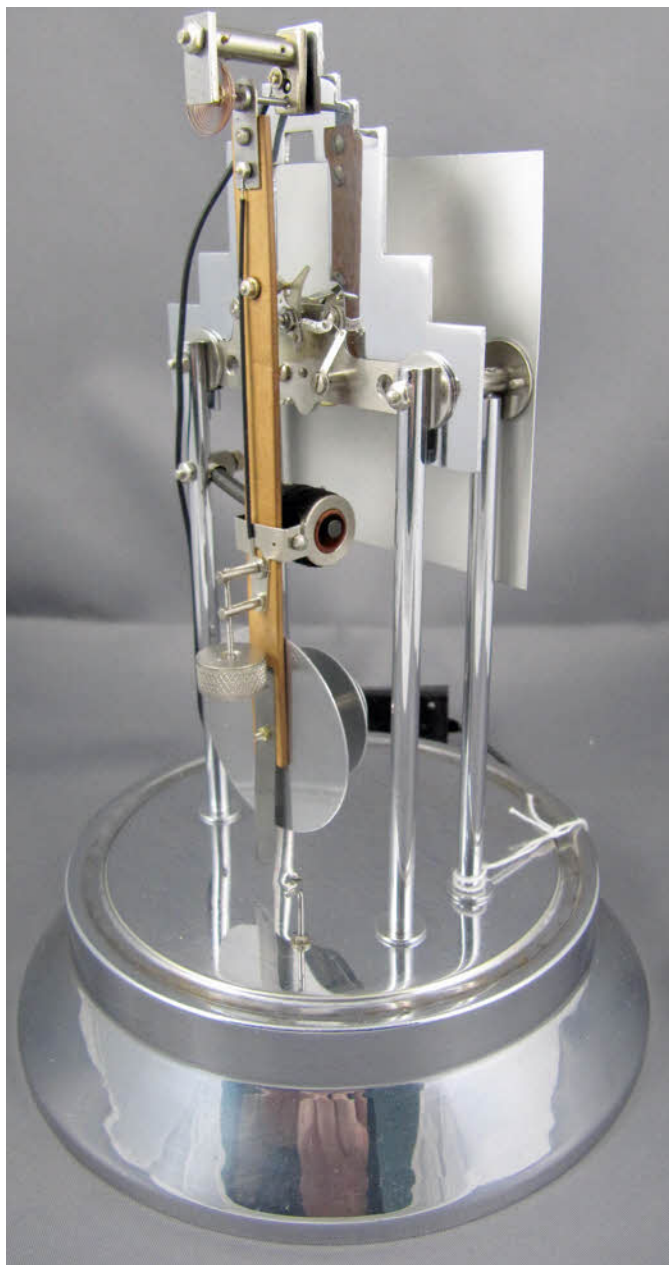
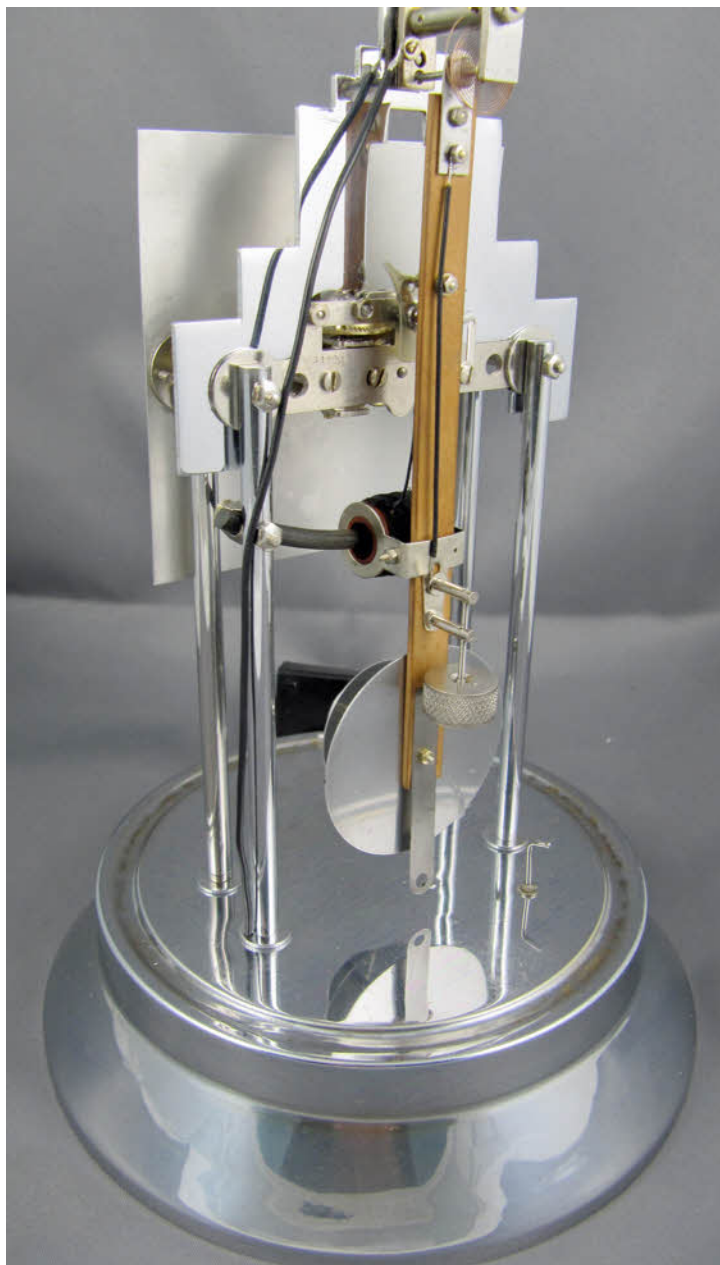
The completed movement from both sides.

The magnet proved to be a little weak even after re-magnetising. Unlike the earlier magnets the cobalt version is only magnetised with two poles and not three. I had great problems trying to get the clock to give enough impulse to the pendulum to drive the count wheel successfully. I even changed the brass contact pin for a silver one. After many trials I decided to introduce a voltage regulator to the base which would allow a little more voltage to be introduced to increase the amplitude of swing. I found that the minimum required was 1.8 volts which is just over the maximum you would expect from a brand new "AA" or "C" cell battery.

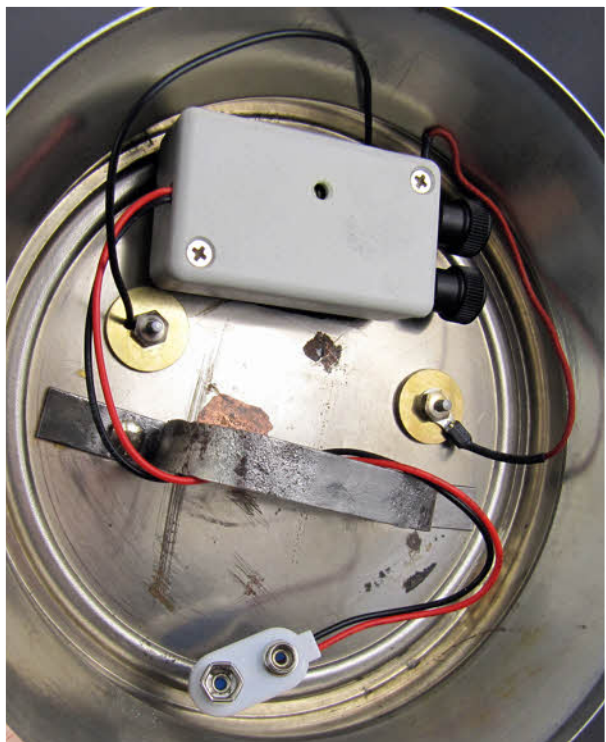
The regulator in place within the base. It is the same circuit as in the BU022 and EU005 regulated battery holders, but because the aluminium base of this clock is quite shallow I had to house it in a small box. The regulator allows any voltage from 1.25v up to 3.0v.

The clock has now been running well within 3 minutes a week for the last 3 months.

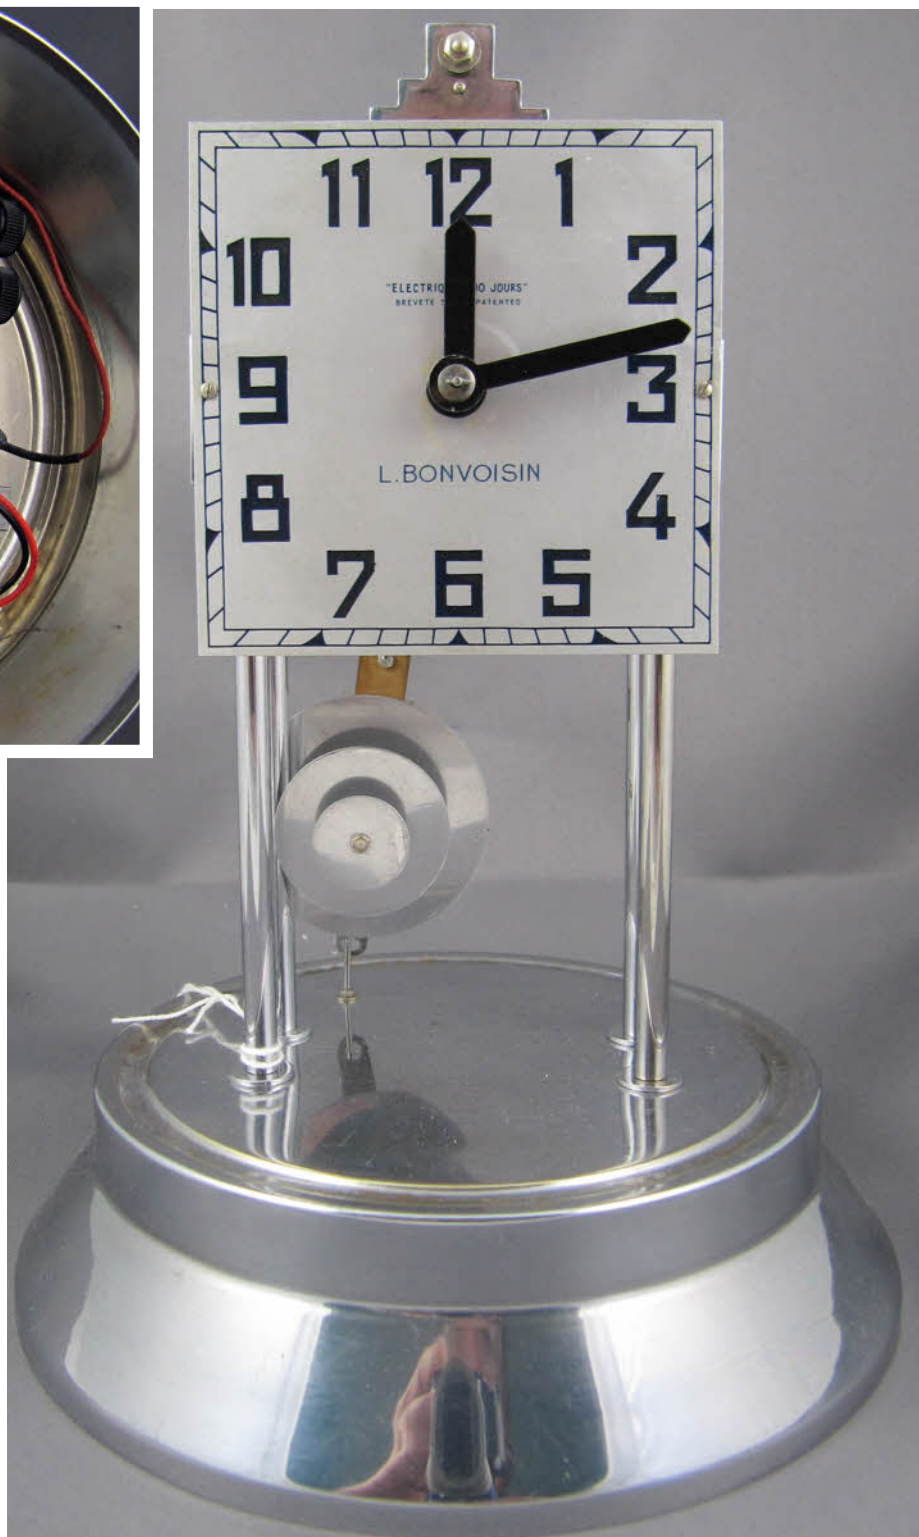
The last photo shows the finished clock.

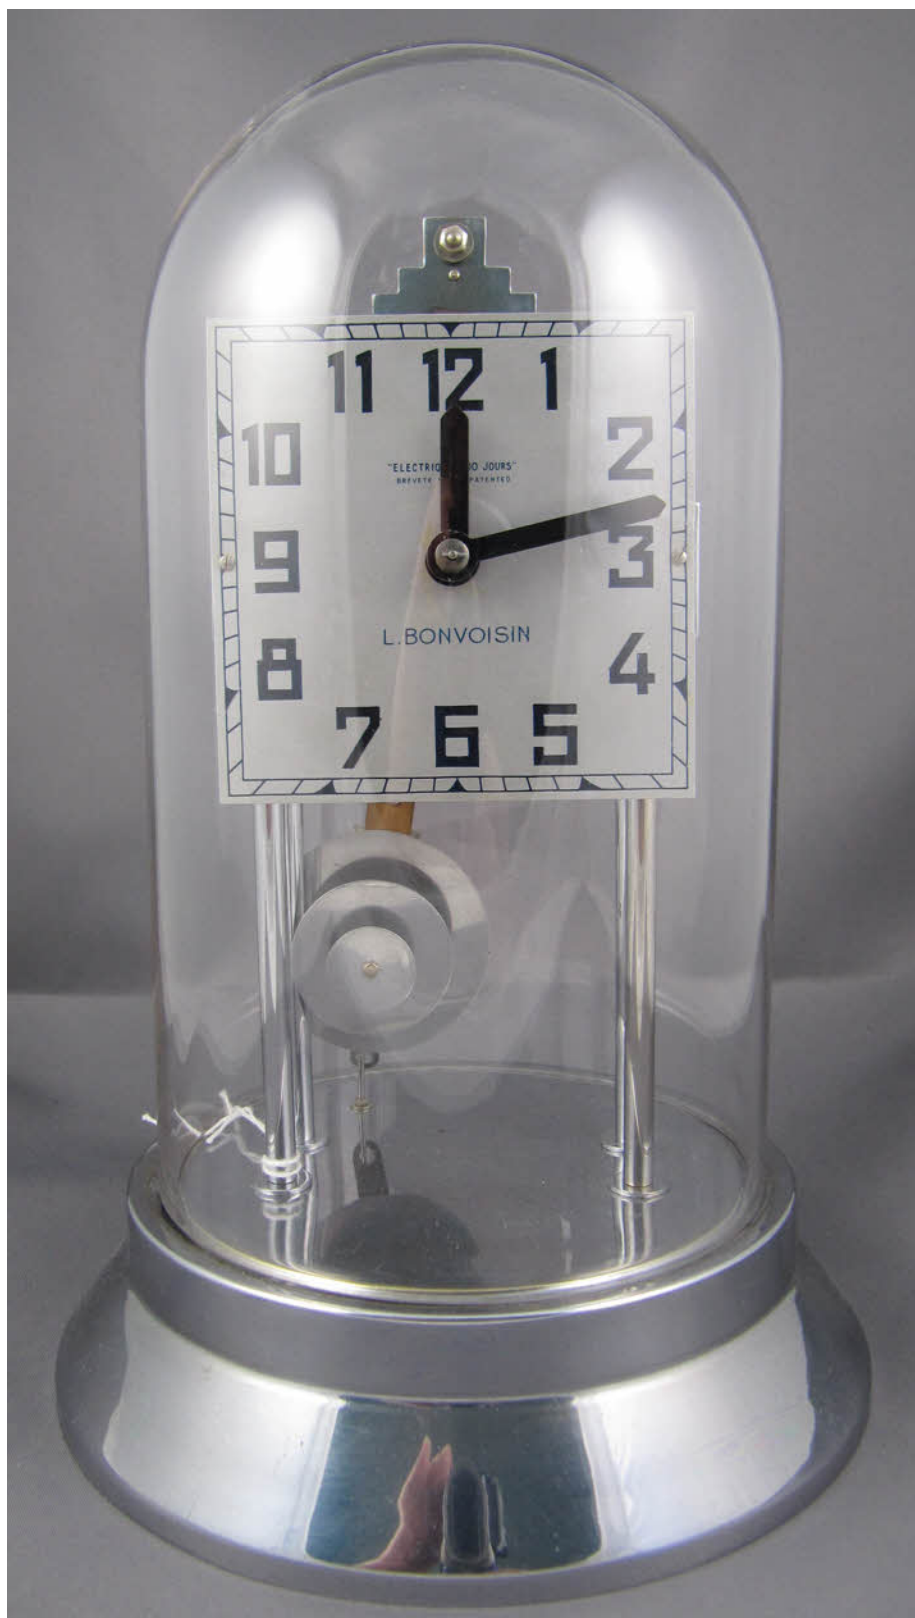
The finished clock
