Bulle Clock Serial Number 3899

*Restoration of Bulle Clock
Serial Number 3899*

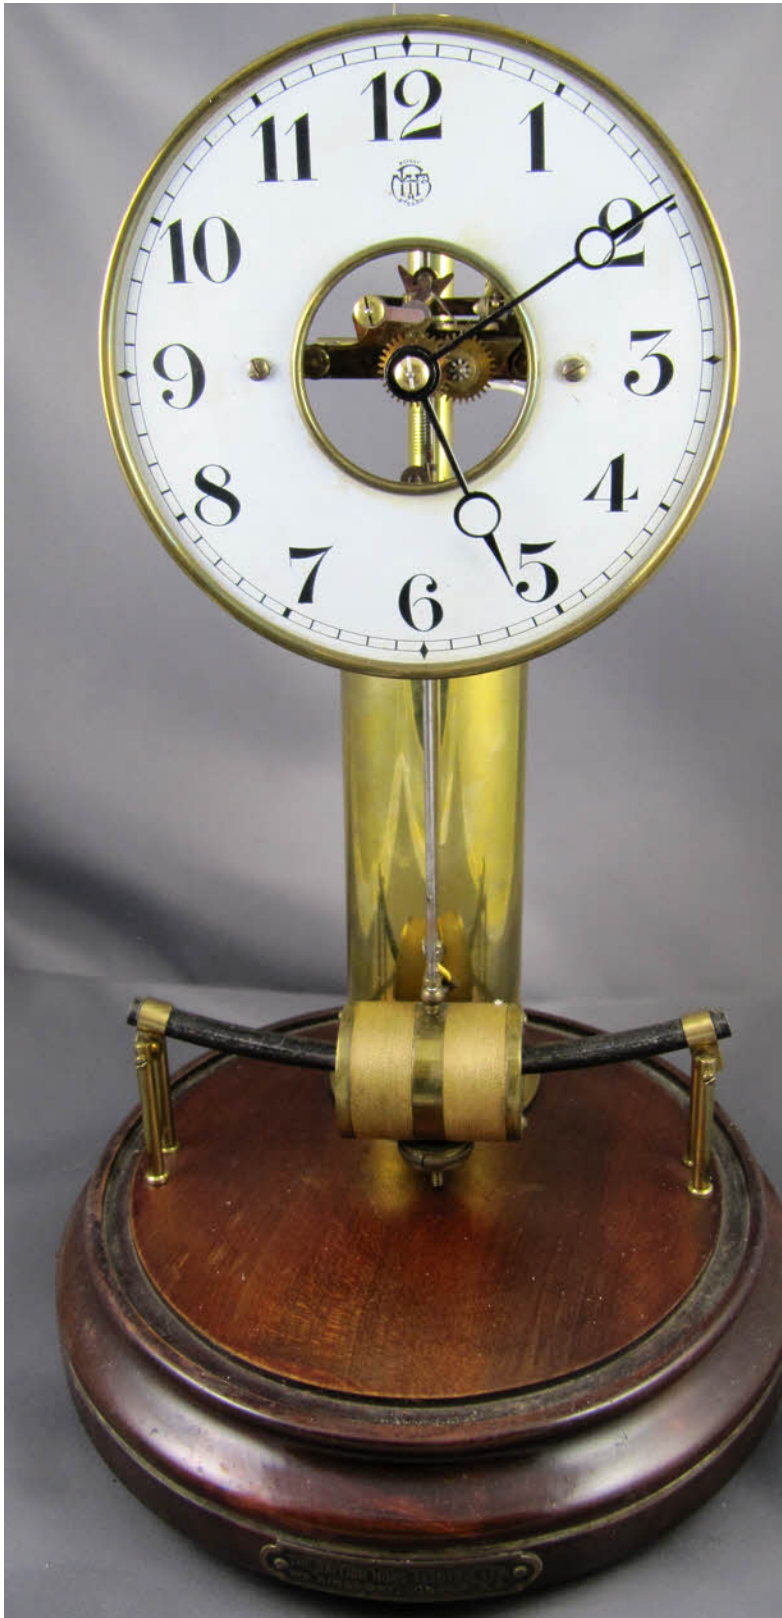
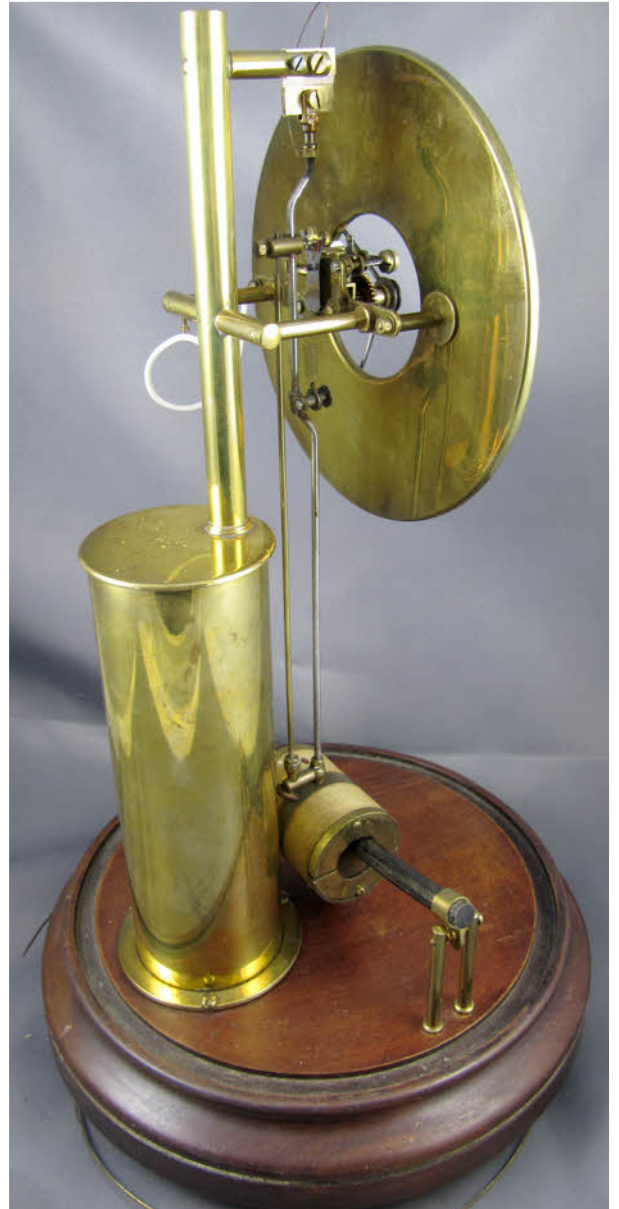
Photos by kind permission of the owner. This is a tall movement on a round wood base found in the 1925 catalogue as an "A" type. This early clock dates from circa 1921. The dial with its moon hands, is in excellent condition. The whole clock looks in good original condition and doesn't seem to have been played around with too much.

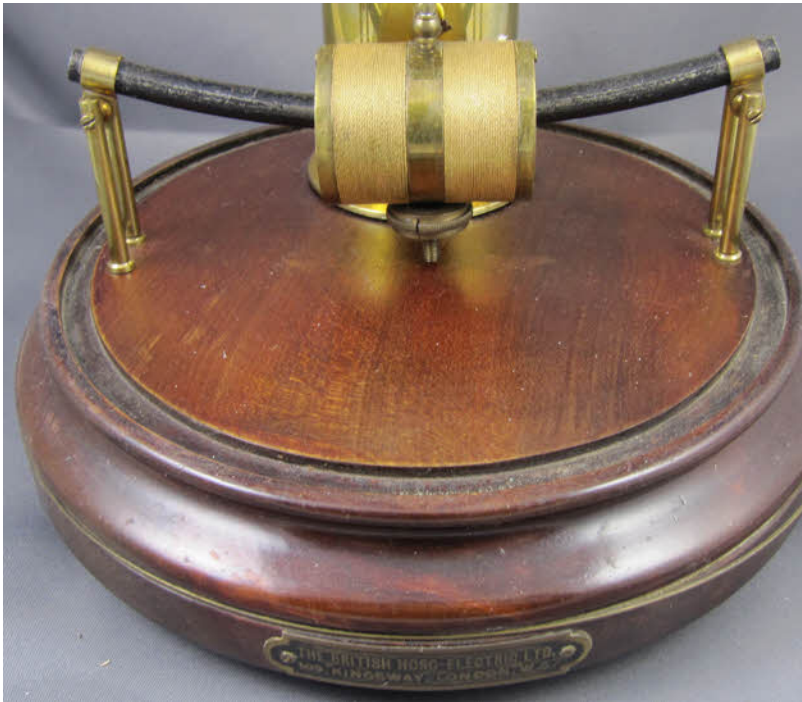
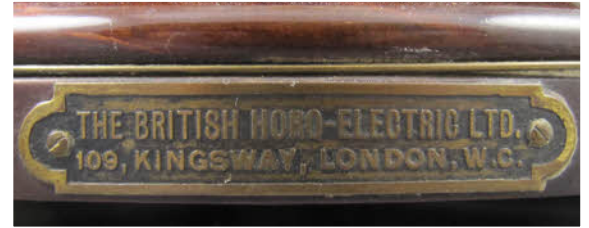
The base is a little tired with some scratches. It will be cut back and given a few coats of French Polish. The oblong label shows that this was imported and sold by "The British Horo-electric Company of London. Although it looks as though the label is secured by small screws they are in fact sharp pins as can be seen below

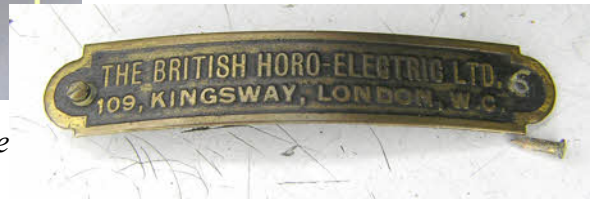
This photo shows the base of the clock with the mm brass wire banding which is heavily corroded and broken (arrowed).

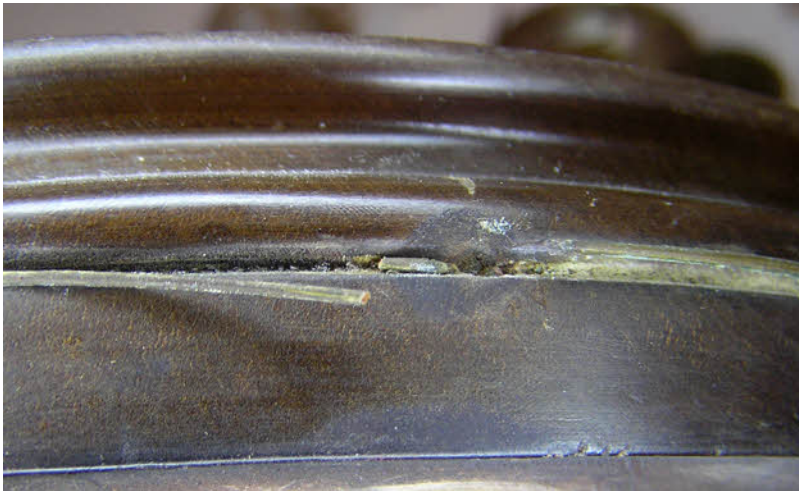
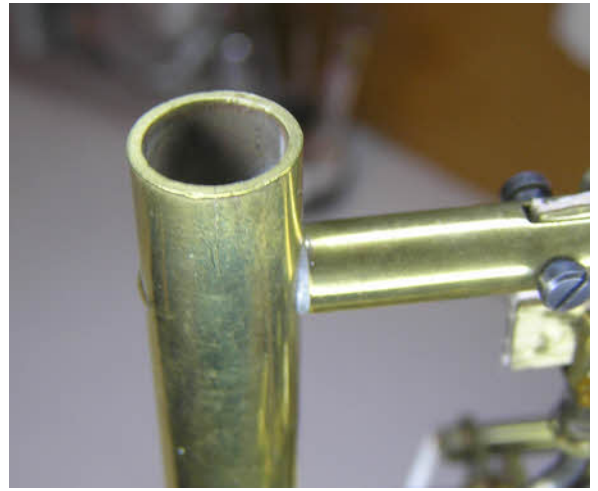
Two photos showing the corroded brass decorative wire and the top of the frame tube.

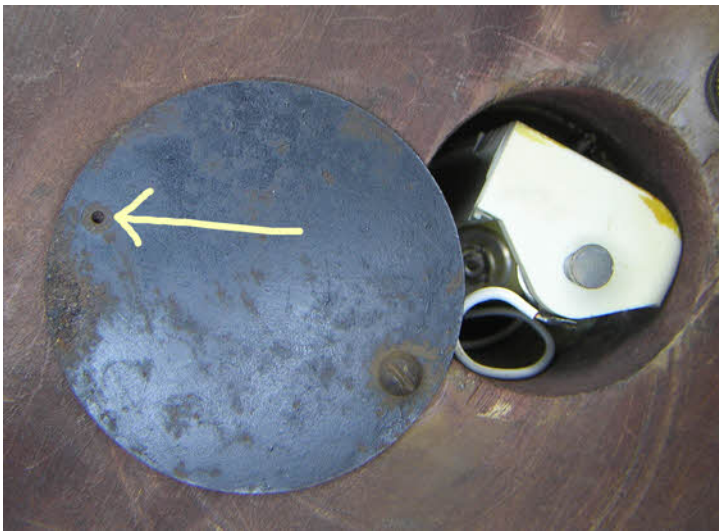
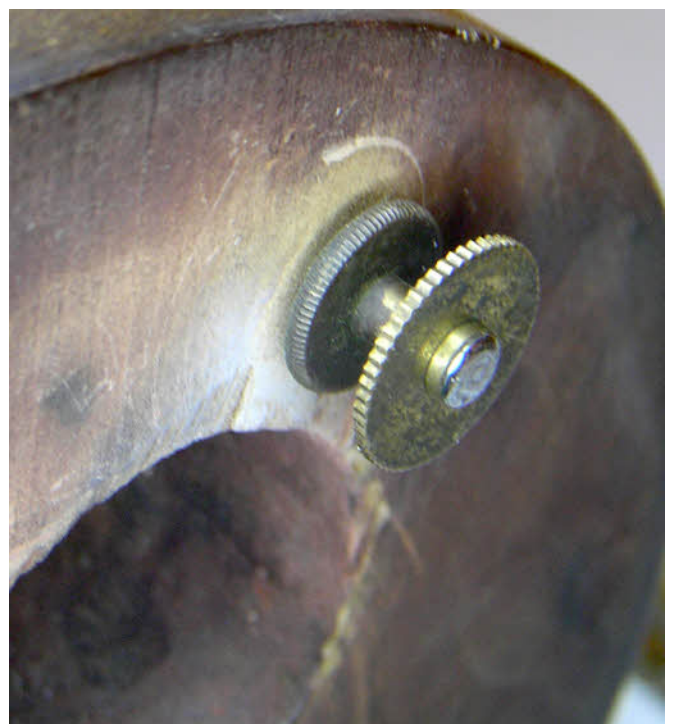
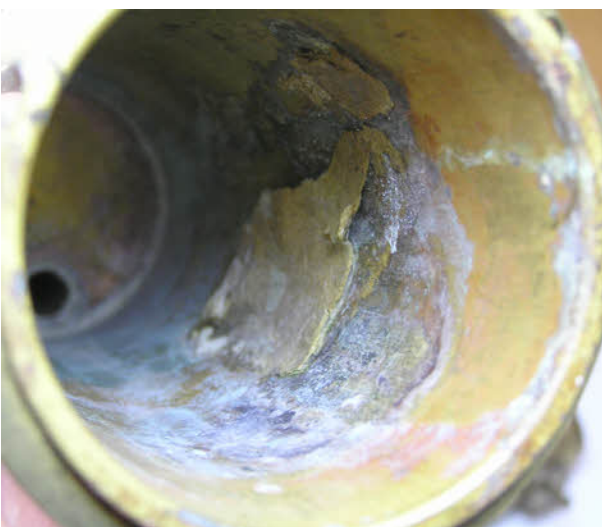
The photo left above shows the corroded battery compartment cover with missing brass knob. The photo above shows the third levelling foot which has a knurled extension added to compensate for the fact that the original screws has worked loose over the years and will fall out of the wood if unscrewed by more than a millimetre or two. This will be corrected. The photo as left shows the corrosion inside the tube.

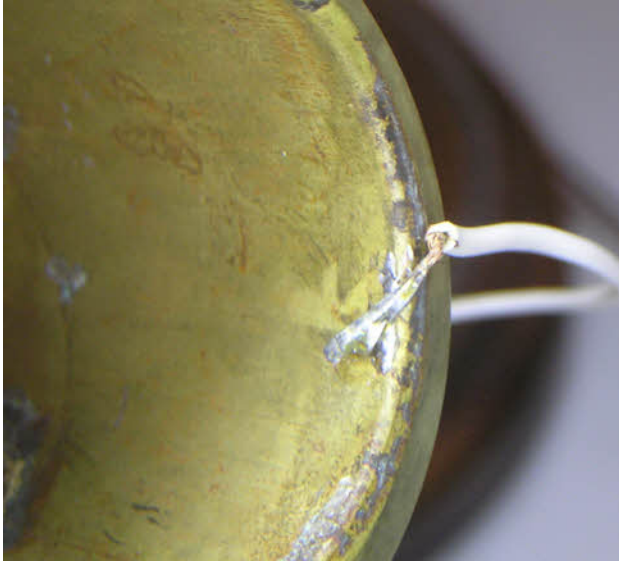
This photo shows the negative lead wire soldered to the column. This will be removed.

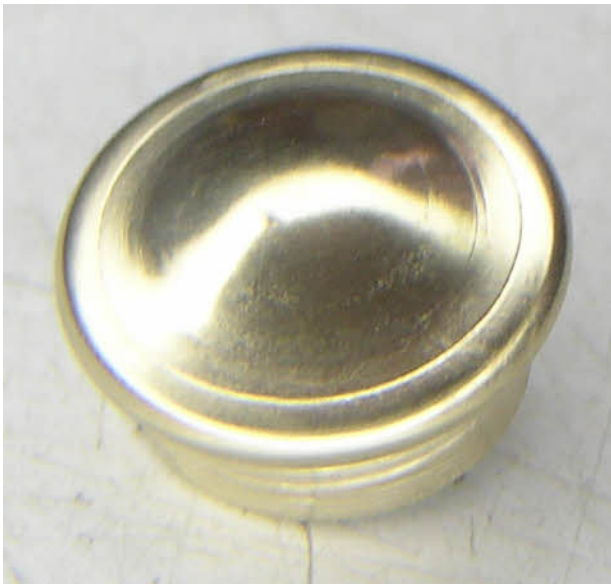
The new domed cap (above) ready for insertion into the top of the frame.

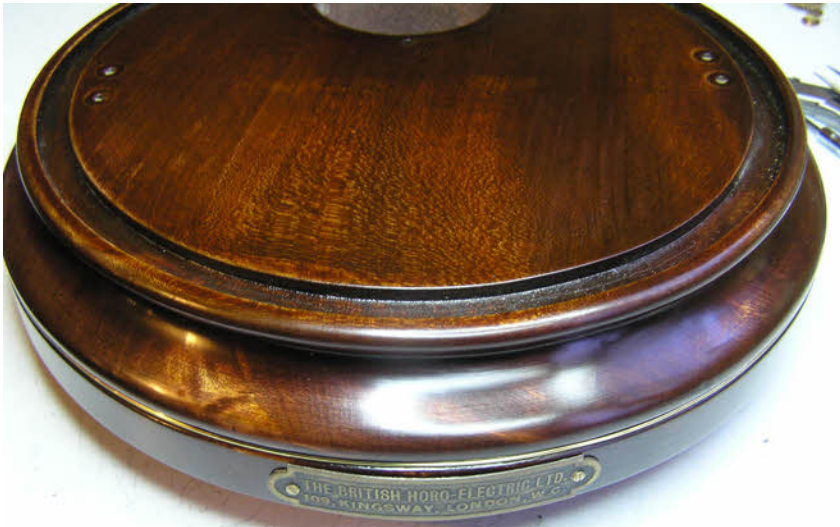
The polished base with new decorative 1.00mm brass wire, and the restored levelling screw back in place

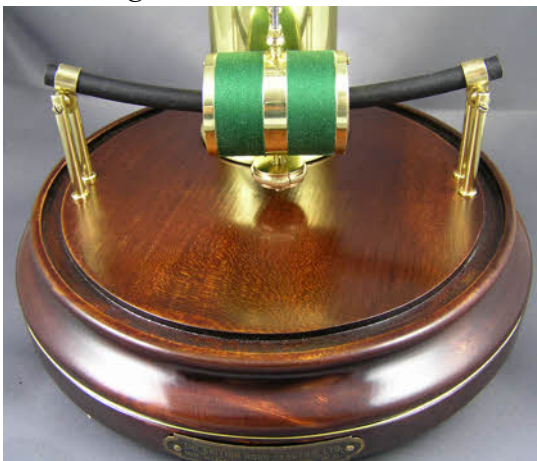
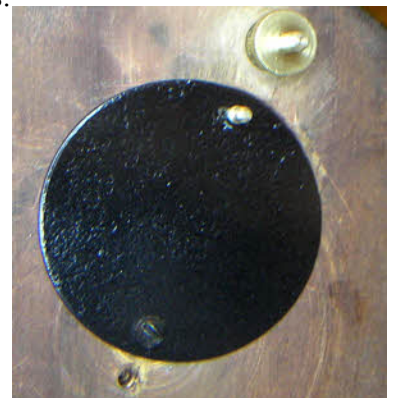
The pendulum base and magnet back together and the refurbished battery compartment cover with

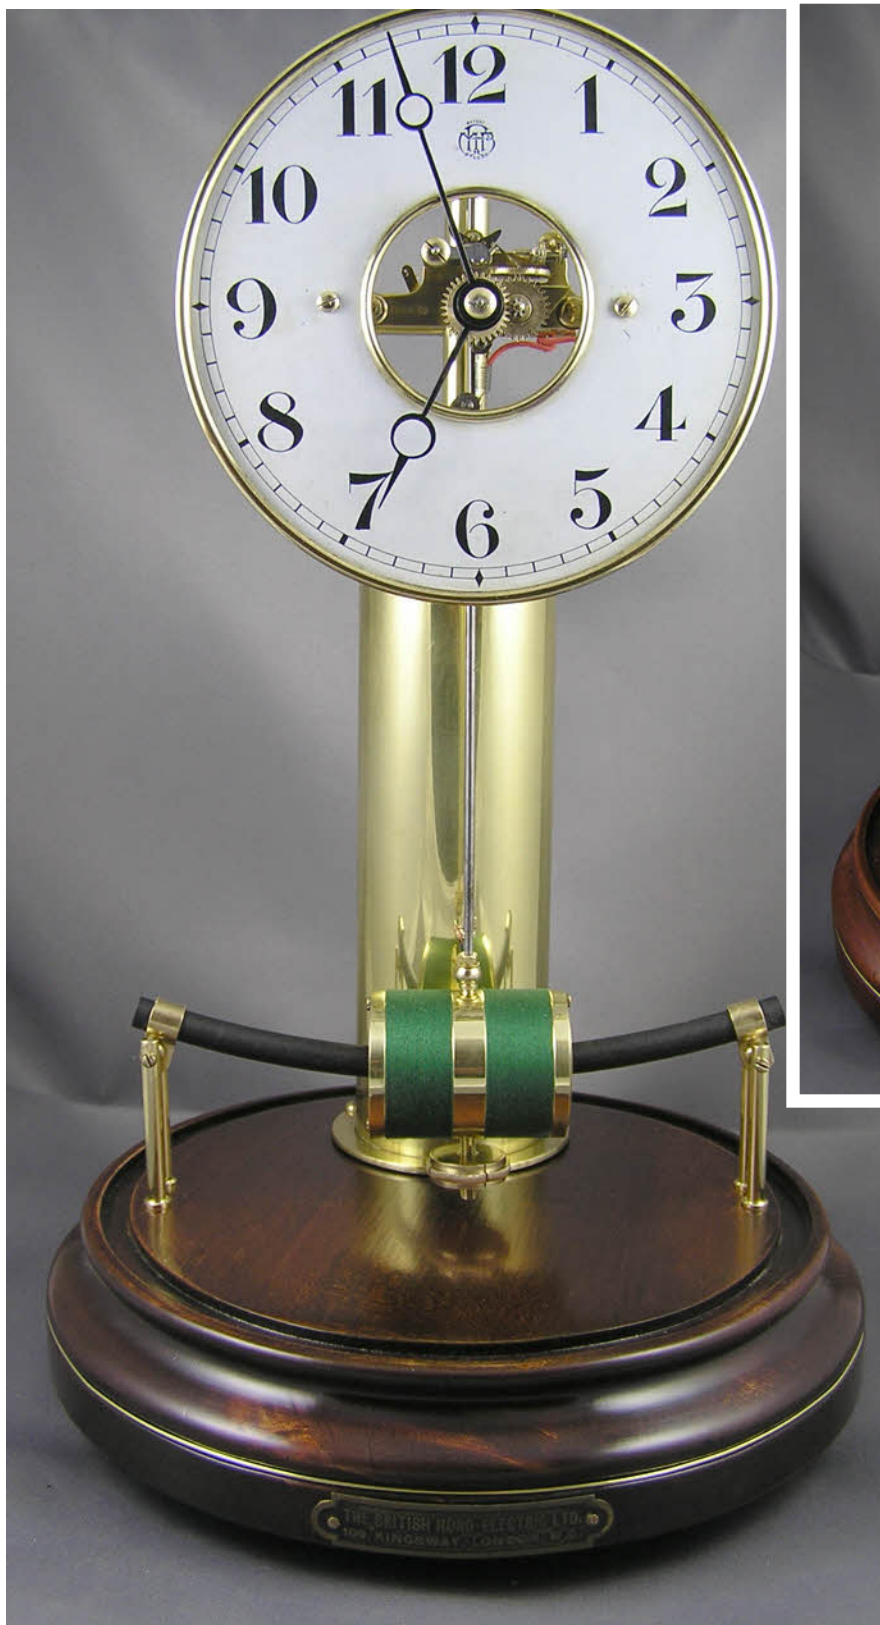
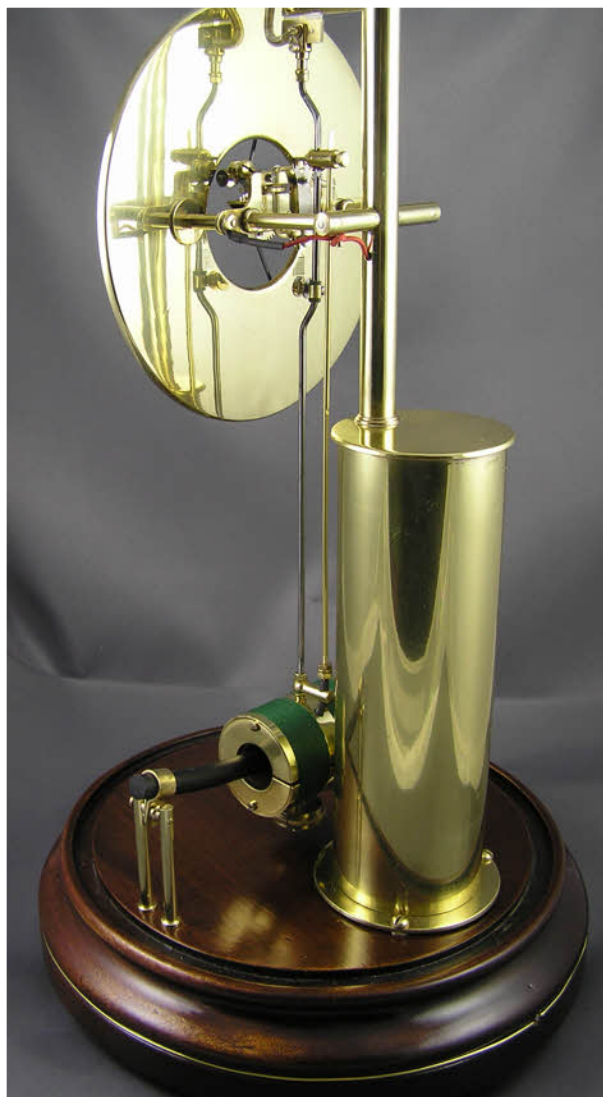
The finished clock.
