Bulle Clock Serial Number 51029

Restoration of Bulle Clock Serial Number 51029

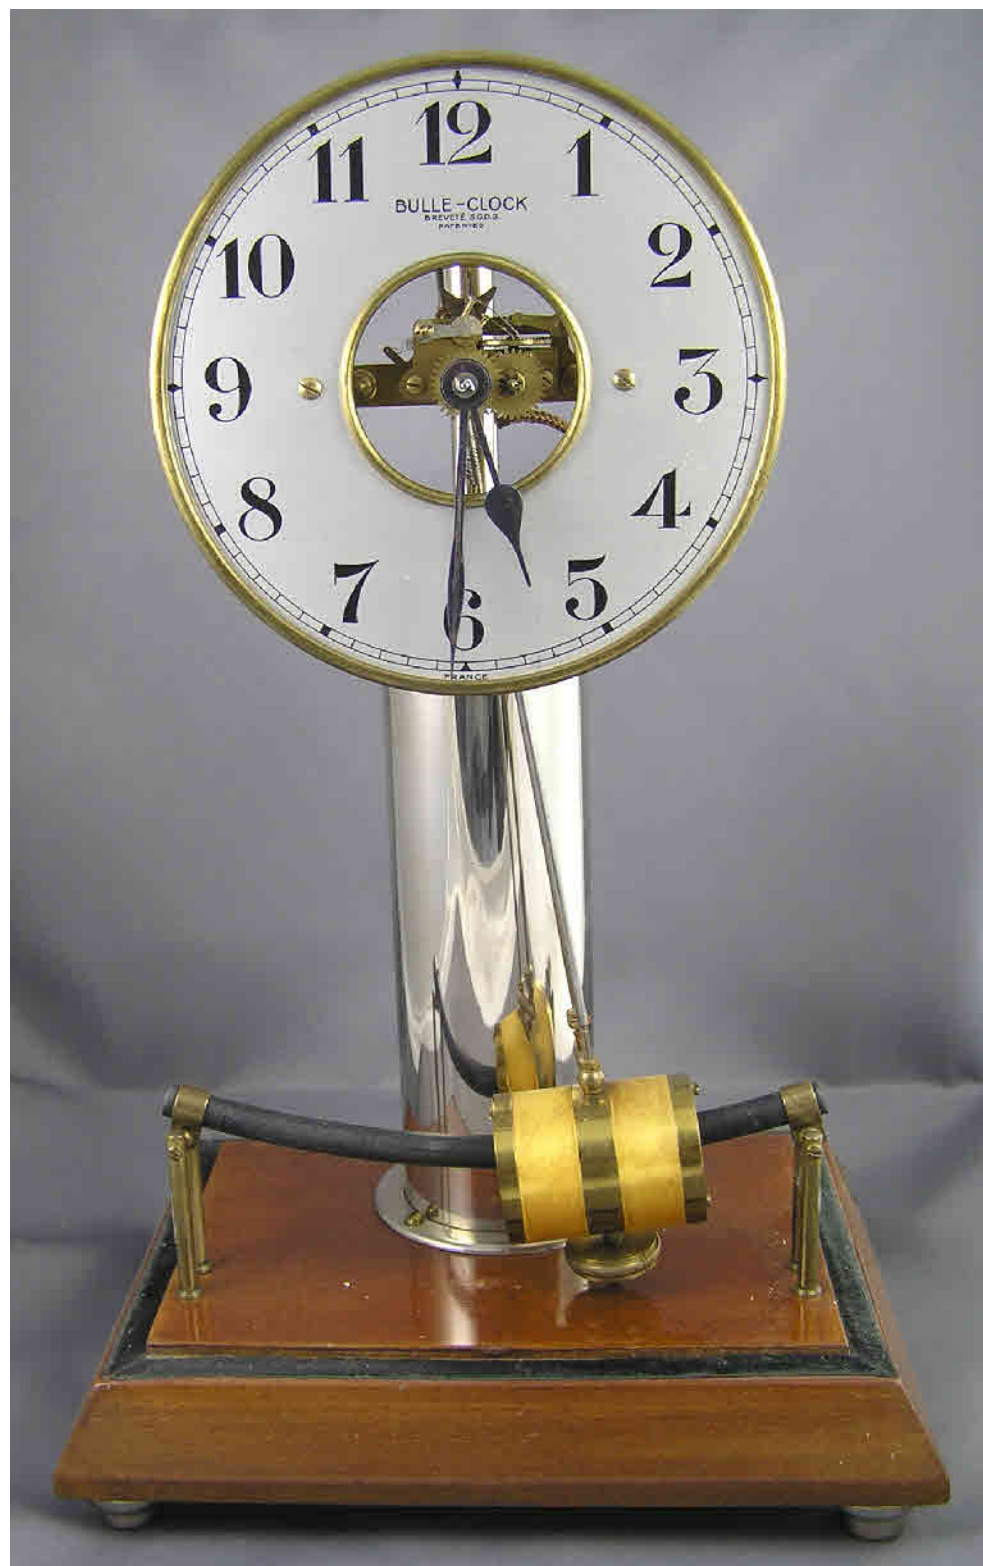
*This clock is a tall move-
ment in a four glass case ,
the top and bottom of which
are mahogany, while the
verticals are of brass. The
glass and verticals have
been retained by the owner.
The movement is a two plate
version dating from about
1925. The coil casing still
retains its original cord and
the owner has requested
that it be kept if at all possi-
ble. I will try and cover it
while I clean the casing. The
hands are of the fine spade
type on a dial of aluminium
alloy.*

*The one thing to note about
this clock is the column.
This looks to be plated in
some material like nickel. It
is very bright with no tar-
nish evident and no lacquer.*

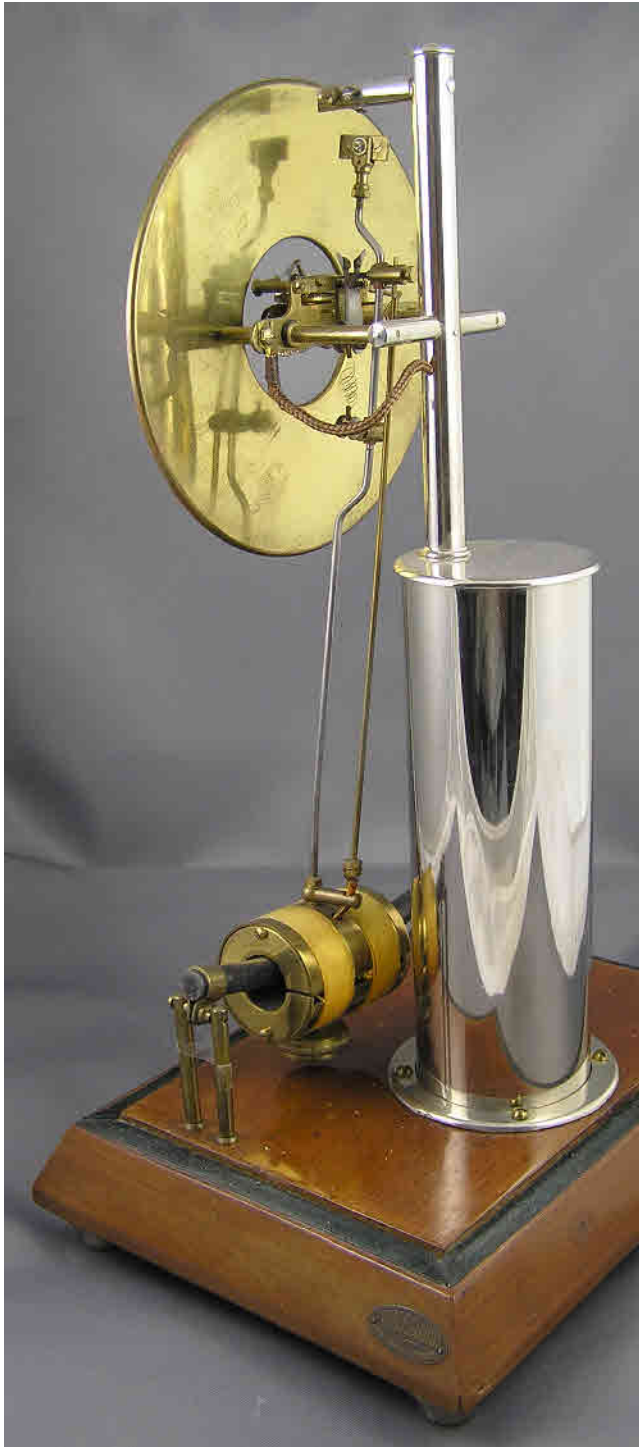
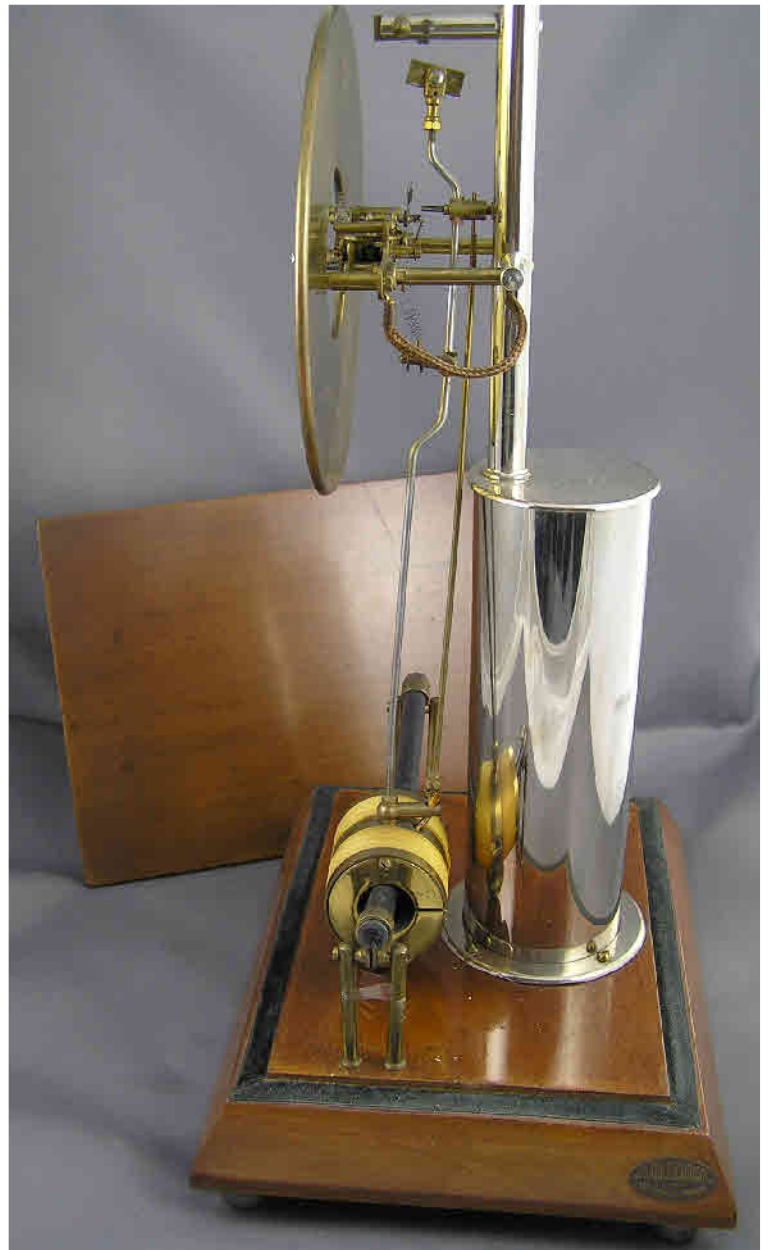
The clock from the rear. This photo highlights the difference in colour between the plated column and the rest of the clock. The second photo includes the mahogany top of the case. The wood will only be treated to a wax polish in line with the wishes of the owner.

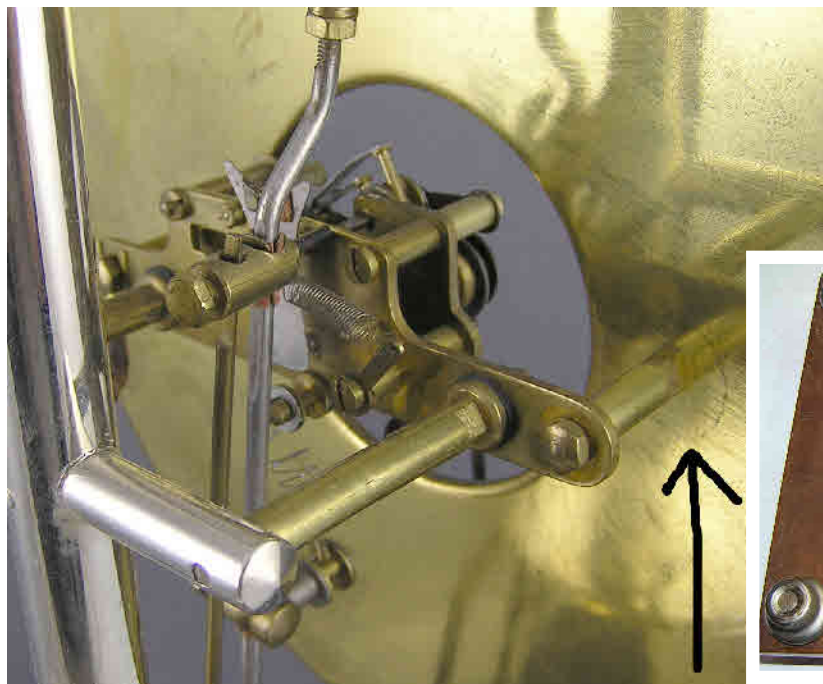
The rear of the dial showing the move-
ment and the marks left from the miss-
ing brass washers that support the back
of the dial where the dial screws pass
through (arrowed).

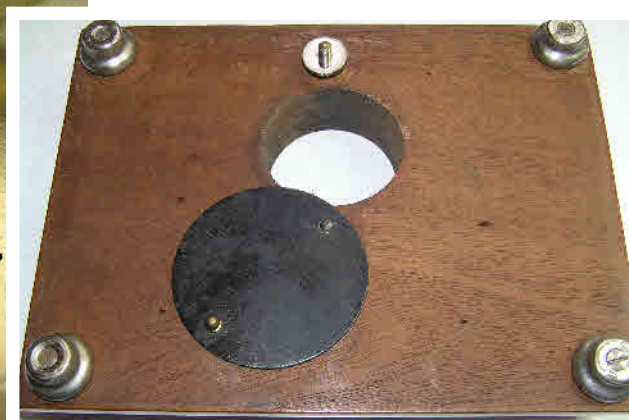
The bottom of the base which shows that
the bottom cover is in good condition
with no acid burns, so we will leave it as
is.

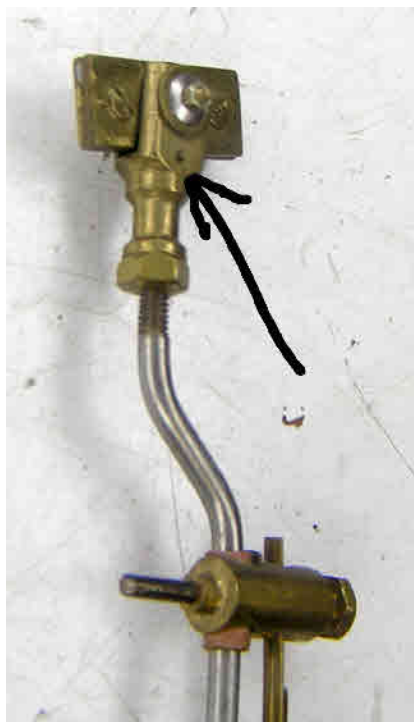
The photo at left shows the missing screw to secure the also missing contact wire that carries the power across the gap of the silk suspension unit. This will be replaced.

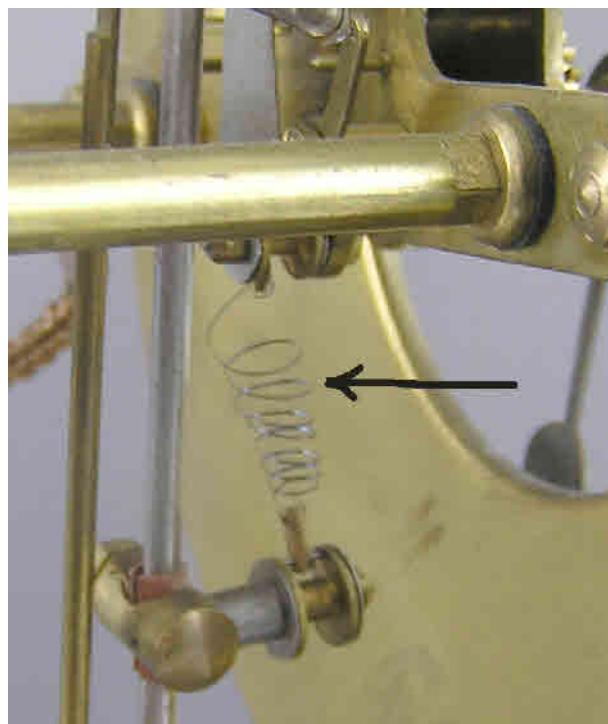
The photo at right shows the remains of the Isochron spring.. This will also be replaced with an original Horologix spring.

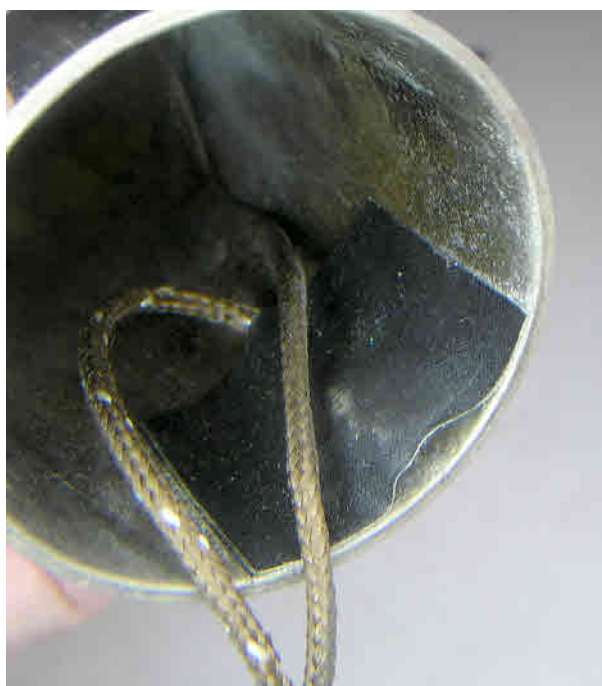
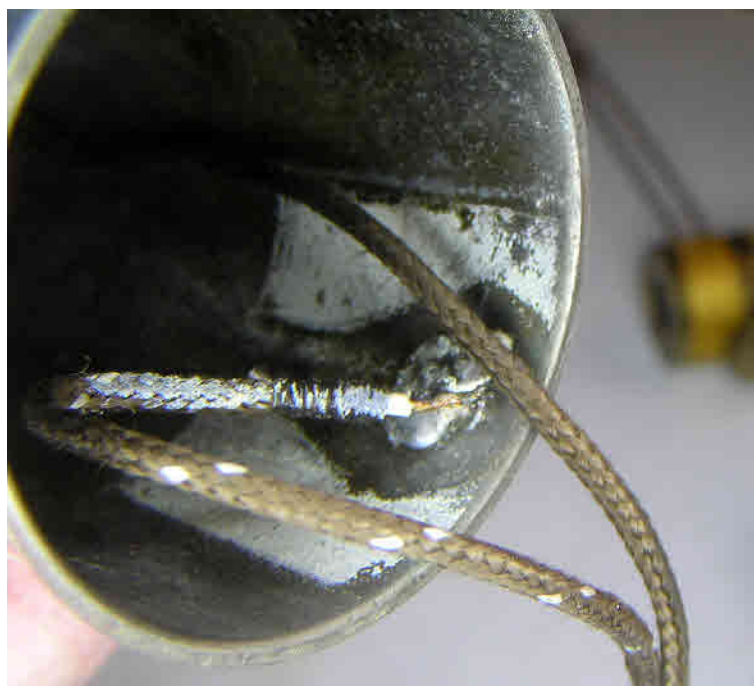
These two photos show what was found inside the column. The negative side of the battery was wired to the case by a large blob of solder. And then covered with tape. This will be removed and cleaned up. There is no need to use solder for this connection at all. The wire from the negative side of the battery will be captured under the column by one of the column screws.

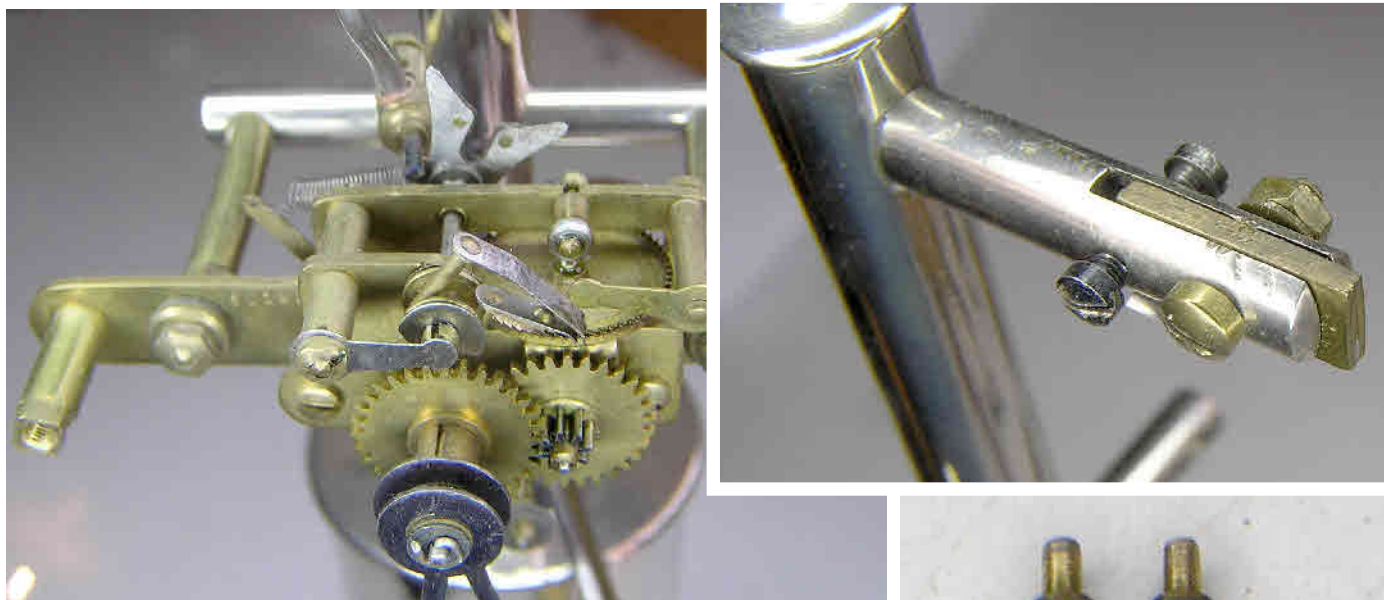
Above we see the movement in good condition and at right the broken suspension unit with the original blued positioning screws. These capture the top block of the suspension and keep it tightly in position. The two movement support pillars can be sigh at right with a slight bend in both to try and align with the holes in the movement.!! So why are the holes in the frame and those in the movement misaligned?

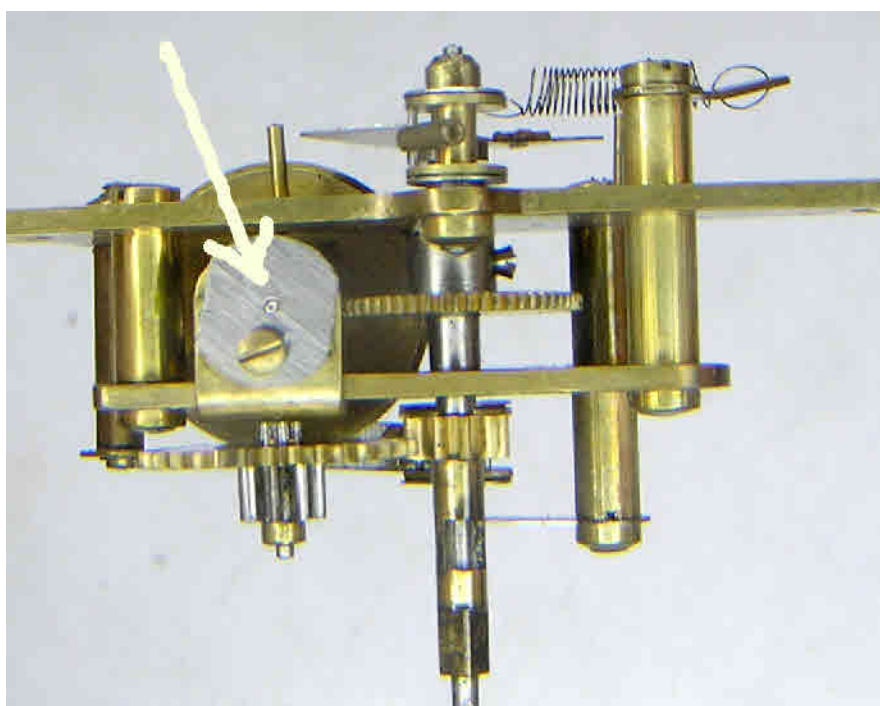
The final photo at left shows the underside of the movement and the count wheel stop plate. The small dimple seen in the photo is wear caused by the count wheel arbour. So this plate must have been turned up-side down to present a new bearing surface, at some time in the past.

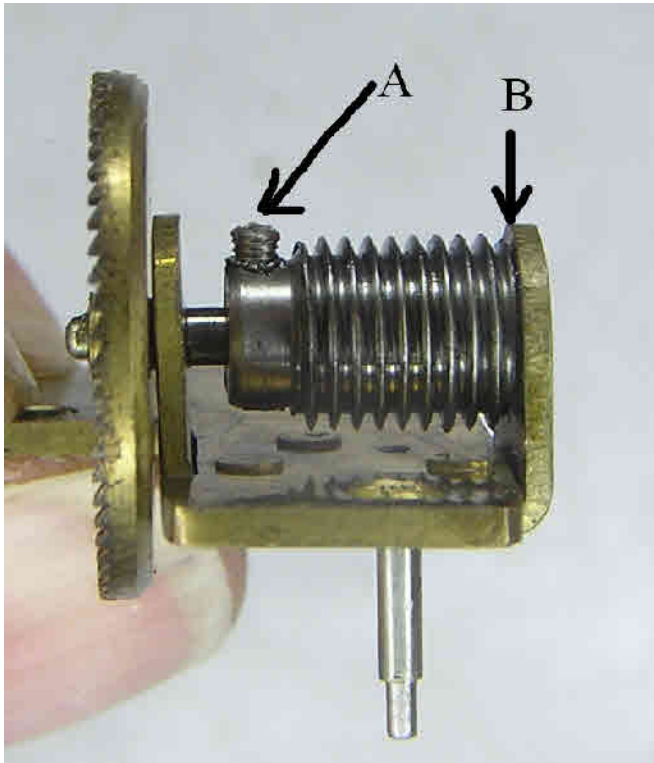
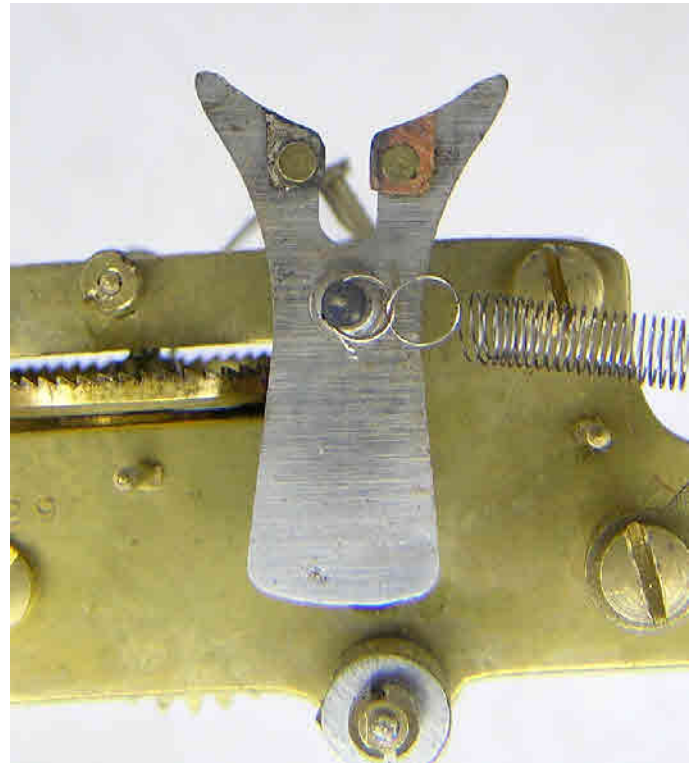
Above can be seen the count wheel and worm. At "A" can be seen the worm retaining screw which screws into a small dimple on the arbour. Why is it sitting so proud? On investigation it was found not to be engaged in the dimple at all. It was screwed down hard further down the arbour which meant the worm was sitting low and just rubbing the bottom plate as seen at "B". Also it scored the arbour which meant it was difficult to remove the worm. This was corrected. But it does mean that the movement has been taken apart and rebuilt at some time.

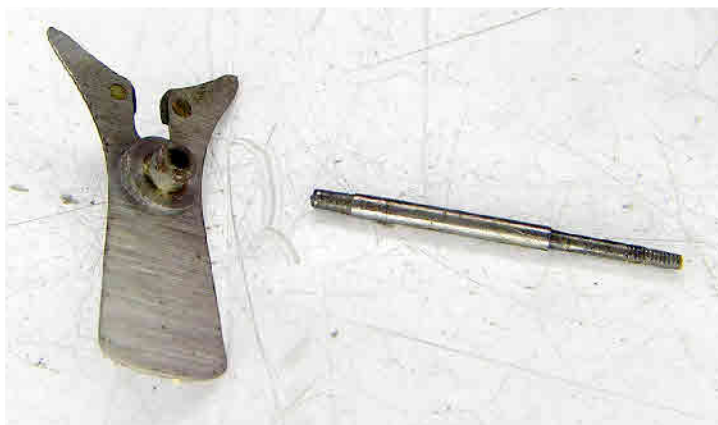
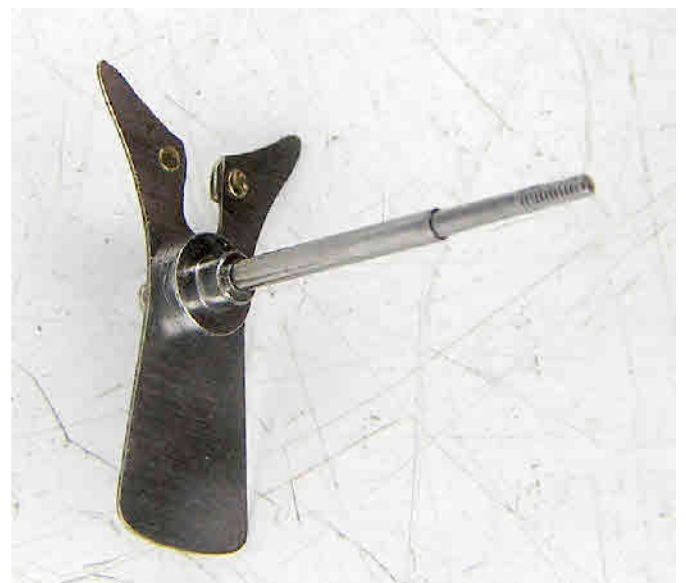
The fork and contacts look to be in good order bar the dirt. Below we see that the fork arbour was only very loosely riveted to the fork and has parted easily on handling. The two parts have been cleaned and riveted together forming a much more secure bond.

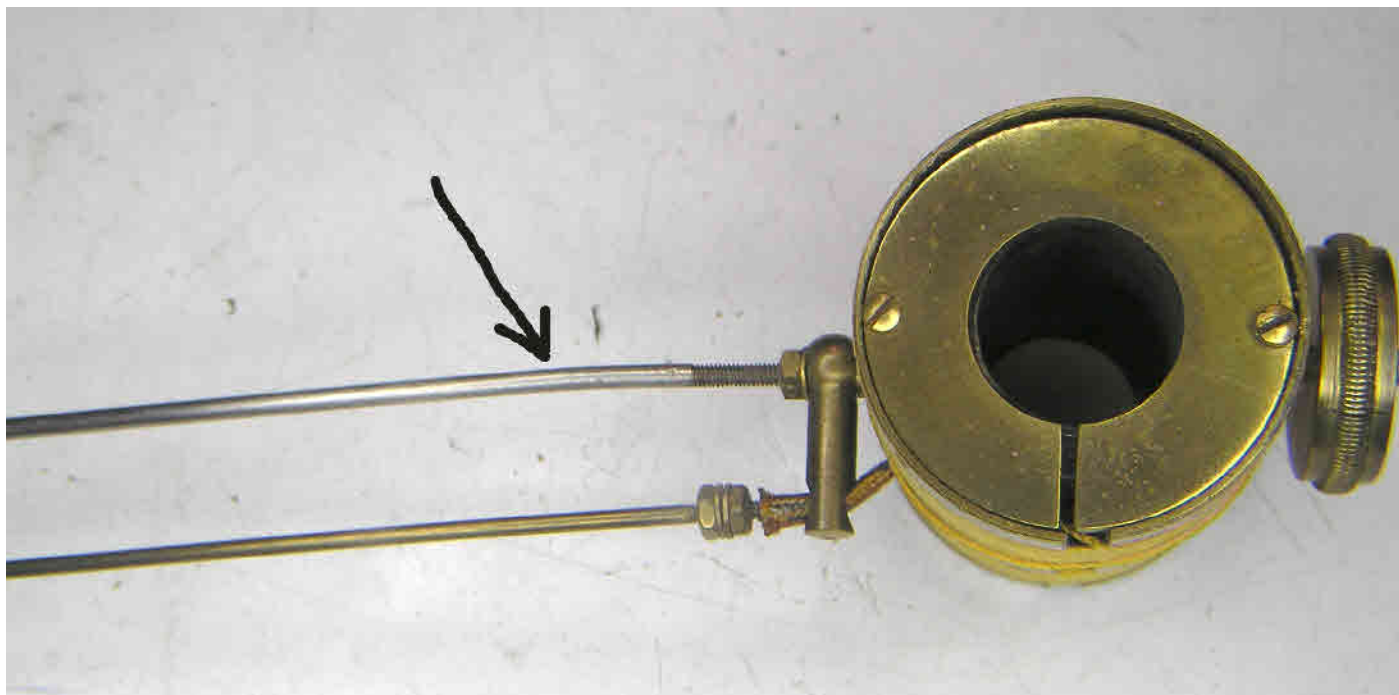
Above can be seen the pendulum bob and rod. The rod has a slight bend which will be easily removed.

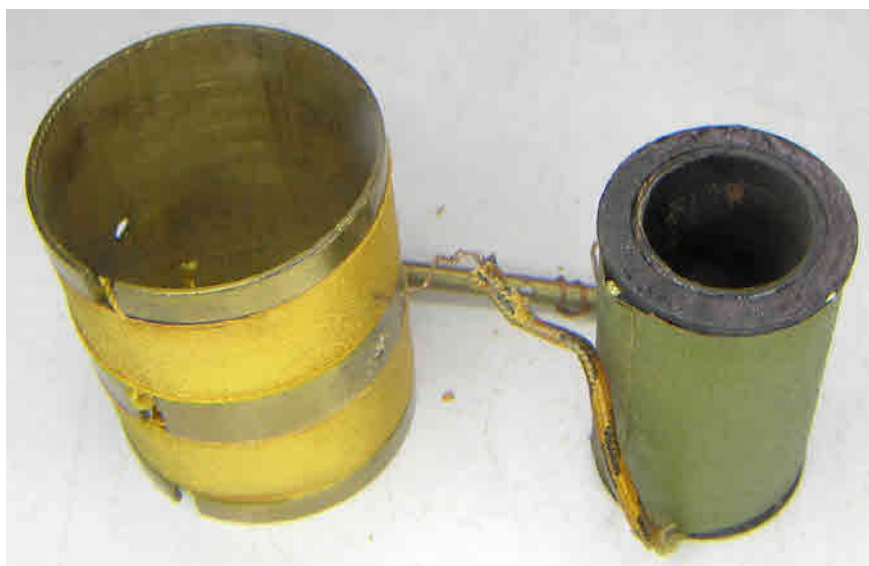
The photo at left shows the coil, casing and cord. The coil proved to be good showing approx 1100 Ohms resistance. The cord looks quite good and should survive being covered while the casing is cleaned and lacquered.

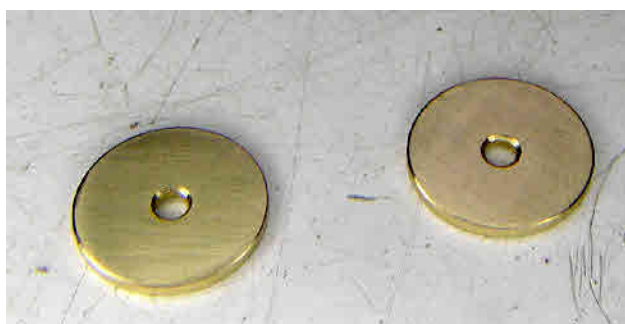
The last photo shows the replacement dial support washers that have been turned up on the lathe.

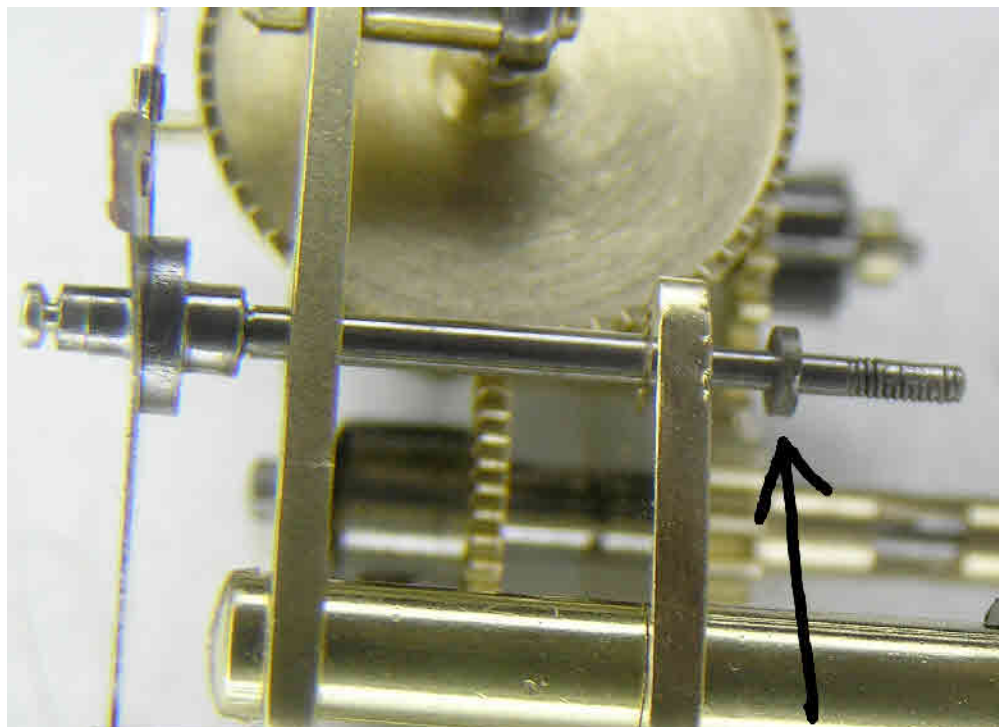
This photo show the movement being reassembled. I thought it interesting to show the small steel bearing washer situated between the pawl lantern assembly and the movement plate. The pawl arbour has a step at this point against which the washer is pushed by the pawl assembly and nut. This provides the arbour with a little end shake. This washer is sometimes difficult to remove and is often the reason for a snapped fork arbour.

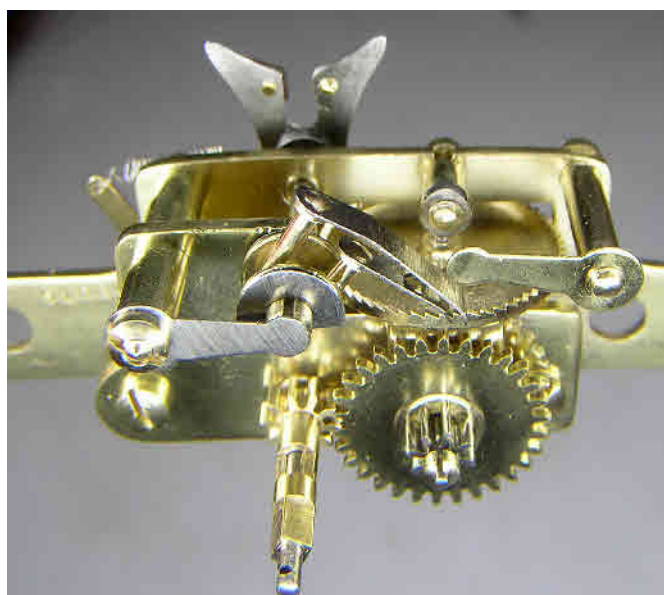
The completed movement.

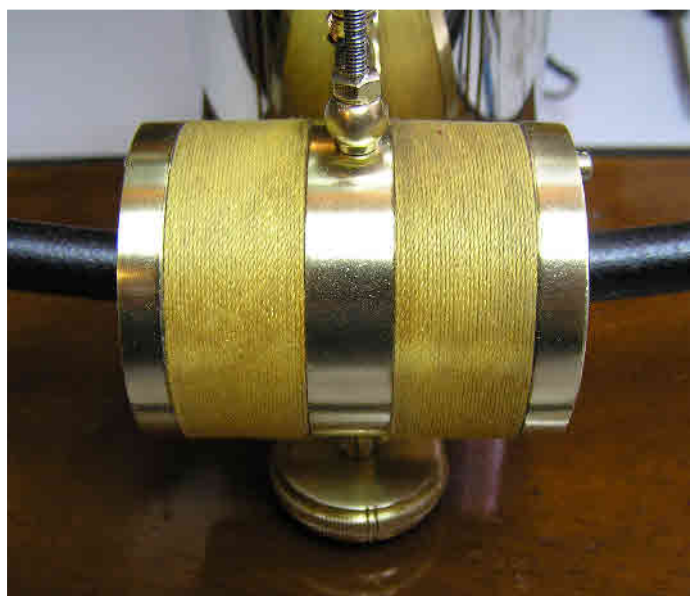
The completed pendulum bob back in place. The cord has survived the cleaning well.

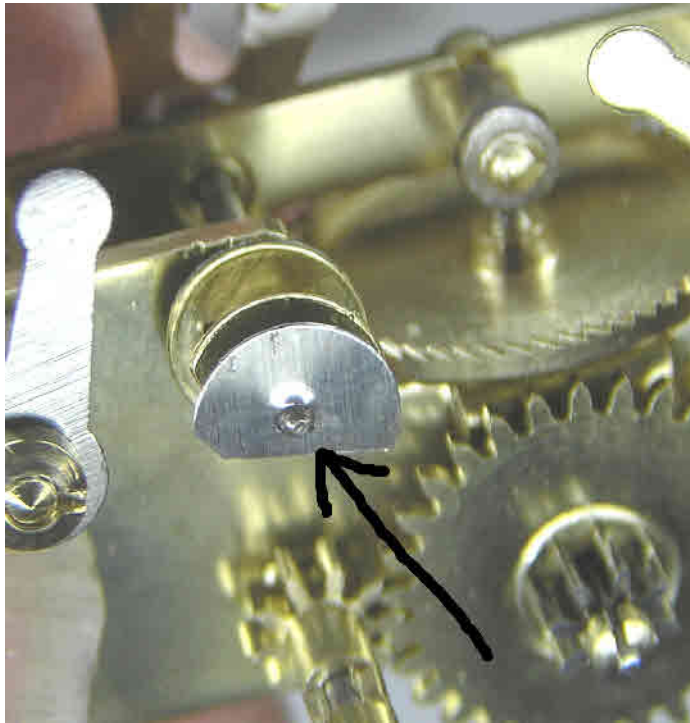
This photo above shows the fork arbour with the shaped washer in place as the last item to be fitted to the arbour before the retaining nut. The whole pawl lantern assembly is now secured against the bearing washer by the small retaining nut

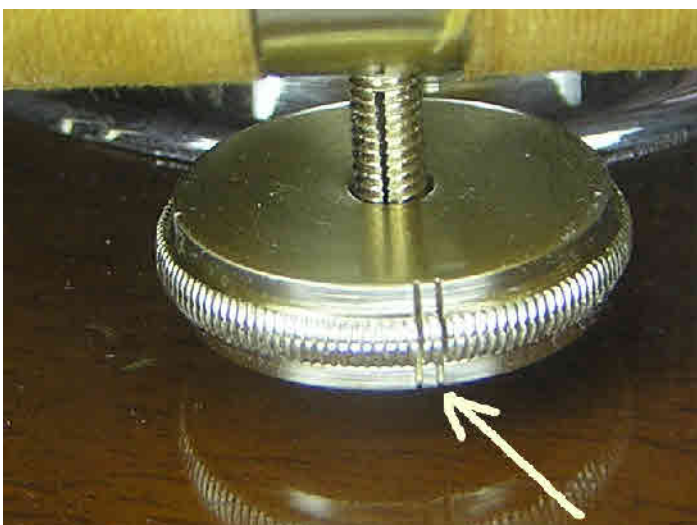
This photo is included to show the manufacturing fault that resulted in two sector cuts being placed next to one another on the pendulum rating nut.

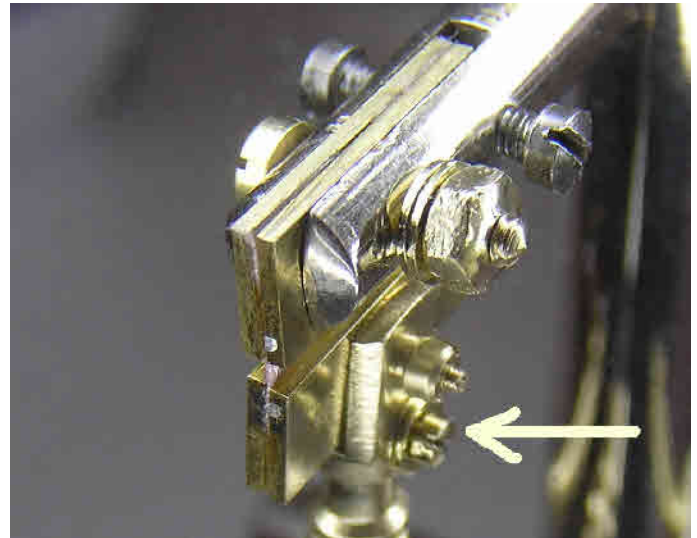
This photo shows the new suspension in place and the new contact wire capture screw.

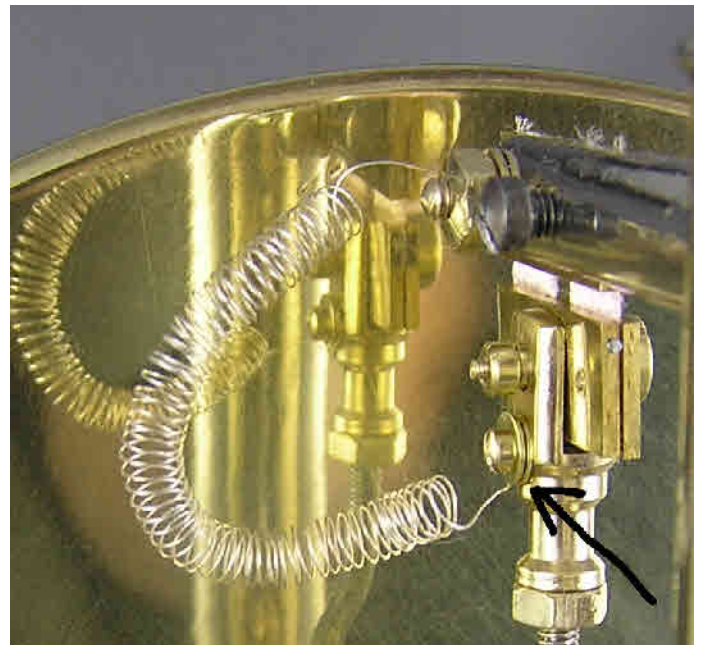
The contact wire in place across the gap caused by the silk suspension utilising the new capture screw. The other end of the contact wire is retained by the washers and nut of the top suspension block.

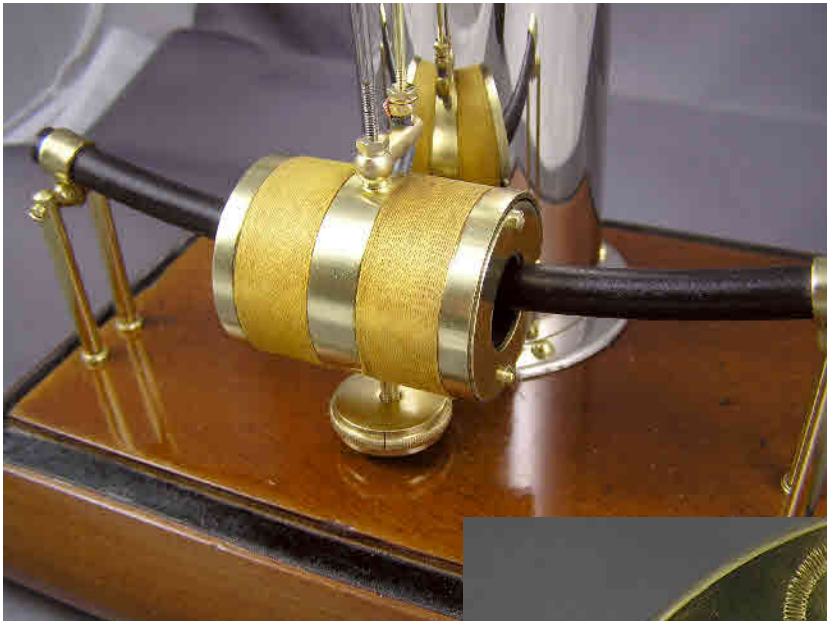
The Pendulum and base. The cord looks elegant against the waxed mahogany of the base.

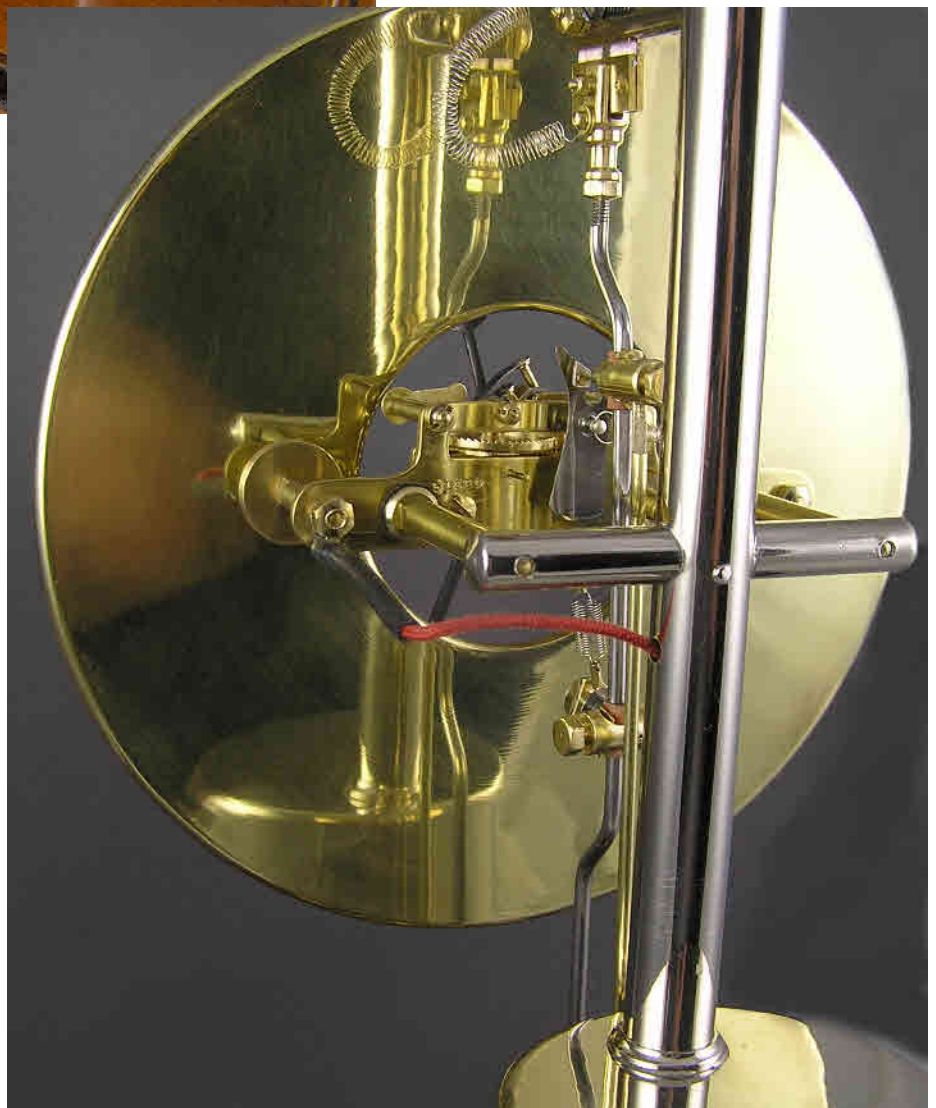
The rear of the cleaned dial and movement.

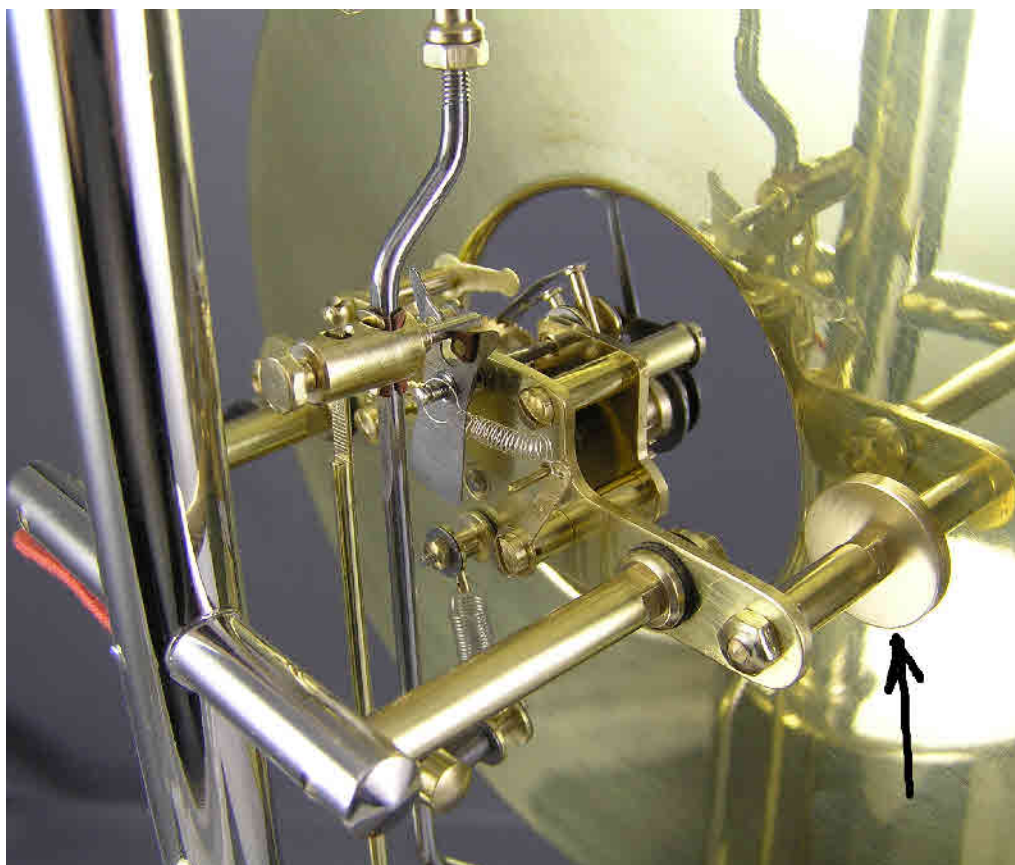
*The rear of the dial showing
the new dial washers in
place.*

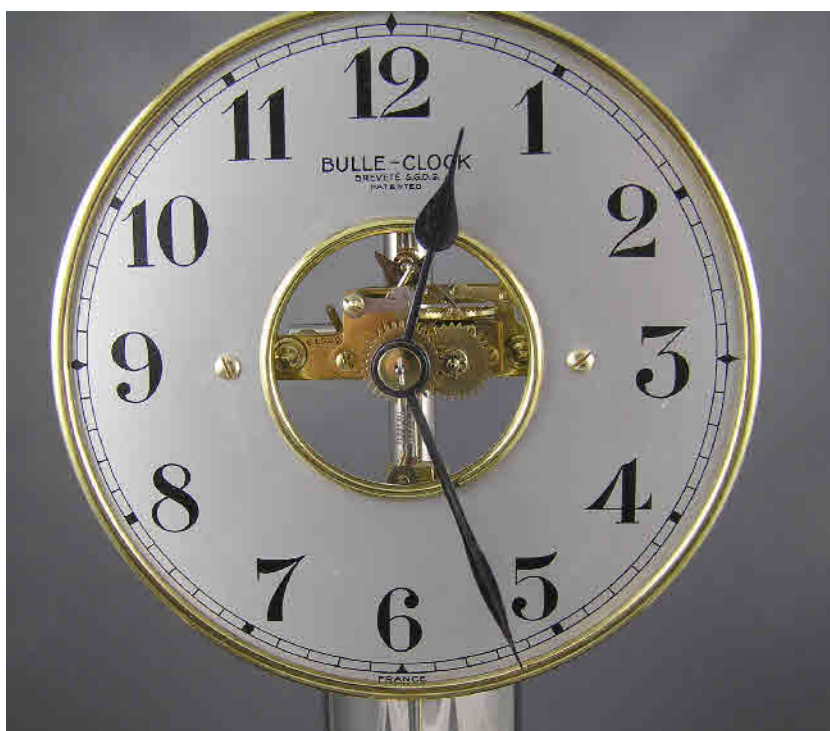
The cleaned dial and hands back in place.

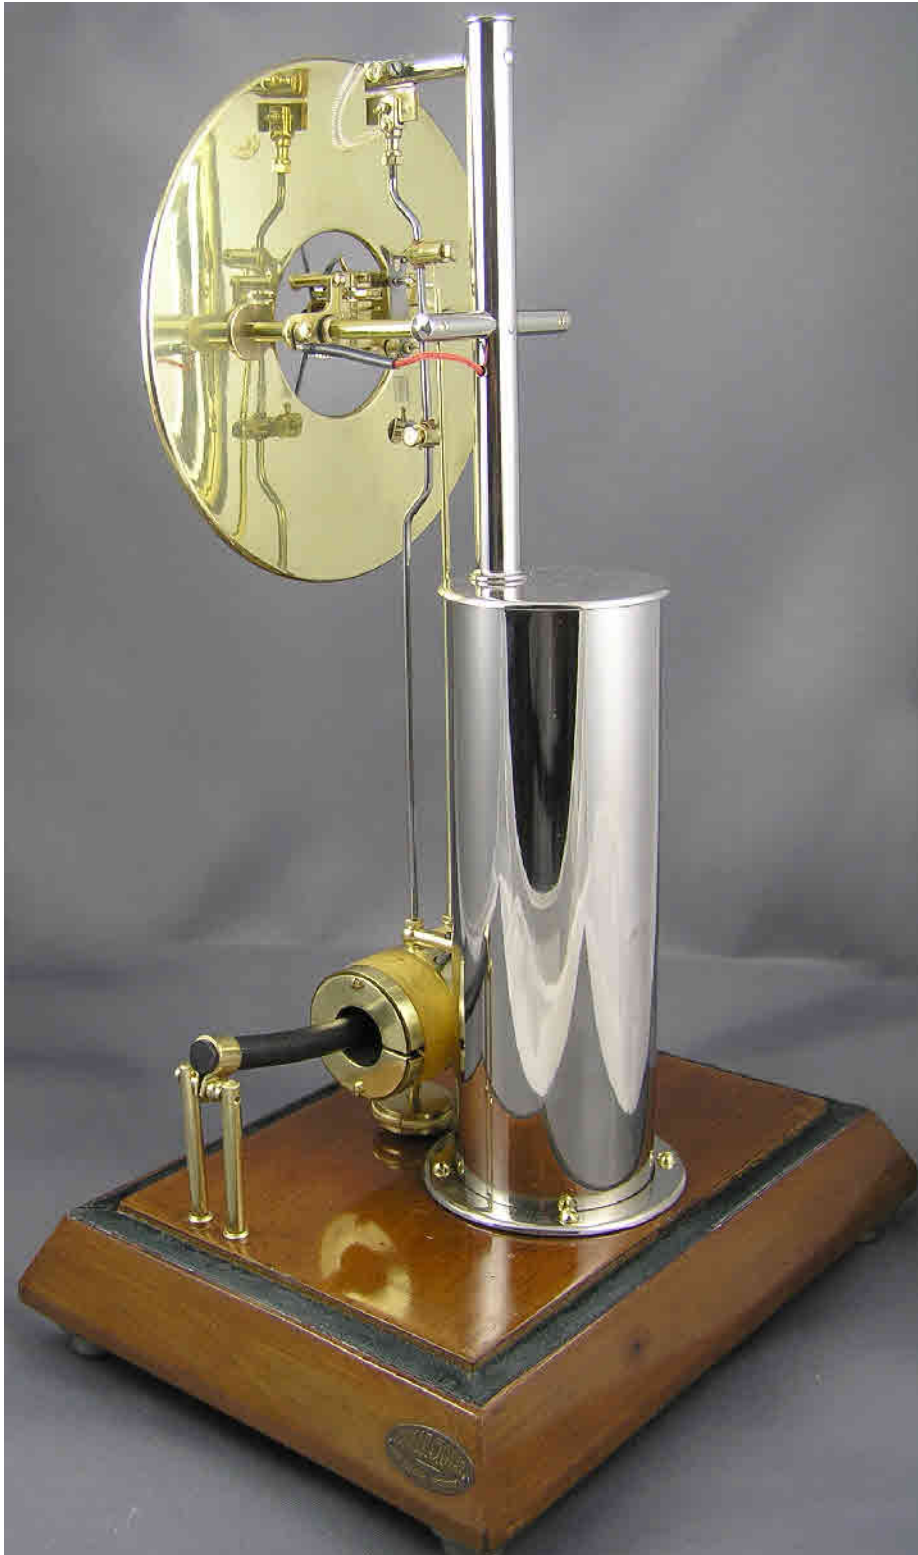
*The rear of the finished clock.
The contrast is quite evident be-
tween the plated column and the
rest of the movement.*

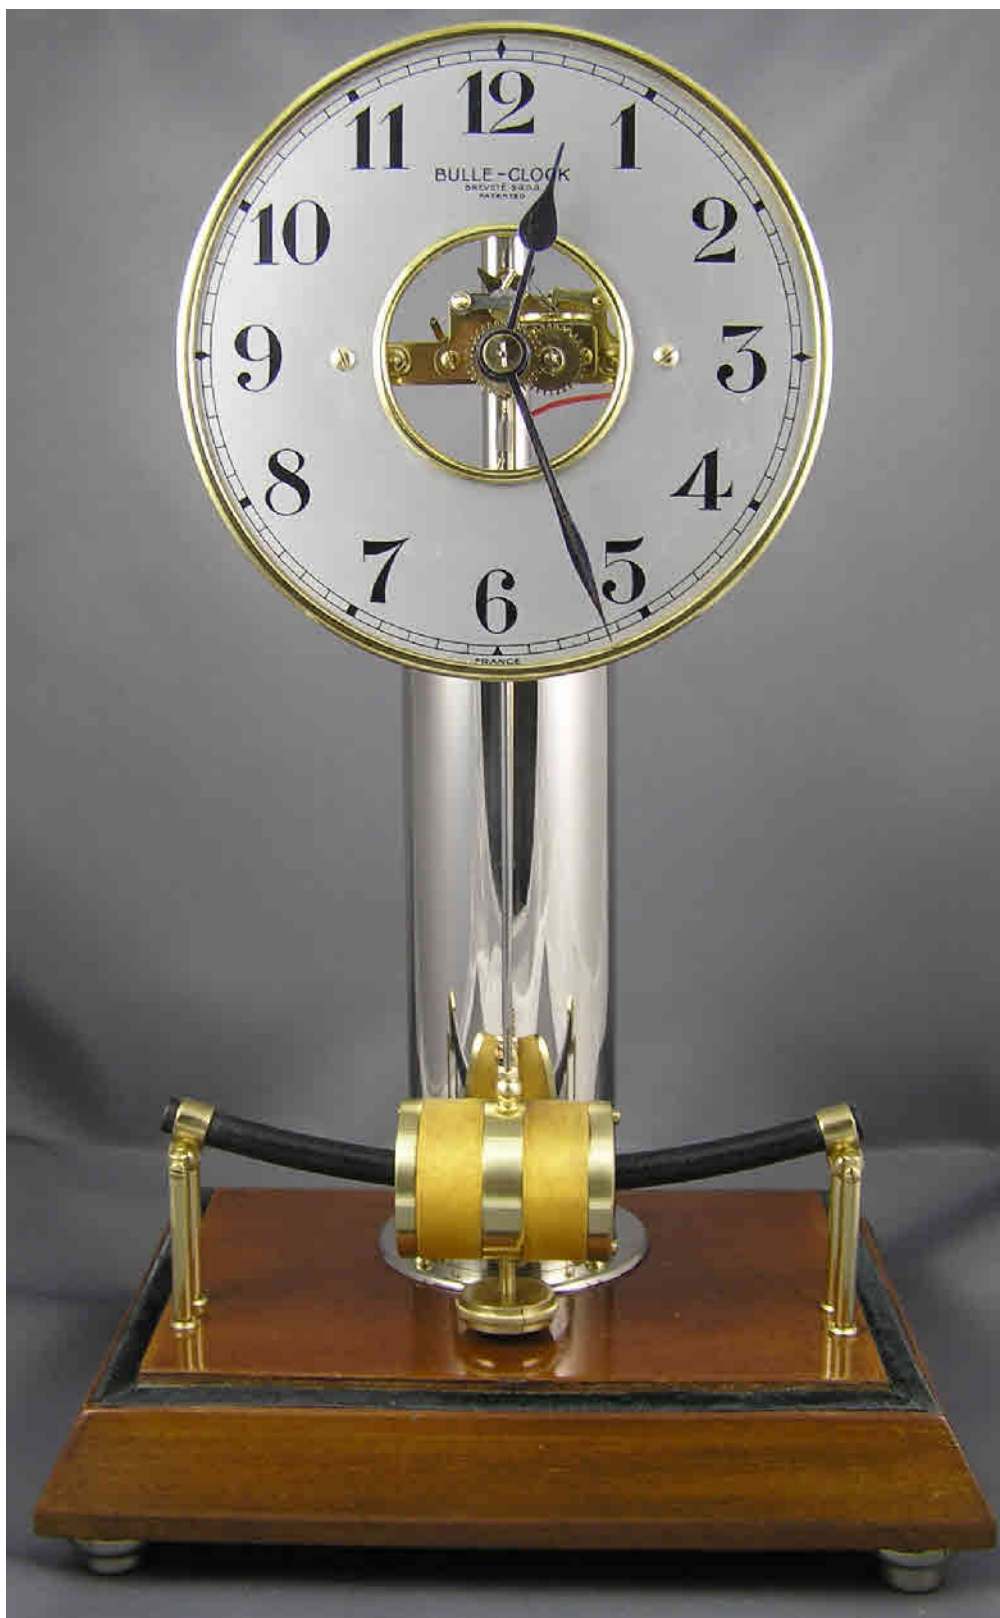
The finished clock.
